# **Experimental campaign on Reinforced Concrete buildings typical of the Groningen region**

**Cyclic testing of a full-scale two-storey Reinforced  
Concrete precast wall-slab-wall structure  
representative of the Groningen building stock  
(EUC-BUILD4).**

**Eucentre**

Date June 2017

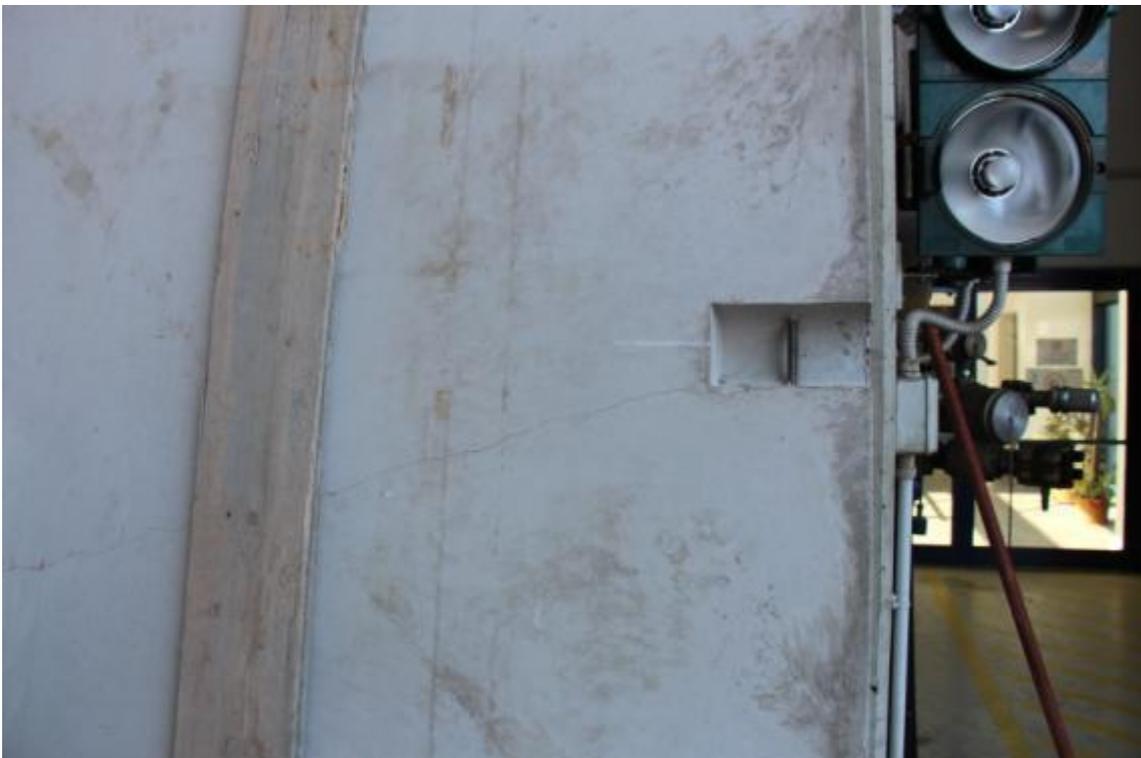
**Figure 21. Detail of pre-cracked stability wall – crack running through the entire wall width and depth.**

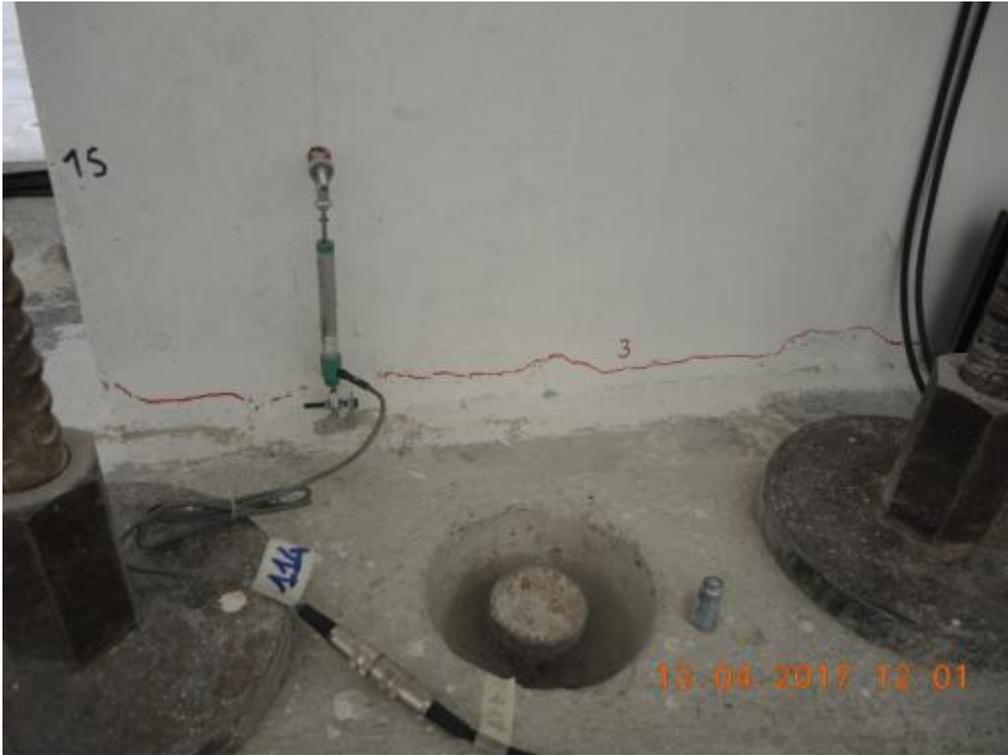
Figure 171. Crack pattern at the base of the first-floor stability wall – Edge of the wall.

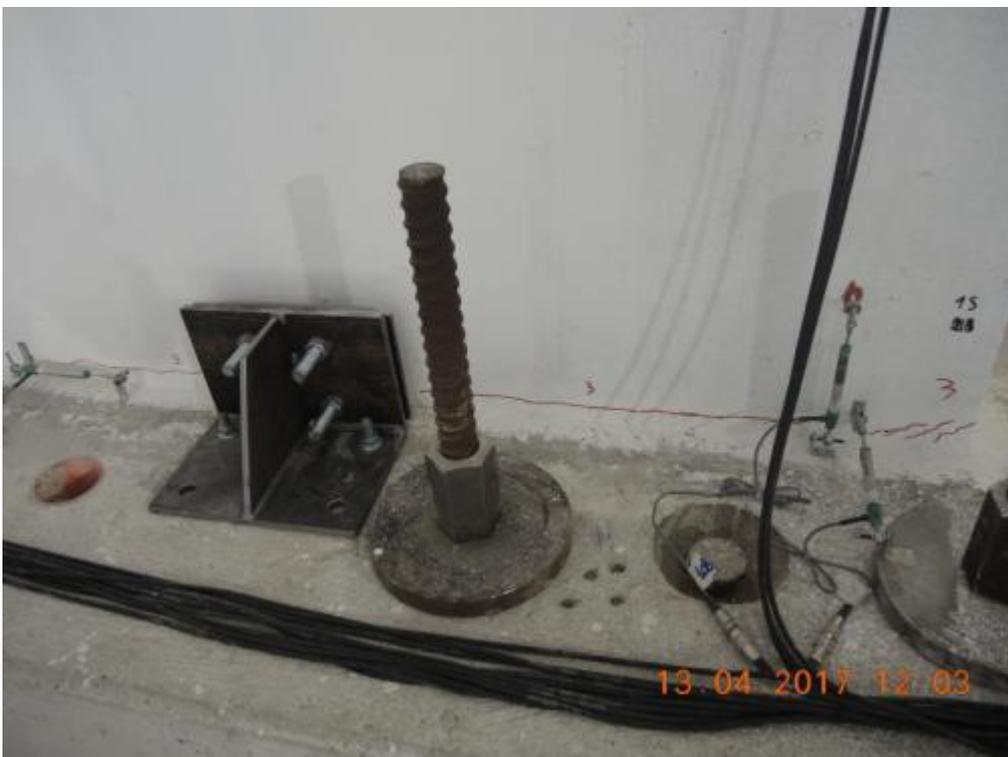
Figure 172. Crack pattern at the base of the first-floor stability wall – Opposite side.

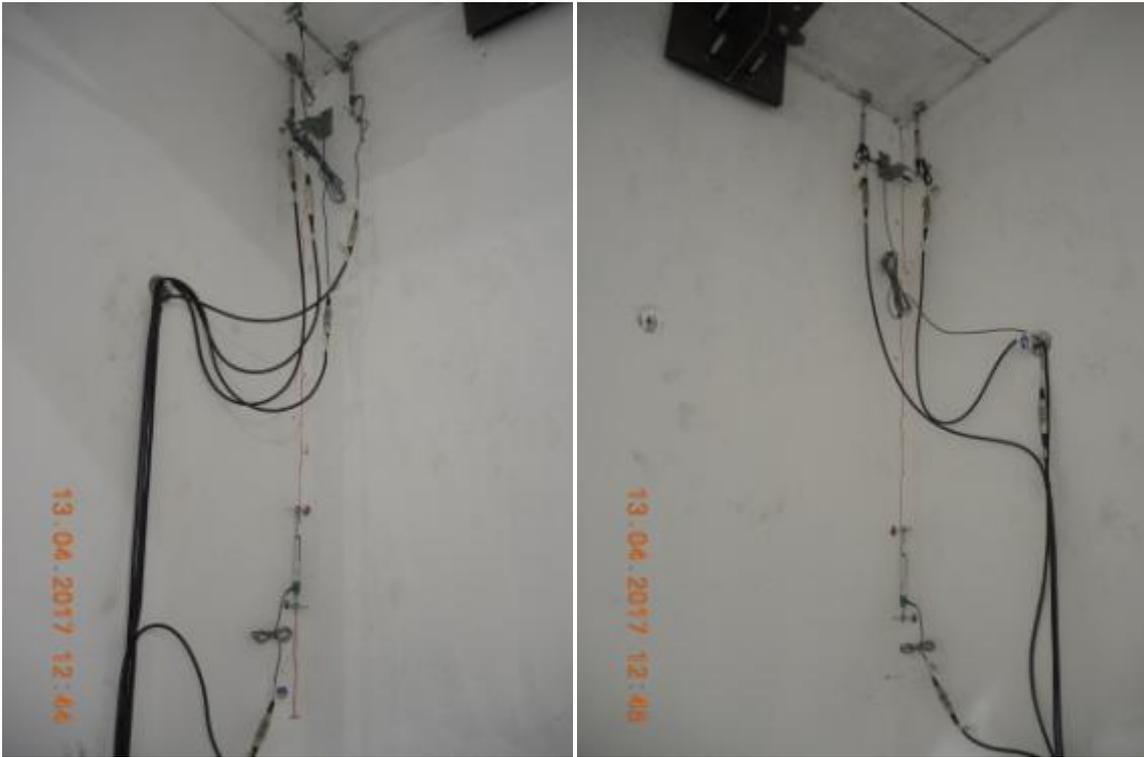
Figure 178. Development of vertical crack in the three-way panel connection (stability-to-lateral walls).

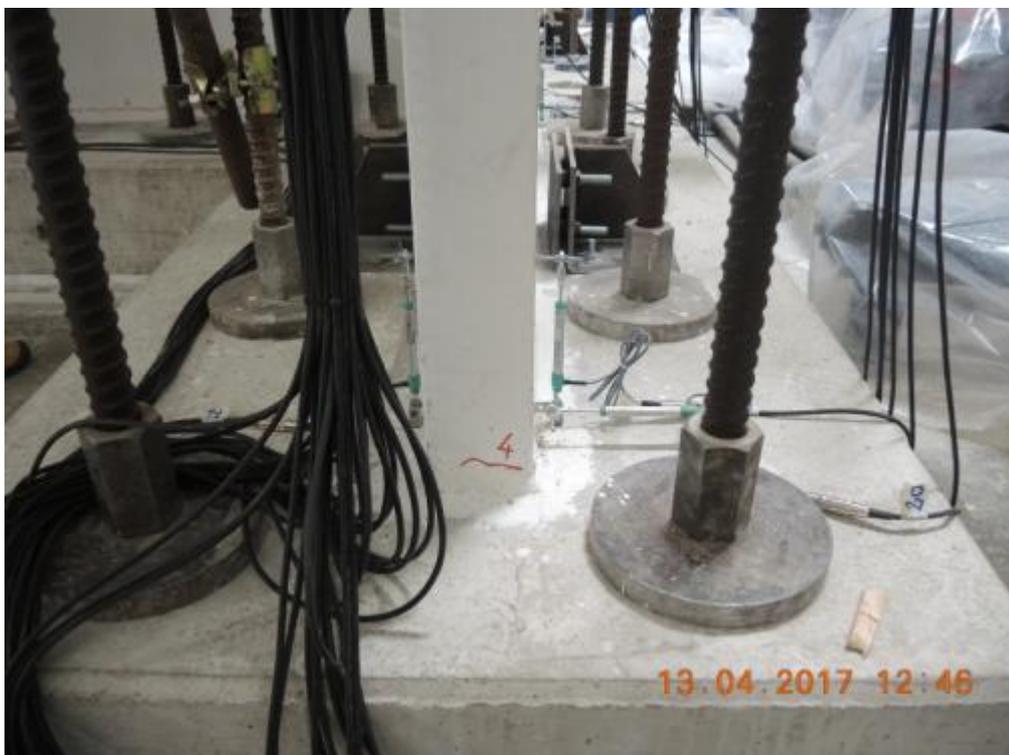
Figure 179. Formation of a new crack at the base of transversal walls – South side of the specimen.

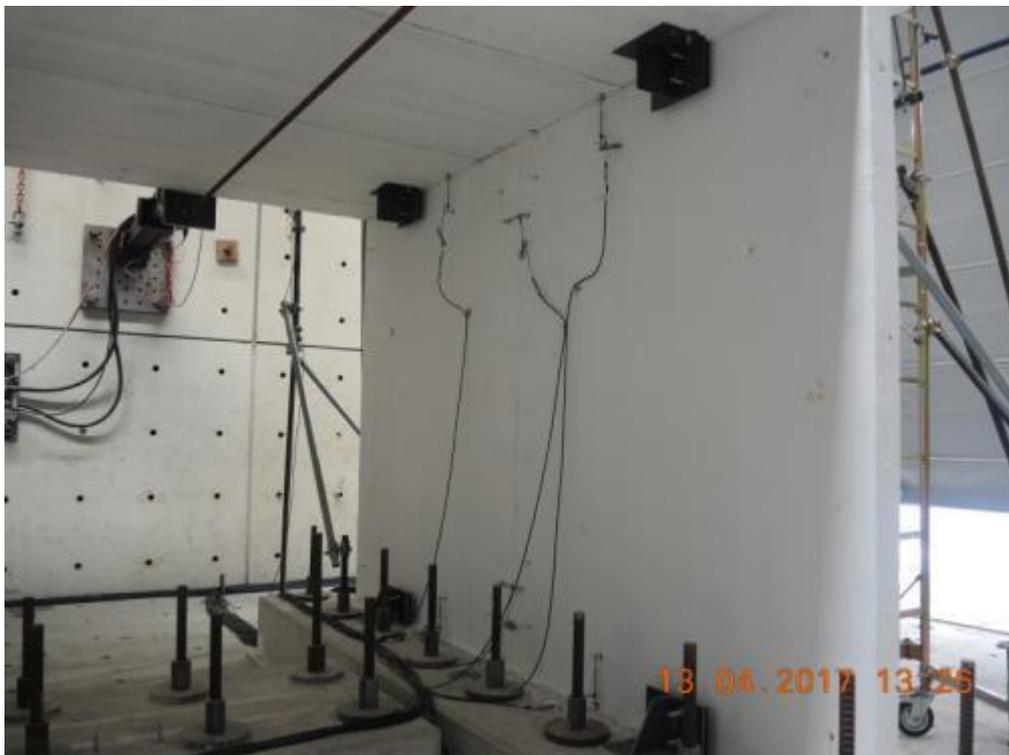
As depicted in Figure 180 to Figure 182, first signs of new damage were found in the North ground-floor transversal walls of EUC-BUILD4 specimen. Indeed, a new crack formed in correspondence to the two-way panel-to-panel connection and propagated along the height of these walls (see Figure 180). In addition to that, some other cracks developed at the wall base, as pointed out in Figure 181 and in Figure 182, which present the South and East faces of the first-storey transversal wall, respectively. Once again, the width of these cracks was relatively moderate; noteworthy is that they did not form on both the two sides of the wall, which means that North and West faces of these wall panels remained intact. Finally, it can be noticed that cracks developed along the wall height in the joints of the two adjacent lateral walls simply because they are disconnected with each other, niches/joints apart. As presented in Figure 184, a similar occurrence was observed in the South lateral walls.

**Figure 180. Development of a new crack along the two-way connection between lateral walls – North side.**

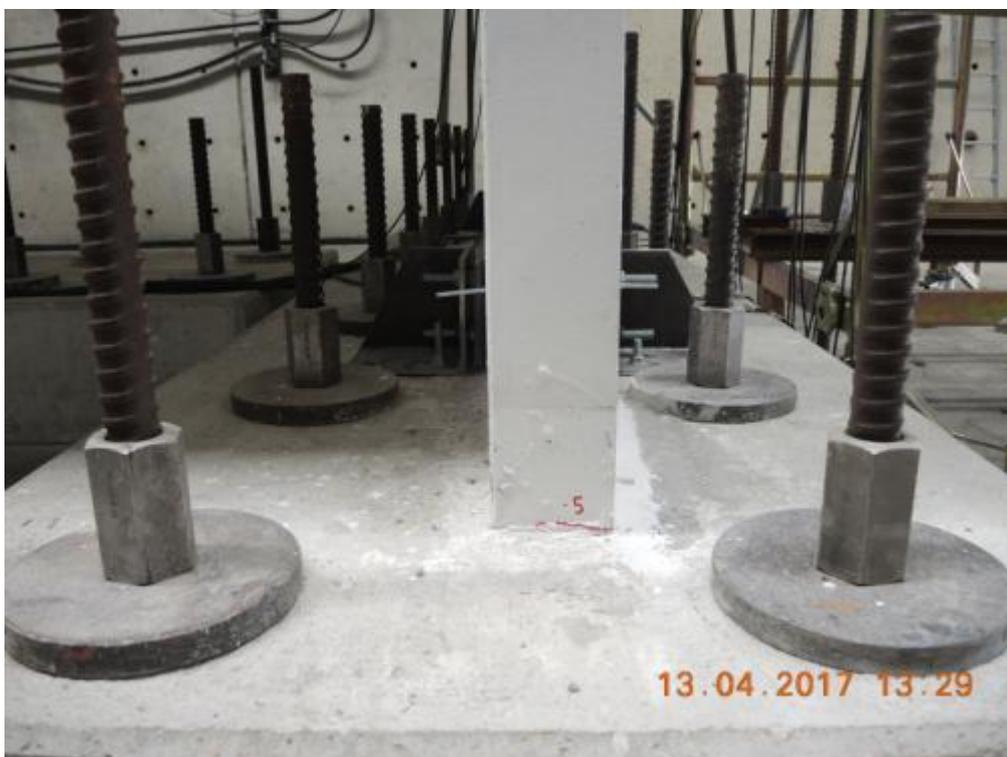
Figure 182. Crack pattern at the base of lateral wall W1L3 – North side, external edge.

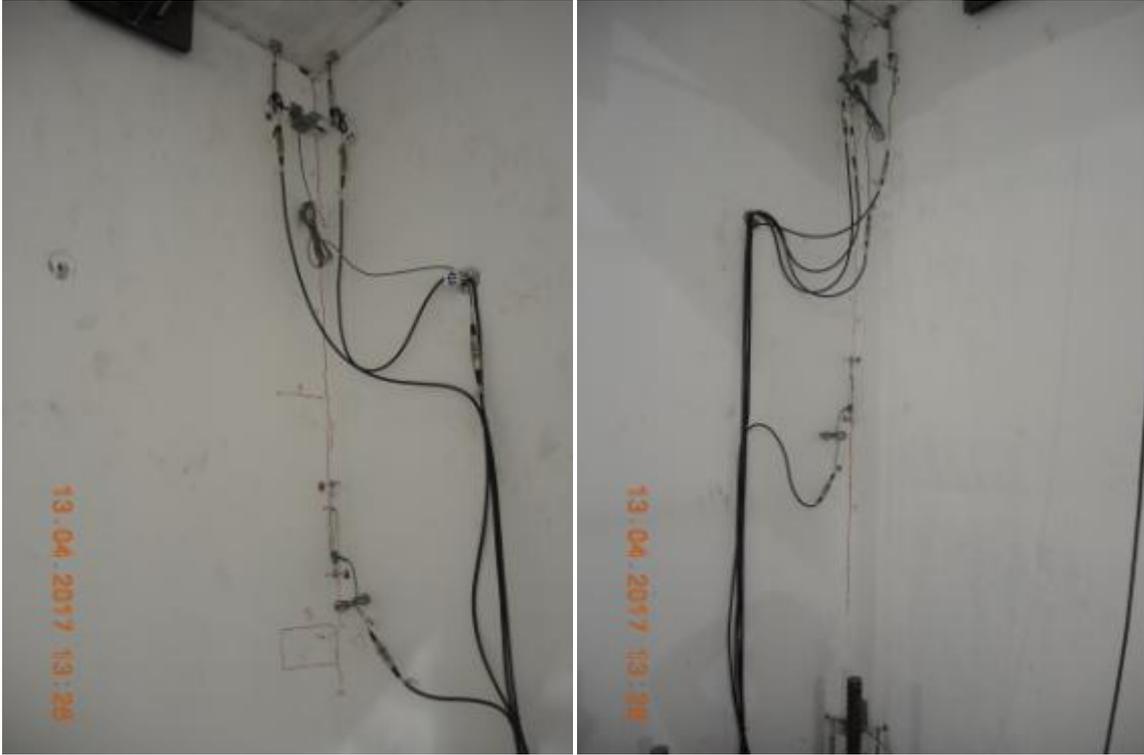
**Figure 183. Three-way connection: propagation of crack pattern in the niches and along the wall height.**

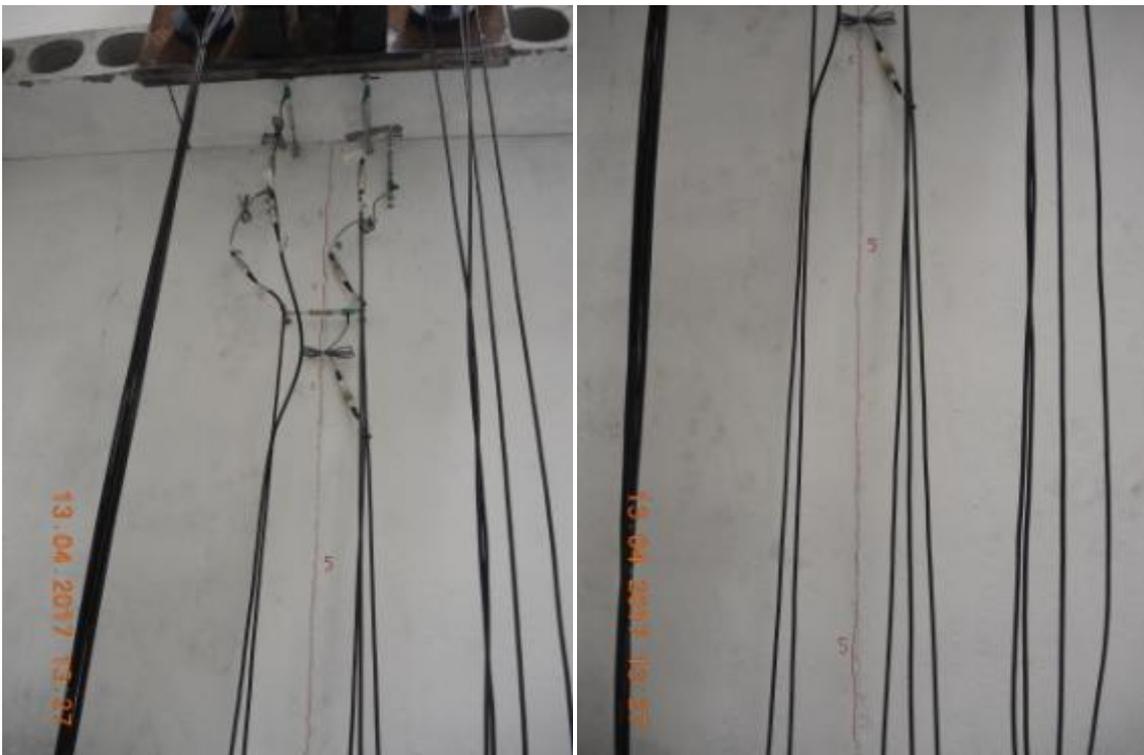
**Figure 184. Three-way connection: development of a new crack at the two adjacent lateral walls.**

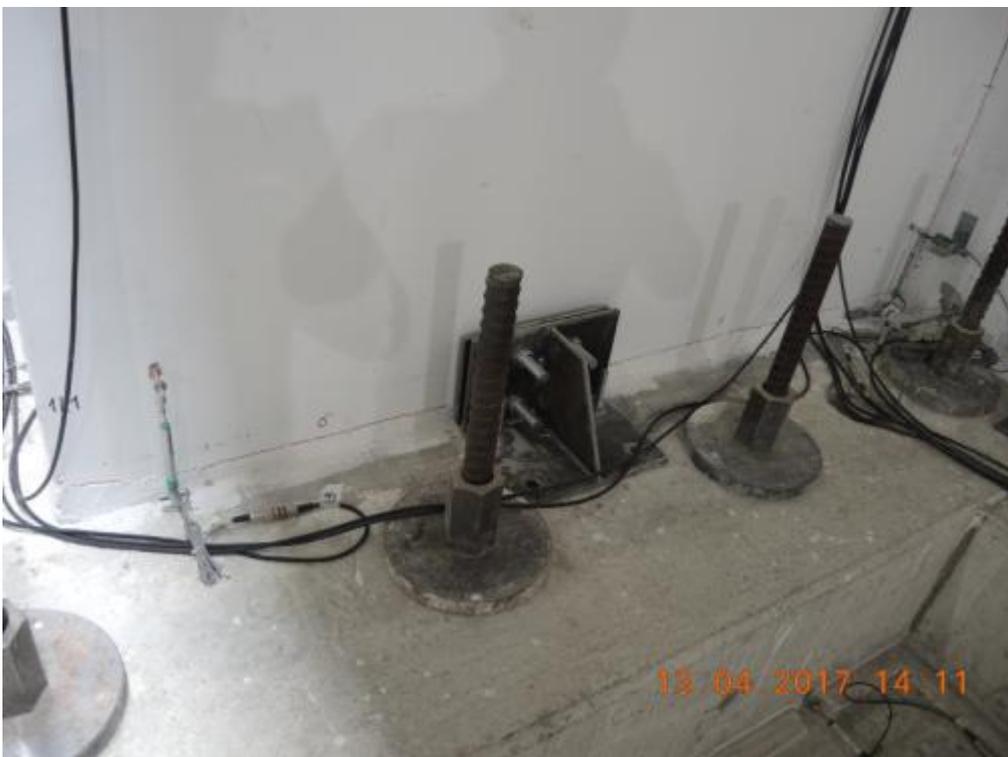
**Figure 187. Crack pattern at the base of lateral wall W1L1 – South side, internal edge.**

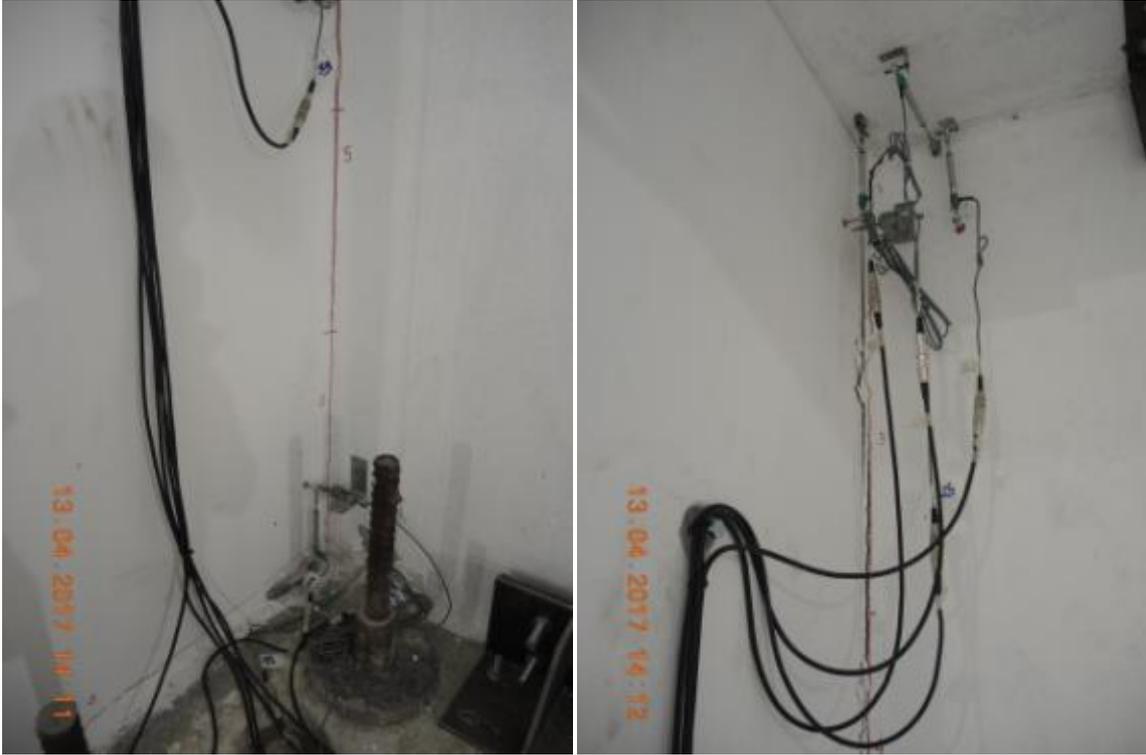
**Figure 188. Three-way connection: propagation of vertical crack along the entire height of the stability wall.**

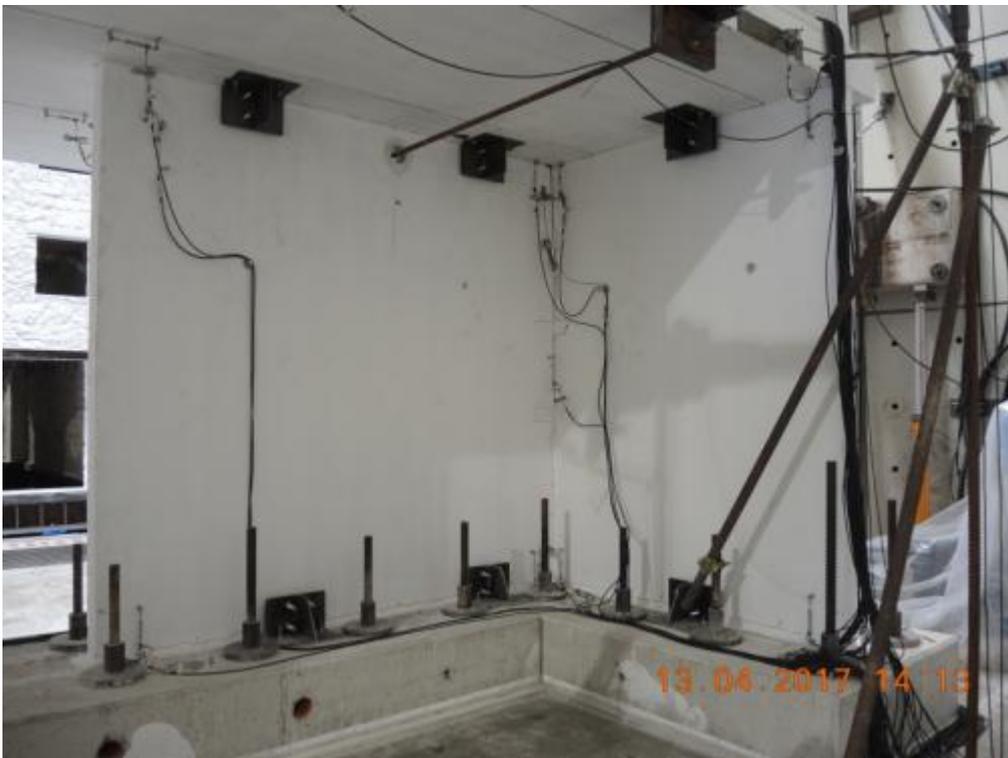
**Figure 189. Three-way connection: propagation of crack along the entire wall height – Opposite side.**

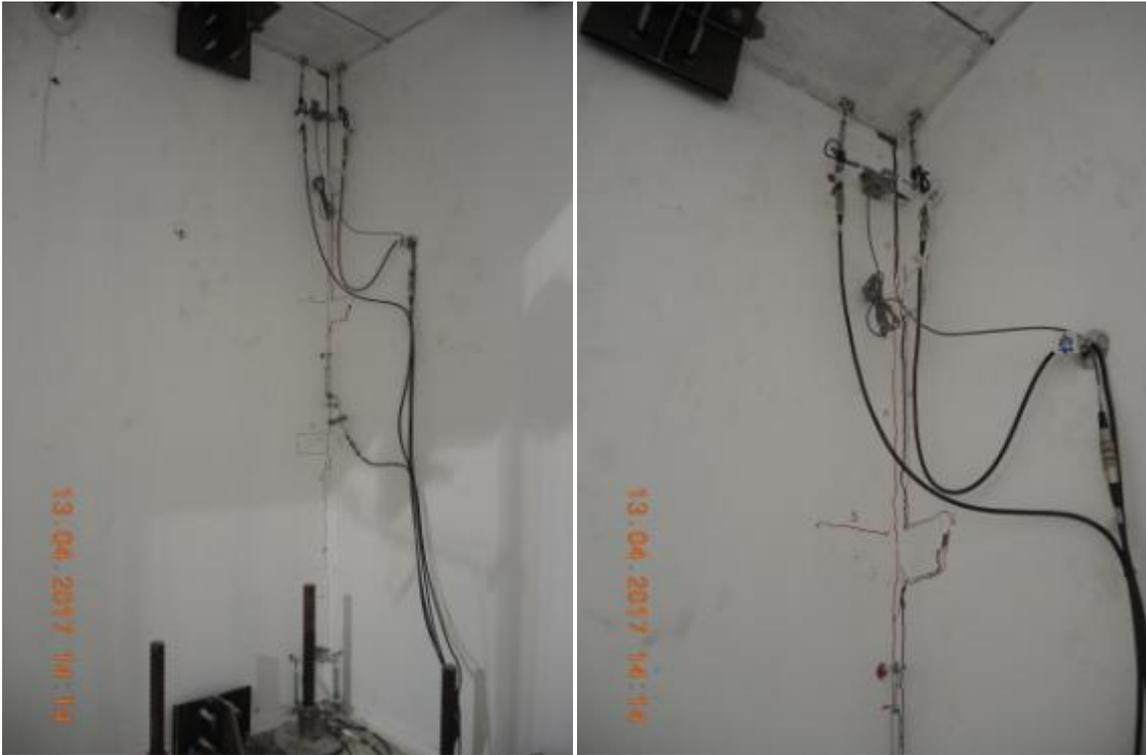
Figure 190. Detachment of stability wall with respect to lateral walls – global view and detail at the top.

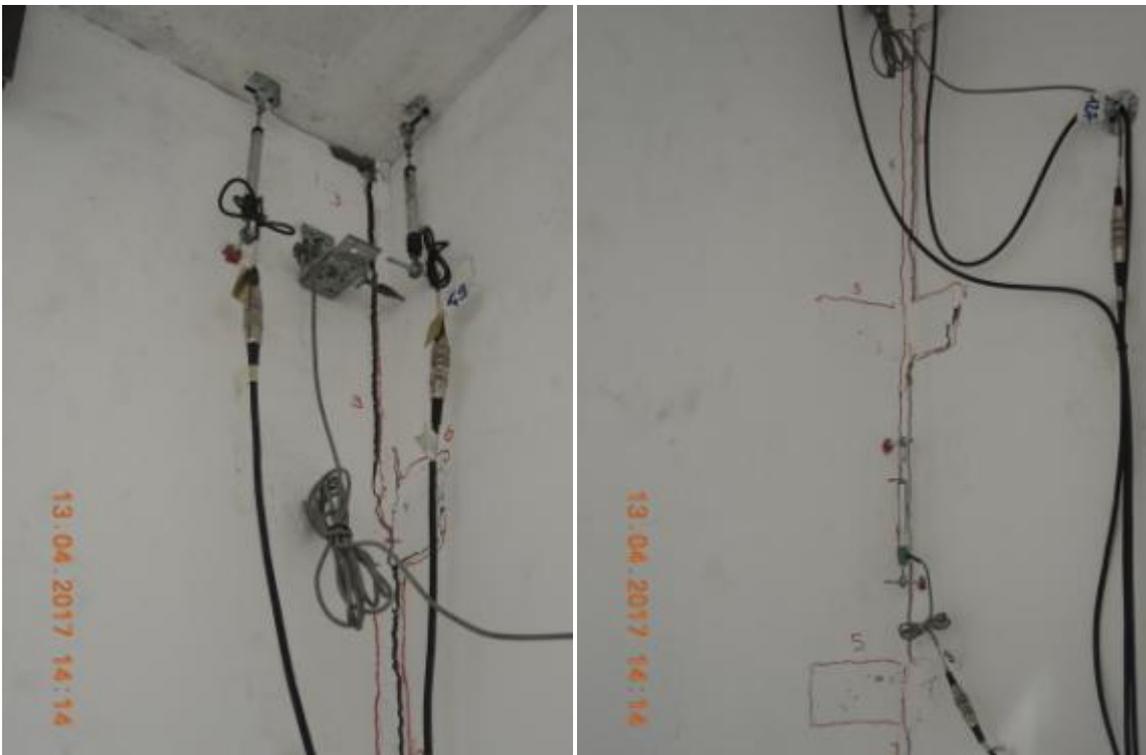
Figure 191. Extensive damage of the top three-way joint – detail of niches and grout, lateral walls.

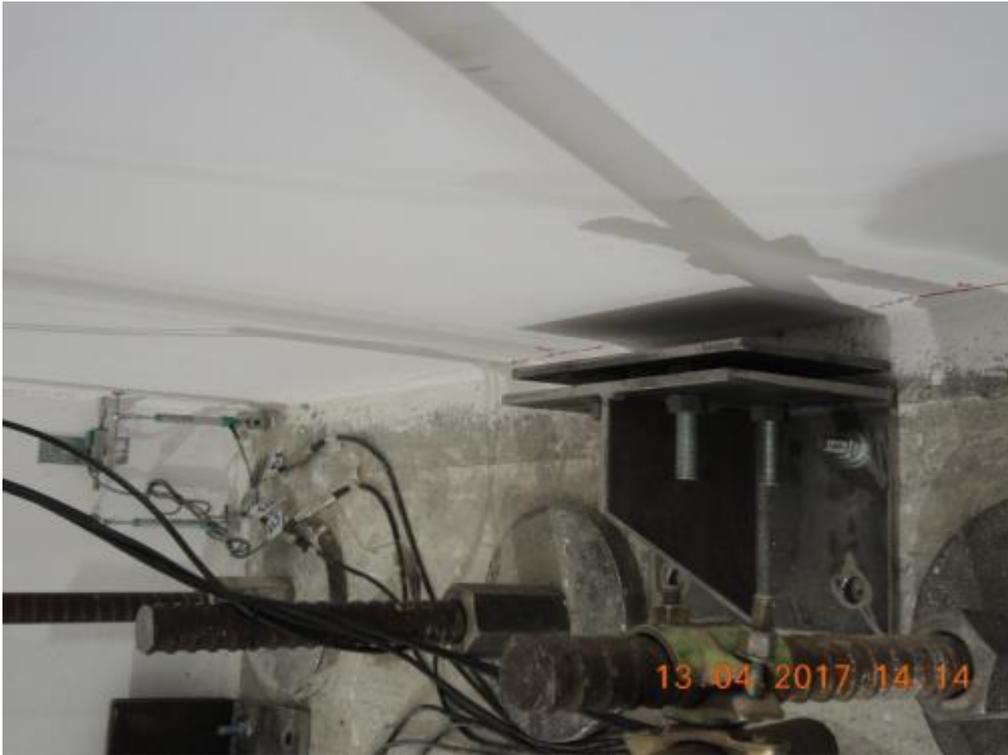
**Figure 192. Detail of the crack pattern at the base of the transversal walls – South side.**

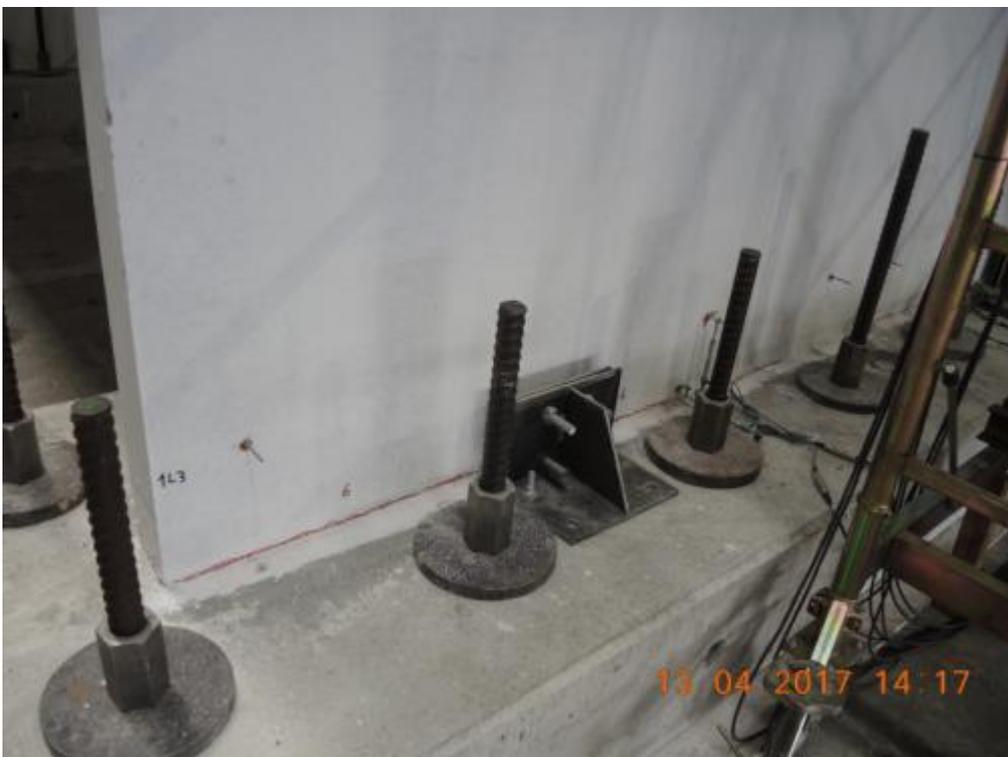
**Figure 193. Formation of horizontal cracks at the base of the transversal walls – North side.**

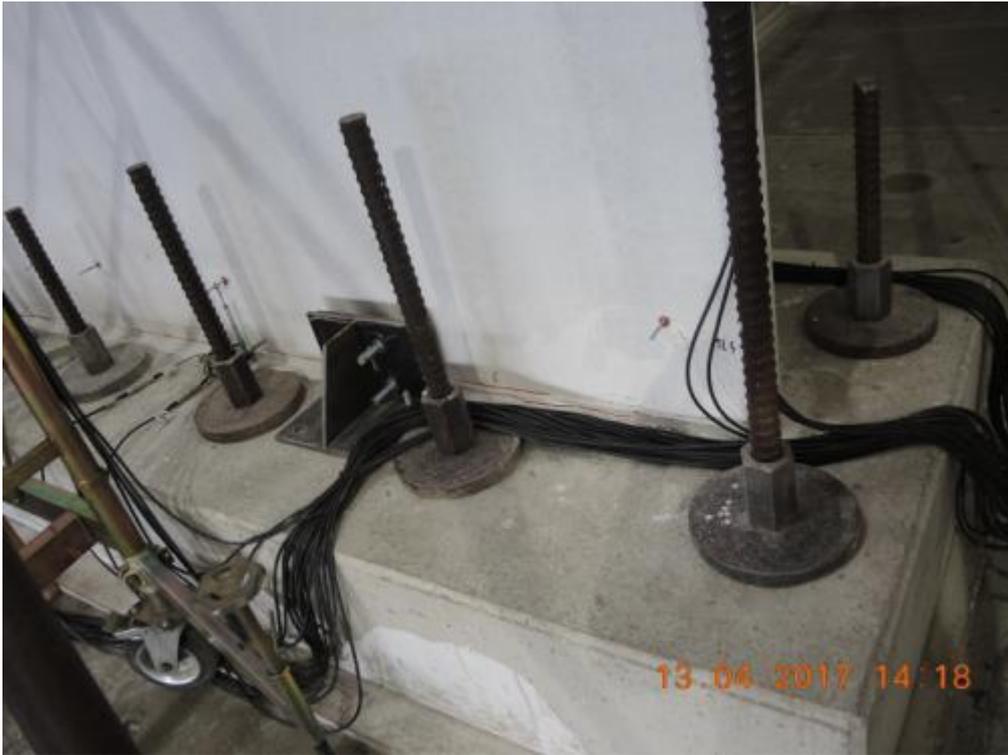
Figure 194. Formation of horizontal cracks at the base of the transversal walls – North side, opposite edge.

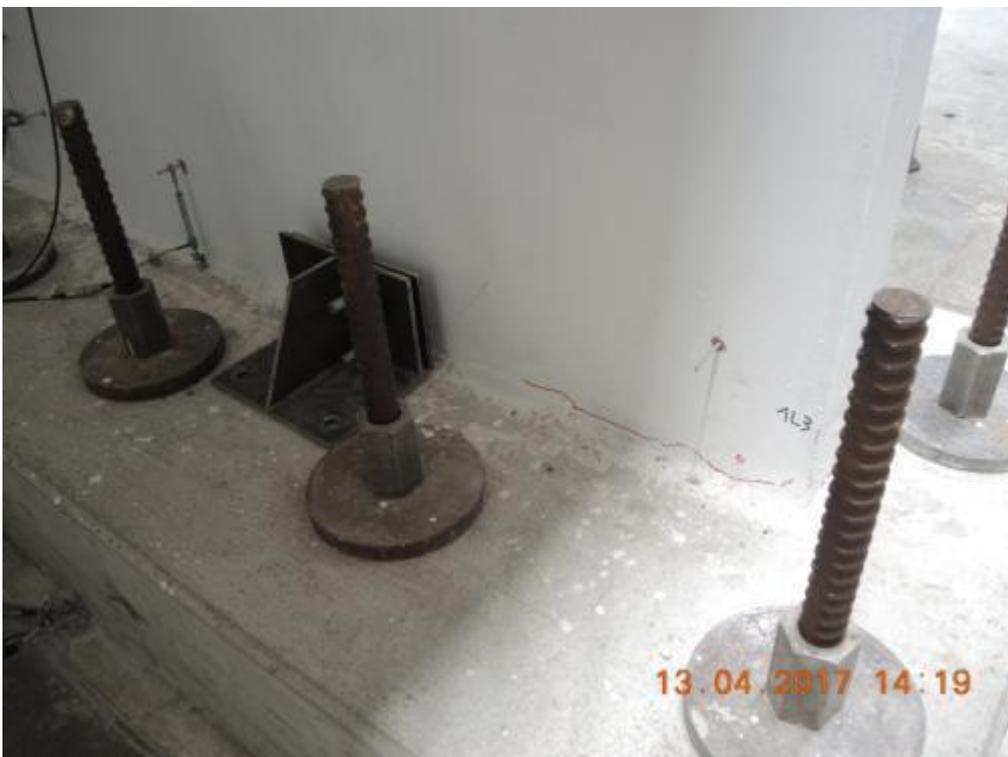
Figure 195. Horizontal cracks at the base of the transversal walls – North side, internal edge.

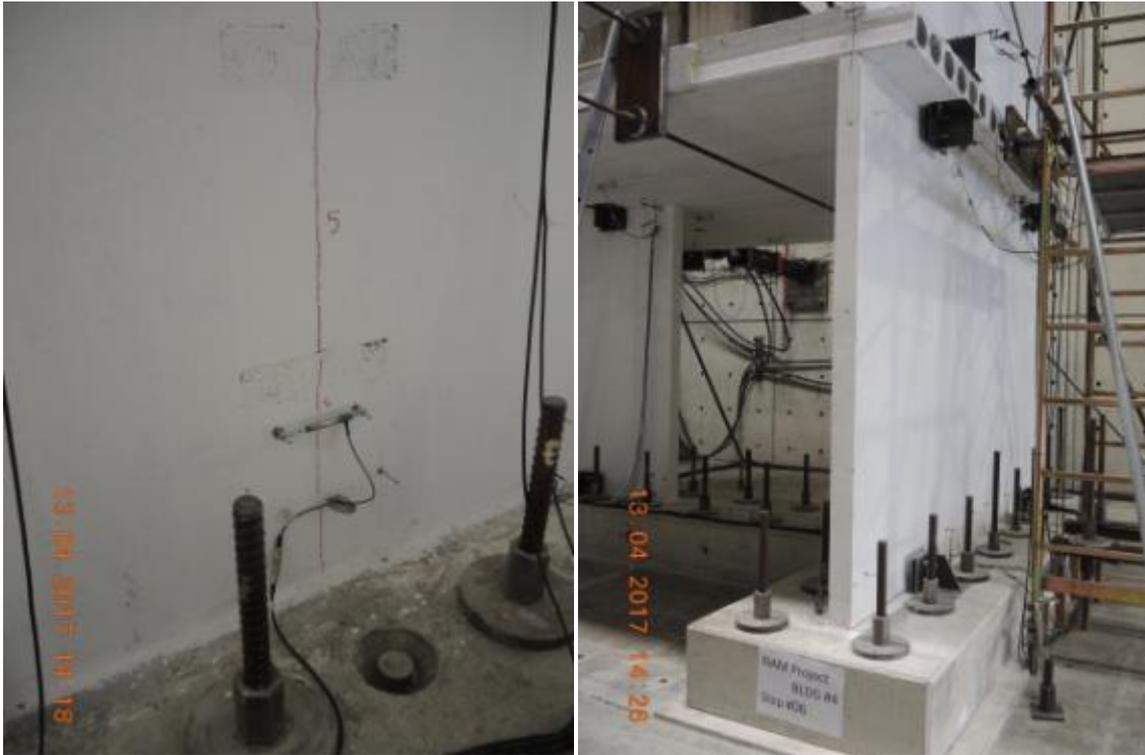
**Figure 196. Propagation of vertical crack in the grout of panel-to-panel joint and loss of verticality.**

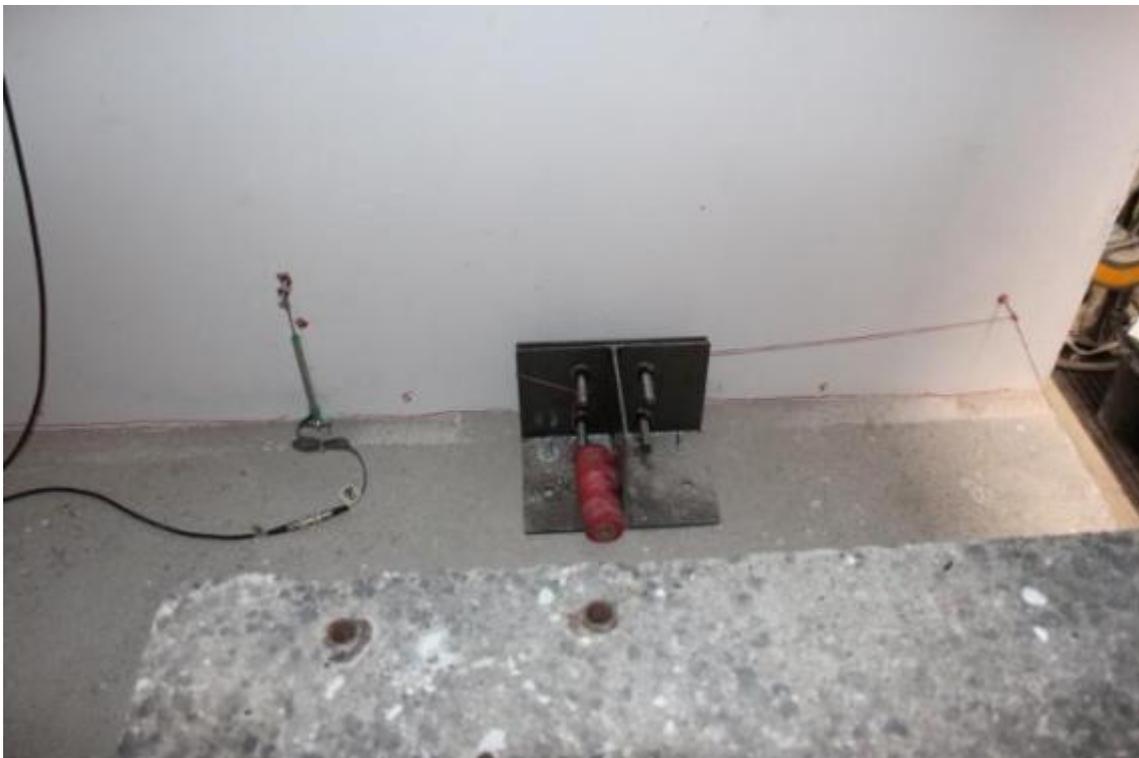
**Figure 197. Crack pattern at the base of the second-storey transversal walls – North side, internal face.**

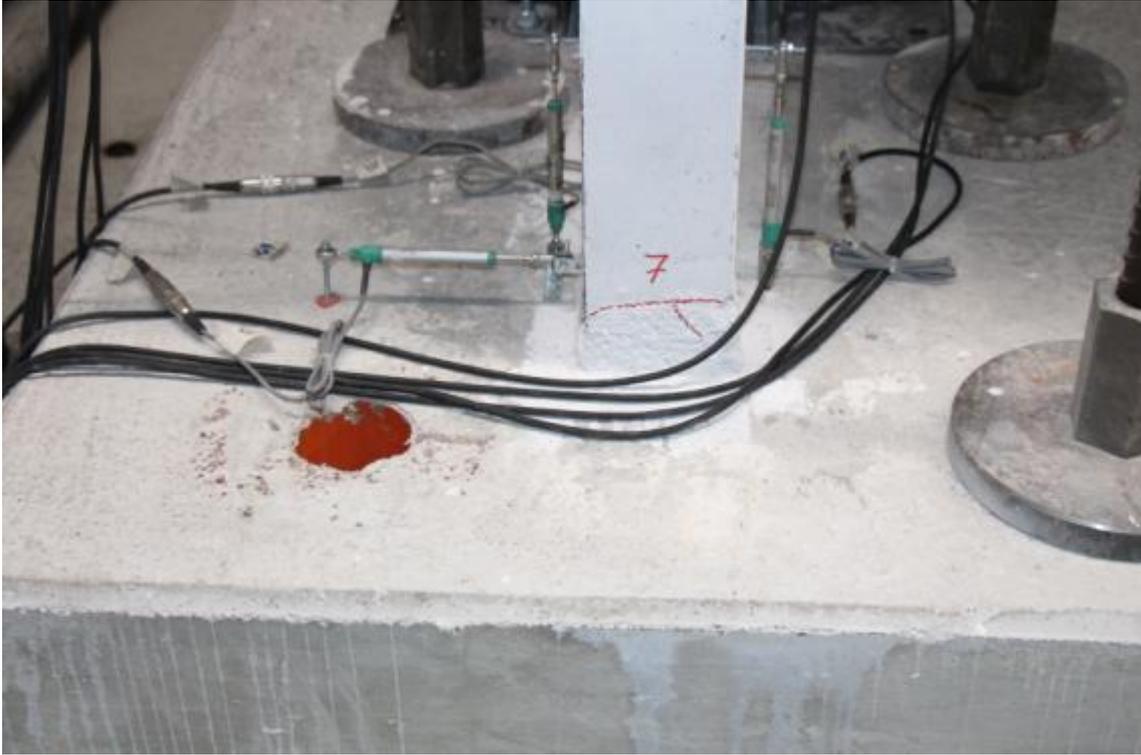
**Figure 200. Detail of the crack pattern at the base of transversal walls – South side of the specimen.**

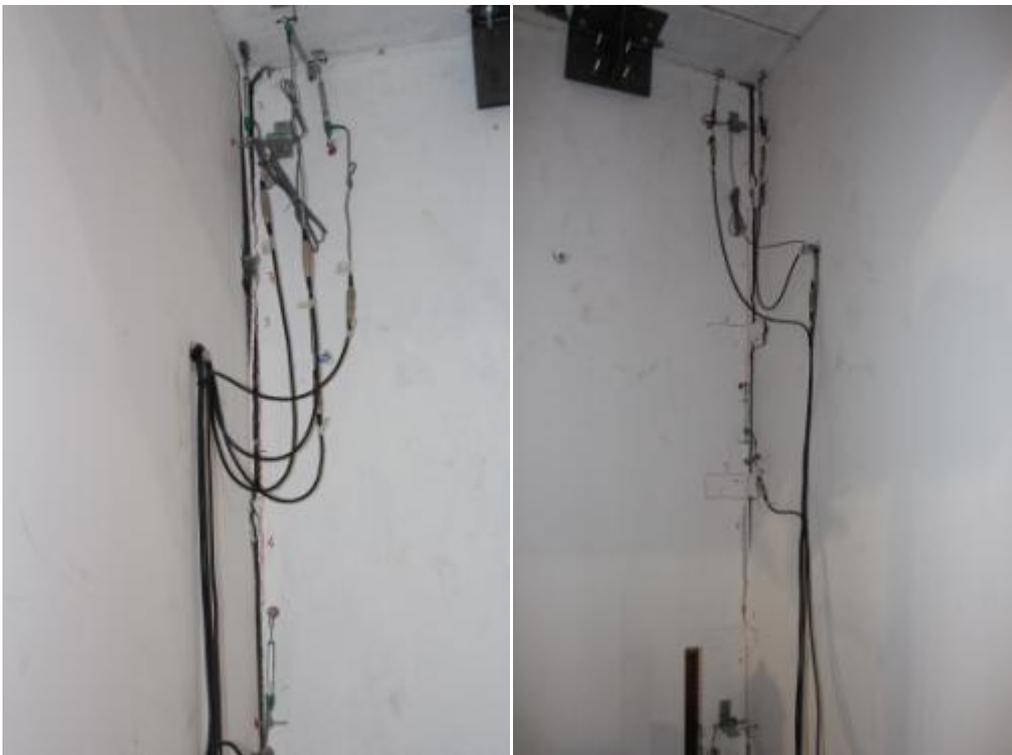
**Figure 201. Failure of three-way connection and complete gap opening between the stability and lateral walls.**

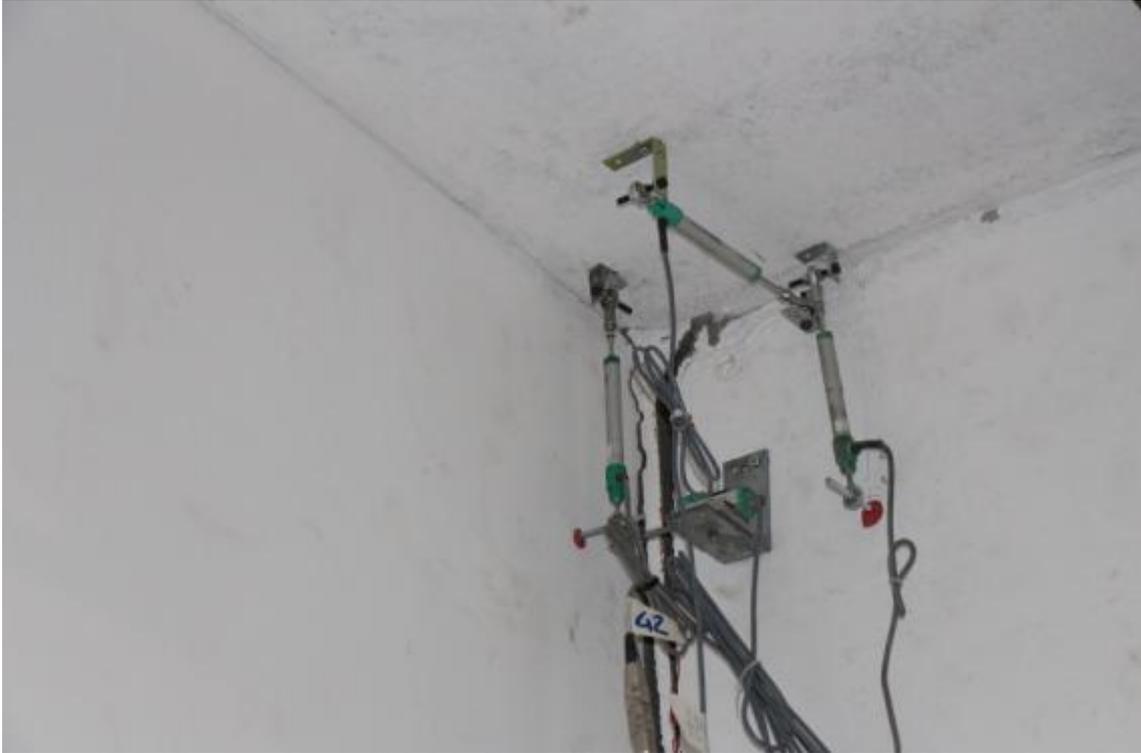
**Figure 202. Detail of the complete gap opening between the stability and lateral walls – Top.**

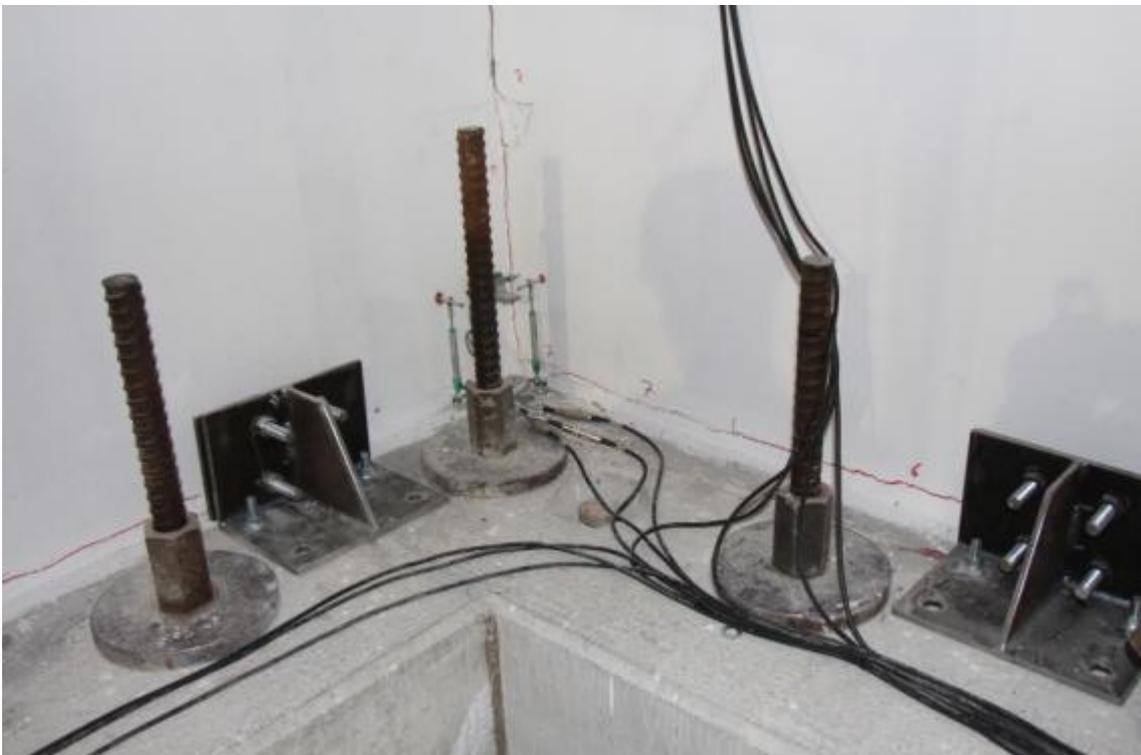
**Figure 203. Damage pattern at the base of the ground-floor stability wall – East face.**

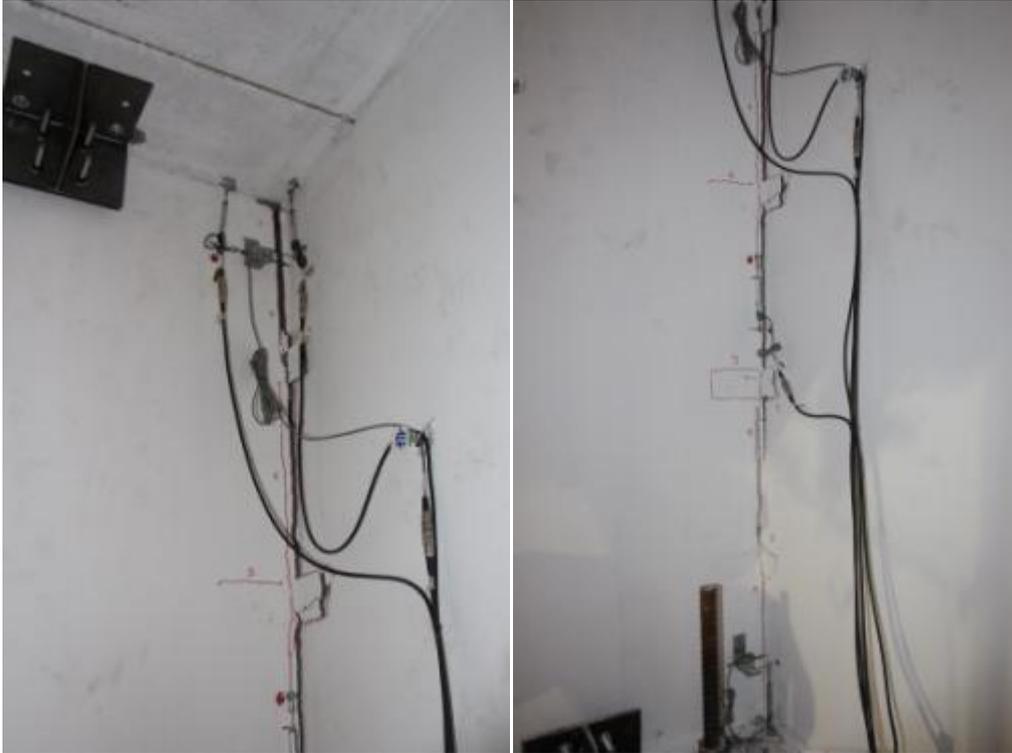
**Figure 204. Gap opening between the stability and lateral walls – Top and mid-height, opposite side.**

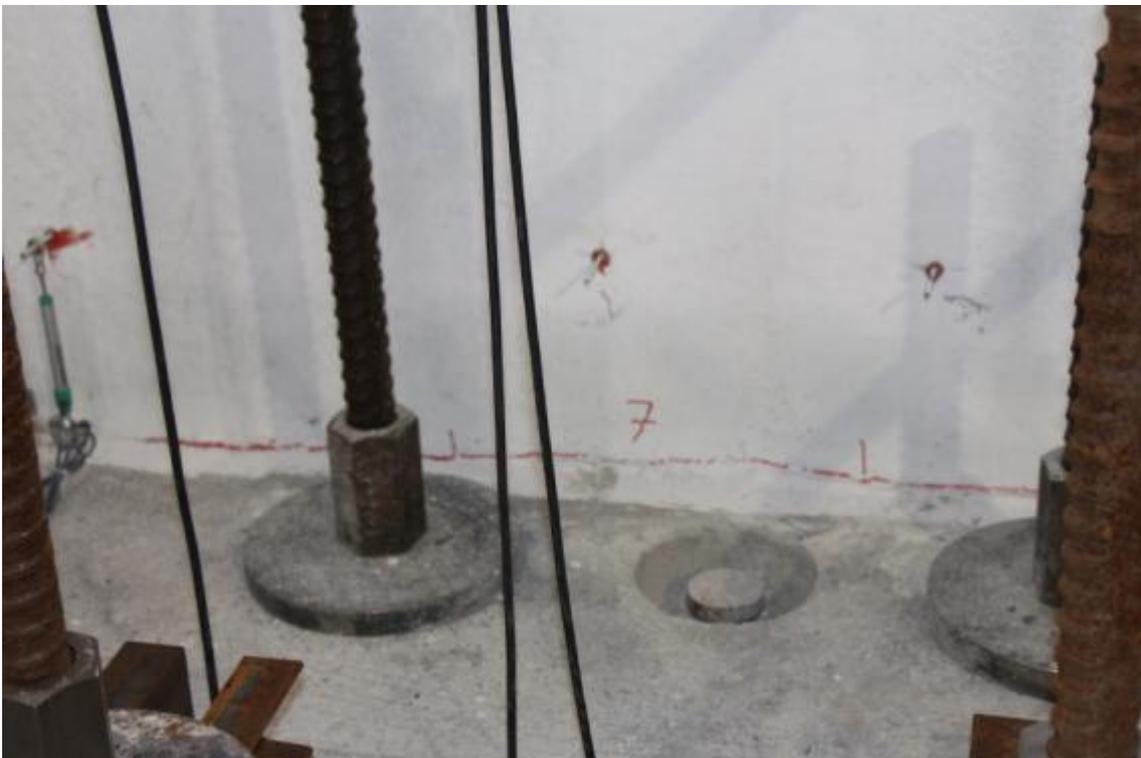
**Figure 207. Evolution of crack pattern at the base of the transversal walls – North side of the specimen.**

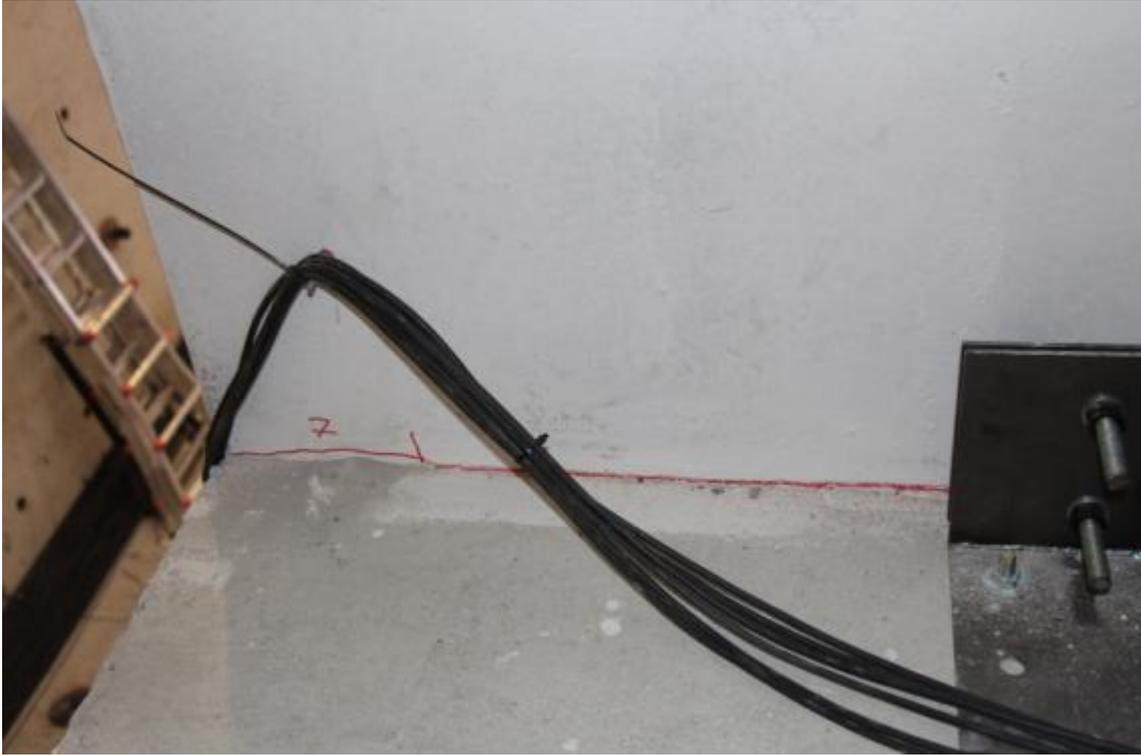
**Figure 208. Crack pattern at the base of the transversal walls – North side, second floor, internal face.**
