# **Experimental campaign on Reinforced Concrete buildings typical of the Groningen region**

**Cyclic testing of a full-scale two-storey Reinforced  
Concrete precast wall-slab-wall structure  
representative of the Groningen building stock  
(EUC-BUILD4).**

**Eucentre**

Date June 2017

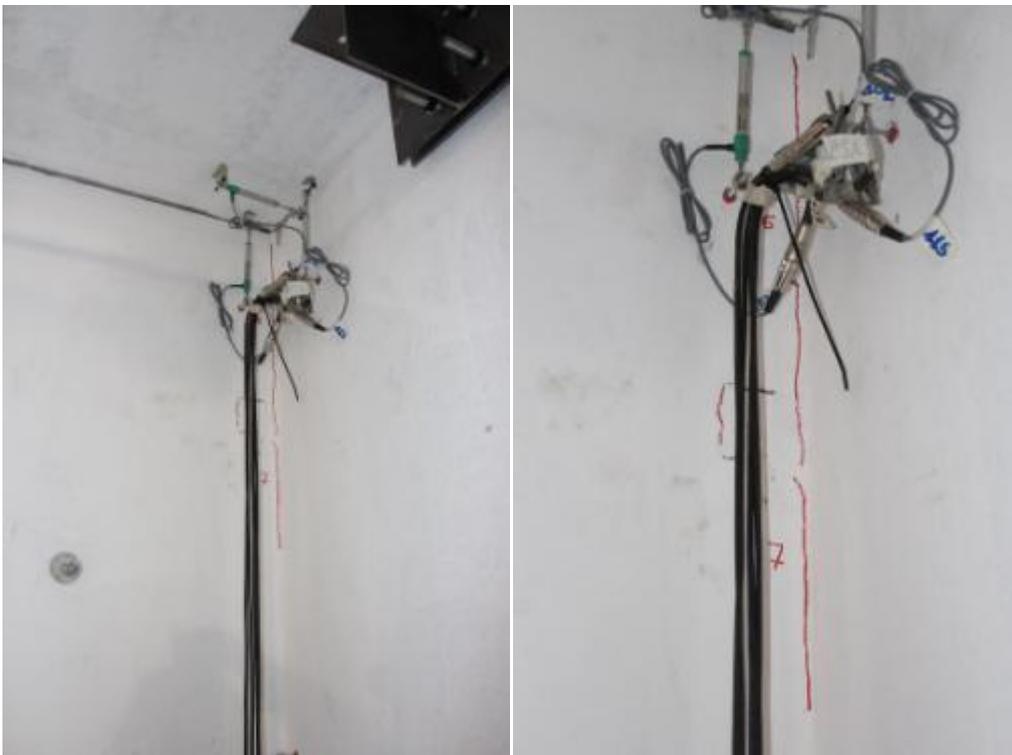
**Figure 209. Vertical crack in the top three-way joint between the stability and lateral walls – Second floor.**

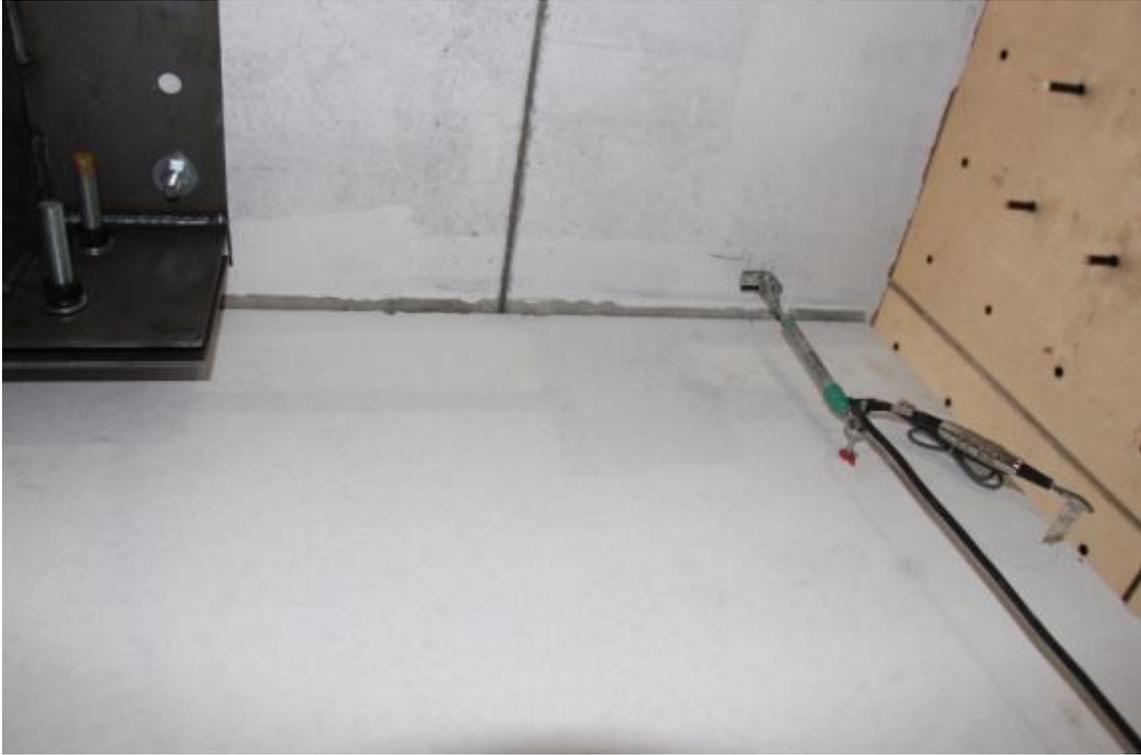
**Figure 210. Accumulation of residuals due to sliding of the second-storey slabs – Bottom view.**

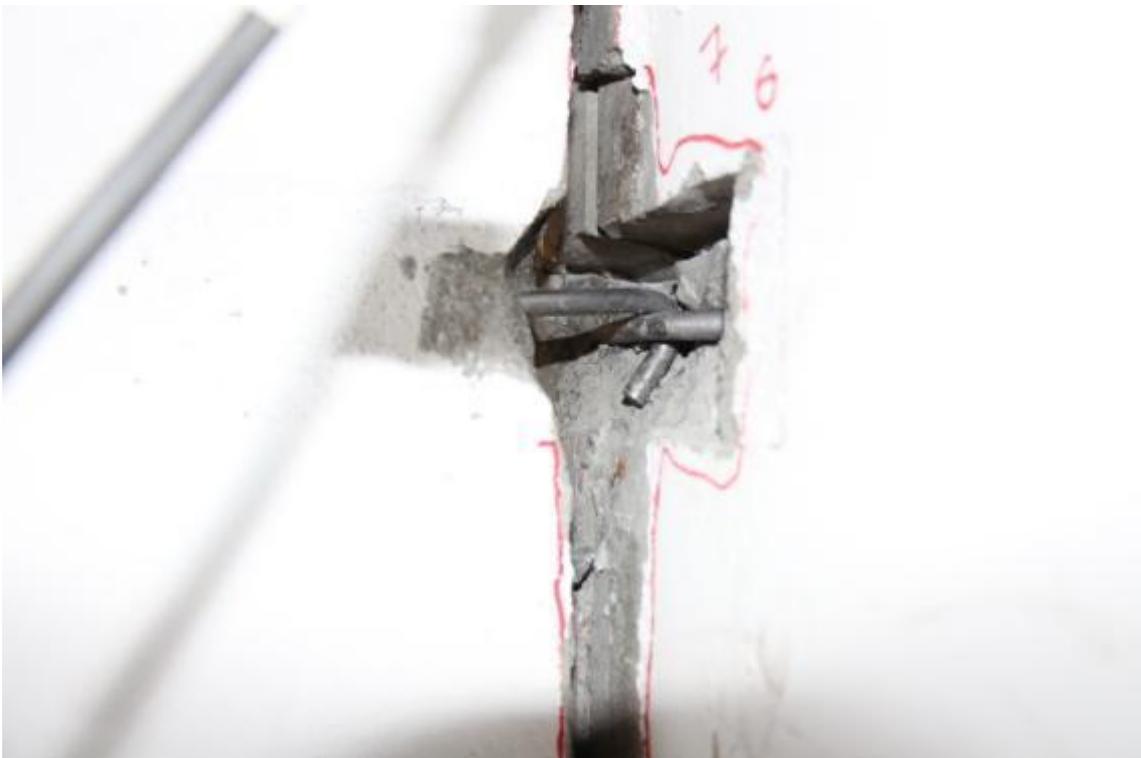
Of paramount importance is therefore the characterization of mechanical properties of those anchors that were observed to fail, by a flexural mechanism, during the testing of EUC-BUILD4 specimen. Standard tensile tests on those smooth steel rebars were undertaken at the DICAr Laboratory of the University of Pavia on June 6<sup>th</sup>, and the corresponding stress-strain relationships

**Figure 211. Flexural failure mode of the anchors embedded in the transversal walls – Top three-way joint.**

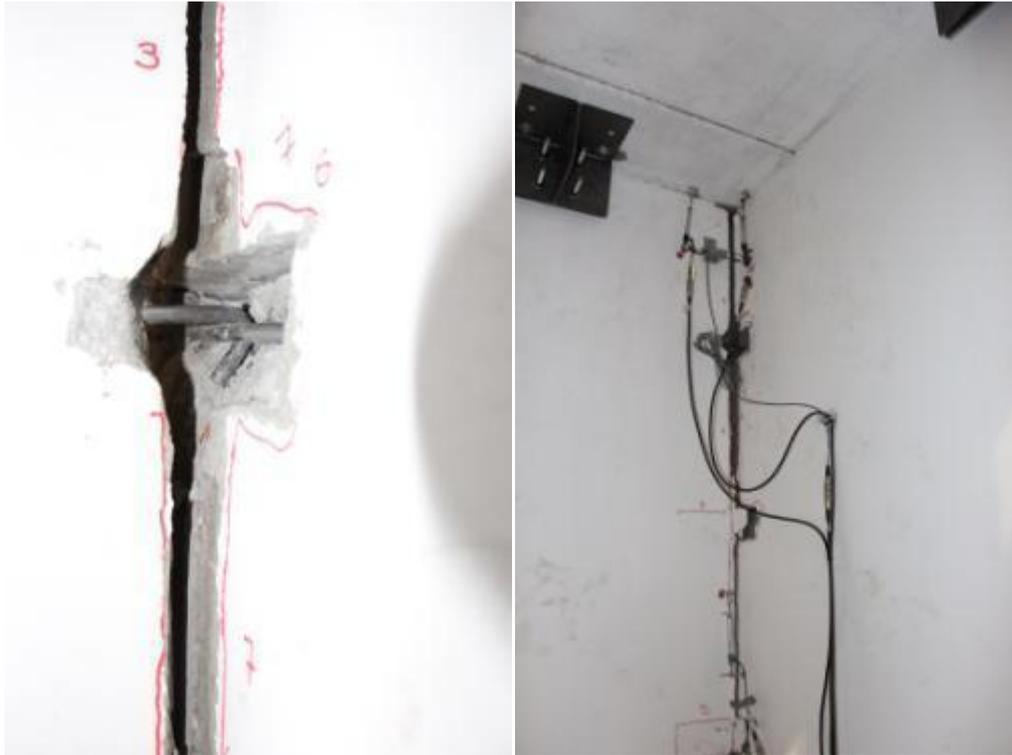
**Figure 212. Damage of the three-way joint at the end of testing – Global and enlarged views.**

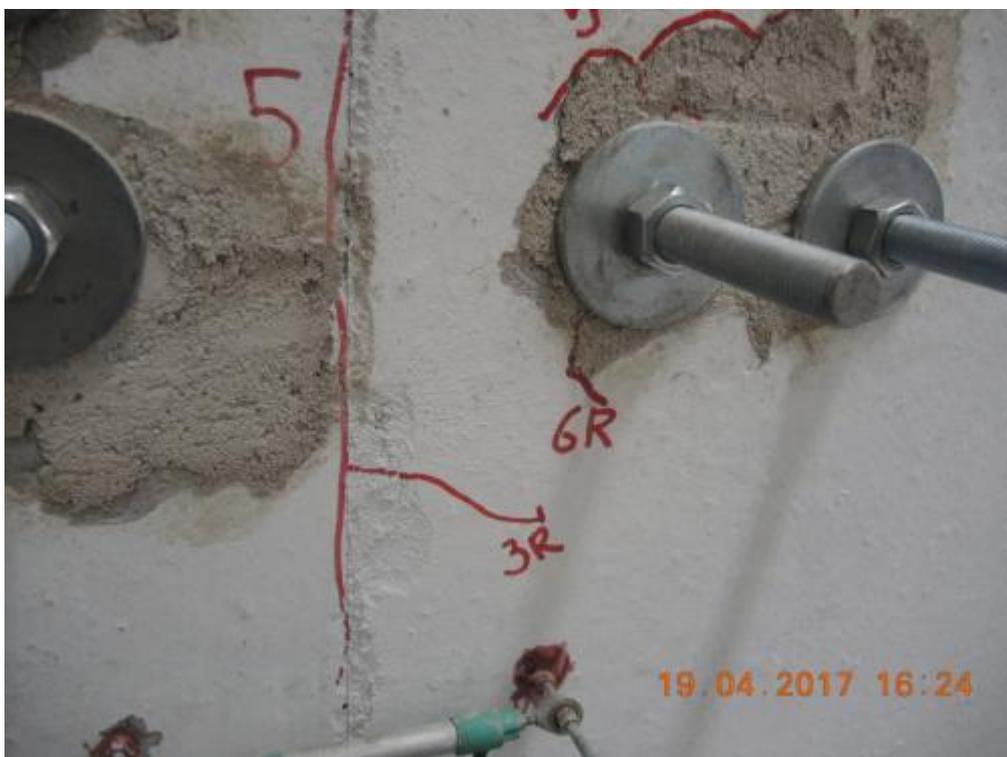
Figure 270. Evolution of crack pattern in correspondence to the implemented retrofitting intervention – Bottom.

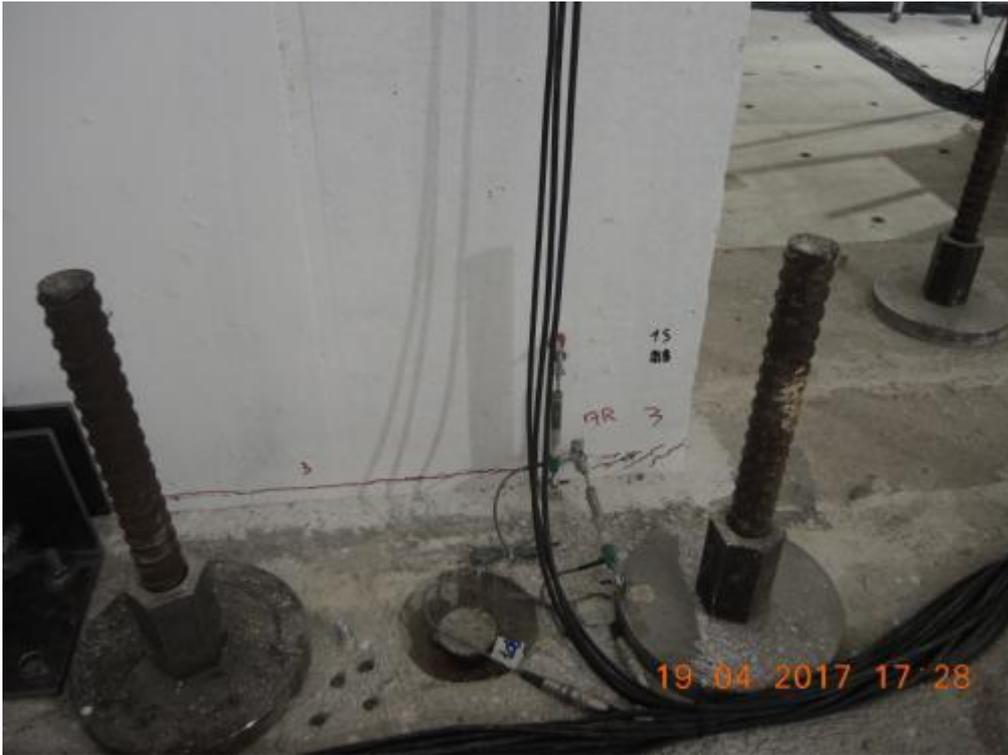
Figure 276. Damage/crack pattern at the base of the ground-floor stability wall – Opposite (North) side.

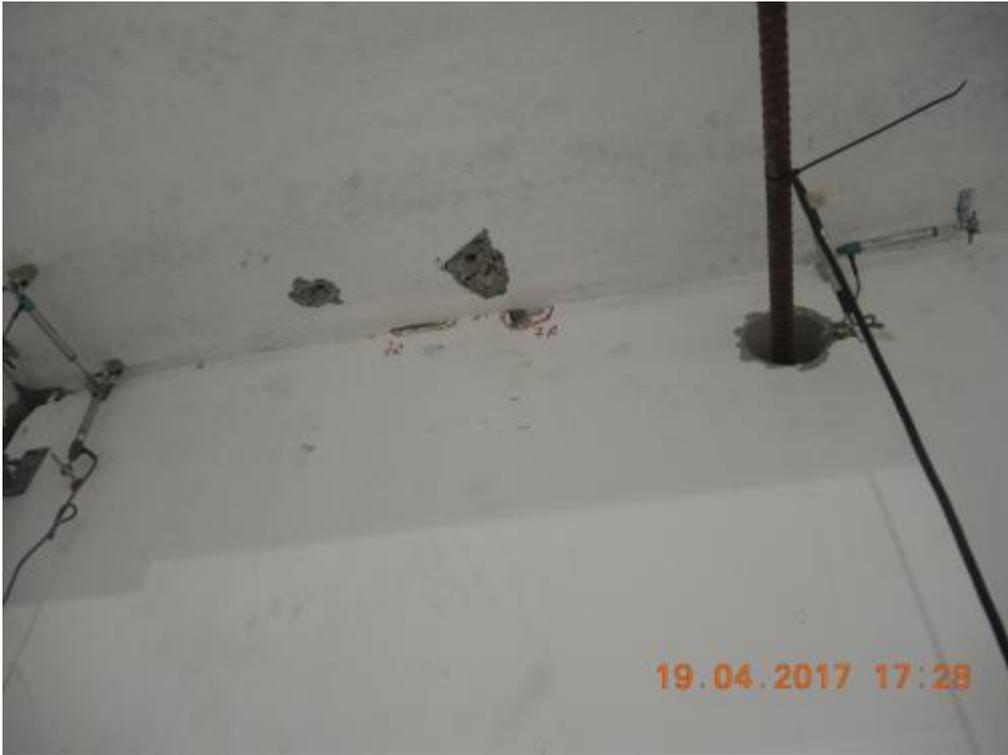
Figure 278. Minor friction-induced concrete chipping at the top of the first-storey stability wall.

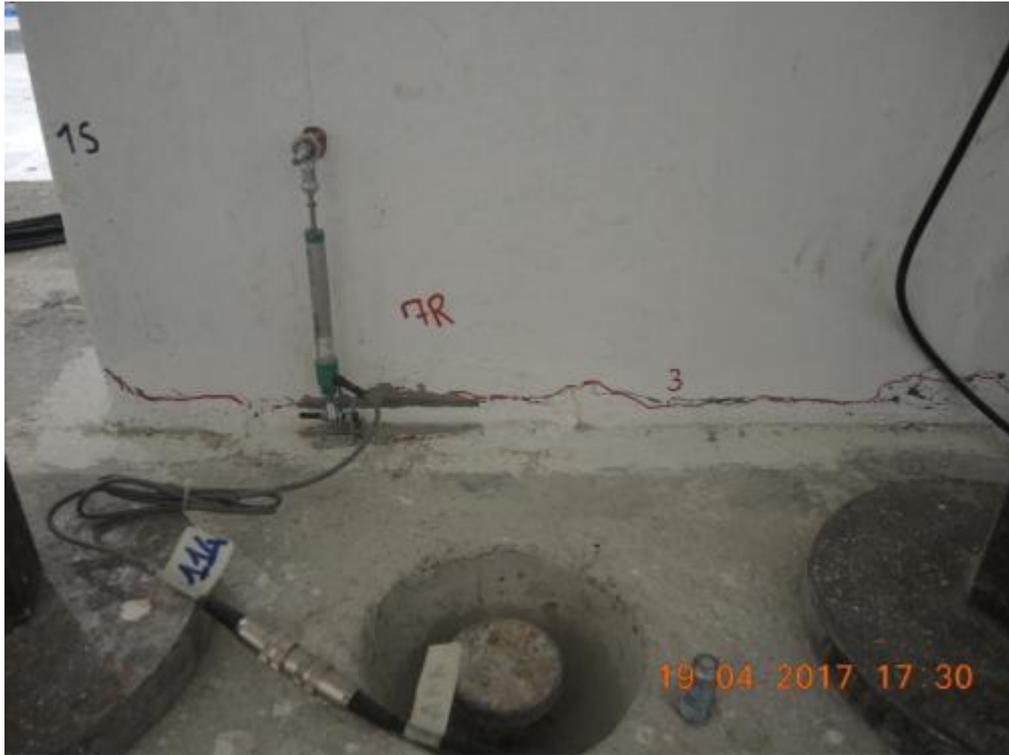
Figure 280. Crack pattern at the base of the ground-floor stability wall – West side, edge.

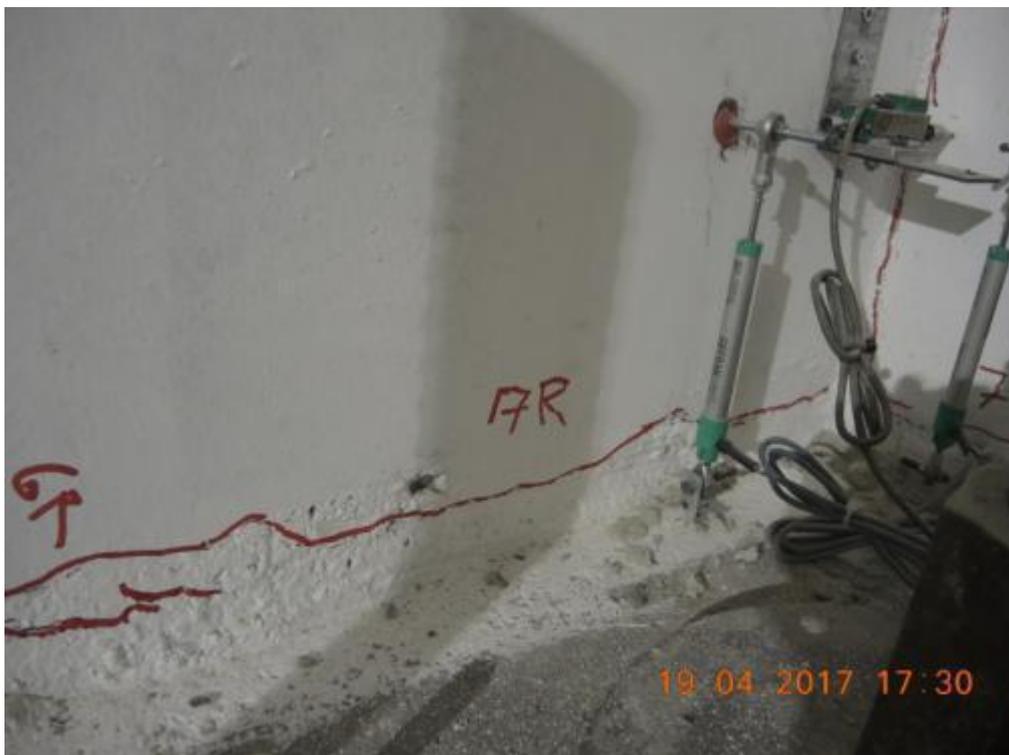
Figure 281. Crack pattern at the base of the ground-floor stability wall – West side, opposite edge.

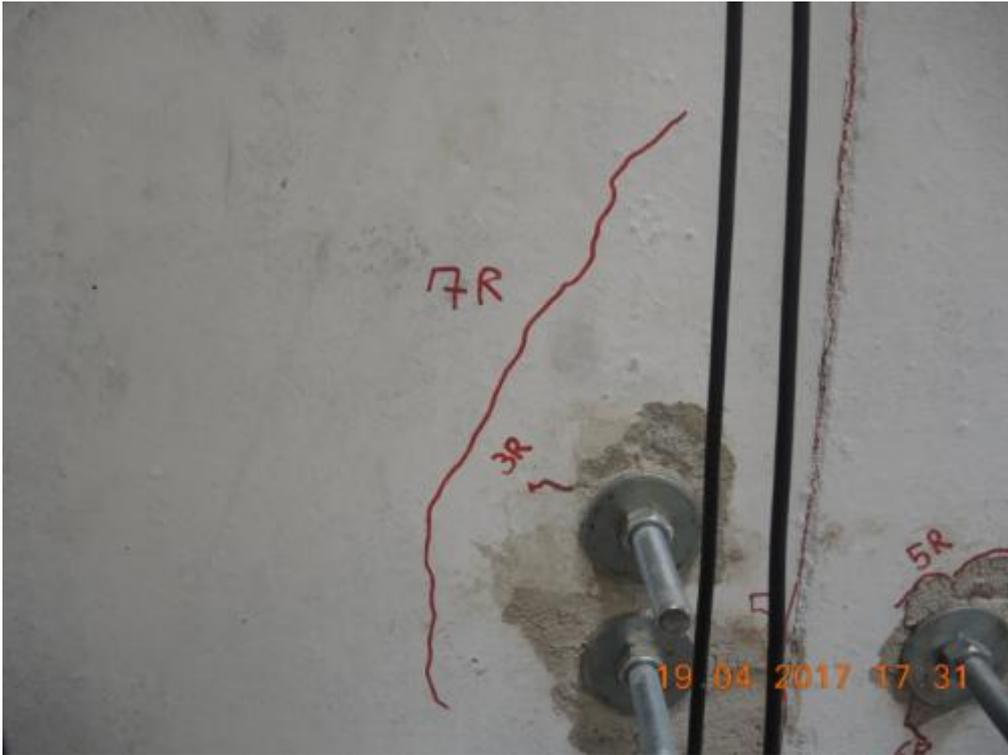
Figure 282. Formation of a new crack in one of the lateral walls close to steel angles and bolted rods.

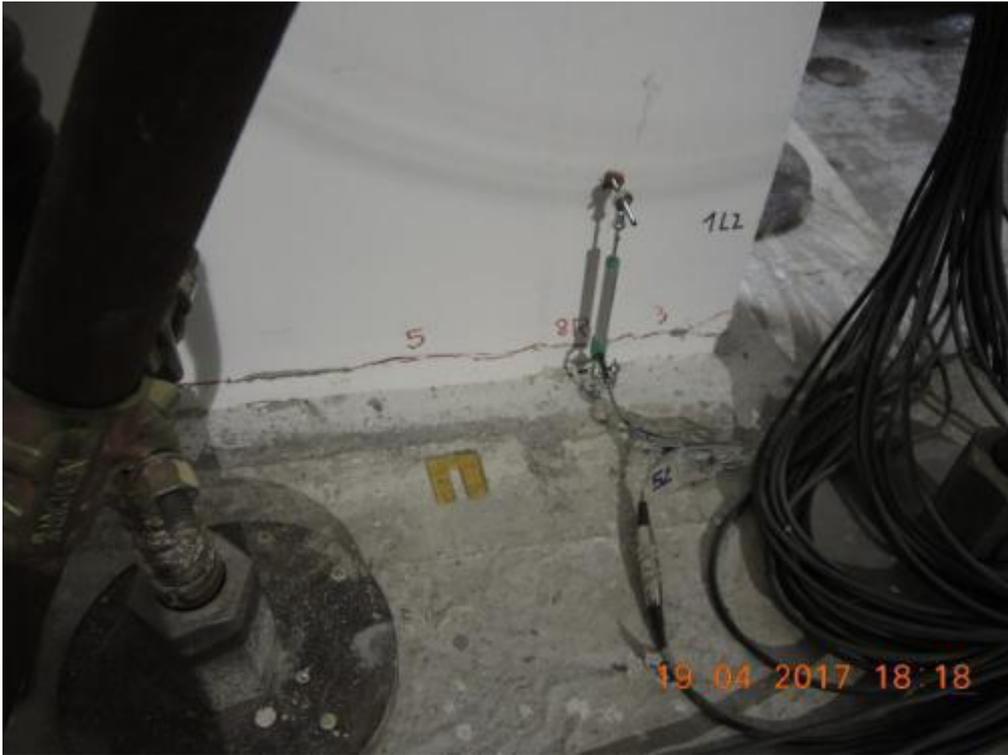
**Figure 291. Damage at the base of lateral wall W1L2 – East side, first floor.**

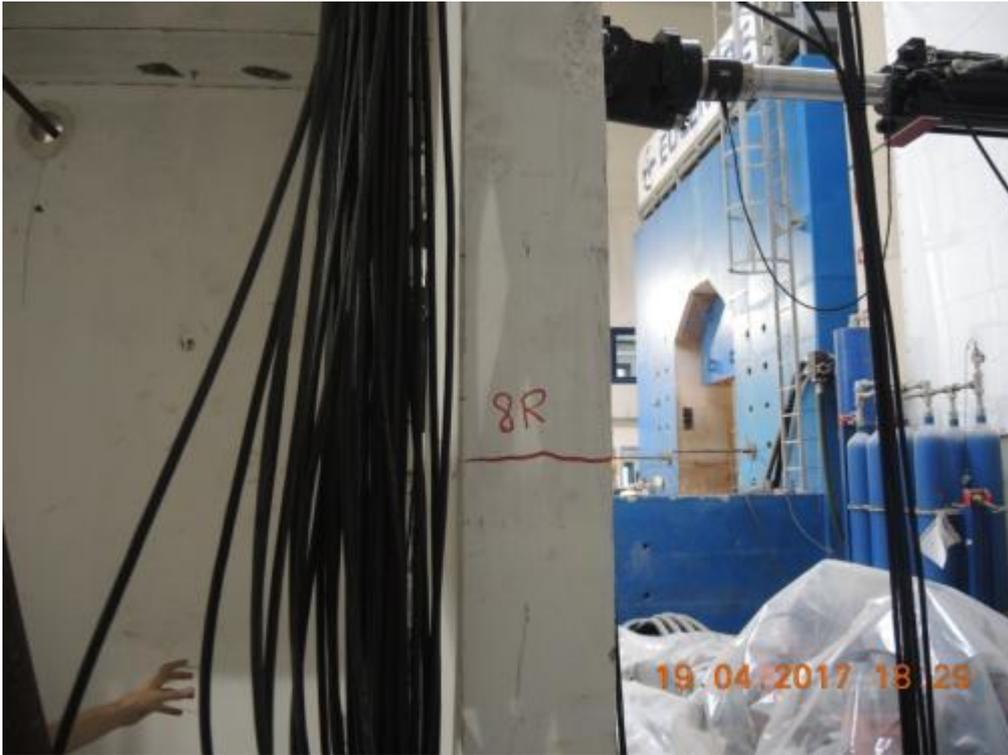
**Figure 293. Side view of the full-depth/full-width/mid-height horizontal crack in lateral wall W1L2.**

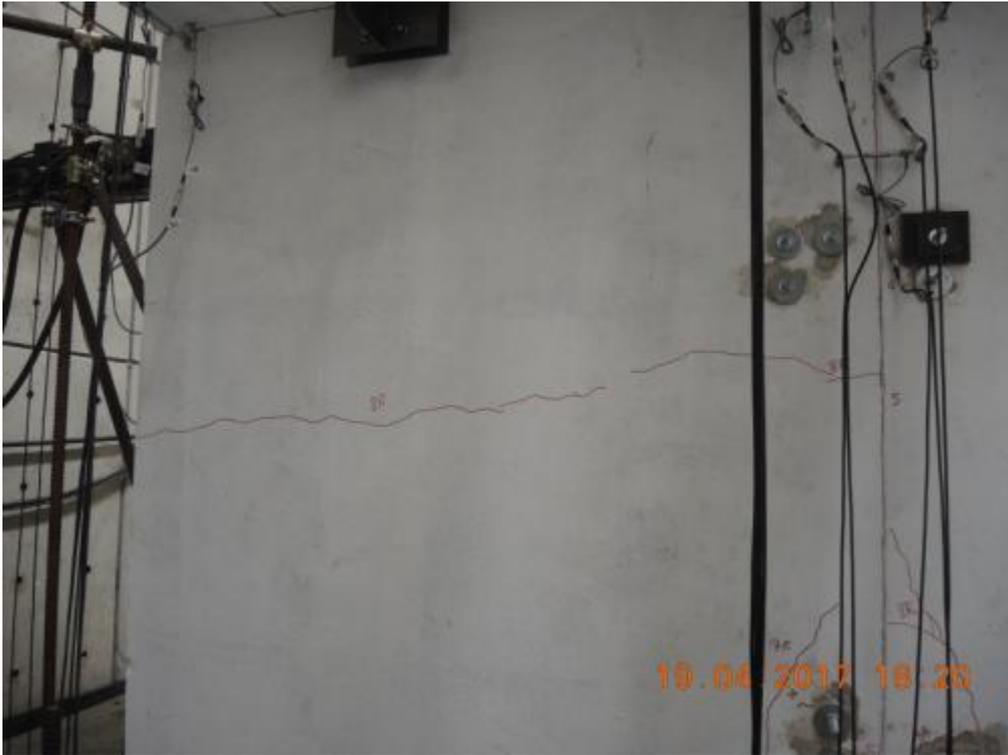
**Figure 295. Front view of the full-depth/full-width/mid-height horizontal crack in lateral wall W1L2.**

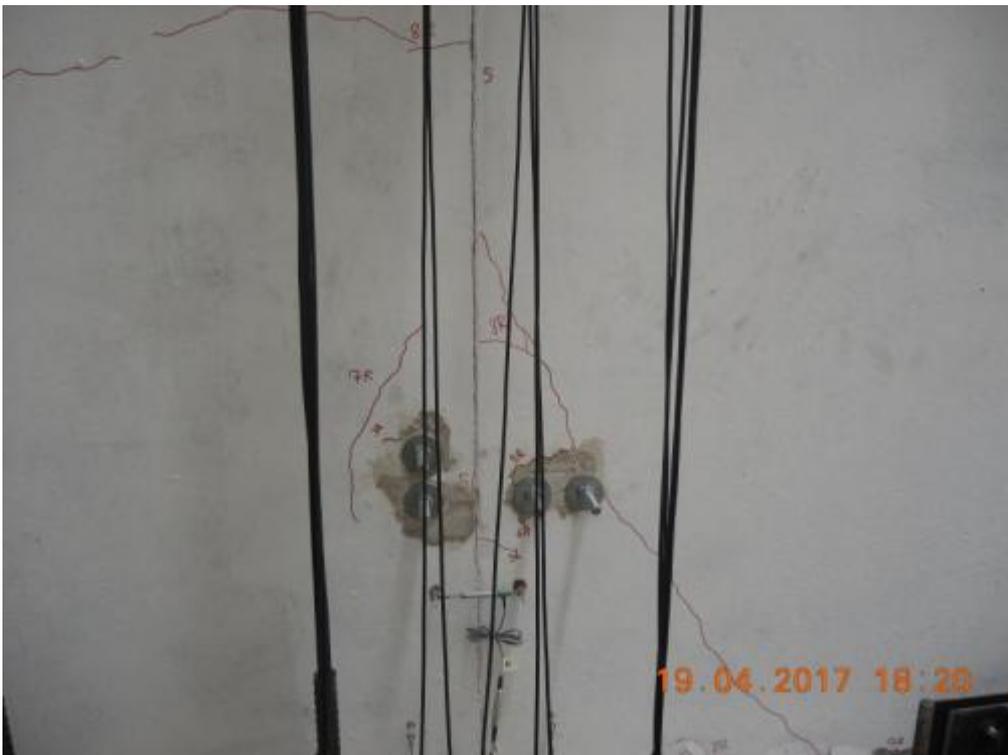
**Figure 296. Crack pattern developed in the transversal wall W1L1 – West side, South face, mid-height.**

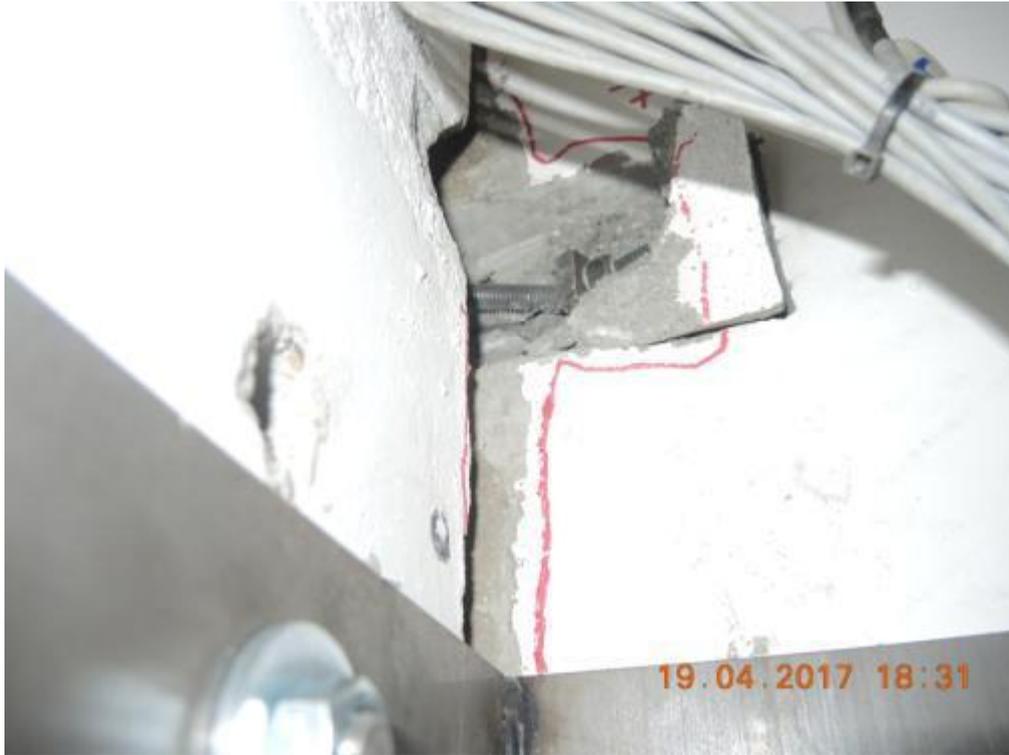
Figure 303. Enlarged view of a three-way connection and bent/failed anchor – West side, first storey.

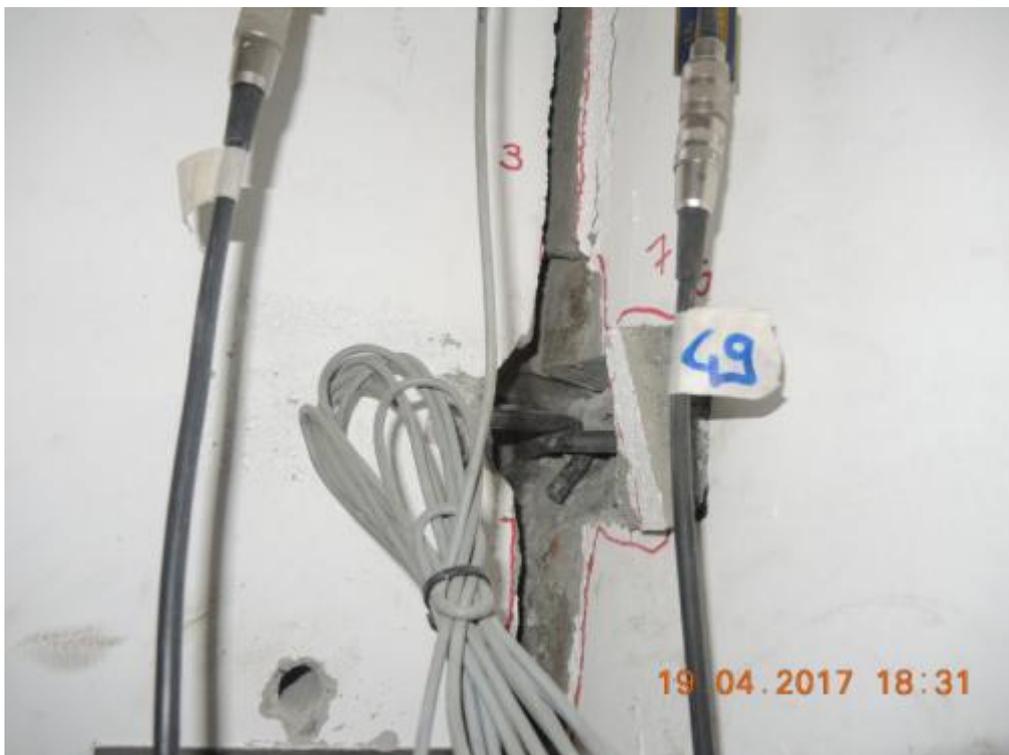
Figure 304. Enlarged view of flexural failure mechanism of a three-way anchor – West side, first storey.

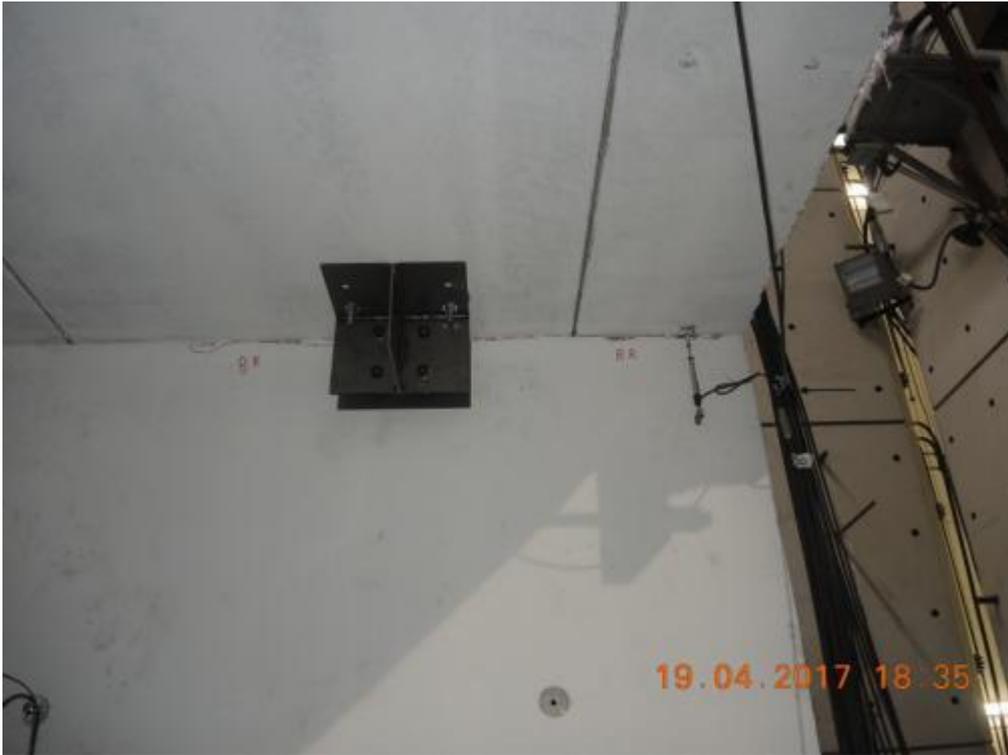
Figure 305. Concrete chipping at the top of lateral wall W1L2 – West side, first storey.

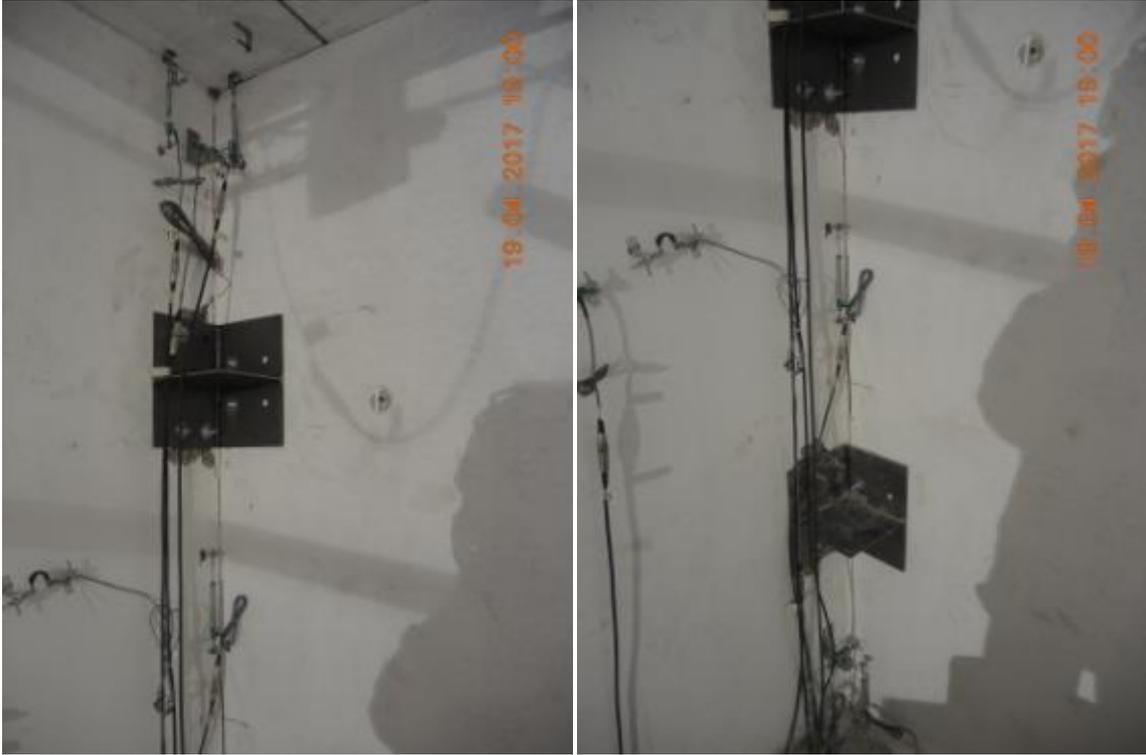
**Figure 313. Damage pattern of retrofitted three-way connections – West side, North face, second storey.**

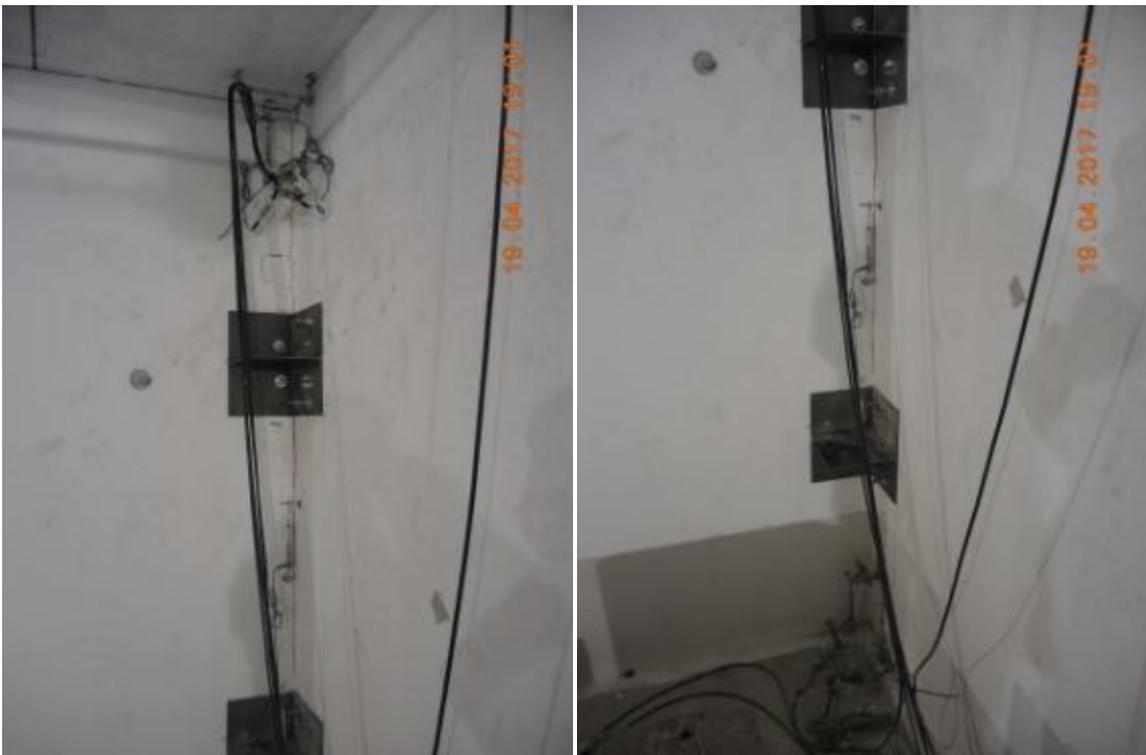
**Figure 314. Damage pattern of retrofitted three-way connections – East side, North face, second storey.**

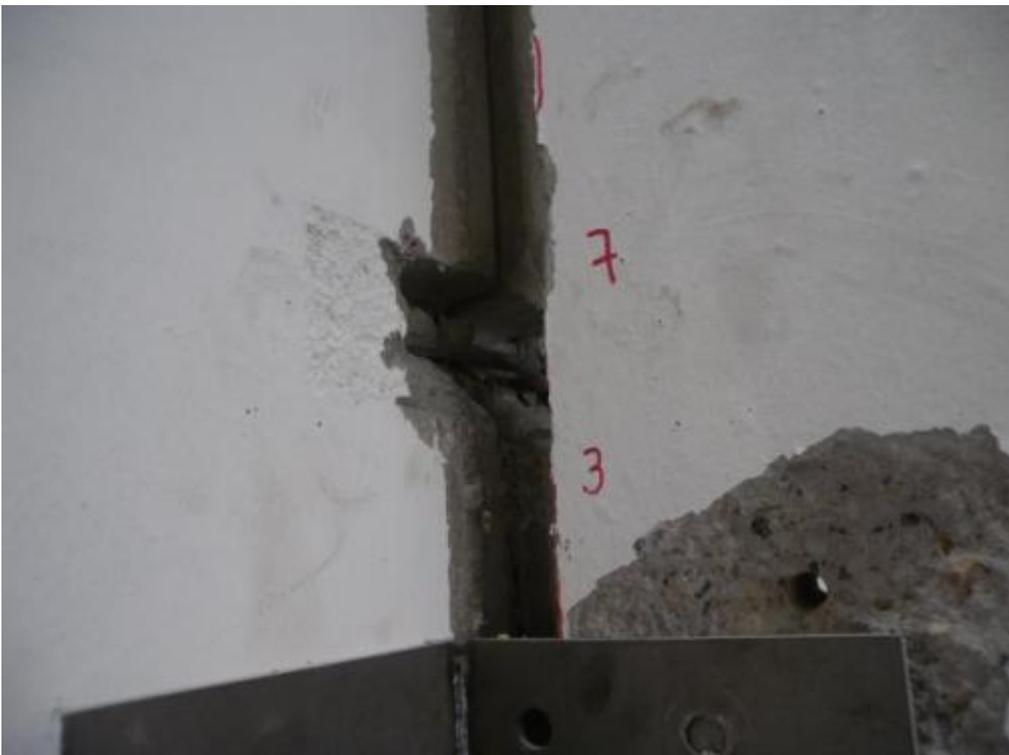
**Figure 353. Removal of screwed clip angles and detail of failed connector – First storey, South side.**

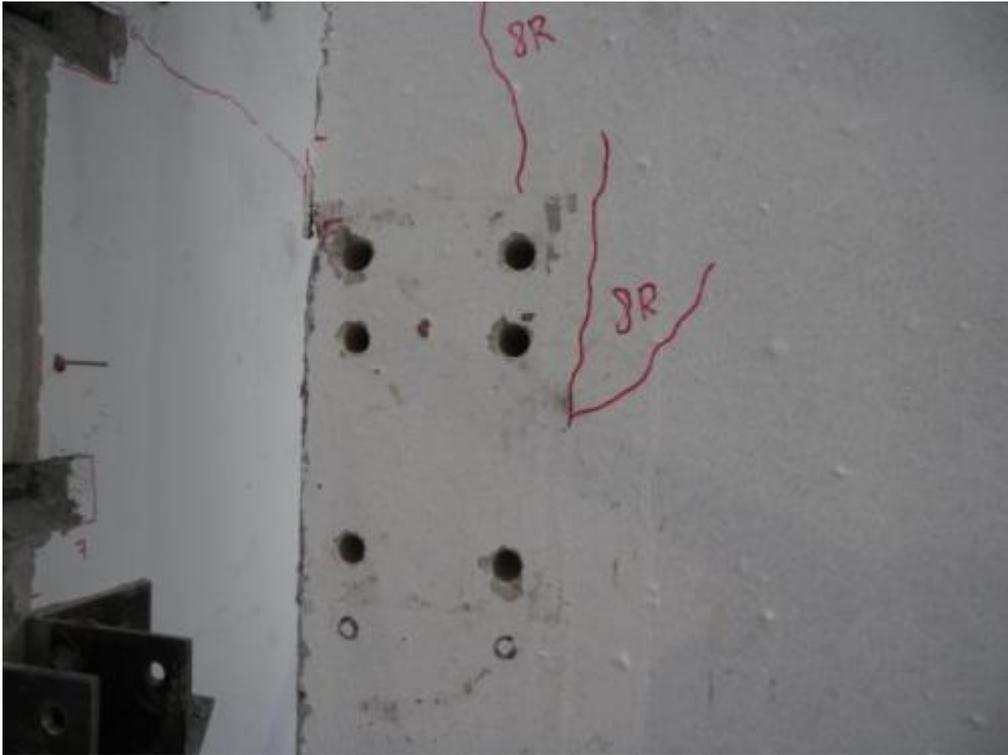
Figure 356. Ground-floor stability wall panel – Detail of cracks at approximately mid-height, South edge.

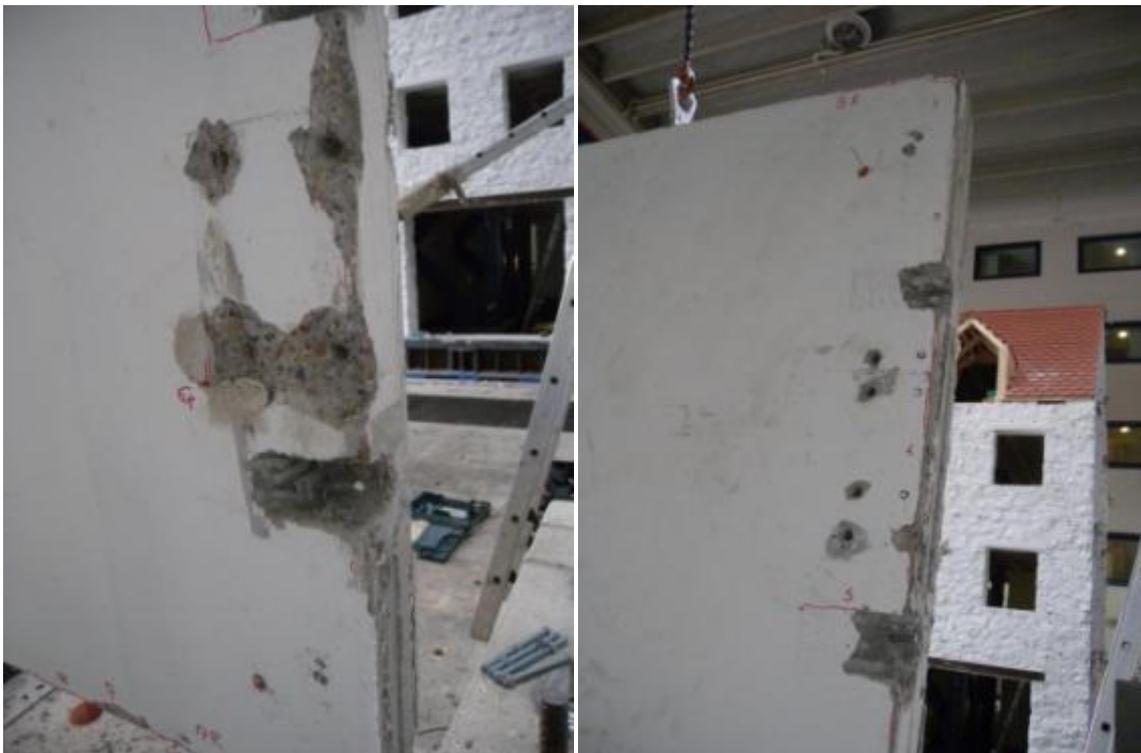
**Figure 359. Damage pattern of the first-floor stability wall after dismantling of connections and setup.**

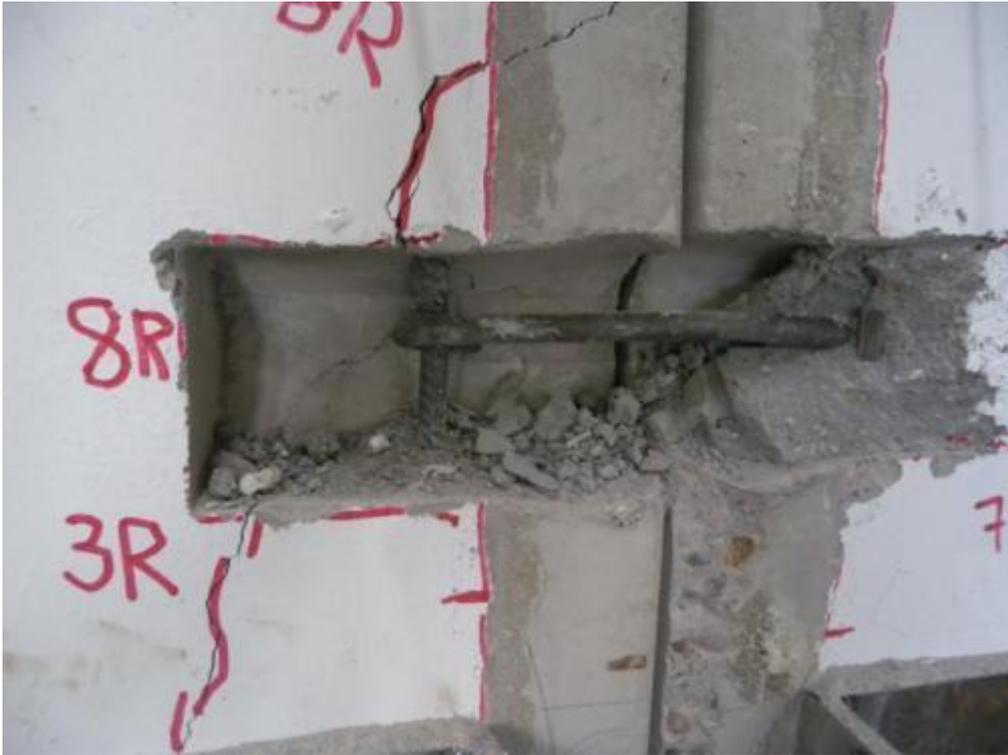
Figure 361. Detail of flexural failure mechanism of a hooked connector – Above the bottom down clip.

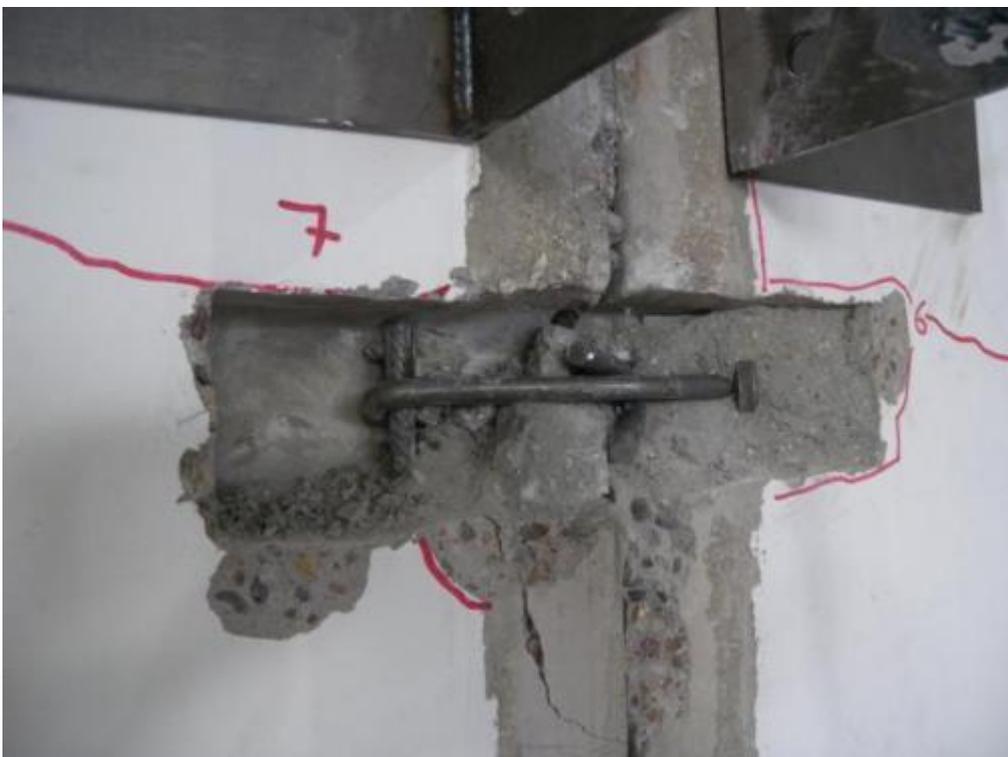
Figure 362. Detail of flexural failure mechanism of a hooked connector – Below the top clip.

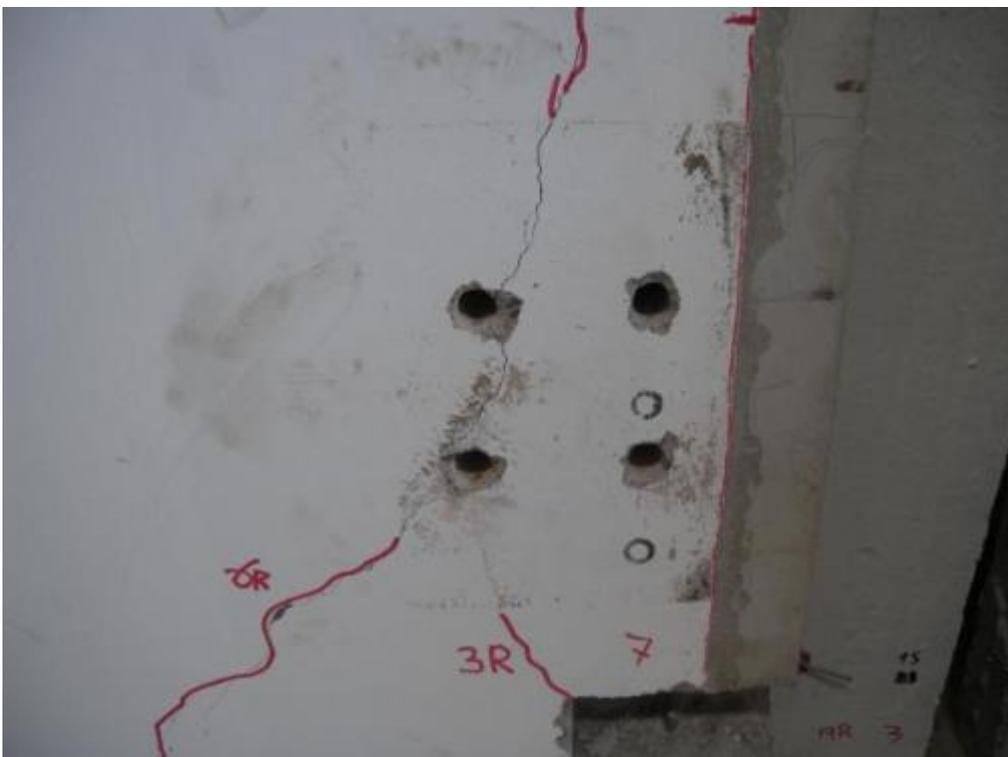
Figure 368. Detail of crack pattern after dismantling of steel angles.

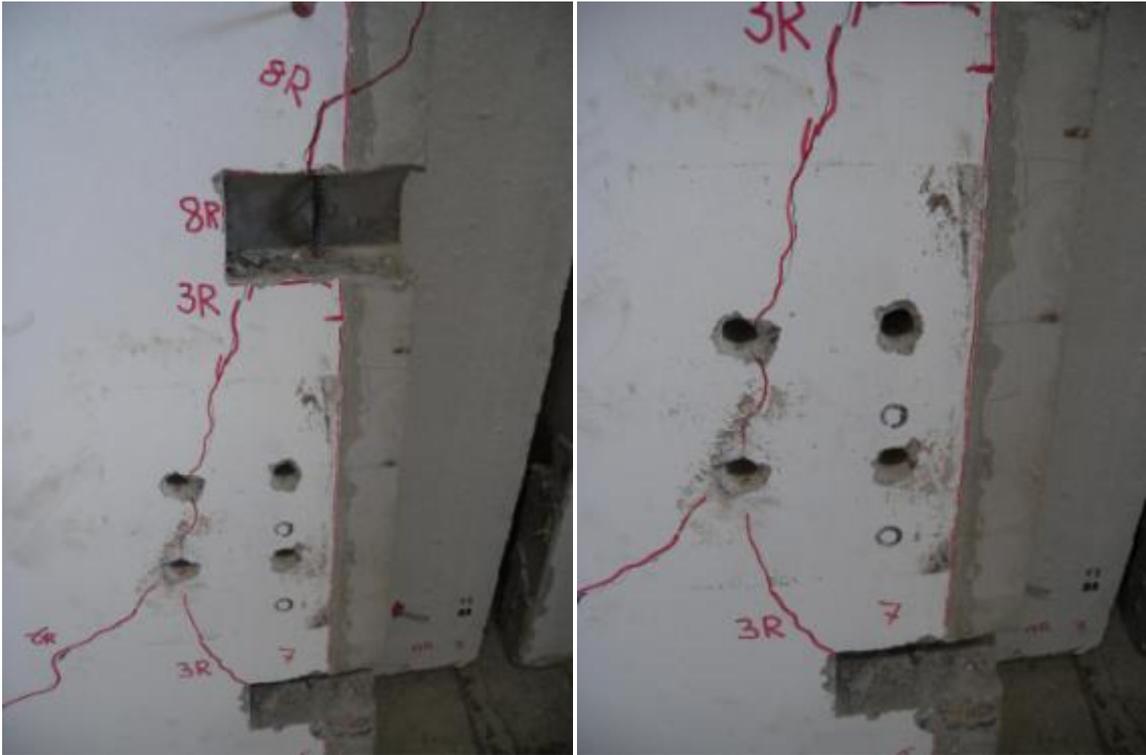
**Figure 369. Global and enlarged view of cracks beneath the steel plate of a clip angle.**

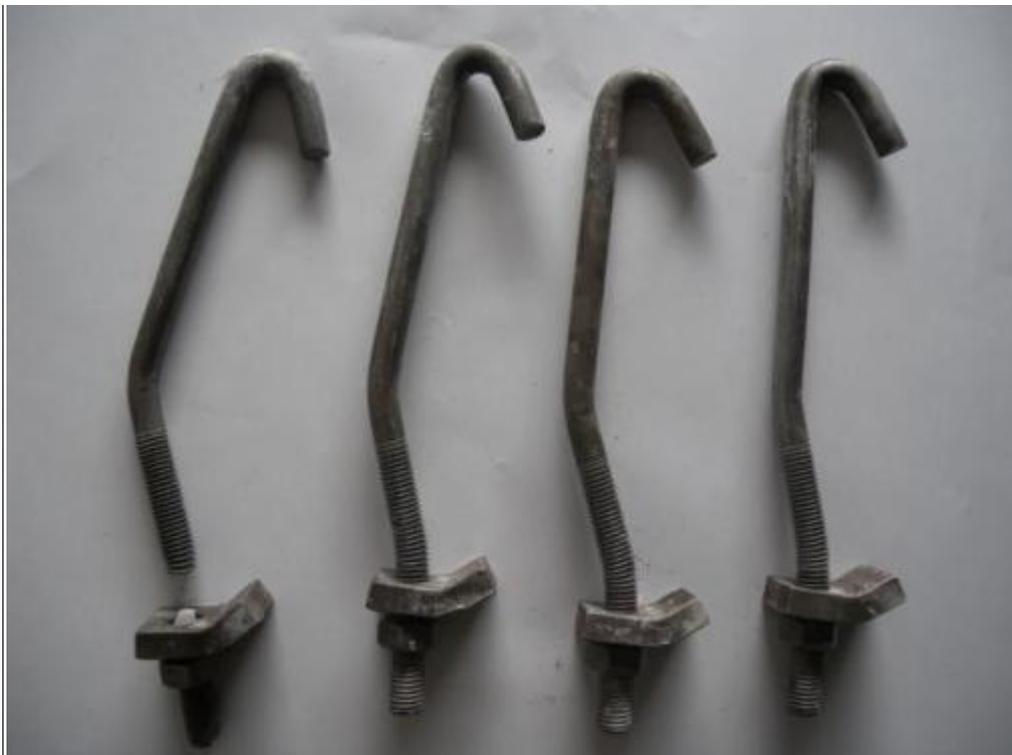
**Figure 370. Permanent bending of transversal connectors in each of the four three-way joints.**
