Full-Scale Shaking Table Test on a Dutch URM Cavity Wall Terraced House end-unit - – EUC-BUILD-6

M. Miglietta, L. Mazzella, L. Grottoli, G. Guerrini, F. Graziotti

EUCENTRE Italy, University of Pavia and IUSS Pavia

Date October 2018

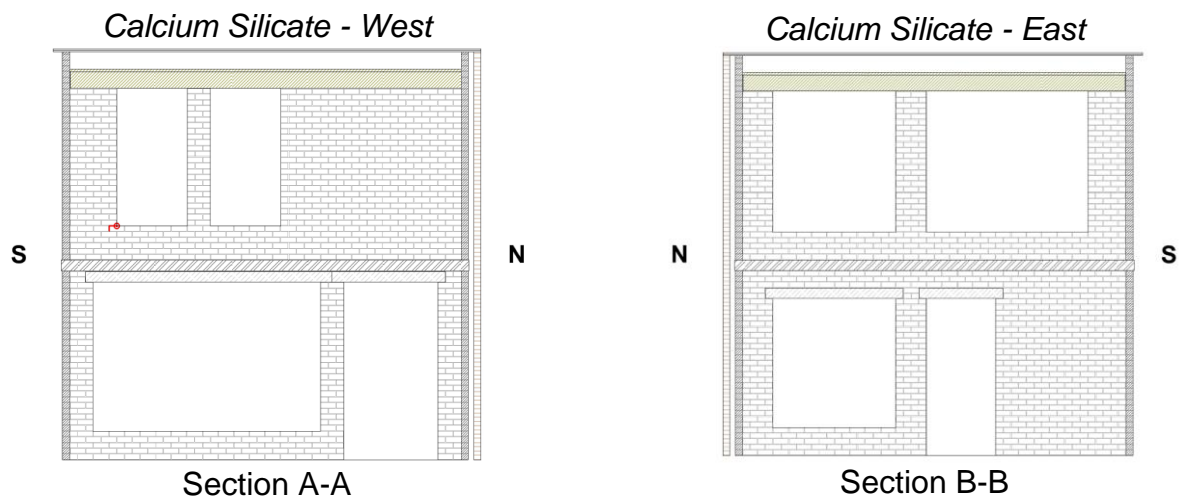
The survey carried out immediately after testing did not show any visible damage. Only a few hairline cracks were detected at the interfaces of pocket connections between roof timber joist-to-perpendicular walls (North and South facades, Figure 131 and Figure 134 a) as well as at the second-floor plank-to-wall interfaces (Figure 131 and Figure 134 b); and at the base of the second-floor pier of the Southern corner of the West façade (Figure 130 and Figure 135).

Figure 130 EQ-NPR 20% cracks - Calcium silicate longitudinal walls.

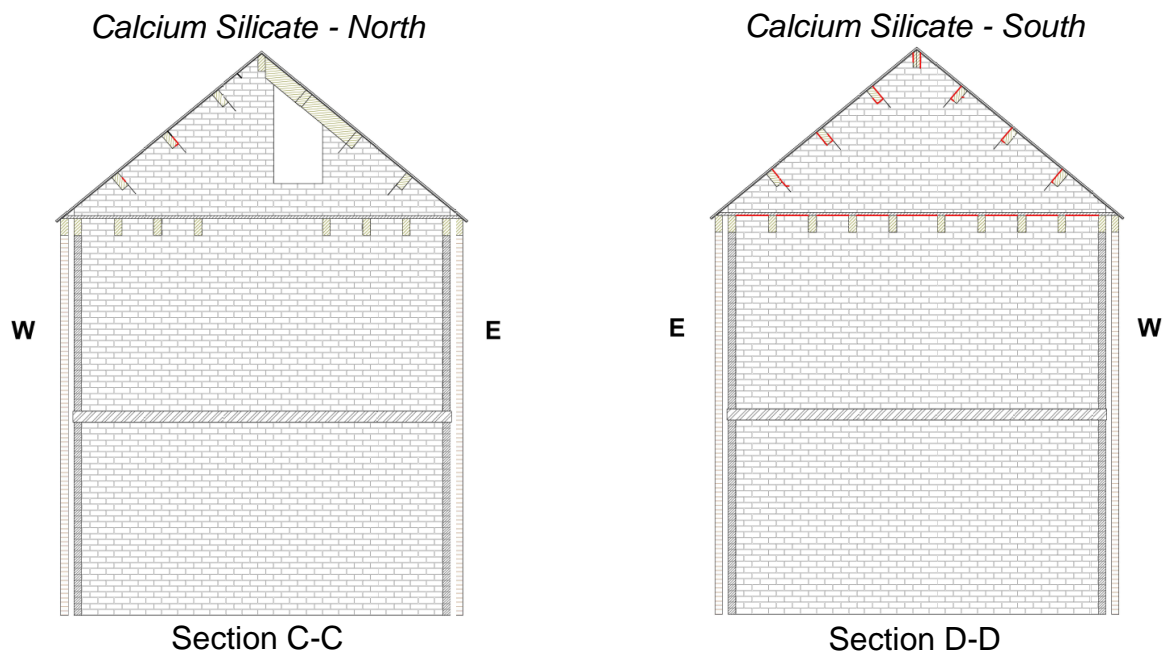
Figure 131 EQ-NPR 20% cracks - Calcium Silicate transversal walls.

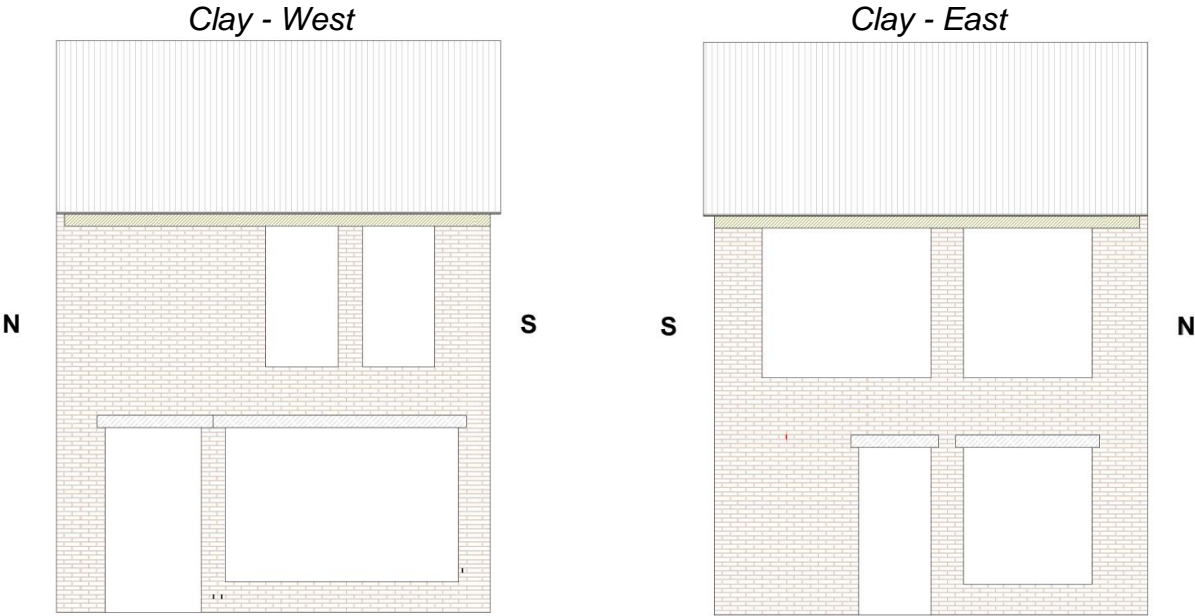
Figure 132 EQ-NPR 20% cracks – West and East clay façades.

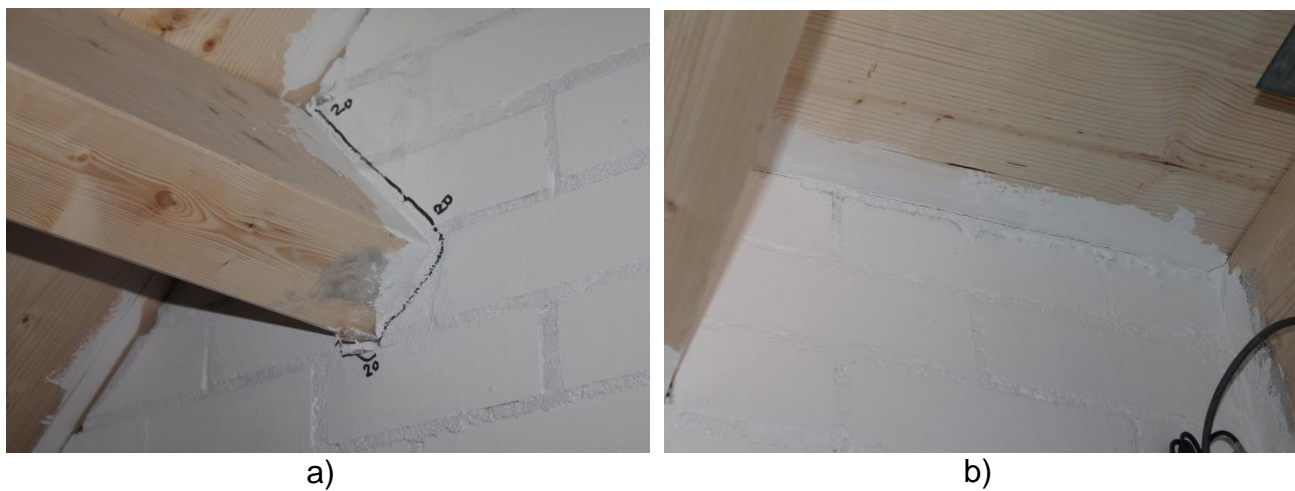
Figure 134 EQ-NPR 20% Cracks view: a) South façade roof joist-to-wall connection; b) plank-to-wall interface.

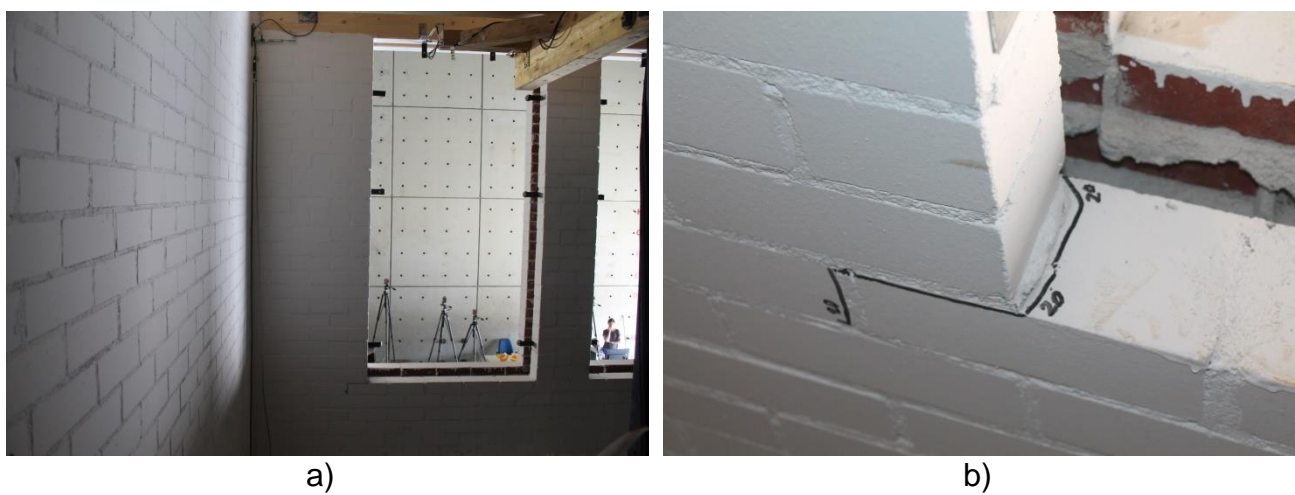
Figure 135 EQ-NPR 20% Cracks on the West facade: a) overall view; b) window corner.

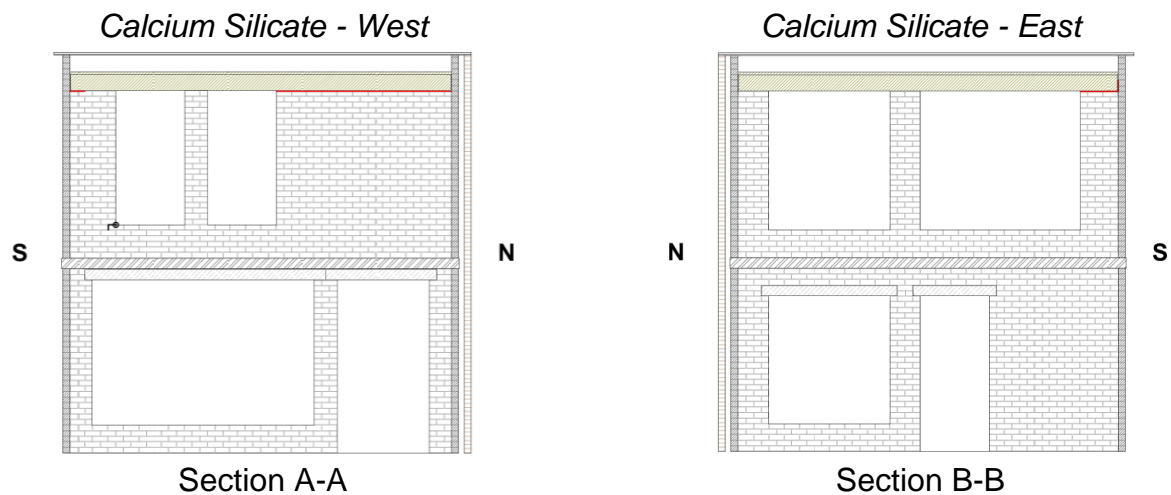
No appreciable extension of crack was found at the base of the first-floor pier of the West façade at its South corner (Figure 136 a).

Figure 136 EQ-NPR 33% cracks - Calcium silicate longitudinal walls.

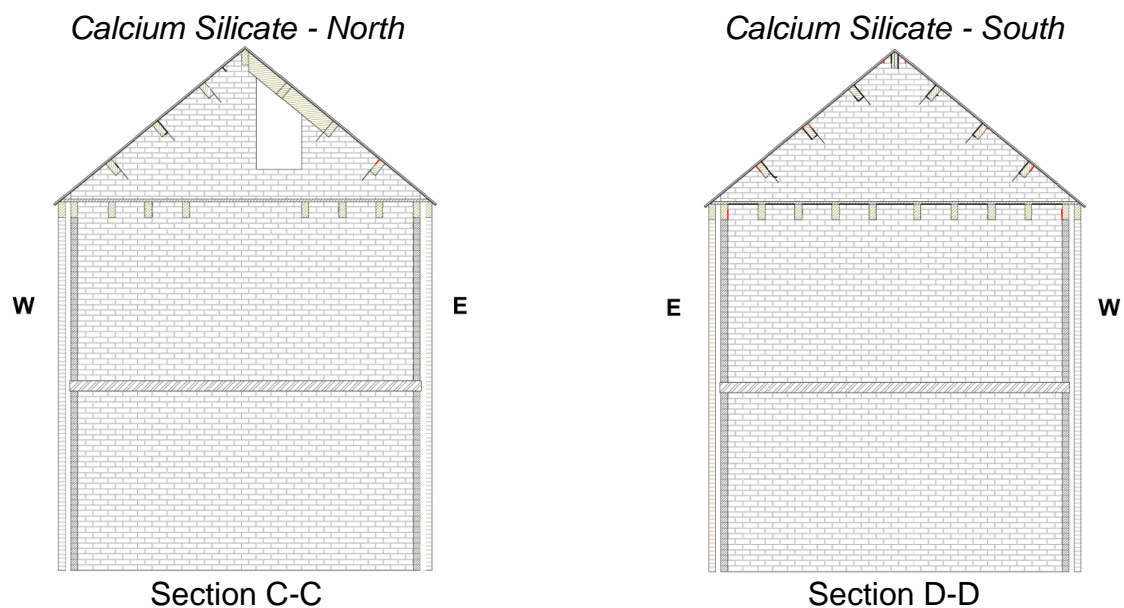
Figure 137 EQ-NPR 33% cracks - Calcium Silicate transverse walls.

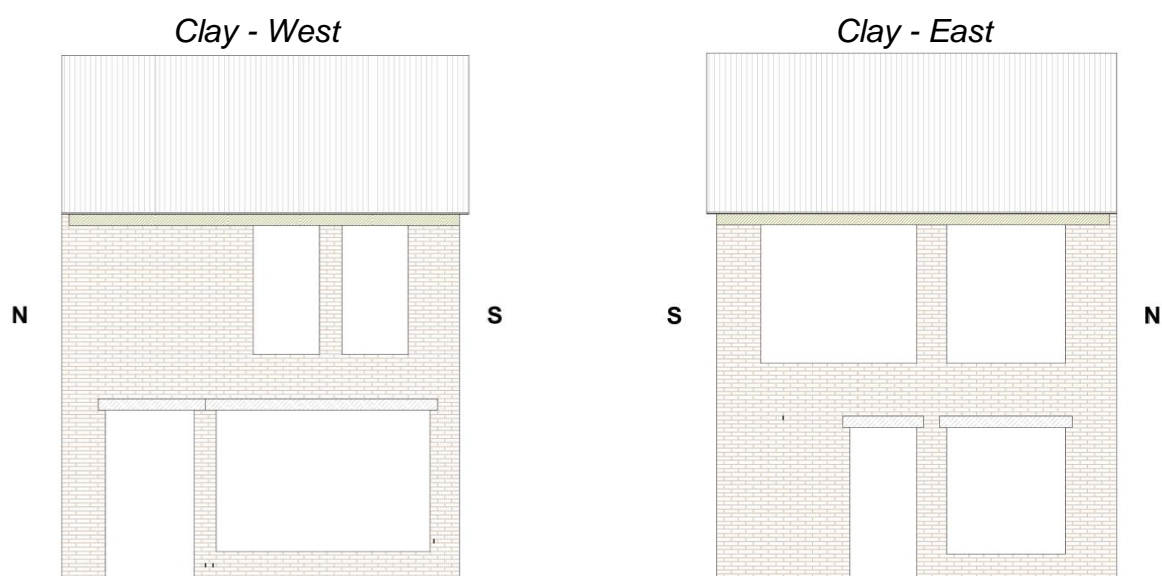
Figure 138 EQ-NPR 33% cracks – West and East clay façades.

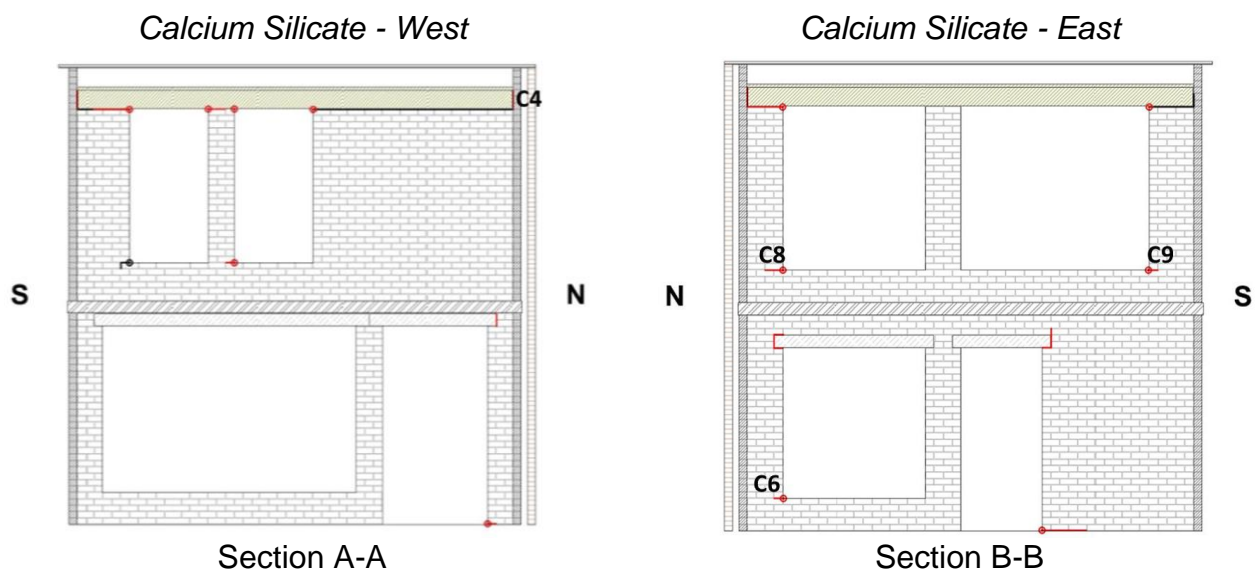
Moreover, some cracks developed at the interface between RC lintels and the calcium silicate inner leaf (Figure 143), as well as at the North and South façades roof joist-to-gable pocket connections (Figure 144).

Figure 143 EQ-NPR 50% cracks - Calcium silicate longitudinal walls.

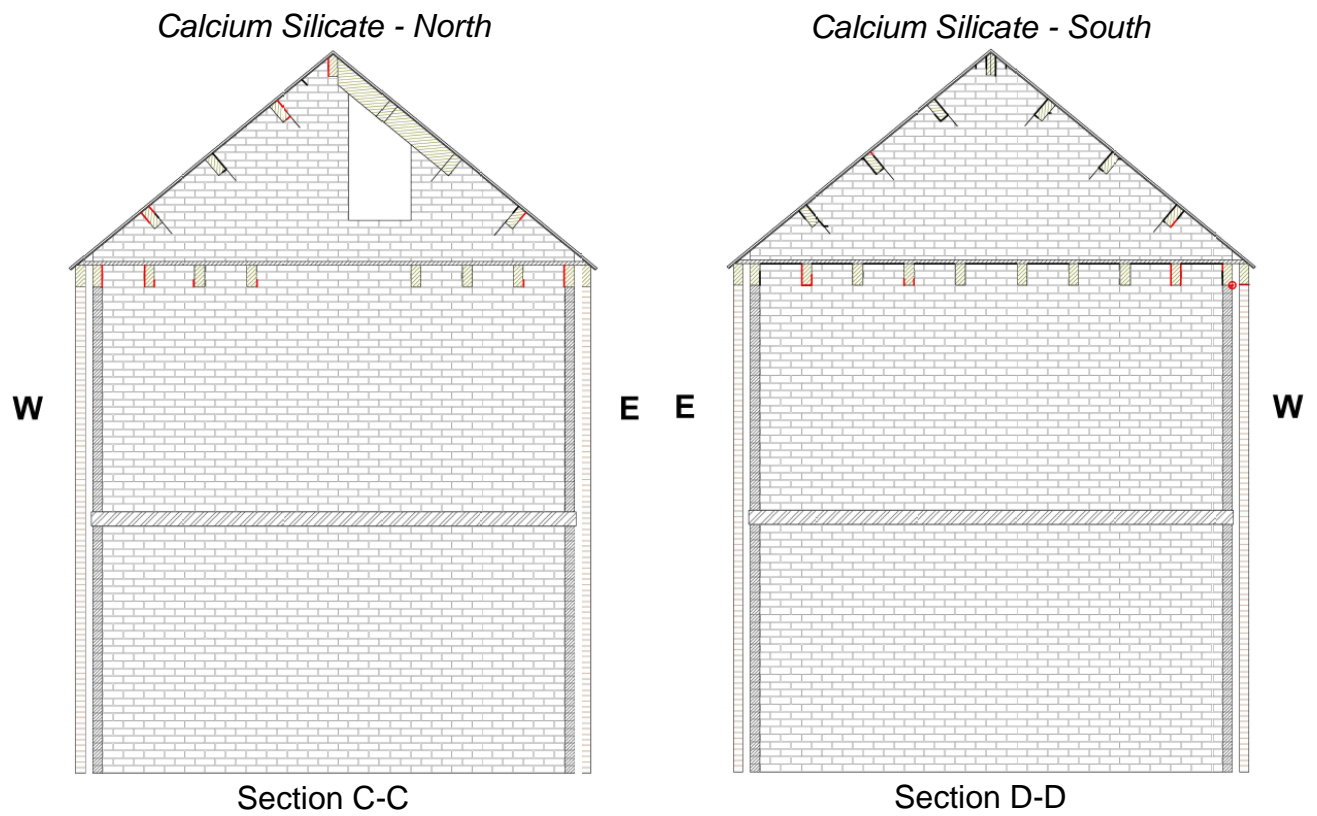
Figure 144 EQ-NPR 50% cracks - Calcium silicate transverse walls.

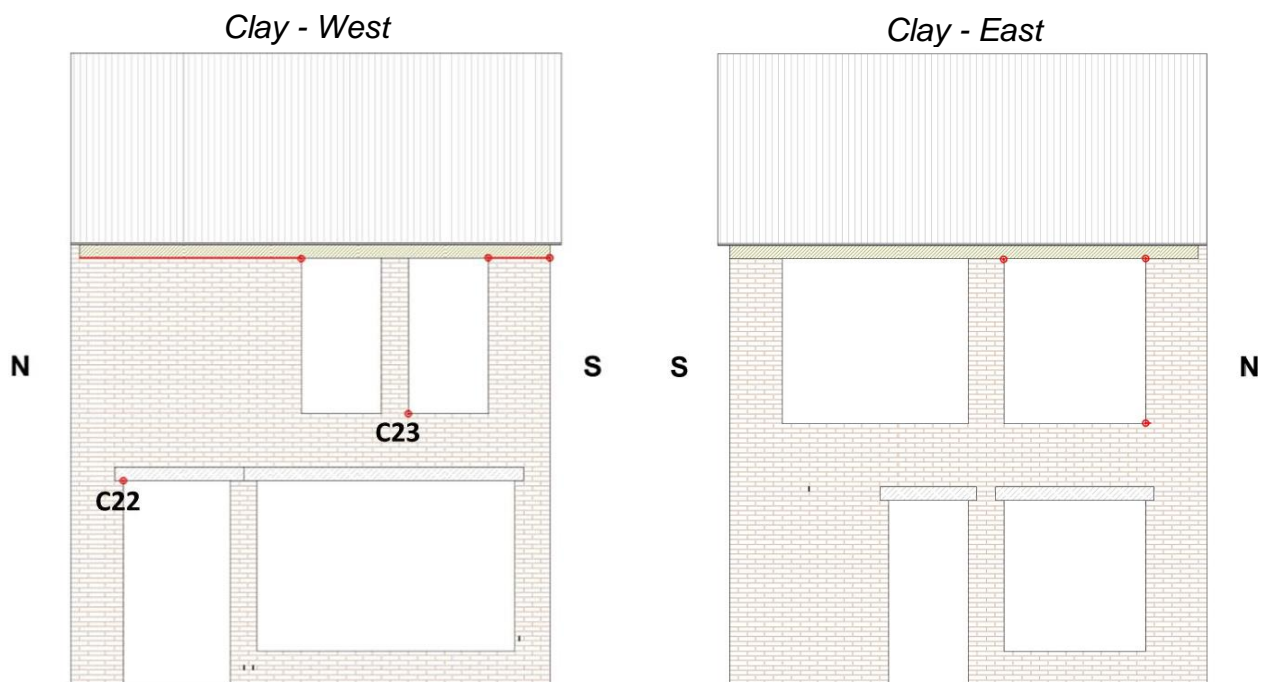
Figure 145 EQ-NPR 50% cracks – West and East clay façades.

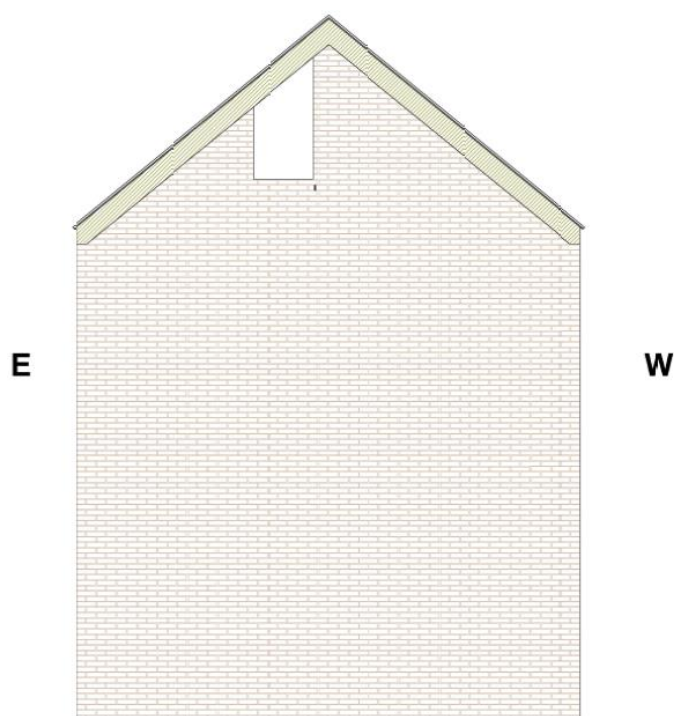
Figure 146 EQ-NPR 50% cracks – North clay façade.

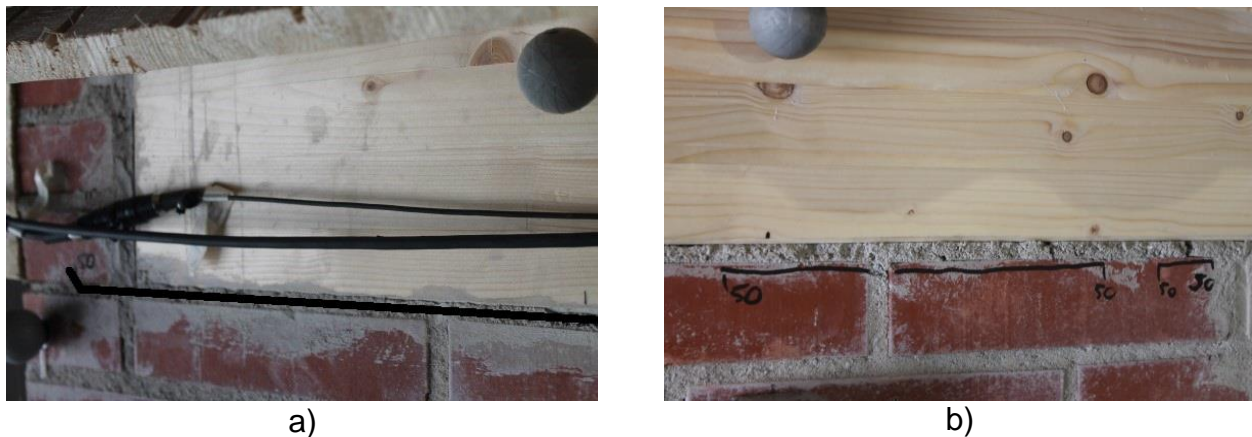
Figure 149 EQ-NPR 50% sliding cracks: between timber spreader beam and West façade outer leaf: a) North end; b) mid-span.

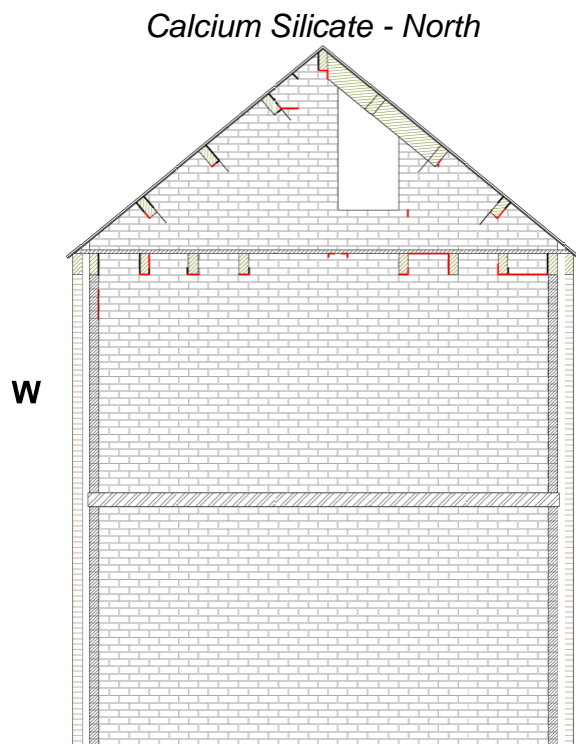
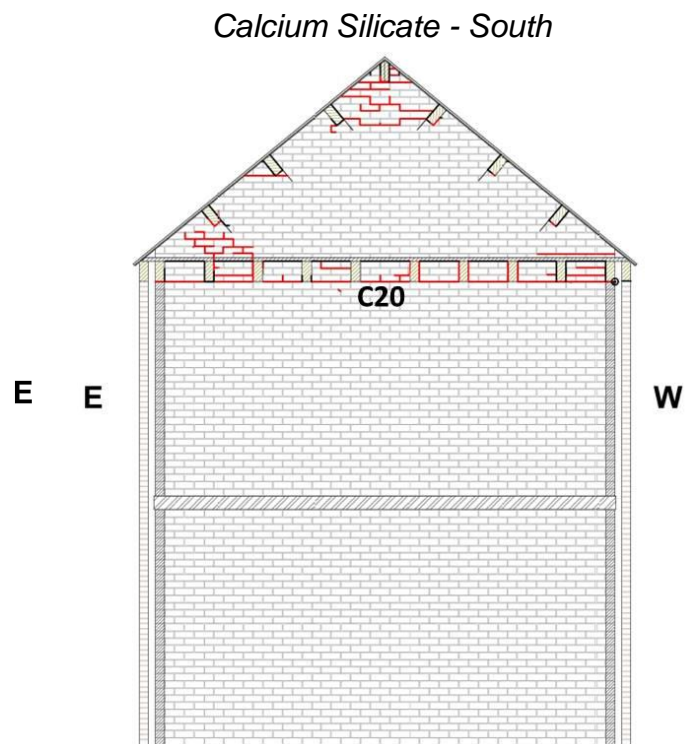
Figure 151 EQ-NPR 66% cracks - Calcium silicate transverse walls.

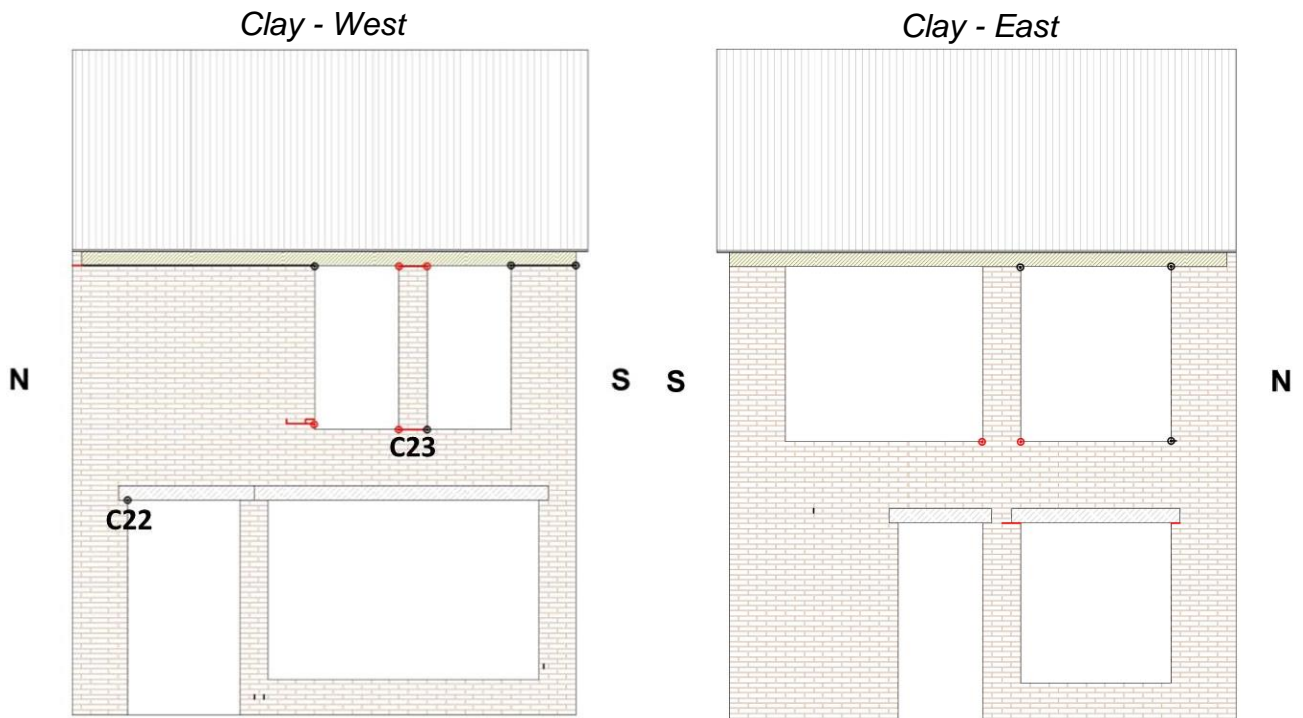
Figure 152 EQ-NPR 66% cracks – West and East clay façade.

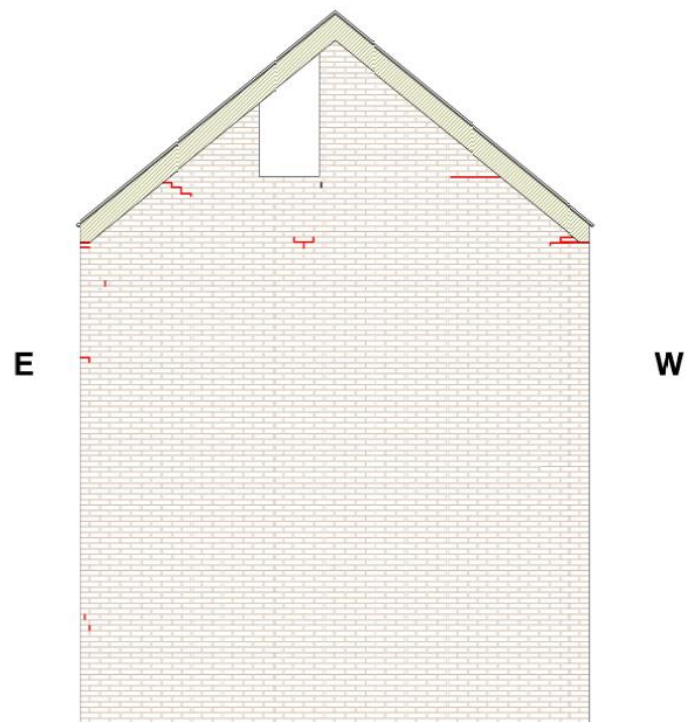
Figure 153 EQ-NPR 66% cracks – North clay façade.

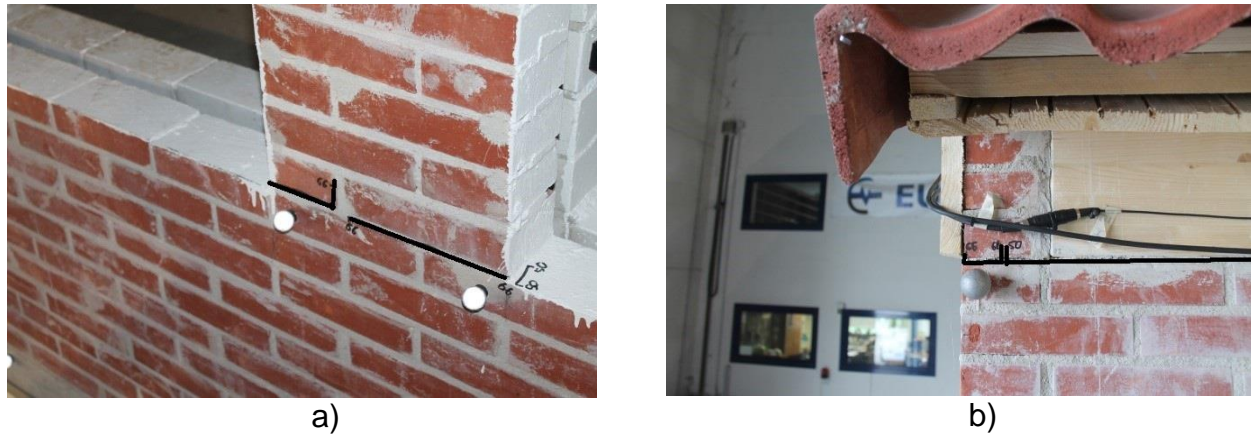
Figure 157 EQ-NPR 66% cracks: a) C23; b) C25.

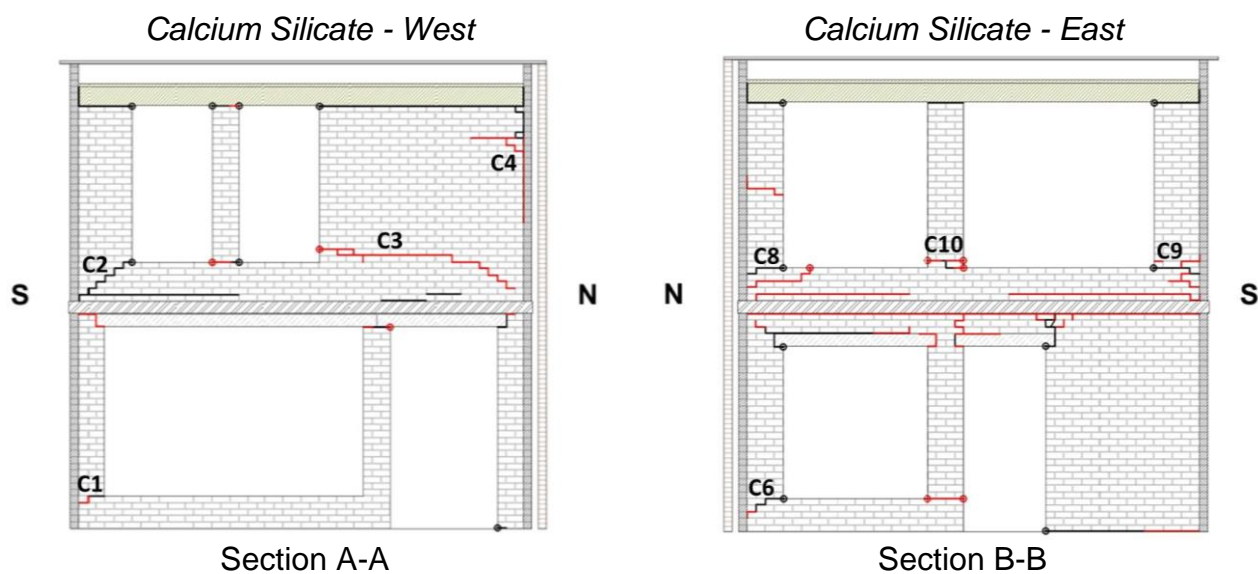
Figure 158 EQ-NPR 85% cracks - Calcium silicate longitudinal walls.

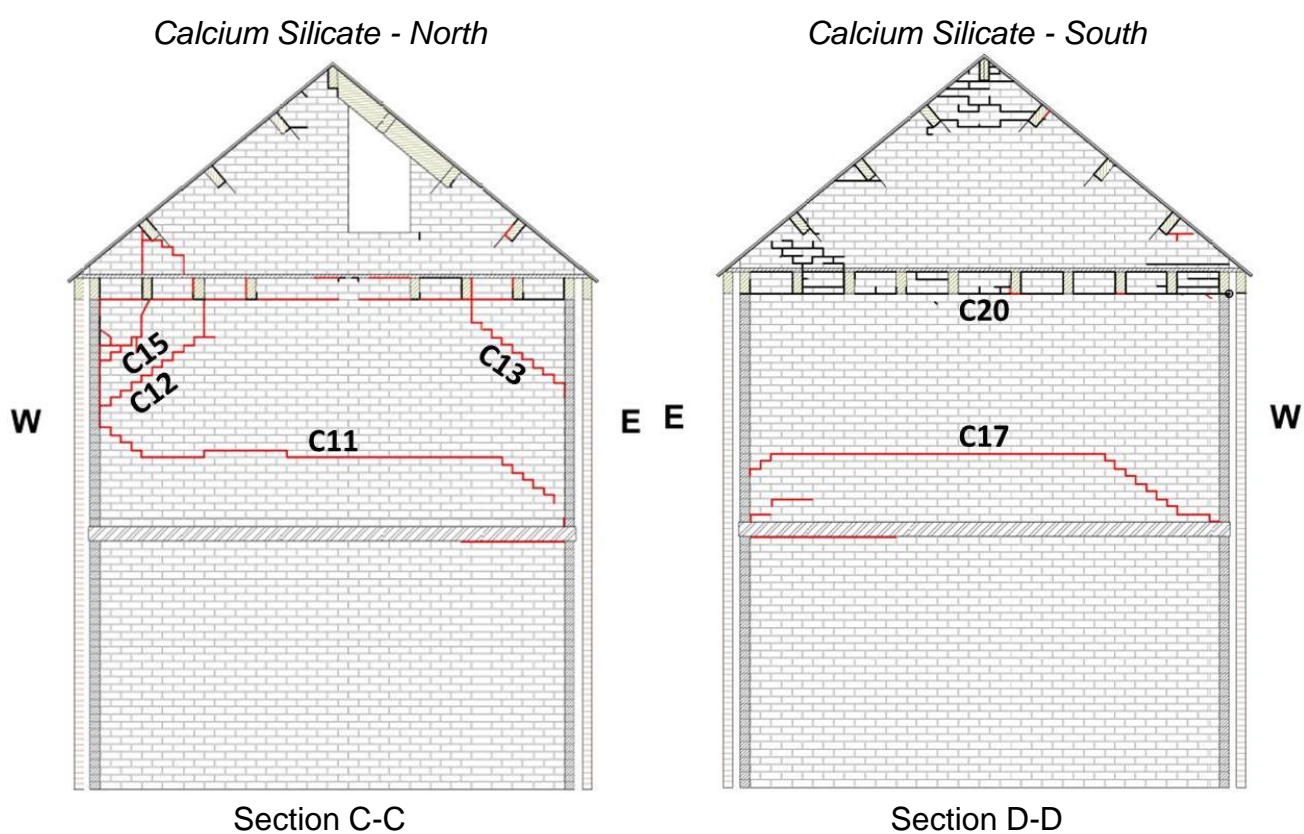
Figure 159 EQ-NPR 85% cracks - Calcium silicate transversal walls.

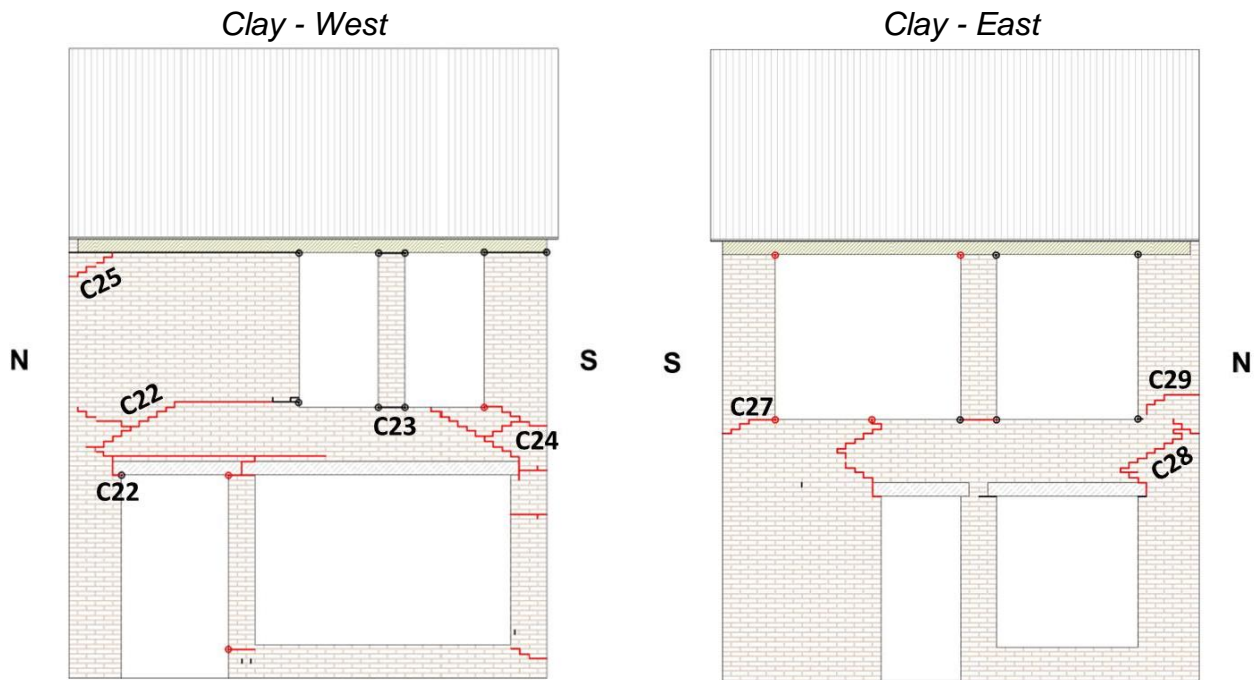
Residual cracks widths after the test were negligible except for crack C24 (Figure 160 and Figure 164), which accumulated around 1 mm.

Figure 160 EQ-NPR 85% cracks – West and East clay façades.

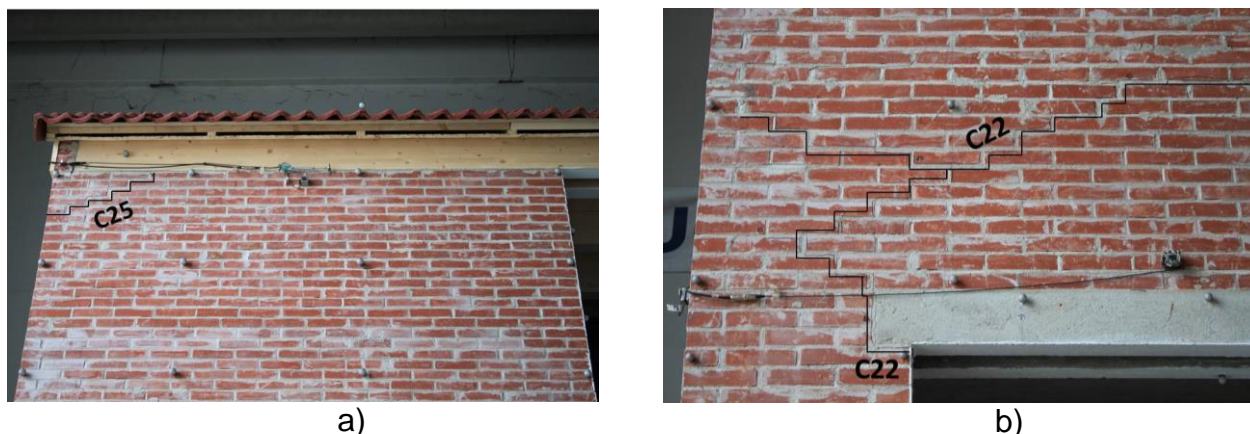
Figure 165 EQ-NPR 85% cracks: a) C25; b) C22.

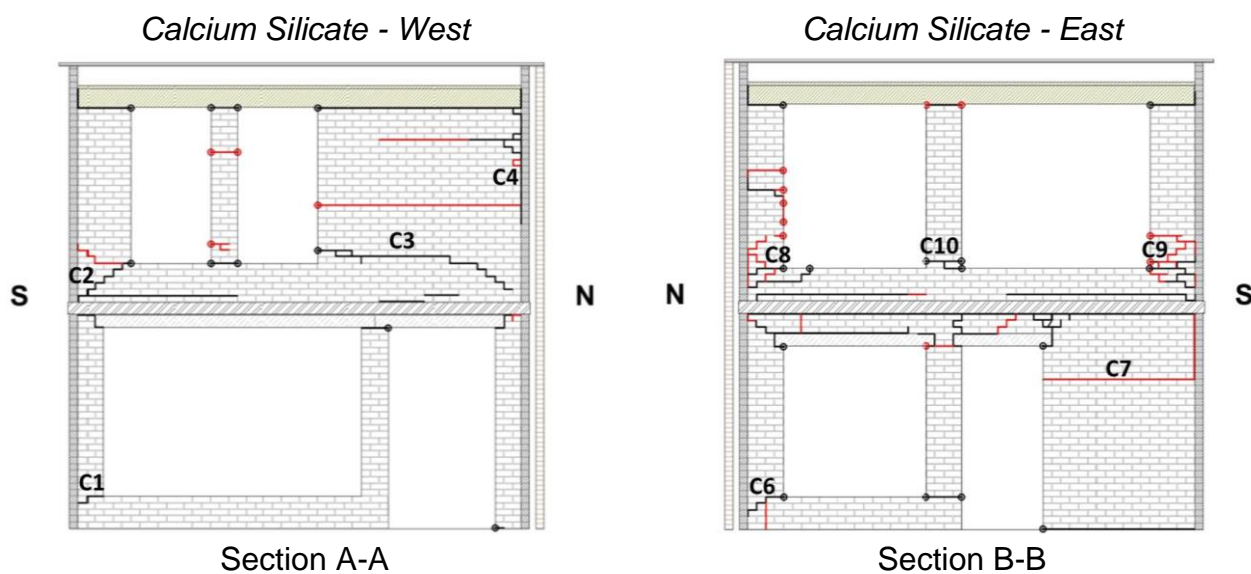
After this test, residual cracks widths became significant: C29 (Figure 168 and Figure 174) C4 (Figure 166 and Figure 171) reached around 1.2 cm; C8 (Figure 166 and Figure 170), C13 (Figure 167 and Figure 170) and C31 (Figure 169, Figure 173 and Figure 174), accumulated 2 cm, 1.5 cm and 1.5 cm respectively, in their out-of-plane directions.

Figure 166 EQ-NPR 100% cracks - Calcium silicate longitudinal walls.

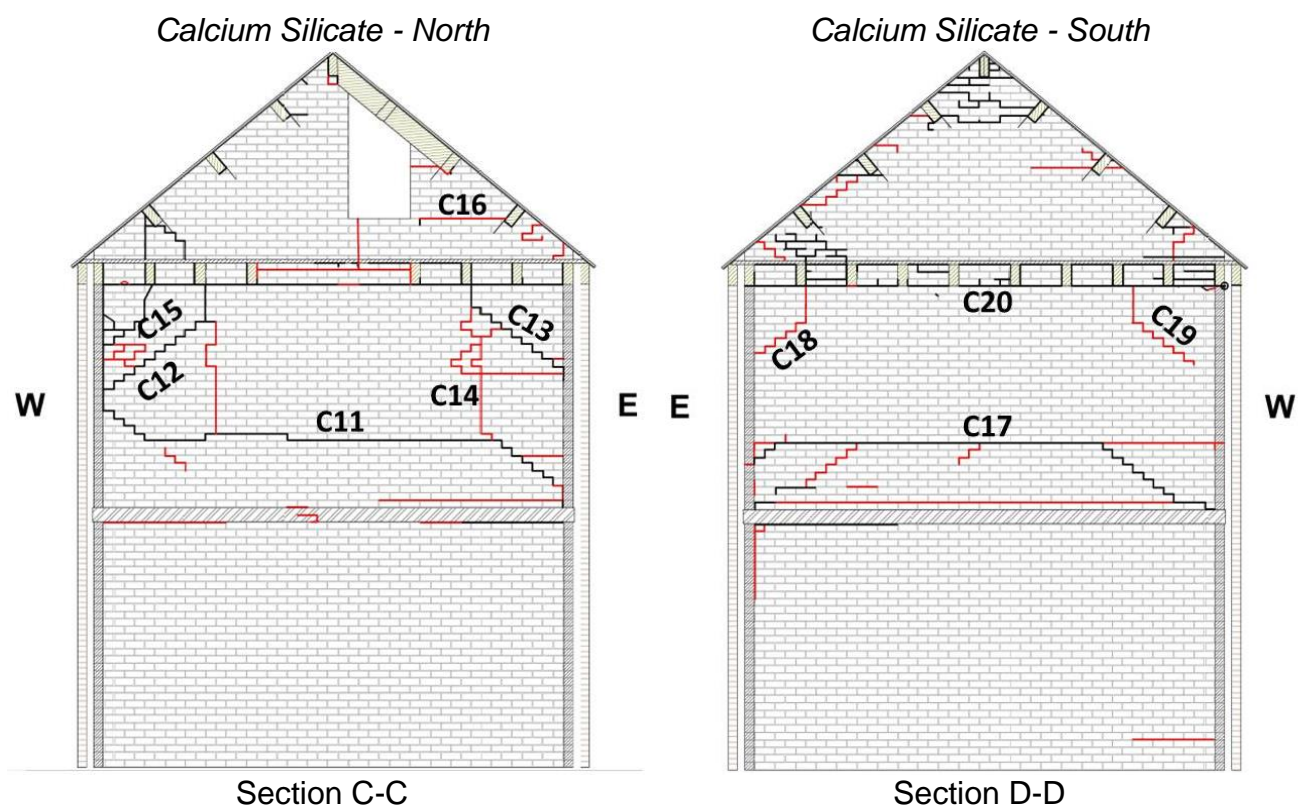
Figure 167 EQ-NPR 100% cracks - Calcium silicate transversal walls.

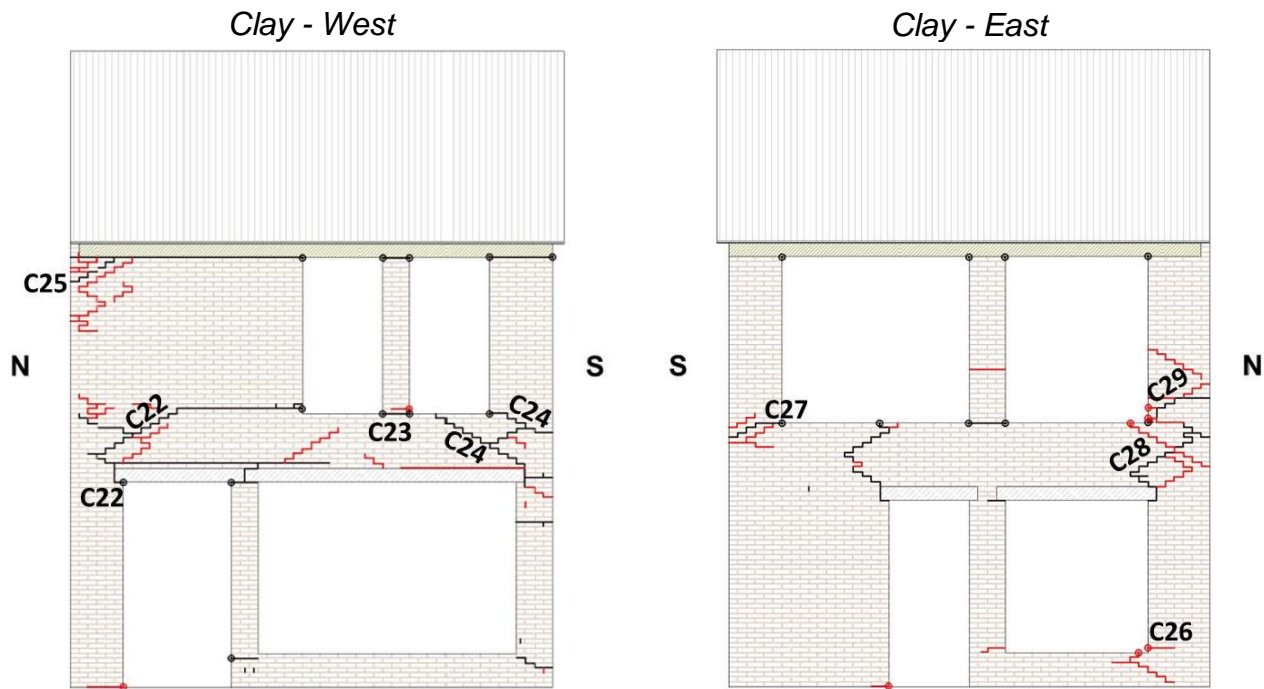
Figure 168 EQ-NPR 100% cracks – West and East clay façades

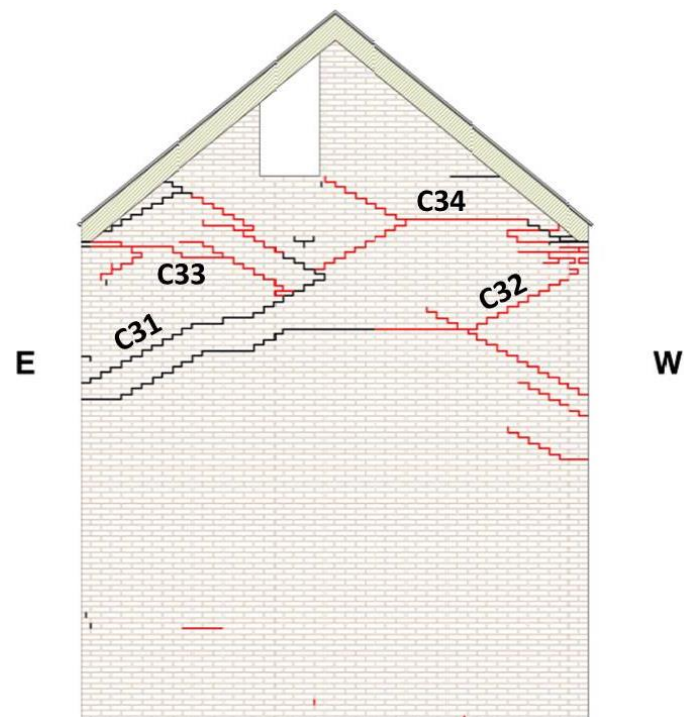
Figure 169 EQ-NPR 100% cracks – North clay façade.

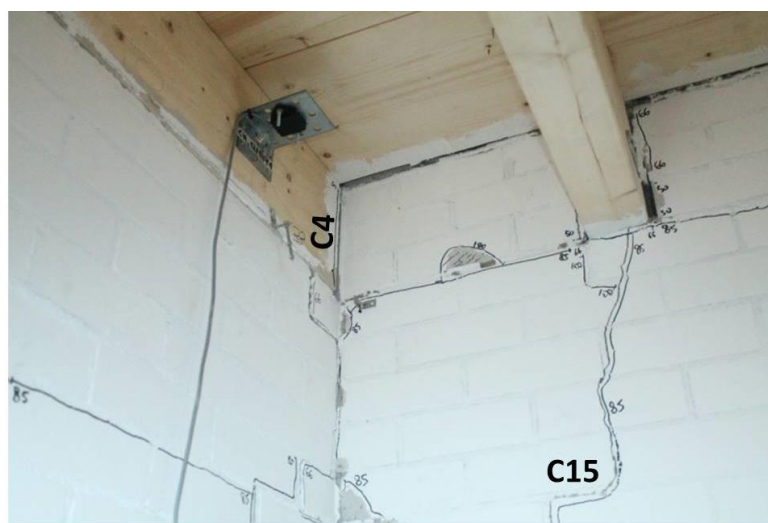
Figure 171 EQ-NPR 100% cracks: a) C4, C11, C12 and C15 overview; b) C4 and C15 zoom in.

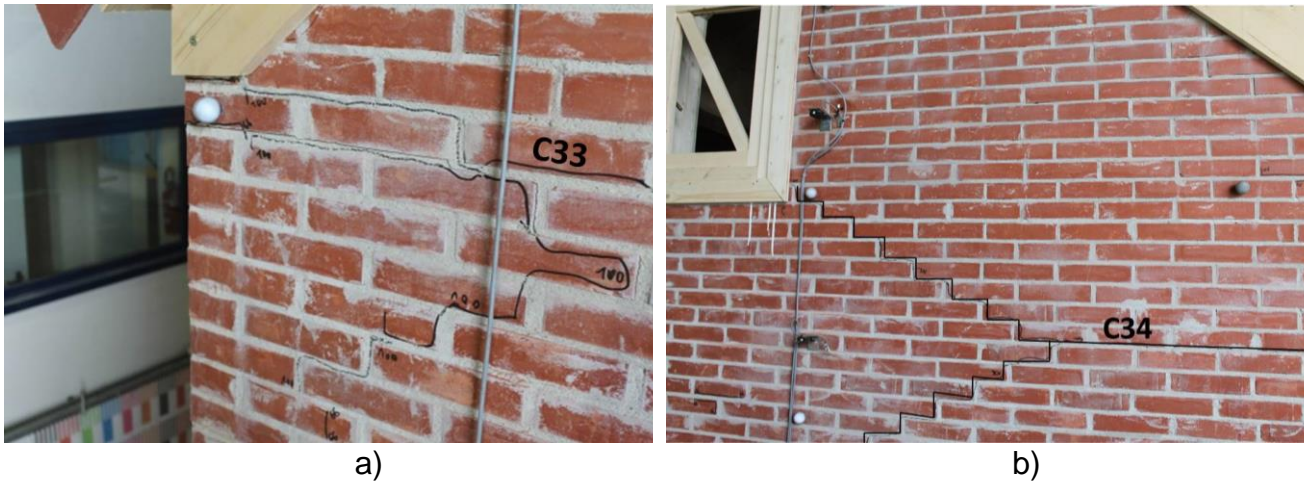
Figure 172 EQ-NPR 100% cracks: a) C33; b) C34.

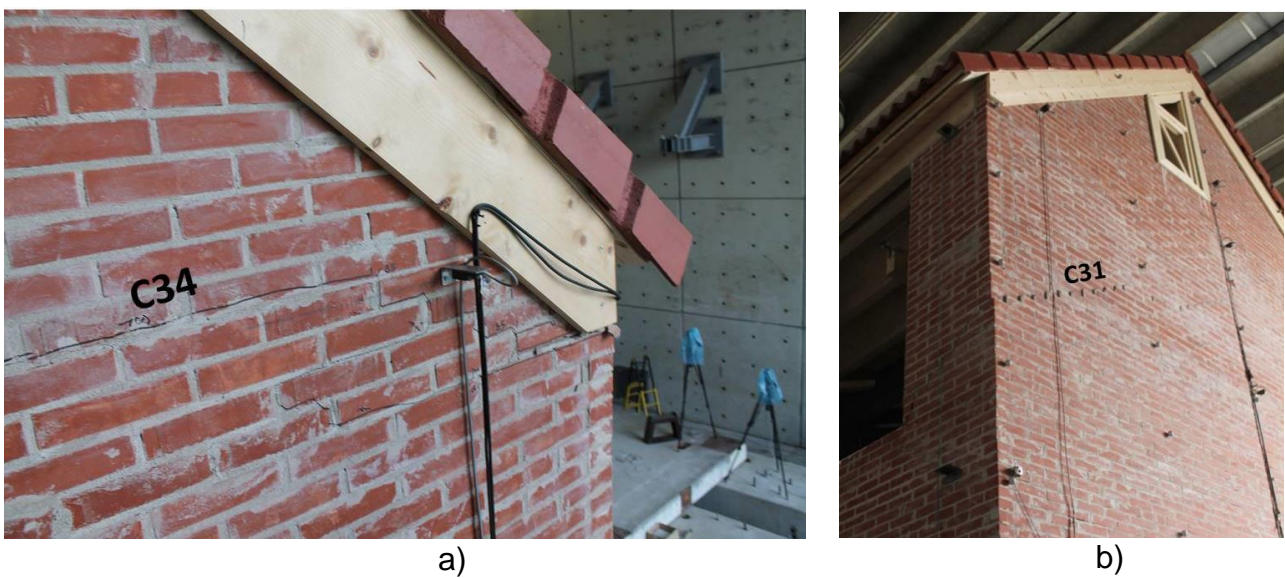
Figure 173 EQ-NPR 100% cracks: a) C34; b) C31.

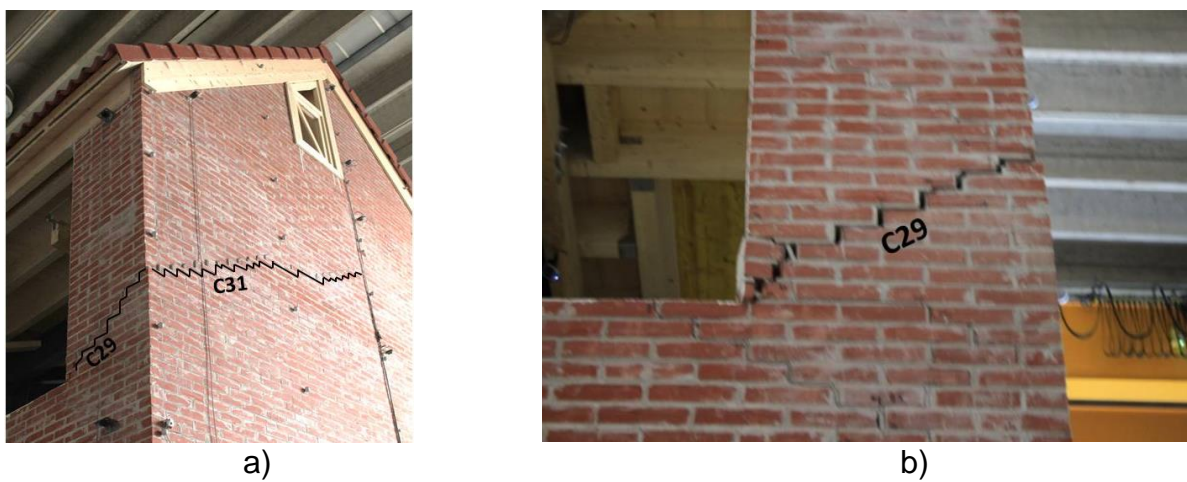
Figure 174 EQ-NPR 100% cracks: a) C29, C31 overview; b) C29 zoom in.

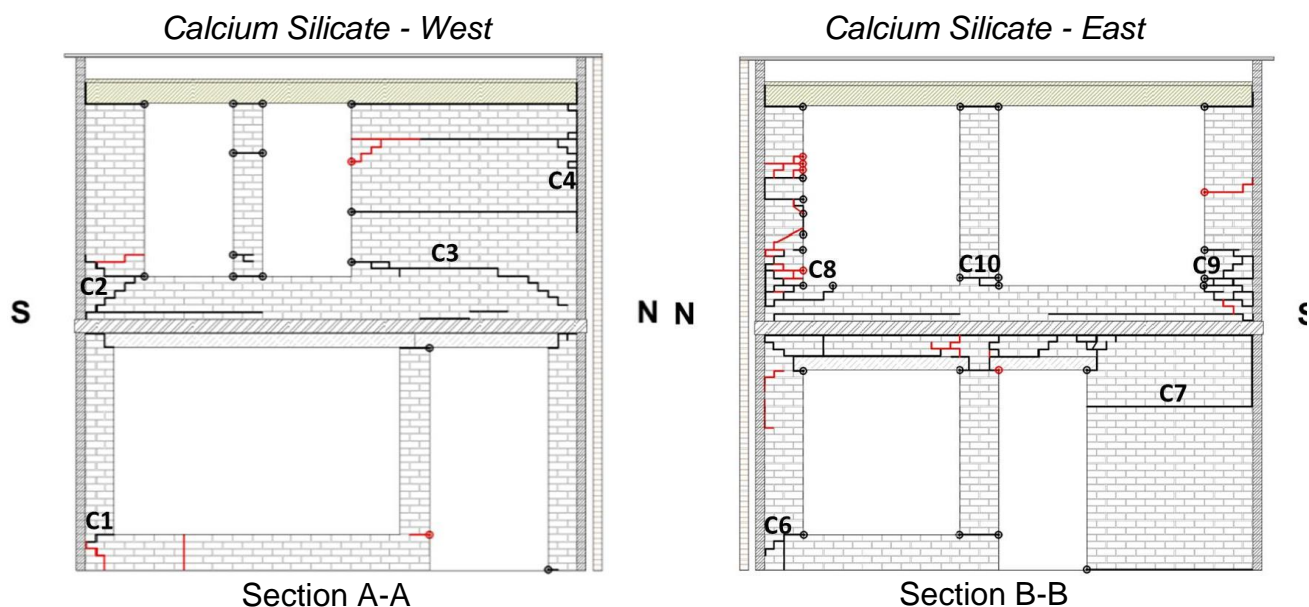
Considering the calcium silicate walls, on the West façade (Figure 175), crack C4 showed 3 cm of residual width (Figure 179); crack C13, on the North façade (Figure 176), led to loss of bricks on the East façade (Figure 181 and Figure 182); crack C14 on the North side (Figure 176) accumulated 3.5 cm (Figure 176, Figure 181 and Figure 183). Considering the clay walls (Figure 177 and Figure 178), the most significant damage was observed on the North façade: cracks C31 and C33 ended with about 3 cm of residual width (Figure 186, Figure 187). Moreover, other cracks (such as C22, Figure 177 and Figure 184; C24 and C25, Figure 177 and Figure 185) showed residual displacements around 1 cm (see Table 25).

Figure 175 EQ-NPR IS 133% cracks - Calcium silicate longitudinal walls.
