Full-Scale Shaking Table Test on a Dutch URM Cavity Wall Terraced House end-unit - – EUC-BUILD-6

M. Miglietta, L. Mazzella, L. Grottoli, G. Guerrini, F. Graziotti

EUCENTRE Italy, University of Pavia and IUSS Pavia

Date October 2018

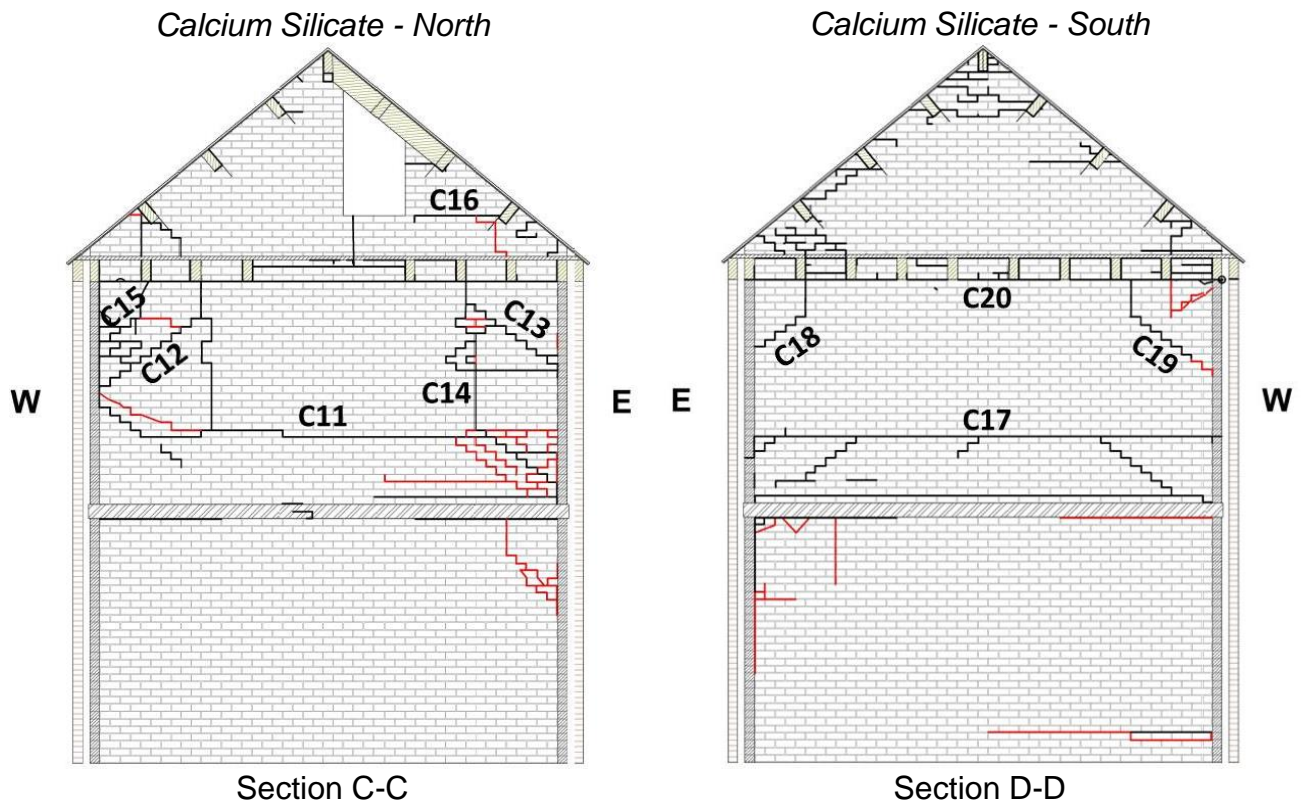
Considering the calcium silicate walls, on the West façade (Figure 175), crack C4 showed 3 cm of residual width (Figure 179); crack C13, on the North façade (Figure 176), led to loss of bricks on the East façade (Figure 181 and Figure 182); crack C14 on the North side (Figure 176) accumulated 3.5 cm (Figure 176, Figure 181 and Figure 183). Considering the clay walls (Figure 177 and Figure 178), the most significant damage was observed on the North façade: cracks C31 and C33 ended with about 3 cm of residual width (Figure 186, Figure 187). Moreover, other cracks (such as C22, Figure 177 and Figure 184; C24 and C25, Figure 177 and Figure 185) showed residual displacements around 1 cm (see Table 25).

Figure 176 EQ-NPR IS 133% cracks - Calcium silicate transversal walls.

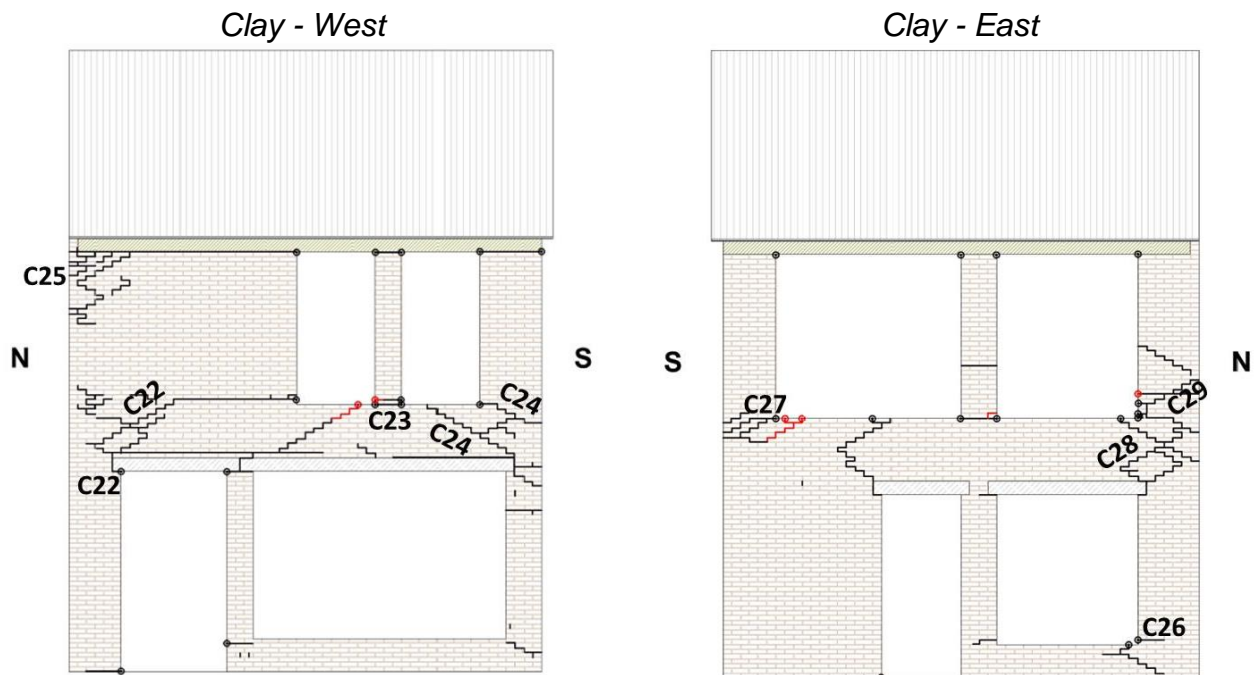
Figure 177 EQ-NPR IS 133% cracks - West and East clay façades.

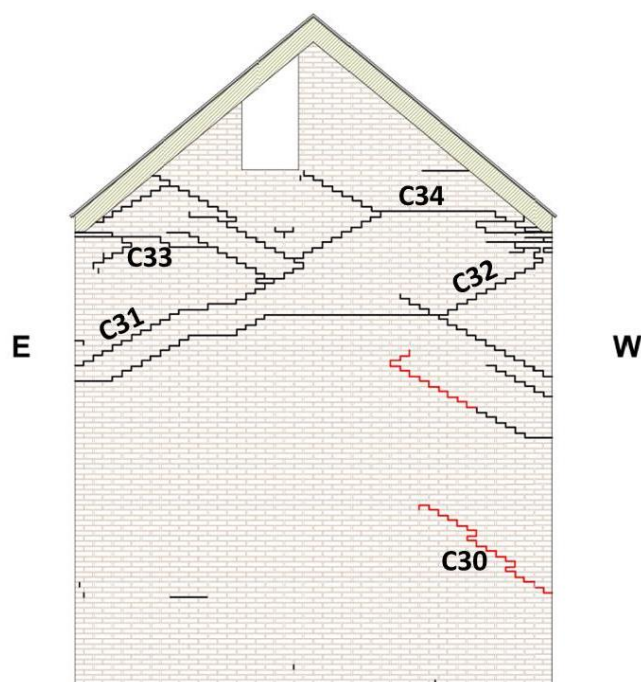
Figure 178 EQ-NPR IS 133% cracks - North clay façade.

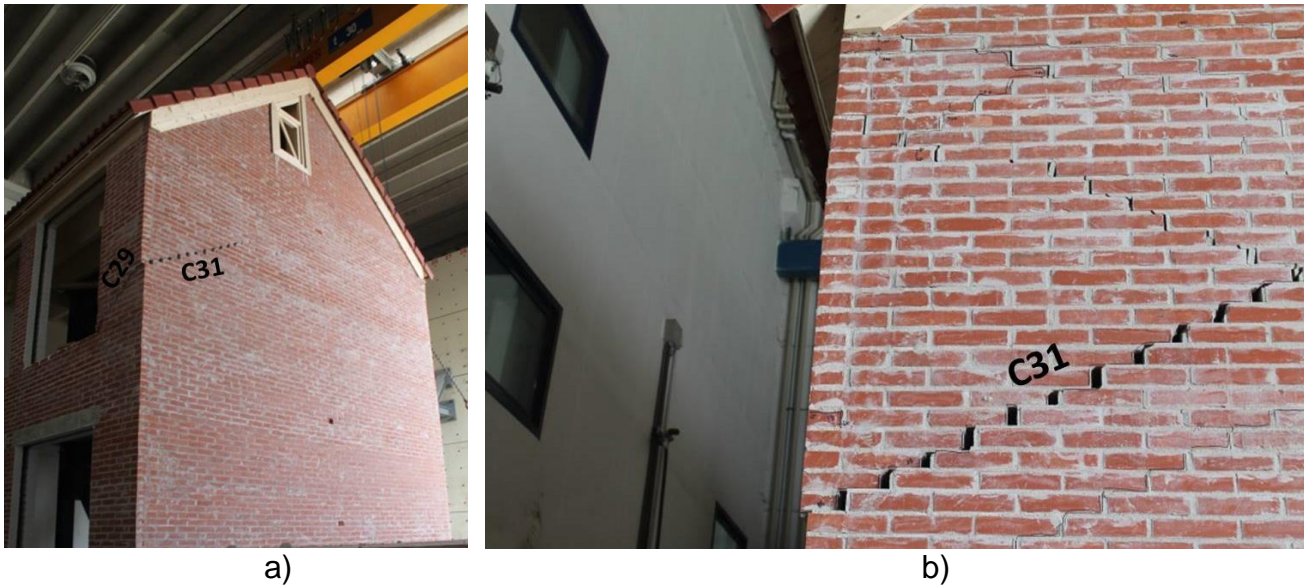
Figure 186 EQ-NPR IS 133% cracks: a) C29 and C31 overview; b) C31 zoom in.

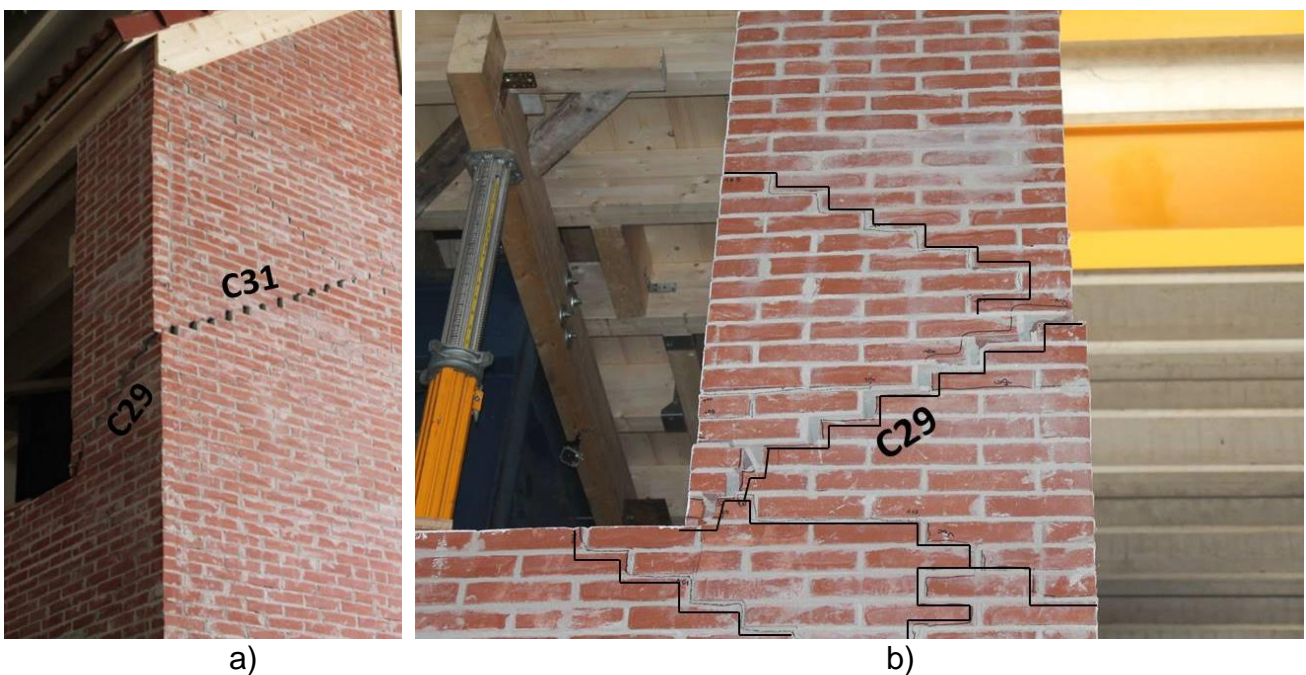
Figure 187 EQ-NPR IS 133% cracks: a) C29, C31 overview; b) C29 zoom in.

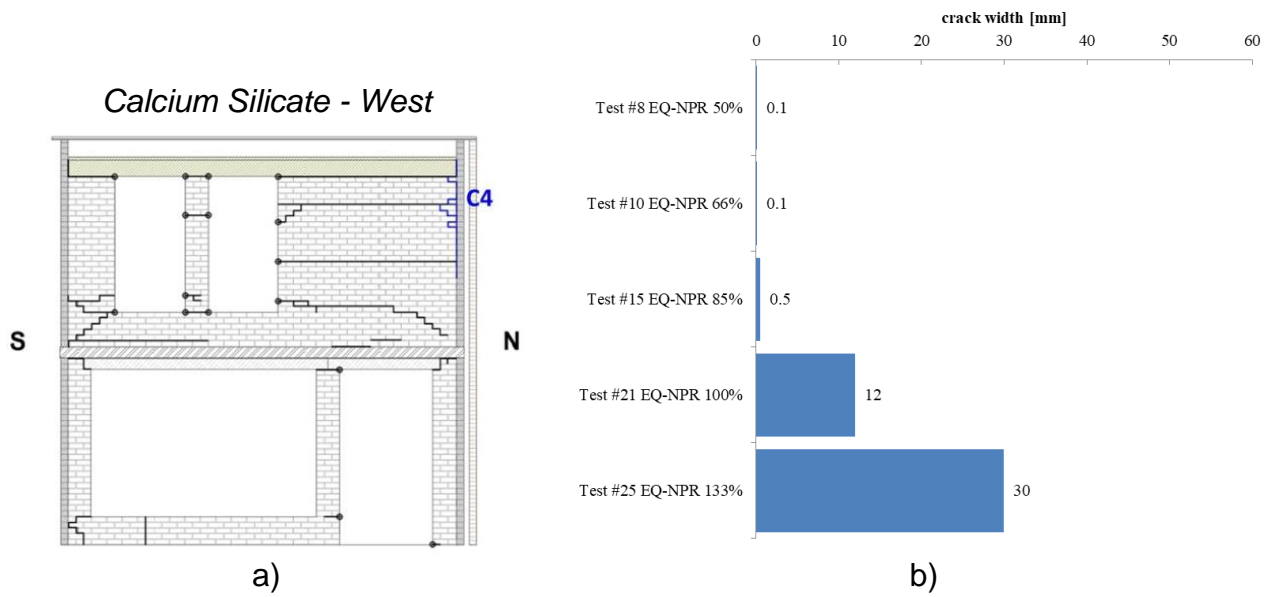
Figure 188 Crack C4 evolution: a) location; b) in-plane residual widths.

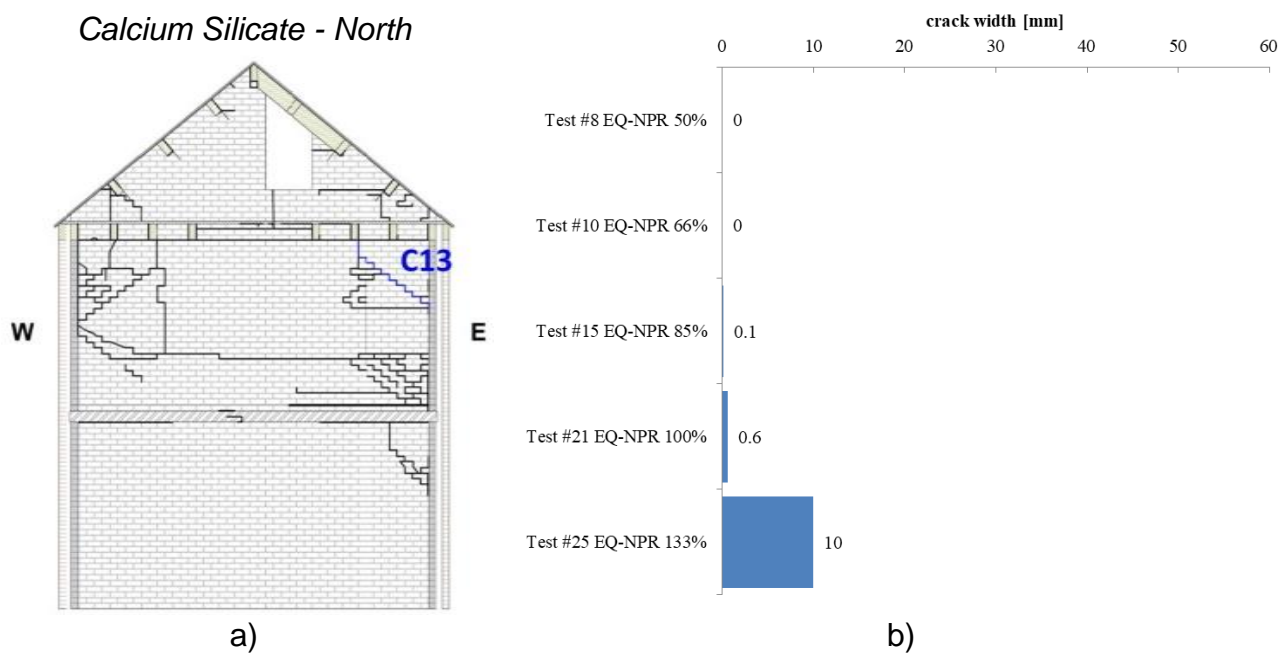
Figure 191 Cracks C4, C13 evolution: a) location; b) in-plane residual widths.

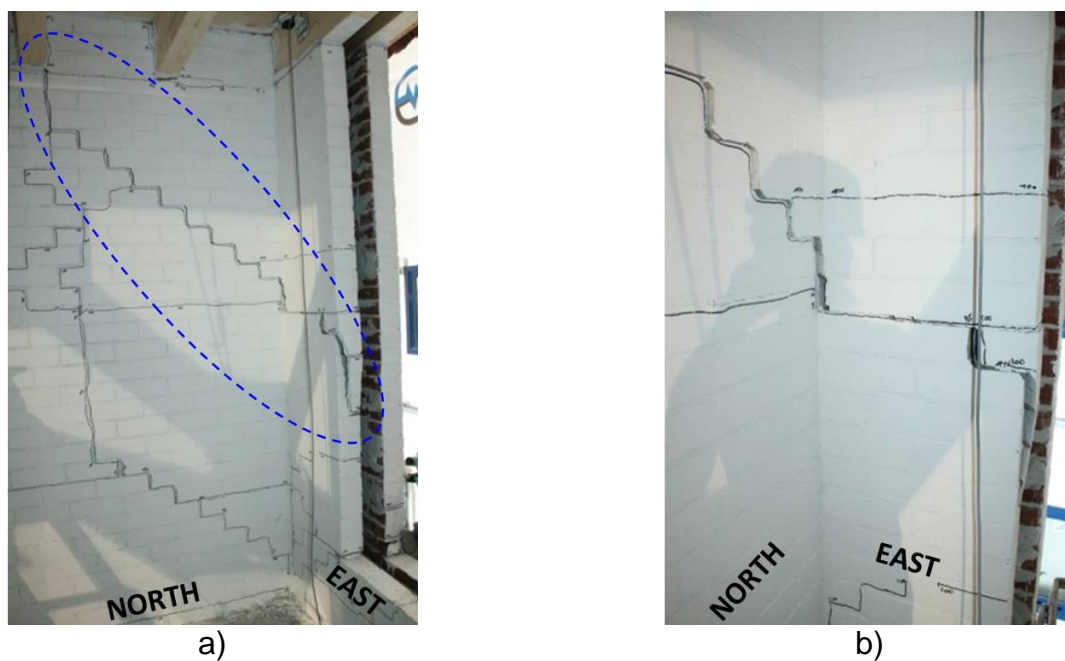
Figure 192 Crack C13 after EQ-NPR 100%: a) overview; b) North-East walls intersection.

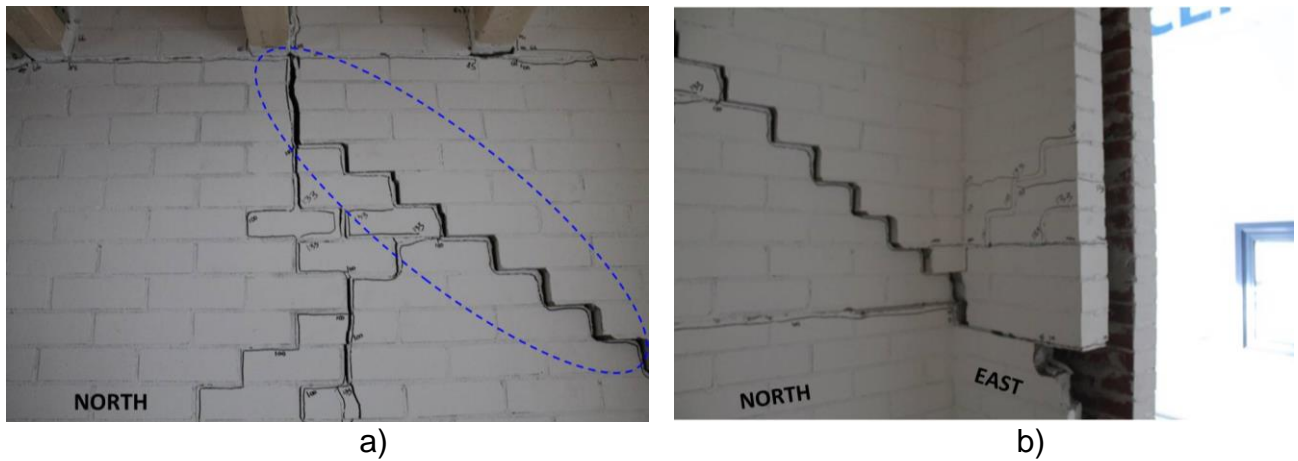
Figure 193 Crack C13 after EQ-NPR IS 133%: a) looking North; b) North-East walls intersection.

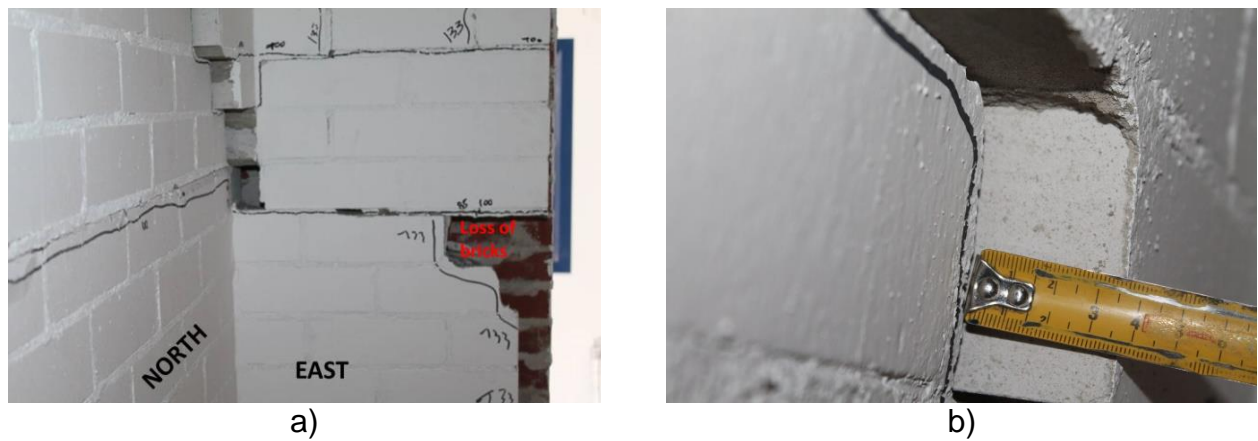
Figure 194 Cracks C13 after EQ-NPR IS 133%: a) looking East; b) Out-of-plane residual width zoom in.

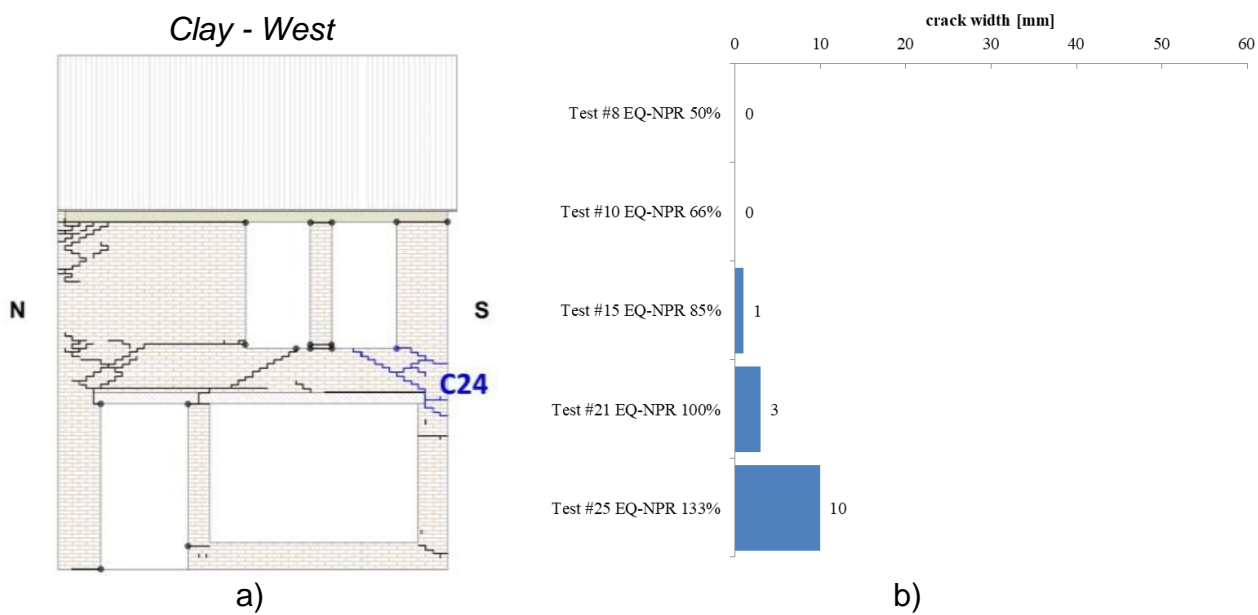
Figure 195 Cracks C24 evolution: a) location; b) in-plane residual widths.

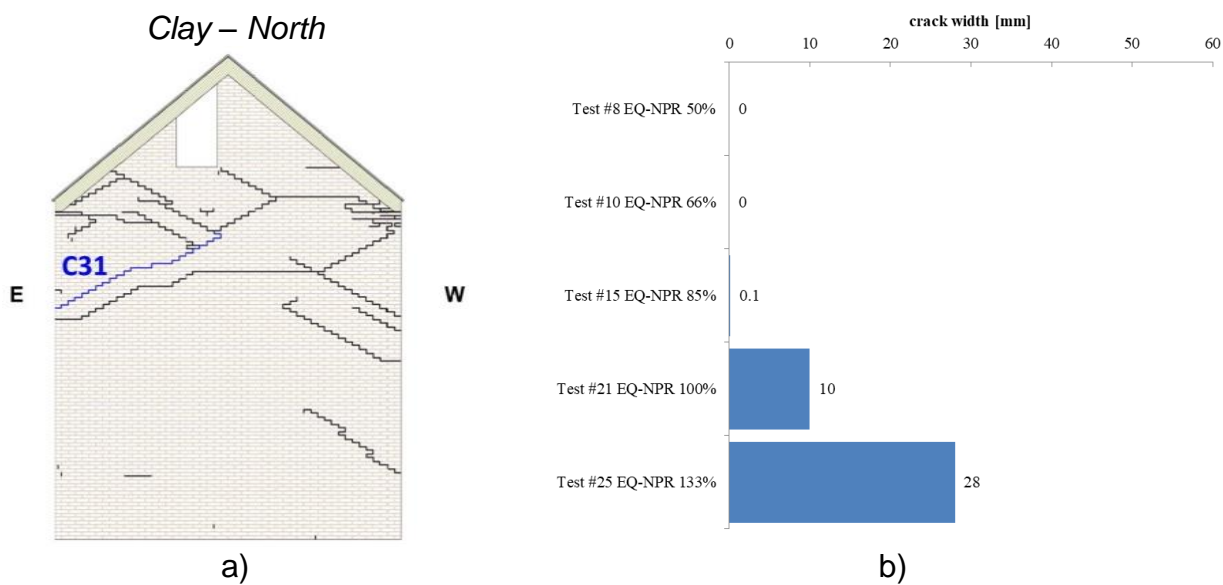
Figure 197 Crack C31 evolution: a) location; b) in-plane residual widths.

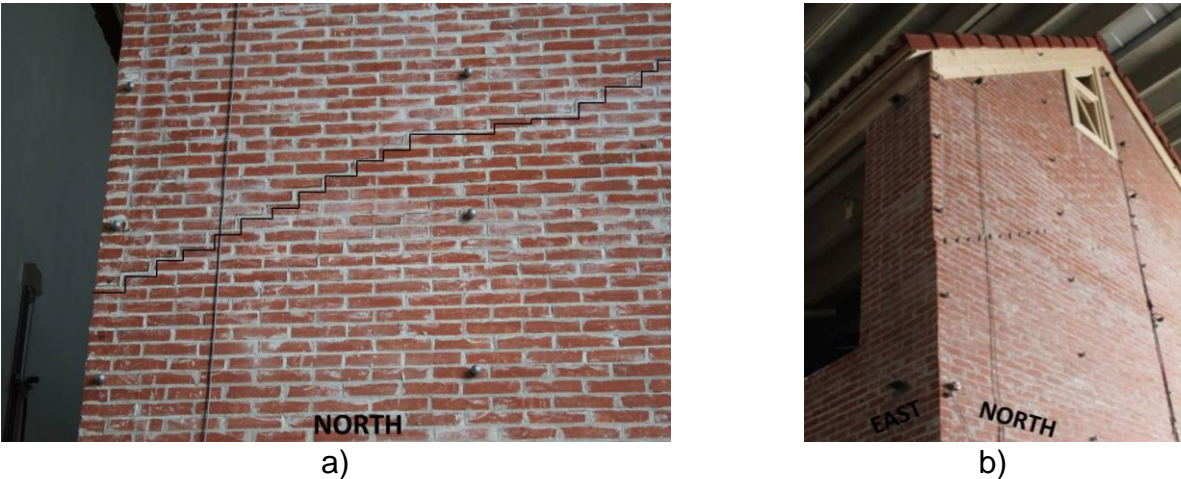
Figure 198 Crack C31: a) after EQ-NPR 85%; b) after EQ-NPR 100%.

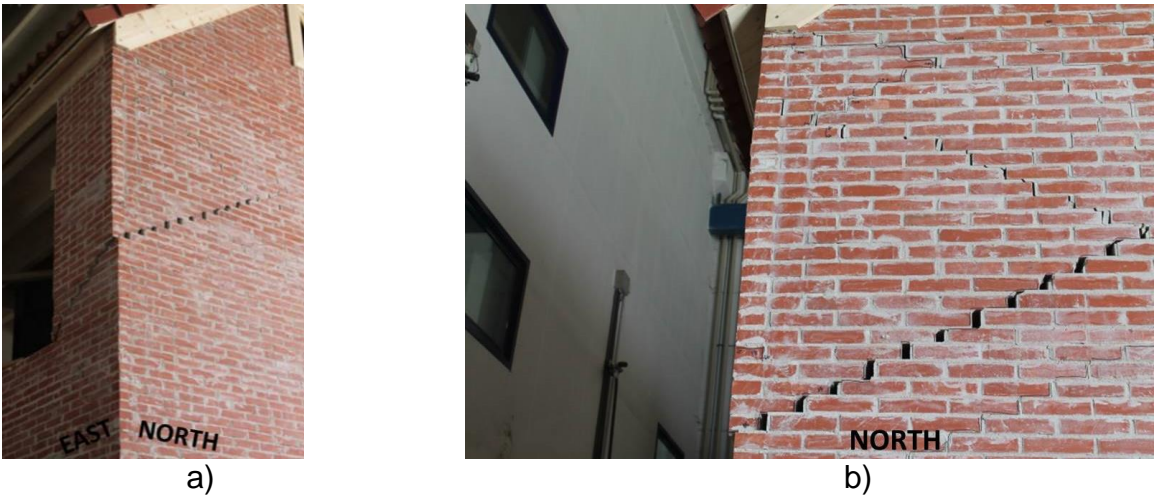
Figure 199 Crack C31 after EQ-NPR IS 133%: a) overview; b) zoom in.
