Experimental campaign on Reinforced Concrete buildings typical of the Groningen region

Dynamic testing of a full-scale two-storey Reinforced Concrete precast wall-slab-wall structure representative of the Groningen building stock (EUC-BUILD5).

Eucentre

Date October 2017

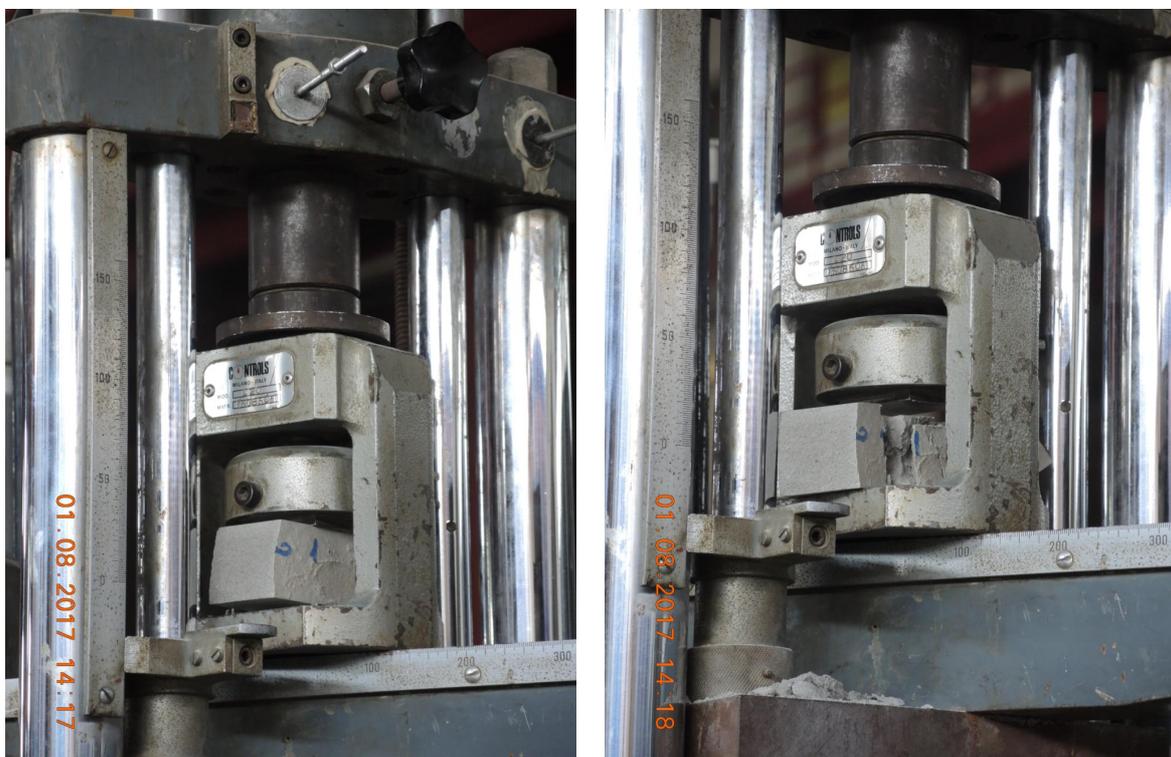
Figure 2. Compression test for characterisation of gap-filling mortar – Setup and failure of a specimen.

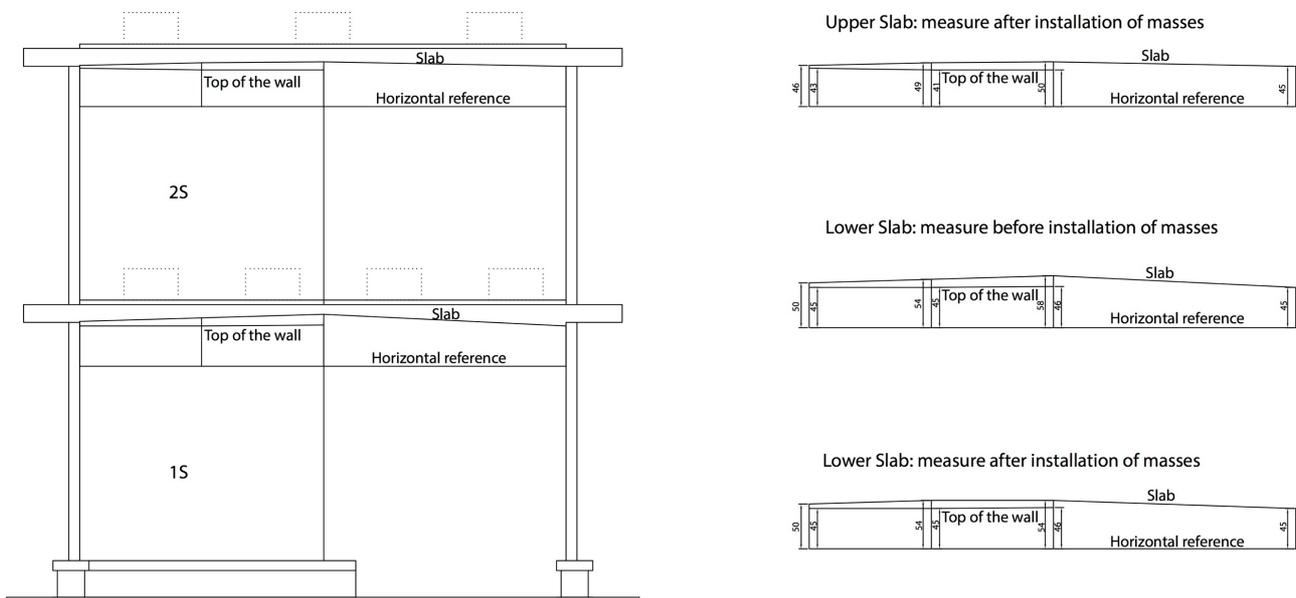
Furthermore, it is also noted that, as more extensively discussed in Section 5.3, at the end of the construction of specimen EUCBUILD5 it was noticed that a conspicuous gap was present between the stability walls and the slabs, and hence a mortar joint was executed between the precast wall and slab panels (seemingly in accordance with what is customarily done in practice, in such cases), thus increasing the relevance and interest on the characteristics of the mortar used for this intervention.

Figure 158. Measurements of the gap between the stability walls and the slabs – First and second storey.

As previously mentioned, laboratory technicians then implemented the “repair” intervention at the first and second storey of EUC-BUILD5 specimen, as documented by the following photographic sequence (Figure 159 to Figure 170). In particular, views of the mortar joint between the first-storey stability wall and the slabs are collected in Figure 159 to Figure 165, whilst details of the one between the second-storey stability wall and the slabs are documented in Figure 166 to Figure 170.

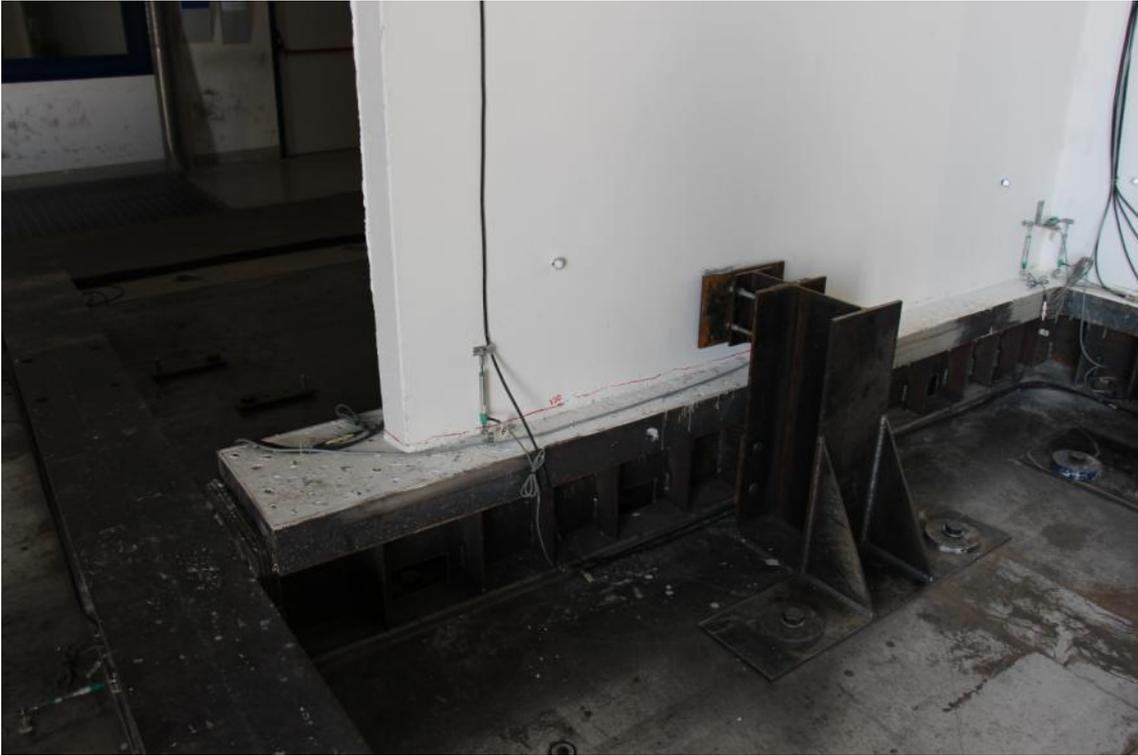
Figure 256. Development of cracks at the base of the ground-floor stability wall.

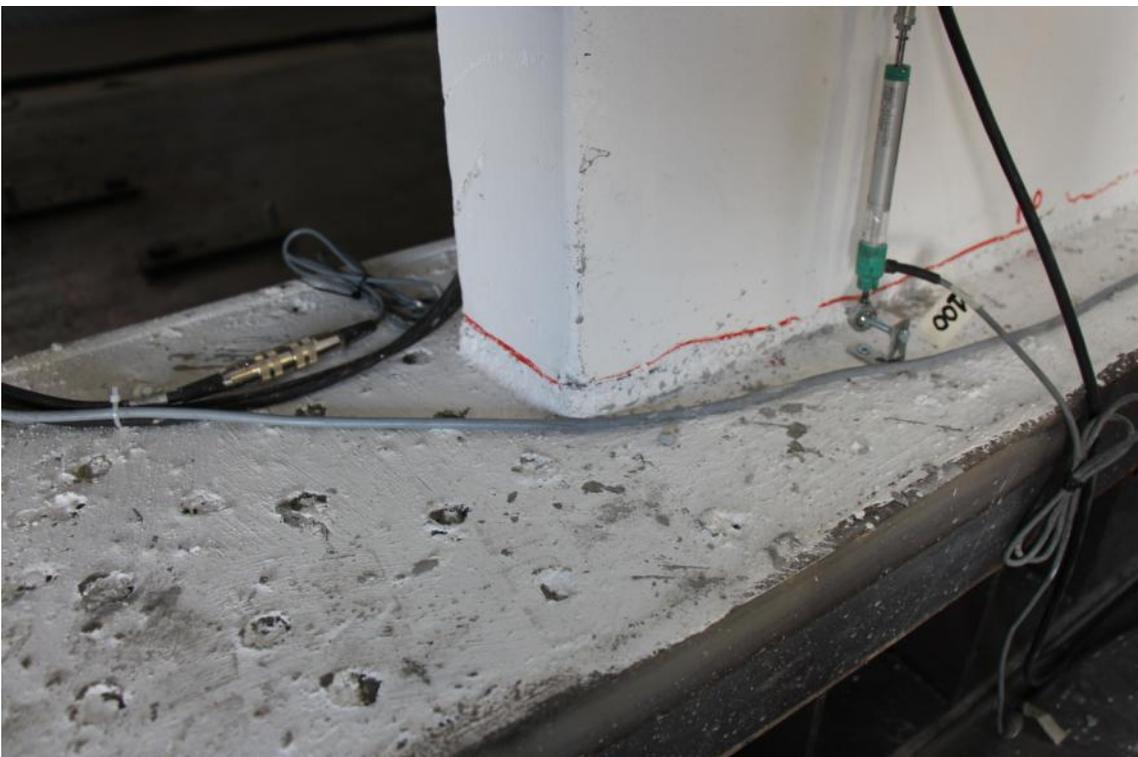
Figure 257. Crack pattern at the base of the first-floor stability wall – Edge of the wall.

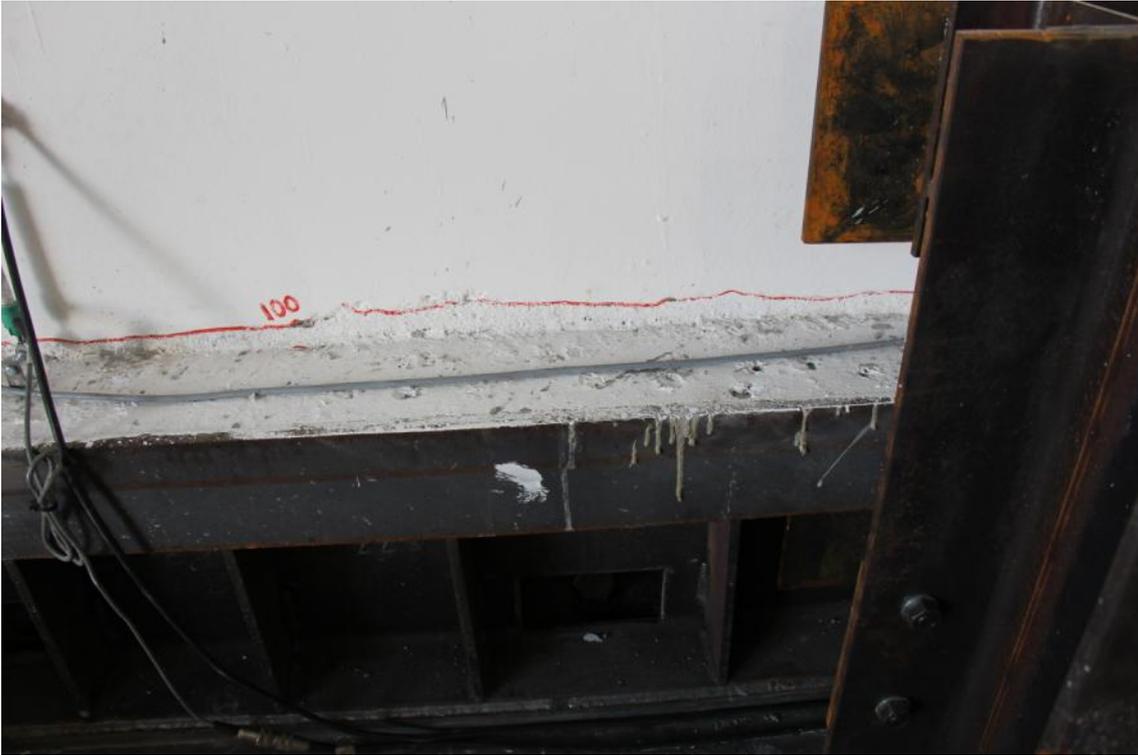
Figure 258. Detail of crack at the base of the first-storey stability wall – Centre of the wall panel.

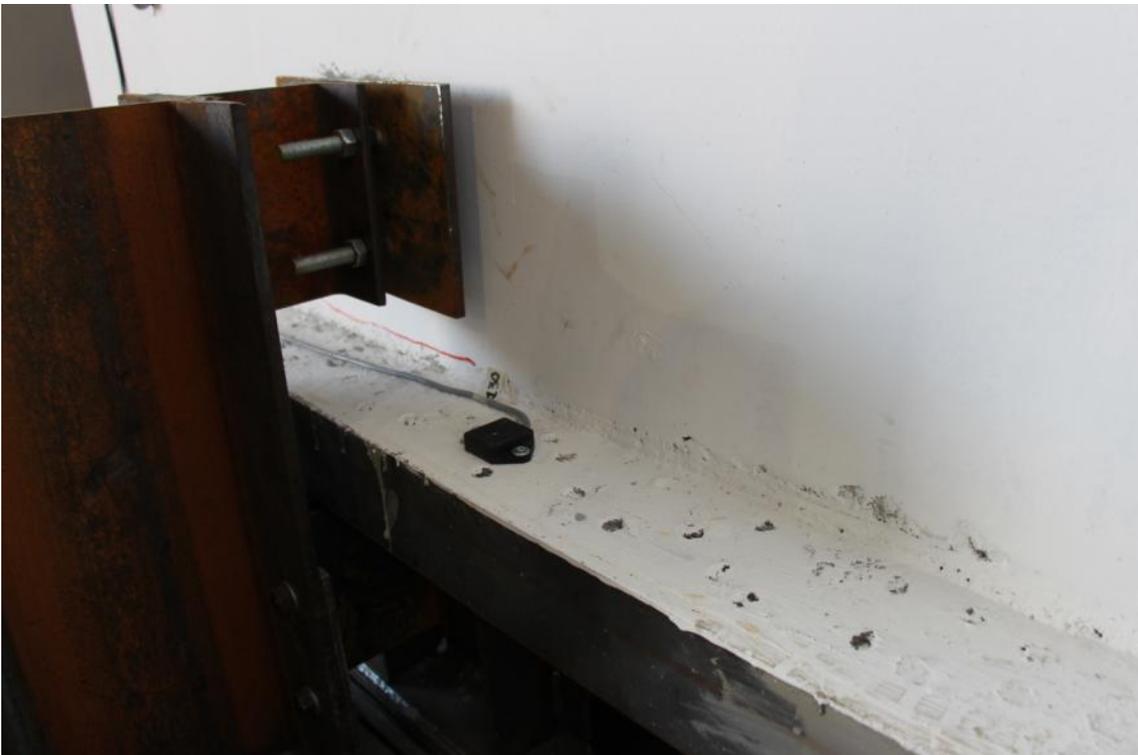
Figure 259. Crack running from the edge to the centre of the first-storey stability wall – Wall base.

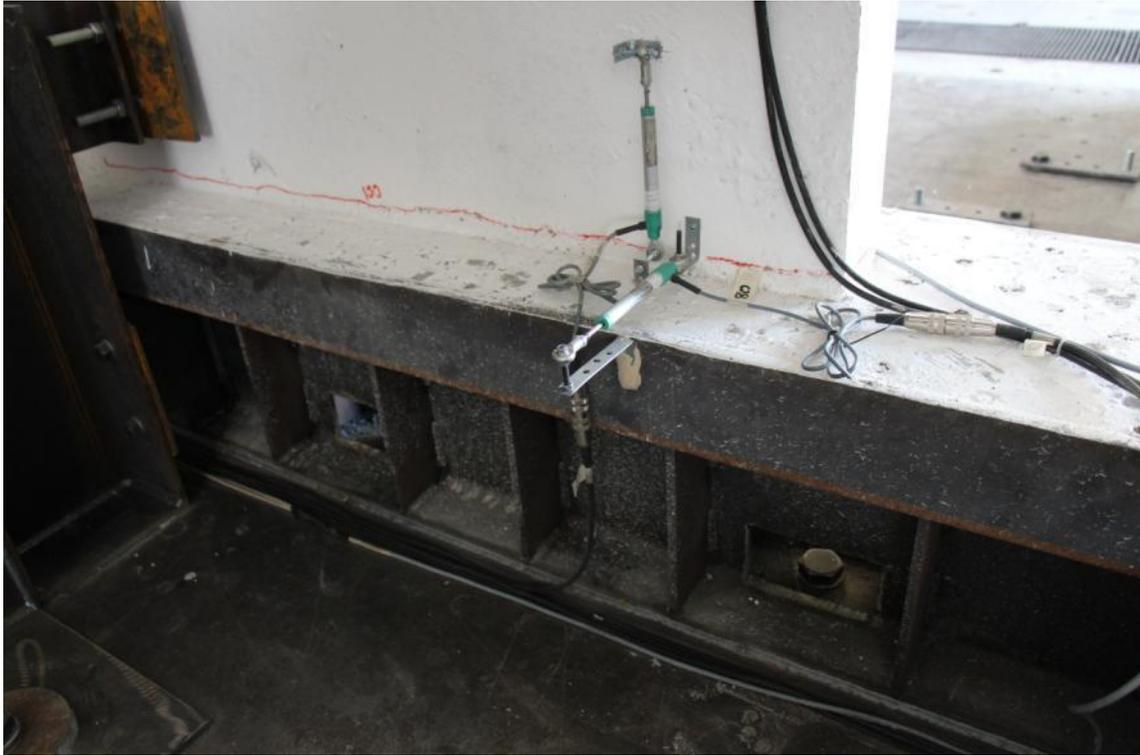
Figure 260. Crack running from the edge to the centre of the first-storey stability wall – East wall face.

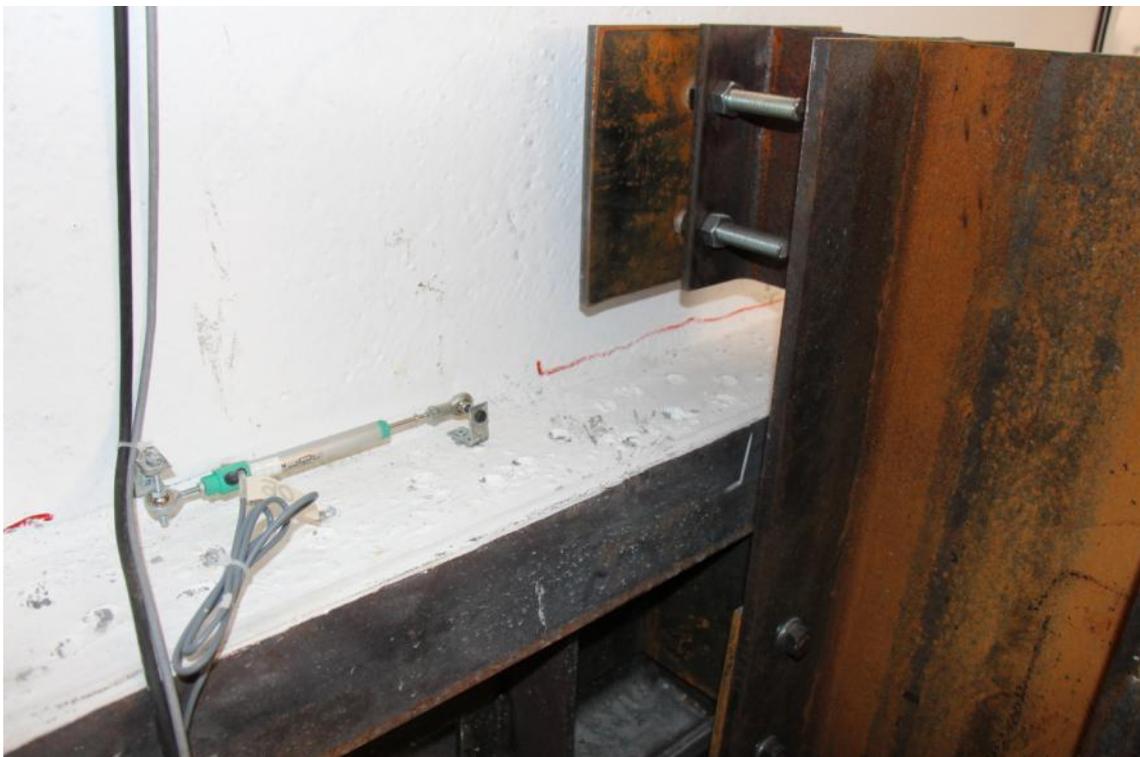
Figure 261. Detail of the crack at the base of the East face of the first-storey stability wall – South side.

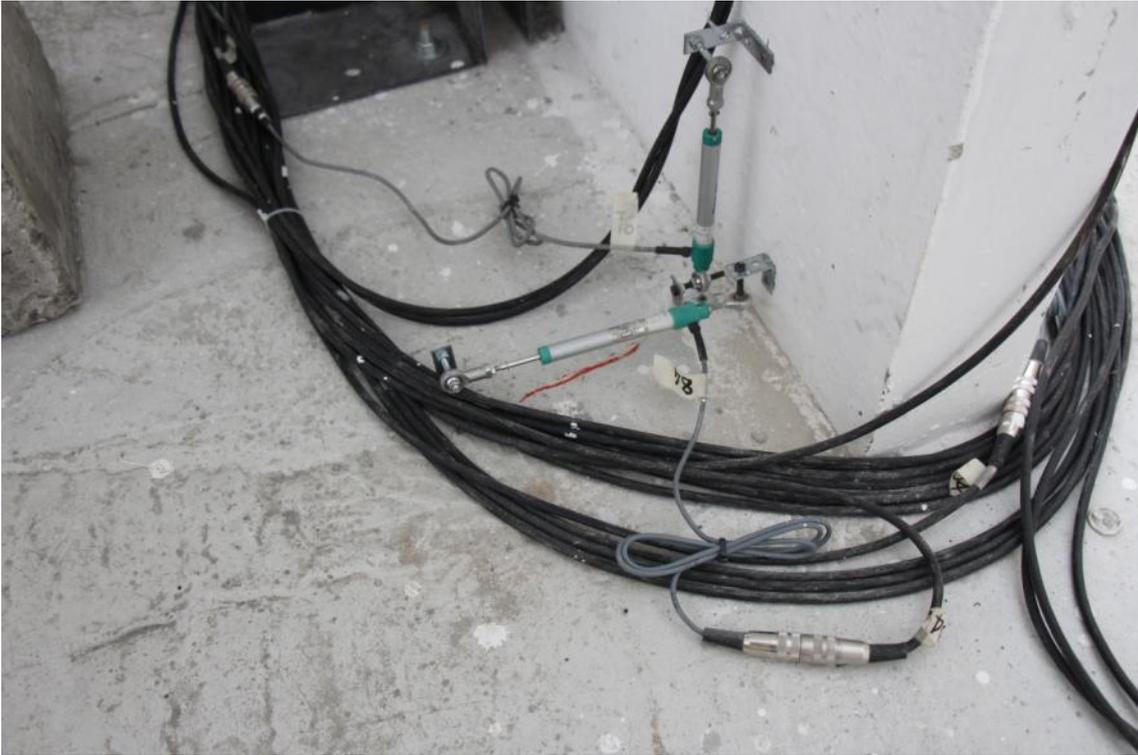
Figure 262. Minor cracks in the concrete topping close to the North edge of the second-storey stability wall.

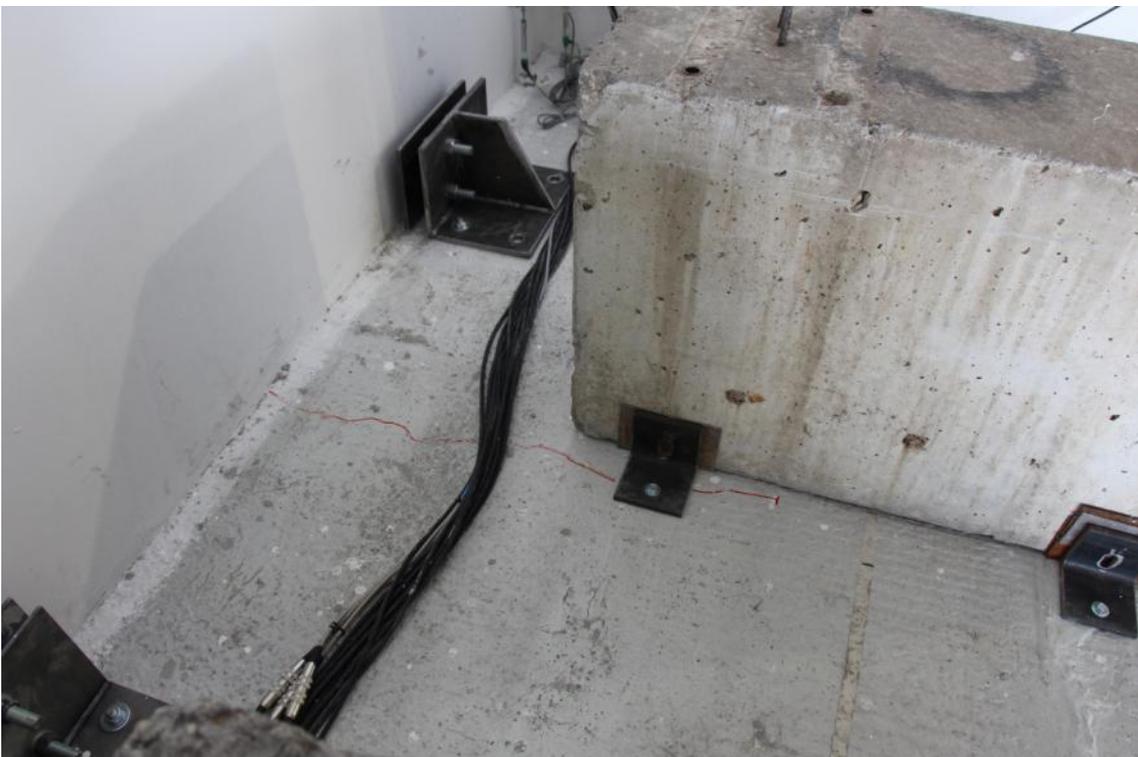
Figure 263. Crack running from the centre of the second-storey stability wall – West wall face.

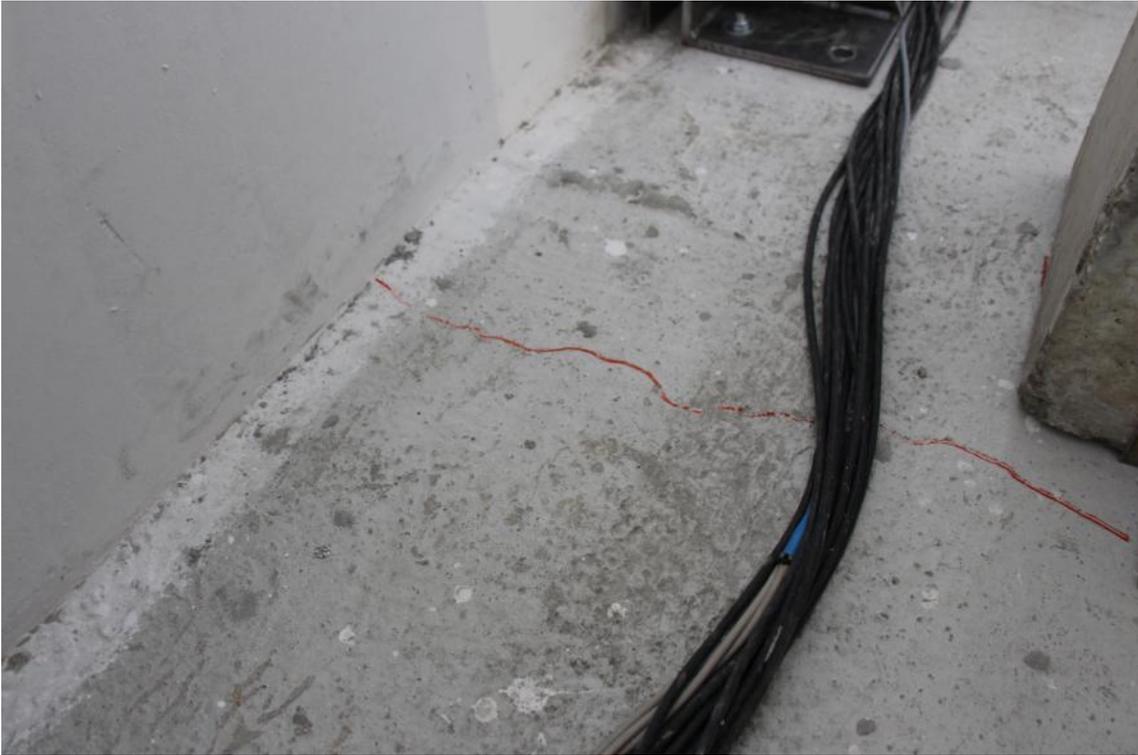
Figure 264. Crack running from the North edge of the second-storey stability wall – West wall face.

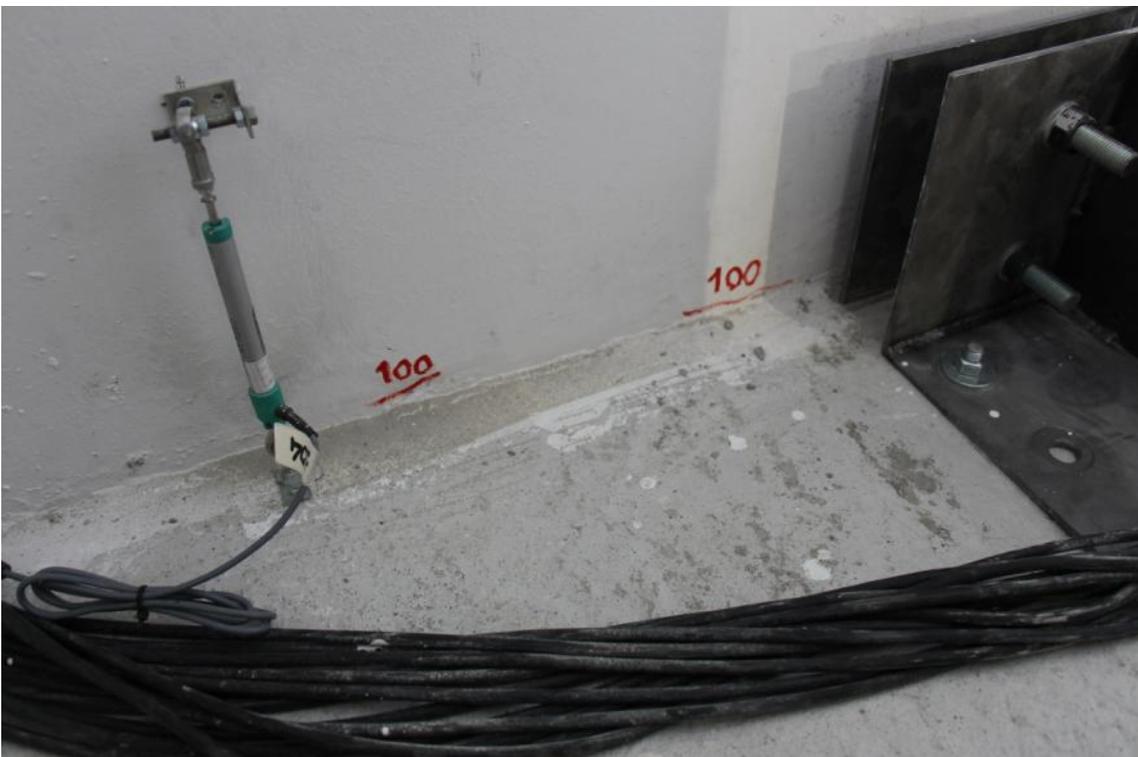
Figure 265. Cracks developed at the base of the second-storey stability wall – West wall face, North edge.

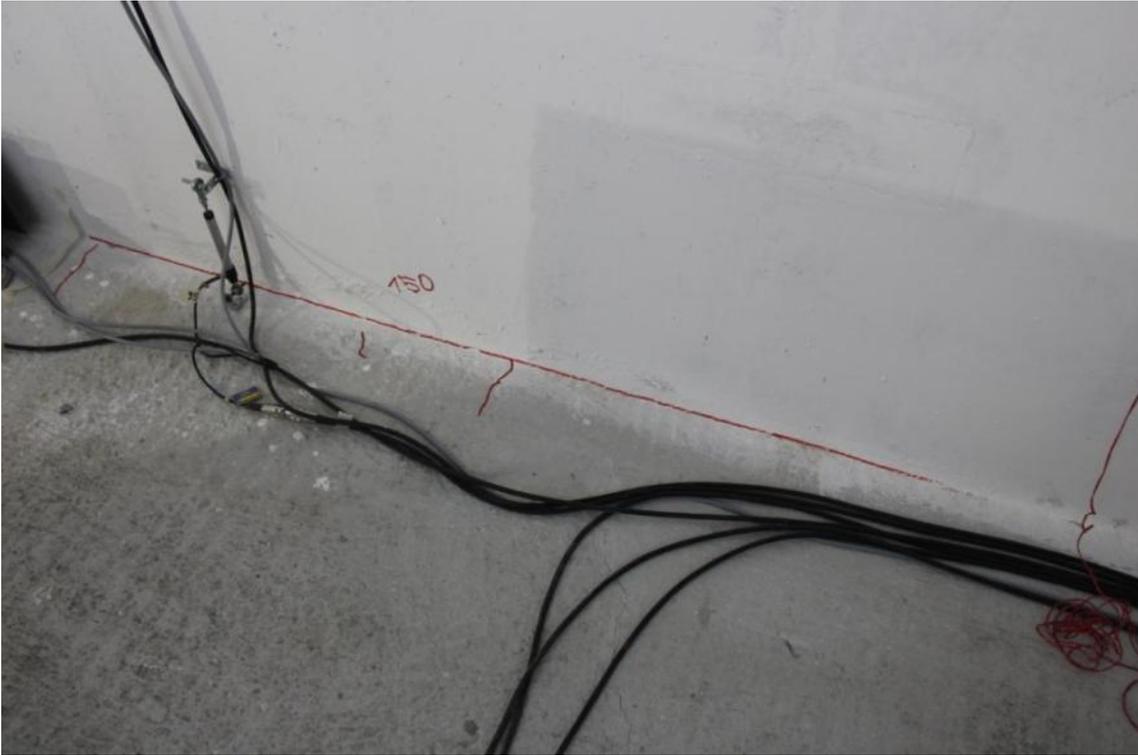
Figure 266. Development of flexural cracks at the base of the North-sided second-storey transversal walls.

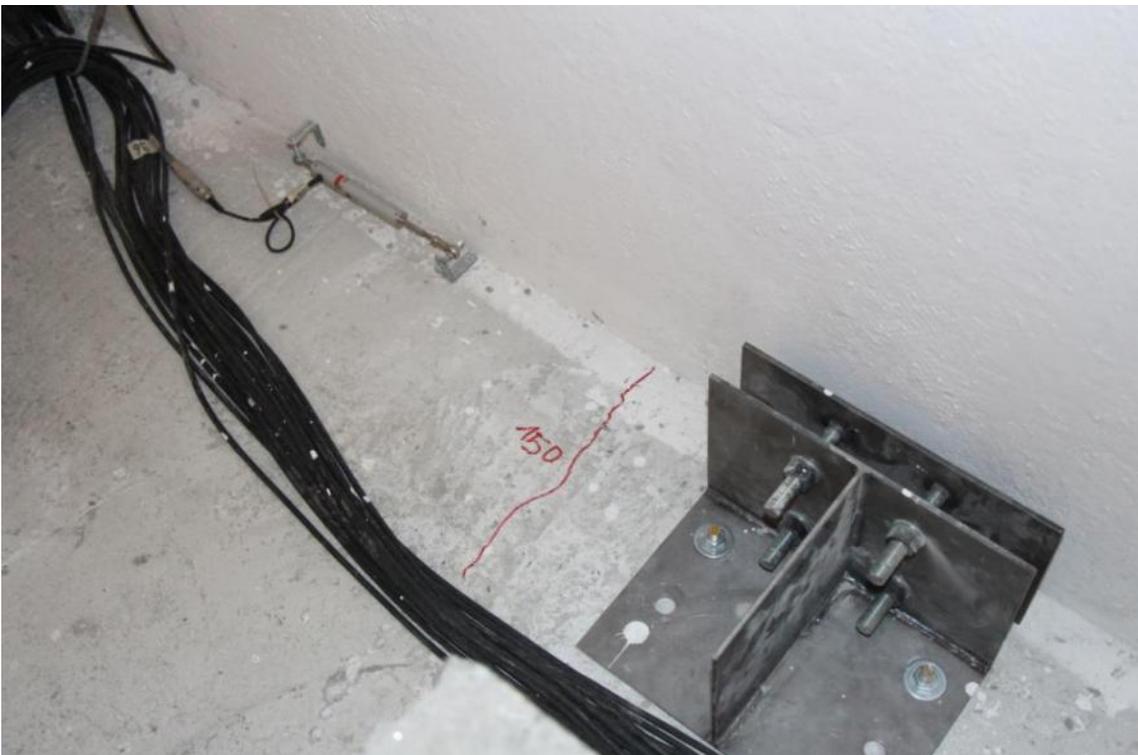
Figure 267. Crack running from the centre of the second-storey stability wall – East wall face.

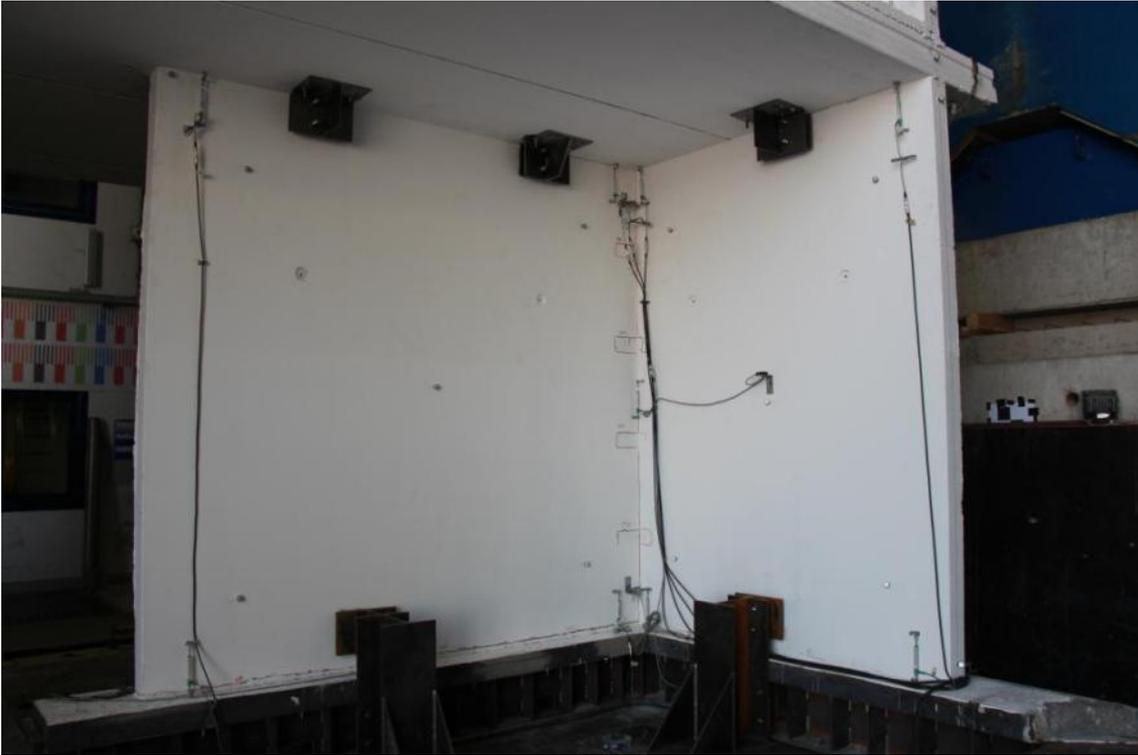
Figure 268. Crack pattern of the ground-floor stability wall – Wall base and connectors sockets.

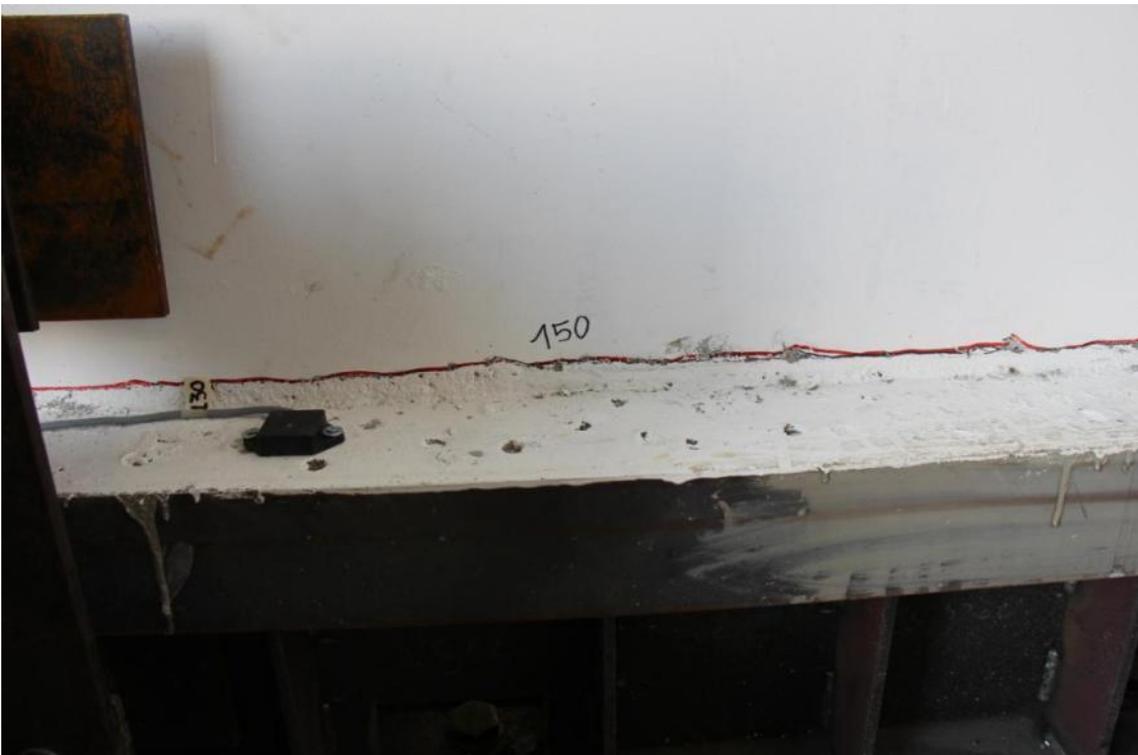
Figure 269. Propagation of horizontal crack along the depth of the ground-floor stability wall – Wall base.

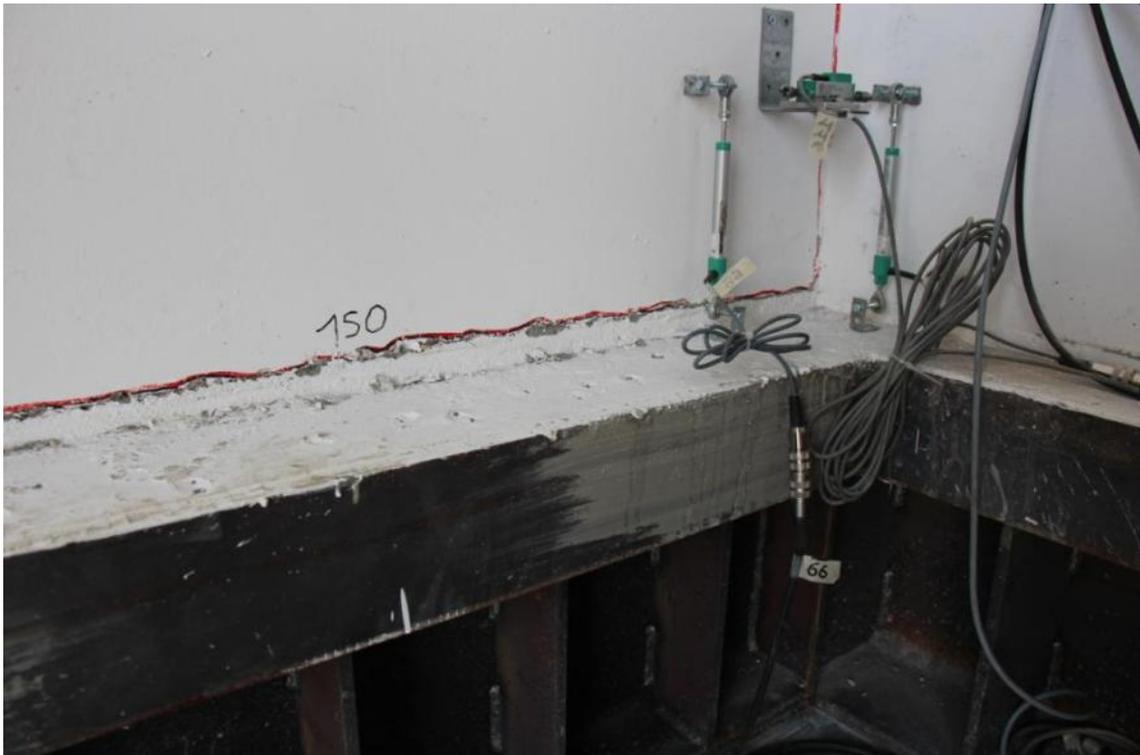
Figure 270. Crack running along the entire depth of the ground-floor stability wall – Wall base.

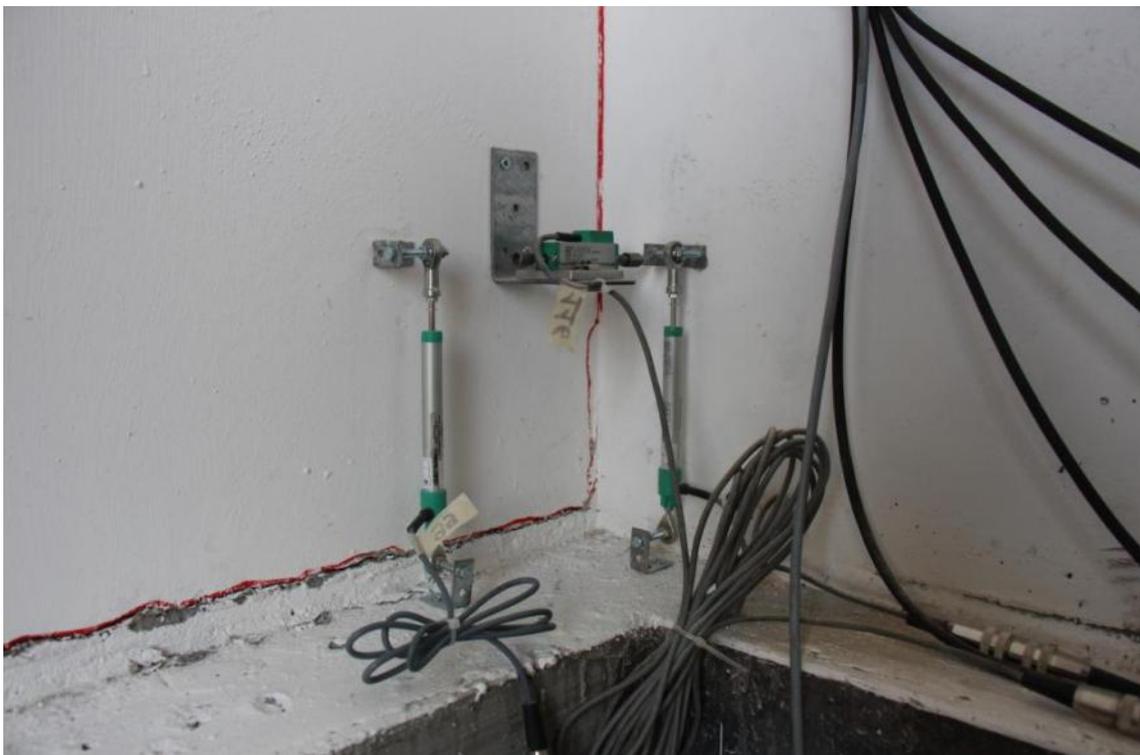
Figure 271. Vertical crack along the height of the first-storey stability wall – South edge.

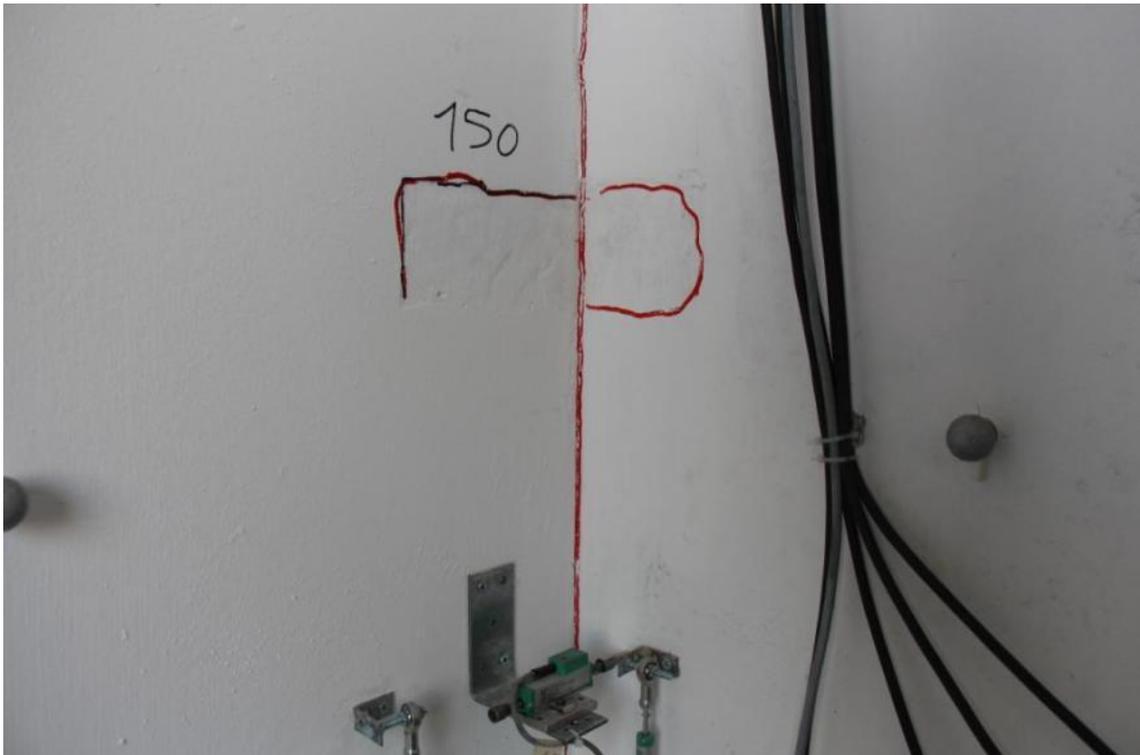
Figure 272. Cracks along the boundaries of the connectors sockets – Detail of the bottom three-way joint.

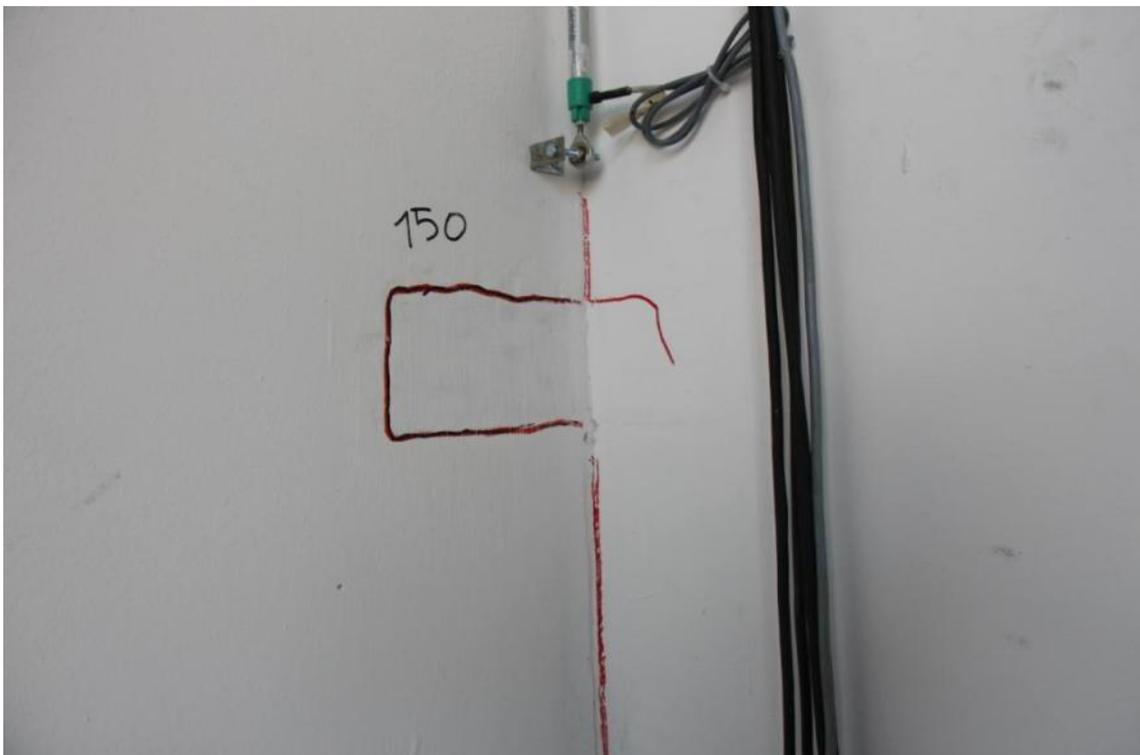
Figure 273. Development of cracks along the boundaries of the connectors sockets.

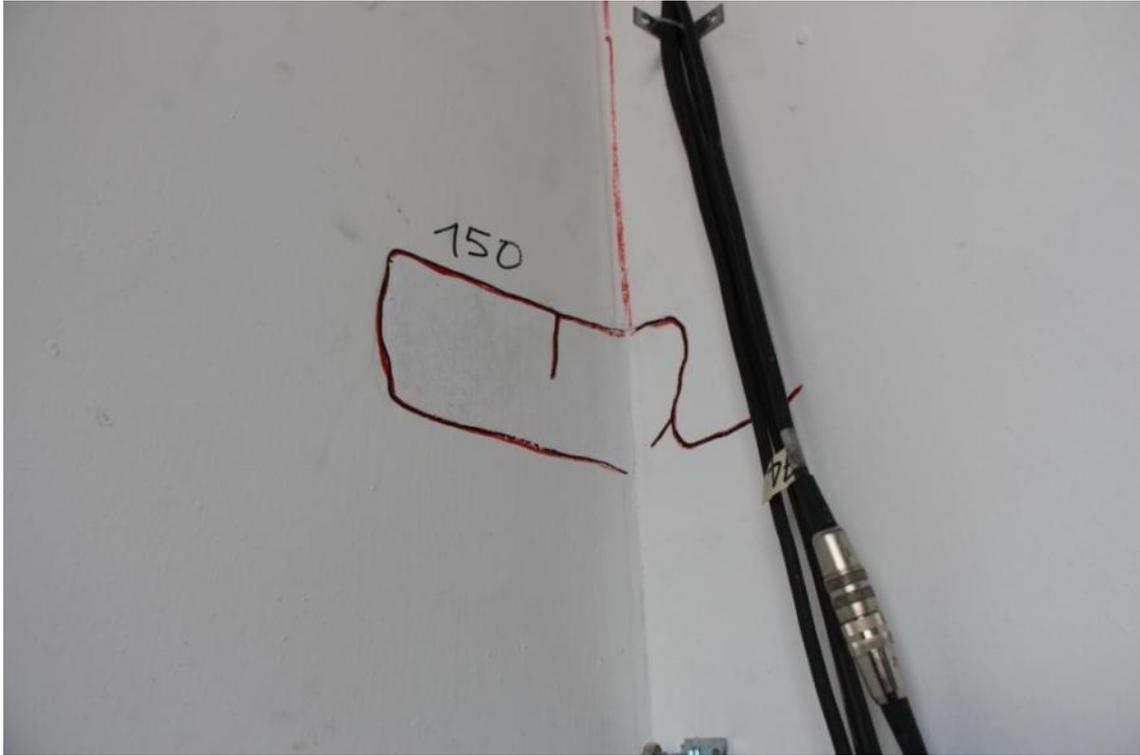
Figure 274. Cracks along the boundaries of the connectors sockets – Stability wall, West face, first storey.

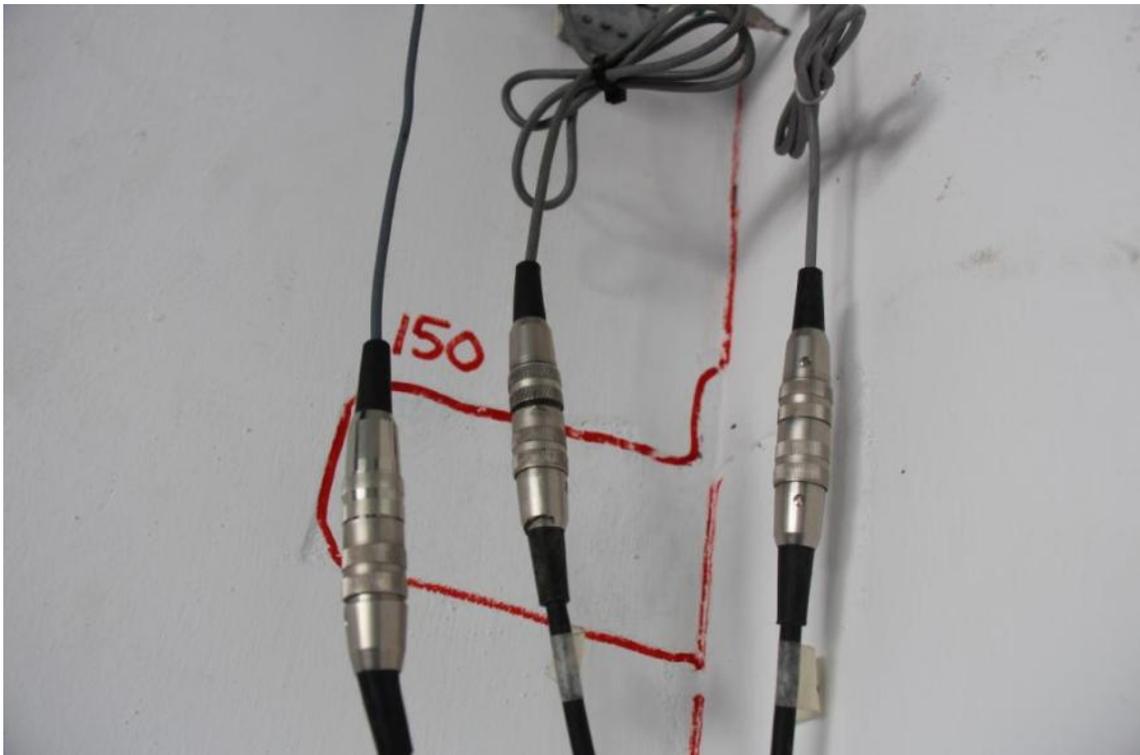
Figure 275. Cracks along the boundaries of the connectors sockets – Detail of the top three-way joint.

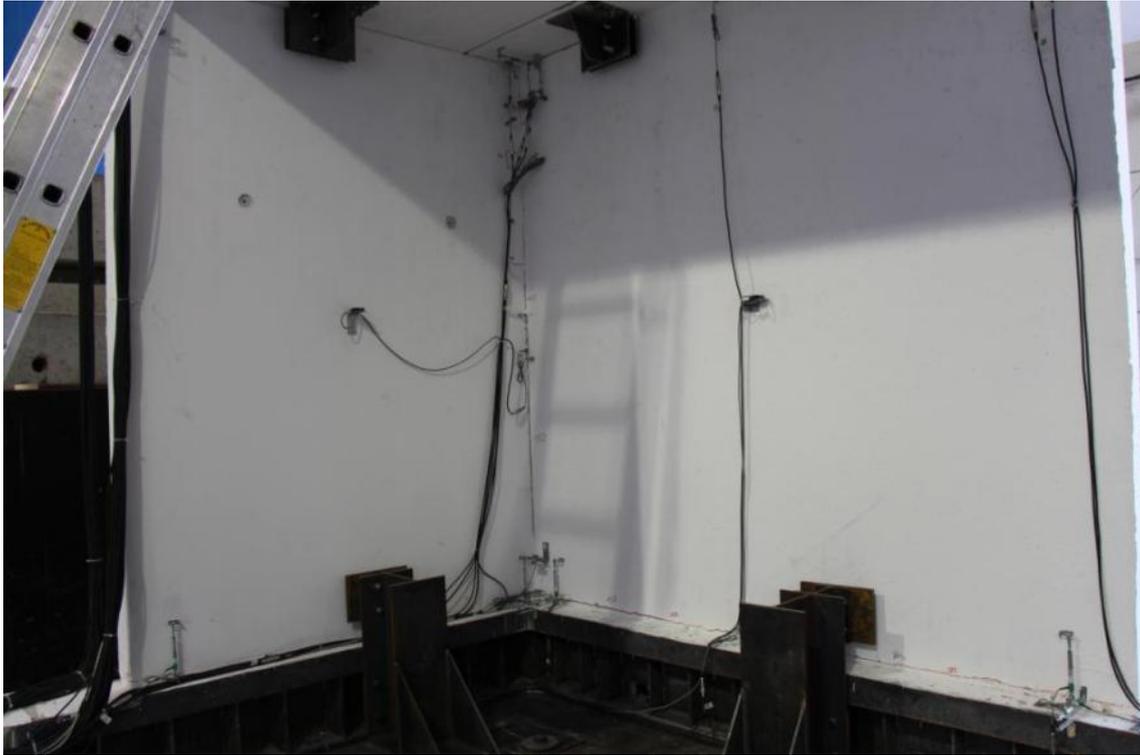
Figure 276. Crack pattern of the ground-floor stability wall – East wall face, base and connectors sockets.

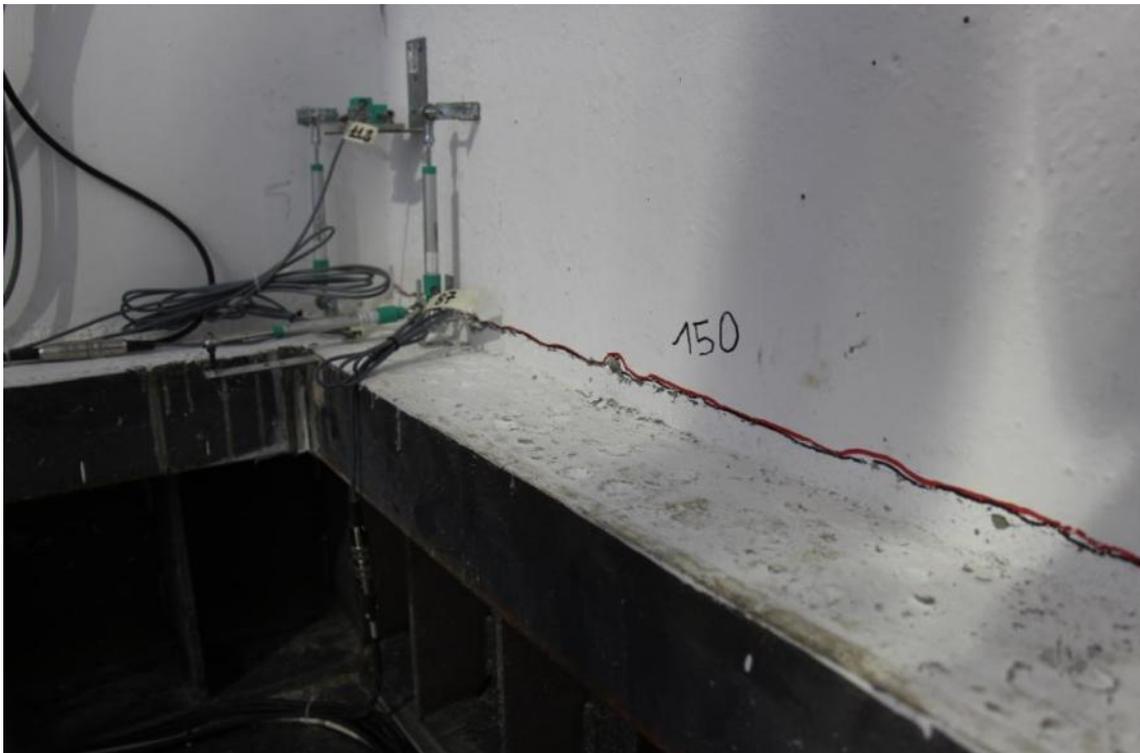
Figure 277. Crack running along the entire depth of the ground-floor stability wall – East wall face, base.

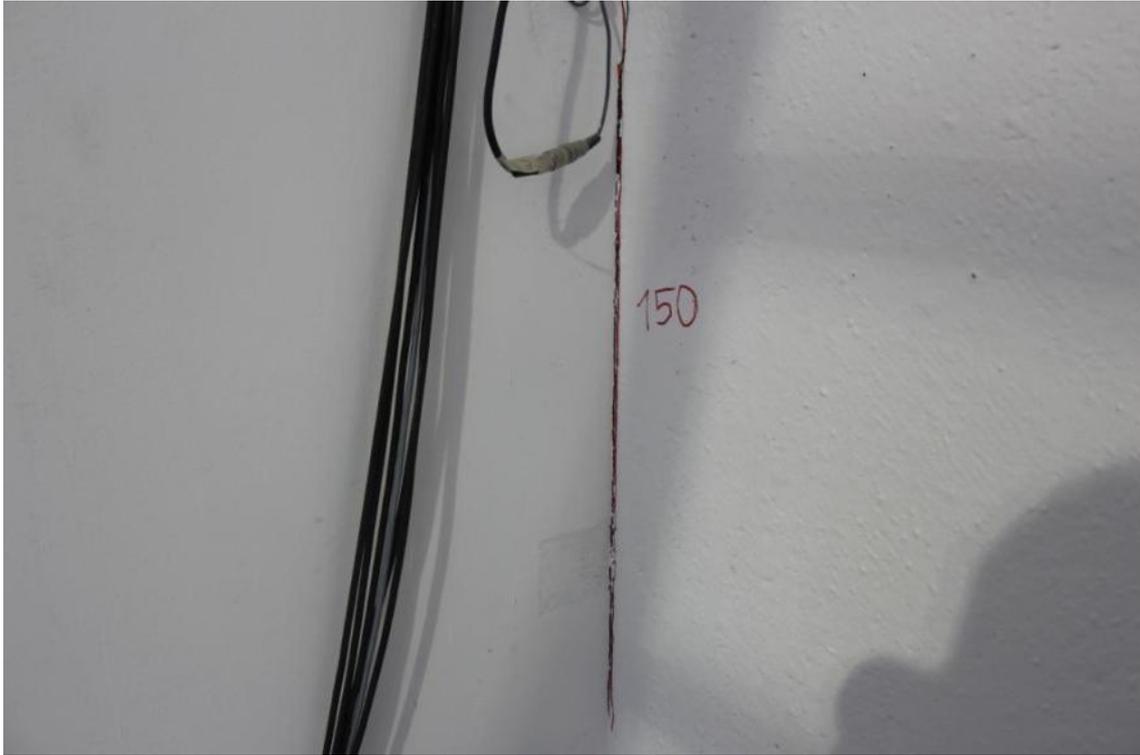
Figure 278. Vertical crack and detachment between stability and transversal walls – East wall face.
