Experimental campaign on Reinforced Concrete buildings typical of the Groningen region

Dynamic testing of a full-scale two-storey Reinforced Concrete precast wall-slab-wall structure representative of the Groningen building stock (EUC-BUILD5).

Eucentre

Date October 2017

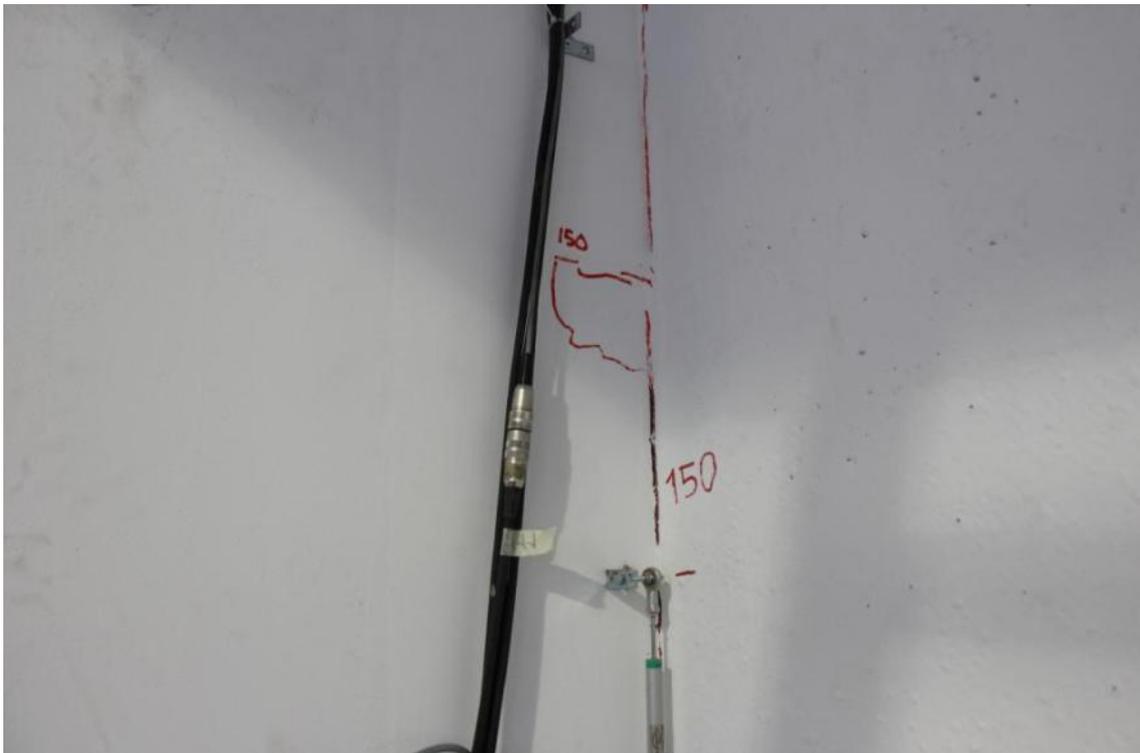
Figure 279. Propagation of a wide crack along the height of the first-storey stability wall – East wall face.

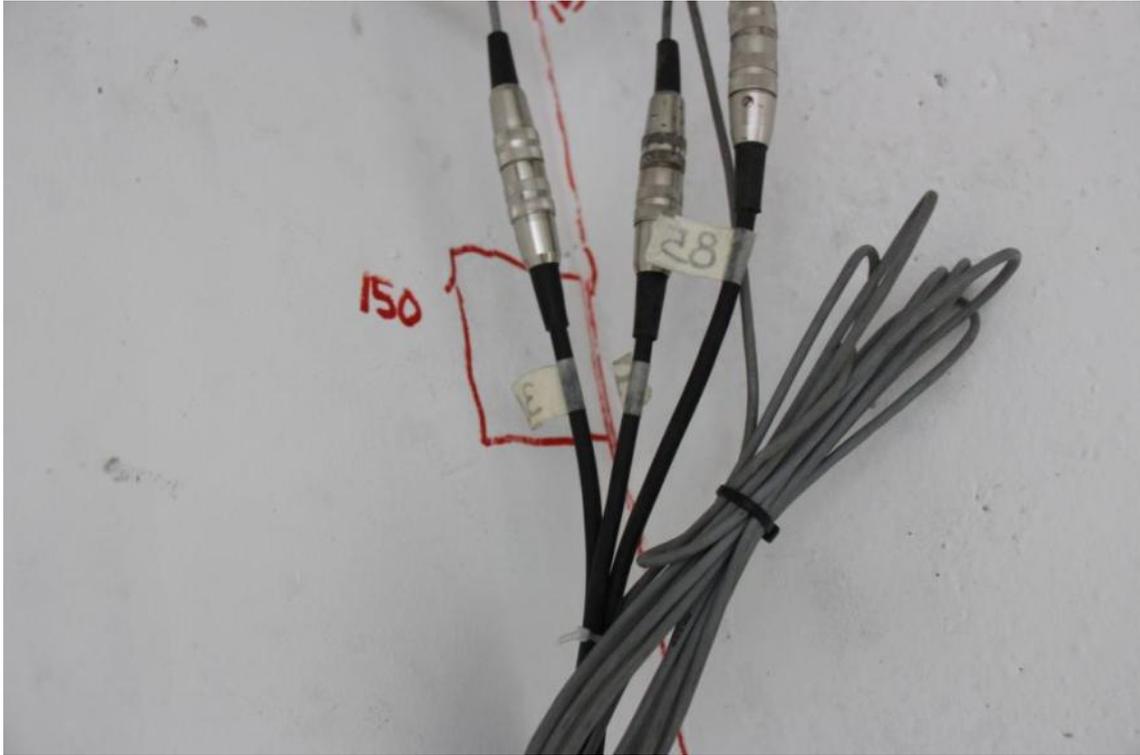
Figure 280. Cracks along the boundaries of the connectors sockets – Top three-way joint, panel.

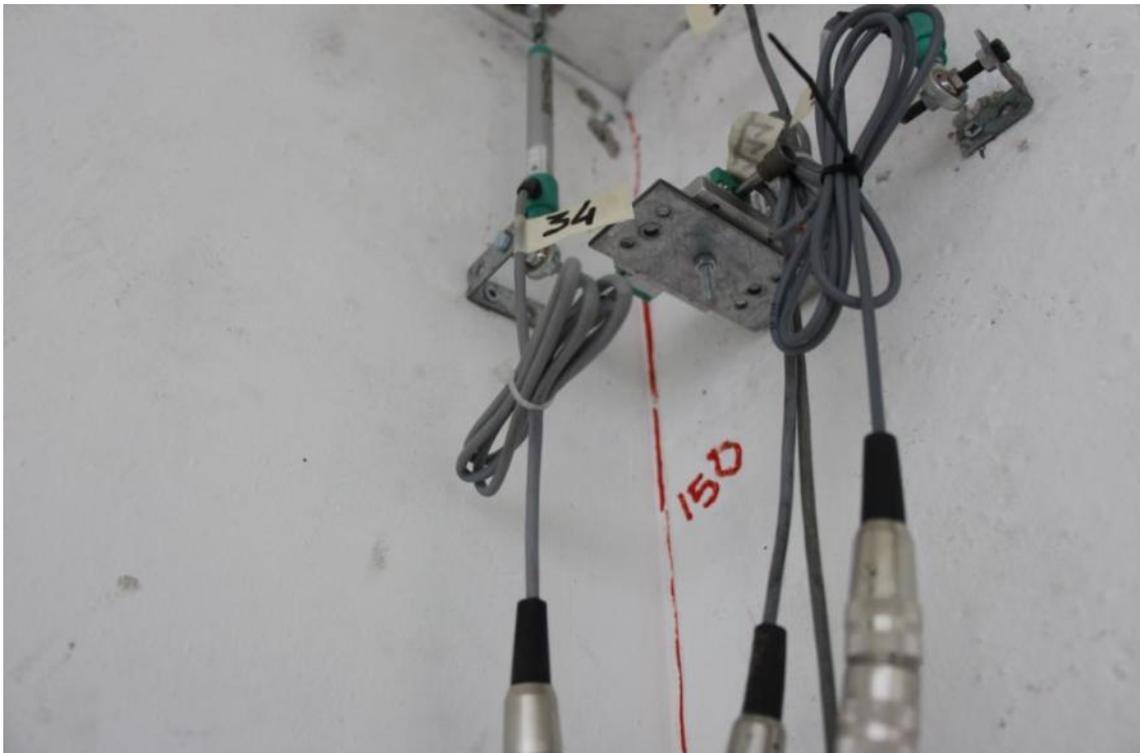
Figure 281. Vertical crack along the entire height of the ground-floor stability wall – East wall face.

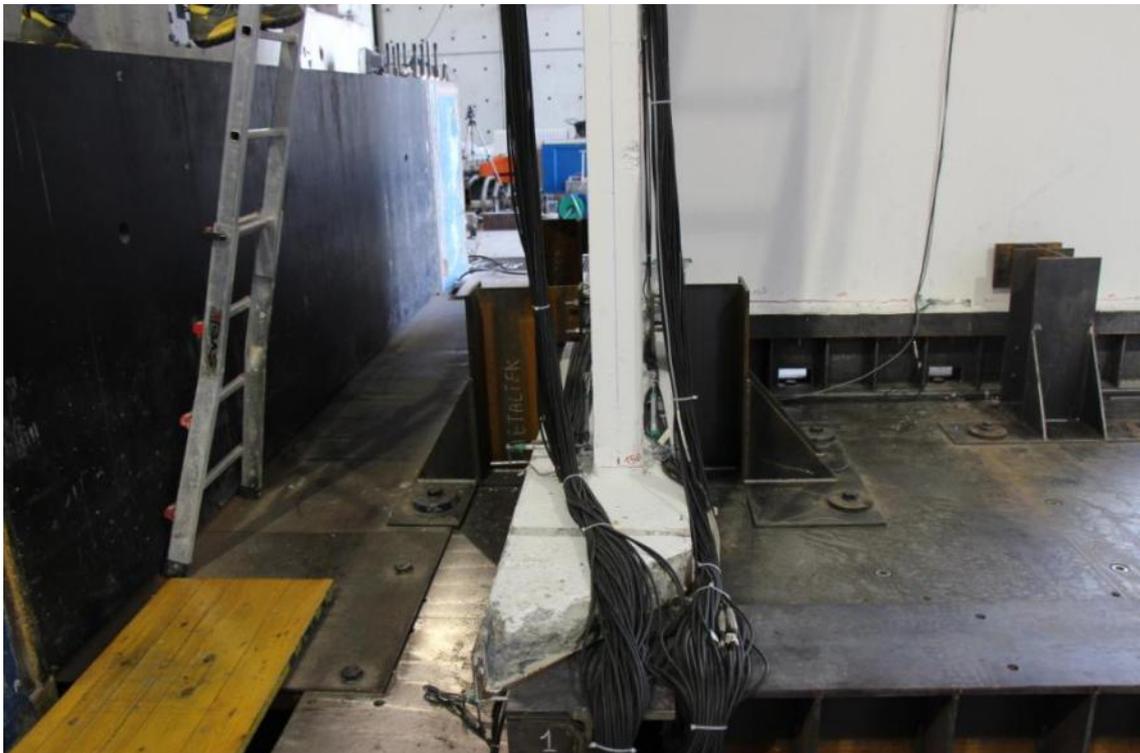
Figure 283. Formation of a new crack at the base of transversal walls – Panel 1L1, South-East side.

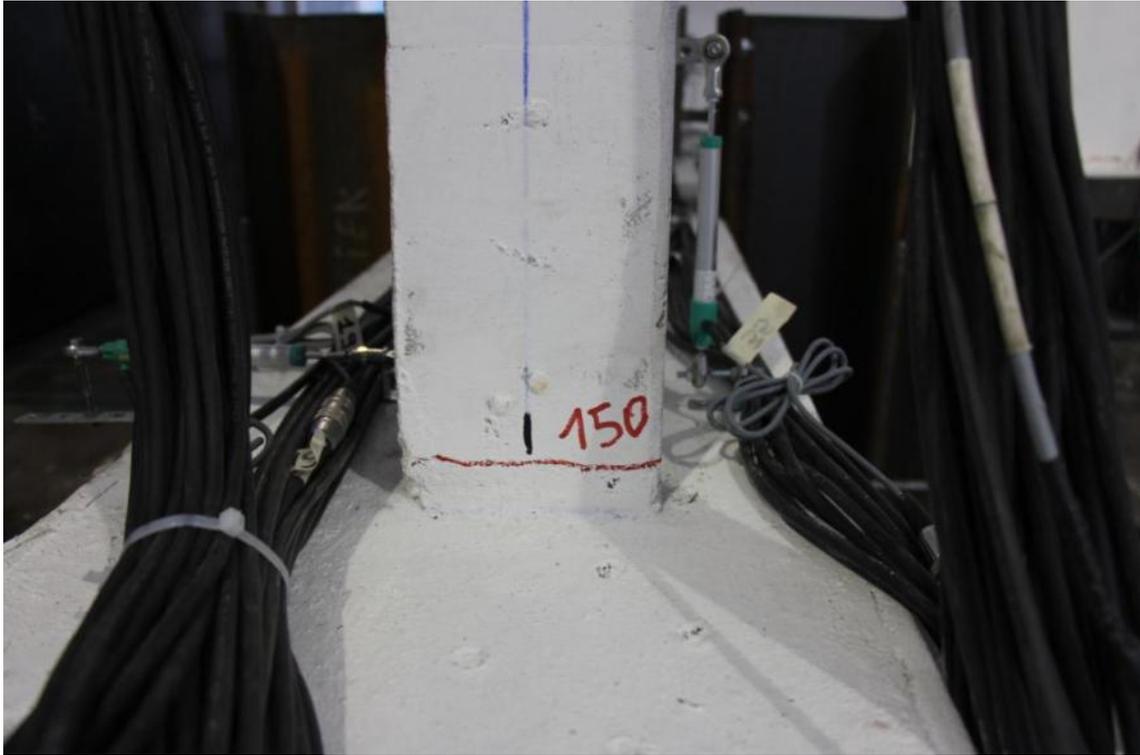
Figure 284. Detail of horizontal crack running through the entire width of transversal wall 1L1.

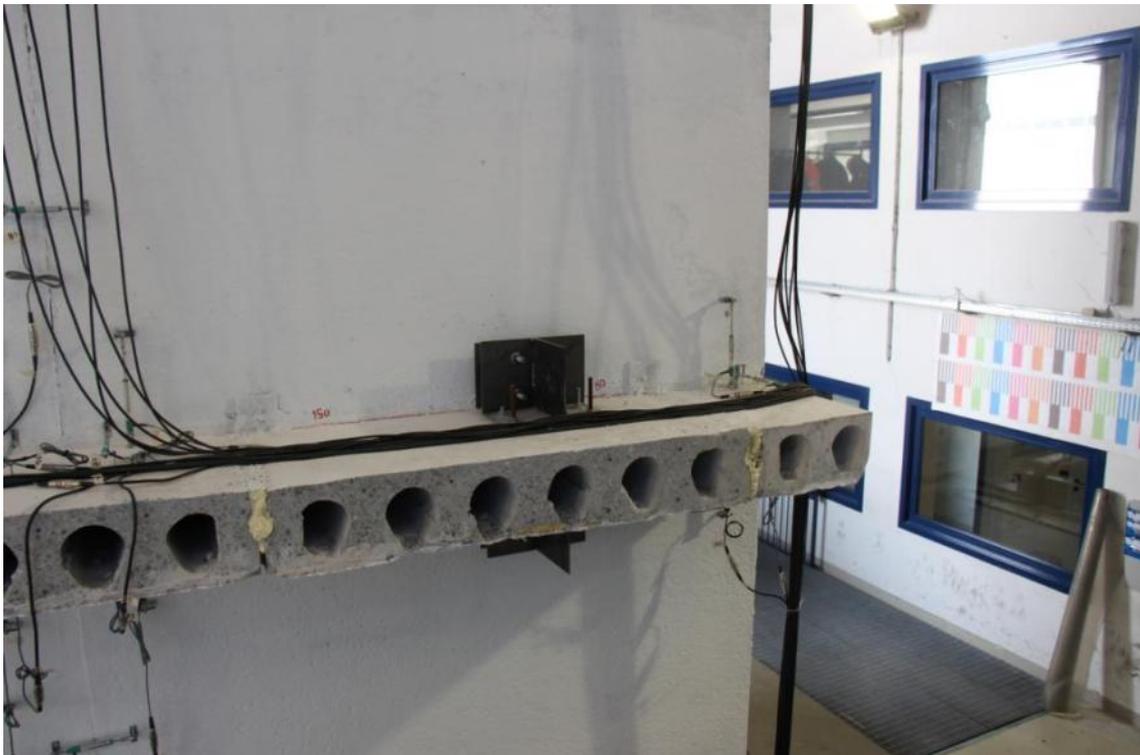
Figure 285. Development of horizontal flexural cracks at the base of panel 2L1 – Second-storey lateral wall.

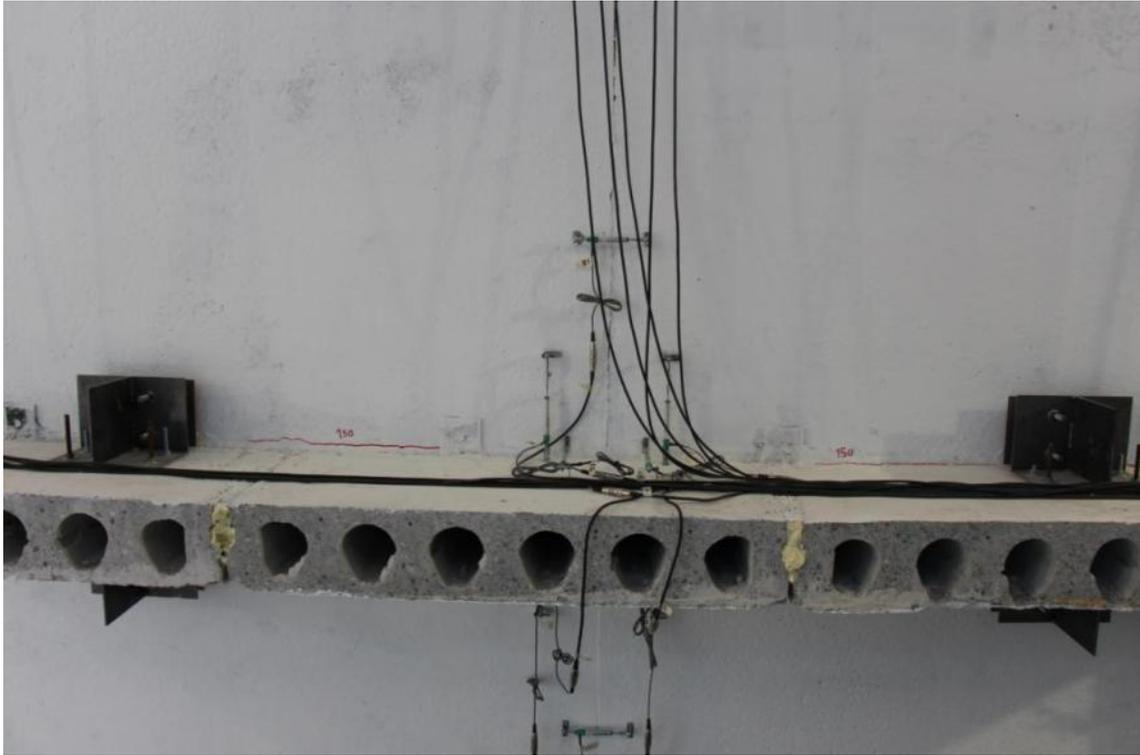
Figure 286. Horizontal flexural cracks at the base of the South-sided second-storey transversal walls.

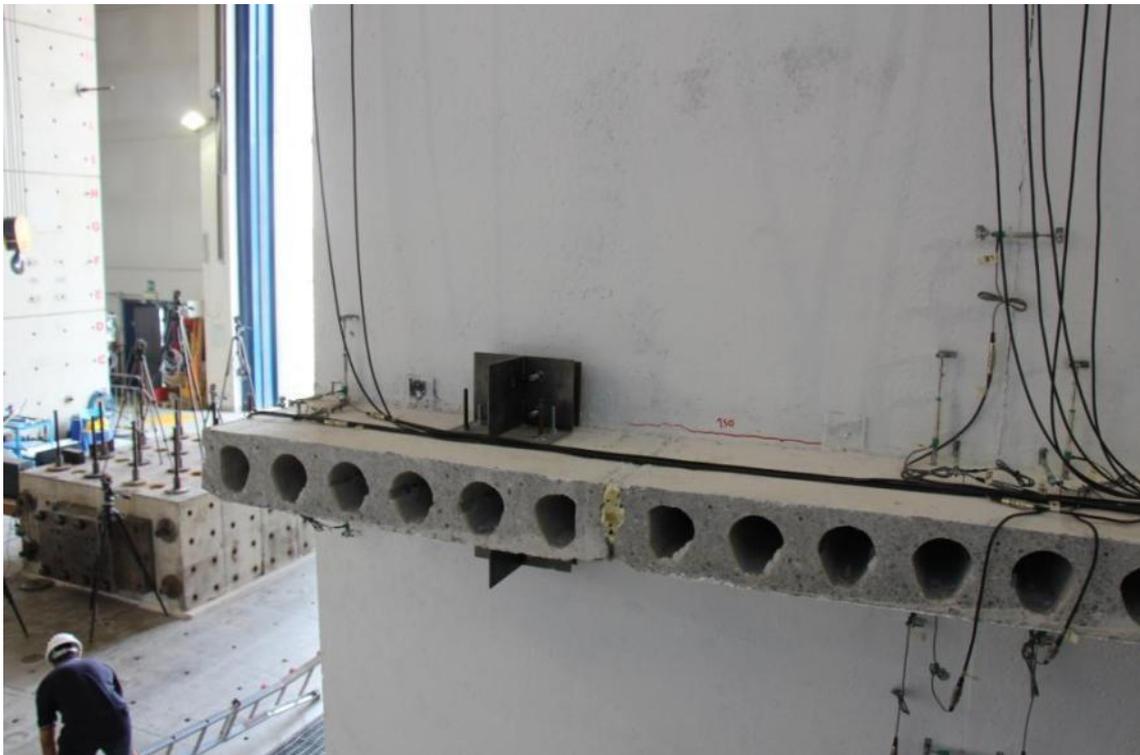
Figure 287. Development of horizontal flexural cracks at the base of panel 2L2 – Second-storey lateral wall.

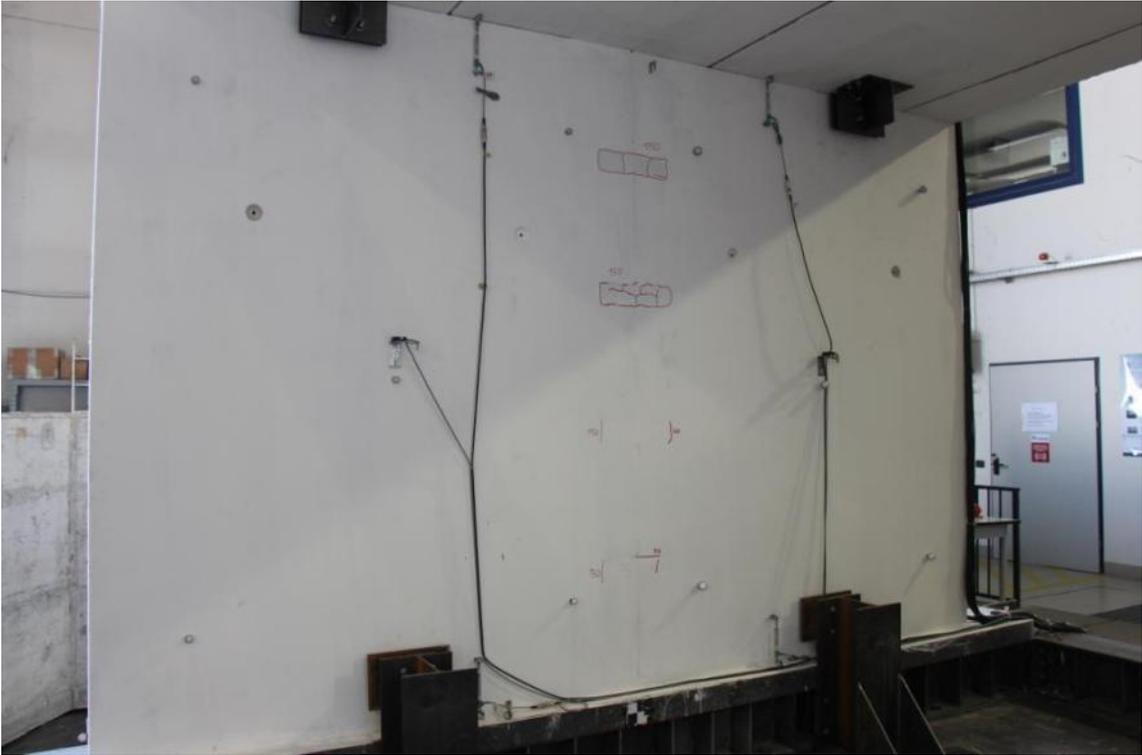
Figure 288. Cracks along the boundaries of the connectors sockets – North-sided ground-floor lateral walls.

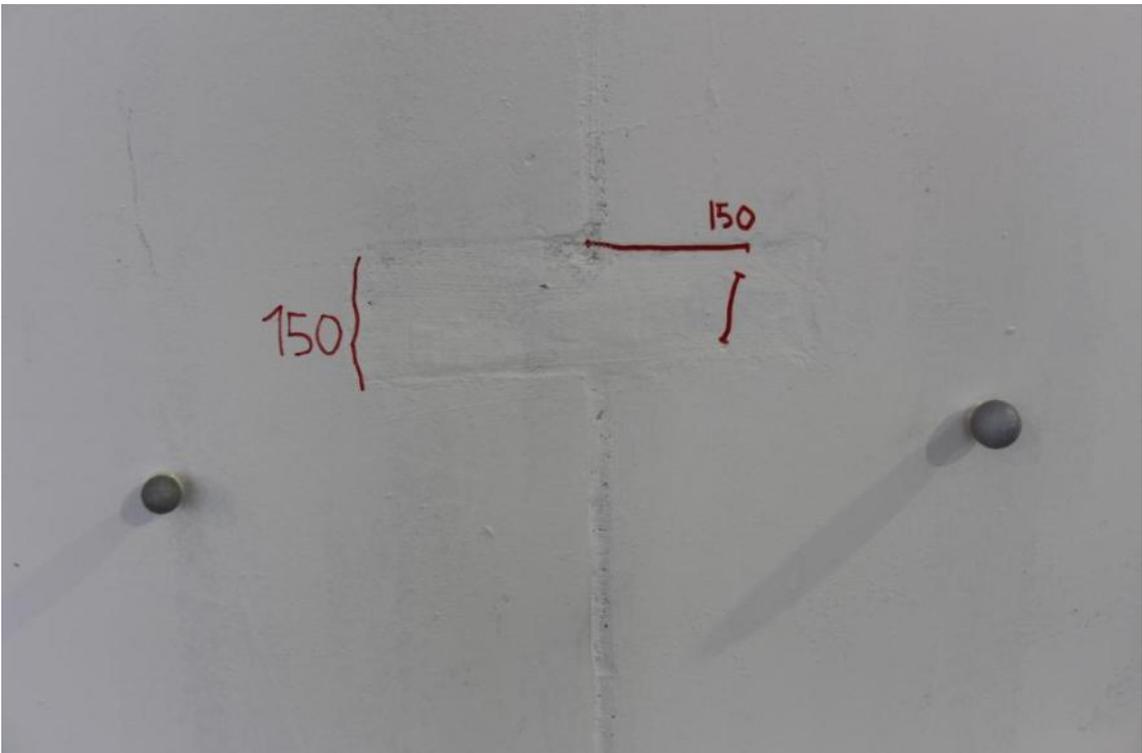
Figure 289. Cracks along the boundaries of the connectors sockets – Bottom two-way connection.

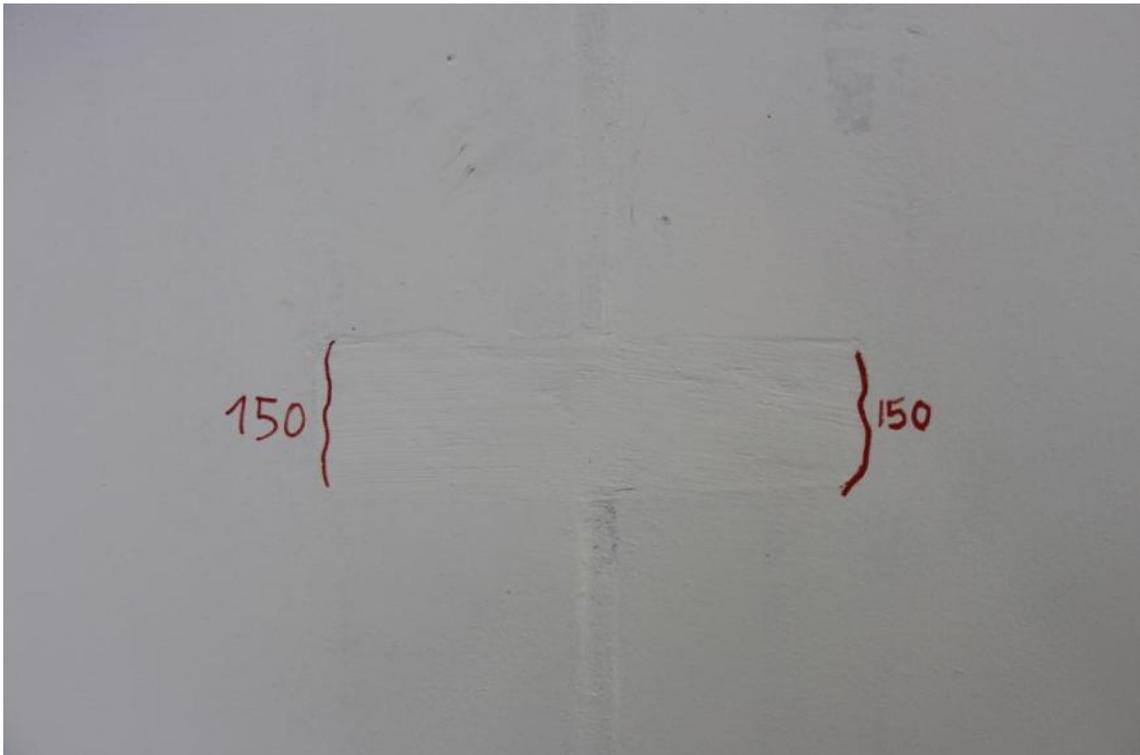
Figure 290. Cracks along the boundaries of the two-way connection – Second joint from the base.

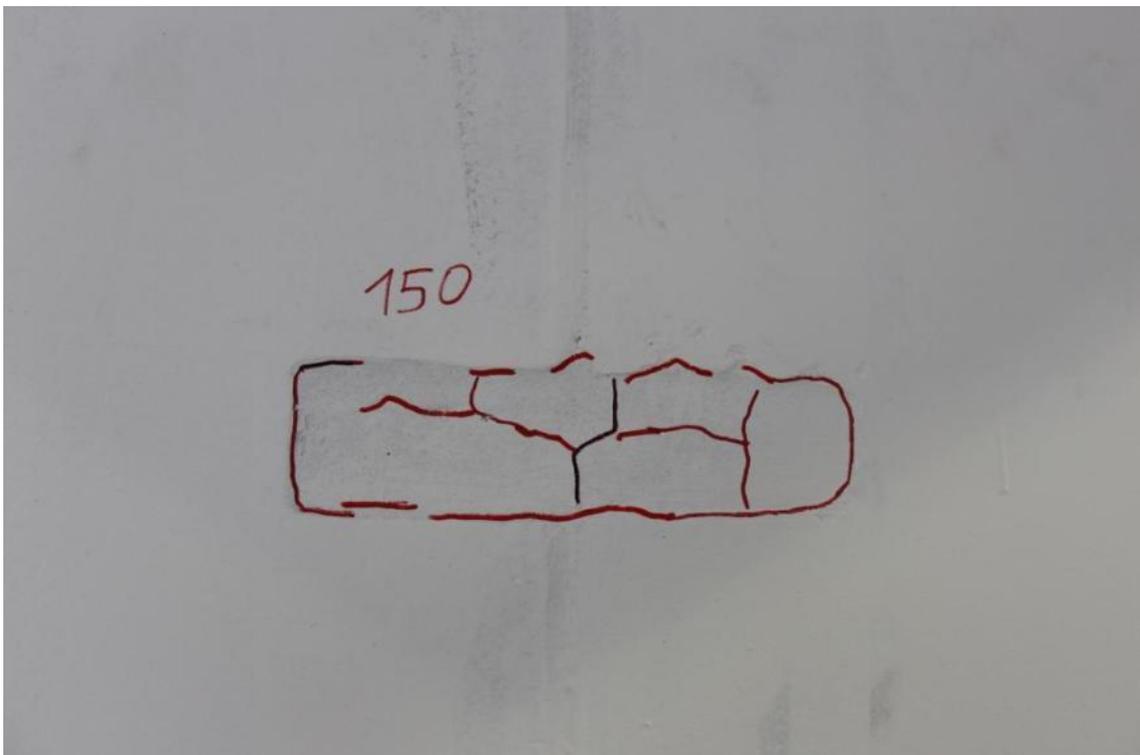
Figure 291. Cracks along the boundaries of the two-way connection – Third joint from the base.

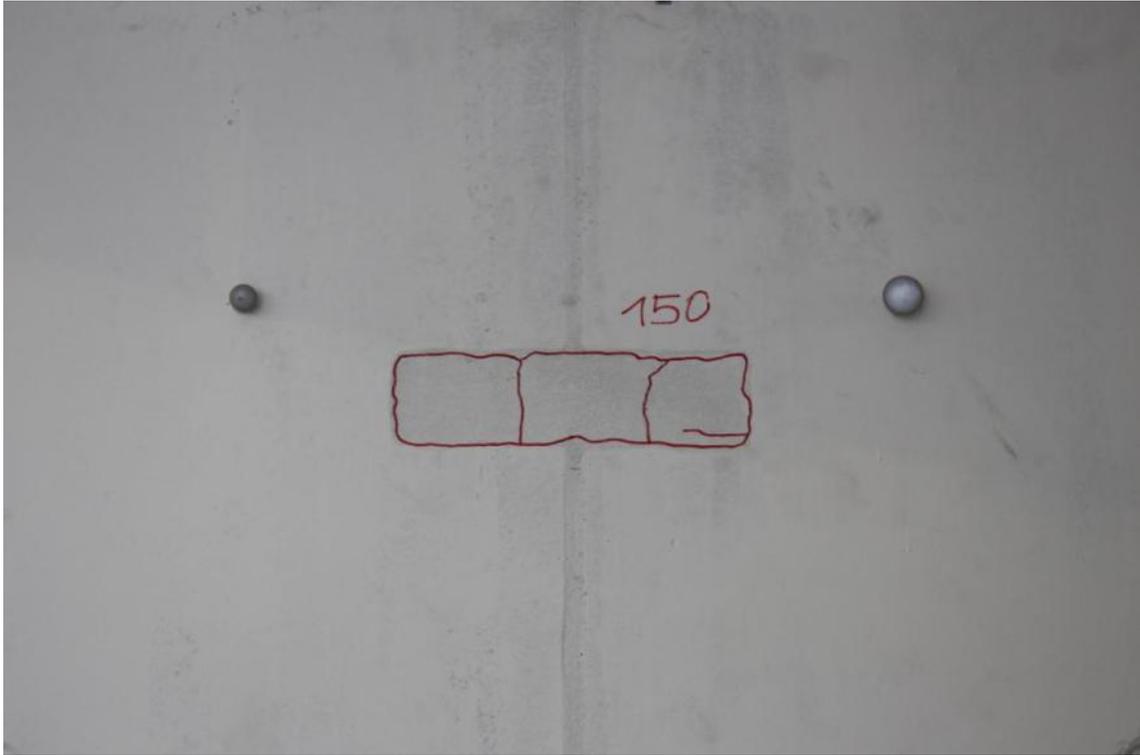
Figure 292. Detail of cracks along the boundaries of the connectors sockets – Top two-way connection.

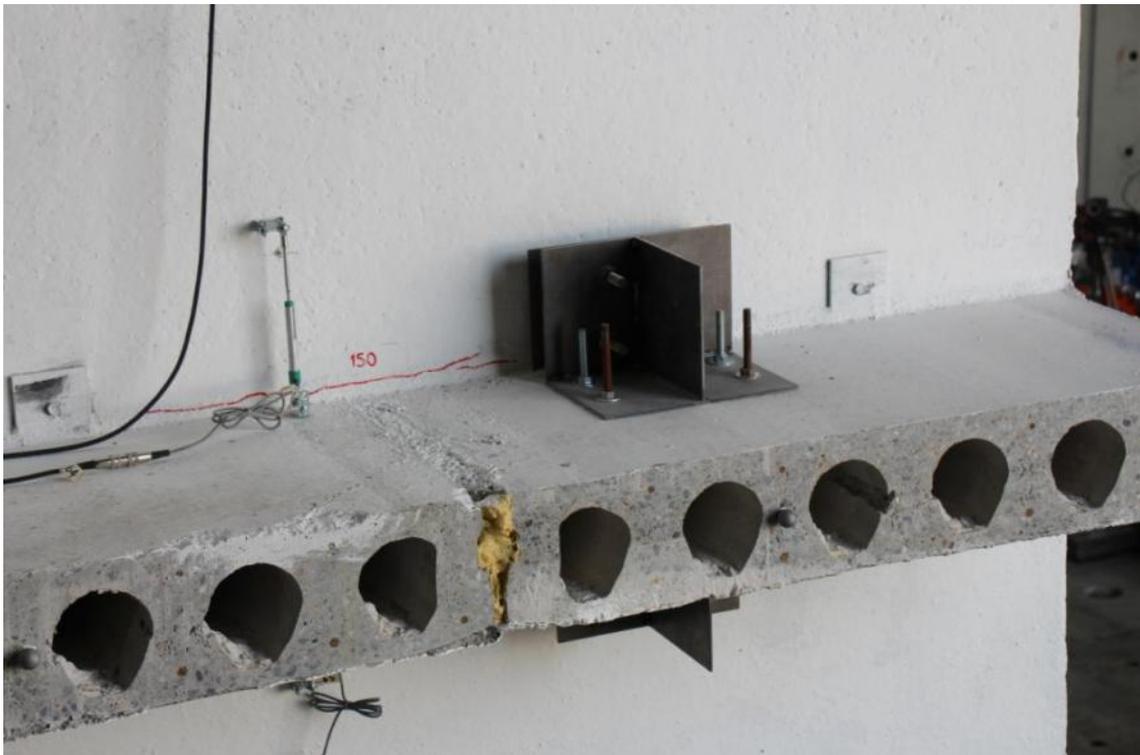
Figure 293. Horizontal flexural cracks at the base of the North-sided second-storey transversal walls.

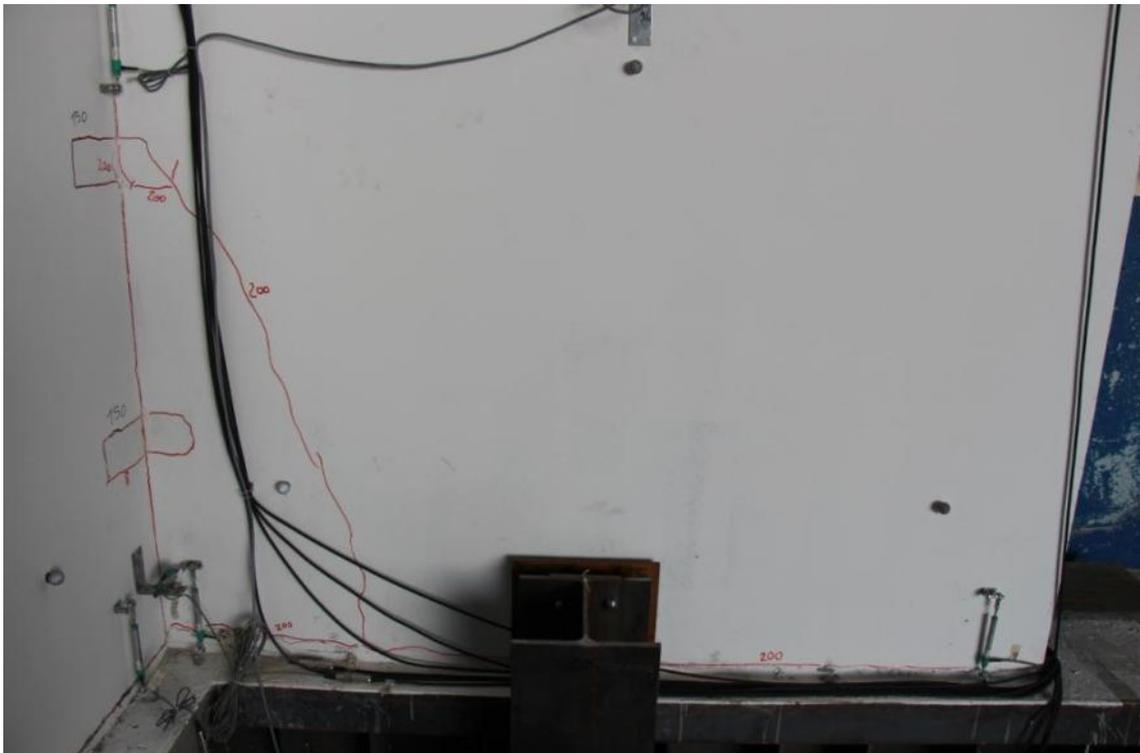
Figure 295. Inclined and full-depth/full-width/base horizontal crack in the lateral wall 1L2.

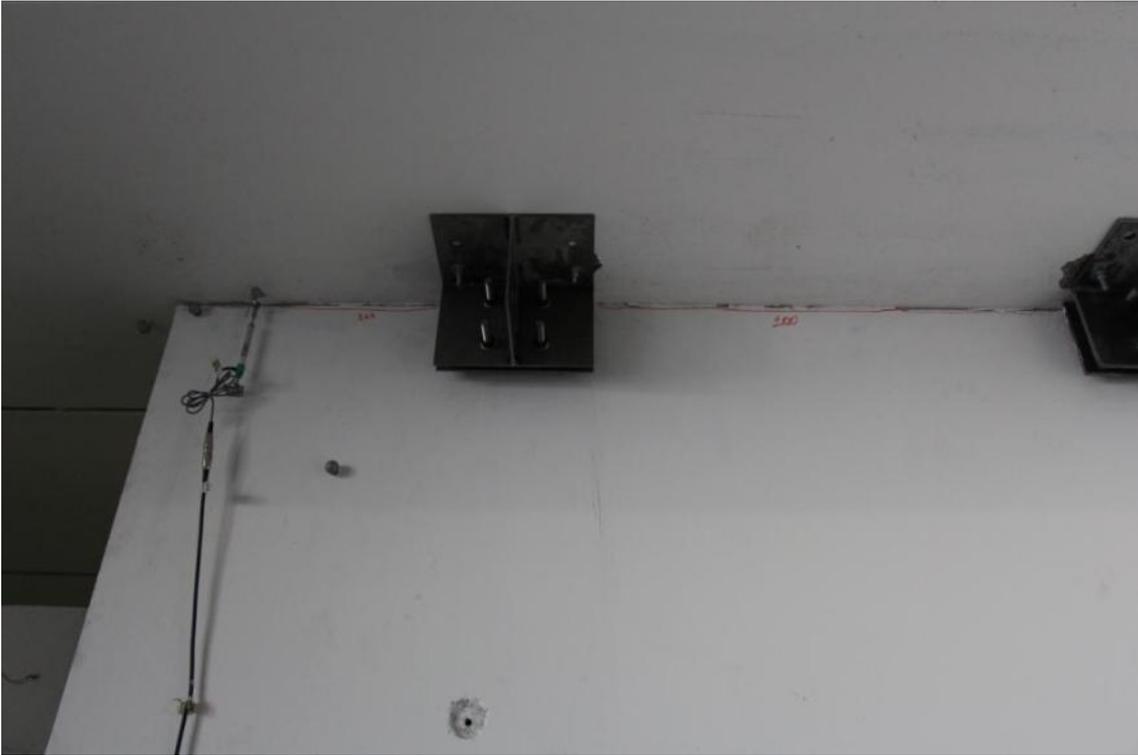
Figure 296. Damage pattern of the mortar joint between the ground-floor stability wall and the slab panel.

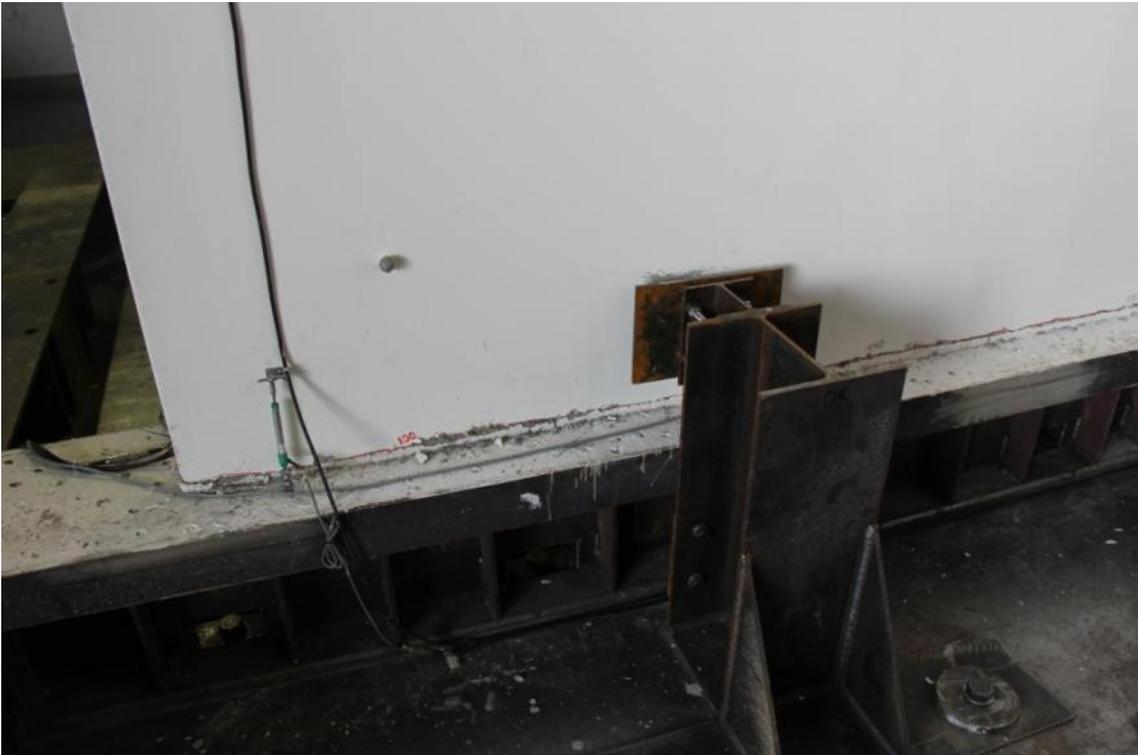
Figure 297. Full-depth/full-width horizontal crack at the base of the first-storey stability wall.

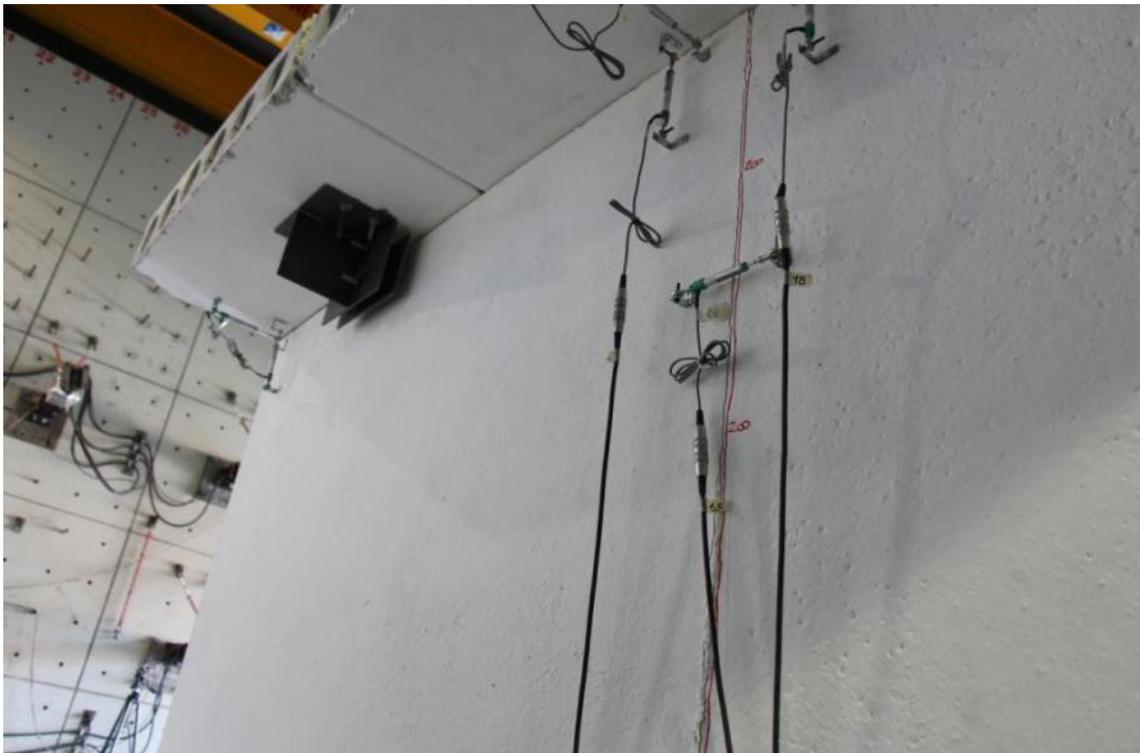
Figure 299. Development of a full-height vertical crack between adjacent lateral walls – South side, South face.

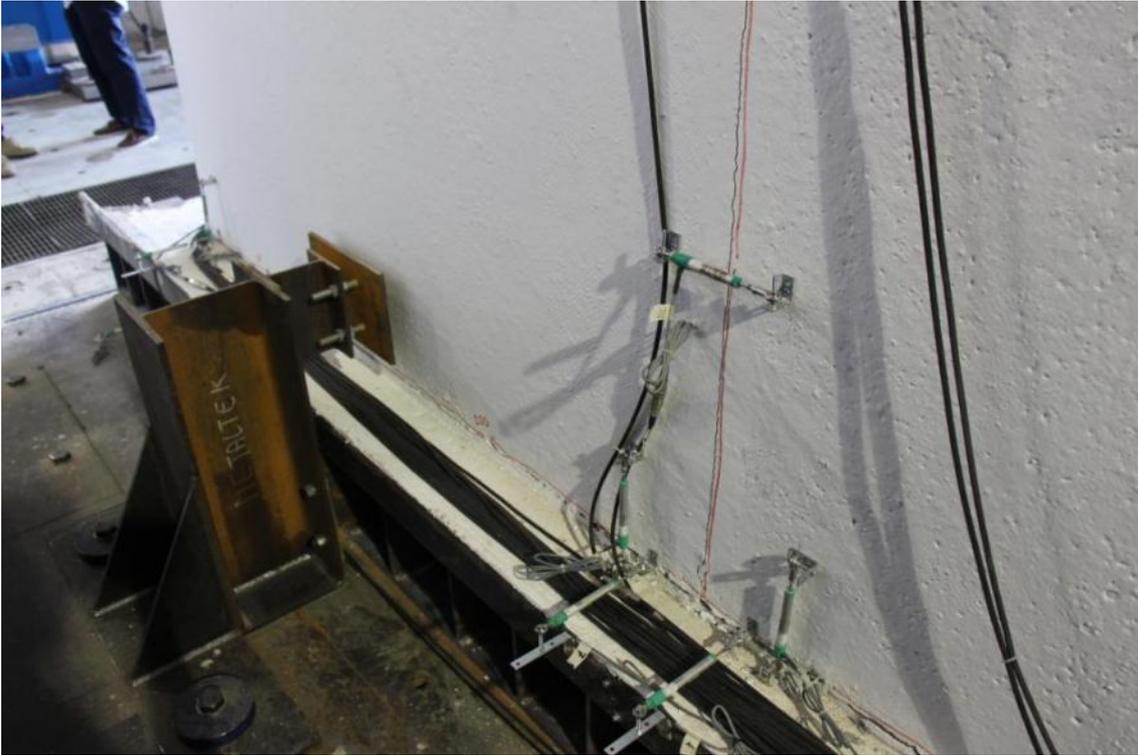
Figure 300. Damage pattern at the base of the South-sided ground-floor lateral walls.

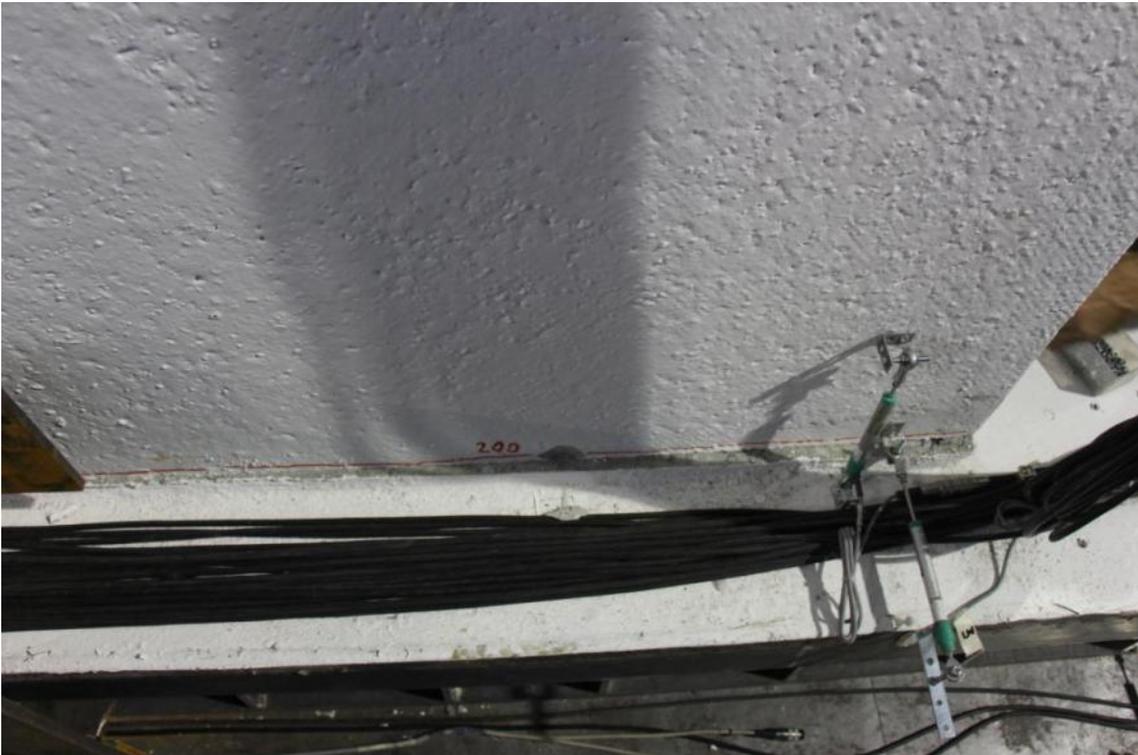
Figure 301. Full-depth/full-width horizontal crack at the base of the first-storey lateral wall 1L1.

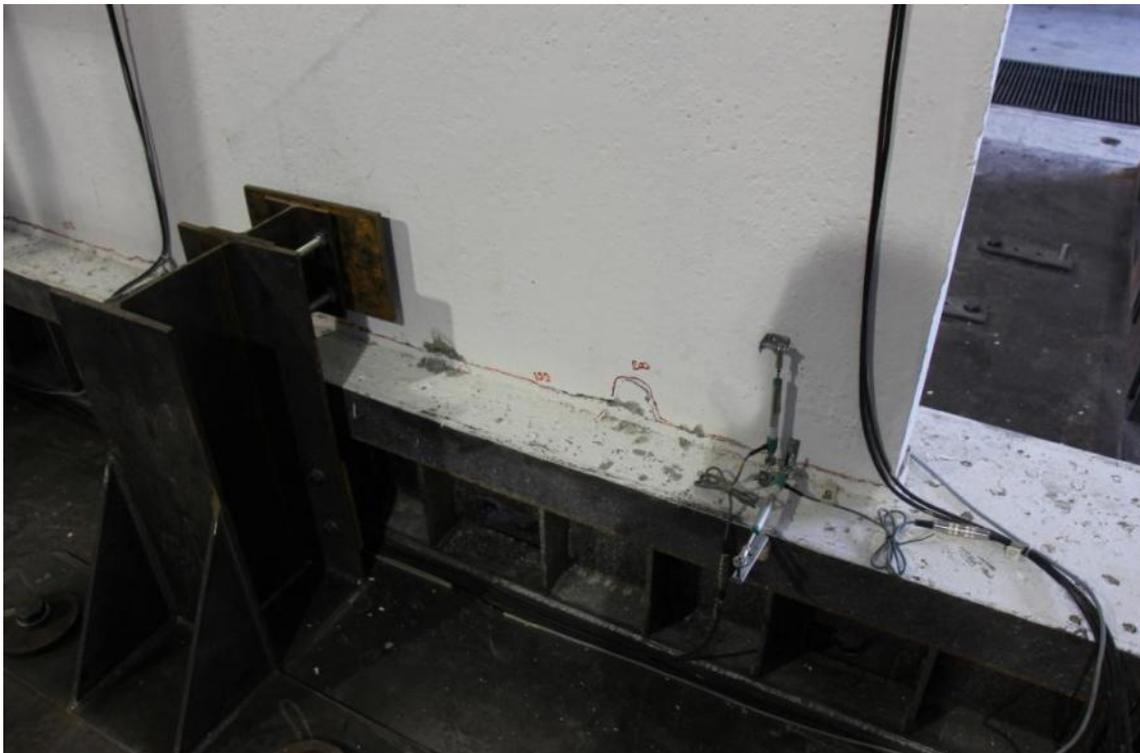
Figure 303. Full-depth/full-width crack at the base of the first-storey stability wall – East wall face.

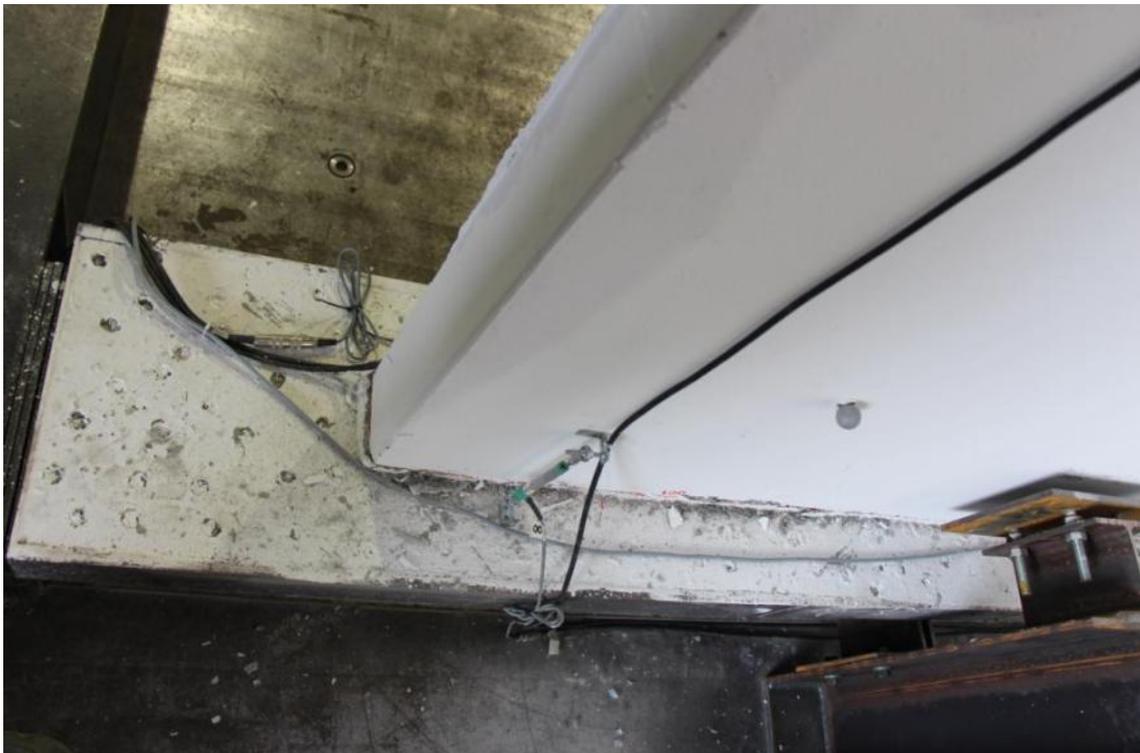
Figure 305. Crack running through the entire width of the first-storey stability wall – Corner, side view.

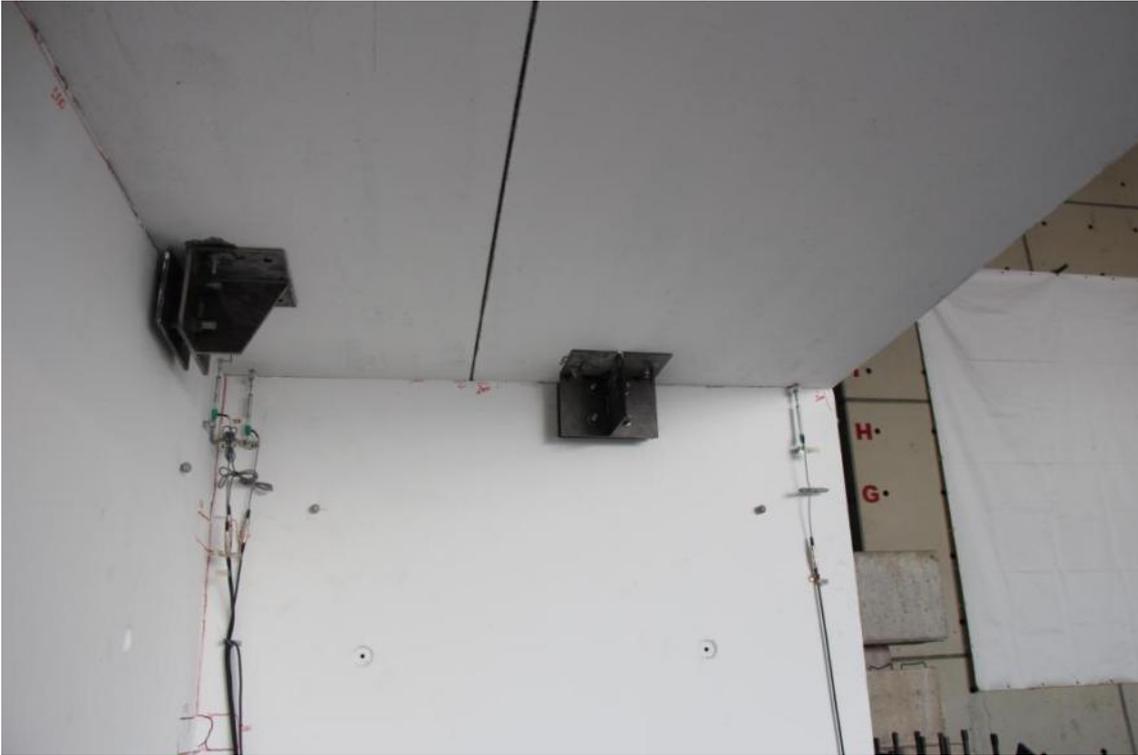
Figure 306. Concrete damage/chipping at the top of the first-storey lateral wall 1L2.

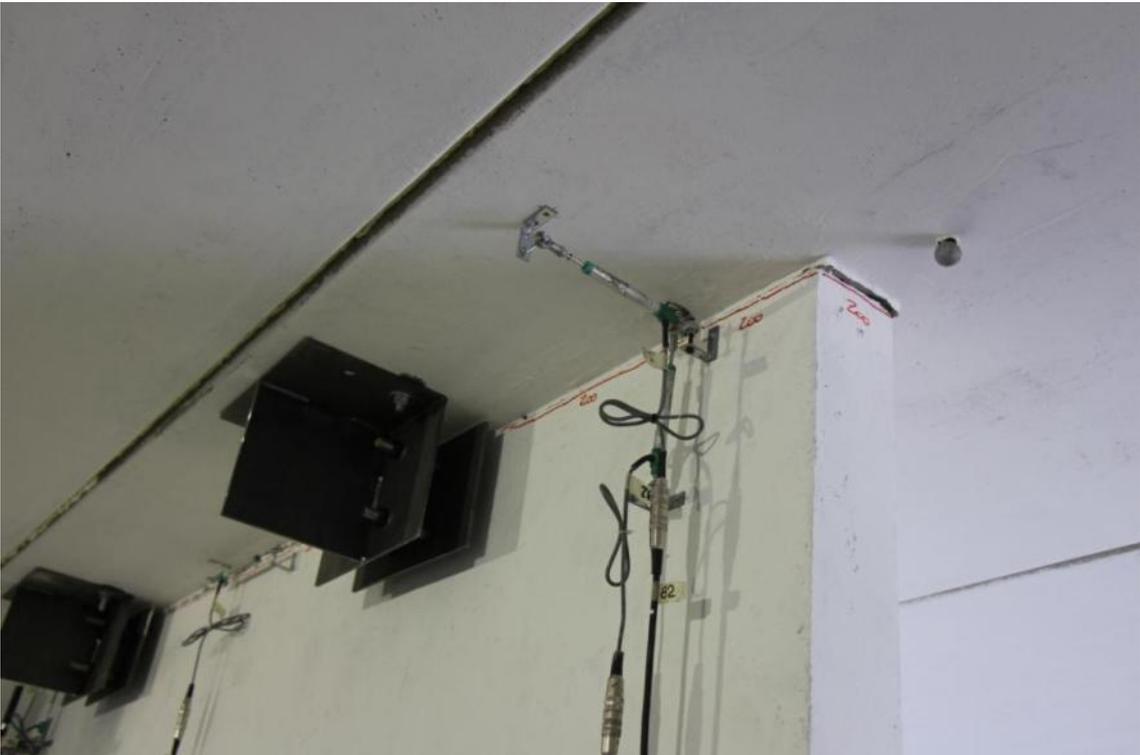
Figure 309. Damage pattern of the mortar joint between the second-storey stability wall and slab.

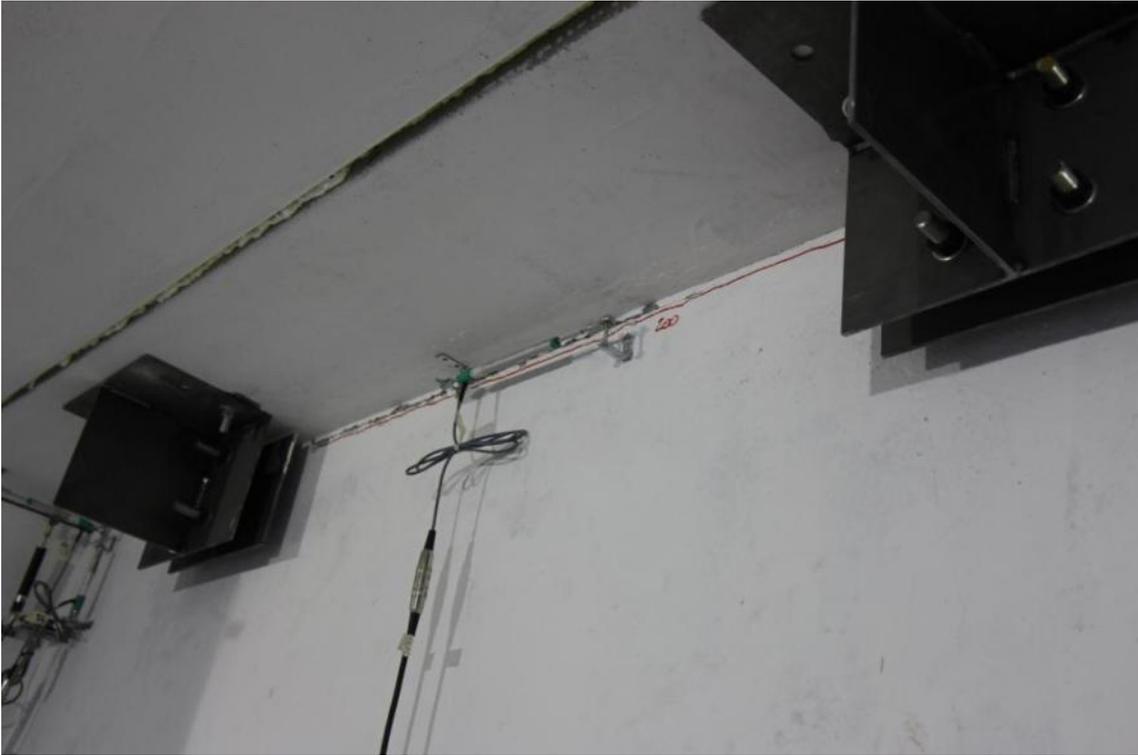
Figure 310. Full-depth crack of mortar joint between the second-storey stability wall and slab.

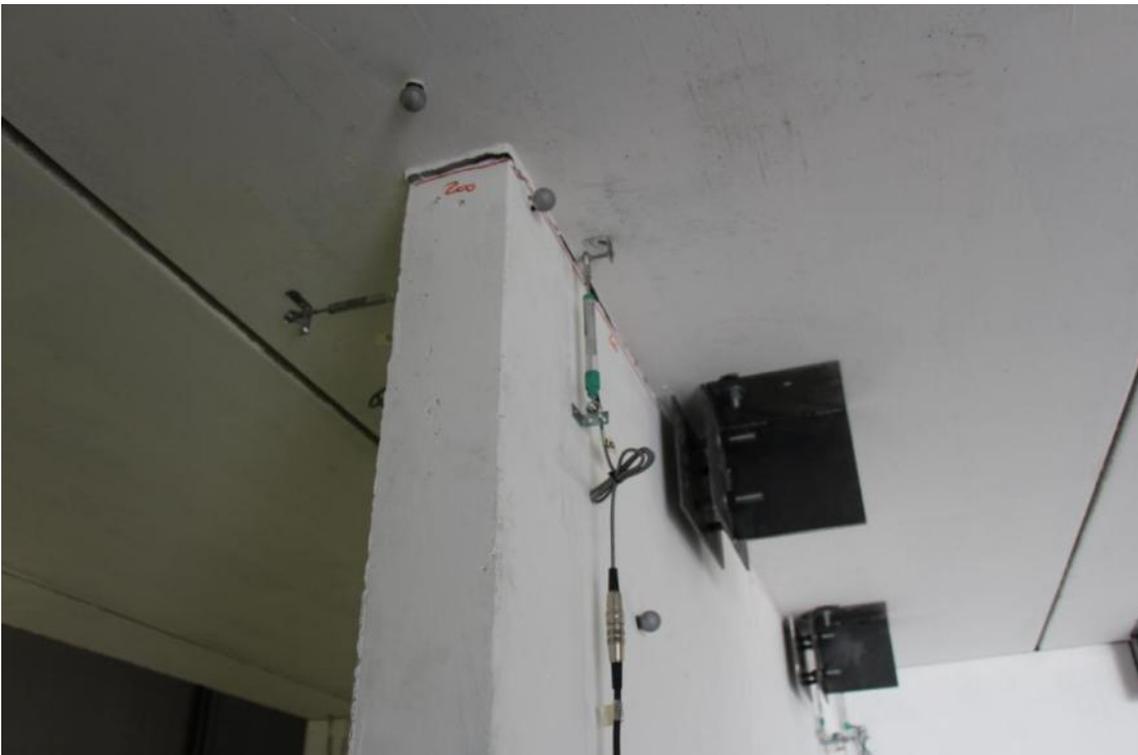
Figure 311. Full-depth/full-width crack of mortar joint between the second-storey stability wall and slab.
