Experimental campaign on Reinforced Concrete buildings typical of the Groningen region

Dynamic testing of a full-scale two-storey Reinforced Concrete precast wall-slab-wall structure representative of the Groningen building stock (EUC-BUILD5).

Eucentre

Date October 2017

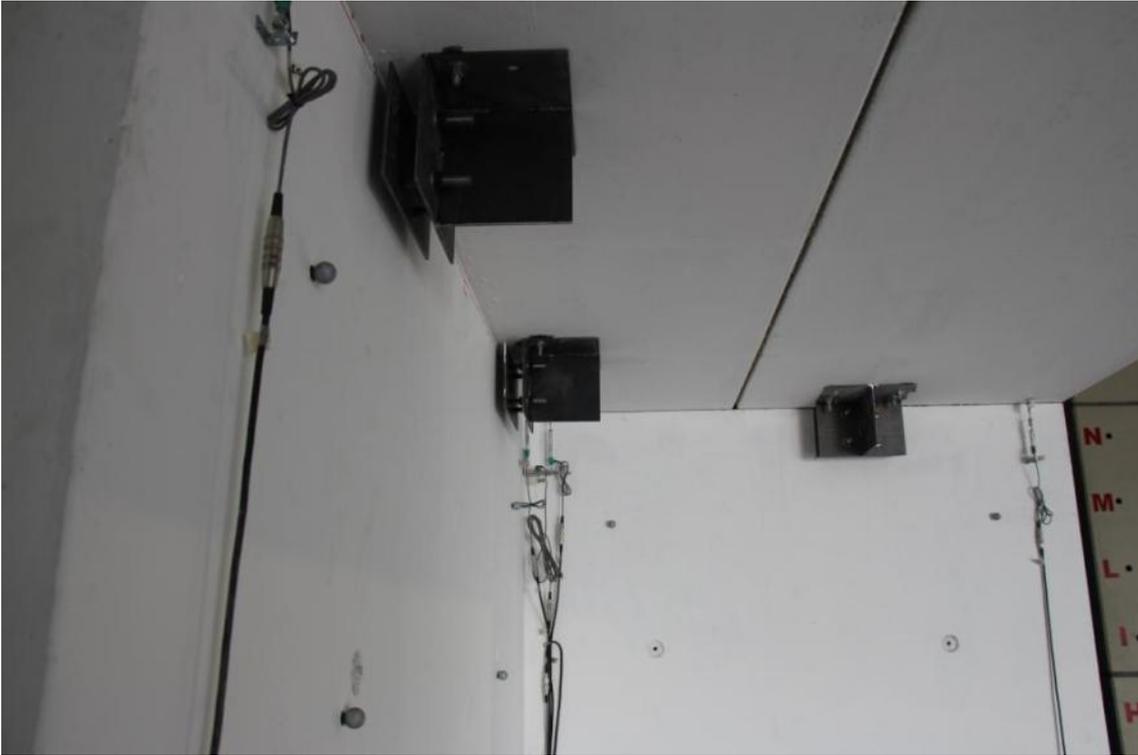
Figure 312. Damage of the mortar joint beneath the second-storey slab and accumulation of displacements.

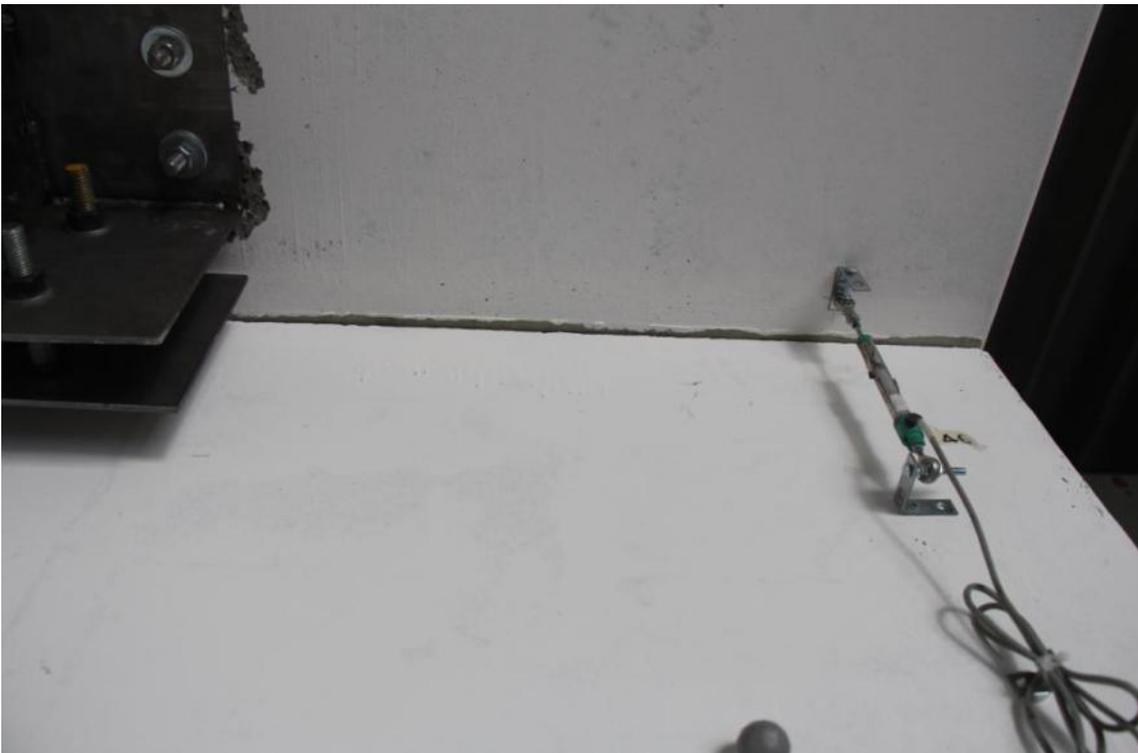
Figure 313. Sliding of second-storey slab and accumulation of displacements – Detail of a lateral wall.

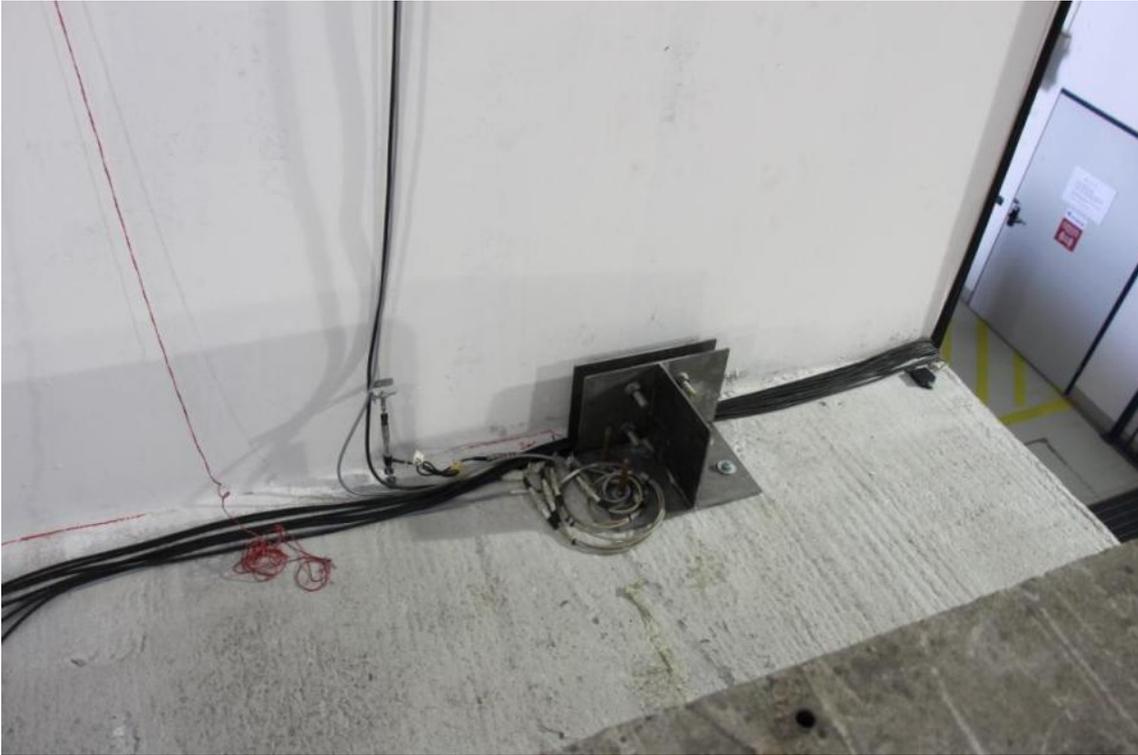
Figure 314. Development of a full-height vertical crack between adjacent lateral walls – North side.

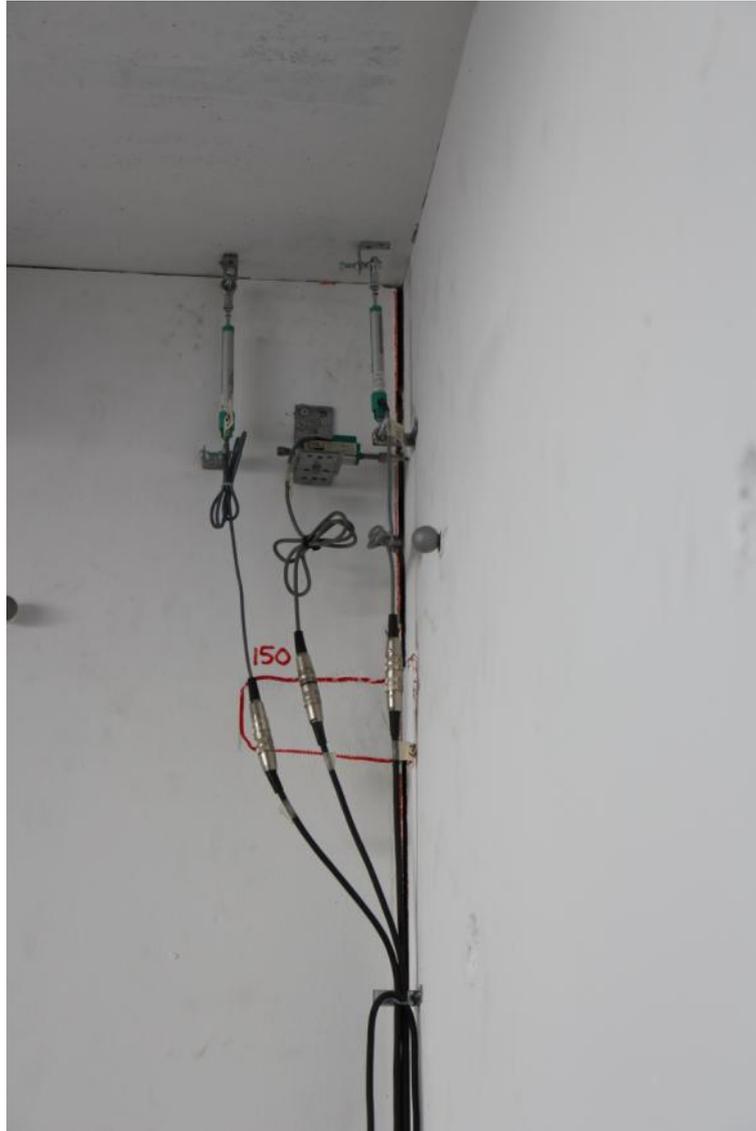
Figure 316. Damage in the top panel joint and gap opening between stability and lateral walls – West face.

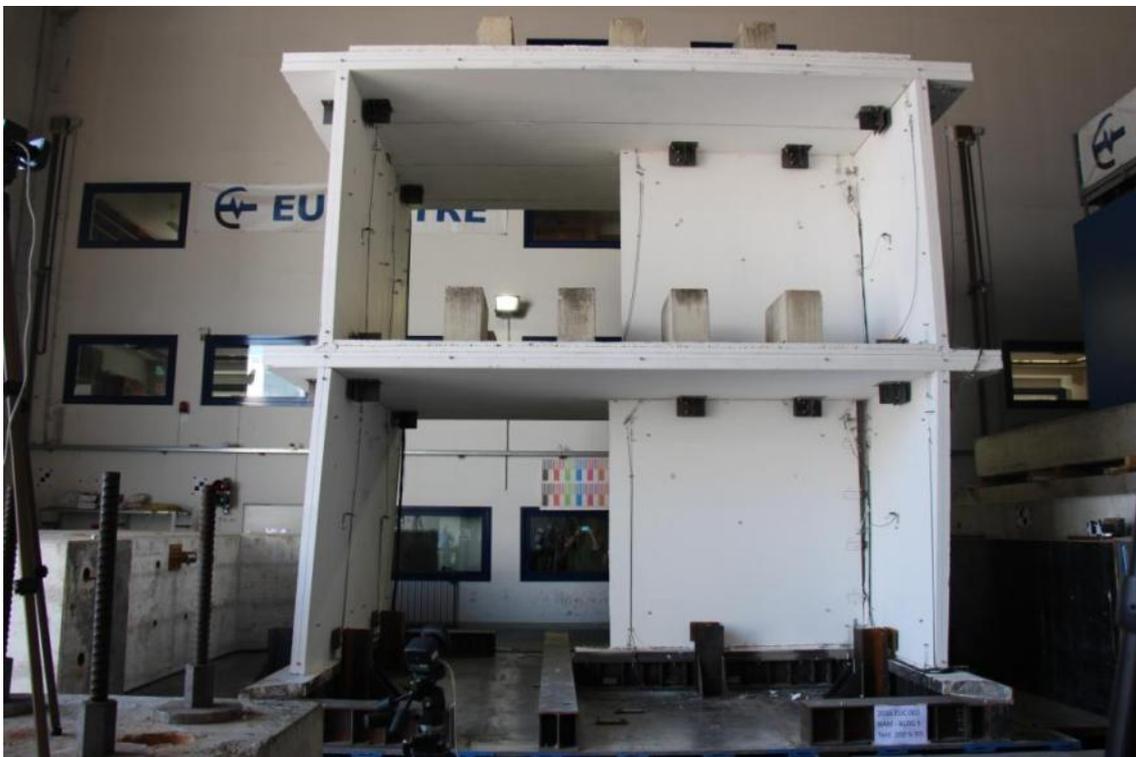
Figure 317. Deformed shape of EUC-BUILD5 specimen at the end of dynamic testing.

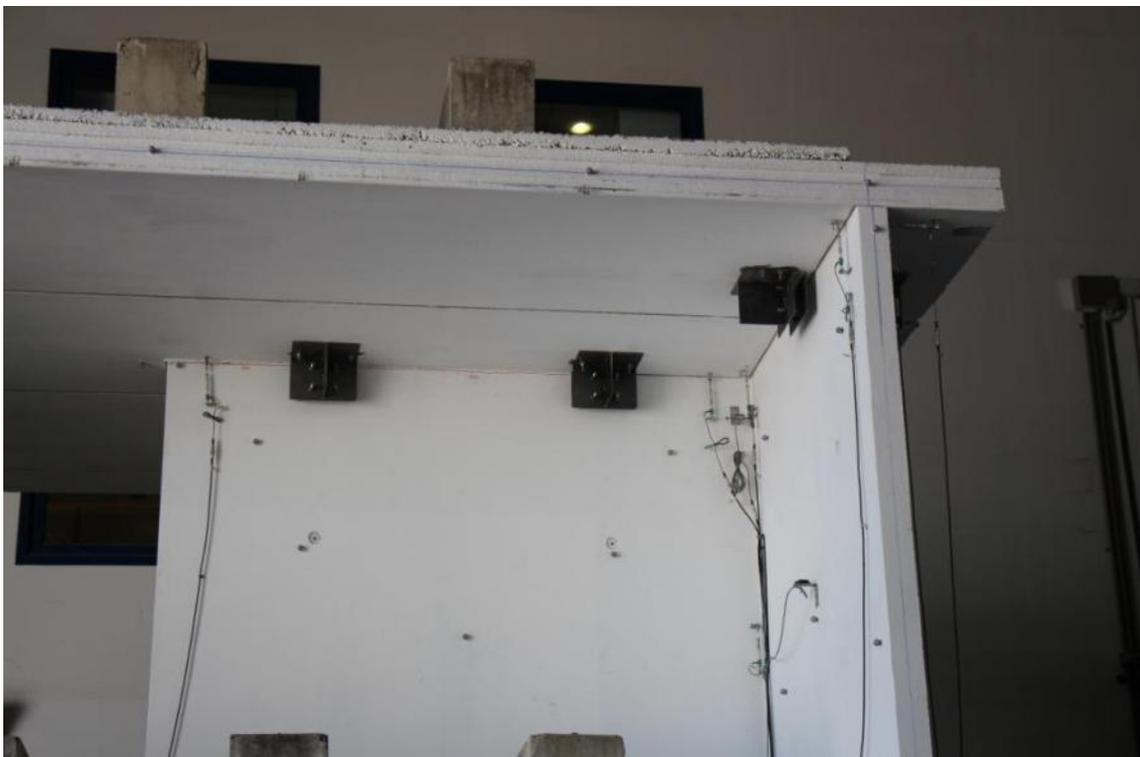
Figure 319. Accumulation of permanent displacements at the second storey of the test specimen.

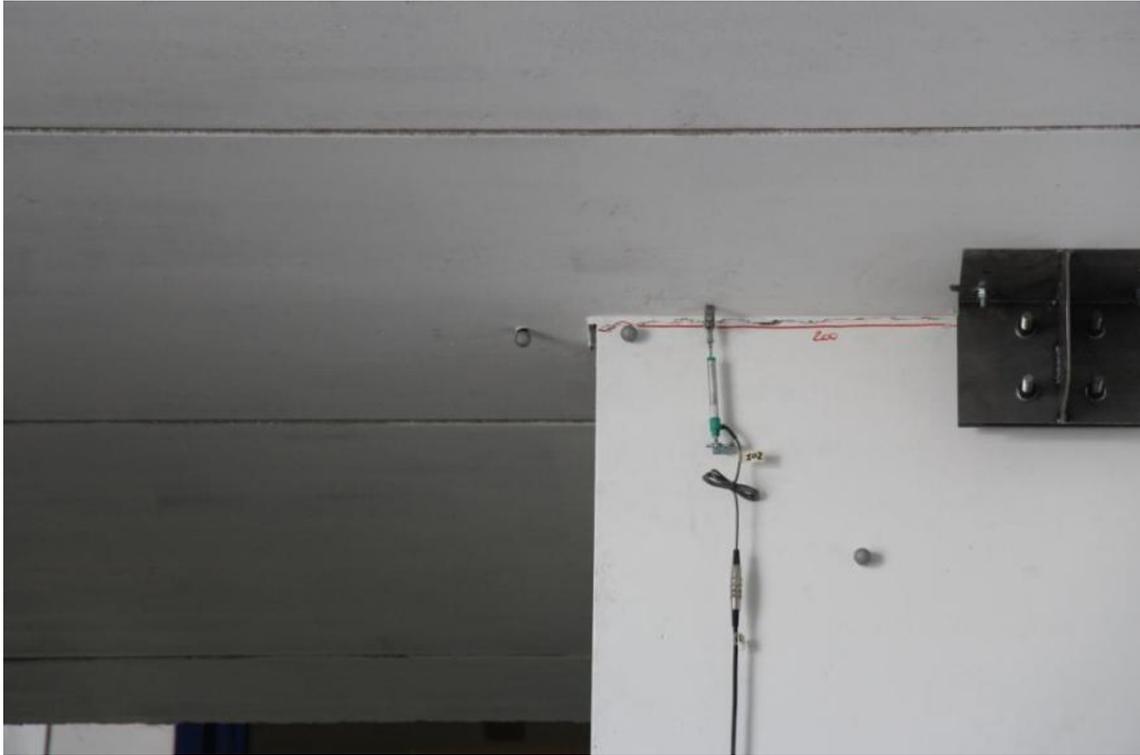
Figure 320. Detail of damage pattern in the mortar joint beneath the second-storey slab – West-side view.

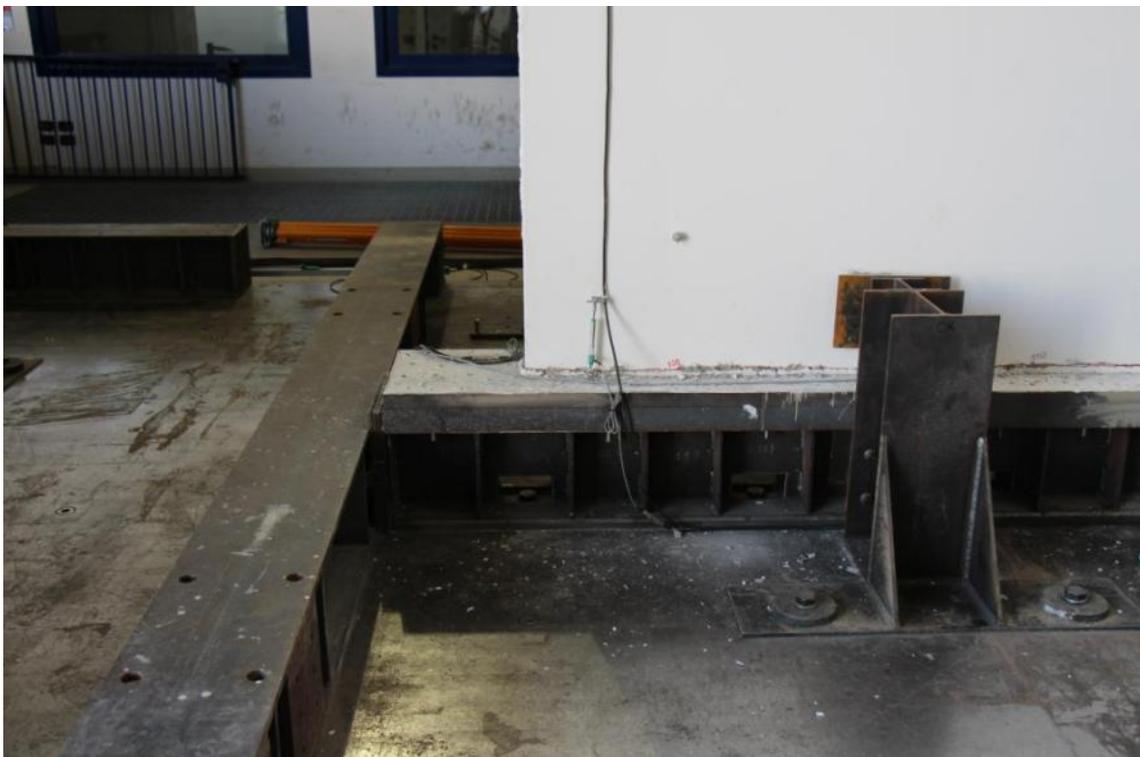
Figure 321. Sliding and concrete crushing at the base of the first-storey stability wall – West-side view.

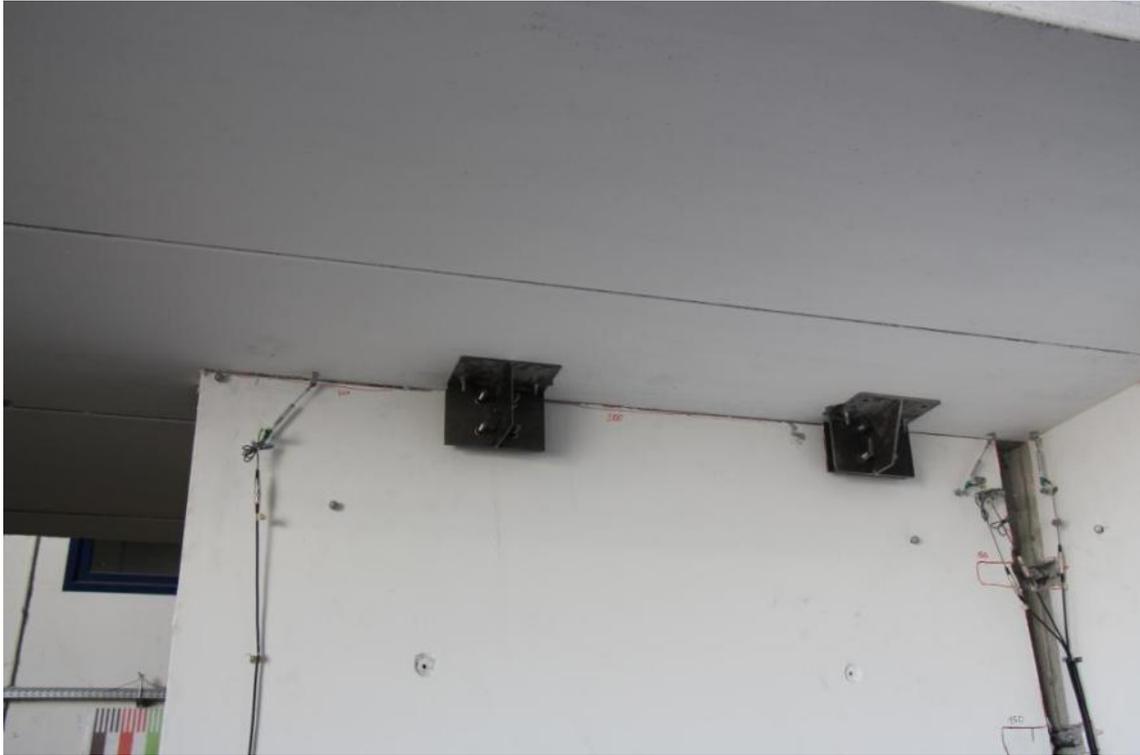
Figure 322. Connection failure and damage pattern in the mortar joint beneath the first-storey slab.

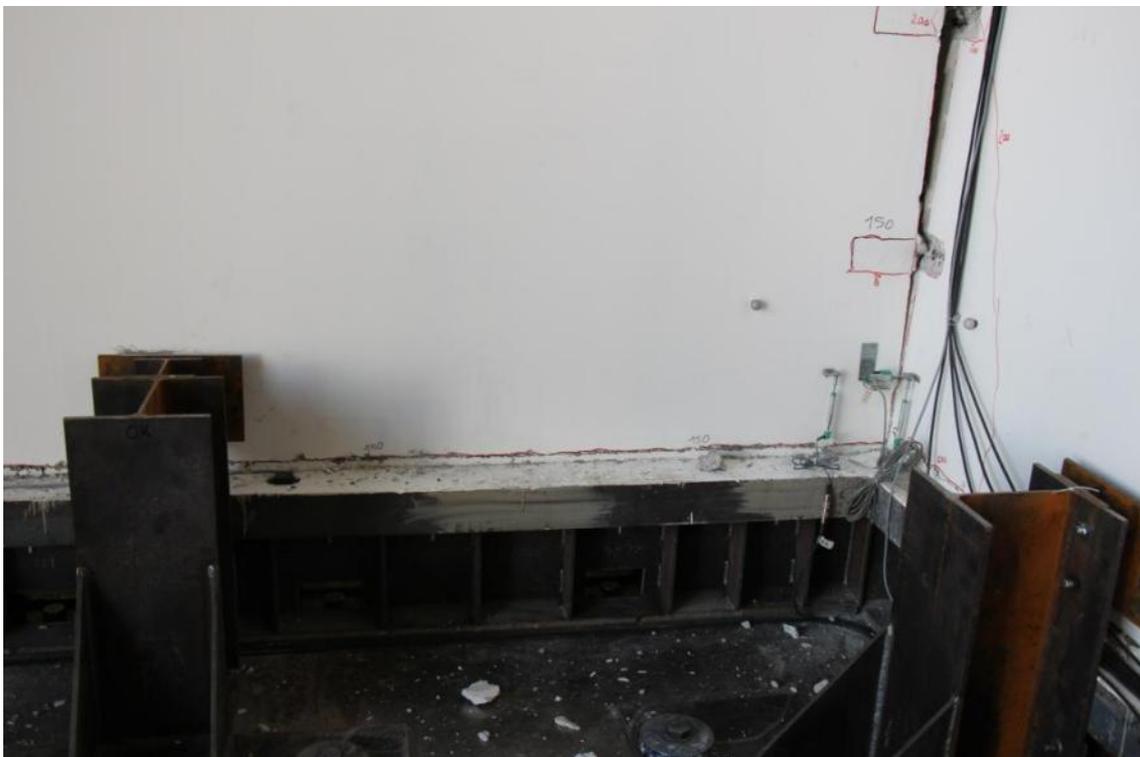
Figure 323. Failure of bottom three-way joints damage pattern at the base of the stability wall.

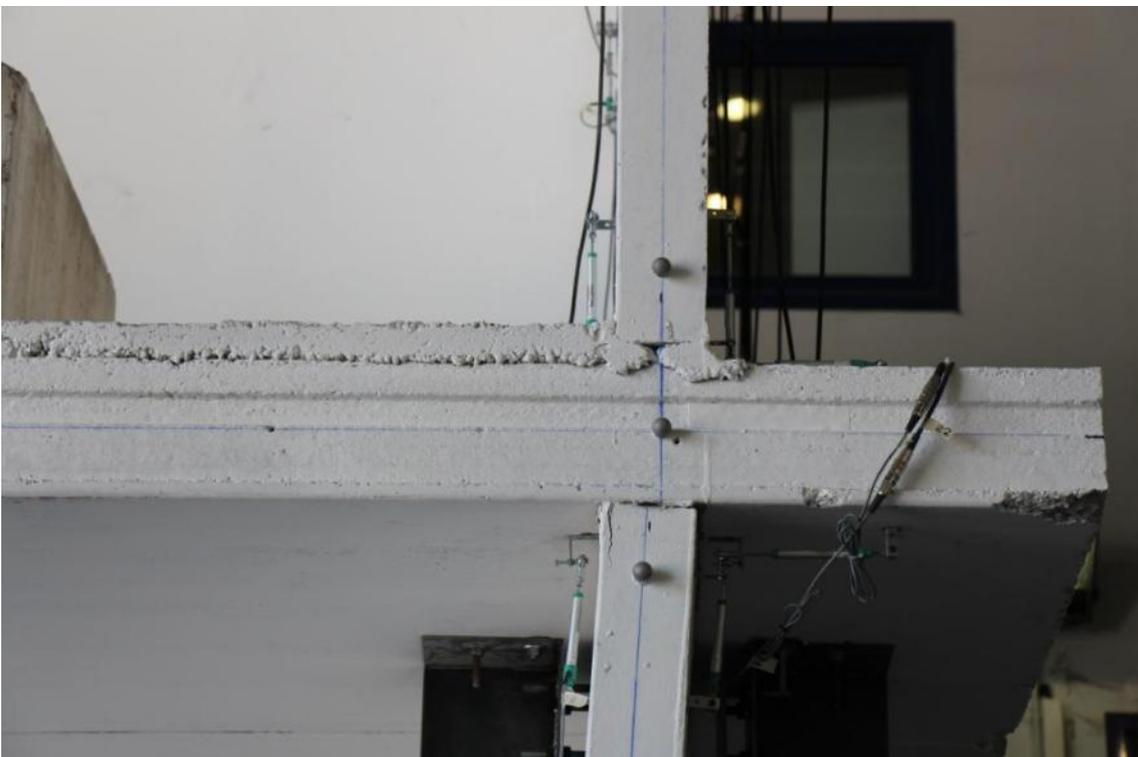
Figure 335. Detail of concrete spalling/crushing at the top of lateral wall 1L2.

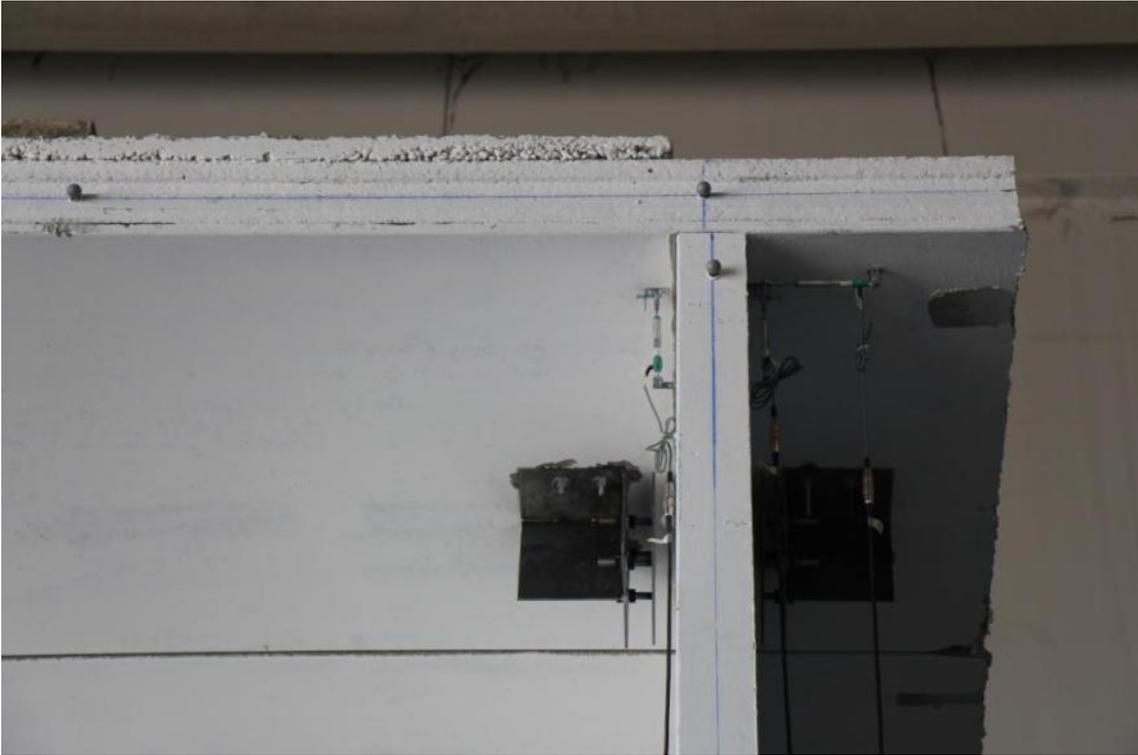
Figure 336. Sliding of second-storey slab on the precast wall – South side of the specimen.

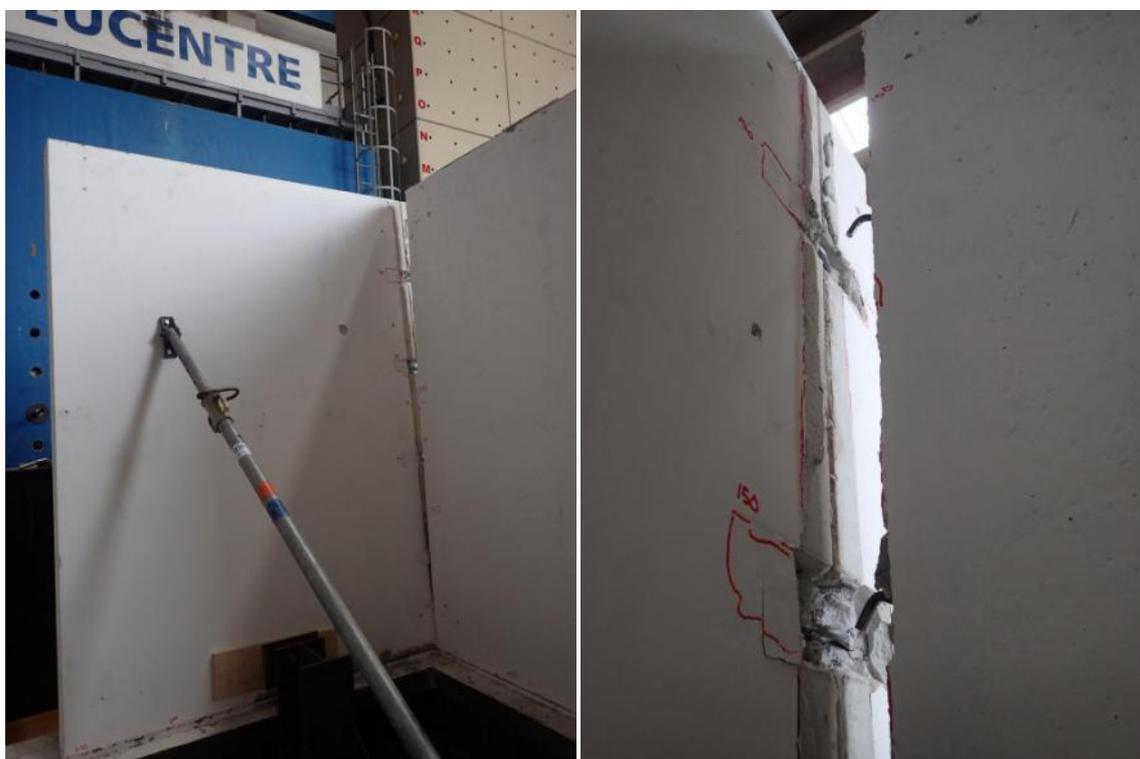
Figure 541. Diagonal props for lateral stability and detail of the damage state of steel connectors.

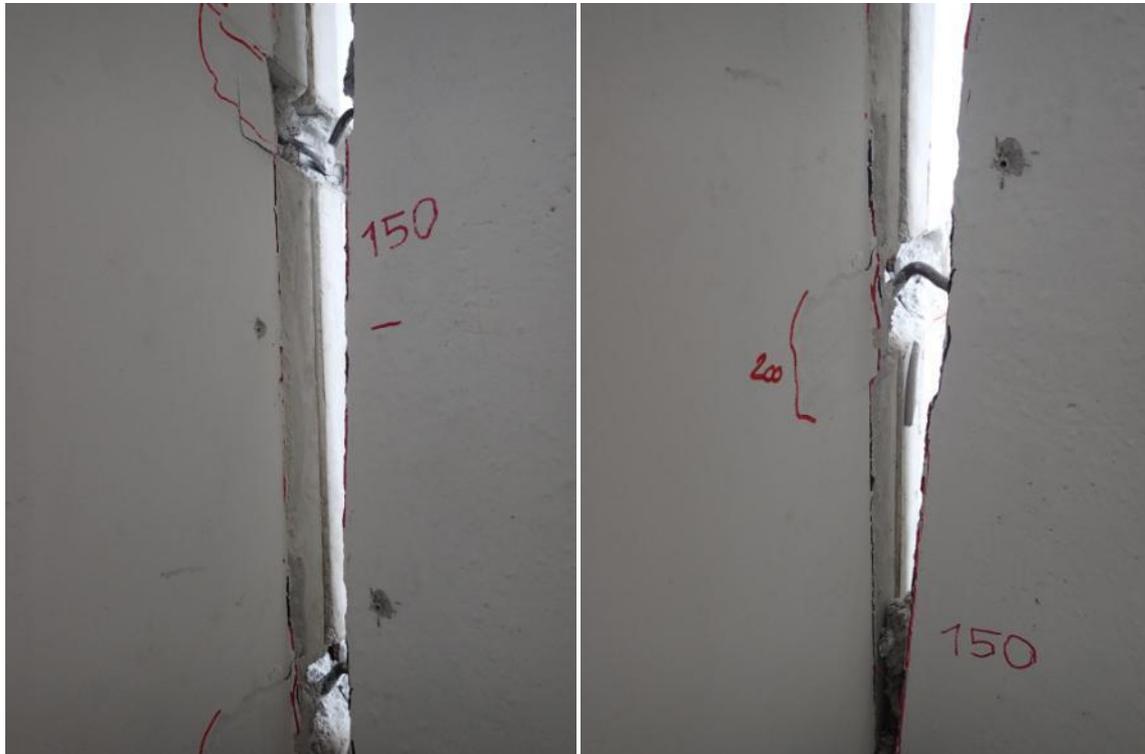
Figure 542. Permanently-bent steel connectors embedded in the sockets of the stability wall.
