Waddenzee LiDAR Survey

Final Report

Datum: 18 February 2014
Client: Nederlandse Aardolie Maatschappij
Author: Fugro Geospatial B.V.
Project number: ASM11085
Version: 2

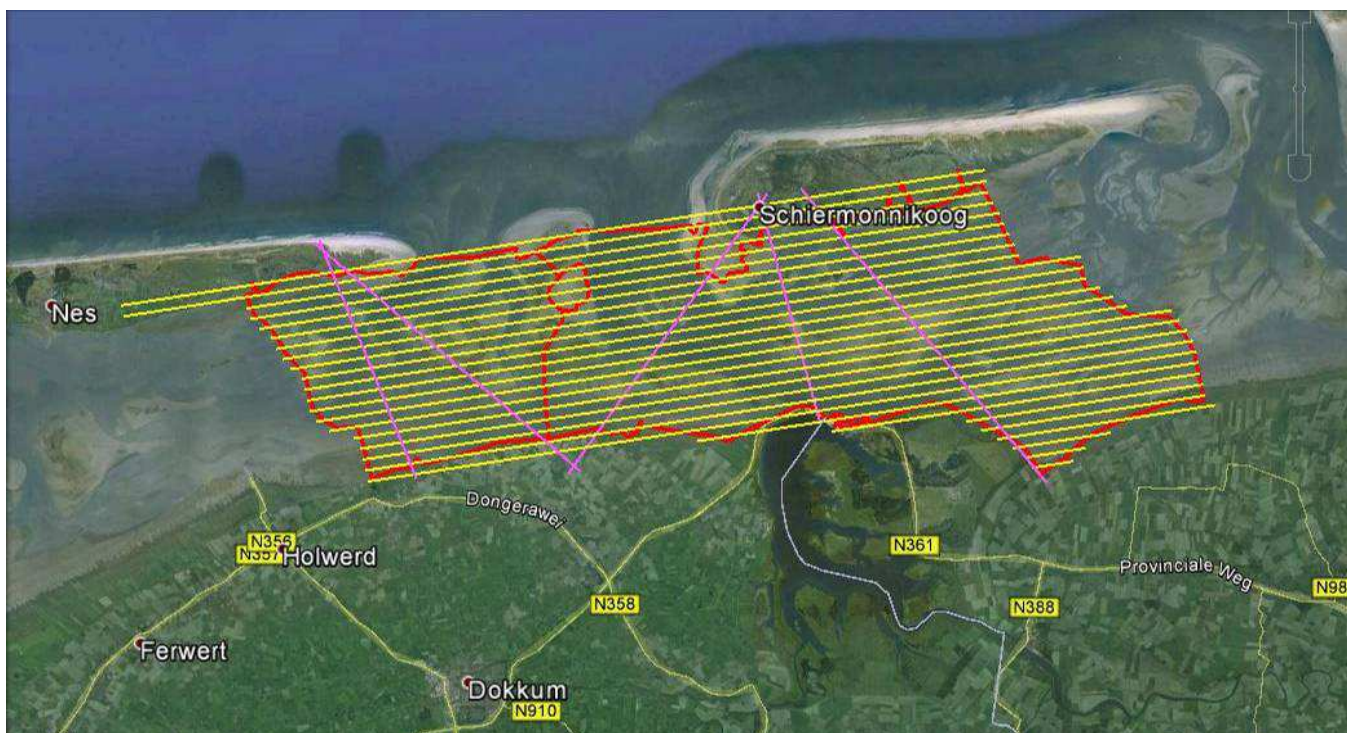
Figure 1: Project area and flightlines.

The airborne survey covers the areas Pinkegat and Zoutkamperlaag. The survey area and flightlines are shown in Figure 1. The survey encompasses 760 kilometres of flight lines with an east-west orientation (indicated in yellow) and five cross lines (indicated in pink). The area to be covered is indicated with the red line.

The coverage of the laser sensor is checked in the acquisition phase. The area covered by the sensor is compared with the boundary file supplied by the client (see Figure 1). Gaps are reported and re-flown.

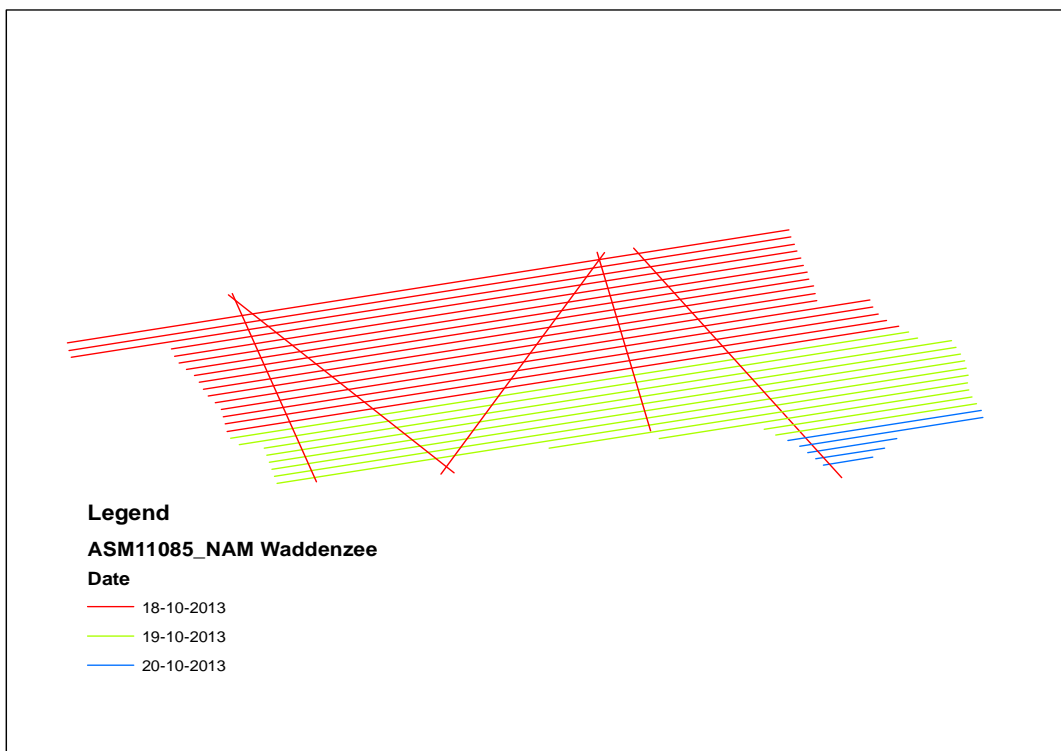
Figure 2: Overview of the 3 flights

In Table 1 and Figure 2 a brief overview of the daily status of the project is given.

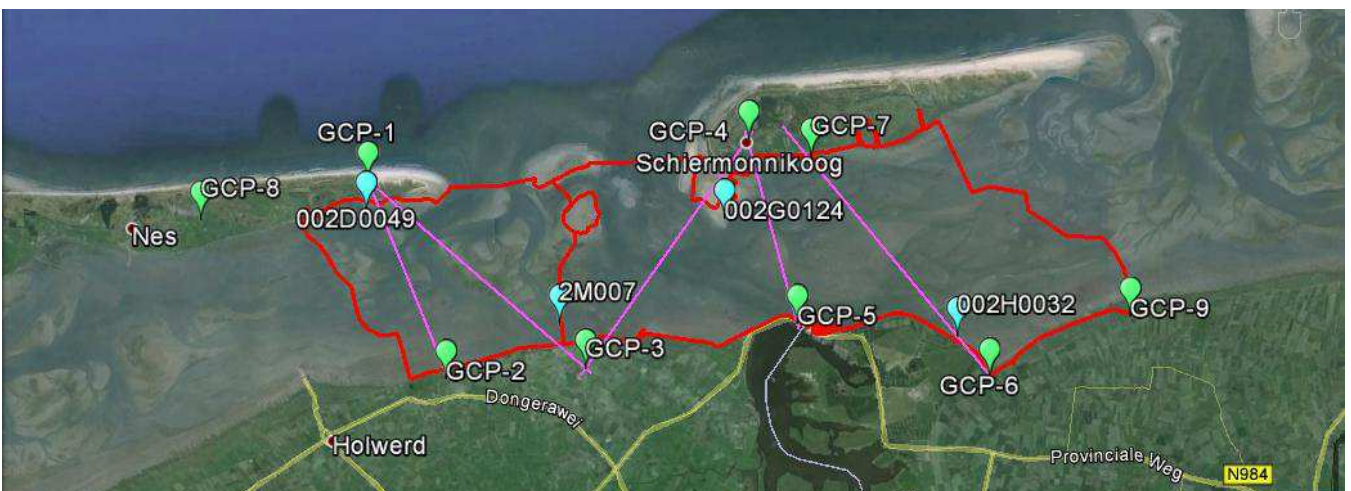
Figure 3: Overview of GCP locations

In the same period 13 control grids are surveyed, 9 on hard surfaces and 4 on the mud flats. In Figure 3 an overview of these locations is given. The locations indicated in green (GCP-1 to GCP-9) are the grids on hard surface, the others (in blue) are the grids on the mud flats. These areas are used to check the positioning of the flights. The cross lines are displayed as well, to show that these are planned over the hard surface GCP locations.

As already shown in Figure 3, for this survey 9 control grids on hard surface and 4 control grids on the mudflats were surveyed. All land surveys have been performed by Fugro GeoServices B.V.

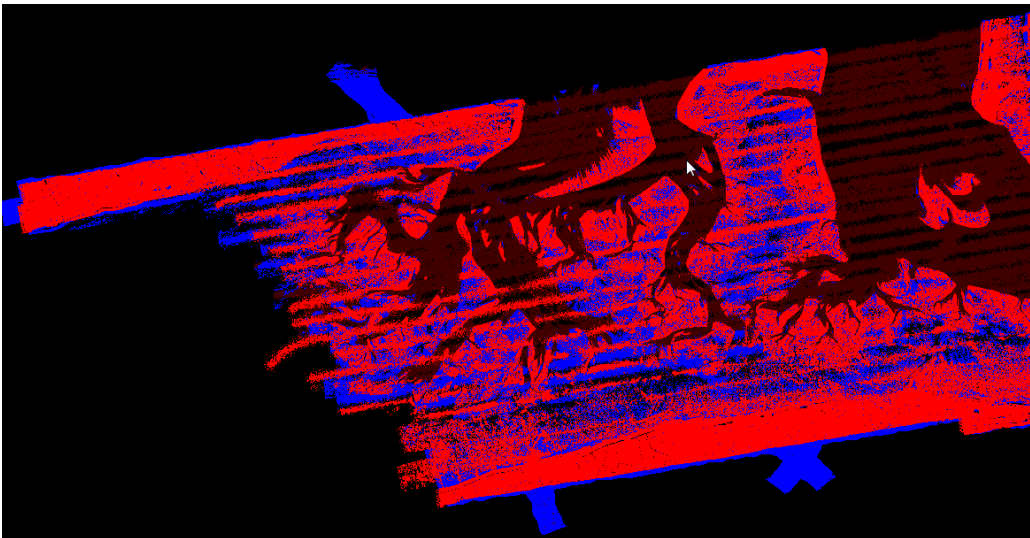
Figure 7: Coverage comparison, 2012 over 2013, eastern part

In Figure 7 and Figure 8 the data is projected the other way around, using the same colour coding. So in these images the blue areas indicate the locations that are covered in 2013 but showed no hits in 2012.

From these images, it can be seen that generally the coverage in 2013 is better than in the previous years. Besides some larger locations at edges of the area, caused by a difference in the flight plan, it can be seen that the coverage on the mud flats in mud flats is better in 2013. Due to the wet nature of the mud flats, there are more hits right below the aircraft and less to the side causing this striped pattern. Due to the fact that the flightlines of 2013 do not exactly overlap the flightlines in 2012, there are differences in the coverage between the two years. Some locations area that wre right below the aircraft, and therefore show good coverage, in one year may be on the side of a strip in the other year, where less hits are. The line spacing however is the same for both years.

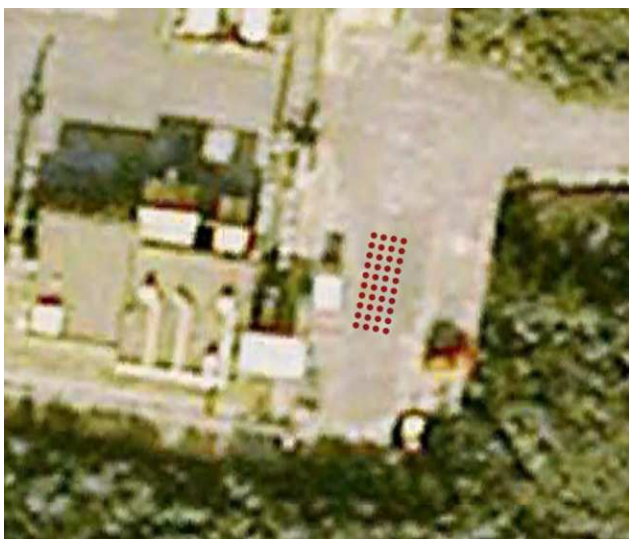
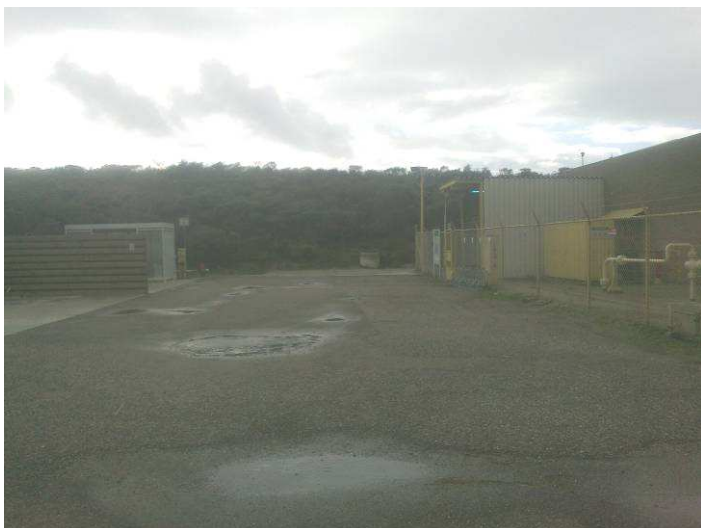
Figure 13: Example of one of the GCP's uses for this project

In Figure 13 an example of one of the control grids on hard surface is given.

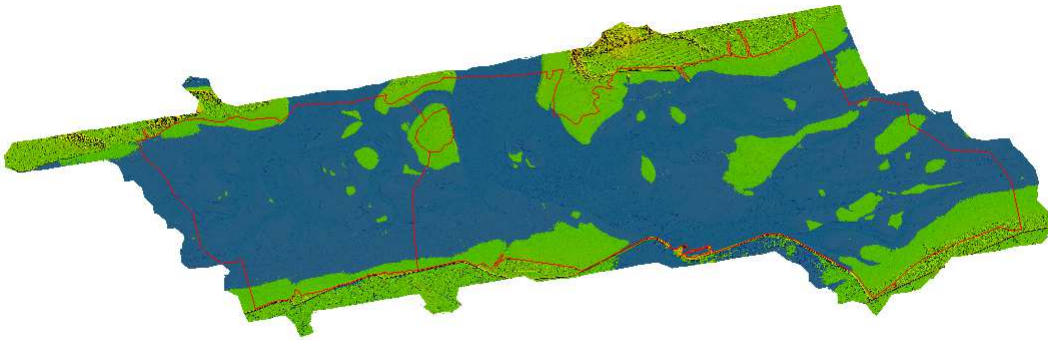
Figure 15: DTM of the project area

The results of the coverage check are given in Figure 15. From the figure can be seen that the entire project area (between the red boundary) is covered.
