# **IN-PLANE TESTS ON REPLICATED MASONRY WALLS**

**Physical Testing and Modelling – Masonry Structures**

**Geert Ravenshorst and Francesco Messali**

**TU Delft**

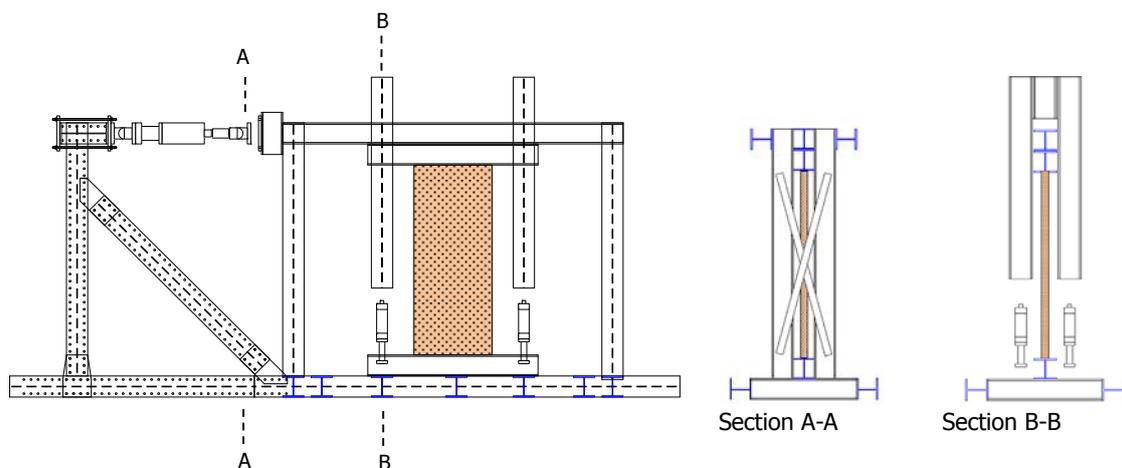
Figure 1. Scheme of the test set-up used for the in-plane tests on short walls.

The specimen were glued on a bottom steel beam and also a steel beam was glued on top of the masonry. The bottom and top brick layer were glued with "Sikadur 30" to the steel beams to prevent sliding shear failure and tension failure at the steel-masonry contact layer. Failure due to tensile bending stresses or shear failure could therefore occur only in the masonry and not at the steel-masonry contact layer. The bottom steel beam was attached to cross-beams that were connected to the frame that was anchored to the floor, and therefore prevented from uplift. On the top steel beam a load-spreading beam was bolted. The horizontal actuator was attached to this load-spreading beam. The horizontal actuator induced a cyclic shear force on the test specimen. The vertical actuators were loaded in tension and were positioned by a steel frame on the load-spreading beam. This steel-frame was horizontally supported to prevent out-of-plane deformation. The vertical actuators were controlled pairwise, to ensure that the actuator load in each pair was the same. The rotation out-of-plane of the top beam and the load spreading beam was prevented by the frame that introduced the tension force of the vertical actuators (cross section B in Figure 1 and Figure 2).

A scheme of the test set-up employed for the short and the long walls is displayed in Figure 1 and Figure 2, respectively.

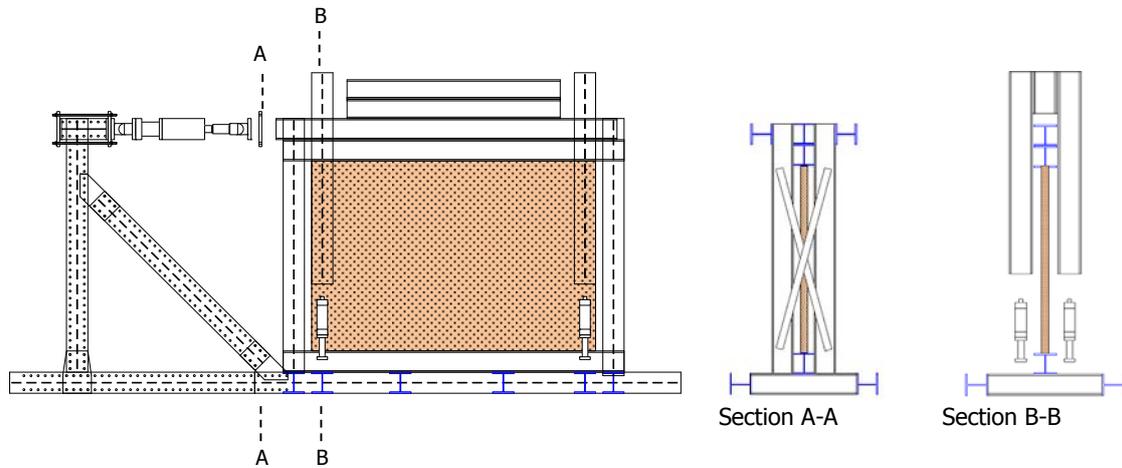
Figure 2. Scheme of the test set-up used for the in-plane tests on long walls.

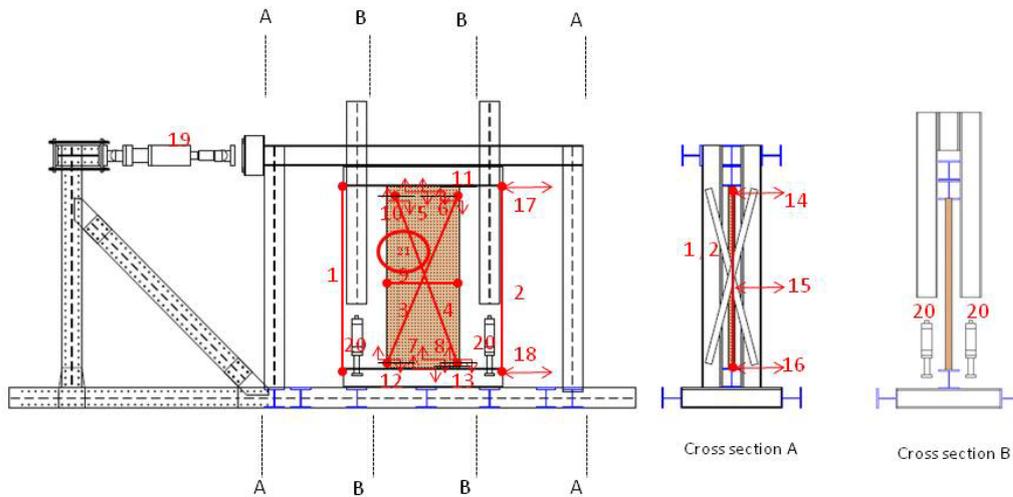
Figure 3. Overview of the measuring points for the short specimens for the in-plane tests at TU Delft.

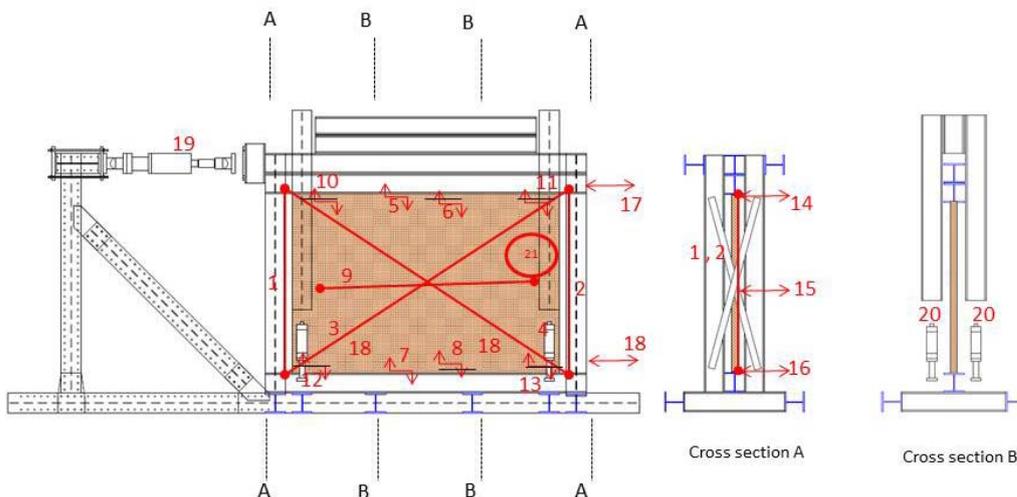
Figure 4. Overview of the measuring points for the long specimens for the in-plane tests at TU Delft.

The reading of the diagonal elongation (provided by this additional sensor), combined with the vertical extension (measured by sensors 1 and 2 in Table 2 and Figure 4), provide a direct measure of the deformation of the wall, and consequently of the net displacement. For the long walls the presented net deflections are obtained by this method.

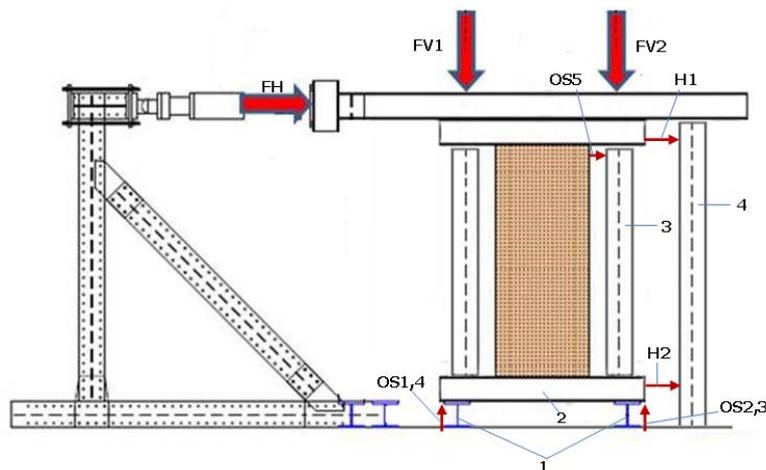
Figure 5. Transducers employed to measure the net deflection of the tested walls.

The calculated net deflection obtained by the methods a and b showed good correlation. The net deflections are presented are primarily obtained by method b.

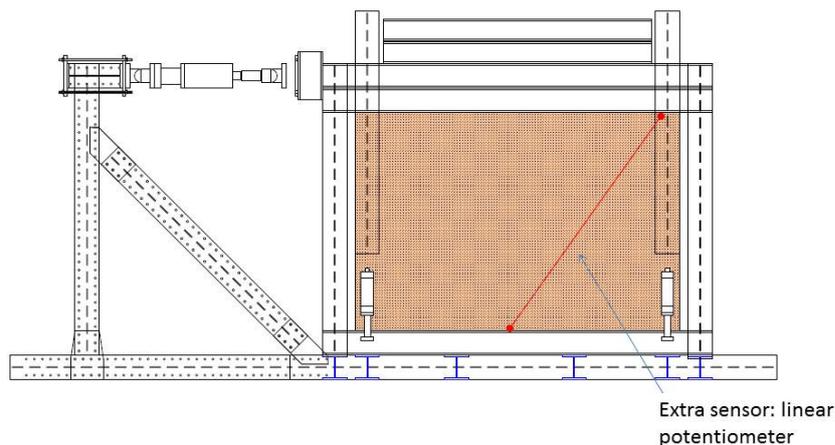
Figure 6. Position of the extra diagonal sensor in long walls (specimen TUD\_COMP-4/6).

In case of long walls, given the high stiffness of the specimens, a specific accurate evaluation of the effective net displacements of the top with respect to the bottom of the wall has been taken into account. Hence, additionally to the system described in the previous section, an additional diagonal sensor, from the bottom-middle to the top-right corner of the wall, was placed (as described in Figure 6).

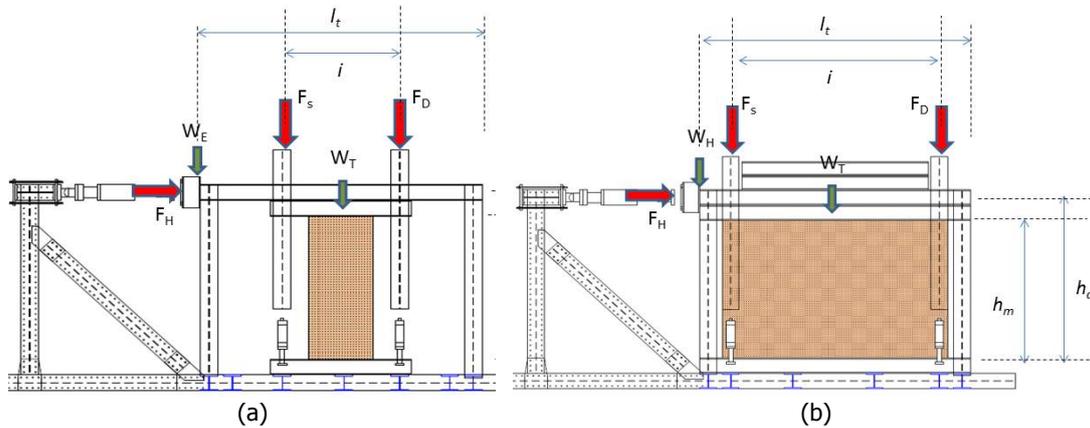
Figure 7. Load application on the short (a) and long (b) walls, respectively.

Two mechanical schemes with different boundary conditions were applied, either as a cantilever, or as a double clamped wall. The mechanical scheme for the cantilever tests (shear span  $H_0/H=1$ ) is given in Figure 7a; the mechanical scheme for the double clamped tests (shear span  $H_0/H=0.5$ ) is given in Figure 7b. The forces  $F_S$  and  $F_D$  were applied by the vertical actuators.  $W_H$  is the weight of the horizontal actuator.  $W_T$  is the weight of the top steel beam, the load spreading beam and the frame for the vertical actuators.  $i$  is the length between the pairs of vertical actuators,  $l_t$  is the length of the load spreading beam,  $h_m$  is the height of the masonry wall and  $h_o$  is the distance between the system line of the horizontal force  $F_H$ . The total load  $P$  is the required vertical compression force.

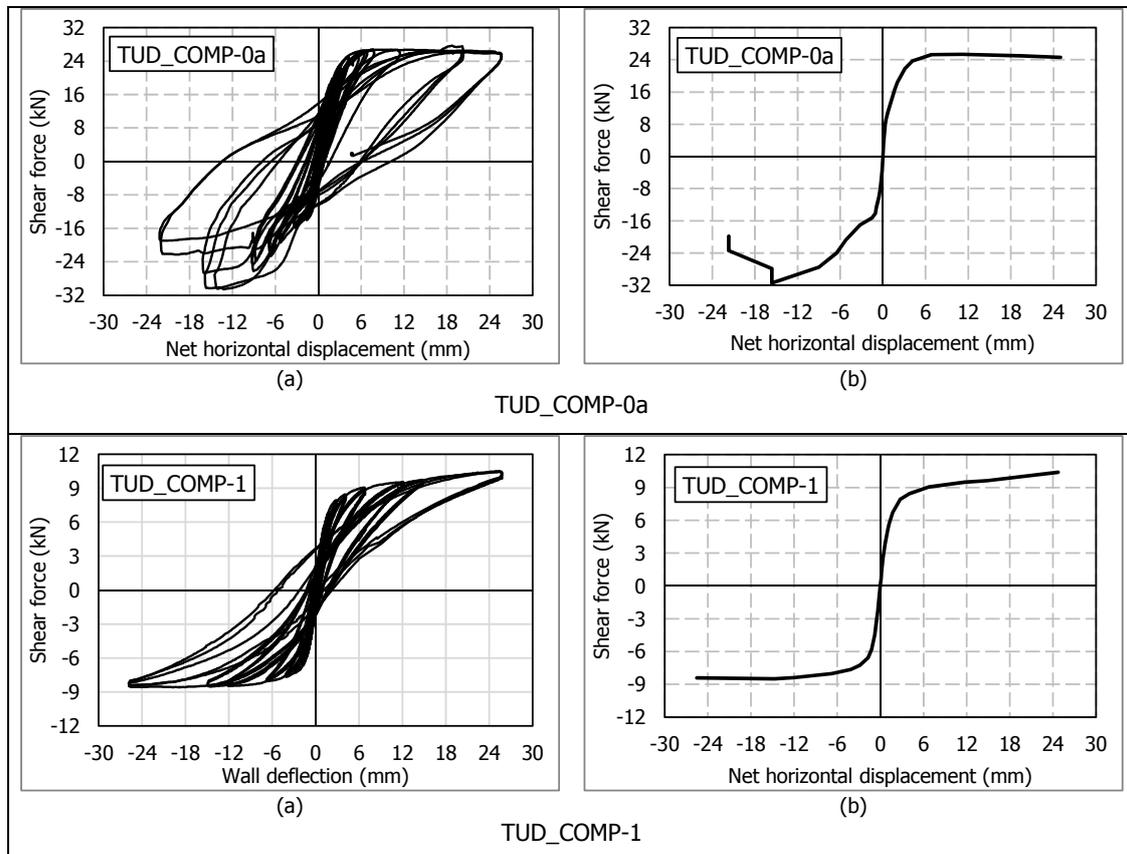
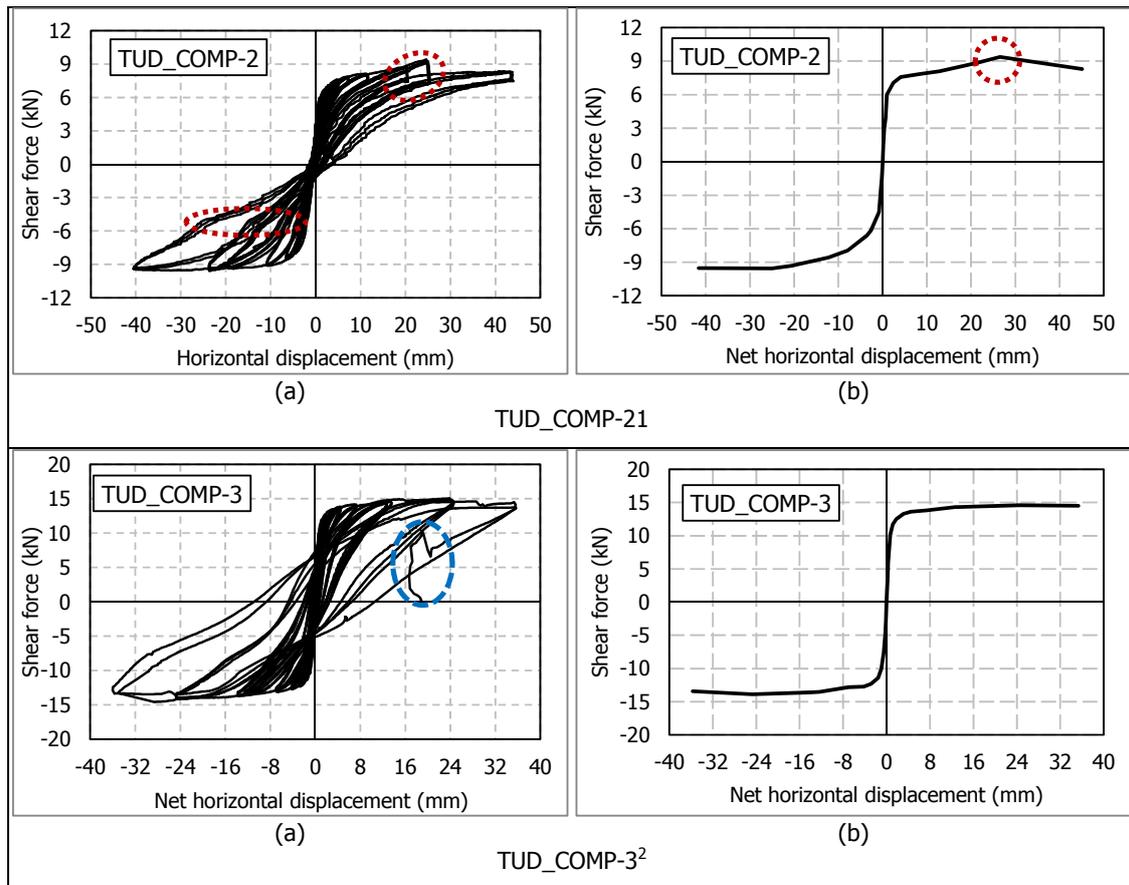
Figure 9. Shear force vs Measured net displacement of the wall for the short walls (TUD\_COMP-0a, TUD\_COMP-1, TUD\_COMP-2 and TUD\_COMP-3). Both total (a) and backbone (b) curves are plotted.

<sup>1</sup> The red circle locates some values of forces which cannot be considered reliable, since alterations in the single vertical forces applied by the actuators were measured (despite the total vertical force remained constant throughout the whole test). Further information can be found in section 3.3.

<sup>2</sup> The end test (in the blue circle) was determined by the instability of the loading system, not by a failure of the wall.

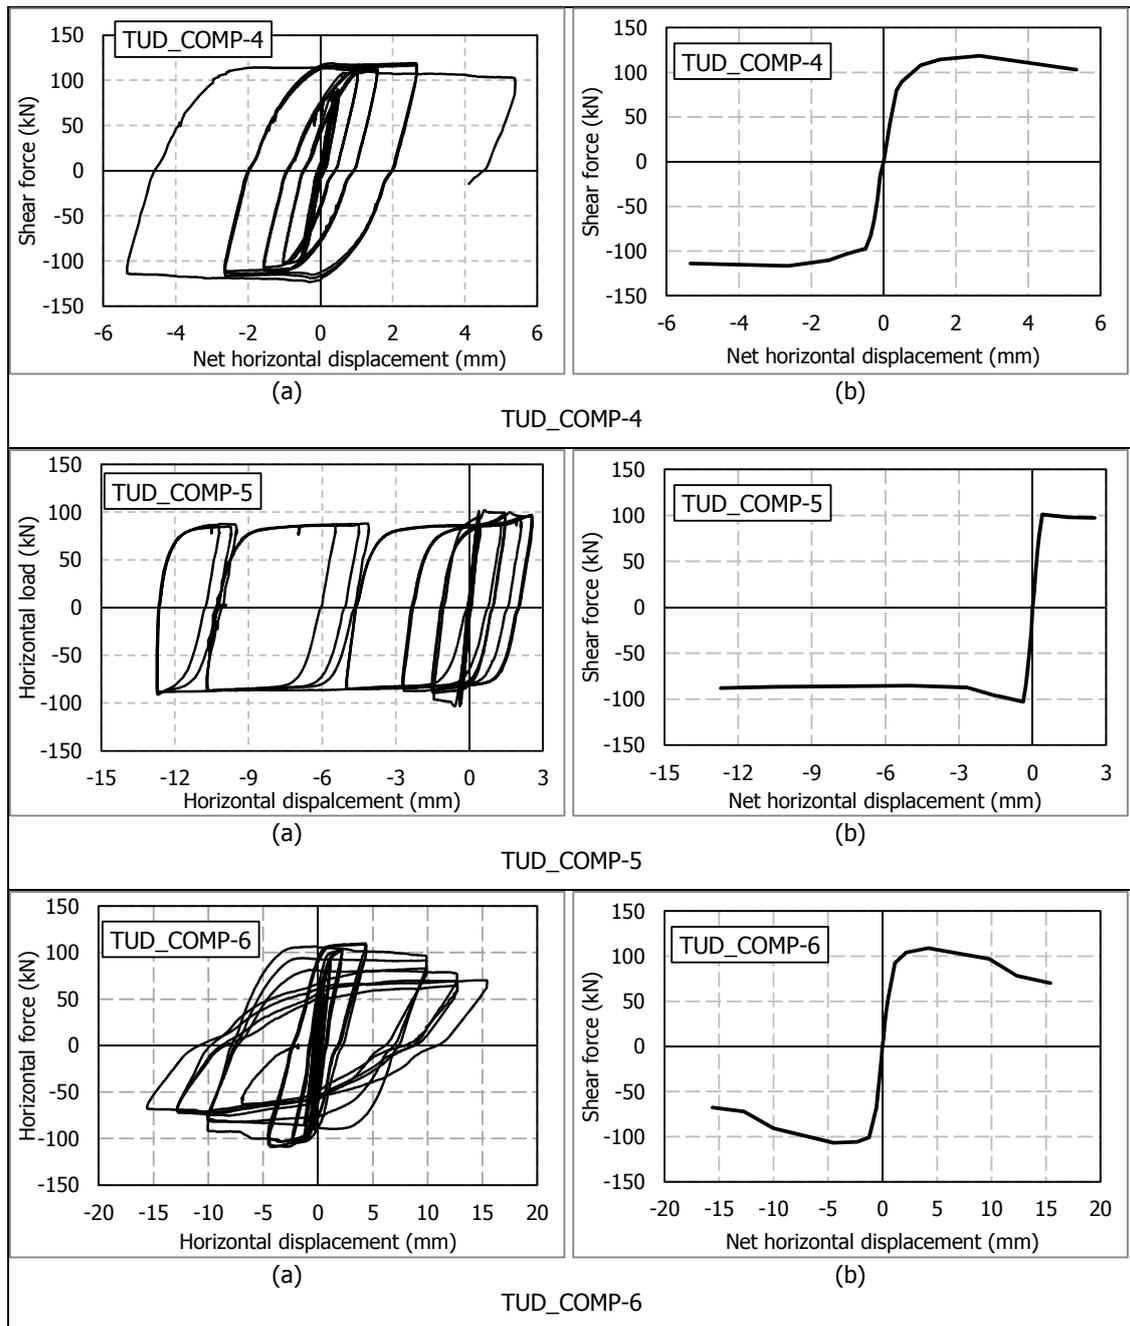
Figure 10. Shear force vs Measured horizontal net displacement of the wall for the long walls (TUD\_COMP-4, TUD\_COMP-5, and TUD\_COMP-6). Both total (a) and backbone (b) curves are plotted.

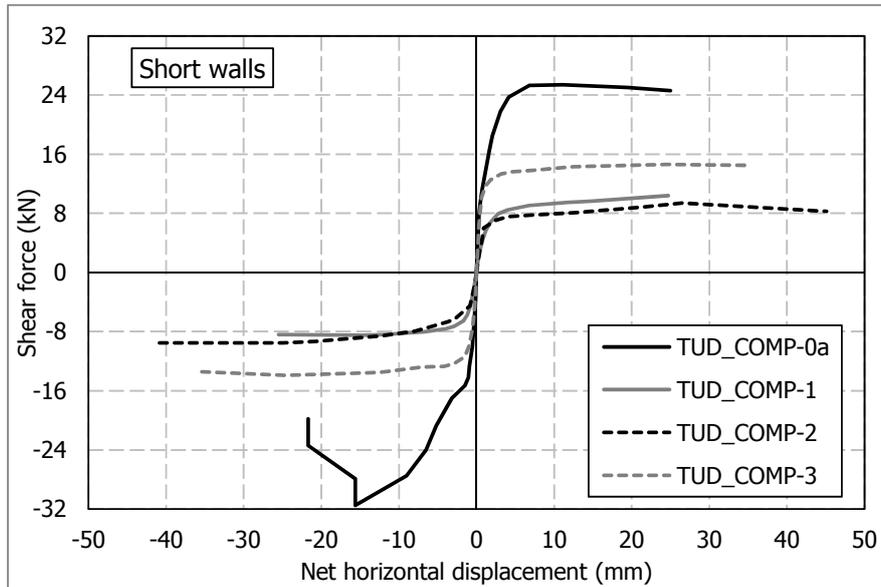
Figure 11. Comparison between the backbone curves of the Shear force vs Measured horizontal net displacement of the wall, for short walls (TUD\_COMP-0a, TUD\_COMP-1, TUD\_COMP-2 and TUD\_COMP-3).

It should be remarked that the final drift listed in Table 4 and showed in Figure 11 and Figure 12 are in most cases determined by limitations in the set-up (as detailed explained in section 3), rather than by the effective failure of the specimens.

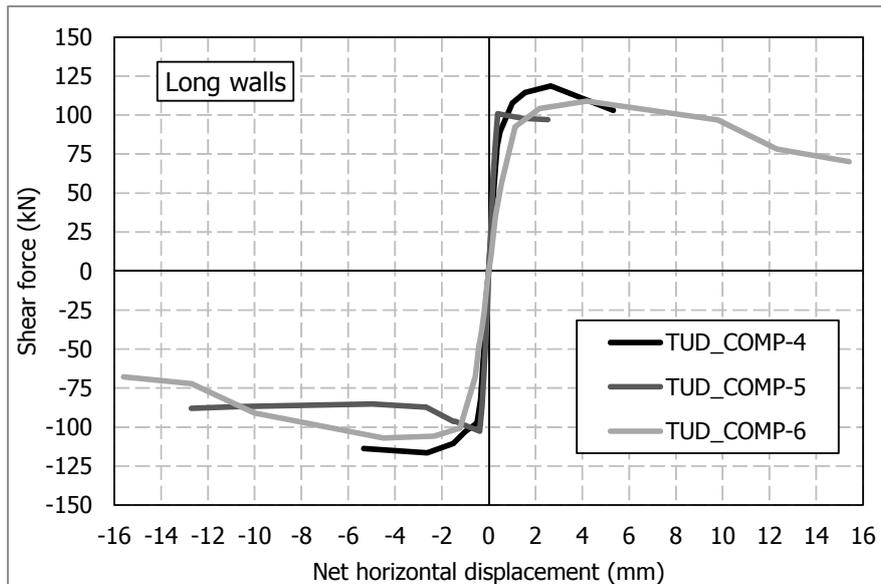
Figure 12. Comparison between the backbone curves of the Shear force vs Measured horizontal net displacement of the wall, for the long walls (TUD\_COMP-4, TUD\_COMP-5, and TUD\_COMP-6).

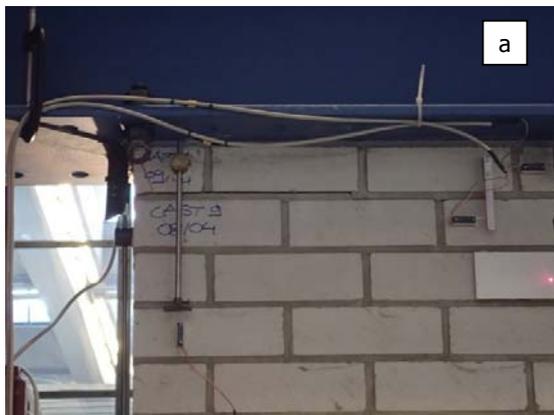
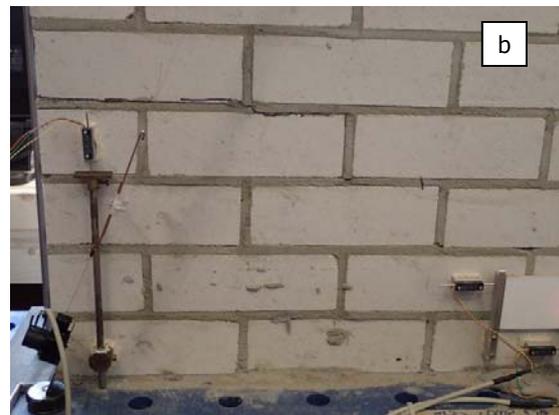
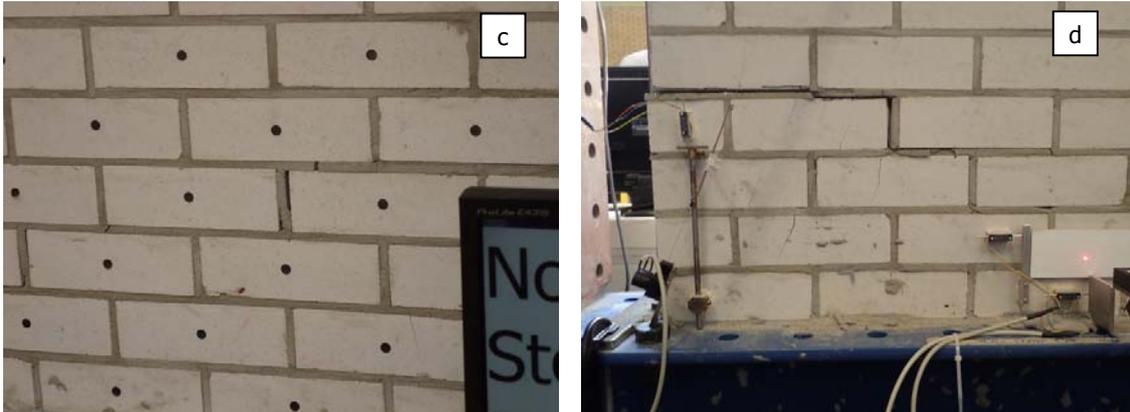
Figure 13. Crack pattern evolution for specimen TUD\_COMP-0a: first bed-joint crack (a) - picture taken from the back of the wall; initiation of the diagonal cracks (b); sliding associated to the diagonal cracks (c); initiation of the toe crushing (d).

First cracks appear in the mortar bed-joint at the top right corner for positive displacements during cycle 4, as depicted in Figure 13a. From cycle 10, diagonal cracks close to corners develop gradually; a combination of flexure (Figure 13b) and sliding (Figure 13c) is observed. Finally, from cycle 12 splitting of bricks, given by compressive failure, is also observed (Figure 13d).

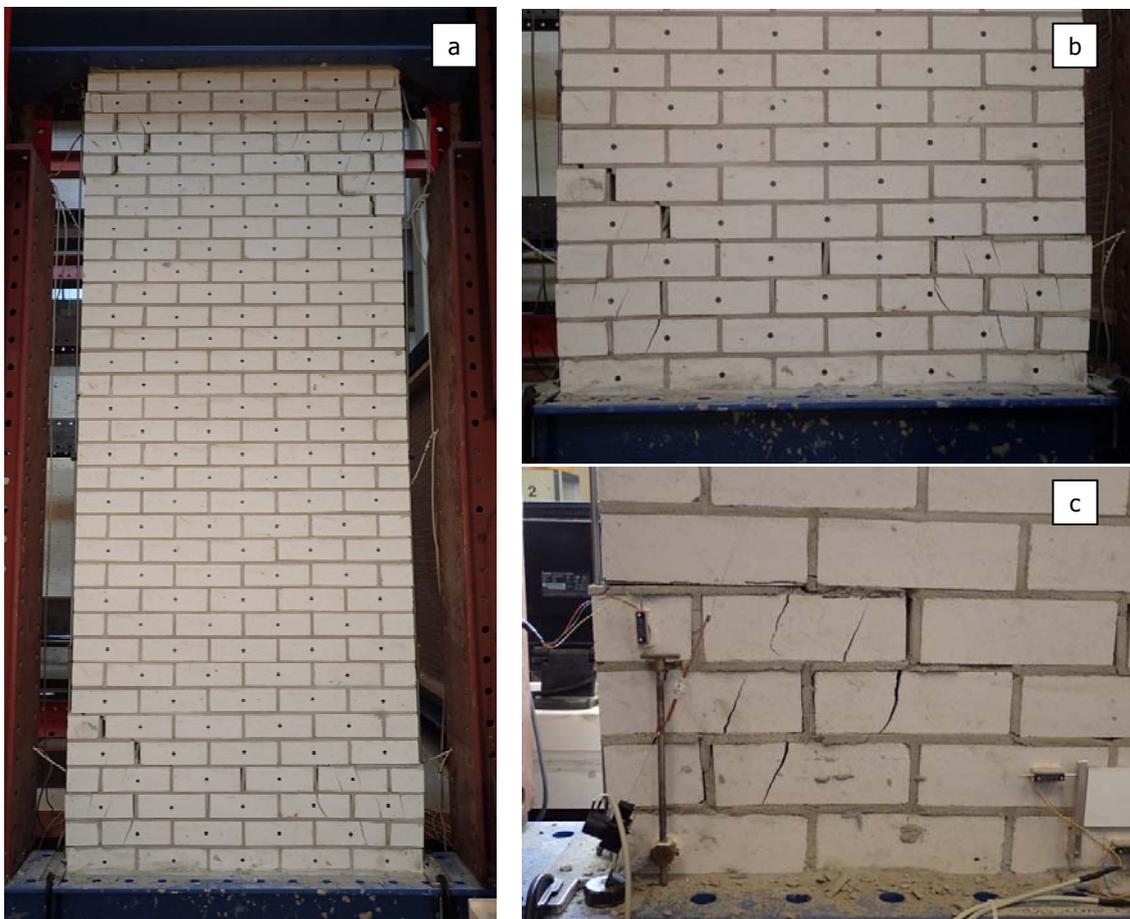
Figure 14. TUD\_COMP-0a: Crack pattern at end stage; general overview (a); detail of the bottom part of the wall (b) and of the toe crushing (c).

The crack pattern at end stage is shown in Figure 14. The failure mode combines flexure, sliding and crushing: flexure determined the peak resistance of the specimen, whereas toe crushing causes the eventual reduction of resistance.

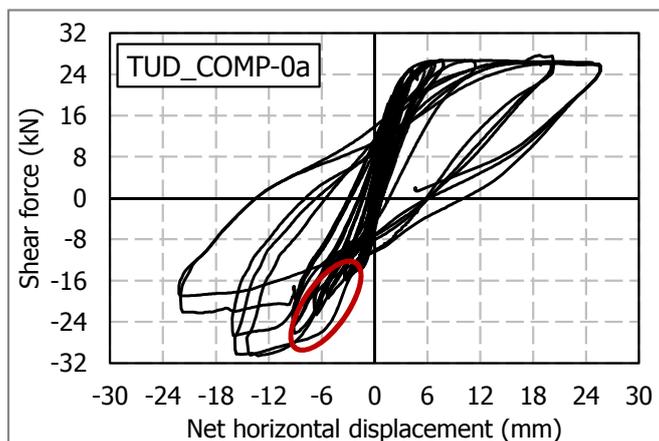
Figure 15. TUD\_COMP-0a: change of stiffness before and after tightening the bolts in cycle 12.

During cycle 12, the bolts of the set-up frame were tightened, since some small relative motions were observed; as a probable consequence a reduced stiffness was measured for negative displacements comprised between -2 mm and -9 mm during the previous cycles (cycles 8 to 11), as shown in Figure 15.

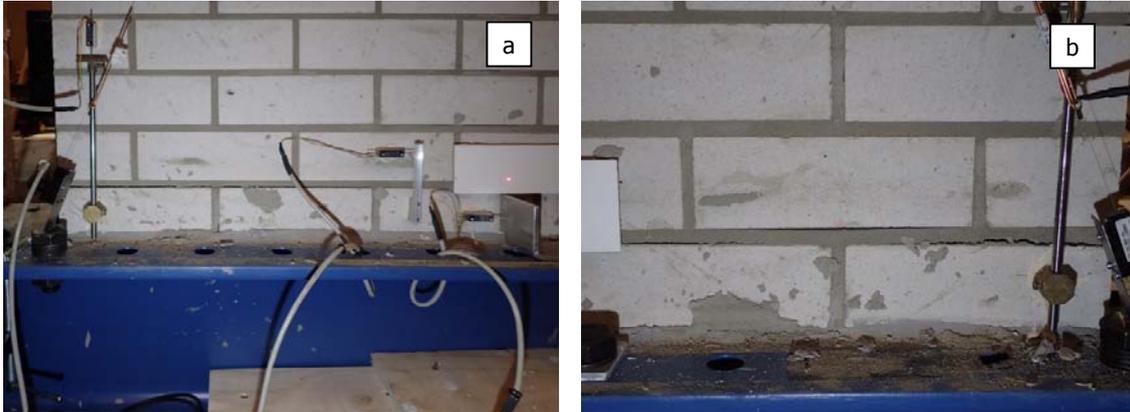
Figure 16. TUD\_COMP-1: Rocking cracks at the base of the wall: details of the left (a) and right (b) toes.

The first five cycles show an elastic behaviour of the specimen; however, a gradual reduction of the initial stiffness occurred after cycle 2 (-10% at 0,15‰ drift). First cracks appeared at the bottom corners during cycle 6 ( $\pm 0,4\%$  drift), as shown in Figure 16.

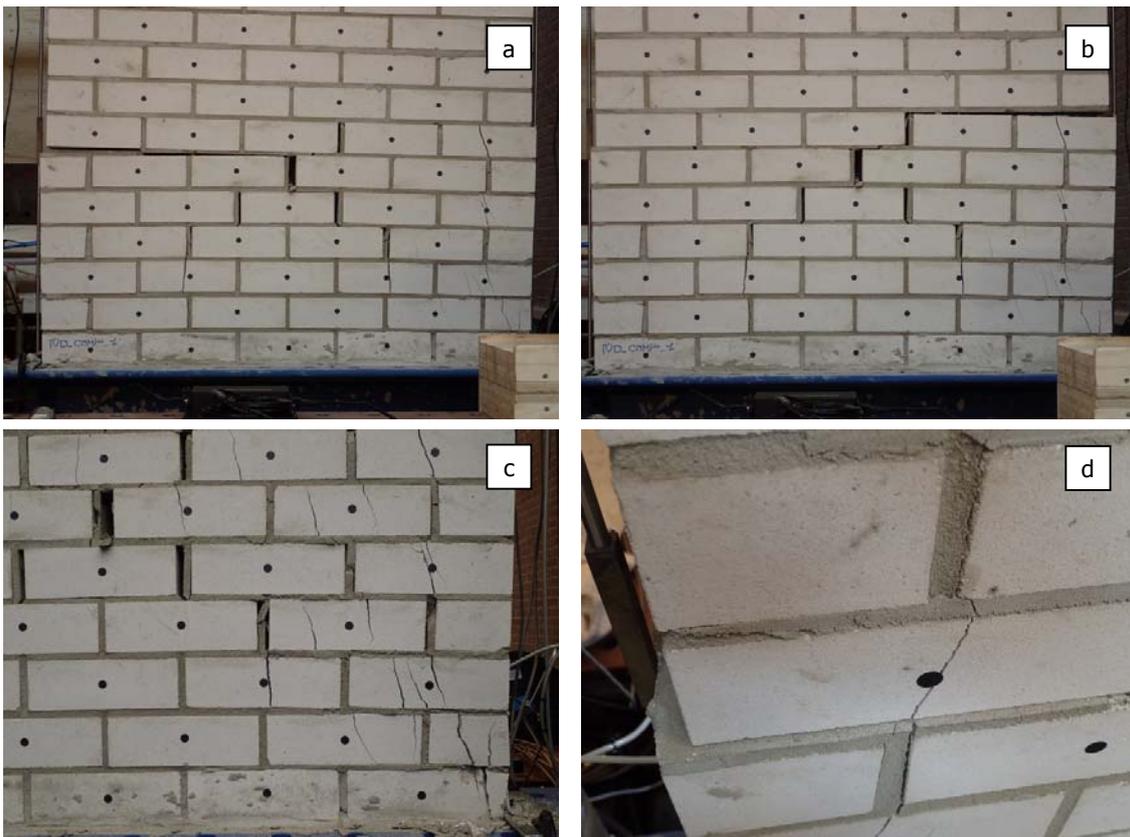
Figure 17. TUD\_COMP-1: Crack pattern at end stage for positive (a) and negative (b) drifts; details of the toe crushing (c) and sliding (d) at end stage.

During cycle 12 ( $\pm 4\%$  drift), new flexural cracks opened, starting from the 6th (positive drifts) or 7th (negative drifts) mortar bed joints; the cracks developed along the mortar joint for approximately the half of the length of the wall, and then was diagonal oriented pointing to the opposite bottom corner of the wall

(Figure 17a,b). At end stage, crushing of the toes and sliding along the flexural cracks could also be observed (Figure 17c,d). Therefore, the failure mode was mainly governed by flexure, but shear sliding contributed to the damage of the specimen. The specimen showed symmetric mechanical behaviour. The test was stopped at a net drift of 1%, after that the maximum allowable extension of the vertical actuators (40 mm) was reached; indeed, the rocking behaviour of the wall determines large vertical displacements of the side of the wall, in correspondence to the position of the actuators.

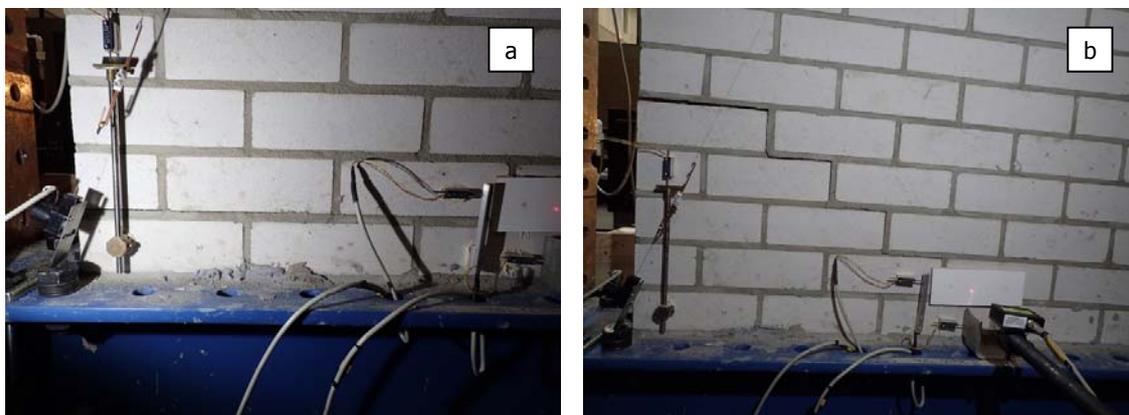
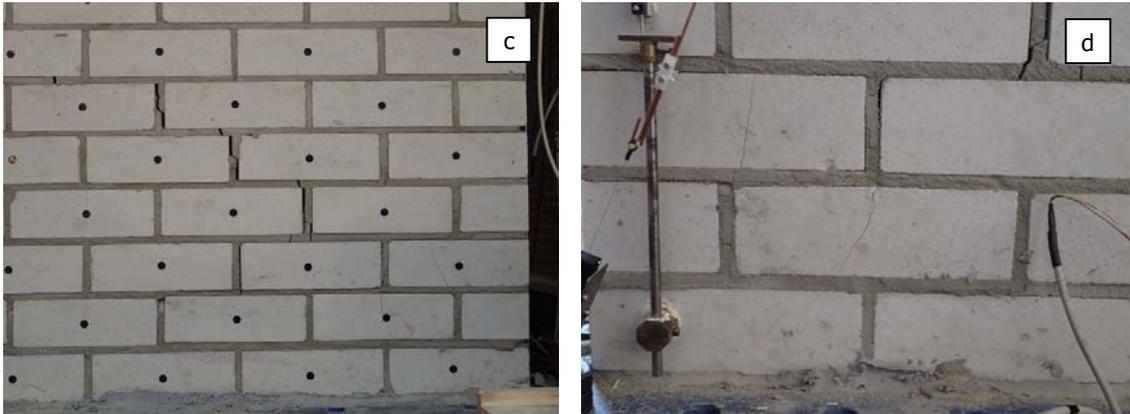
Figure 18. Crack pattern evolution for TUD\_COMP-2: first bed-joint crack (a); initiation of the diagonal cracks (b); sliding associated to the diagonal cracks (c); final toe crushing (d).

During cycle 8 ( $\pm 4\%$  drift), new flexural cracks opened (Figure 18b), starting from the 5th (positive drifts) or 6th (negative drifts) mortar bed joints; the cracks developed along the mortar joints partially horizontally and partially diagonally oriented pointing to the opposite bottom corner of the wall. At end stage, crushing of the toes and sliding along the flexural cracks could also be observed (Figure 18c,d). Therefore, the failure mode was mainly governed by flexure, but shear sliding contributed to the damage of the specimen.

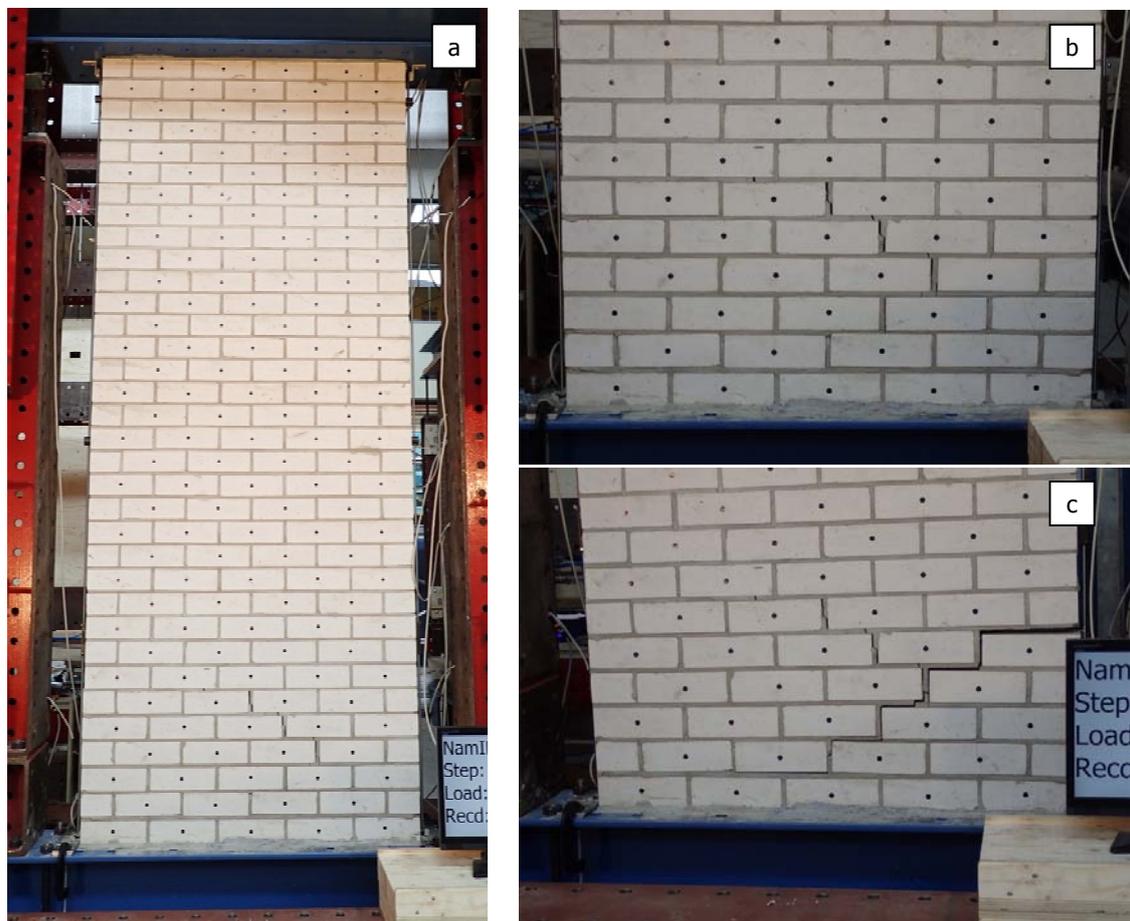
Figure 19. TUD\_COMP-2: Crack pattern at end stage; general overview (a); detail of the bottom part of the wall for positive (b) and negative top displacement (c).

The crack pattern at end stage is shown in Figure 19.

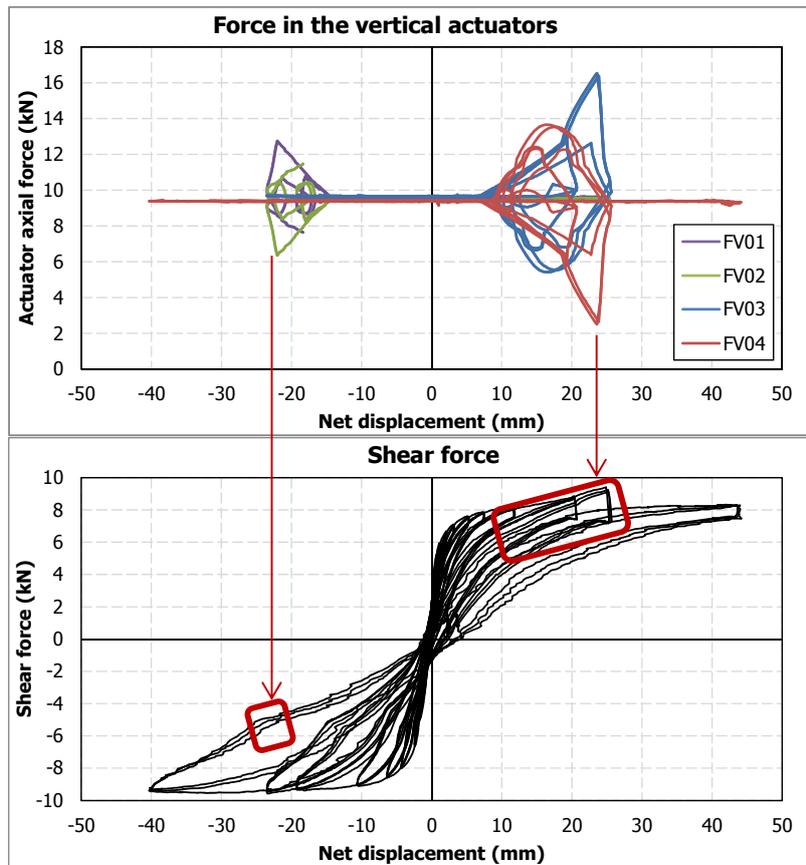
Figure 20. Aberrations of the vertical forces during the test and influence on the wall response.

The values of the shear force at the positive extreme of cycles 9 and 10 and during the unloading phase of cycle 12 are affected by the bending of the load cell, and cannot be considered reliable. Specifically, Figure 20 shows that, despite the compressive vertical load imposed at the top of the wall remained constant throughout the whole test, differences between the forces applied by the single vertical actuators can be detected; this fact might be associated to an out-of-plane rotation of the top beam that induced a torsion of the load cell (and consequently the aforementioned inaccuracy in the horizontal force measurements).

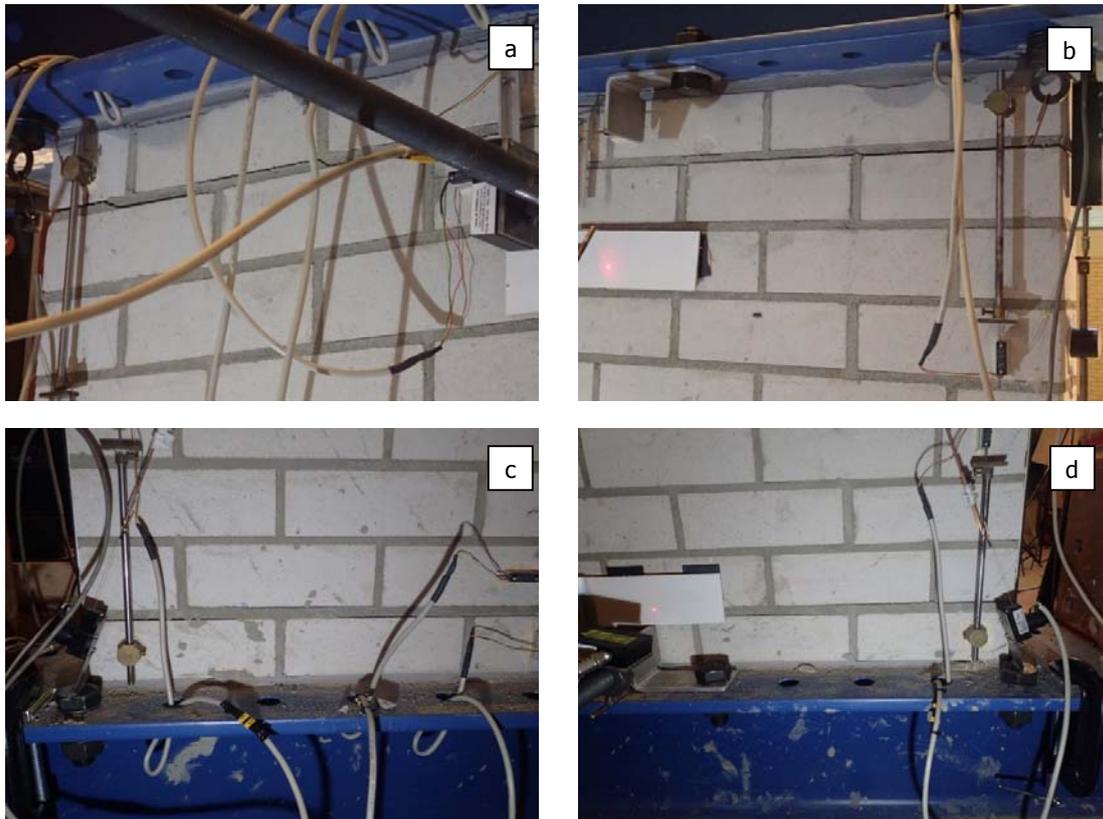
Figure 21. TUD\_COMP-3: Rocking cracks at the bottom and top ends of the wall: details of the left (a) and right (b) top toes (cycle 9), and of the left (c) and right (d) bottom toes (cycle 8).

The first four cycles of the test showed an elastic behaviour. First flexural horizontal cracks appeared along the first top and bottom head joints at the bottom left corner during cycle 5, and then at the other corners of the wall in cycle 6. During cycle 11, new cracks diagonally oriented opened, along the mortar joint. The evolution at the top of the wall is shown in Figure 21a,b and Figure 22a for the top and the bottom portion of the wall, respectively. At end stage, crushing of the toes and sliding can also be observed (Figure 23a,b). The failure mode was mainly governed by flexure.

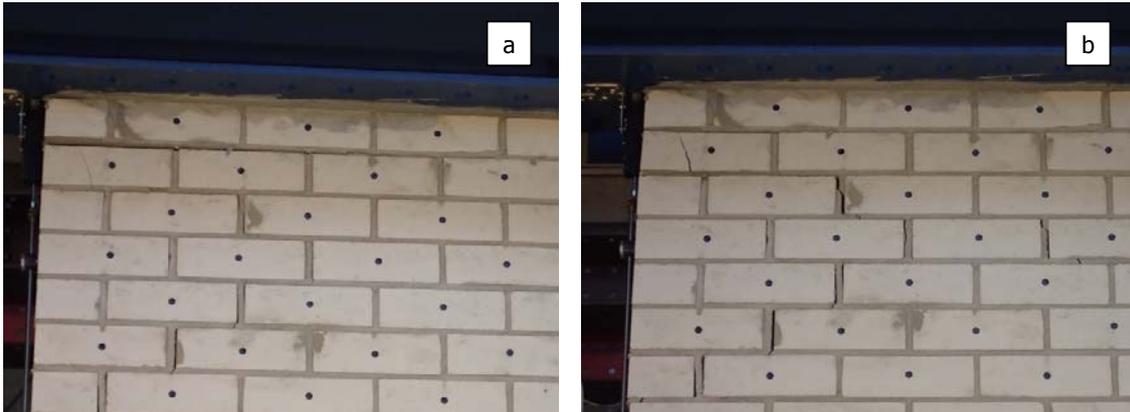
Figure 22. TUD\_COMP-3: Evolution of the crack pattern in the top portion of the wall for positive drifts: cycle 10 (horizontal crack along the bed joint - a) and cycle 11 (diagonal cracks - b).

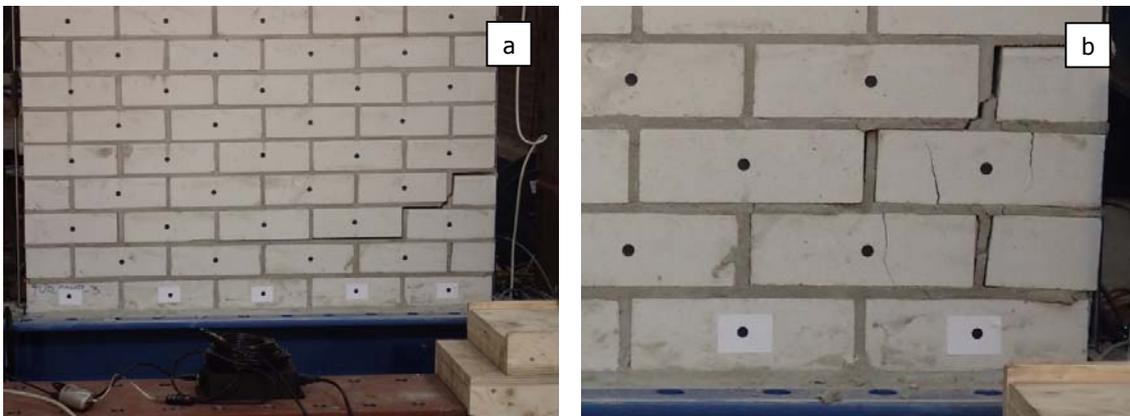
Figure 23. TUD\_COMP-3: Crack pattern at end stage: details of the bottom portion of the wall for negative loading (a) and toe crushing (b).

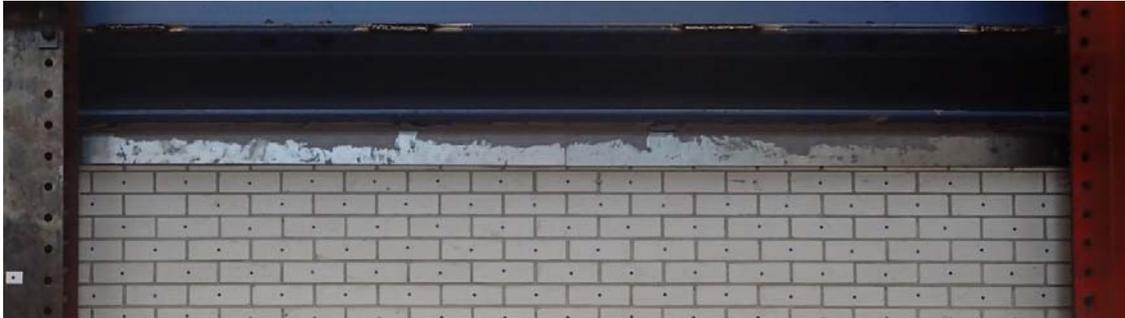
Figure 24. Detail of the repaired top bricklayer of TUD\_COMP-4.

During a pre-test to determine the stiffness of the top frame, a horizontal crack was formed in between the first and second bricklayer from the top, caused by the unloading of the actuators. The crack was repaired by gluing steel plates on both sides of the wall, making a stiff connection between the first and second top bricklayers. The consequence is that during the test, cracking of the bed joints is possible below the second bricklayer, instead of below the first layer; de facto the specimen was one bricklayer shorter. The described restoration is shown in Figure 24.

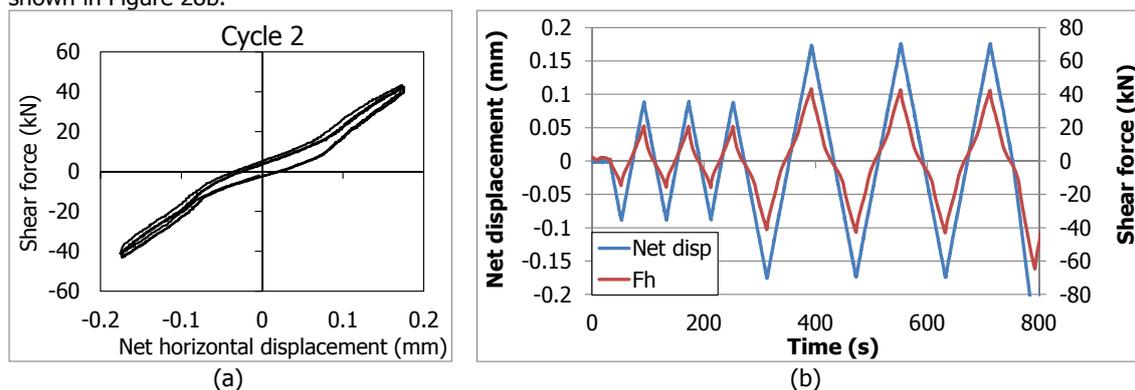
Figure 25. Initial cycles of sample TUD\_COMP-4: details of the nonlinearities of the recorded forces in the elastic domain.

The behaviour of the specimen under the imposed cyclic loading can be described as follow. The first four cycles of the test showed an elastic behaviour. The secant stiffness increases until cycle 3 and after that cycle decreases; indeed, for small forces the stiffness is lower than for large (Figure 25a). Since the nonlinearities can be observed in the recordings of the forces (measured by the load cell of the horizontal actuator – 19 in Figure 4 and Table 2), whereas the net displacements of the wall are perfectly linear (Figure 25), the change of stiffness is probably due to some play in the test frame which could not be identified and removed; for this reason, the same issue occurs during all the three tests on the long walls (TUD\_COMP-4/6). However, this behaviour should not be visible in numerical simulations, and the initial stiffness of the wall should be slightly higher than the value derived from cycle 3 (223 kN/mm). The first visible cracks (four diagonal cracks from the corners, connected by a short horizontal crack in the middle of the panel) were visible in cycle 6; the cracks started to develop close to the centre of the panel (Figure 27a), and quickly expanded to the corners (Figure 27b). At the end of the test (Figure 27) the horizontal crack width was much larger than the maximum imposed displacement, clearly showing the presence of residual sliding. Indeed, in the last cycles, the top part of the wall moved over the middle bed joint over three bricks, causing the crushing of the mortar (Figure 28a); that movement allowed the top part of the wall to clamp the loose side triangles, move them further outwards, and, eventually, leave them in that position (and move them again the next step). The test was stopped when the loose triangles were close to be sheared out of the top and bottom part, as shown in Figure 28b.

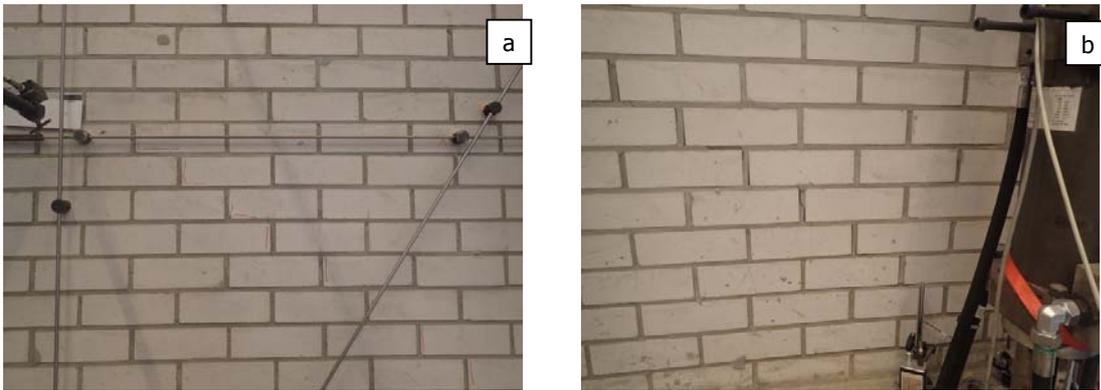
Figure 26. TUD\_COMP-4: Diagonal cracks in the middle of the panel (a) and close to the corners (b).

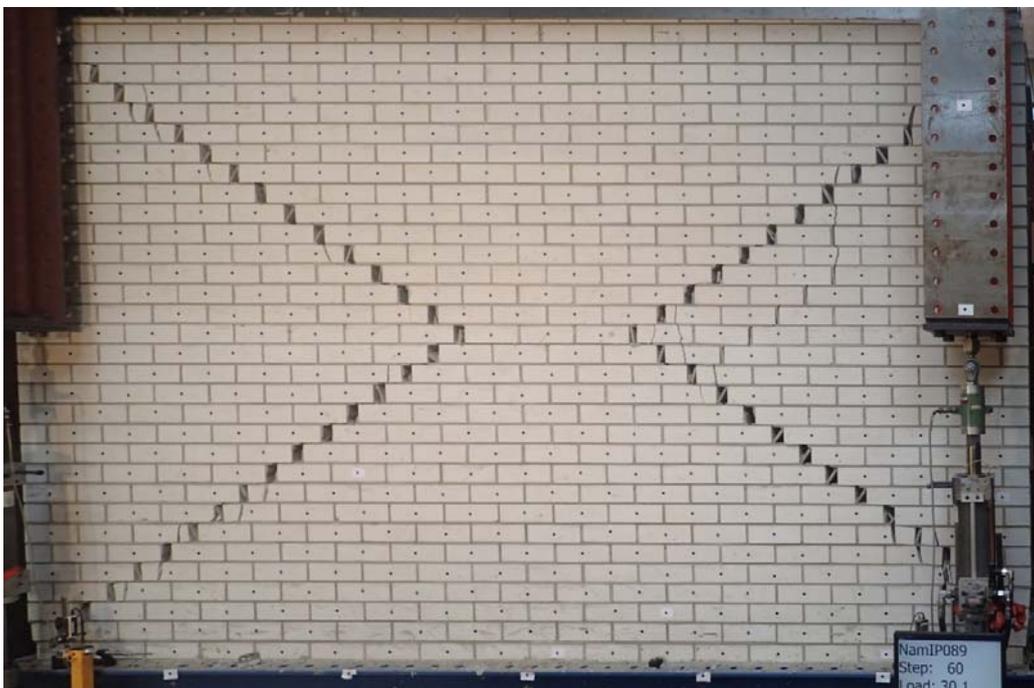
Figure 27. TUD\_COMP-4: Crack pattern at end stage.

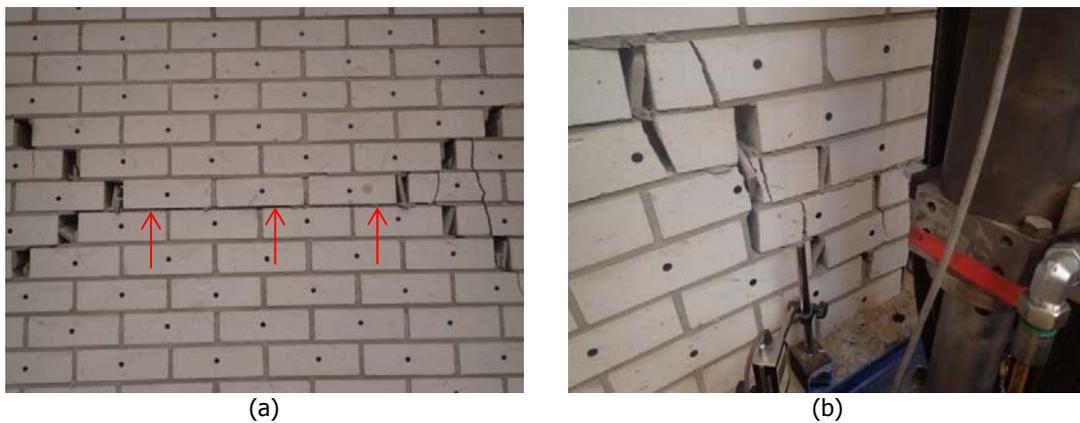
Figure 28. TUD\_COMP-4: details of the crack pattern at end stage. Crushing of the mortar bed joint at the centre of the wall (a); shearing out of the loose triangle at the bottom corner (b).

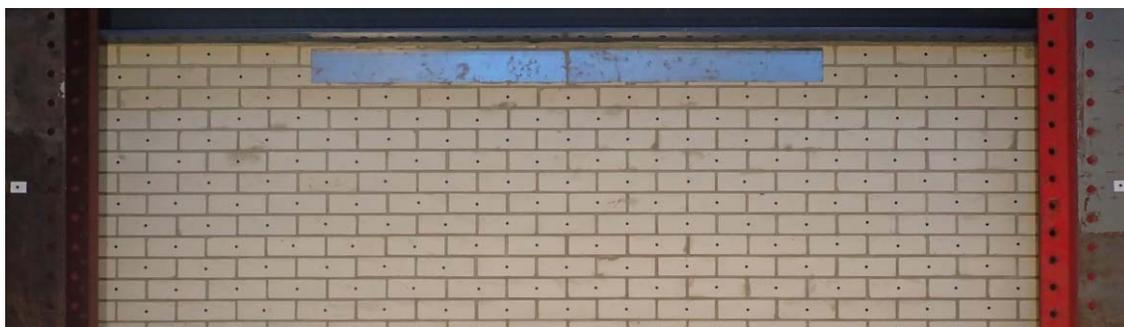
Figure 29. Detail of the repaired top bricklayer of TUD\_COMP-5.

Similarly to specimen TUD\_COMP-4, during the placing of the beams on the top of the wall, a horizontal crack developed in between the first and the second bricklayer from the top; however, the crack was not continuous for the whole length of the joint, and was localised in the central part of the specimen. The crack was then repaired by gluing steel plates on both sides of the wall, making a stiff connection between the first and second top bricklayers, as shown in Figure 29. Therefore, in the same way of specimen TUD\_COMP-4, the cracking of the bed joints could occur below the second bricklayer, instead of below the first layer; de facto the specimen was one bricklayer shorter.
