# **IN-PLANE TESTS ON REPLICATED MASONRY WALLS**

**Physical Testing and Modelling – Masonry Structures**

**Geert Ravenshorst and Francesco Messali**

**TU Delft**

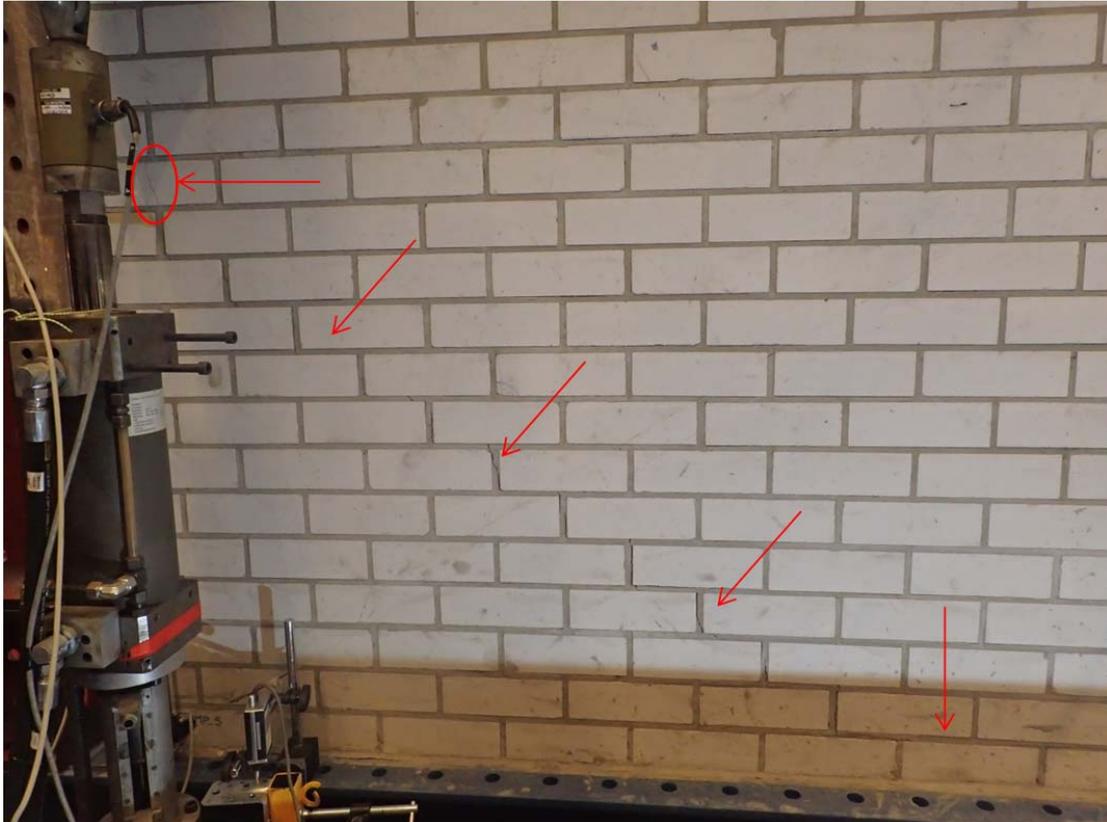
Figure 30. TUD\_COMP-5: first cracks during cycle 6.

The first visible cracks were observed during cycle 6, given by a combination of a diagonal crack and a horizontal crack along the mortar joint between the first and the second bricklayer from the bottom; the crack intercepted not only the mortar joints, but also some bricks (Figure 30).

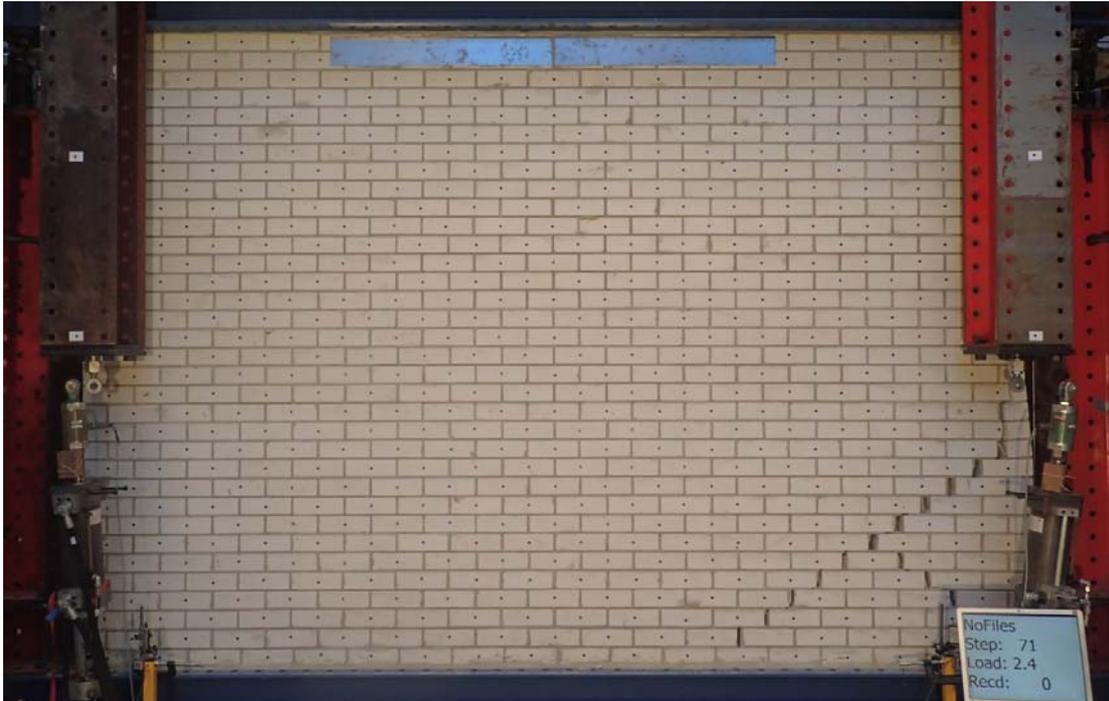
Figure 31. TUD\_COMP-5: crack pattern at end stage.

At increasing imposed amplitudes, other minor cracks opened; however, at end of the test, the main crack trace the pattern of the first crack (Figure 31 and Figure 32a). A vertical crack close to the edge of the wall crosses the brick and the mortar layers (Figure 32b).

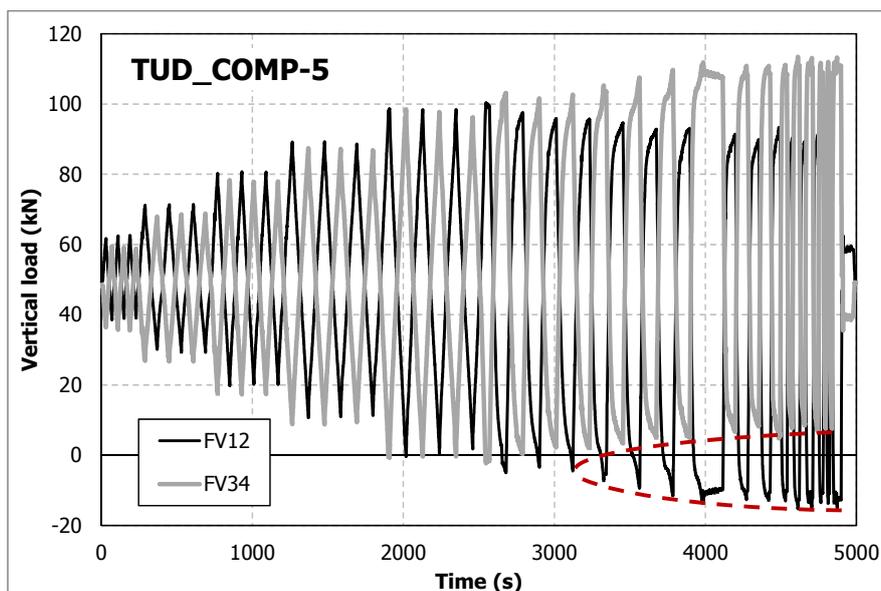
Figure 33. TUD\_COMP-5: vertical force applied by the left (FV34) and right (FV12) actuators to the specimen during the test.

After the peak load, the asymmetric damage of the wall (the bottom-right corner was more severely damaged than the opposite one) determined a redistribution of the forces in the actuators in order to guarantee zero rotations (hence a clamped condition) at the top of the wall. Because of this, the force in the right actuators (actuators 1 and 2) decreased gradually cycle after cycle for the same imposed displacement, reaching negative values (of traction), as displayed in Figure 33. For this reason in cycles 8

and 9 the displacements could be increased in one direction only (i.e. negative direction), and not go back to zero. It should be noted that compression stresses acted on the top of the wall during the whole test, because the forces of traction in the actuators were compensated by the self-weight of the steel structure on the top of the wall.

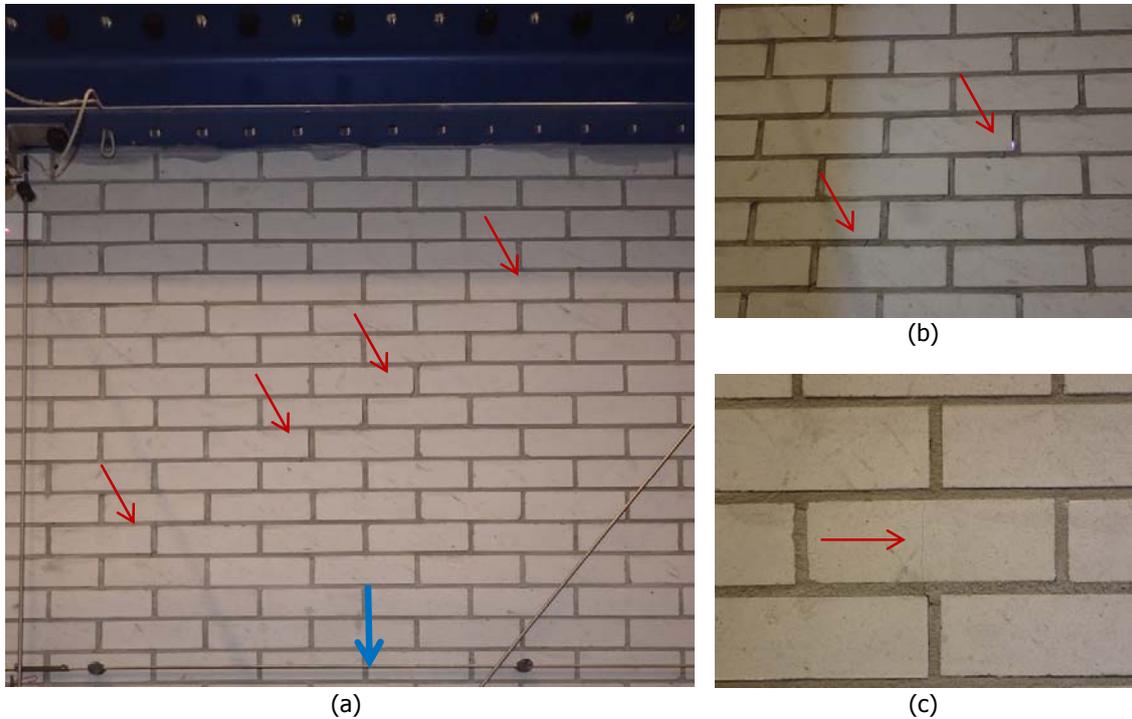
Figure 34. First cracks visible in cycle 5. General overview (a) and details (b,c). The blue arrow points out the horizontal measuring device, for which the results are plotted in Figure 35.

The first visible cracks were observed during cycle 5, along the main diagonal of the wall (Figure 34a). This gave horizontal deformations that were detected by the transducer measuring the horizontal deformation at mid-height over the length of the wall (Figure 35), and the crack intercepted not only the mortar joints, but also some bricks (Figure 34c).

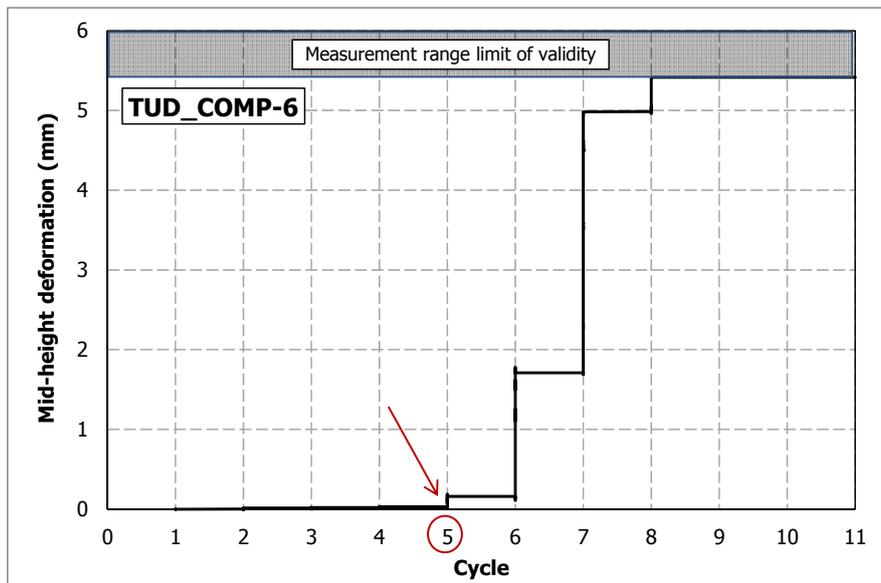
Figure 35. TUD\_COMP-6: Mid-height horizontal deformation of the wall vs Loading cycle. See also Figure 34.

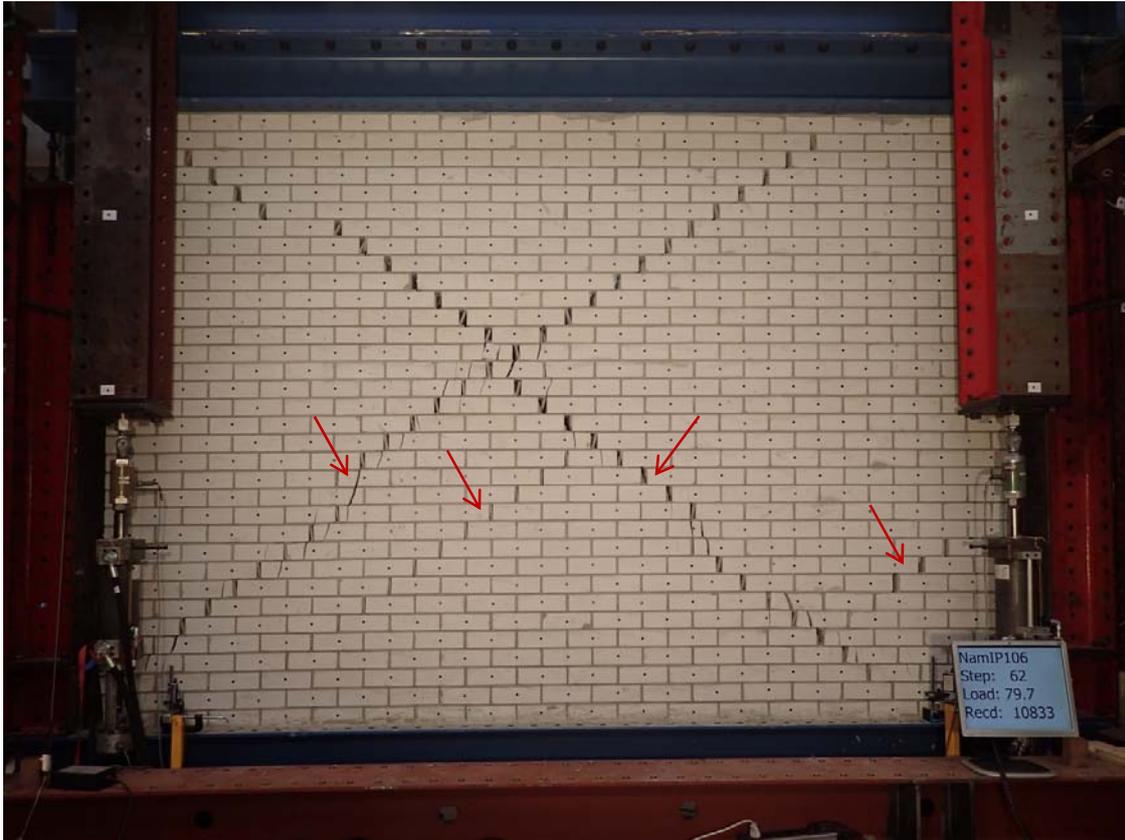
Figure 36. Cracks visible at the end of cycle 9.

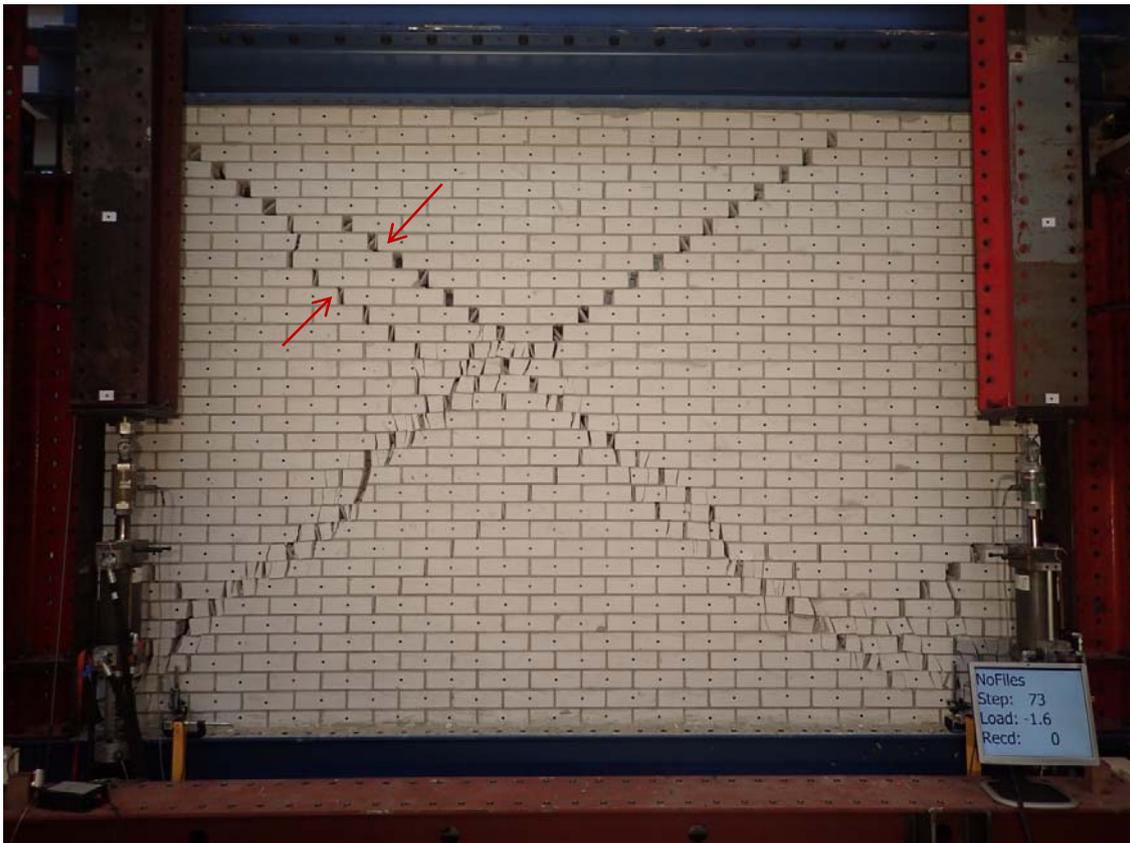
Figure 37. TUD\_COMP-6: crack pattern at end stage.

At increasing imposed amplitudes (cycles 6-9), the diagonal cracks got larger and larger, more than one crack opened along the diagonal for negative loading, the bottom corners started to be pushed off the wall and residual sliding appeared (Figure 37).

At the end of the test the detected crack pattern (Figure 37) is similar to that described at the end of cycle 9; however, more diagonal cracks appeared also for positive loading. Besides, the crack width is larger and the crushing along the diagonals, and especially in the central region of the panel (Figure 38a) and at corners (Figure 38b), is more evident.

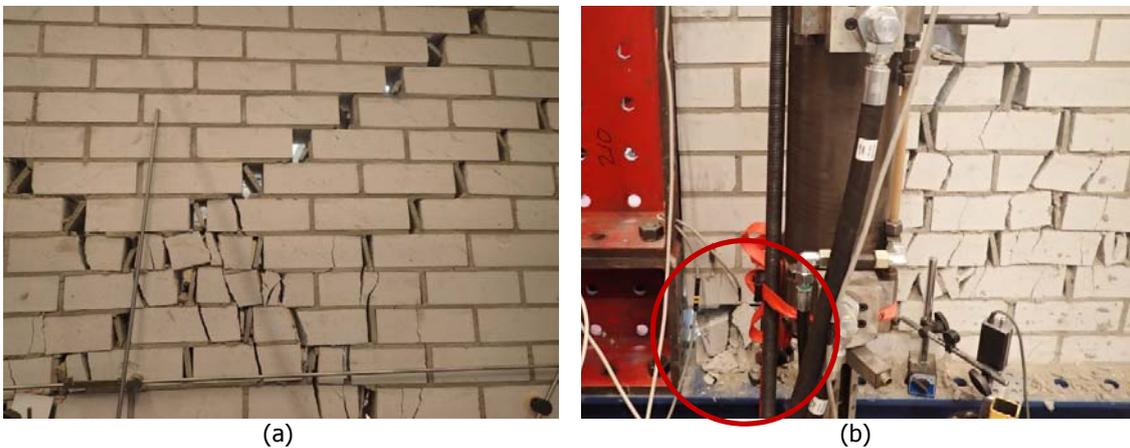
Figure 38. TUD\_COMP-6: detail of the crushing of bricks in the central portion (a) and at the bottom-right corner (b) of the wall at the end of the test.

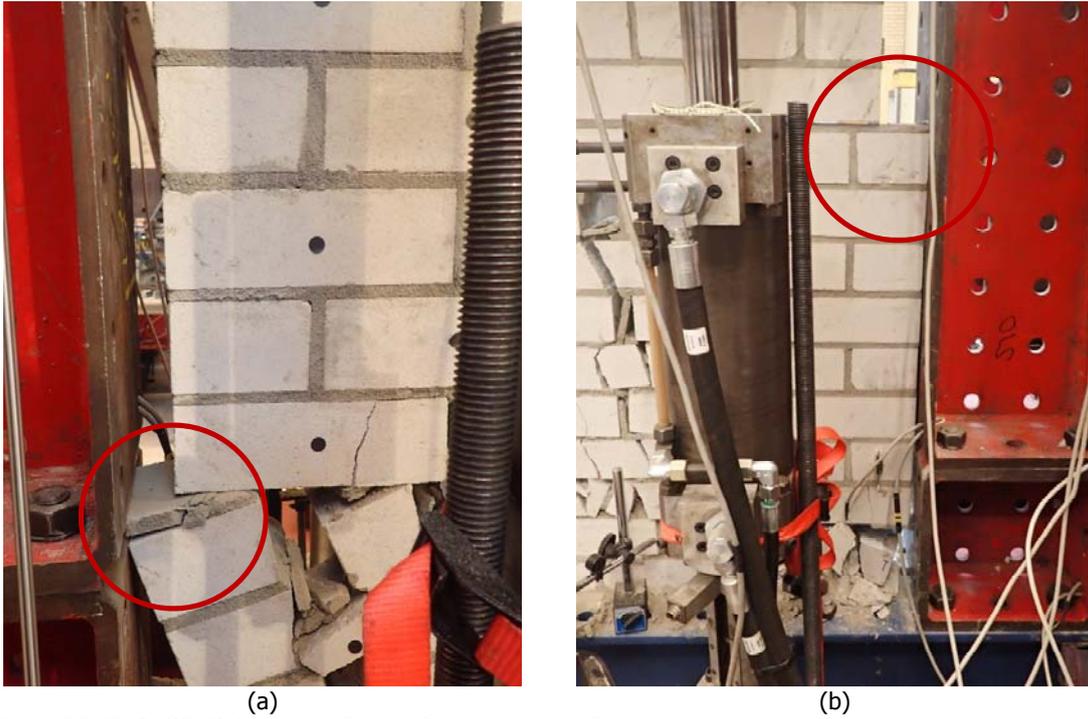
Figure 39. TUD\_COMP-6: detail of the left (a) and right (b) corners supported by the steel columns at the end of the test.

The test was stopped because the corners were eventually supported by the steel columns of the loading frame, so that any further result would have been affected by these accidental supports (Figure 39). Besides, the imposition of larger displacements could determine the collapse of the damaged toes, compromising the stability of a portion or of the whole wall, and causing its collapse.
