Laboratory Component Testing: Modelling Post-Test Predictions and Analysis Cross Validation

ARUP, Eucentre and TU Delft

Date February 2016

**Arup Project Title: Groningen
Earthquakes - Structural Upgrading**

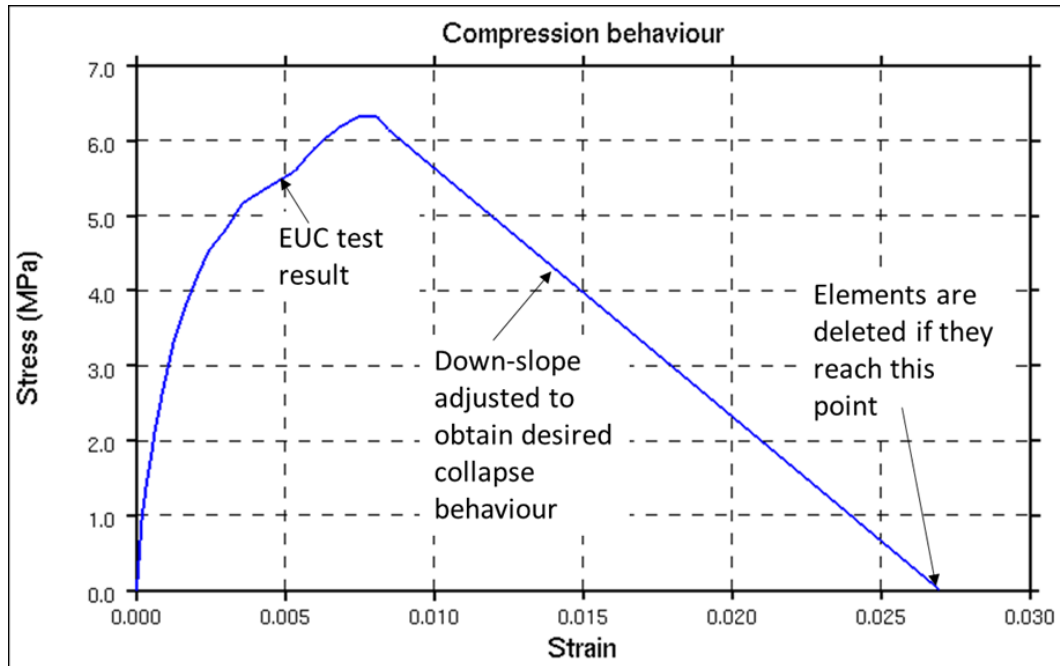
Figure 2: Compressive stress-strain input data for post-test LS-DYNA analyses of CaSi components

the peak stress. The softening slope may be regarded as an artificial modelling parameter and was determined by trial and error. It controls the drift at which collapse occurs in rocking mode. Elements are deleted from the analysis automatically when the compressive strength reaches zero. A stress-strain curve for clay masonry has also been developed similarly.

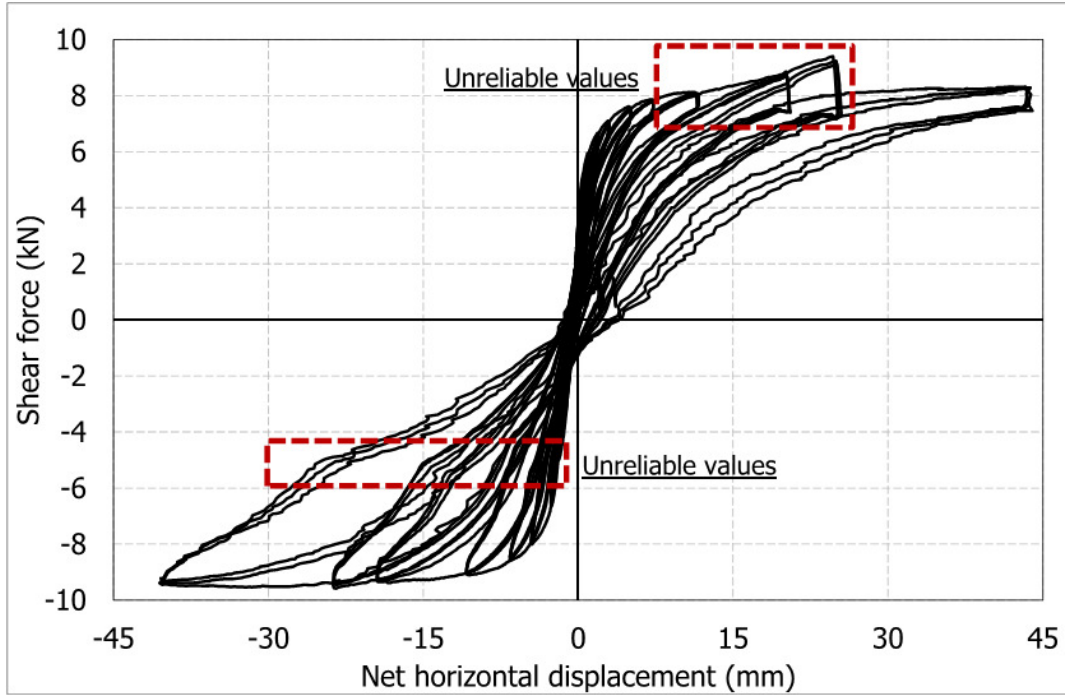
Figure 14: TUD-COMP-1: Lab test result – Shear force-displacement curve

The measured hysteresis is shown in Figure 14. Some readings of the load cell were compromised and thus rendered some sections of the test response unreliable for comparison purposes. These sections are highlighted in Figure 14.

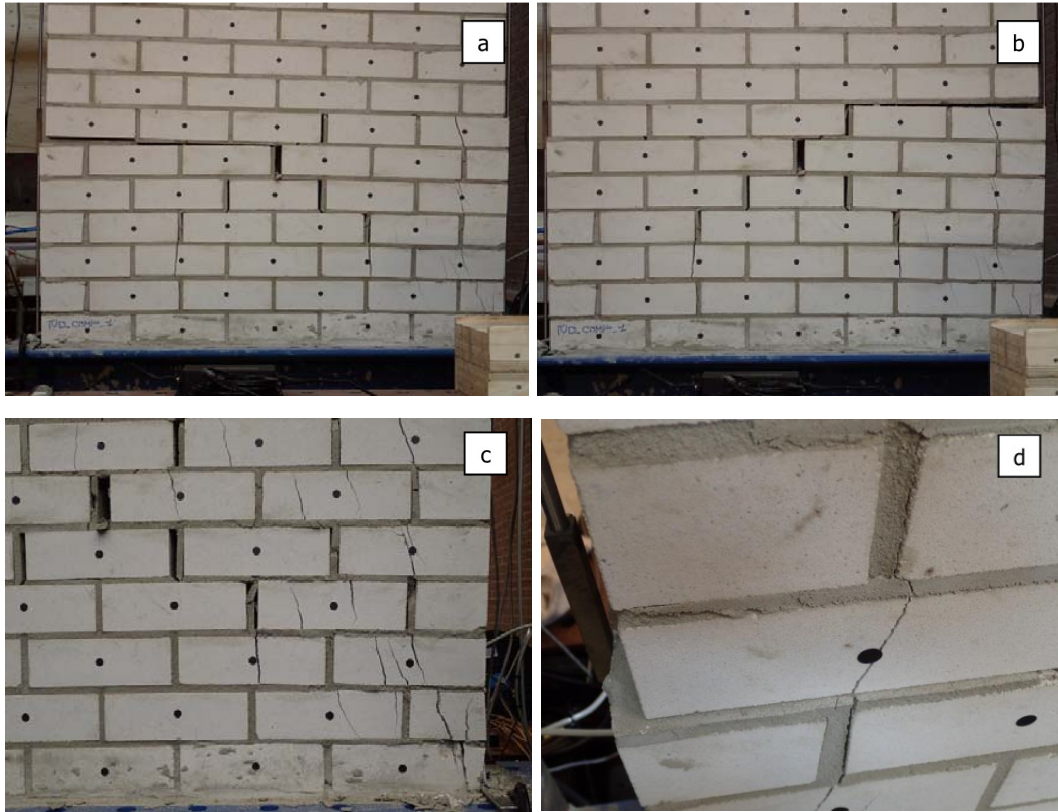
Figure 22: TUD-COMP-2: Crack pattern at failure for positive (a) and negative (b) drifts; details of the toe crushing (c) and sliding (d) at end stage.

At the end stage, crushing of the toes and sliding along the flexural cracks were observed. The failure mode was mainly governed by rocking and diagonally oriented damage, followed by toe-crushing and sliding. The specimen showed symmetric mechanical behaviour. The test was stopped at a net drift of 1%, when an extensive cracking at the base of the wall was detected.

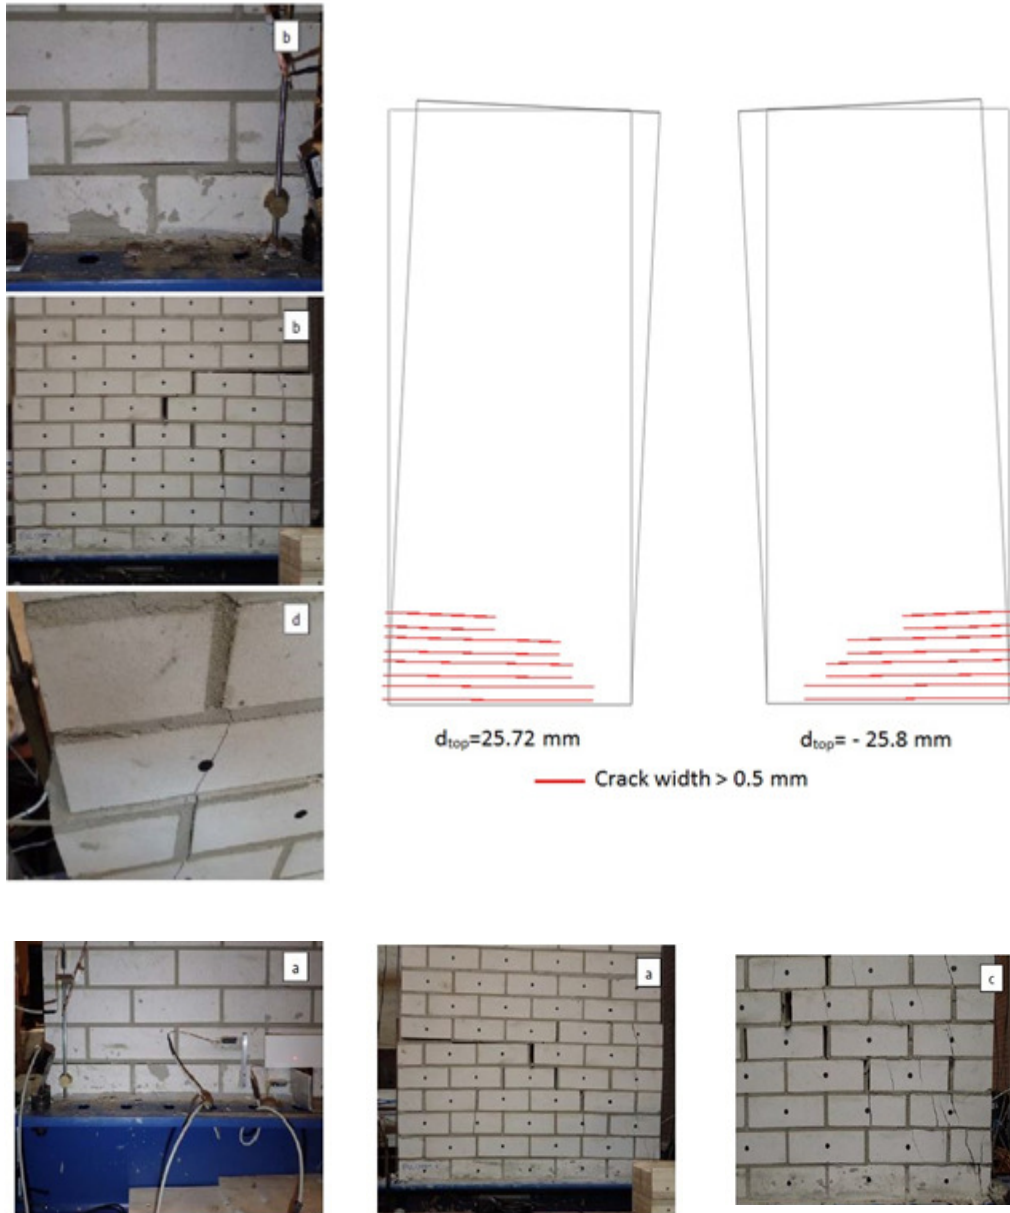
Figure 26: TUD-COMP-2: DIANA post-test refined prediction - Damage plot at end of analysis (top right) compared to observed damage in laboratory

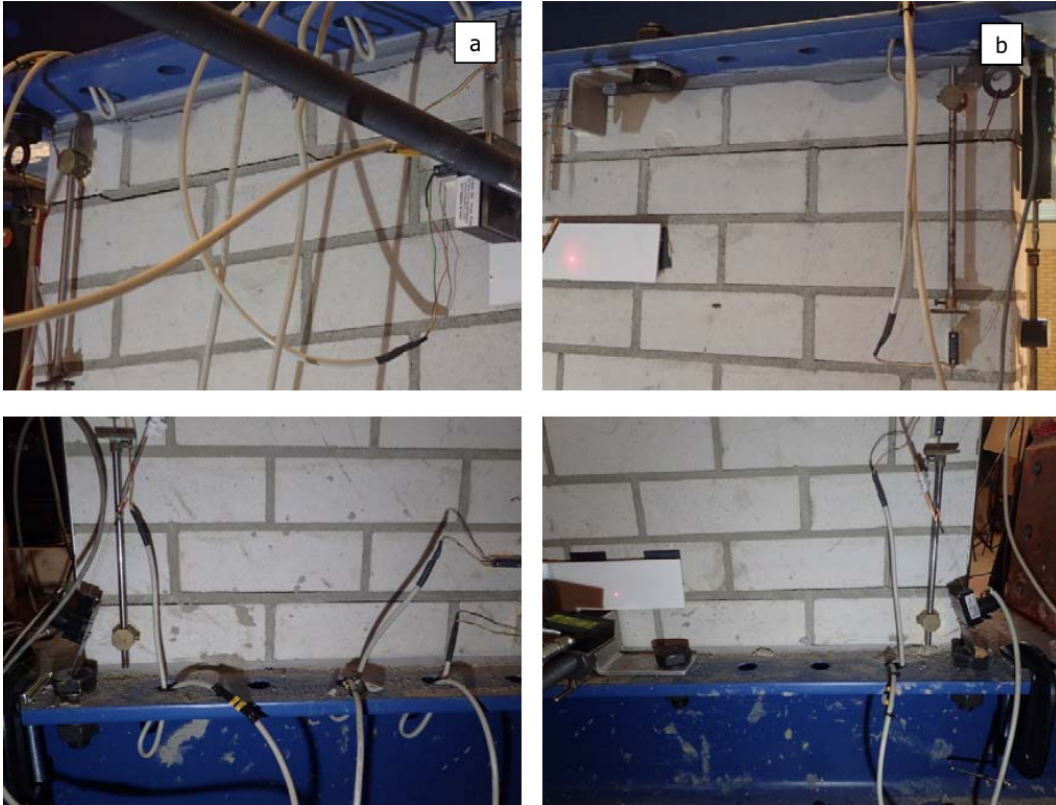
Figure 28: TUD-COMP-3: Rocking cracks at the top & bottom left corners (a) and top & bottom right corners (b)

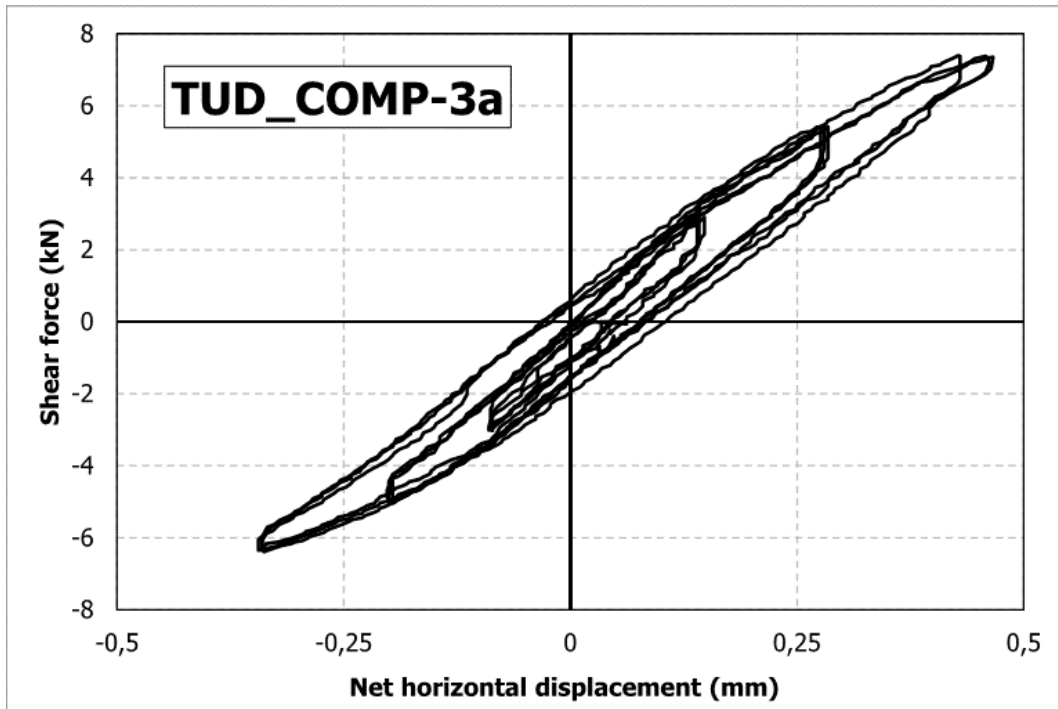
Figure 31: TUD-COMP-3a: Lab test result with 0.3 MPa overburden – Shear force-displacement curve

The measured hysteresis during the first phase and second phase of the test is shown in Figure 31 and in Figure 32, respectively.

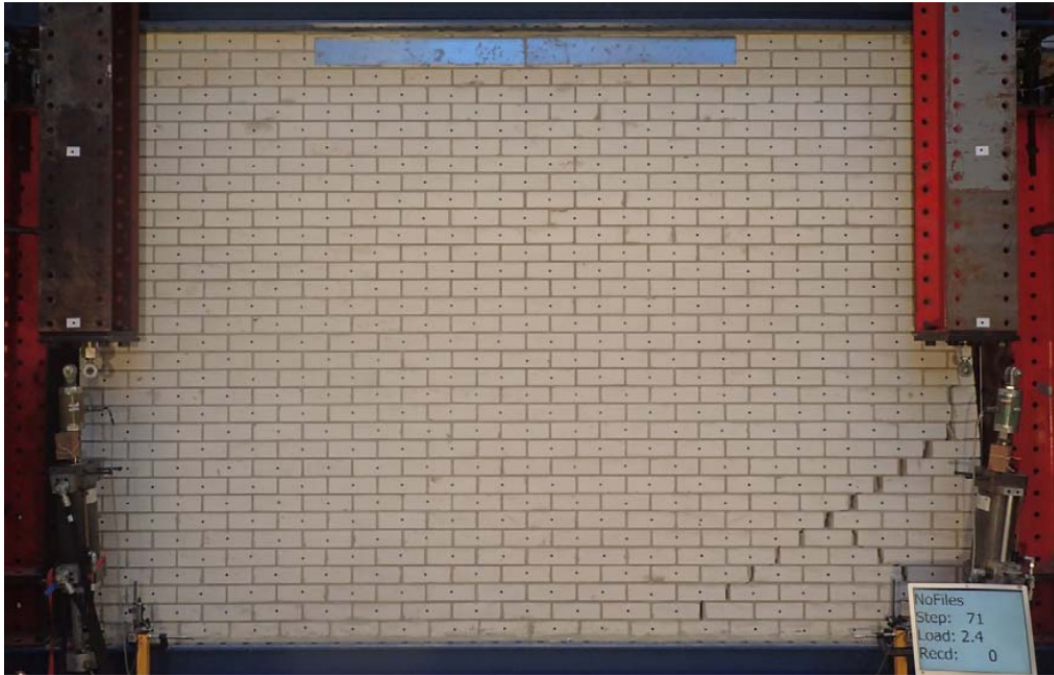
Figure 49: TUD-COMP-5: Crack pattern at the end of the test

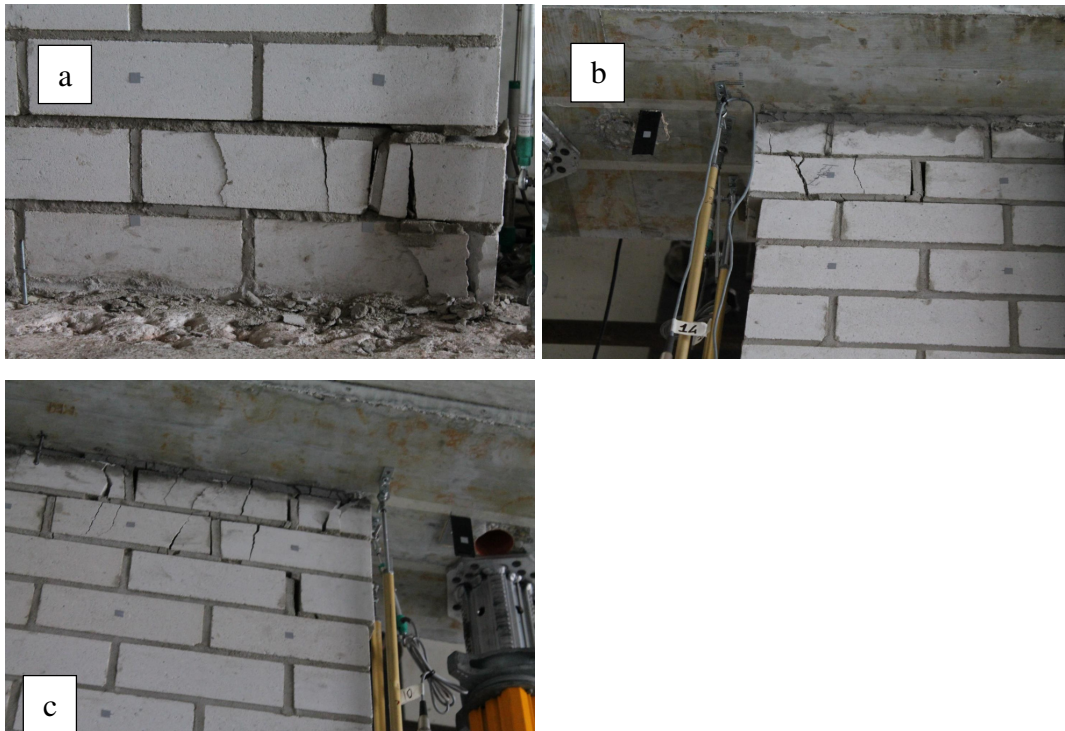
Figure 68: EUC-COMP-1: Toe-crushing damage at end of test (a) bottom right; (b) top left corner; (c) top right corner

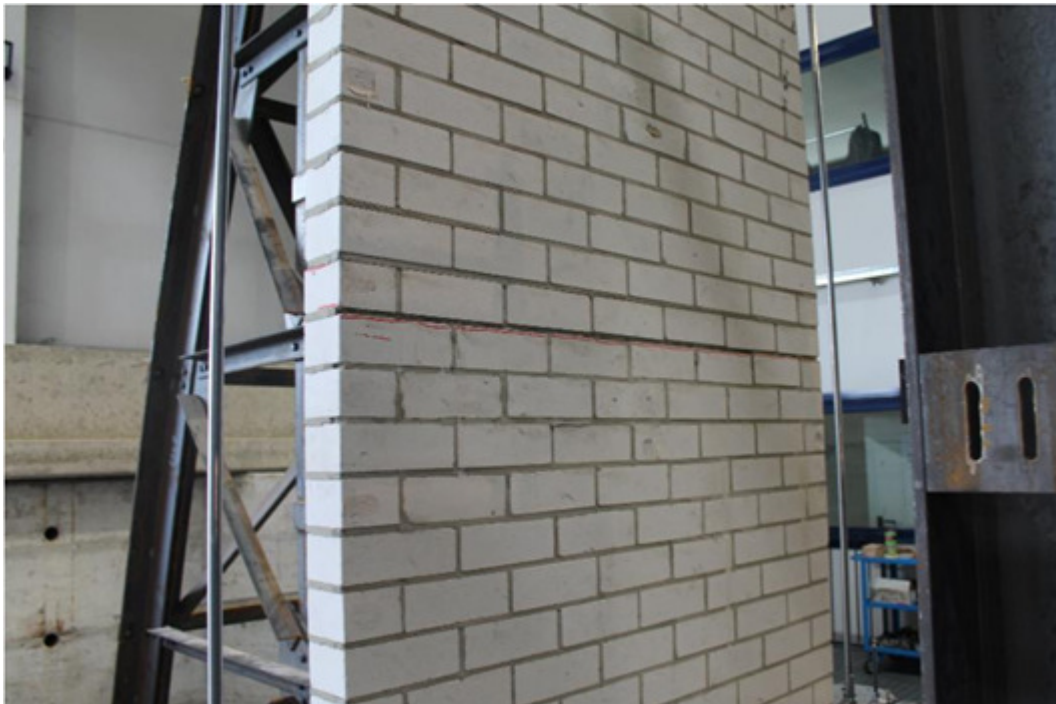
Figure 130: EUC-COMP-4: View of mid-height crack

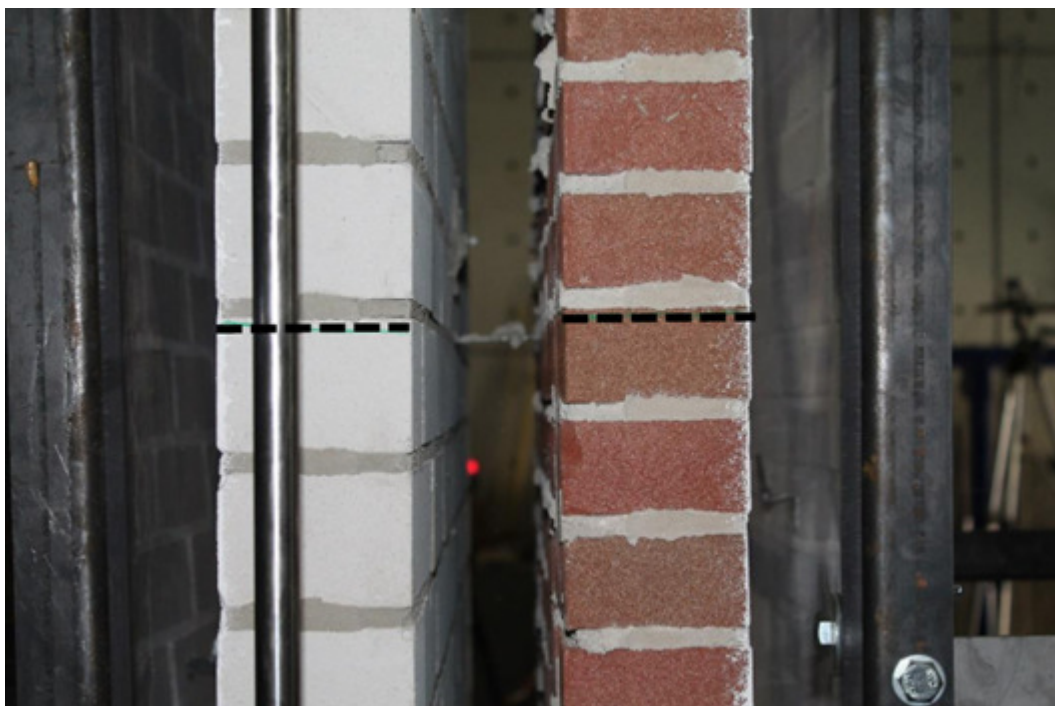
Figure 141: EUC-COMP-5: Formation of mid-height cracks at the tie location

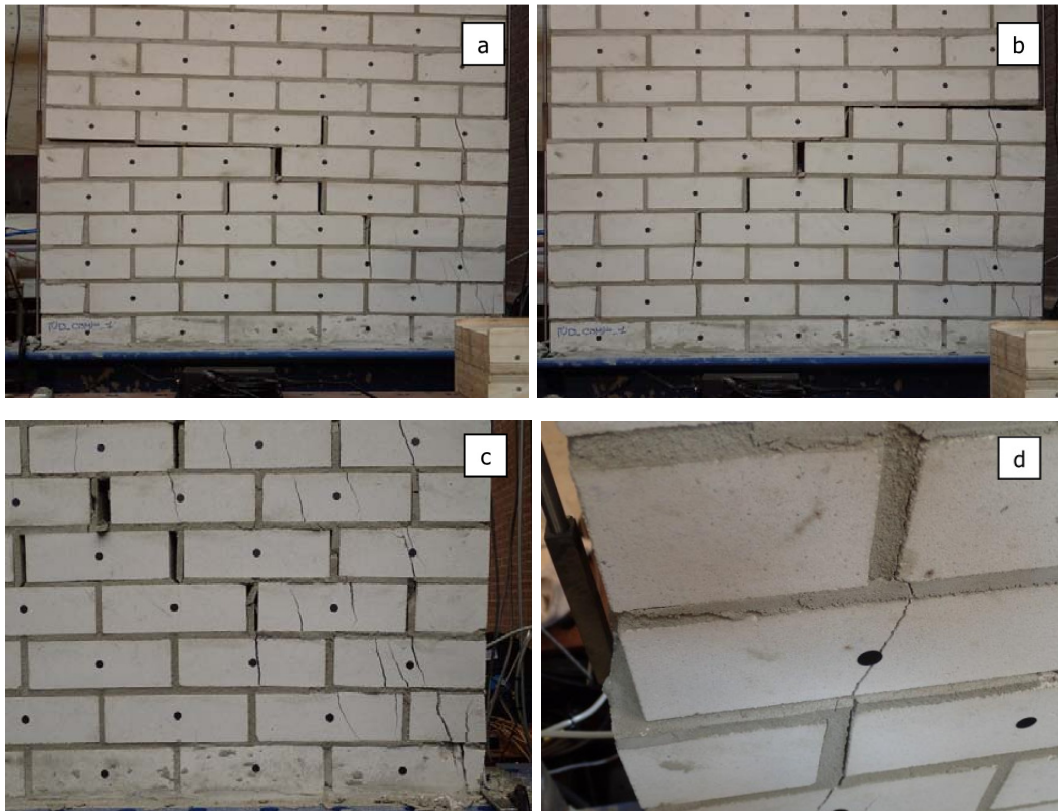
Figure 21: TUD-COMP-2: Crack pattern at failure for positive (a) and negative (b) drifts; details of the toe crushing (c) and sliding (d) at end stage.

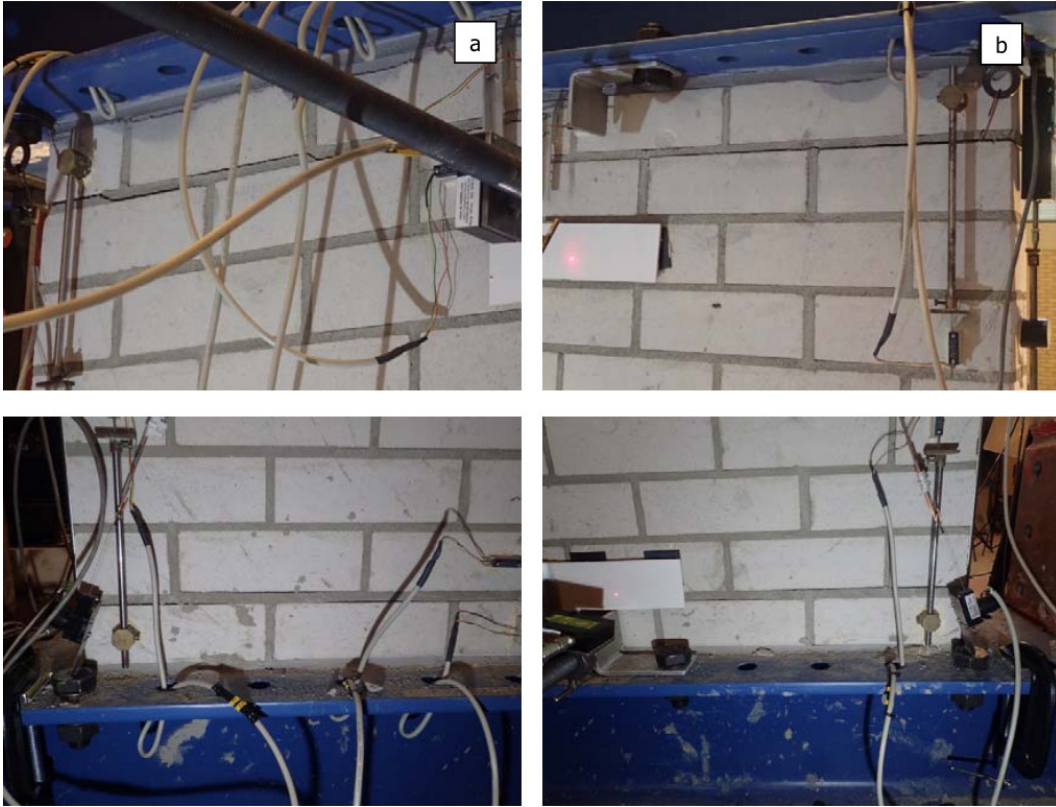
Figure 30: TUD-COMP-3: Rocking cracks at the top & bottom left corners (a) and top & bottom right corners (b)

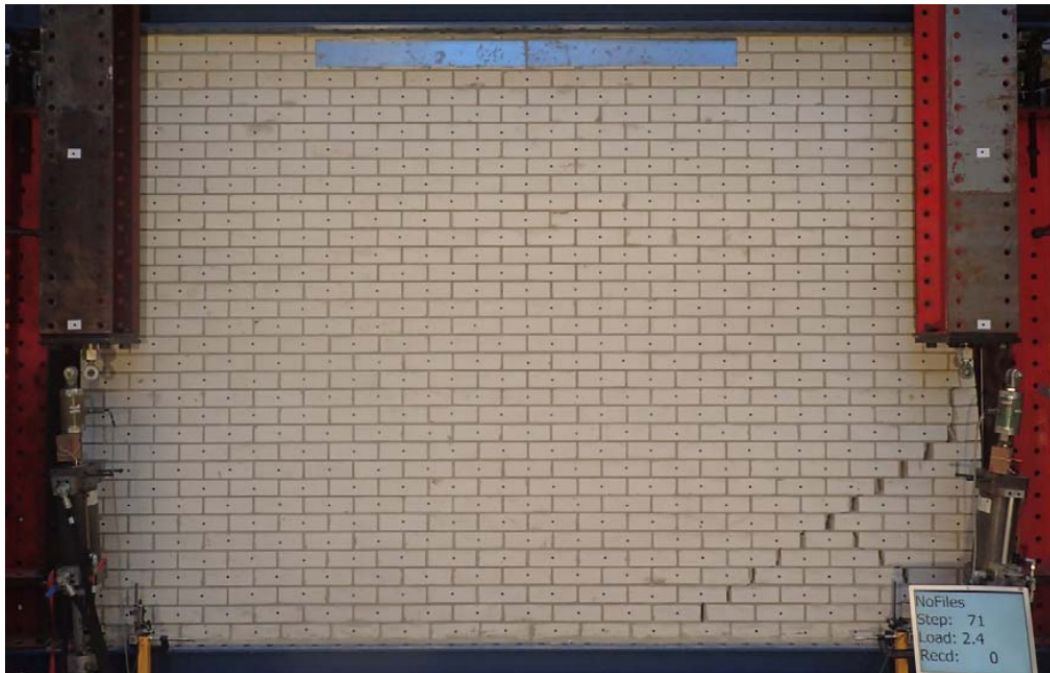
Figure 53: TUD-COMP-5: Crack pattern at the end of the test

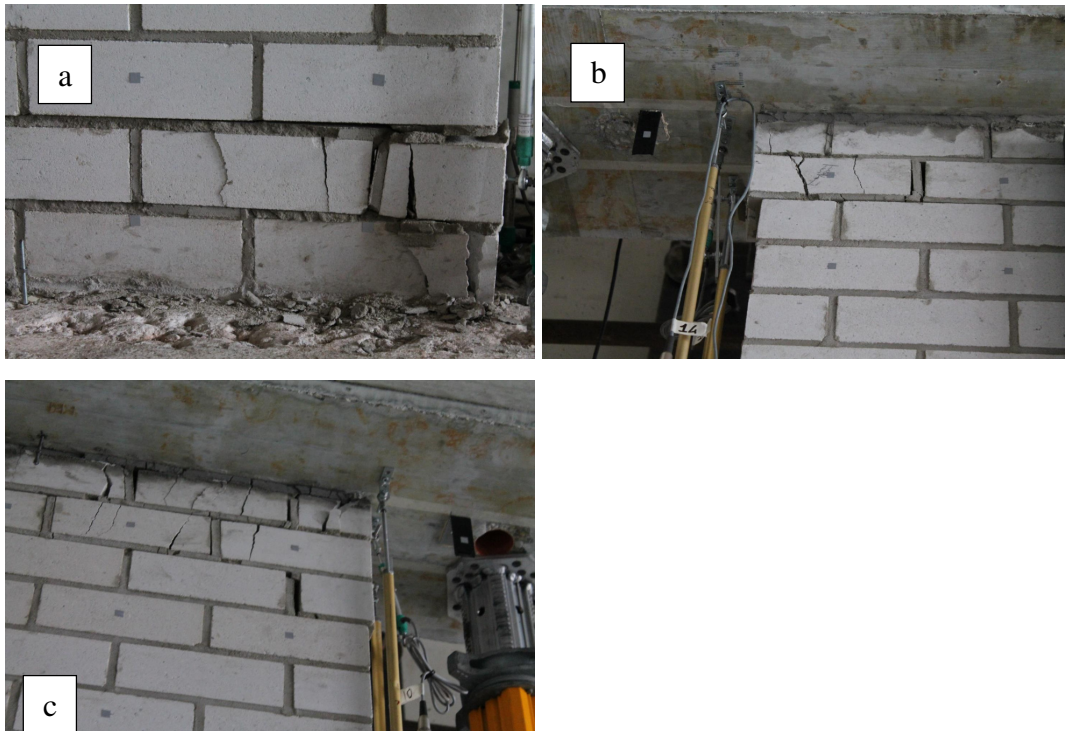
Figure 74: EUC-COMP-1: Toe-crushing damage at end of test (a) bottom right; (b) top left corner; (c) top right corner

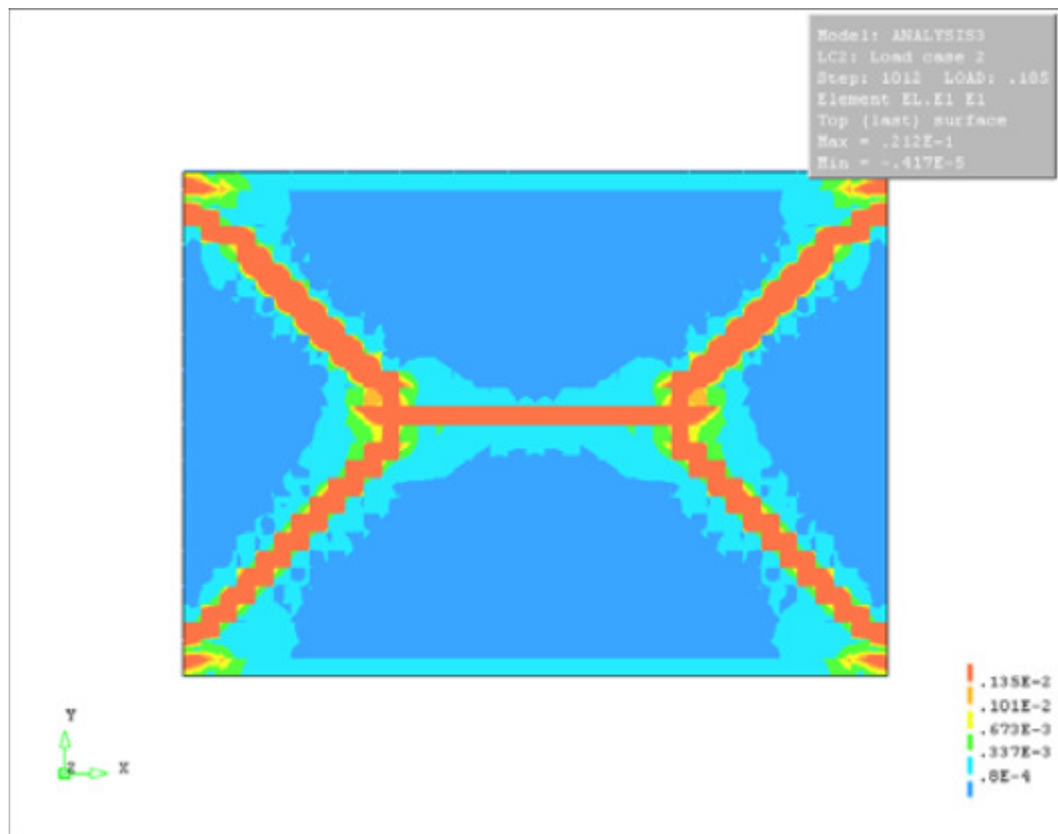
Figure 112: TUD-COMP-10: DIANA blind prediction - Damage plot at end of analysis—maximum principal strain contour

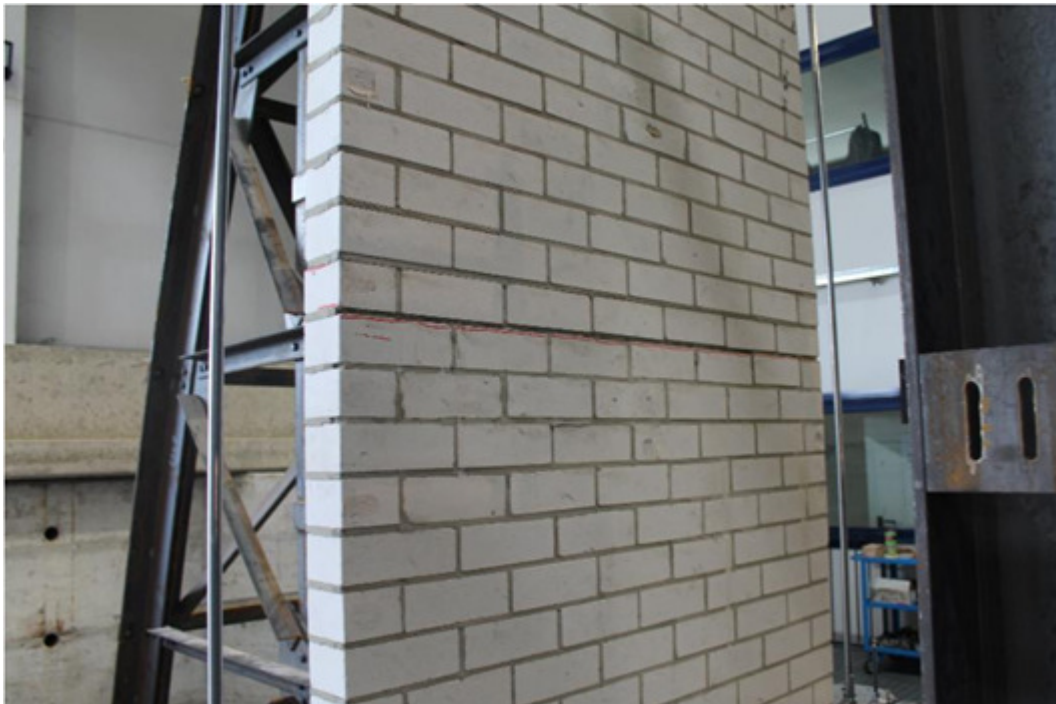
Figure 124: EUC-COMP-4: View of mid-height crack

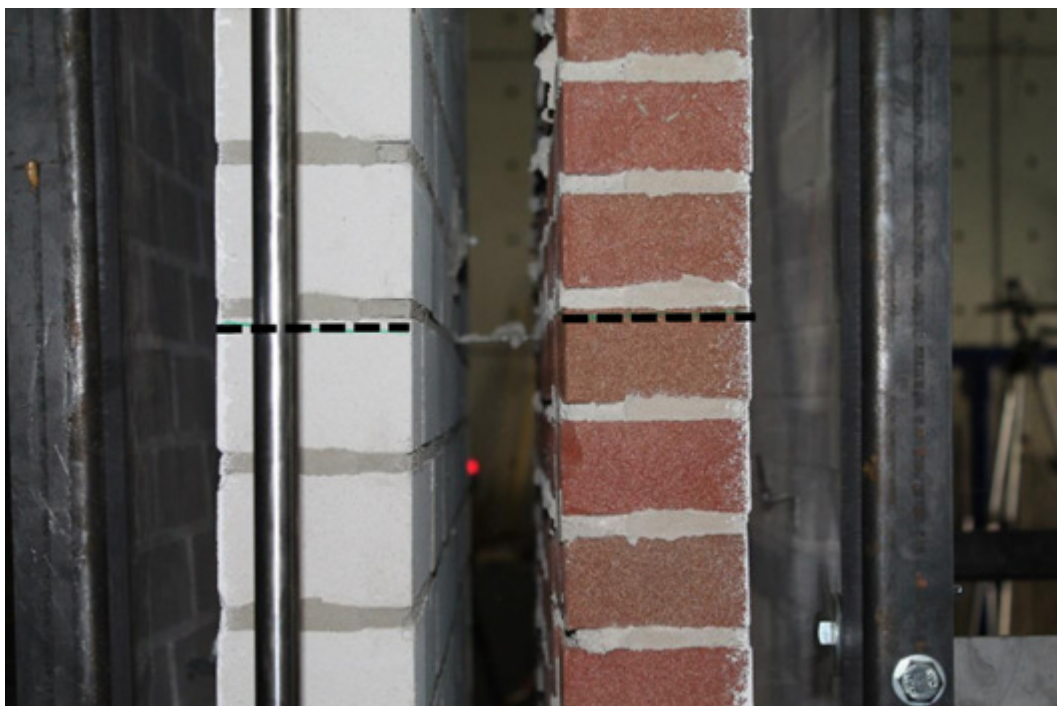
Figure 137: EUC-COMP-5: Formation of mid-height cracks at the tie location
