LNEC-BUILD-3 - An incremental shake-table test on a Dutch URM detached house with Chimneys

Stylianos Kallioras, António Araújo Correia, Ana Isabel Marques, Vasco Bernardo, Paulo Xavier Candeias and Francesco Graziotti

Date October 2018

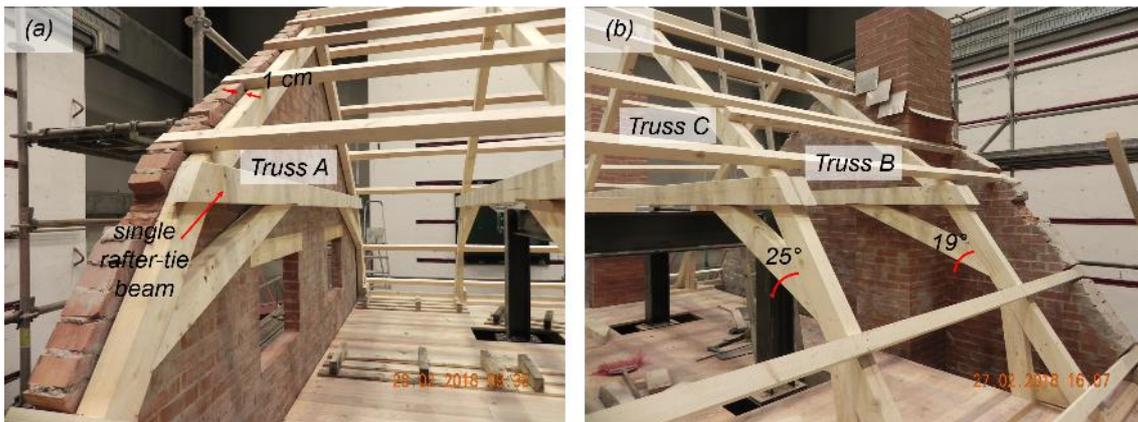
Figure 2.19 Construction details of the roof trusses: (a) Truss A and East gable; (b) Truss B and Truss C.

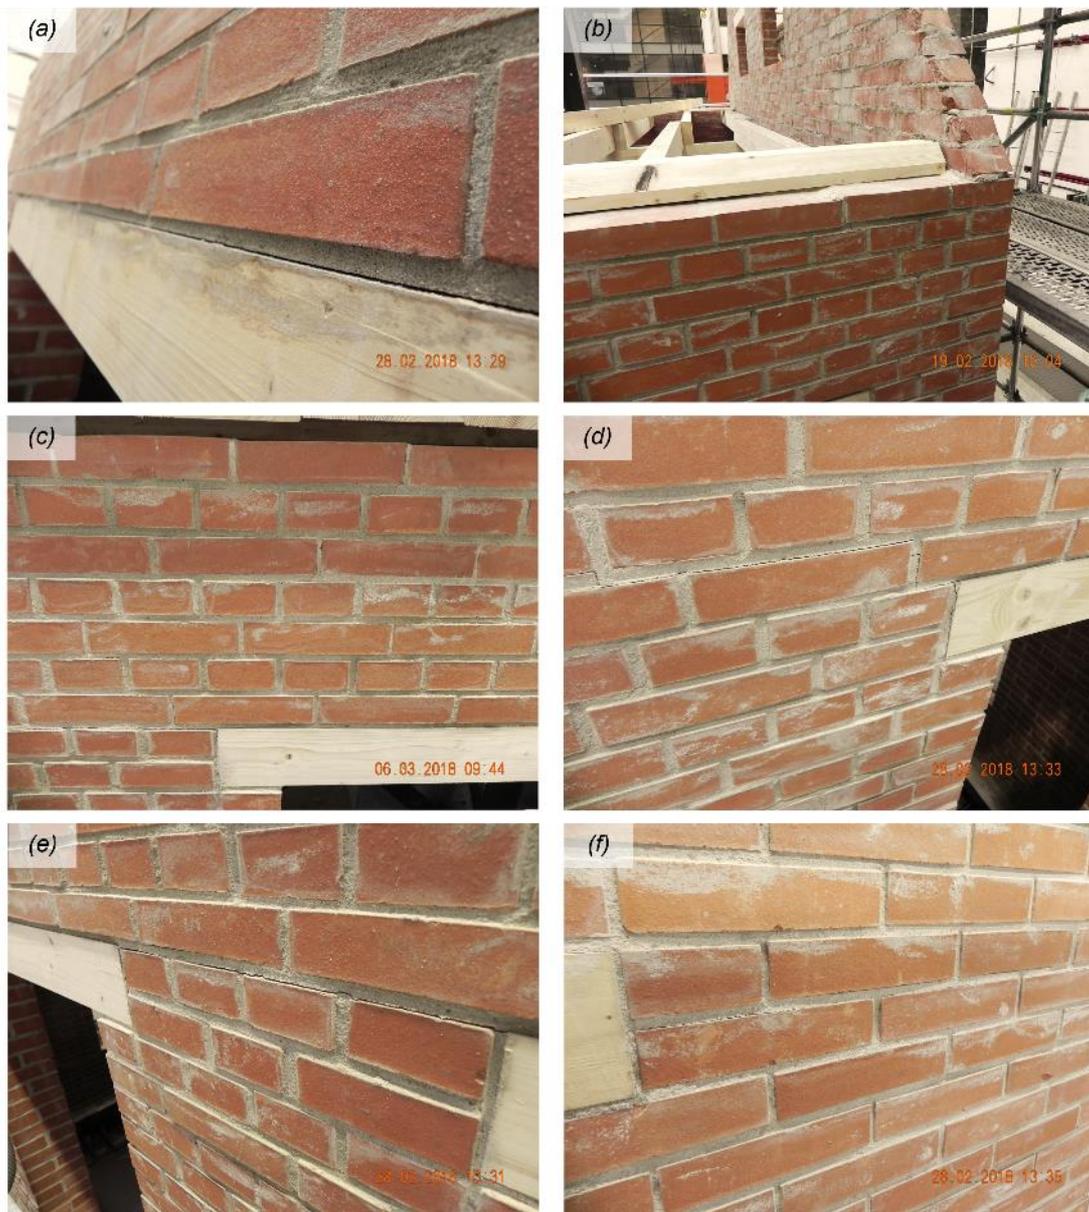
Figure 2.28 Damage detected prior to the testing: (a) cracking at the mortar-timber interface; (b, c) cracking due to floor joists-wall interaction; (d) crack propagation from the corner of an opening; (e) crack propagation between two lintels of the North façade; (f) crack propagation between the lintels of the East gable wall.

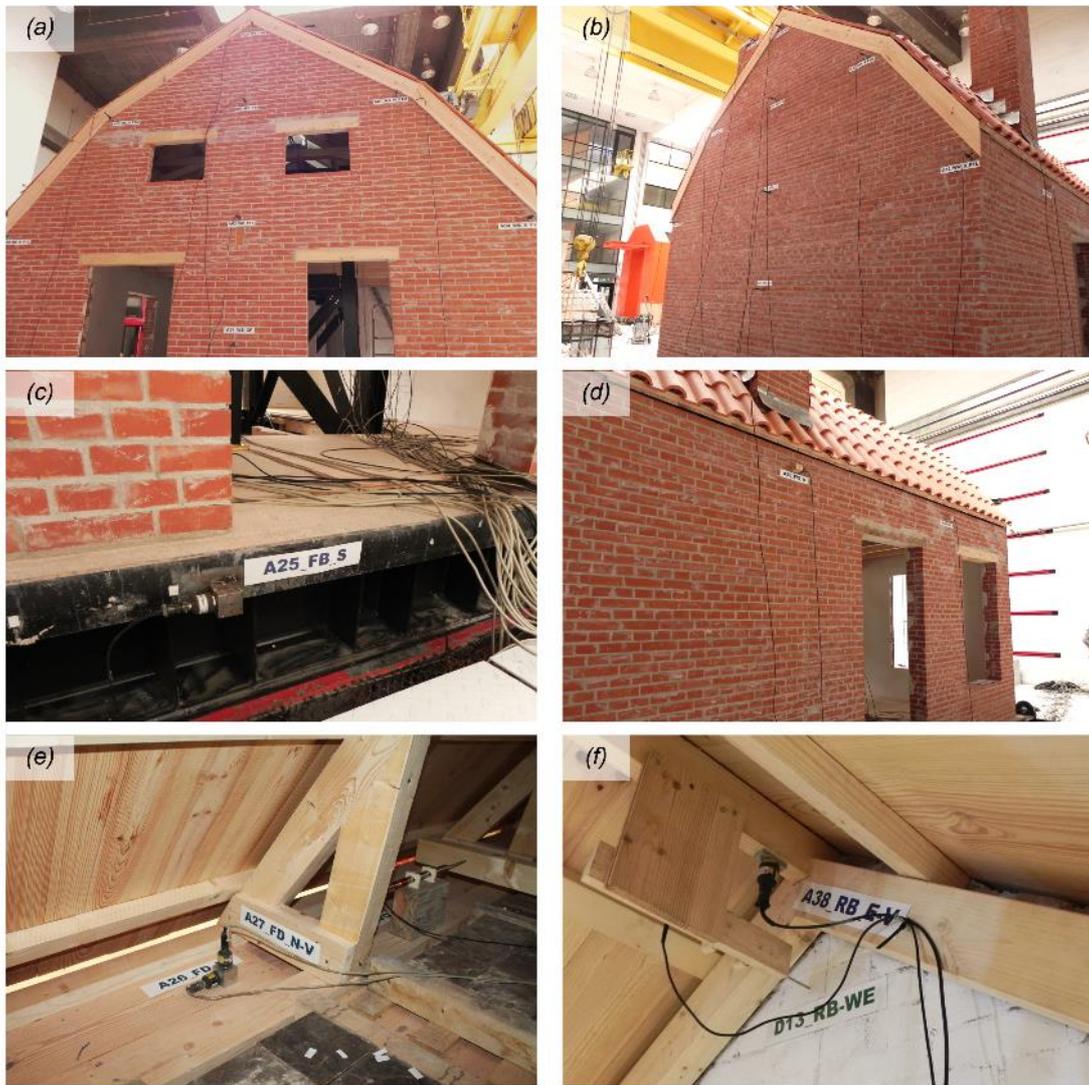
Figure 3.3 Accelerometers mounted on (a) the East façade; (b) the West façade; (c) the foundation beam; (d) the South façade; (e) the floor diaphragm; (f) the roof ridge beam.

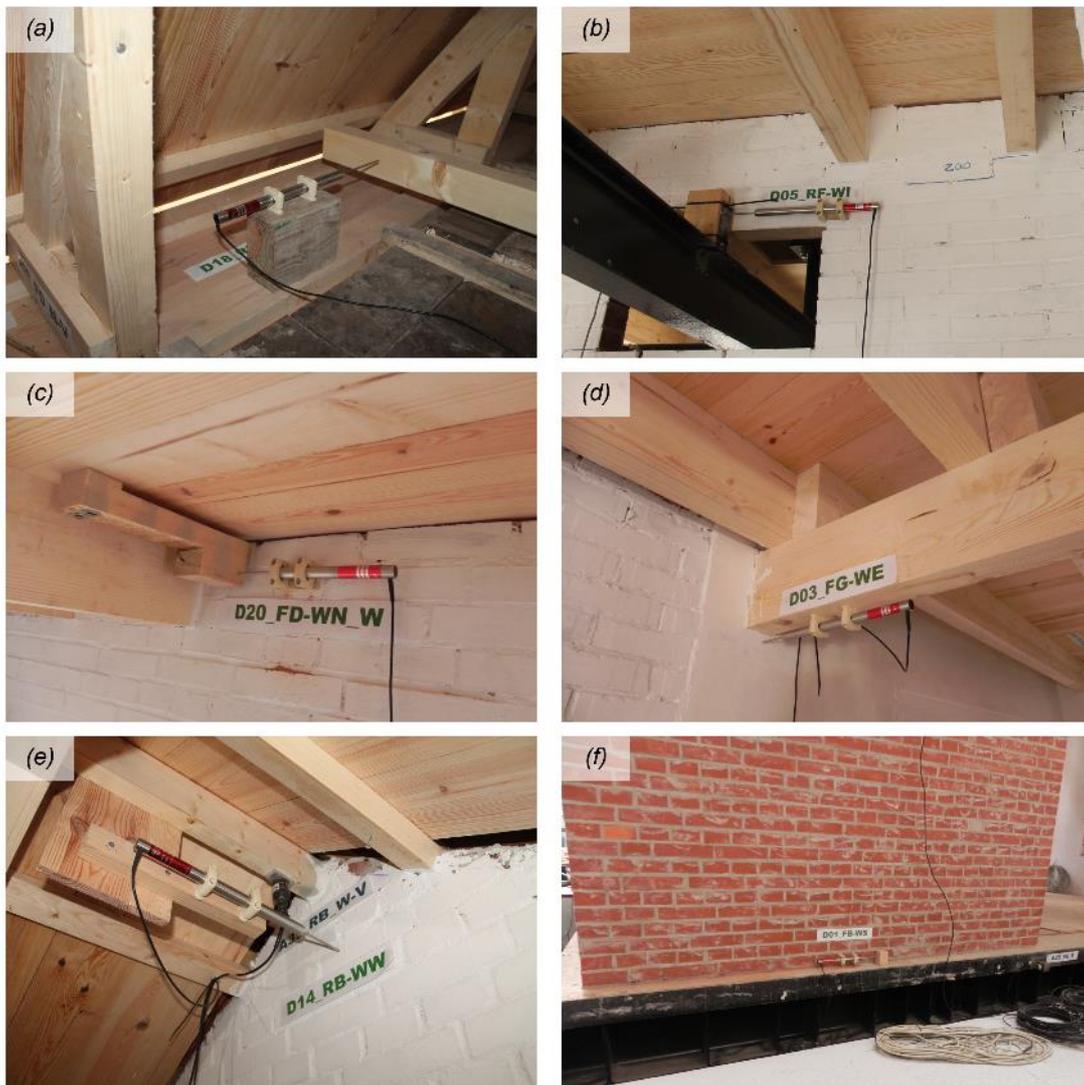
Figure 3.4 LVDTs monitoring differential displacements between (a) reference frame-floor diaphragm; (b) reference frame-interior wall; (c) longitudinal walls-floor diaphragm (i.e. lower plates); (d) floor girder-East wall; (e) gable wall-ridge beam; (f) foundation beam-South squat pier.

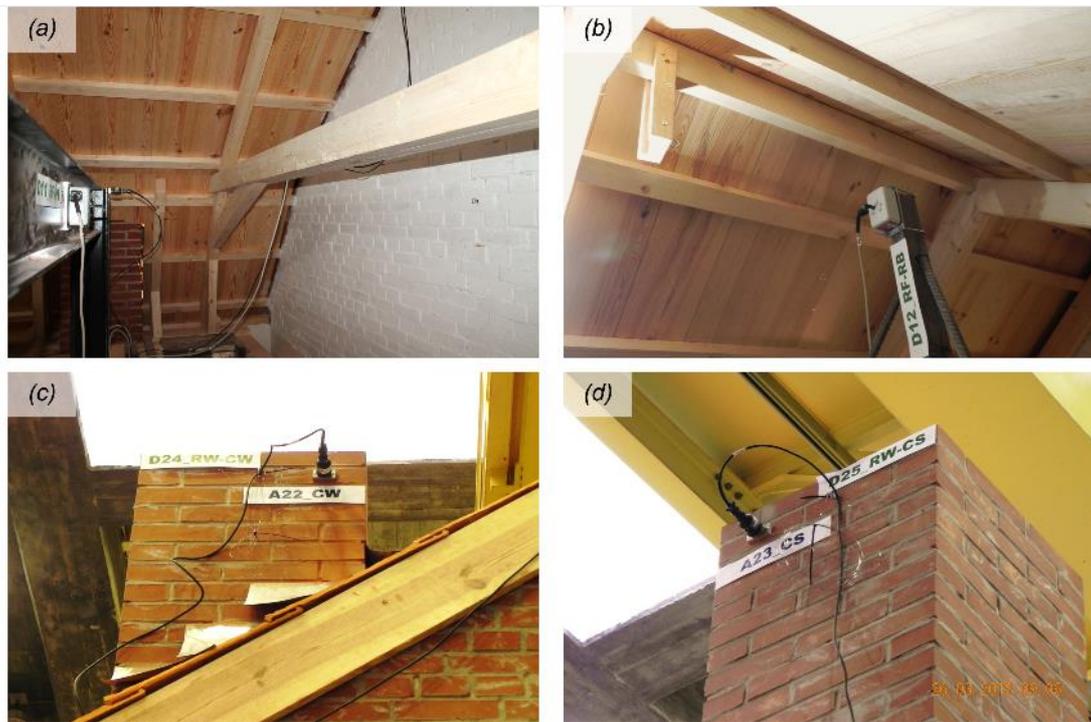
Figure 3.5 Wire potentiometers recording displacements at (a) the mid-height of the West gable wall (w.r.t. the reference frame); (b) the roof ridge beam (w.r.t. the reference frame); (c) the top of the West chimney (w.r.t. the reaction wall); (d) the top of the South chimney (w.r.t. the reaction wall).

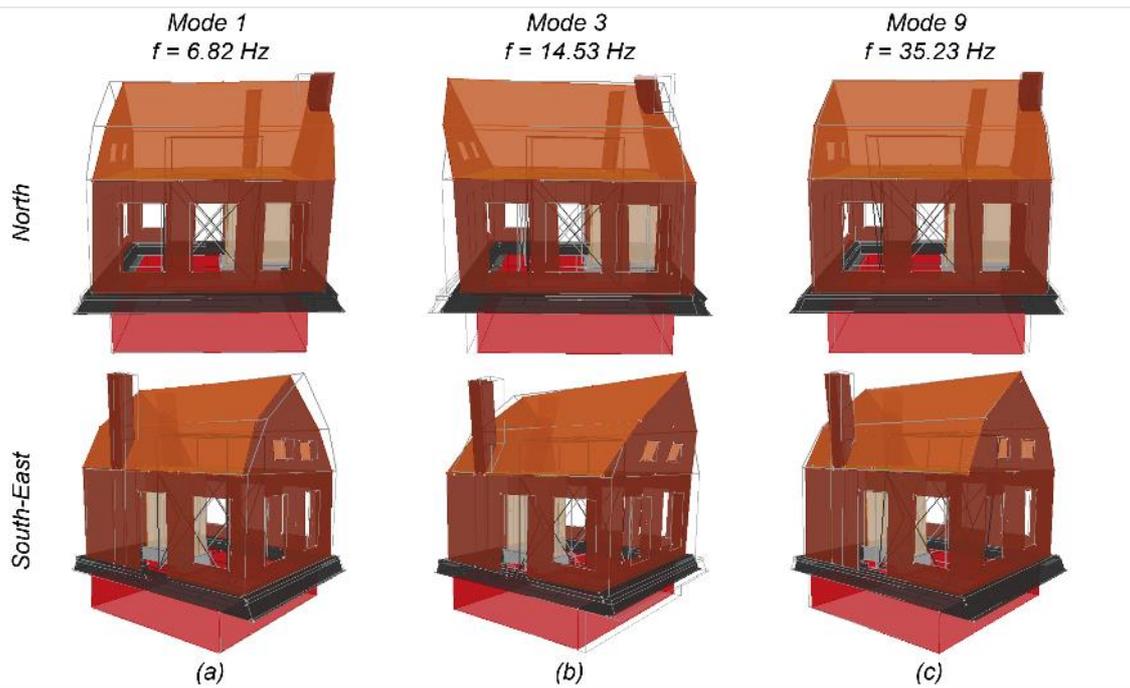
Figure 6.6 Dynamic identification test CHAR#0: vibration-mode shapes.

A dynamic identification test was performed before proceeding with the earthquake simulations to obtain an image of the dynamic properties of the building in its undamaged state. Figure 6.5a depicts the set of the accelerometers considered for visualisation of the mode shapes. Frequencies and damping values for the first nine modes were evaluated through the application of both FDD and EFDD methods (Table 6.1). Figure 6.5b shows the FDD analysis results: a frequency around 6.8 Hz characterised the fundamental vibration mode of the building. The shapes of the first, third and ninth modes are visualized in Figure 6.6.

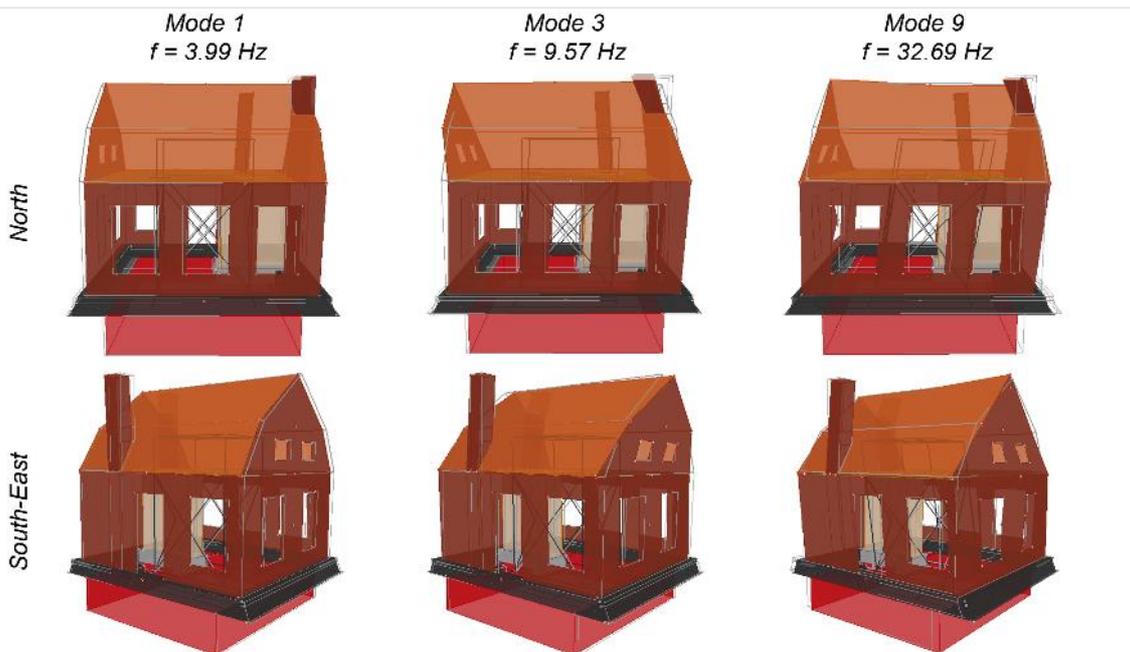
Figure 6.8 Dynamic identification test CHAR#9: vibration-mode shapes.

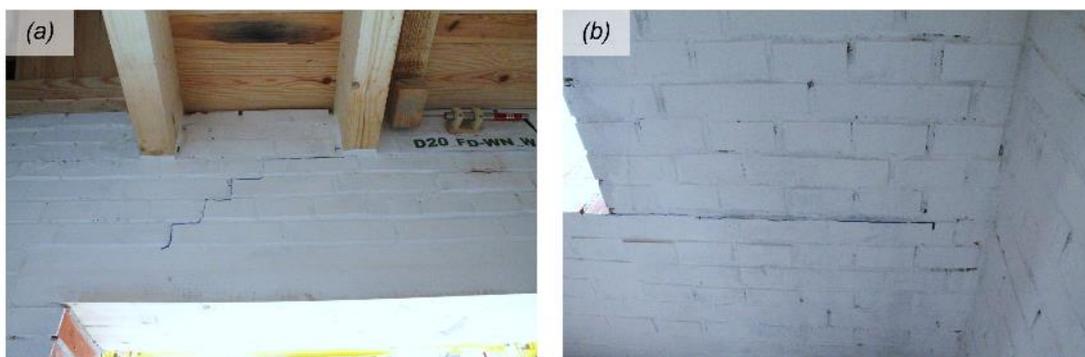
Figure 6.15 Damage on the North wall after test SC2-200%: (a) diagonal crack above the opening; (b) flexural crack at the base of the pier.

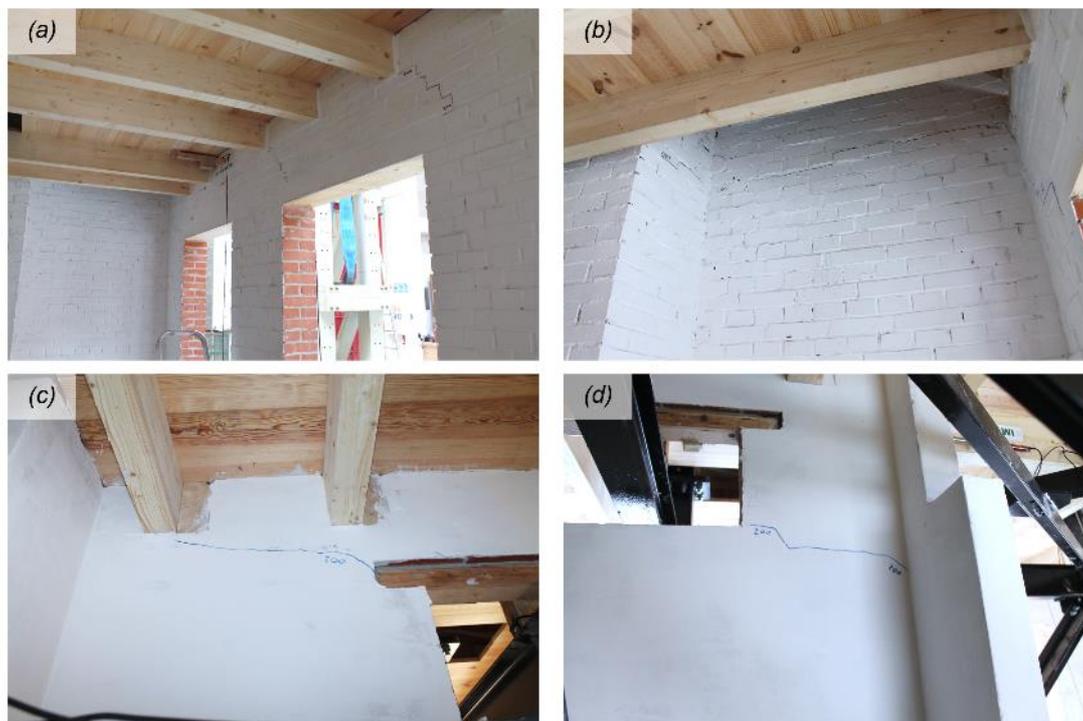
Figure 6.16 Damage after test SC2-200%-bis: (a) diagonal cracks above the openings of the North wall; (b) horizontal crack on the West façade; (c, d) cracks on the plaster of the interior wall.

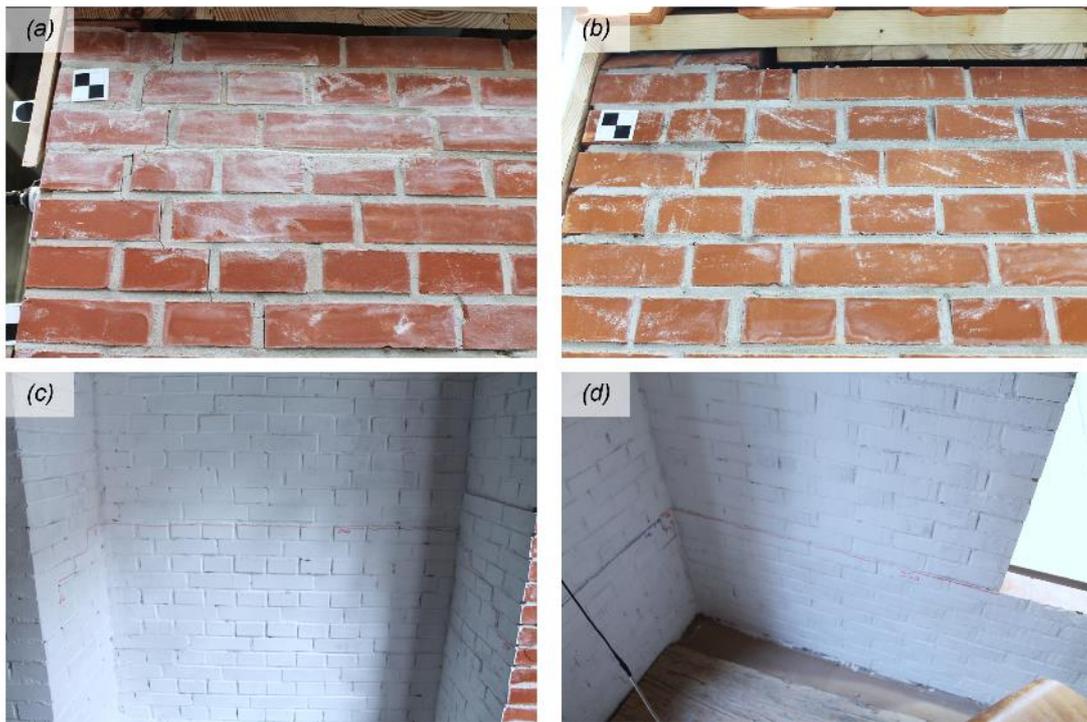
Figure 6.18 Damage due to interaction between in-plane and out-of-plane wall responses after test SC2-250%: (a, b) vertical cracks at the top of the longitudinal corner piers; (c) horizontal crack at mid-height of the West façade; (d) horizontal crack along the base of a pier of the East façade.

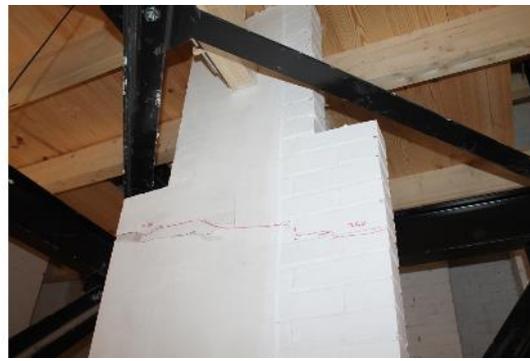
Figure 6.21 Damage on the interior wall after test SC2-250%.

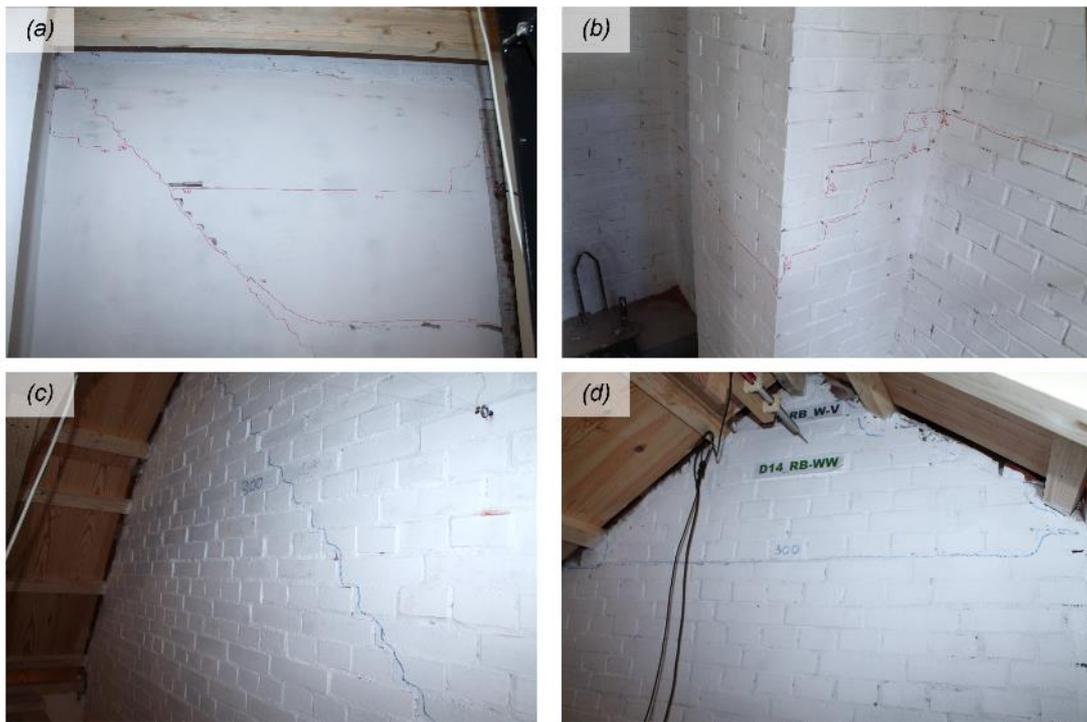
Figure 6.22 Damage on the West façade after test SC2-300%: (a, b) cracks at mid-height of the first storey; (c, b) cracks on the gable wall.

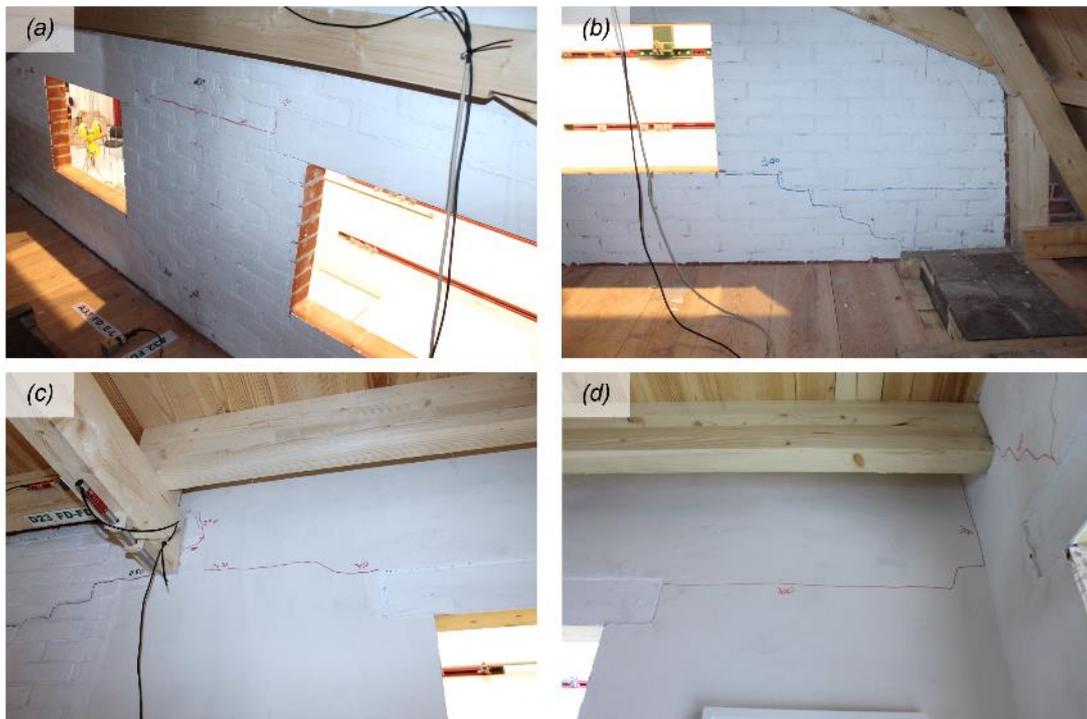
Figure 6.23 Damage on the East façade after test SC2-300%: (a, b) cracks on the gable wall; (c) cracks around the support of the floor girder; (c) horizontal cracking above the level of the windows.

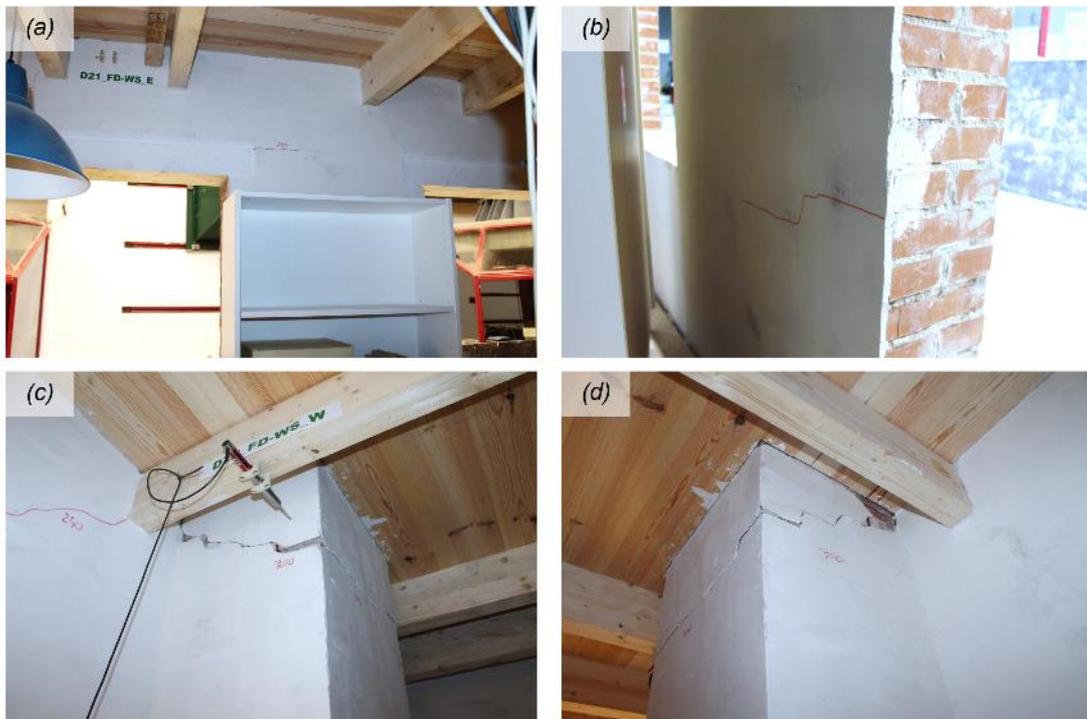
Figure 6.25 Damage on the South building façade after test SC2-300%: (a, b) cracks at the top and bottom ends of the central pier; (c, d) flexural crack at the base of the chimney stack.

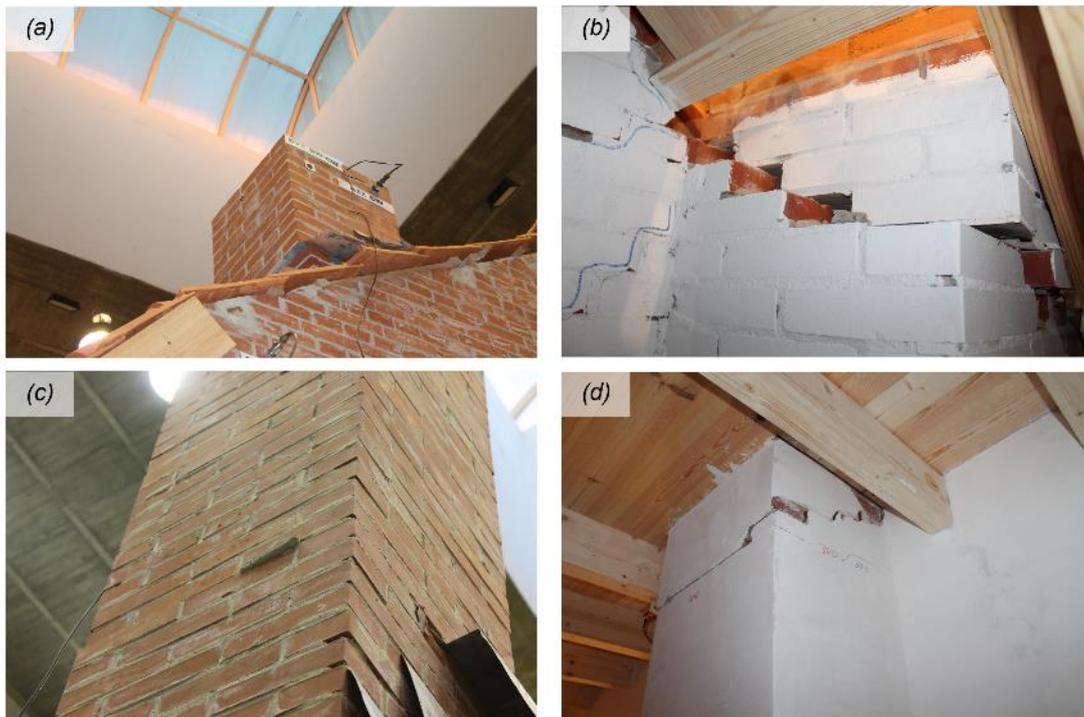
Figure 6.26 Damage to the chimneys during test SC2-350%: (a) failure in the West chimney at the location of flashing; (b) permanent sliding of the West at the level of the roofline; (c) fracture at mid-height of the South chimney stack; (d) residual displacement at the base of the South chimney stack.

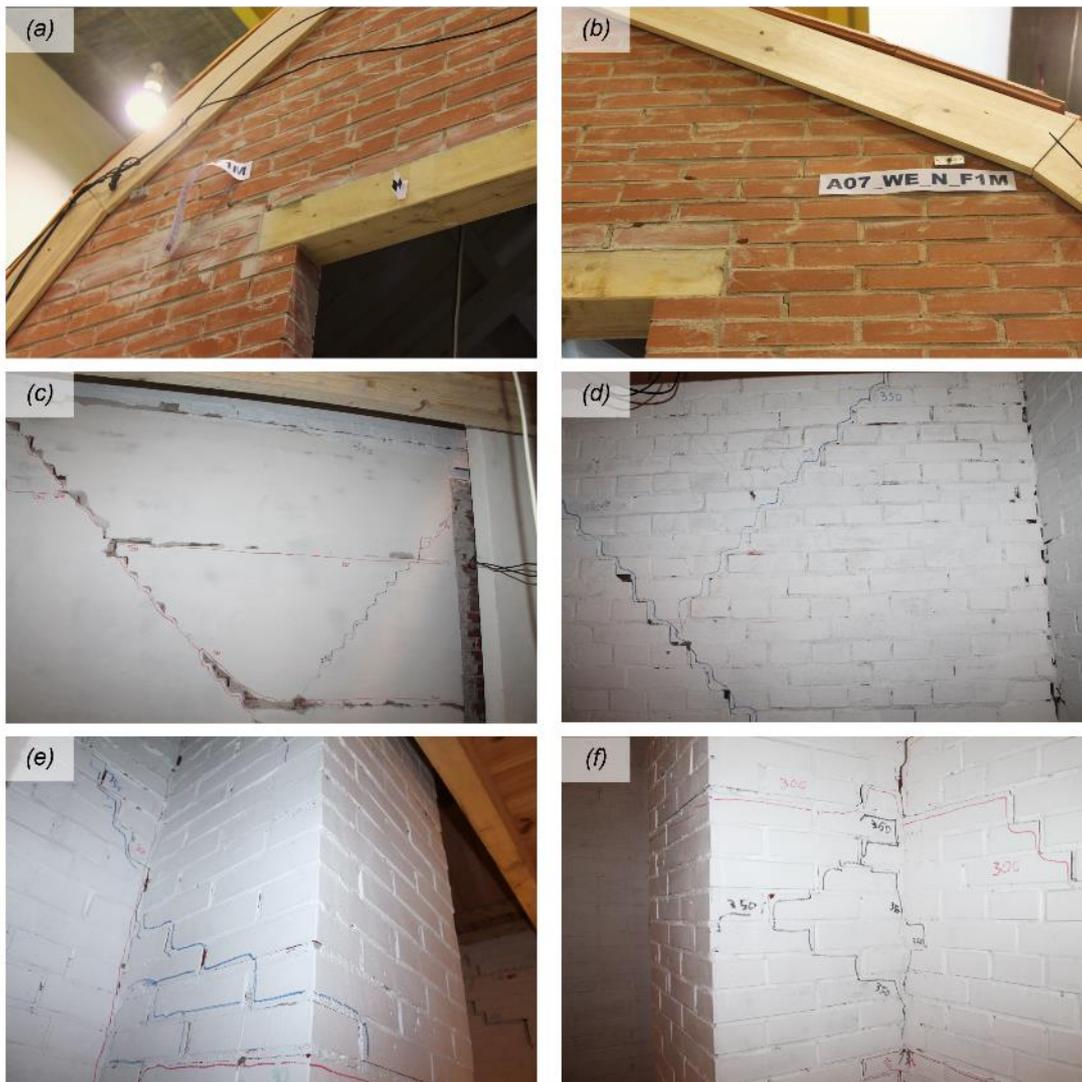
Figure 6.27 Damage on the transverse walls after test SC2-350%: (a, b) diagonal cracks propagating from the lintels to the supports of the purlins on the East gable wall; (c, d) new horizontal and diagonal cracks in both stories of the West wall; (e, f) damage at the connection of the chimney to the West building façade.

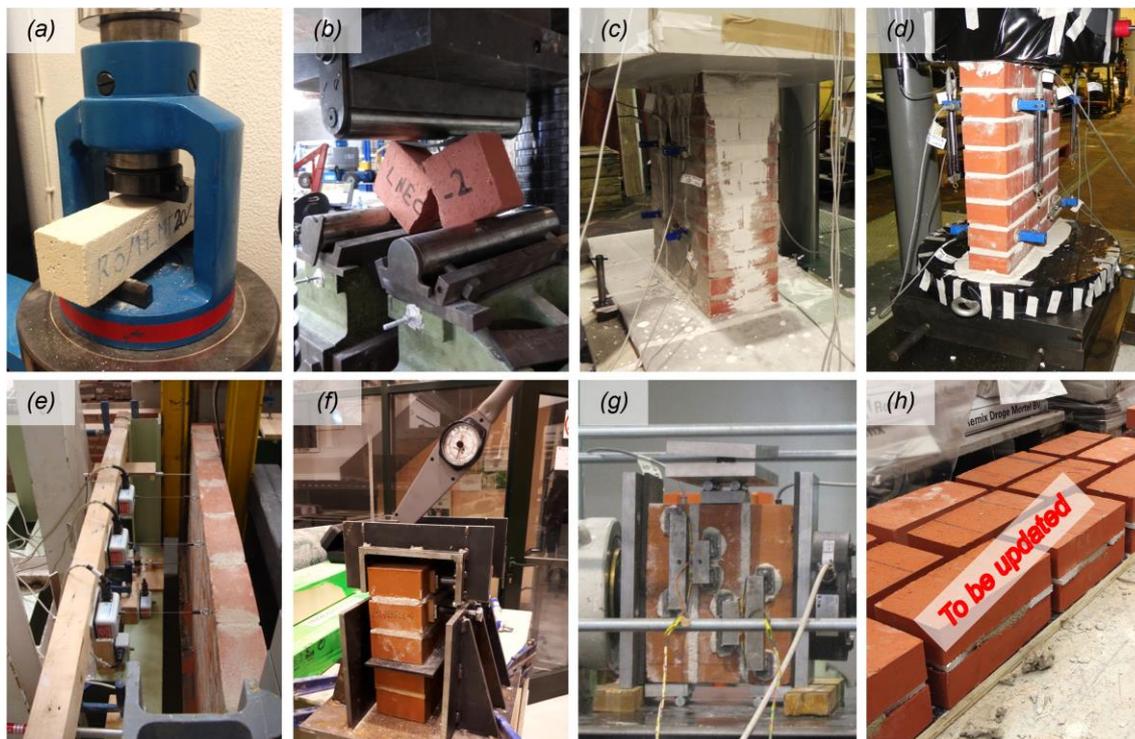
Figure 8.1 Mechanical characterization tests: (a) three-point bending test on a mortar specimen; (b) three-point bending test on a solid-clay brick; (c) compression test on a double-wythe masonry wallette; (d) compression test on a single-wythe masonry wallette; (e) four-point out-of-plane bending test; (f) bond wrench test; (g) direct shear test on a triplet; (h) shear test in torsion on a doublet.

A series of mechanical characterisation tests were conducted on the clay-brick masonry of the building specimen at the testing facilities of LNEC. The testing series comprised strength tests on mortar samples (Figure 8.1a) and clay units (Figure 8.1b), as well as compression and bending tests on small masonry assemblies (Figure 8.1c to e), bond wrench tests (Figure 8.1f), direct shear tests on triplets (Figure 8.1g), and torsional-shear tests on doublets (Figure 8.1h). All specimens were fabricated from the batches of units and mortar used to build the prototype building.

The solid clay bricks had compressive strength $f_b = 74$ MPa (EN 772-1, 2011) and flexural-tensile strength $f_{bt} = 6.5$ MPa for bending in the strong axis. The compressive and flexural-tensile strengths of the mortar were $f_c = 2.65$ MPa and $f_t = 1.22$ MPa, respectively (EN 1015-11, 1999), at the testing age of 28 days.

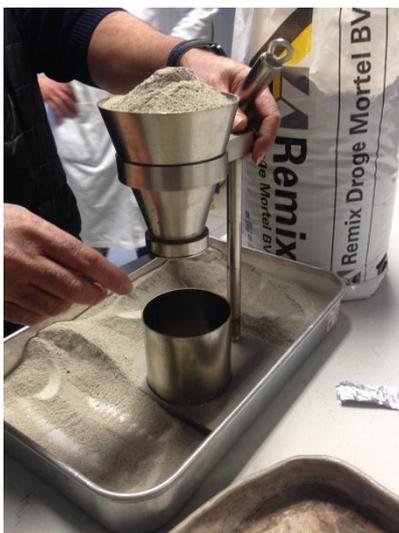
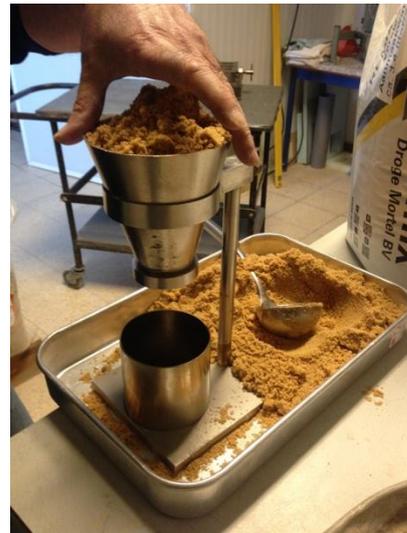
Figure 8.3 Determination of the bulk density on each type of material used in mortar.

The bulk density of the mortar powder and of the aggregate was determined by the procedure described in Cahier du CSTB 2669-4:1993 "Enduit monocouches d'imperméabilisation à base de liant hydraulique" (CSTB, 1993). Three samples of both products were prepared and homogenised in order to avoid the risk of segregation. Bulk density of the products was determined using the equipment shown in Figure 8.3 by filling the container, opening the shutter and, if necessary, helping the powder to go down using a spatula. When the container was full, the excess was removed by levelling the surface with the help of a ruler. The container and the product were weighted rounding to the nearest gram (M_1).

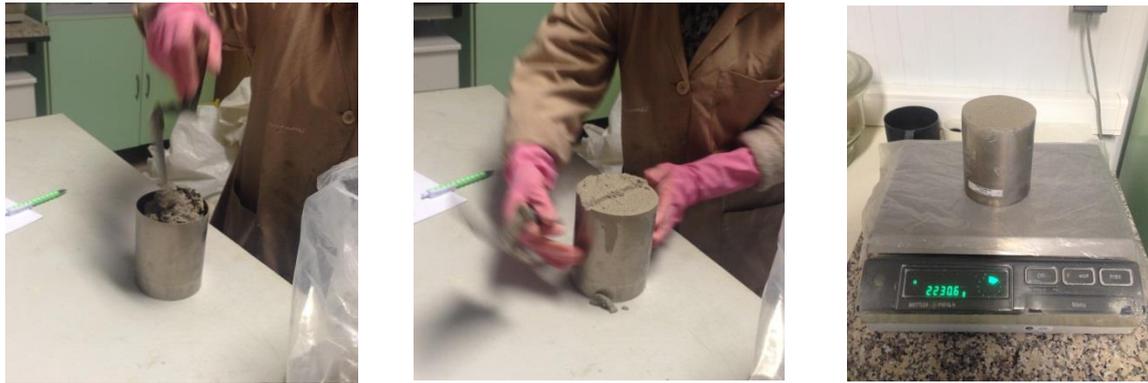
Figure 8.6 Carrying out the determination of bulk density of fresh study mortars.

Figure 8.6 shows some phases of the test being performed, while the results obtained for the study mortars are given in Table 8.7.

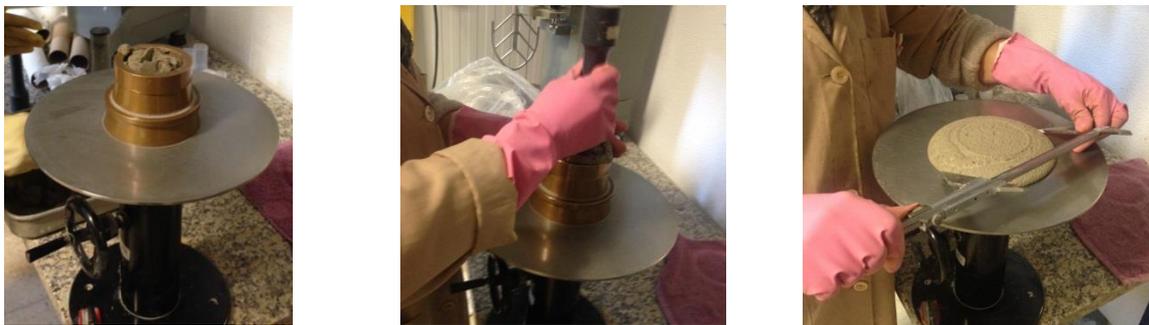
Figure 8.7 Determination of consistence of fresh study mortars by scattering: (a) schematic representation of equipment; (b) test run.

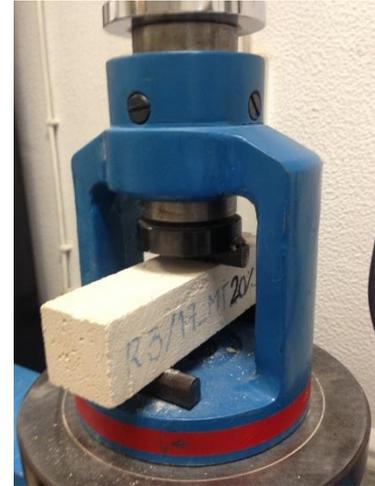
Figure 8.15 Test for determination of flexural strength: (a) scheme of positioning of the specimen and (b) specimen being tested.

The test to determine the flexural strength was performed according to the standard EN 1015-11:1999 "Methods of test for masonry – Part 11: Determination of flexural and compressive strength of hardened mortar" (EN 1015-11, 1999). The purpose of this test is to obtain the flexural strength of the mortar (hardened mortar), by applying a half-span load to a simply supported prismatic specimen as depicted in Figure 8.15 (a). The specimen is placed on the test machine and is centred with the longitudinal axis perpendicular to the two supports, ensuring that one of the side moulding faces stays fixed on the supports. The load is applied at mid-span through an upper bearing point, and imposing a gradual force and increasing continuously, between 10 and 50 N/s, forcing the failure to occur in a range of time between 30 and 90 seconds. The maximum force supported by the specimen is recorded until failure and the flexural strength of the specimen is then calculated. In Figure 8.15 (b) one of the test specimens is shown.

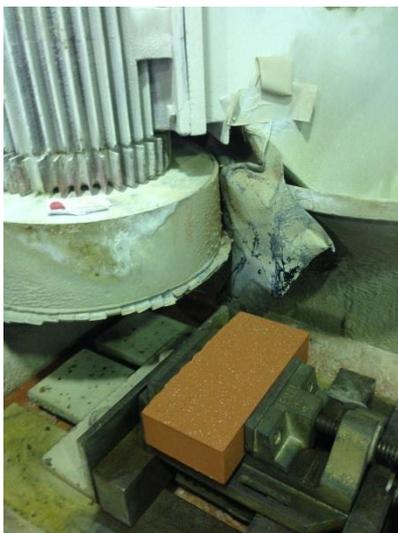
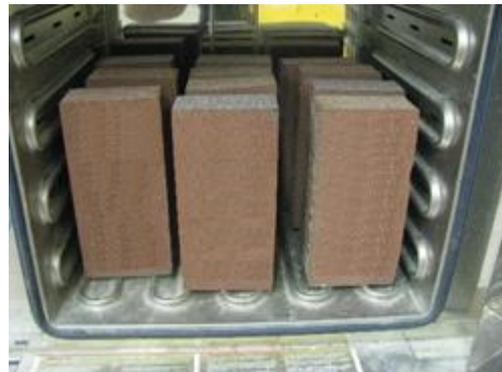
Surfaces smoothed by wear

Drying of specimens

Figure 8.64 Preparation of bricks.

The faces of bricks of the specimens were smoothed by wear, as shown in Figure 8.64. Considering that this process is carried out using a mechanical device cooled by water, the specimens were wetted. Afterwards they were heated in a ventilated oven at ± 105 °C until a constant mass was reached, as shown in Figure 8.64.

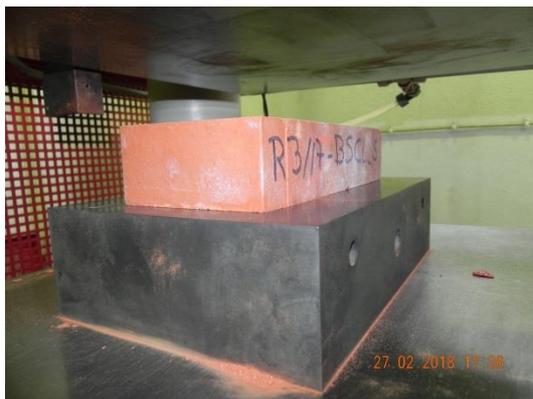
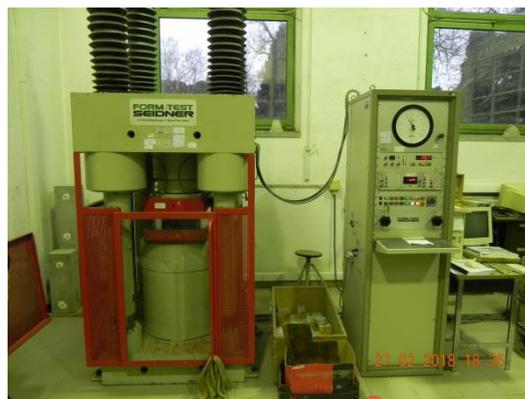
Figure 8.65 Specimens subjected to compressive strength tests.

Figure 8.65 illustrates how the tests were performed to determine the compressive strength for the bricks. The compressive strength was calculated considering the average gross area of the two faces in contact with the press plates. To obtain the standard compressive strength, f_b , the compressive strength of each specimen is multiplied by a shape factor d , which depends on the width and height of the bricks according to the aforementioned standard.

Eleven solid clay bricks were tested in compression for the determination of the brick compression strength. This test was carried out on the solid clay bricks specimens designated as BSCL_1 to BSCL_11. In Table 8.24 the compressive strength results for solid clay bricks are presented.

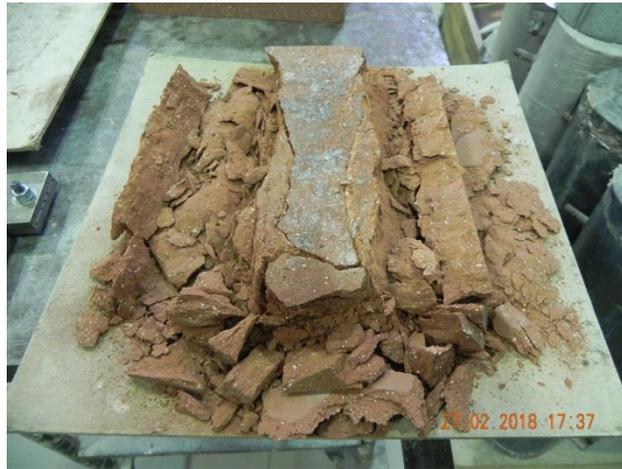
Figure 8.66 Brick for the compressive strength test after failure.

Figure 8.66 presents a typical failure of bricks that were tested, while in Appendix G the figures with the obtained fractures are presented for all specimens.

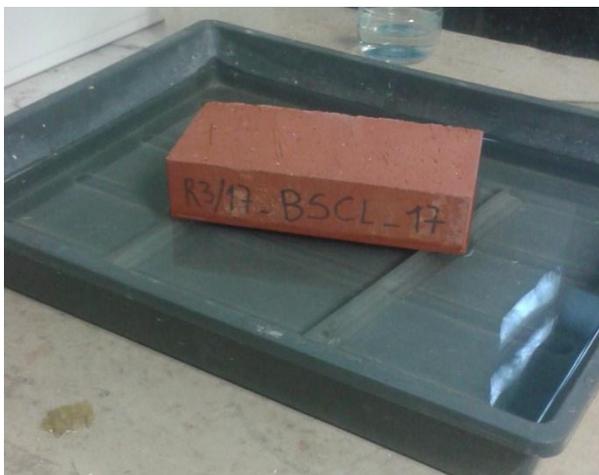
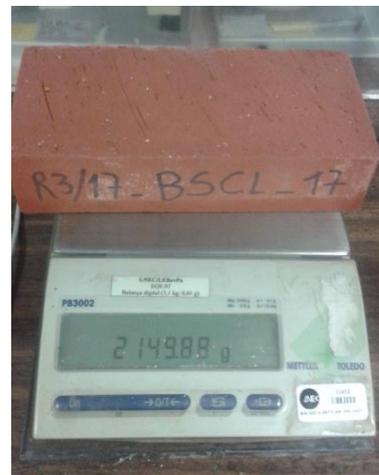
Figure 8.67 Determination of the water absorption coefficient by capillarity of the bricks.

The test for determination of the capillarity coefficient was performed on six specimens of each type of block by the procedures described in EN 772-11 "Methods of test for masonry units Part 11: Determination of water absorption of aggregate concrete, autoclaved aerated concrete" (EN 772-11, 2011). To perform this test the specimens were initially dried at $105 \pm 5 \text{ }^\circ\text{C}$ until 0.1% of constant mass was obtained. After cooling, the faces that were immersed in water (2 measurements per dimension, near the edges) are measured and the area that is in contact with the water is determined. Subsequently the initial mass of the specimen was measured and the bricks inserted in a tray with elements that allow the passage of water under them, with the face to be submerged downwards, immersed in water up to $5 \pm 1\text{mm}$, as shown in Figure 8.67. After the specified period for the material concerned, which in this case is $60 \pm 2 \text{ s}$, the specimen is removed and the surface water is removed with absorbent paper and the specimens are weighed.

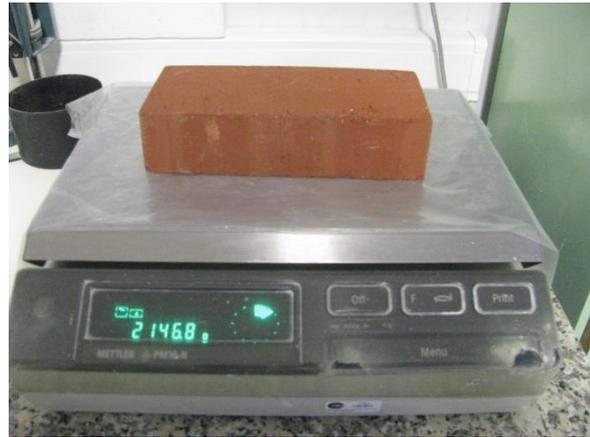
Figure 8.69 Weighing of blocks.

To carry out this test, six solid clay bricks specimens were selected with the designation BSCL_18 to BSCL_23. After the selection of the specimens, they were individually weighed and placed in a ventilated oven at a constant temperature of 105 ± 5 ° C, as shown in Figure 8.68, and weighed every 24 hours. This procedure must be carried out until a constant weight is obtained, i.e. until two consecutive weighings correspond to a mass loss of less than 0.2% of the total mass. After the specimens had reached a constant mass, the test pieces were again weighed, according to Figure 8.69.

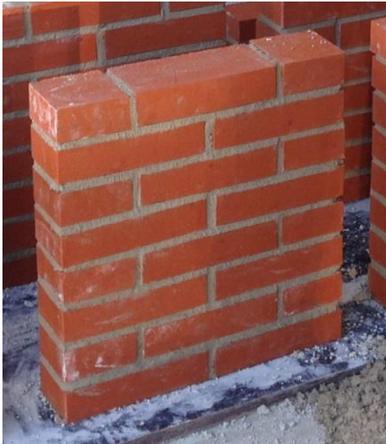
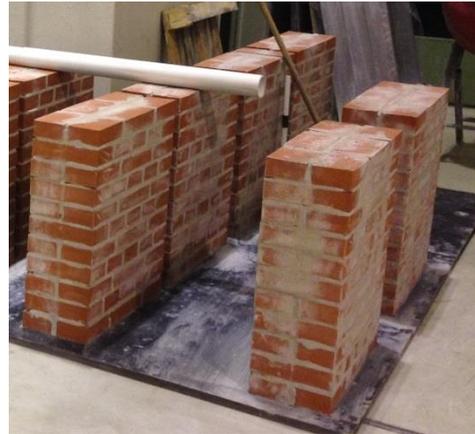
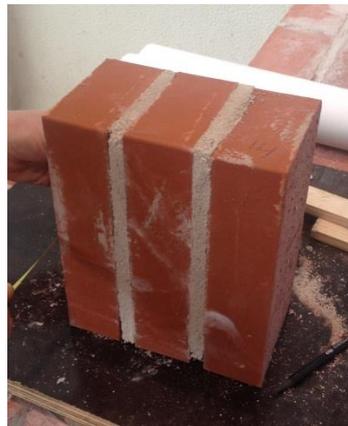
Figure 8.70 Types of masonry specimens (*wallettes* and *triplets*) built for testing.

Sixteen *wallettes* were built (eight simple-wythe and eight double-wythe). The simple *wallettes* have eight layers with dimensions approximately 435 x 100 x 470 mm and the double *wallettes* have eleven layers with dimensions approximately 550 x 210 x 650 mm. These dimensions are according to the provisions of norm EN 1052-1 “Methods of test for masonry – Part 1: Determination of compressive strength” (EN 1052-1, 1998). Forty-two *triplet* specimens were tested, with approximately 210 x 100 x 165 mm. Figure 8.70 shows the *wallettes* (simple and double) and *triplets* that were constructed for the tests.

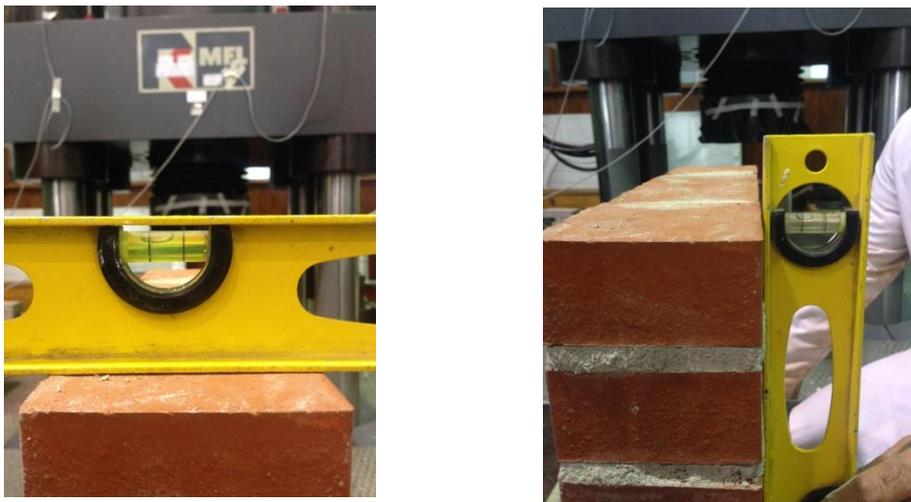
Figure 8.73 *Wallettes* with lack of orthogonality between them.

This test was performed on some of above mentioned *wallettes* specimens designated as CTBSCL_1S to CTBSCL_6S and CTBSCL_1D to CTBSCL_6D. *Wallettes* were not perfectly tiled at the time of construction, as shown in Figure 8.73. To fix this problem and due to the small irregularities of the lower and upper faces of the single *wallettes* (areas that would be in contact with the plates of the press), these faces were regularised with a thin layer of gypsum, as shown in Figure 8.74. After this regularisation a very fine layer of gypsum is placed on both sides already with the specimen on top of the testing machine, which are levelled by the plates of the press machine, as shown in Figure 8.74.

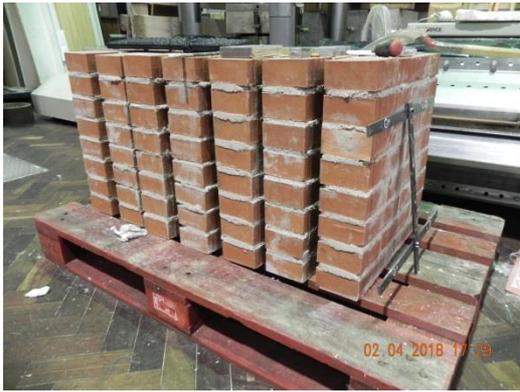
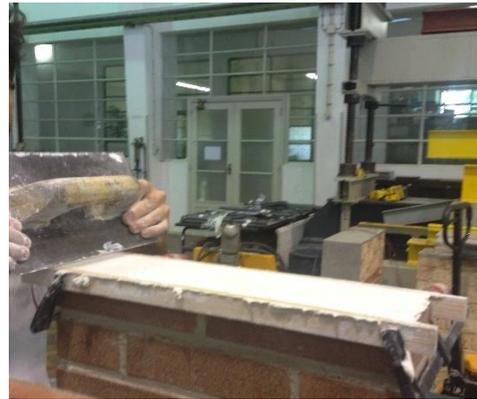
Preparation

During the process

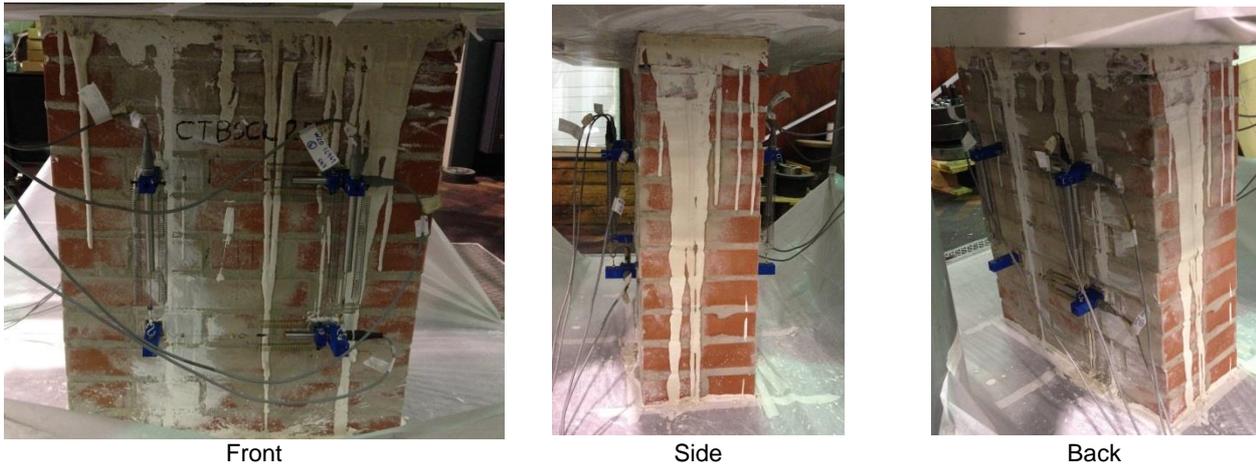
Figure 8.78 Instrumentation placed on each face of the double wallettes.

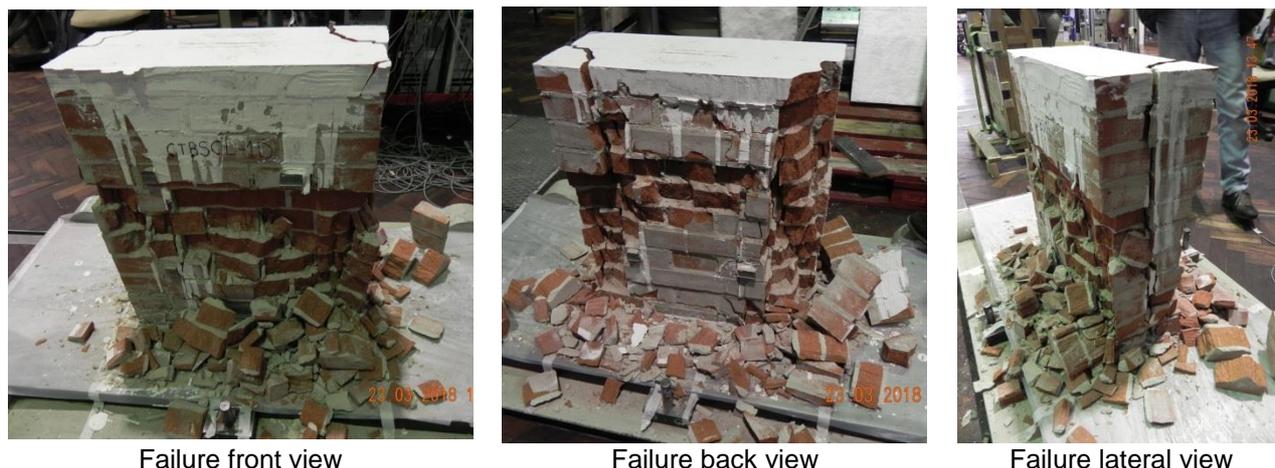
Figure 8.82 Double wallette during the test and after failure.
