LNEC-BUILD-3 - An incremental shake-table test on a Dutch URM detached house with Chimneys

Stylianos Kallioras, António Araújo Correia, Ana Isabel Marques, Vasco Bernardo, Paulo Xavier Candeias and Francesco Graziotti

Date October 2018

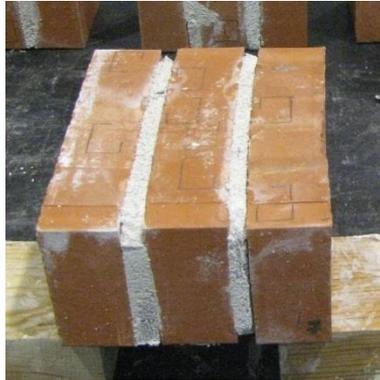
Figure 8.109 Type of specimens subjected to bond strength test.

The purpose of this section is to describe the complementary destructive tests that were carried out on 26 masonry triplets, as shown in Figure 8.109, to determine the bond strength of their horizontal bed-joints at different maturation ages using the bond wrench method described in the standard EN 1052-5:2005 "Methods of test for masonry – Part 5: Determination of bond strength by the bond wrench method" (EN 1052-5, 2005).

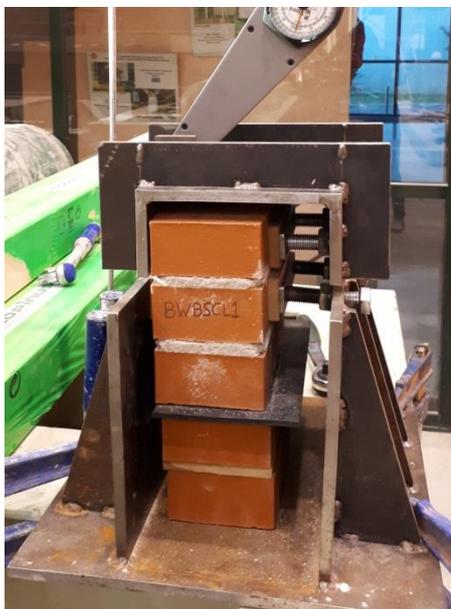
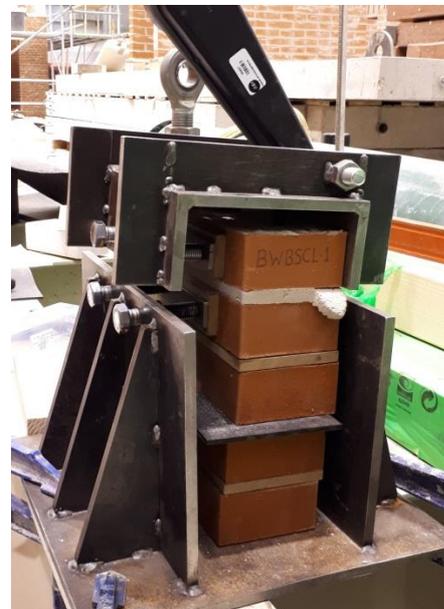
First bed joint

Second bed joint

Figure 8.112 Test of the two connections in triplets using the same test device.

1. The lower frame was attached to a rigid plate and a position for the *triplet* was defined, according with the standard. The screws were clamping approximately with equal torque (a ratchet torque wrench was used). Bricks and small pieces of timber were used with the thickness of the joints to ensure the same fixing height as defined in the standard. This was envisaged for two reasons: i) since the lower structure is common to the two types of *triplets* which have different heights; and ii) so that after the first failure of the connection the specimen could be raised to the required height, allowing the second connection to be tested, as shown in Figure 8.112;

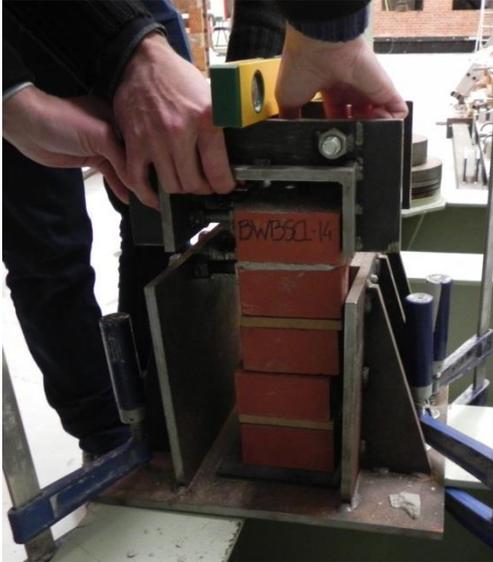
Figure 8.113 Application of vertical force until bond failure.

3. Fix the upper clamp with lever arm on the upper block to be tested, respecting the tightening location indicated by the standard (a distance equal to or greater than 10 mm from the test joint) and ensuring that the lever is horizontal, as shown in ;
4. Apply the vertical force on the torque wrench and read the value of the moment that leads to a bond failure, as shown in Figure 8.114;
5. Weighing of the top unit and the adherent mortar leading to a bond failure, as shown in Figure 8.115.

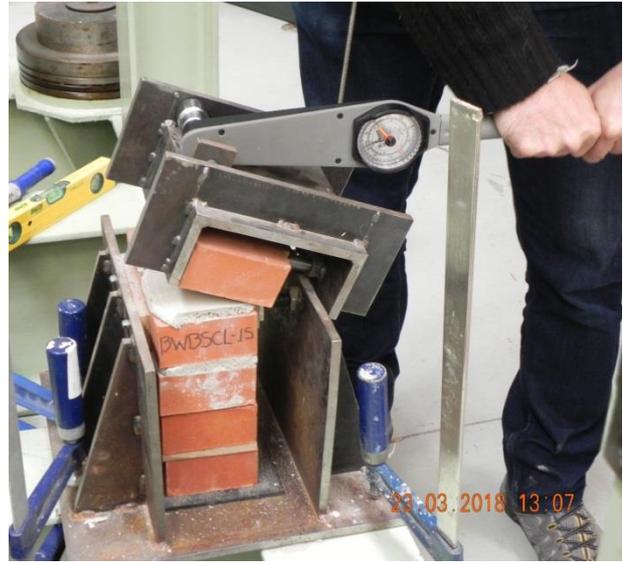
Figure 8.114 Application of vertical force until bond failure.

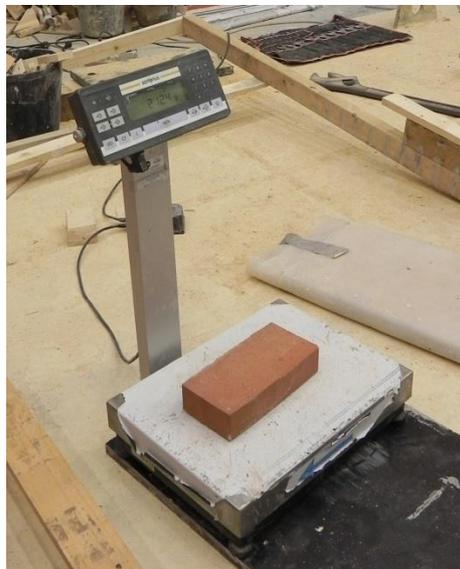
Figure 8.115 Measure of the weight of the top unit and adherent mortar.

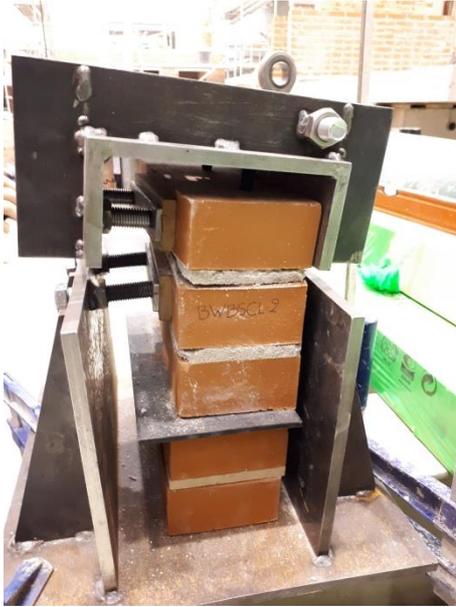
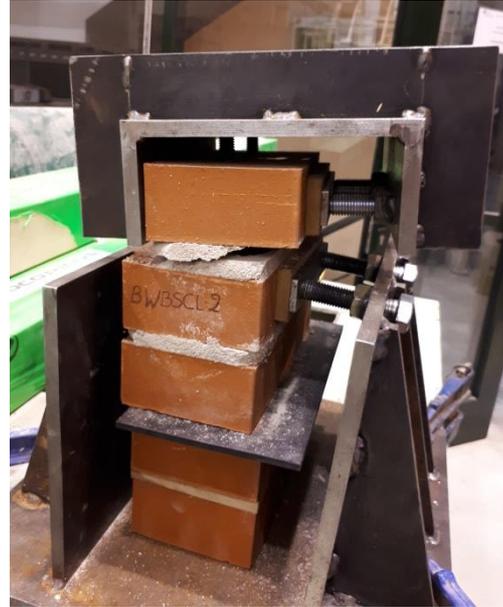
Failure of second joint

Figure 8.116 Measure of the weight of the top unit and adherent mortar.

Figure 8.81 present triplets during the bond wrench test after break the first and second bed joint.

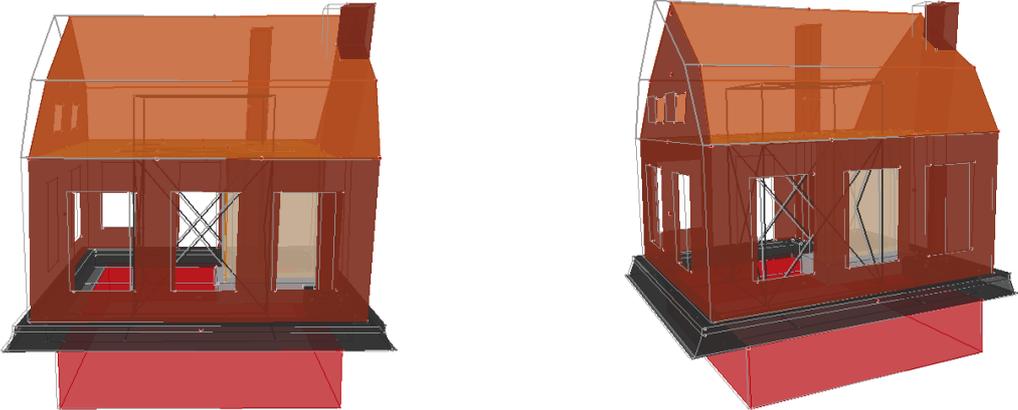
Mode 1: 6.24 Hz

Mode	FDD Frequency [Hz]	EFDD Frequency [Hz]	Damping [%]
1	6.24	6.24	4.68
2	14.16	14.20	2.17
3	16.44	16.49	1.89
4	20.24	20.19	1.31
5	22.83	22.82	1.27
6	26.79	26.71	1.15
7	28.31	28.22	0.59
8	30.14	30.09	0.23
9	32.88	32.66	0.56
10	35.46	35.60	0.49

EFDD dynamic identification (CHAR#6)

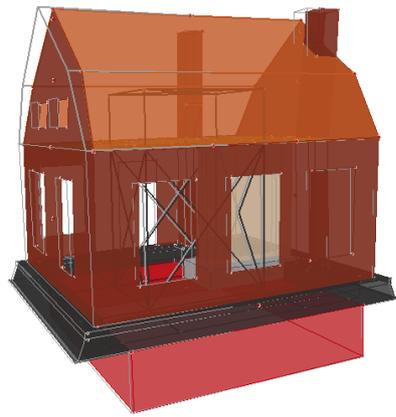
Mode 1: 6.33 Hz

Mode	FDD Frequency [Hz]	EFDD Frequency [Hz]	Damping [%]
1	6.39	6.33	4.04
2	14.16	14.20	2.16
3	16.13	16.19	1.96
4	19.33	19.28	1.09
5	22.83	22.78	1.08
6	26.48	26.46	0.98
7	28.31	28.28	0.44
8	30.14	30.18	0.87
9	32.88	32.70	0.55
10	35.01	34.98	0.17

EFDD dynamic identification (CHAR#7)

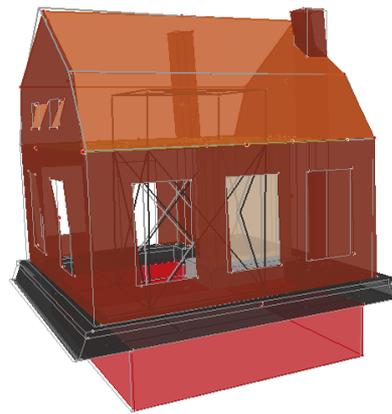
Mode 1: 5.20 Hz

Mode	FDD Frequency [Hz]	EFDD Frequency [Hz]	Damping [%]
1	5.33	5.20	4.42
2	9.59	9.51	2.64
3	14.92	15.14	1.22
4	18.11	18.20	1.24
5	22.22	22.19	0.18
6	24.66	24.65	0.88
7	28.31	28.24	0.41
8	29.53	29.21	0.63
9	32.12	32.01	0.51
10	34.25	34.31	0.59

EFDD dynamic identification (CHAR#8)

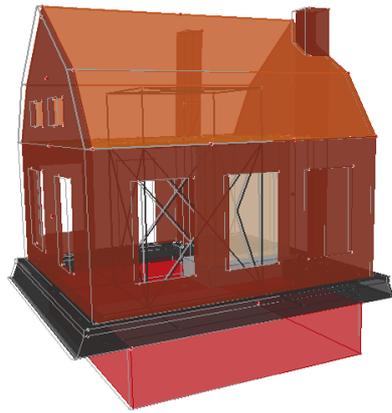
Mode 1: 3.99 Hz

Mode	FDD Frequency [Hz]	EFDD Frequency [Hz]	Damping [%]
1	4.11	3.99	3.44
2	9.59	9.57	3.11
3	14.31	14.36	0.59
4	17.66	17.68	1.65
5	22.07	22.09	0.49
6	23.44	23.37	0.51
7	28.01	28.11	0.70
8	30.14	30.07	0.52
9	32.88	32.69	0.55
10	33.94	33.82	0.72

EFDD dynamic identification (CHAR#9)

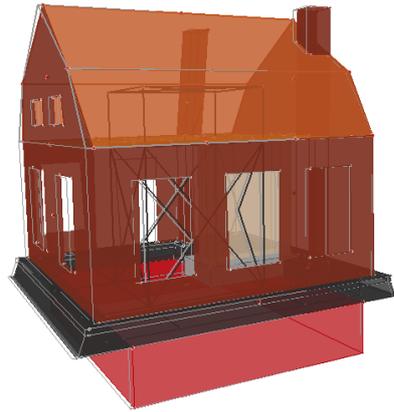
Mode 1: 3.58 Hz

Mode	FDD Frequency [Hz]	EFDD Frequency [Hz]	Damping [%]
1	3.65	3.58	2.41
2	9.59	9.56	3.20
3	13.70	13.83	1.62
4	17.20	17.20	1.46
5	21.77	21.61	0.80
6	23.14	23.06	0.36
7	28.16	28.16	0.60
8	30.14	30.15	9.06
9	32.88	32.73	0.62
10	34.40	34.171	0.52

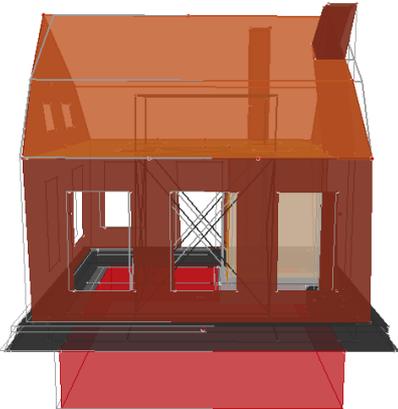
Mode 2: 7.66 Hz

EFDD dynamic identification (CHAR#11)

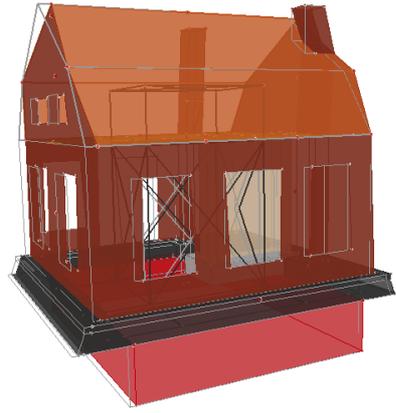
Mode 1: 3.18 Hz

Mode	FDD Frequency [Hz]	EFDD Frequency [Hz]	Damping [%]
1	3.35	3.18	5.44
2	7.35	7.91	1.68
3	9.59	9.55	3.14
4	12.33	12.39	1.44
5	14.61	14.67	1.80
6	17.05	17.02	0.76
7	21.92	21.87	0.23
8	23.29	23.26	0.68
9	28.01	27.98	0.81
10	30.14	30.12	0.63
11	32.12	32.08	0.66

EFDD dynamic identification (CHAR#12)

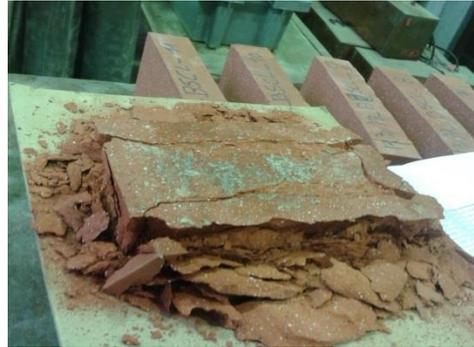
BSCL_2

Failure mechanisms of solid clay bricks for compressive strength tests:

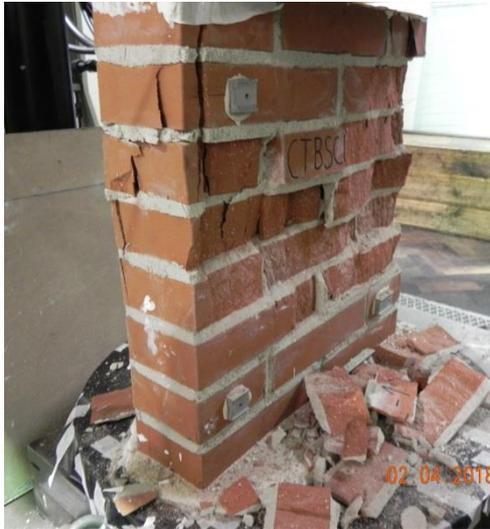
Walleto CTBSCL_1S – front side

Failure mechanisms of triplets for shear strength tests:

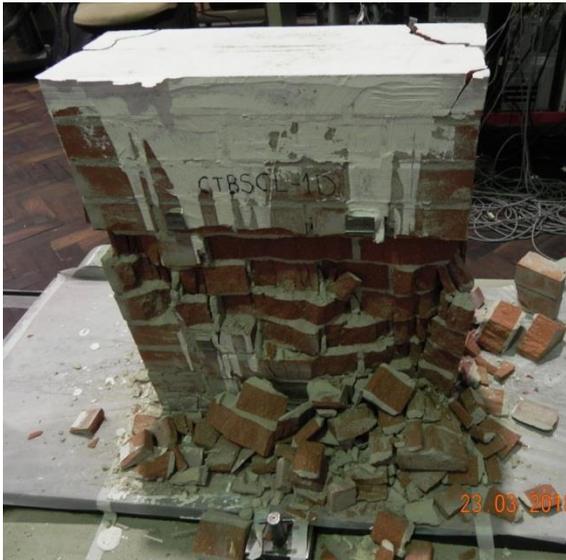
Wallette CTBSCL_1D – front side

Failure mechanisms of double wallettes for compressive strength tests:

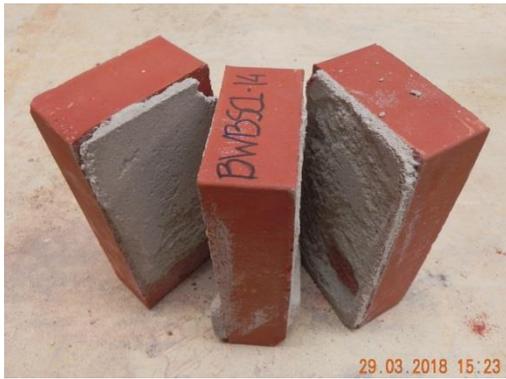
Triplet BWBSCL_14

Failure mechanisms of triplets for bond wrench tests after 6 weeks:

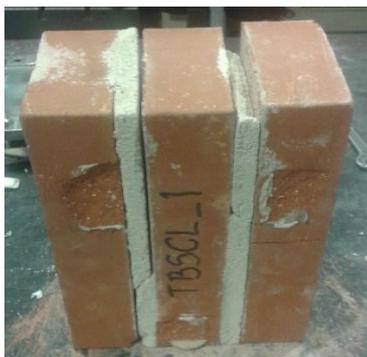
Triplet TBSCl_1

Failure mechanisms of triplets for shear tests:
