**TNO report****TNO 2016 R11323/A****Monitoring Network Building Vibrations -  
Analysis Earthquakes in 2014 and 2015****Technical Sciences**Van Mourik Broekmanweg 6  
2628 XE Delft  
P.O. Box 49  
2600 AA Delft  
The Netherlands[www.tno.nl](http://www.tno.nl)T +31 88 866 30 00  
F +31 88 866 30 10

Date	12 December 2016
Author(s)	ir. H. Borsje ir. J.P. Pruiksma ir. S.A.J. de Richemont
Copy no	0100300465
No. of copies	
Number of pages	48 (incl. appendices)
Number of appendices	4
Sponsor	NAM PO Box 28000 9400 HH Assen
Project name	Earthquakes 2014-2015
Project number	060.16792

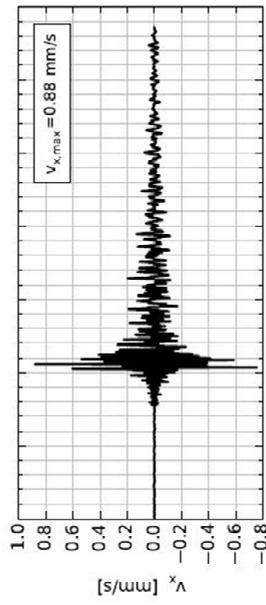
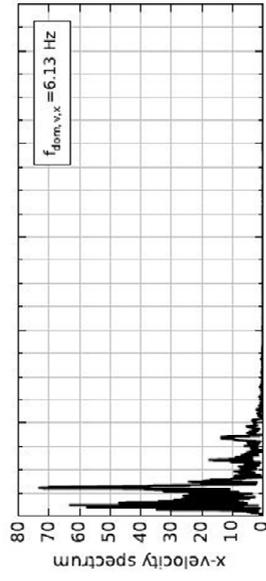
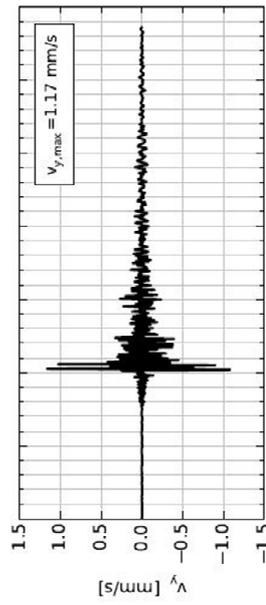
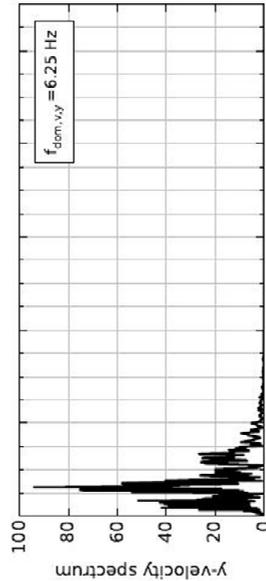
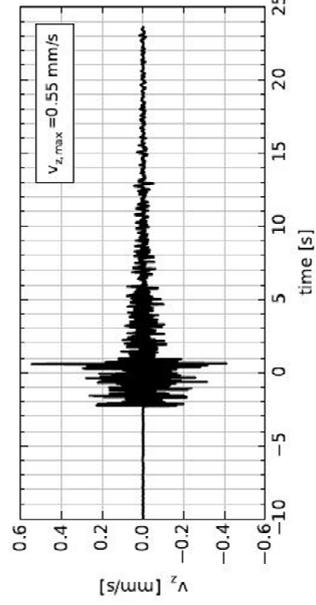
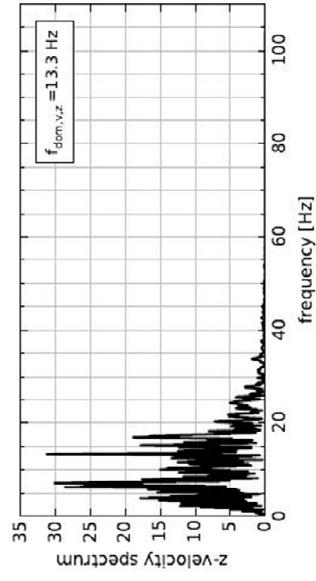
Event Time (UTC): Jan 06 2015 06:55:32.399, TNO ID=:  $|v(t)|_{\max} = 1.4 \text{ mm/s}$
