A Database of Damaging Earthquakes of Moment Magnitude from 4.0 to 5.5

**Cecilia Inés Nievas, Helen Crowley, Michail Ntinalexis & Julian J
Bommer**

Datum June 2016

A report to NAM

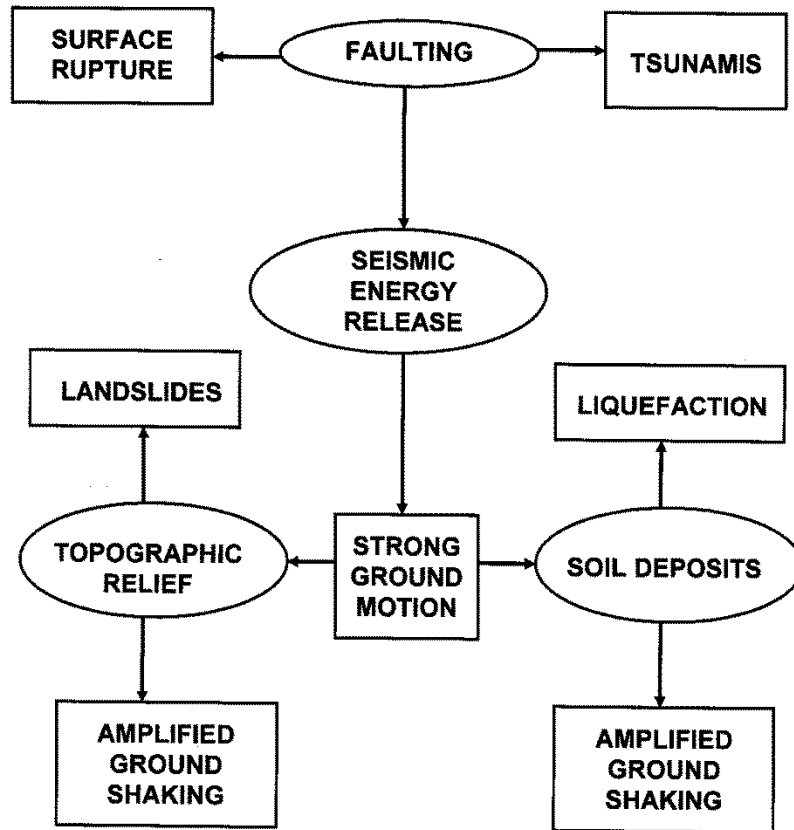
Figure 2.2. Potentially damaging earthquake effects (rectangles) associated with earthquake processes (ellipses) (Bommer & Boore, 2004)

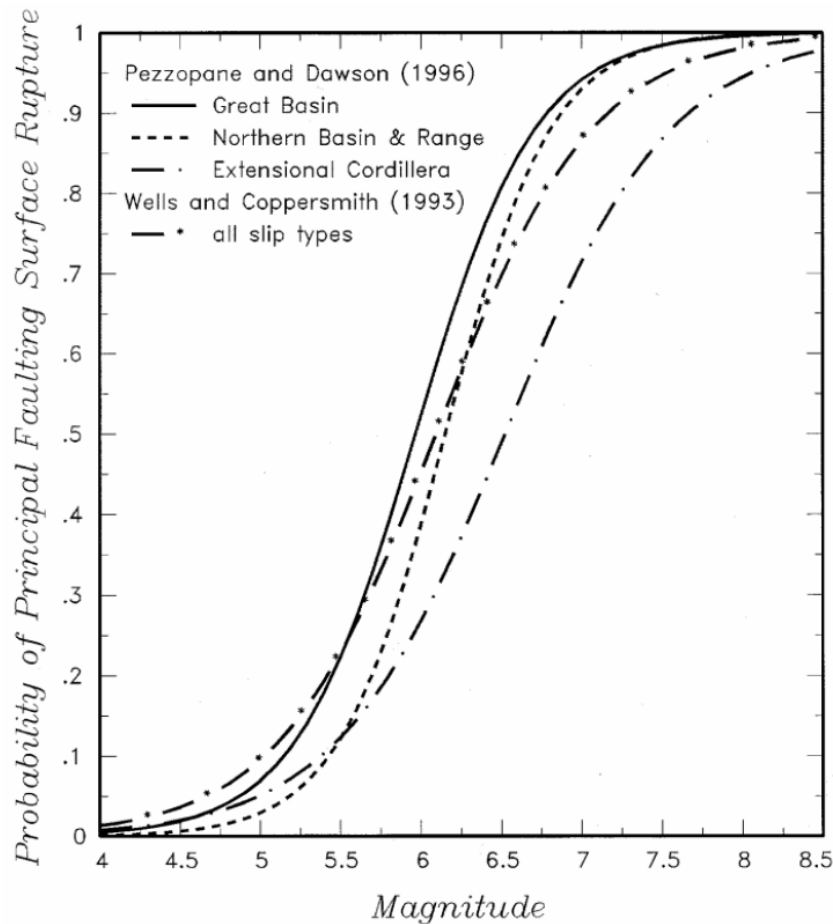
Figure 2.3. Probabilities of surface rupture as a function of earthquake magnitude (Youngs *et al.*, 2003)

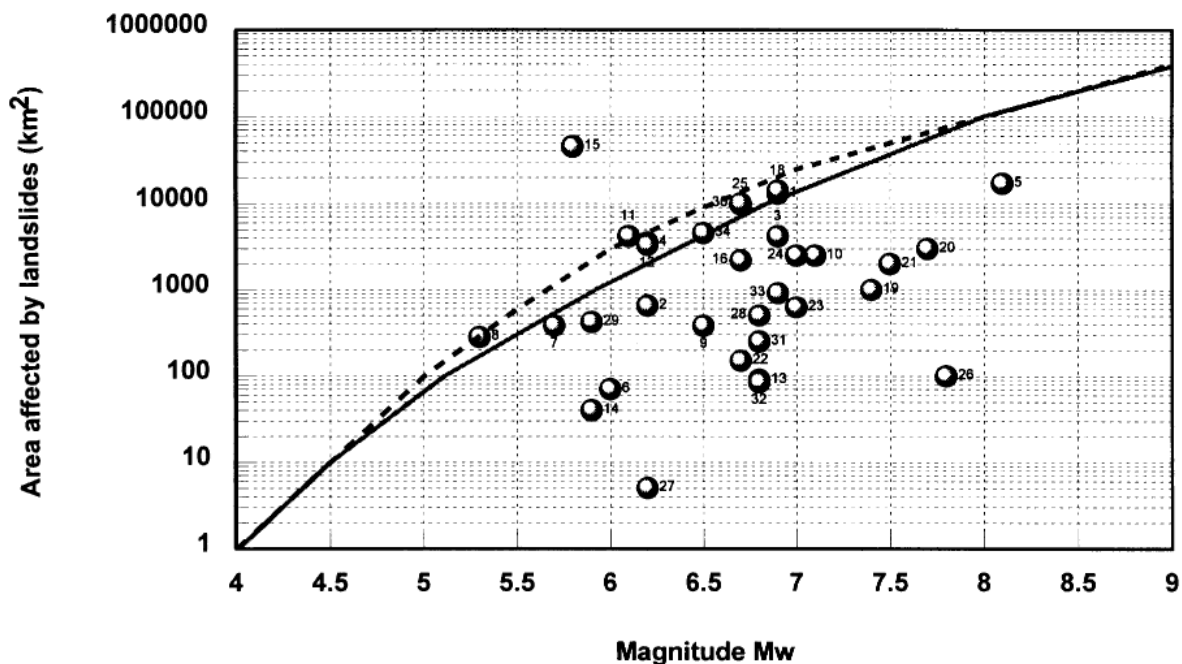
Figure 2.4. Areas affected by landsliding as a function of earthquake magnitude from the study of Rodriguez *et al.* (1999)

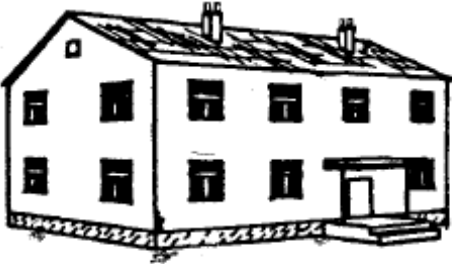
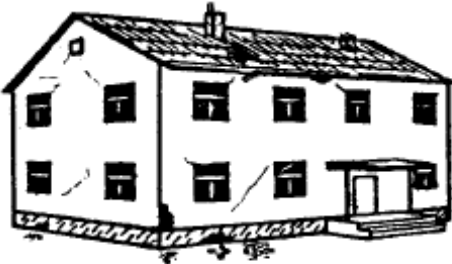
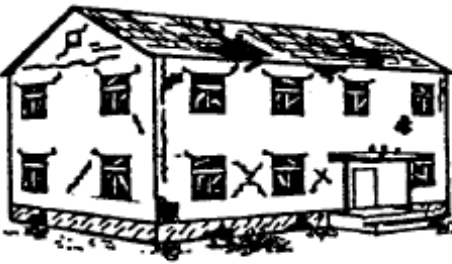
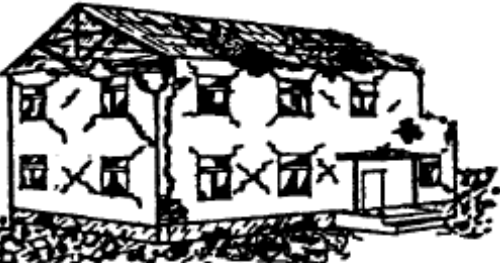
Figure 2.6. Definition of EMS-98 damage grades for masonry buildings, from Grünthal (1998).

<p>Grade 1: Negligible to slight damage (no structural damage, slight non-structural damage) Hair-line cracks in very few walls. Fall of small pieces of plaster only. Fall of loose stones from upper parts of buildings in very few cases.</p>

<p>Grade 2: Moderate damage (slight structural damage, moderate non-structural damage) Cracks in many walls. Fall of fairly large pieces of plaster. Partial collapse of chimneys.</p>

<p>Grade 3: Substantial to heavy damage (moderate structural damage, heavy non-structural damage) Large and extensive cracks in most walls. Roof tiles detach. Chimneys fracture at the roof line; failure of individual non-structural elements (partitions, gable walls).</p>

<p>Grade 4: Very heavy damage (heavy structural damage, very heavy non-structural damage) Serious failure of walls; partial structural failure of roofs and floors.</p>

<p>Grade 5: Destruction (very heavy structural damage) Total or near total collapse.</p>

The European Macroseismic Scale (EMS-98; Grünthal, 1998) classifies damage into five grades, defined separately for masonry and reinforced concrete buildings. The following tables (in Figures 2.5-2.7), extracted from Grünthal (1998), define said damage grades, and the intended definitions of the qualitative expressions "few", "many" and "most".

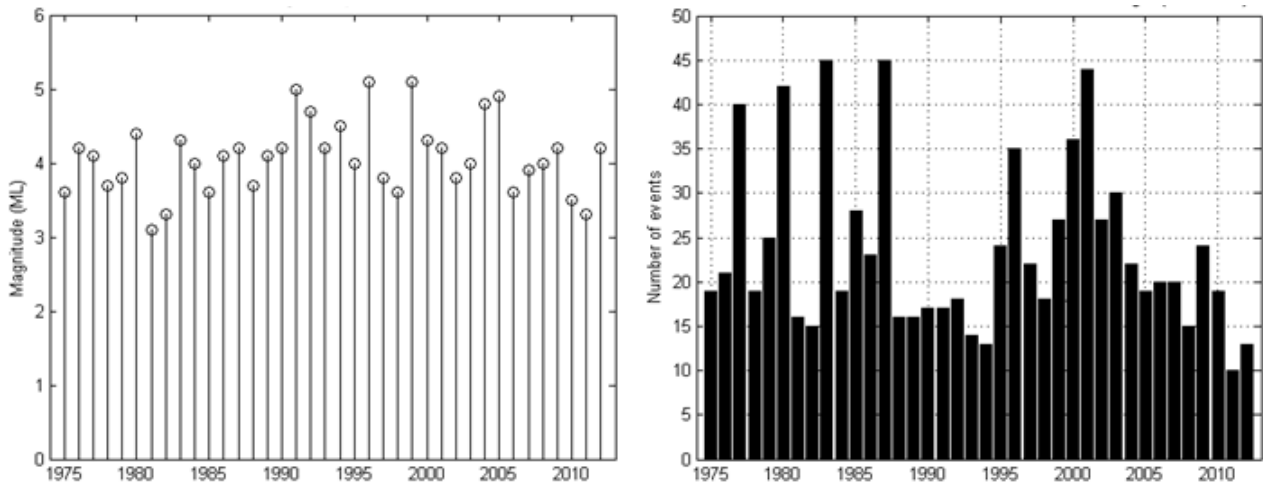
Figure A2.1.4. Magnitudes of the strongest earthquakes from 1975 to 2012 (left), and number of earthquakes with a magnitude M_L of 2.5 or greater from 1975 to 2012 (right) (Swiss Seismological Service, 2015).

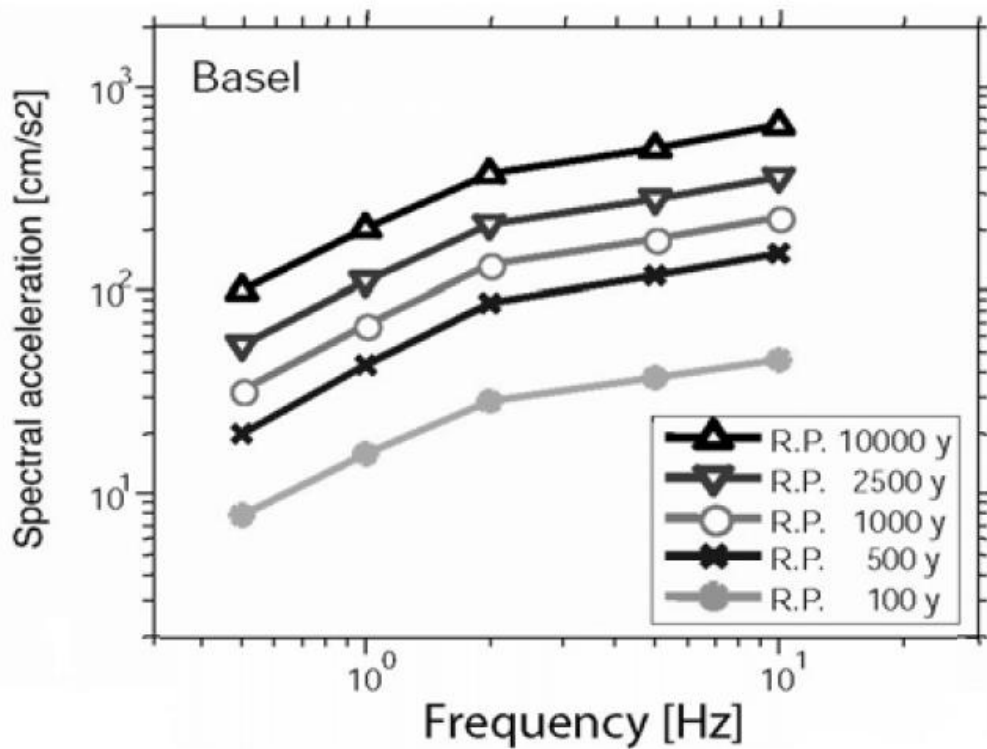
Figure A2.1.6. 5% damped uniform hazard spectra for Basel for different return periods, from Giardini *et al.* (2004).

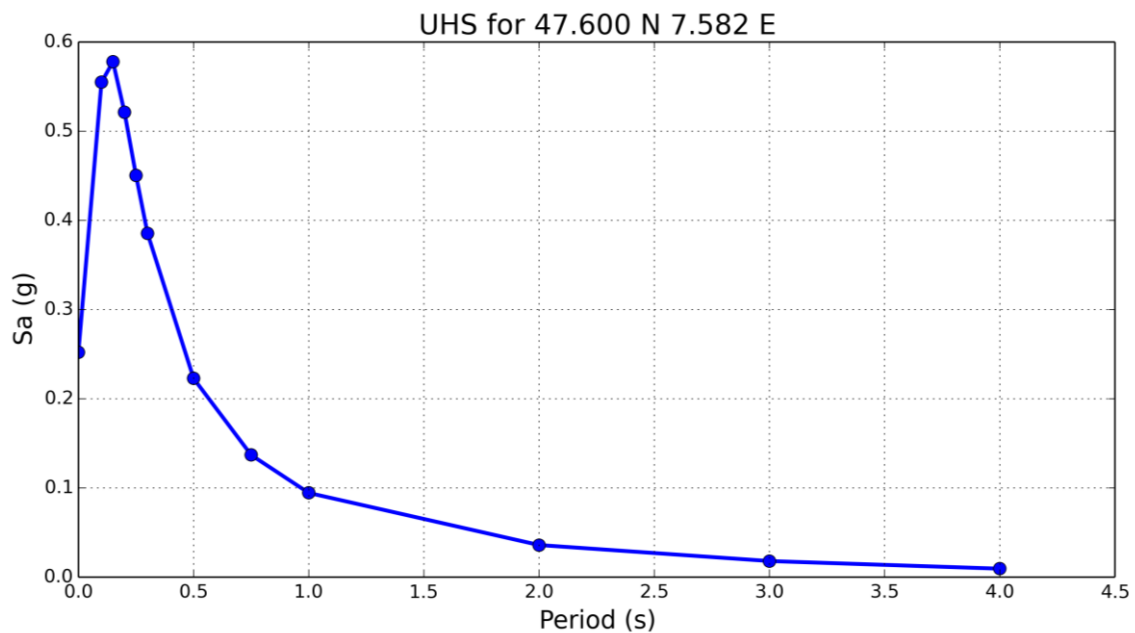
Figure A2.1.7. Uniform Hazard Spectrum for point 47.600° N 7.582° E (closest available to the city of Basel) according to SHARE. Values correspond to PGA and spectral acceleration in rock with a 10% probability of exceedance in 50 years (mean).

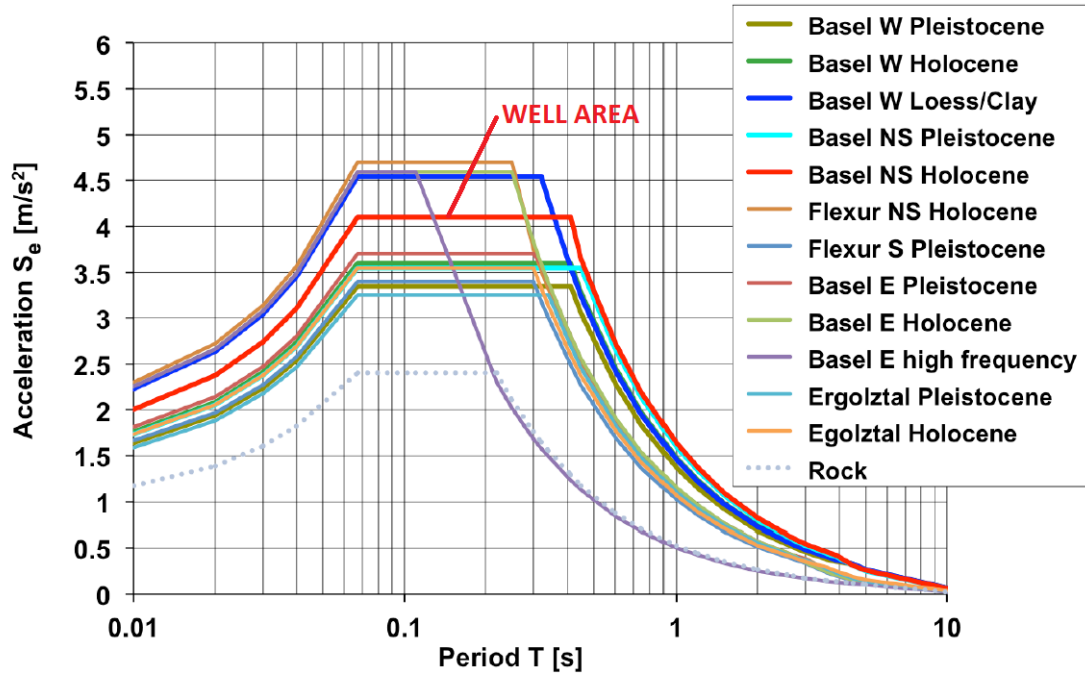
Figure A2.3.16. 5%-damped design elastic pseudo-acceleration response spectra for the microzones of the Basel area. (Wenk & Fäh, 2012).

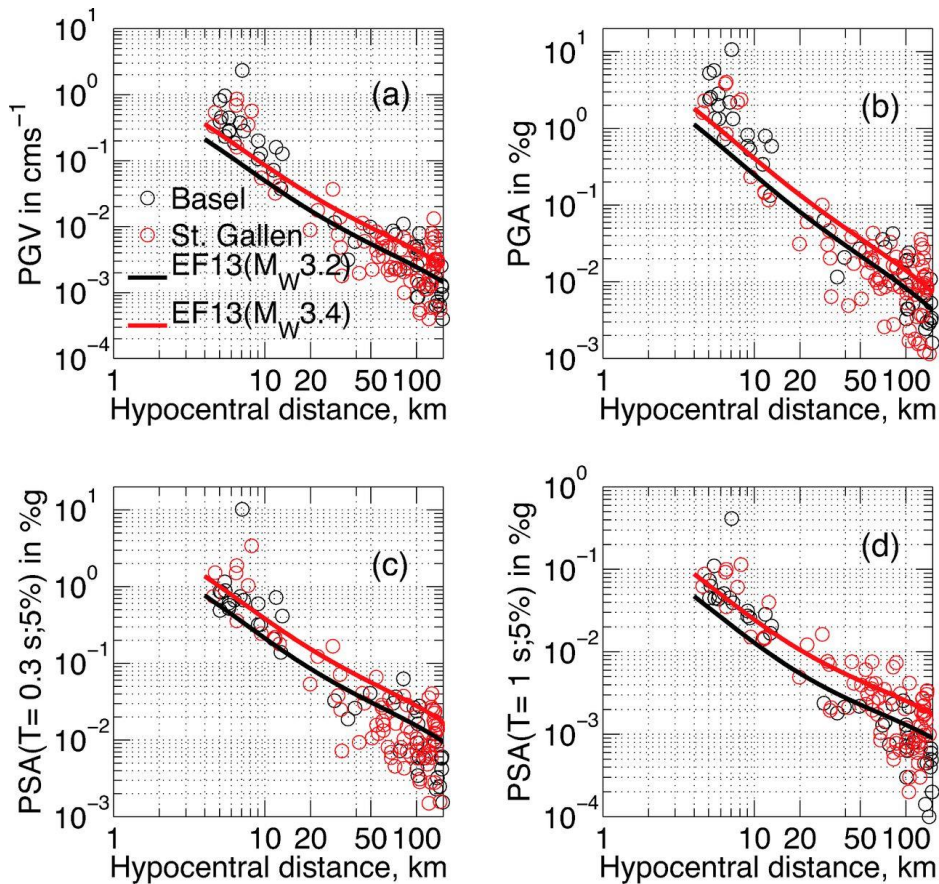
Figure A2.1.20. Attenuation of PGV (a), PGA (b) and 5%-damped pseudo-spectral acceleration at $T = 0.3$ s (c) and $T = 1$ s (d), as a function of hypocentral distance. Black circles show the geometric mean of the two horizontal components for the Basel 2006 main shock. The thick black line labeled EF13 is the median attenuation curve for events occurring in the Swiss foreland (Edwards & Fäh, 2013; Cauzzi *et al.*, 2015). Ignore red dots and red lines. (Edwards *et al.*, 2015).

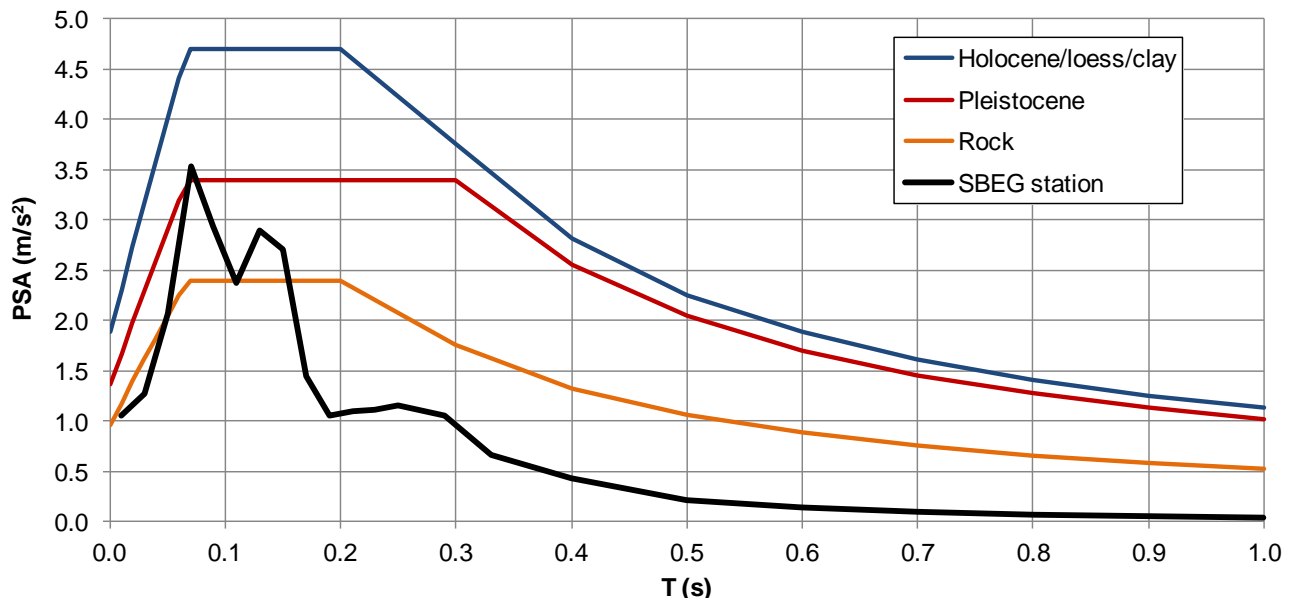
Figure A2.1.22. 5%-damped pseudo-acceleration (PSA) spectra (geometric mean of the horizontal components) observed at station SBEG compared against the design spectra for the three soil types that can be found in the area close to the station. Data for station SBEG: Edwards *et al.* (2015)

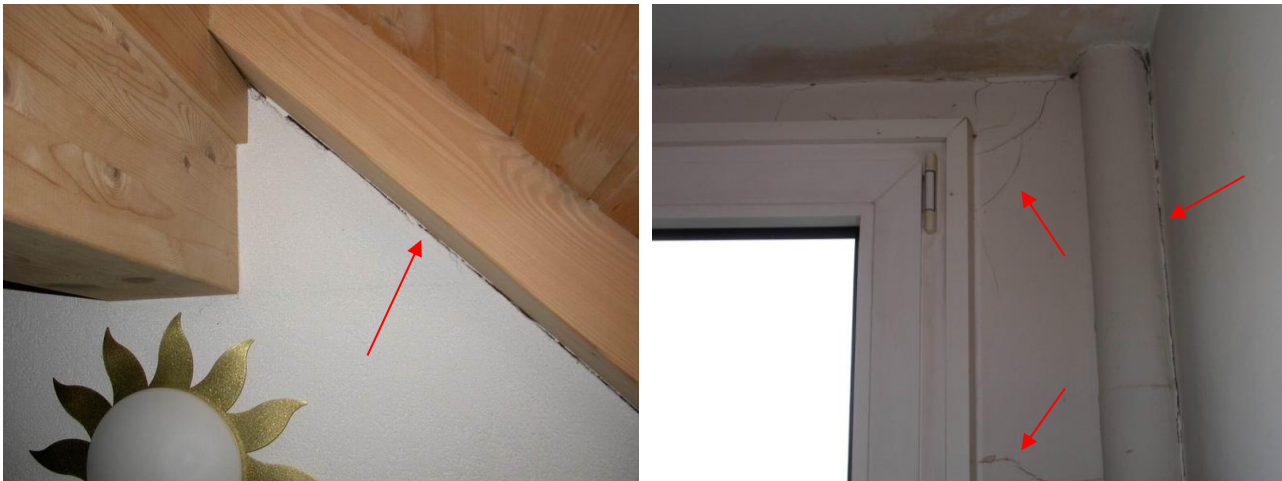
Figure A2.1.32. Crack in connection between wall and timber roof (left). Cracks in corner of a window (right).

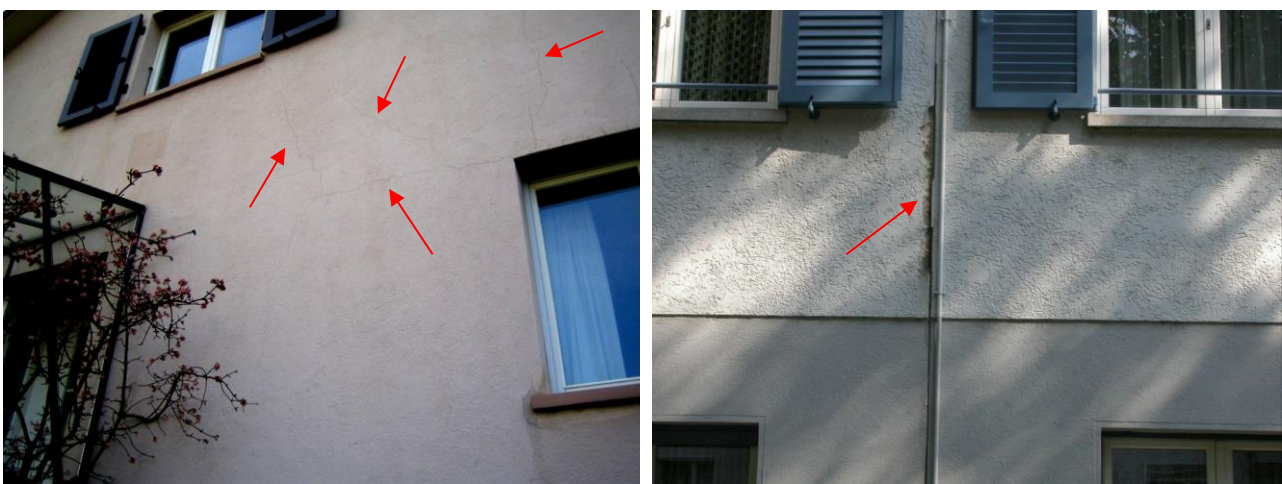
Figure A2.1.33. Hairline cracks in plaster (left). Minor plaster spalling (right).

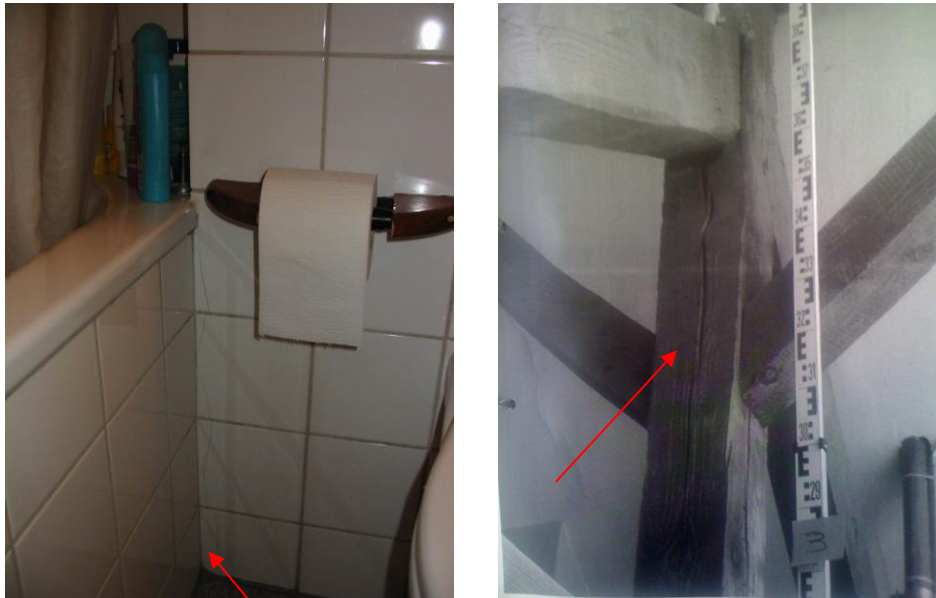
Figure A2.1.34. Crack in intersection of two perpendicular masonry elements (left). Crack parallel to the orientation of fibres in a timber element (right).

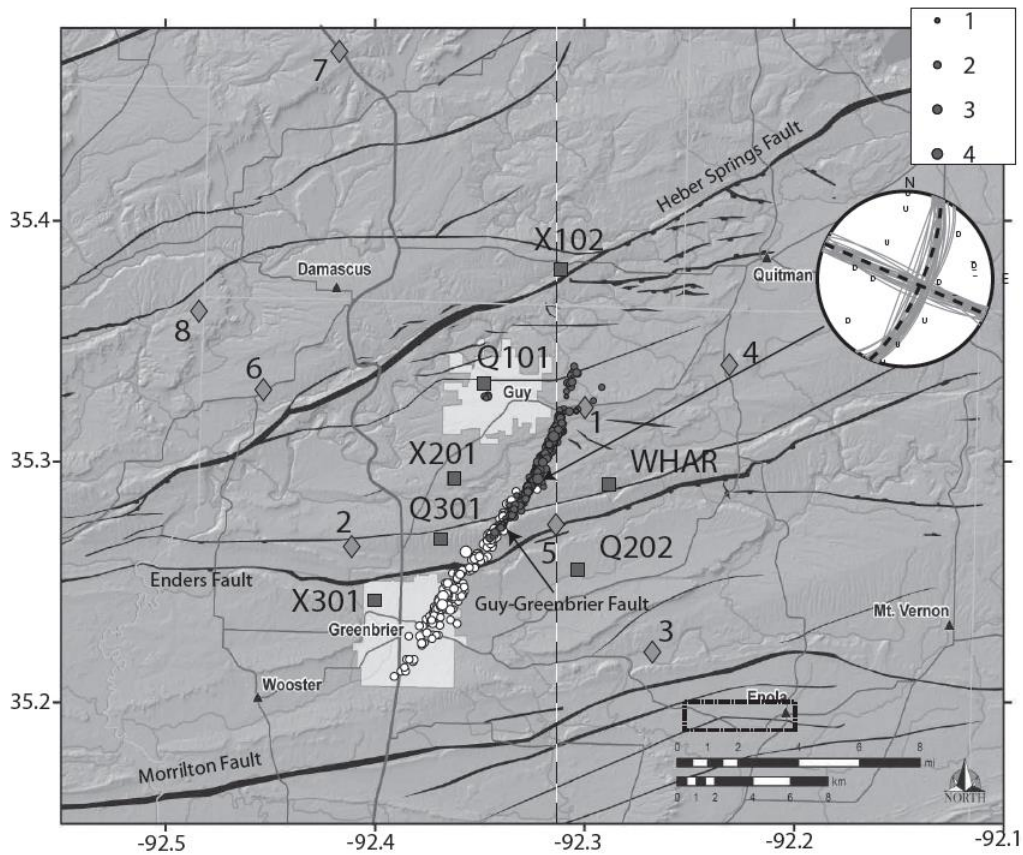
Figure A2.2.2. Known faults around the epicentral area and the newly-identified Guy-Greenbrier fault (Horton, 2012). Circles indicate the epicentres of events that occurred between 1st October 2010 and 15th February 2011 (dark gray filled) and between 16th February 2011 and 8th March 2011 (white filled). Numbered diamonds indicate waste disposal wells. First-motion focal mechanism for M4.0 event on 11th October 2010 shown. From Horton (2012).

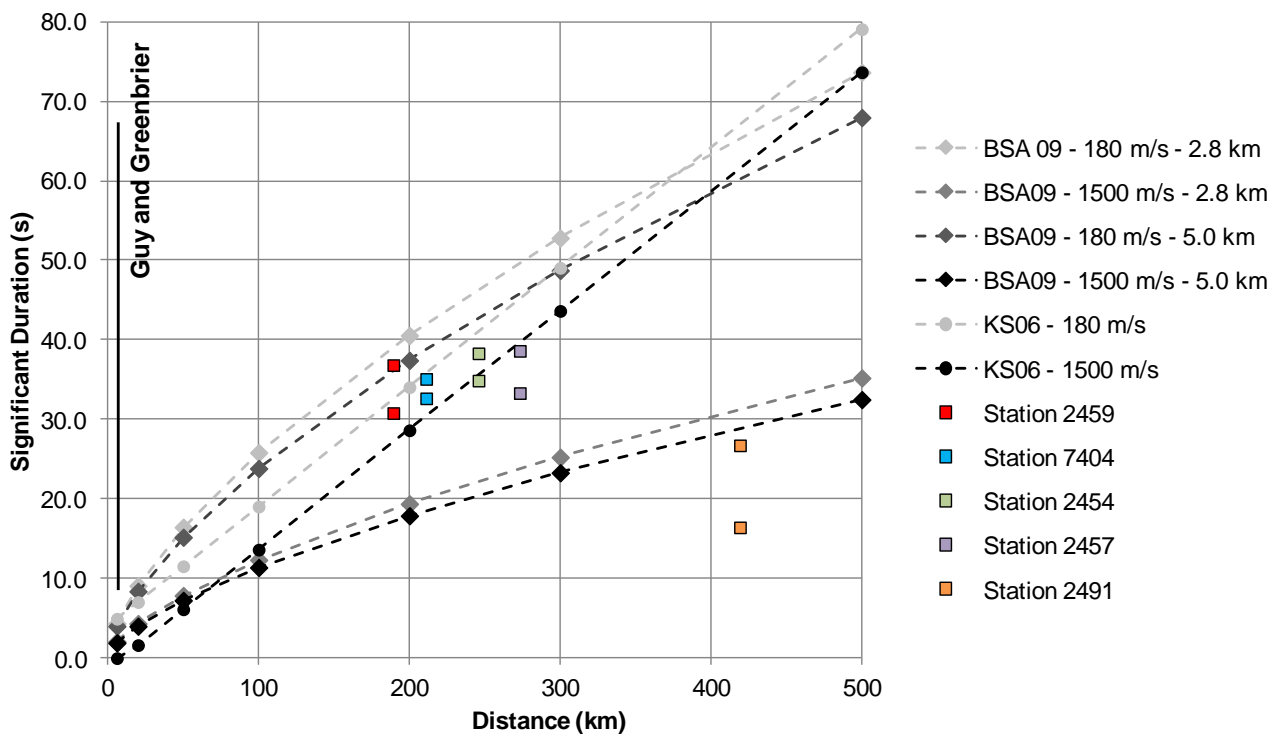
Figure A2.2.14. Estimation of the significant duration of the main shock, using prediction equations by Bommer *et al.* (2009, BSA) and Kempton & Stewart (2006, KS), and significant duration calculated for the two horizontal components of the five available accelerograms.

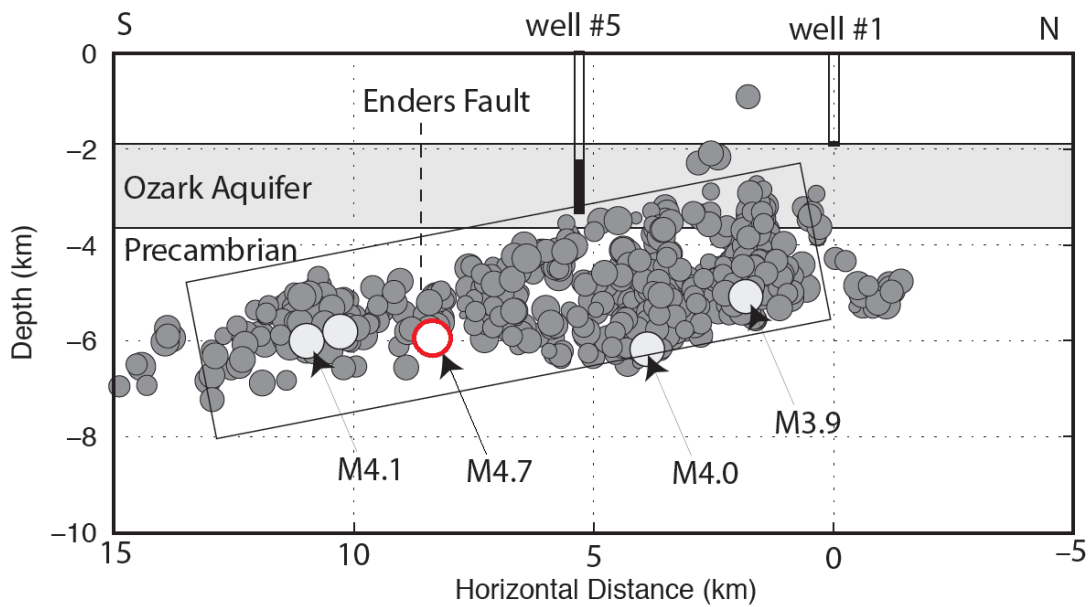
Figure A2.2.15. Cross section along the Guy-Greenbrier fault, showing the hypocentres of the **M4.7** main shock and three foreshocks (Horton, 2012).

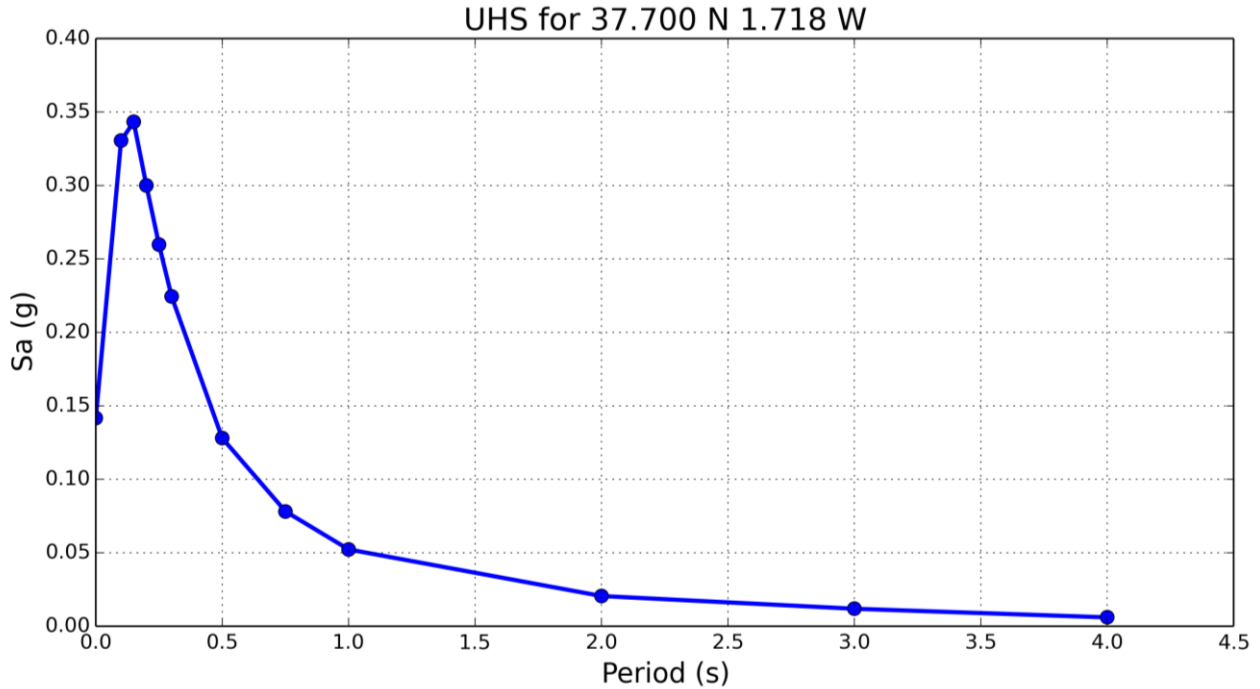
Figure A2.3.5. Uniform Hazard Spectrum for point 37.700° N 1.718° W (closest available to the city of Lorca) according to SHARE. Values correspond to PGA and spectral acceleration in rock with a 10% probability of exceedance in 50 years (mean).

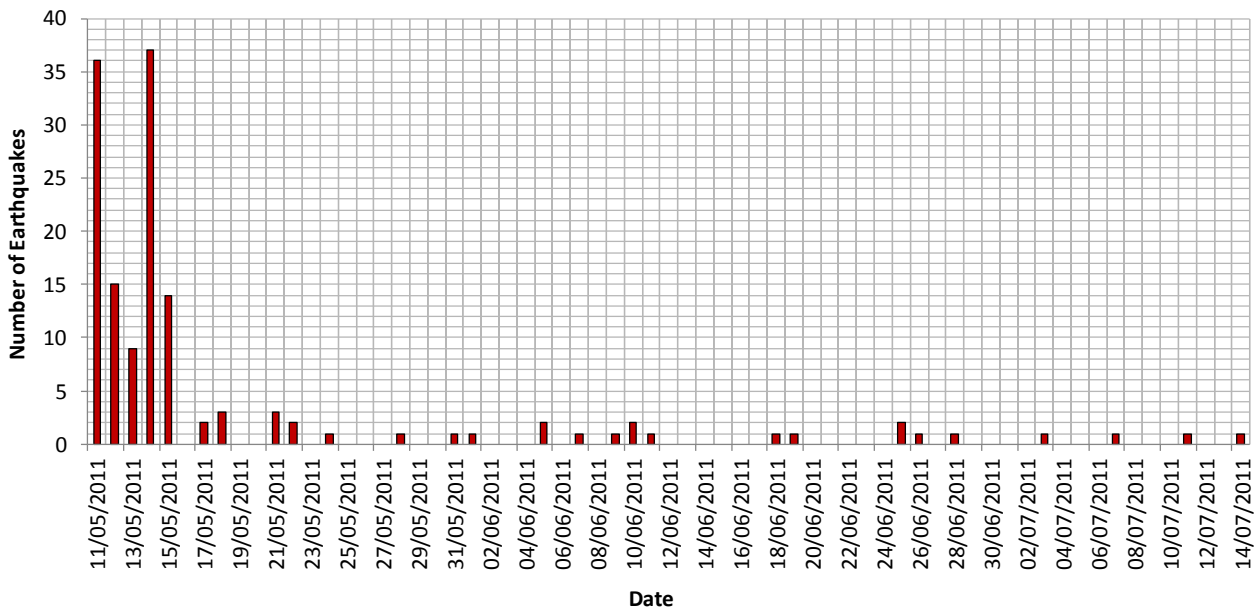
Figure A2.3.8. Distribution in time of the earthquake sequence. Data from Cabañas Rodríguez *et al.* (2011).

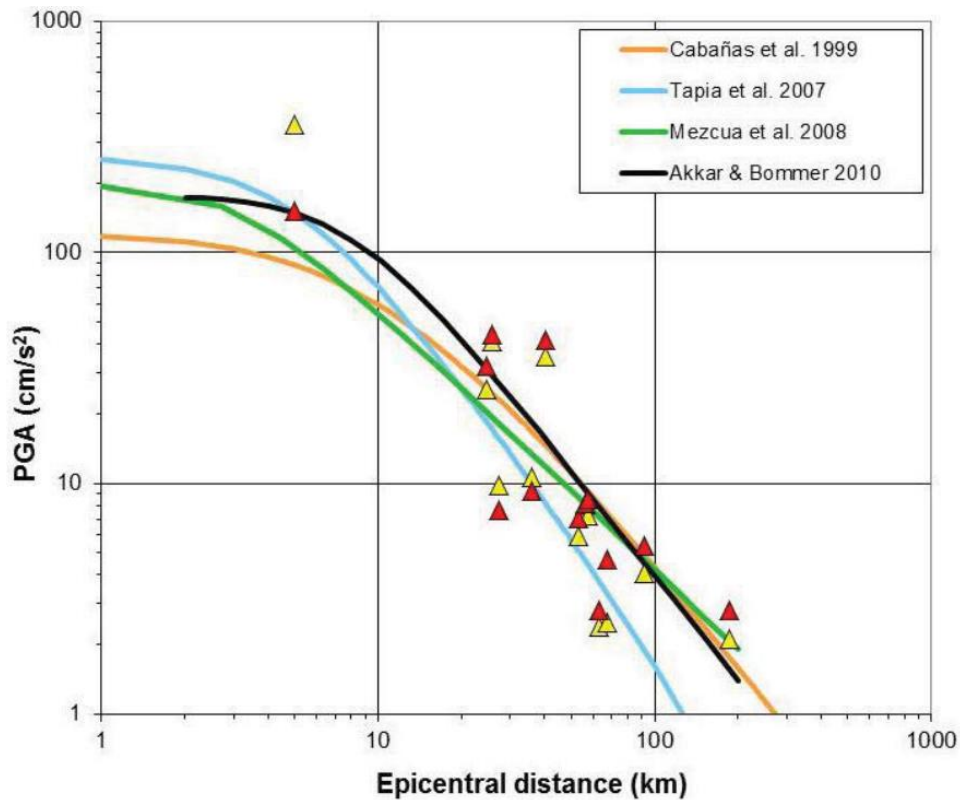
Figure A2.3.23. PGA values recorded at different stations during the main shock against estimations from ground motion prediction equations, from Belvaux *et al.* (2014).

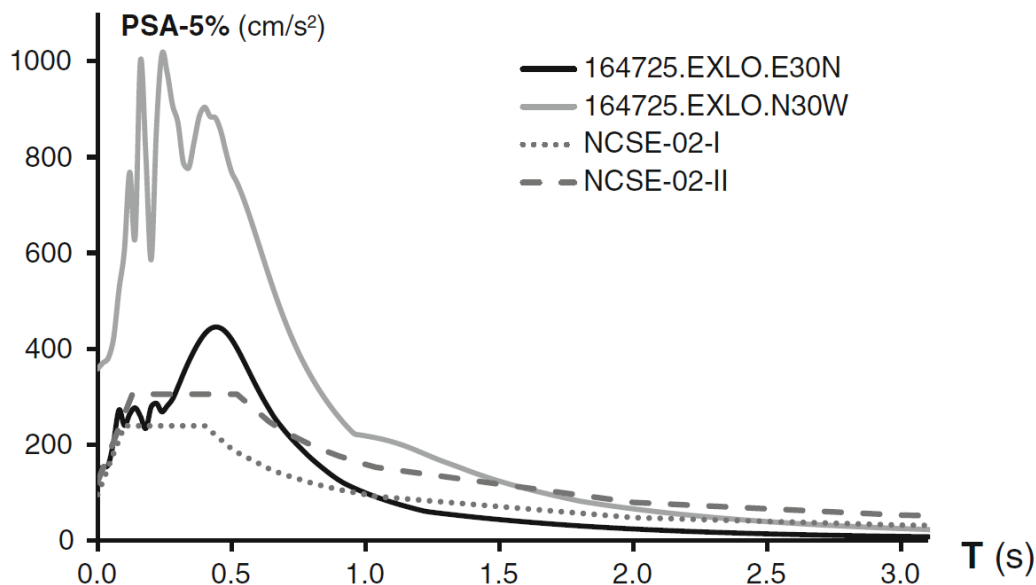
Figure A2.3.24. Pseudo-acceleration response spectra (5% critical damping) from the accelerograms recorded at the Lorca station, compared with the elastic design spectra from the NCSE-02 Spanish building code for soil types I and II (equivalent to soil classes A and B in Eurocode 8), from Cabañas *et al.* (2014).

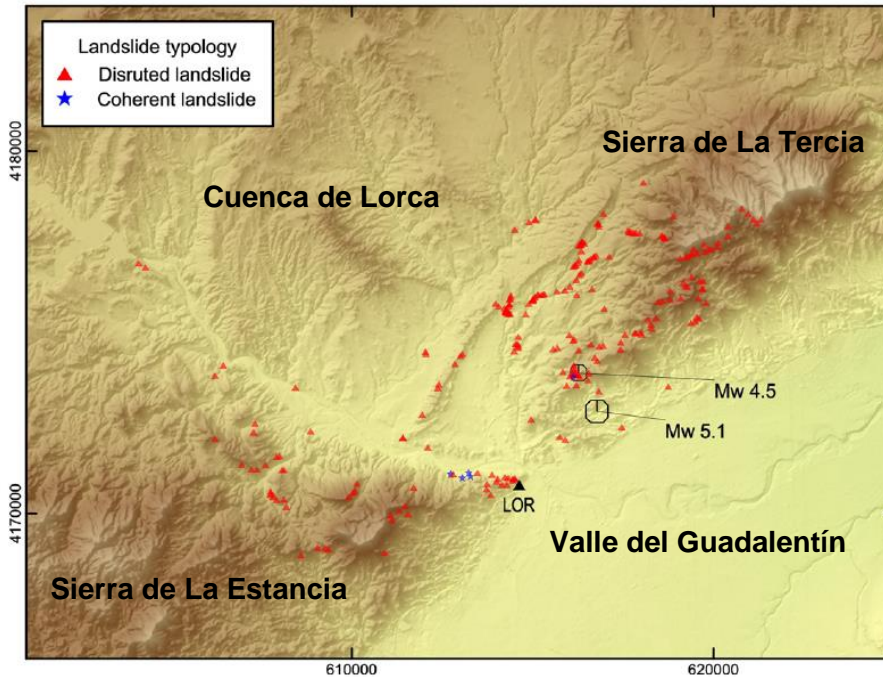
Figure A2.3.28. Landslides identified by Alfaro *et al.* (2012). "LOR" makes reference to Lorca station (Alfaro *et al.*, 2012).

Alfaro *et al.* (2012) do not report any damage to the building stock or casualties directly associated to the landslides, and only mention disruption in roads and communications between the city of Lorca and rural areas nearby. Rodríguez-Peces *et al.* (2014) and Martínez-Díaz *et al.* (2011) make reference to these disruptions as well and describe some damage in buildings and civil structures attributable to these instabilities. In particular, they mention that part of a wall enclosing the courtyard of a house was destroyed by a fallen

rock, at the easternmost point of the Lorca's castle cliff, and that the pavement of the road leading to the castle as well as that on the road to the Pantano de Puentes dam were seriously damaged by rock falls. Martínez-Díaz *et al.* (2011) believe that some of these areas might be related to instabilities prior to the 2011 earthquake, and highlight that both roads were open to traffic again ("with relative normality") between 24 and 48 hours after the main shock. However, Cabañas Rodríguez *et al.* (2011) indicate that circulation along the road to the Pantano de Puentes dam was still disrupted by July 2011.

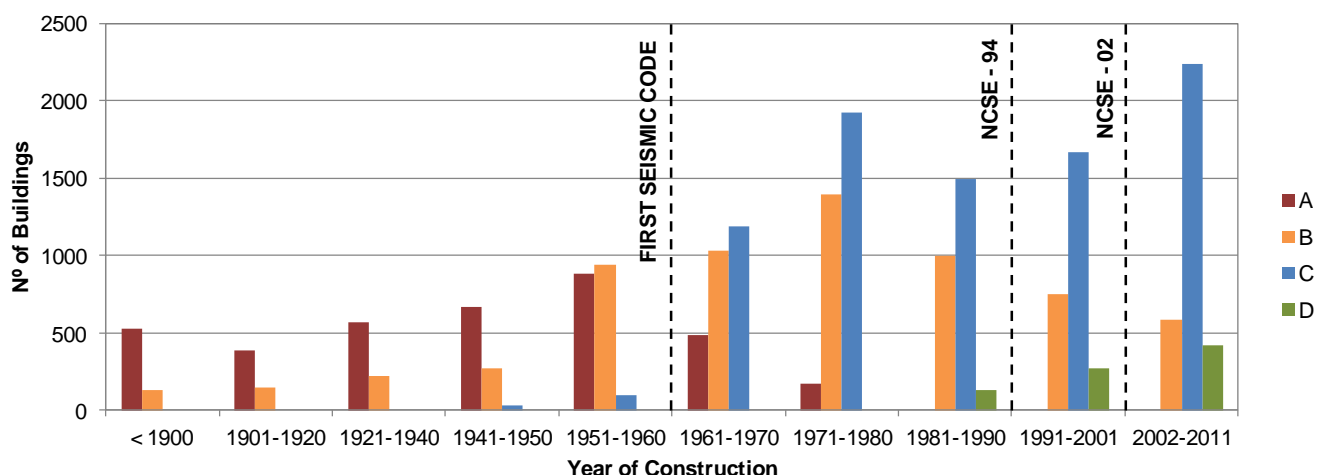
Figure A2.3.31. Number of residential buildings in the municipality of Lorca per year of construction and EMS-98 vulnerability class, estimated from the available data. Vertical dashed lines indicate the introduction of the first Spanish seismic code (1962) and the codes of 1994 and 2002.

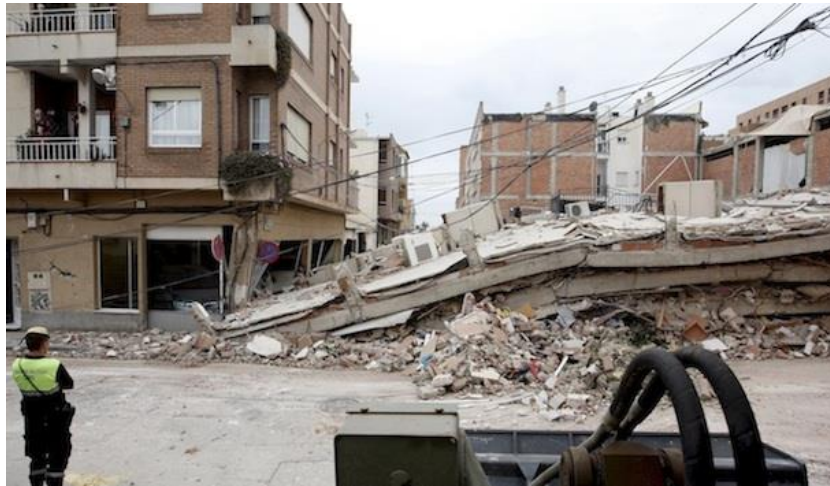
Figure A2.3.34. Building located in La Viña neighbourhood which collapsed during the main shock (Meteoweb, 2016). A street runs in between the two buildings shown.

The RC building that collapsed during the main shock was located in La Viña neighbourhood, an area that was particularly damaged, as reported in the Damage Distribution section. This building was a 10-year old, 3-storey residential structure, with a partially subterranean parking lot constructed on a slope. The collapse was due to the short column effect of the parking level columns, as it became clear from a neighbouring building with similar characteristics whose columns exhibited damage associated to this phenomenon (Cabañas Rodríguez *et al.*, 2011). While collapsing, the building across the street was hit and damaged. The figure below shows the collapsed building.

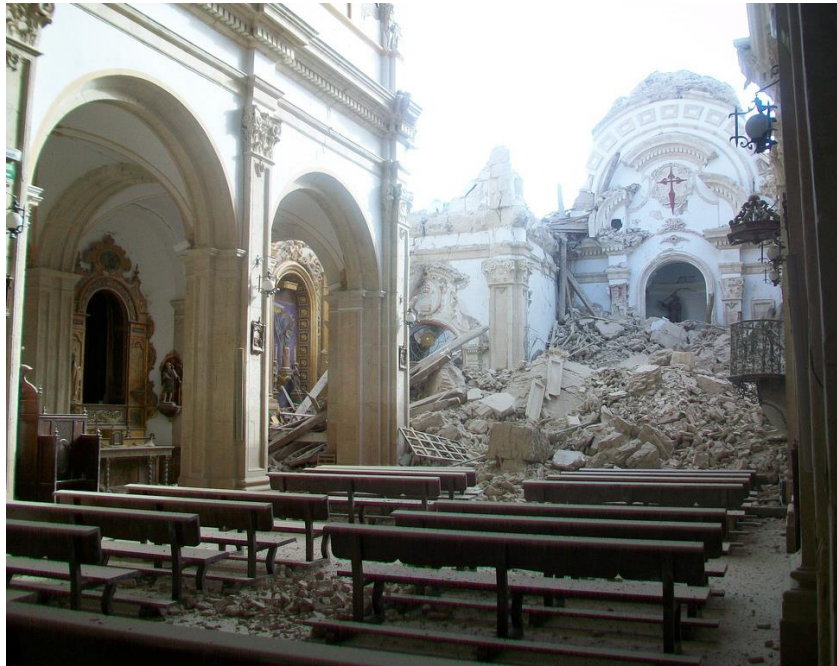
Figure A2.3.37. Collapse of the transept area of the Church of Santiago (Wikipedia).

The possible examples of damages in churches are several, but that of the Church of Santiago is of particular interest not only due to its severity but also to the fact that said building had been retrofitted in the 1960s. At that time, the dome and transept area were strengthened using reinforced concrete with the aim of providing some kind of diaphragm action (Romão *et al.*, 2013; Feriche *et al.*, 2012). During the main shock, the dome, roof and vaults collapsed, as shown in Figure A2.3.37.

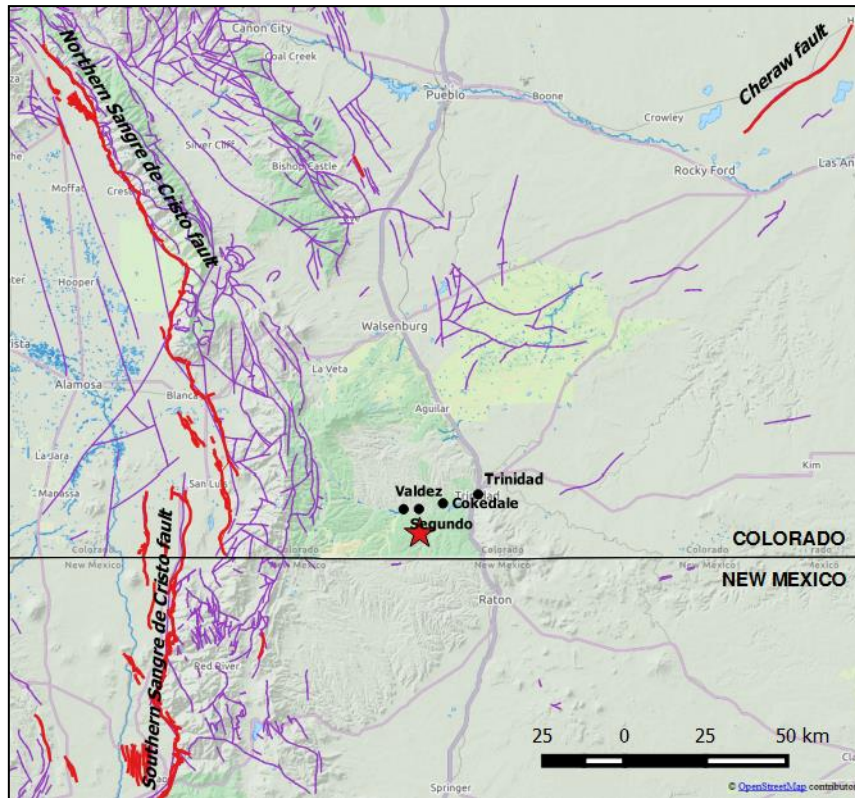
Figure A2.4.1. Quaternary faults (red) and fault traces (violet) close to the Raton Basin. The four locations marked are those at which damage was observed during the 2011 Trinidad earthquake. Faults locations from the Quaternary Fault and Fold Database of the United States (USGS) and the Mineral Resources Online Spatial Data (USGS).

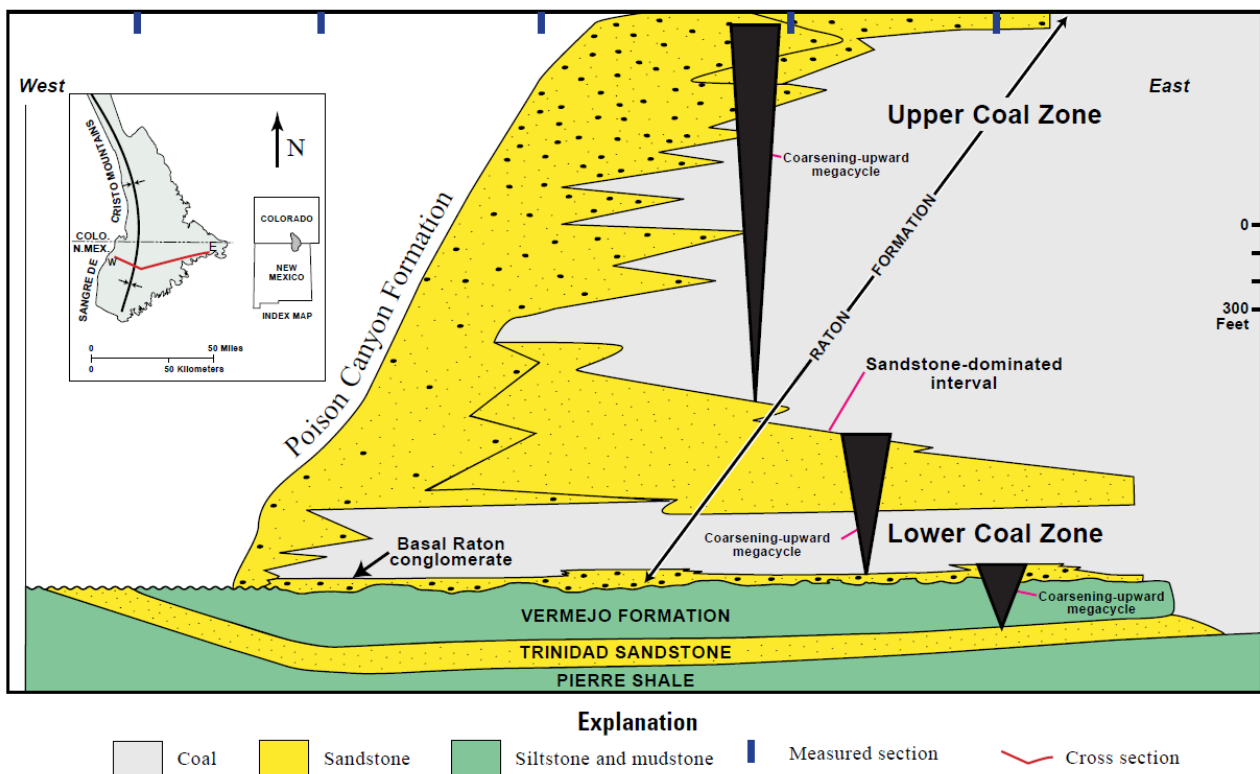
Figure A2.4.8. East-west stratigraphic cross section across the southern part of the Raton Basin. From Flores (1987) and Flores & Bader (1999), in Johnson & Finn (2001).

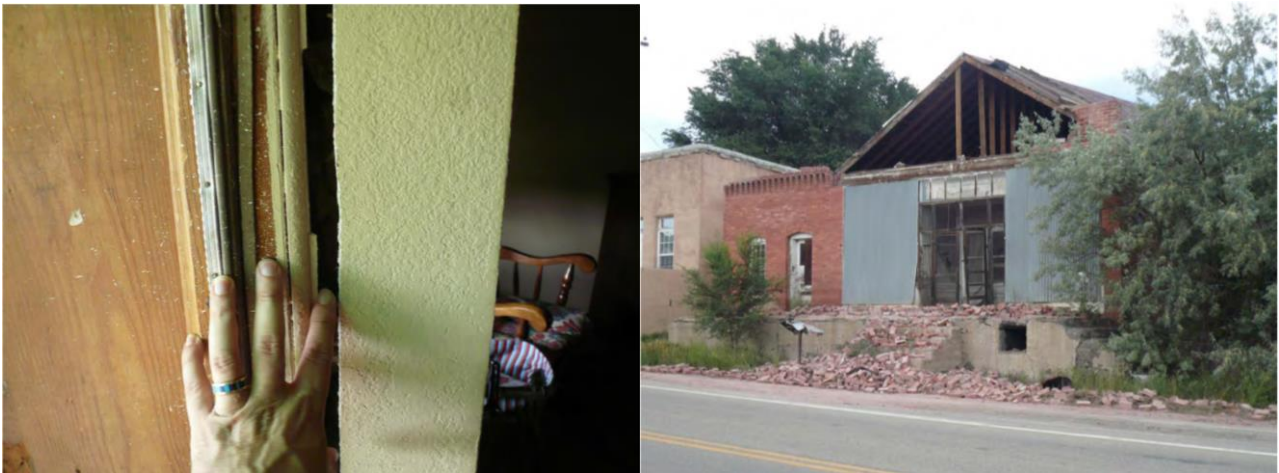
Figure A2.4.19. Damage observed at Segundo: on the left, the exterior wall pulled away approximately 2.5 cm from the interior wall; on the right, the front of this brick building collapsed (Morgan & Morgan, 2011).

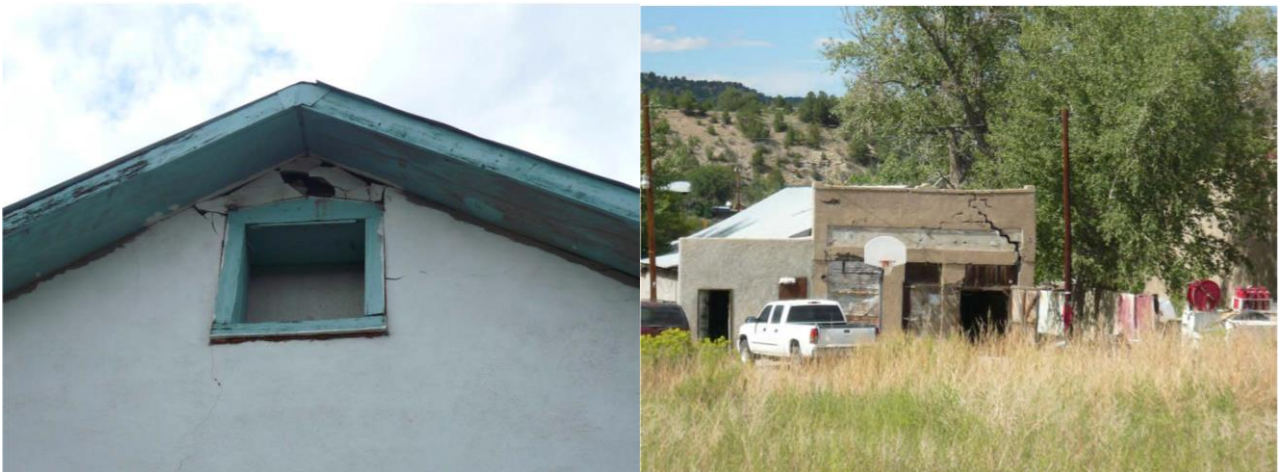
Figure A2.4.20. Major brick damage to a home in Segundo (left) and to a garage in Valdez (right) (Morgan & Morgan, 2011).

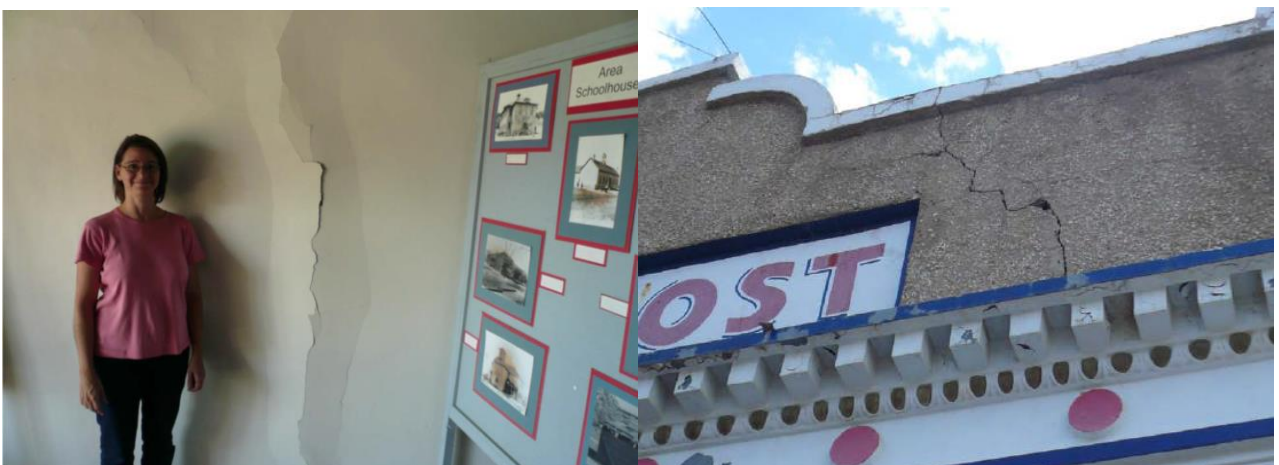
Figure A2.4.21. A 3 metres long vertical crack in the building of the Cokedale post office/city hall (left); cracked plaster on a façade in Segundo (Morgan & Morgan, 2011).

Cracked plaster was observed in all four towns mentioned, being the case of the 3 metres vertical crack at the Cokedale post office/city hall building the worst (Figure A2.4.21).
