A Database of Damaging Earthquakes of Moment Magnitude from 4.0 to 5.5

**Cecilia Inés Nievas, Helen Crowley, Michail Ntinalexis & Julian J
Bommer**

Datum June 2016

A report to NAM

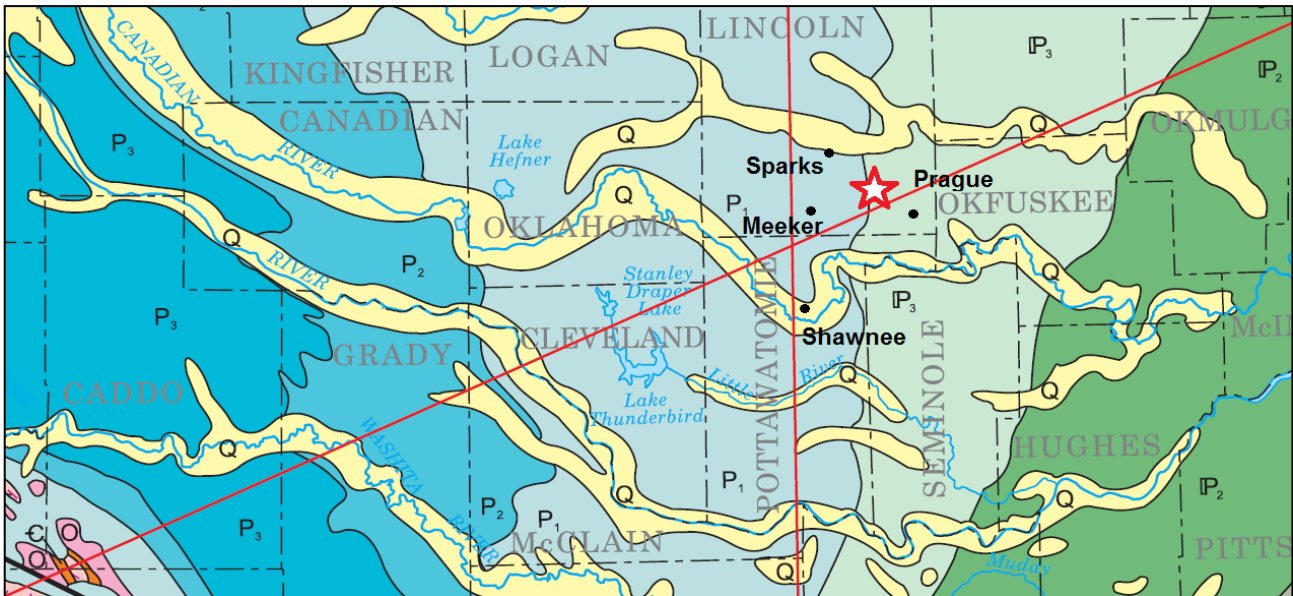
Figure A2.5.9. Geologic map of sediments and sedimentary rocks of the area affected by the 2011 Prague earthquake. Permian (P): shallow-marine, deltaic and alluvial deposits of red sandstone and shale predominate, generally between 0.3 and 2.0 km thick; subdivided into lower (P1) and upper (P2, P3 and P4) units. Pennsylvanian (IP): mostly marine shale, with interbedded sandstone, limestone, and coal, generally between 0.6 and 1.5 km thick; subdivided into lower (IP1), middle (IP2) and upper (IP3) units. Quaternary (Q): sand, silt, clay and gravel in flood plain and terrace deposits of major rivers, generally 8.0 to 30.0 m thick. Black dots indicate the locations of cities affected by the 2011 Prague earthquake, and the red star indicates the epicentre, as determined by the United States Geological Survey. From Johnson (2008).

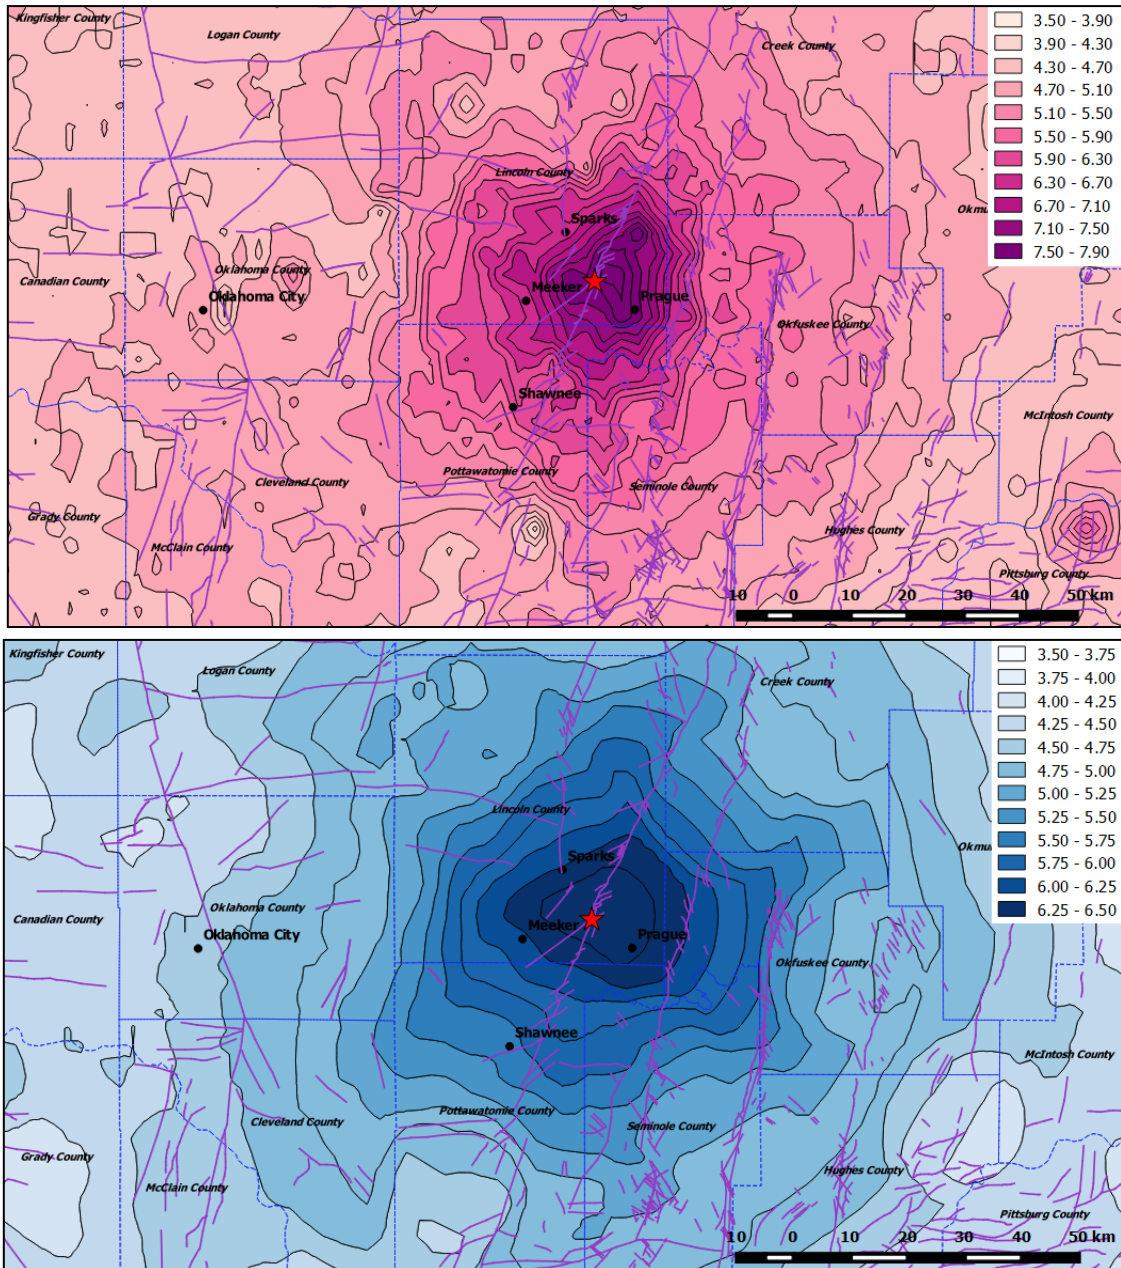
Figure A2.5.12. USGS ShakeMaps (2015) in terms of Modified Mercalli Intensities (MMI): initial automatic calculation (top), and revised calculation (bottom). The red star is the epicentre of the main shock.

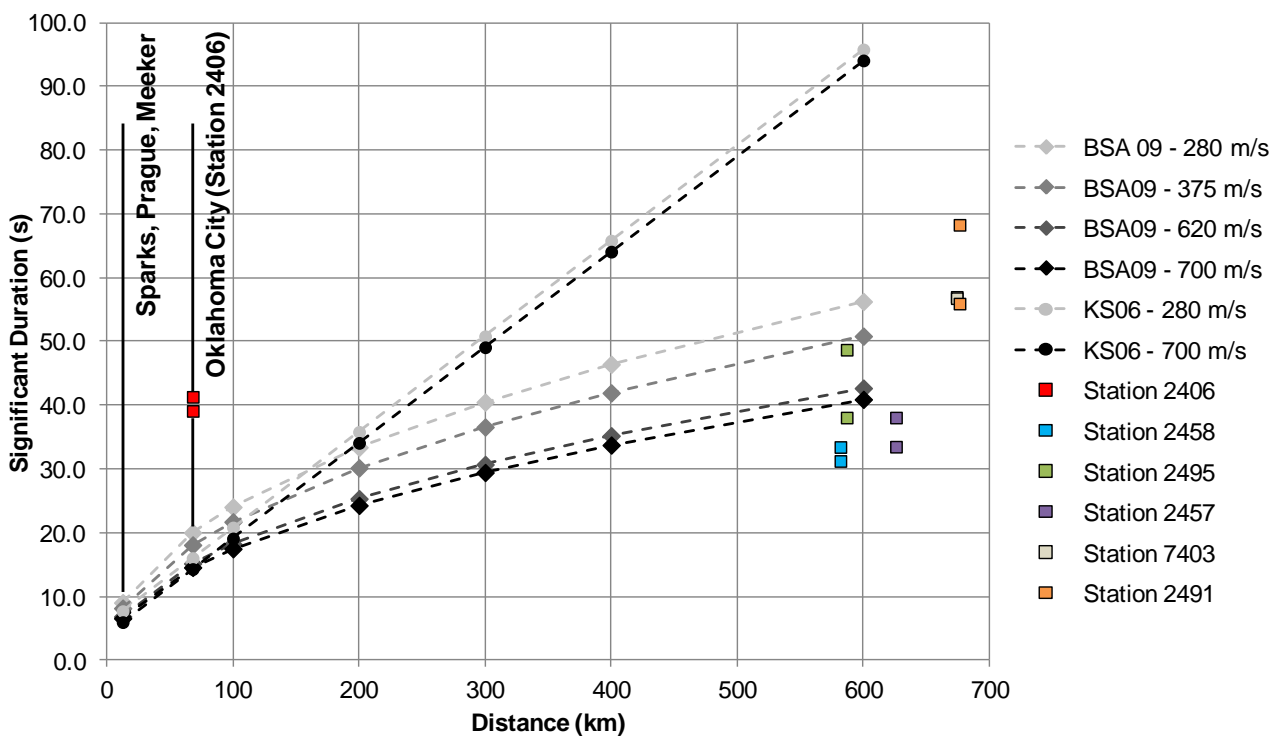
Figure A2.5.17. Estimation of the significant duration of the main shock, using prediction equations by Bommer *et al.* (2009, BSA) and Kempton & Stewart (2006, KS), and significant duration calculated for the two horizontal components of the six available accelerograms.

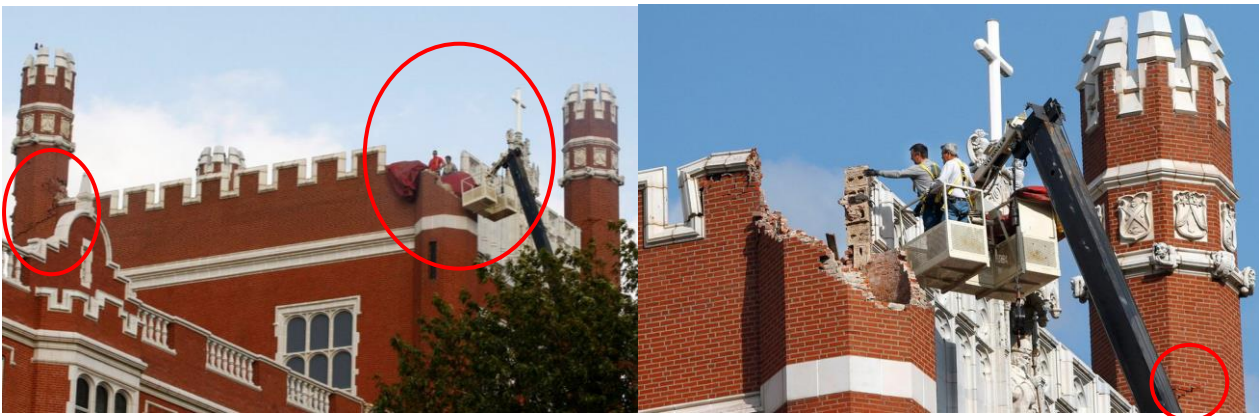
Figure A2.5.22. Damage to one of the towers of Benedictine Hall at St. Gregory's University in Shawnee. Photos by Jim Beckel, from <http://newsok.com/gallery/articleid/3621379/pictures/1555036>.

Figure A2.5.22 shows the damage to Benedictine Hall, a five-storey administrative building at St. Gregory's University, in Shawnee, built in 1915, one of whose 7-8 metre four towers collapsed (Reuters). According to Brad Collins, spokesman for the University, and as can be observed in Figure A2.5.22, the other three towers also sustained damage (Fox News).

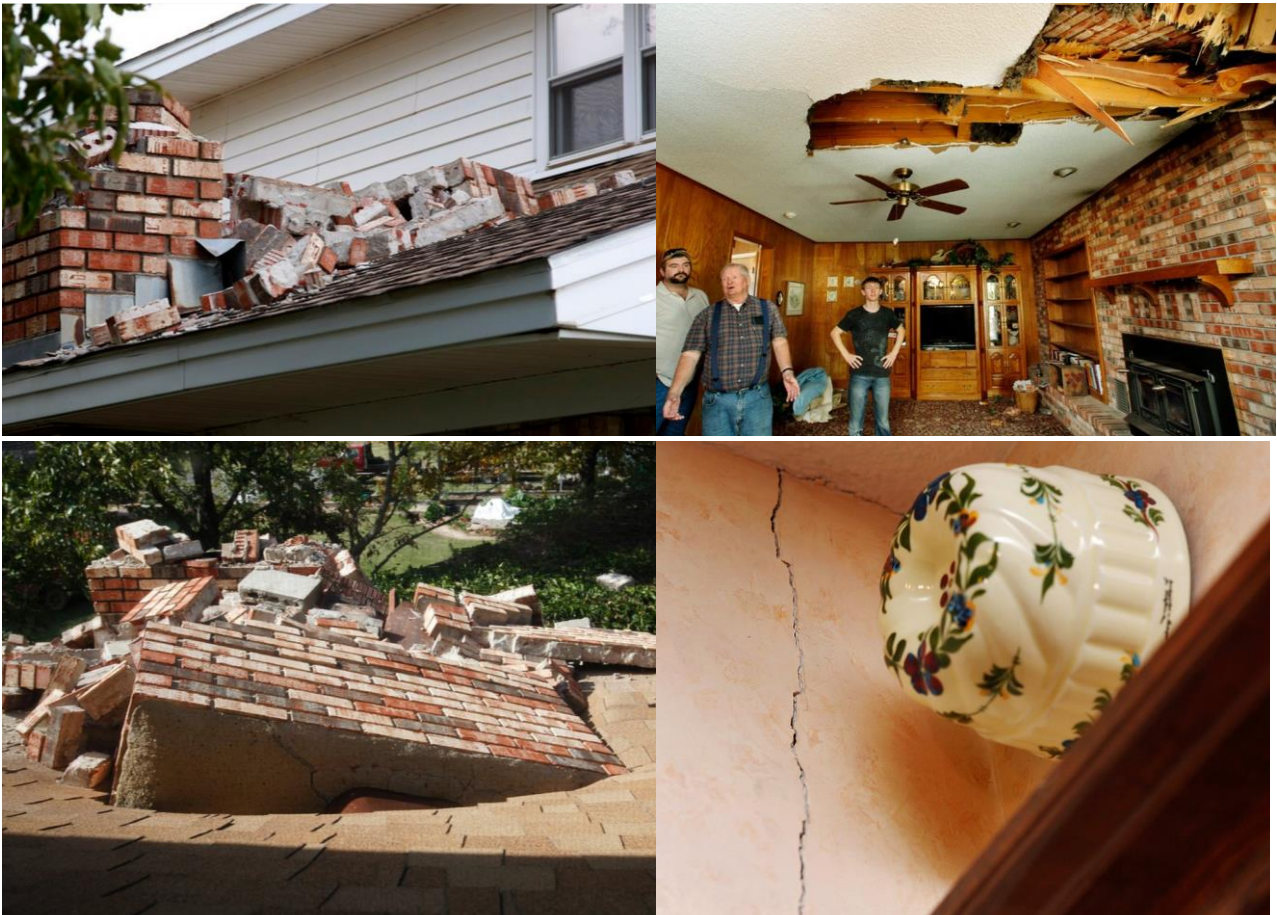
Figure A2.5.23. Damage to a house in Sparks. The chimney toppled over the roof. Photos by Sue Ogrocki(2015)

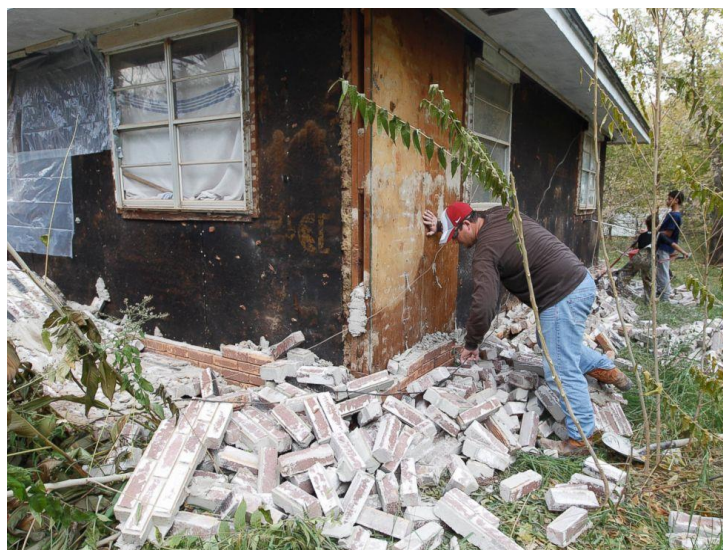
Figure A2.5.24. Façade bricks detached from the wood-frame structure of a house in Sparks

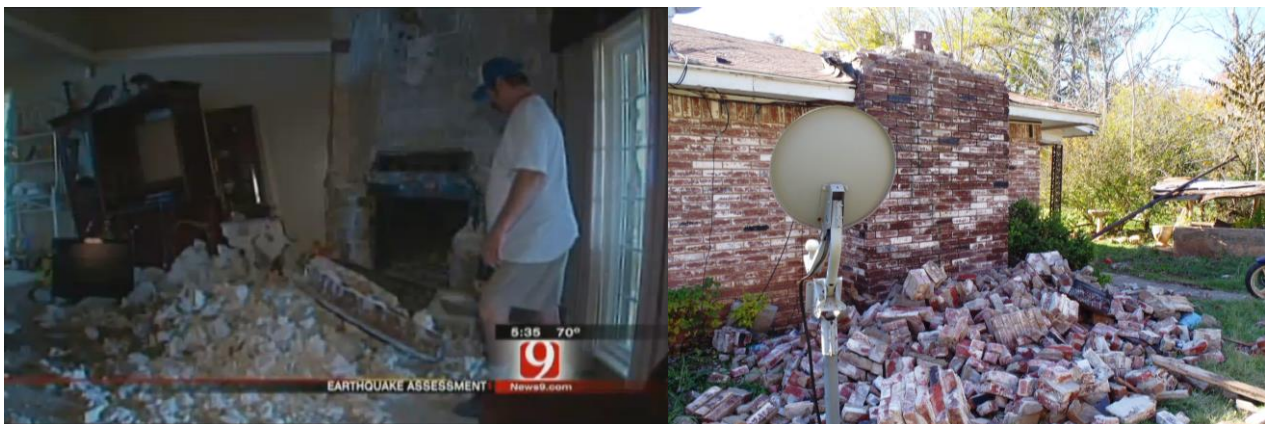
Figure A2.5.25. Complete collapse of a fireplace in the interior of a house in Sparks (left, News 9), and collapse of the top of a chimney of a house.

It should be noted that a commonly observed failure was the toppling or complete collapse of masonry chimneys/fireplaces. Apart from the case reported above (Figure A2.5.23), other chimneys were also severely damaged, as shown in Figure A2.5.25.

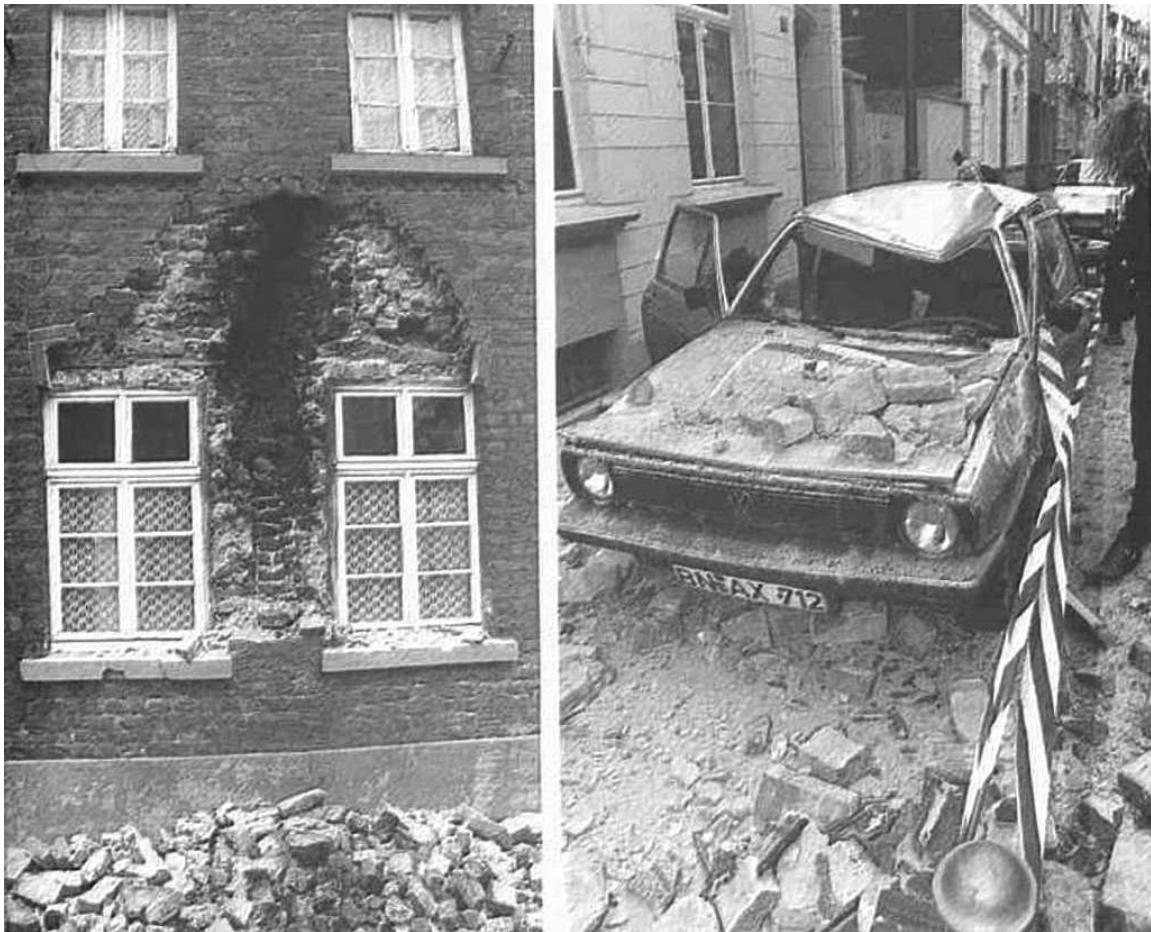
Figure A3.1.36. Damage to a residential house (left) and a car (right) in the city of Bonn (Germany). Photos copyright of Seismic Workgroup, St.-Michael-Gymnasium Monschau (2005)

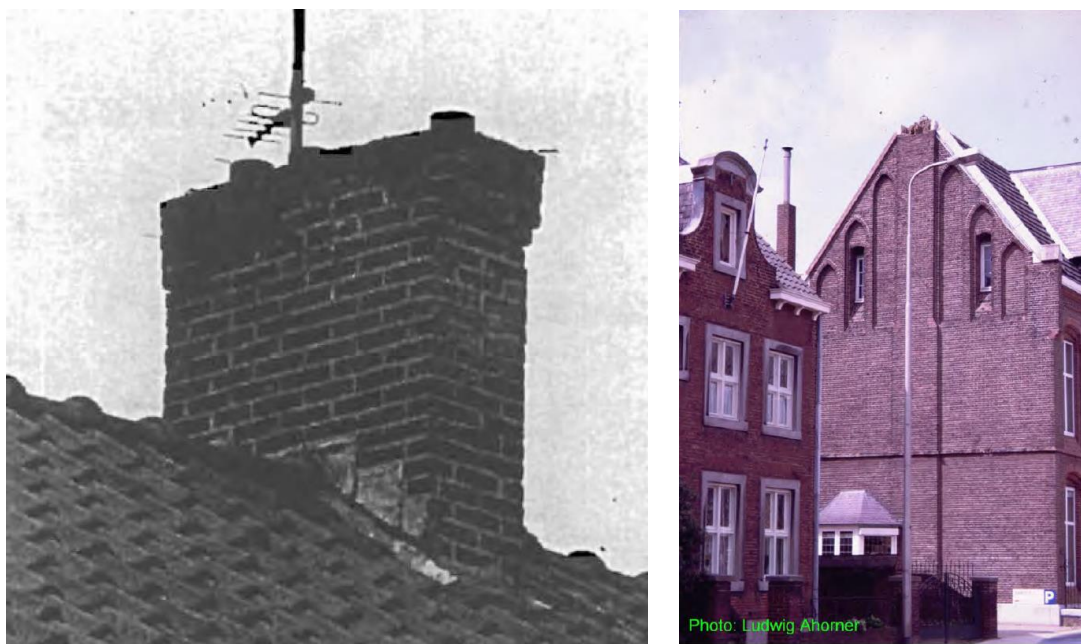
Figure A3.1.40. D2 (left) and D3 (right) damage to chimneys (Schwarz *et al.*, 2010).

No details regarding systematic causes of failure and damage were found in the literature. However, from the results of Pappin *et al.* (1994) it becomes clear that older masonry buildings were significantly more vulnerable than more modern ones. Furthermore, and as observed during other small-to-moderate magnitude earthquakes (e.g., Sargeant *et al.*, 2008), the frequency with which damage to chimneys was observed is also a sign of an increased vulnerability of these structures (Figure A3.1.40).
