Collapse Shaking Table Test on a URM Cavity Wall Structural (LNEC-BUILD1) Representative of a Dutch Terraced House

**U. Tomassetti, A. A. Correia, F. Graziotti, A. I. Marques, M. Mandirola
and P. X. Candeias**

Eucentre

Date September 2017

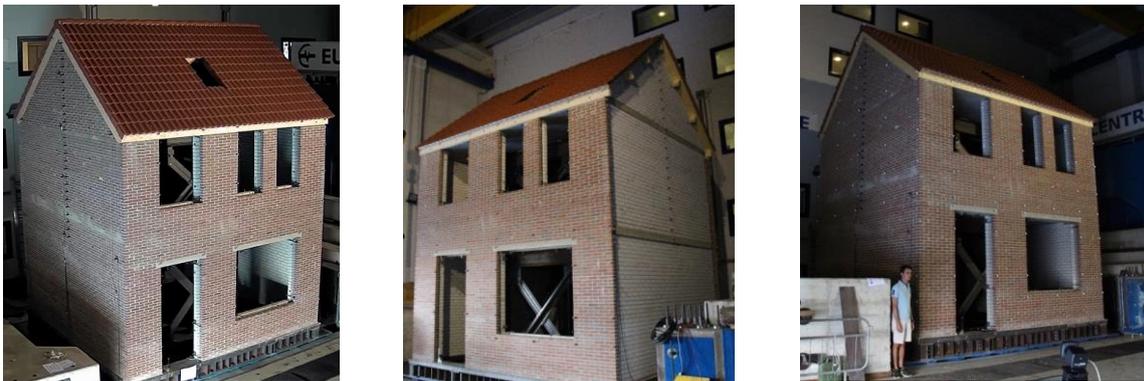
Figure 1.2 Views of the full-scale specimen built in Eucentre, Pavia, Italy.

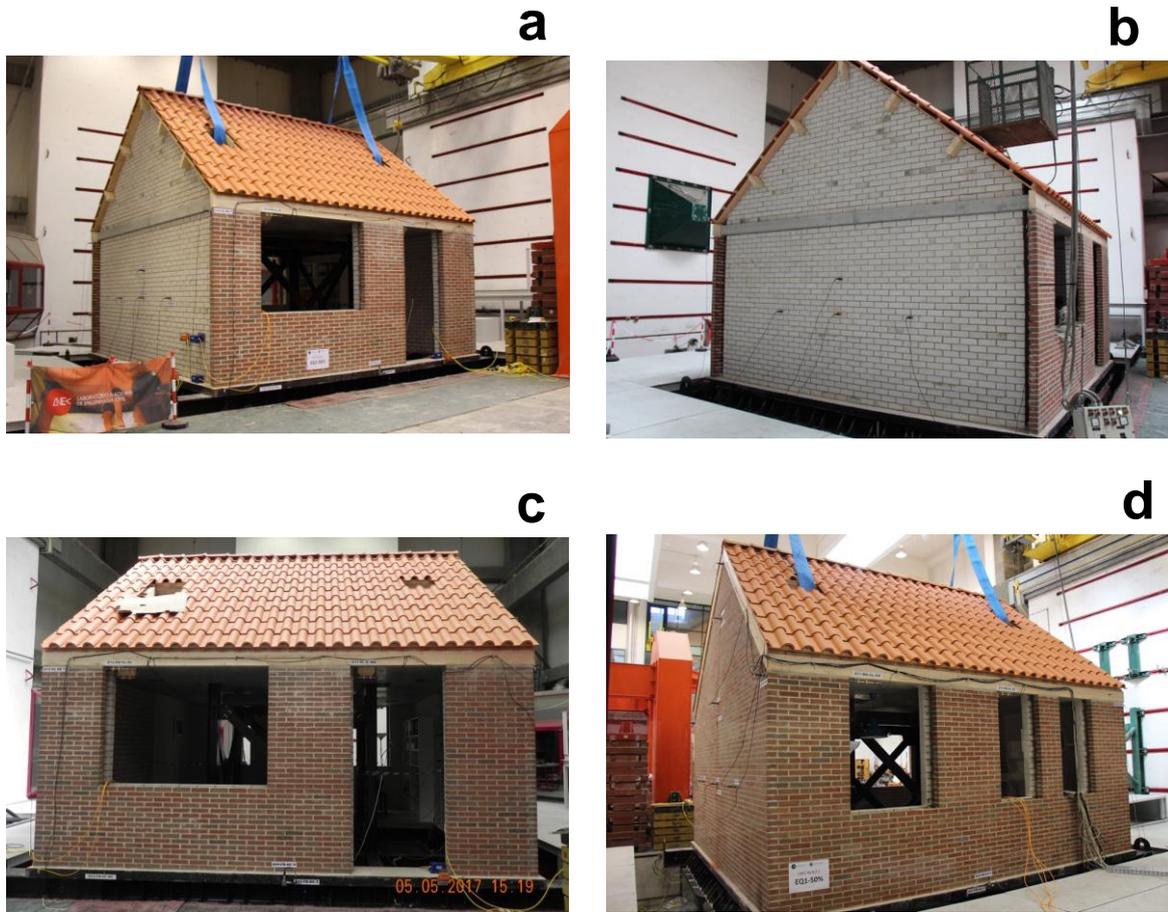
Figure 1.3 Views of the full-scale specimen built in LNEC, Lisbon, Portugal: (a) North-East elevation; (b) East elevation; (c) North elevation; (d) South-West elevation.

The walls, supported by a steel-concrete composite foundation, consisted of two unreinforced masonry leaves. The inner load-bearing leaf was made of calcium silicate (CS) bricks whereas the external leaf was a clay brick veneer without any load-bearing function. The RC floor slab

covered the span between the two transverse (East and West) inner CS walls. The inner CS masonry was continuous along the entire perimeter of the house, while the outer clay brick leaf was not present in the East façade, simply because the specimen was meant to represent the end-unit of a system of terraced houses. The only geometric difference with respect to the specimen built in Pavia is represented by the door in the North elevation, which allowed an easy access to the inside of the prototype building. Pictures of the specimen after the end of the construction are shown in Figure 1.3. Figure 1.4 depicts the specimen's ground plan views and the horizontal direction of shaking.

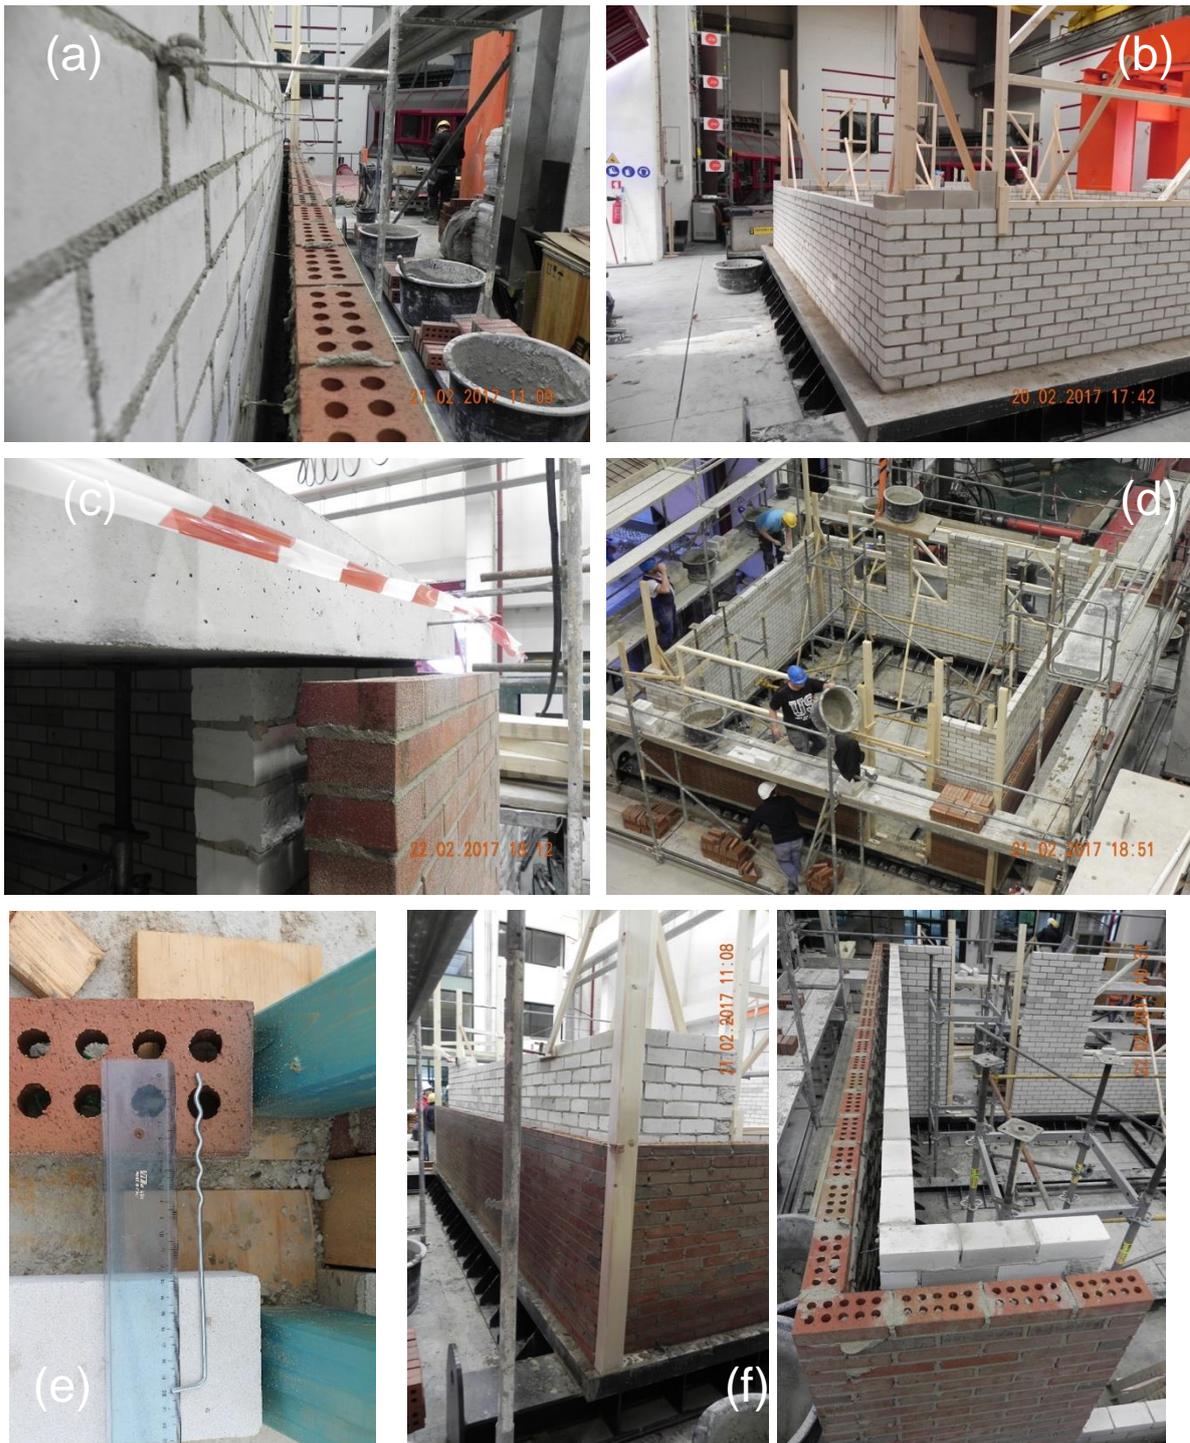
Figure 1.7 Construction details of the specimen: (a) positioning of cavity steel ties; (b) building phase of inner CS leaf; (c) laying of the first-floor slab; (d) construction of the first floor (e) geometry of steel tie; (f) construction of the first-floor level; (g) inner and outer leaves before the laying of the RC slab.

1960s and 1970s. Figure 1.7 presents pictures captured during the construction phase of the specimen.

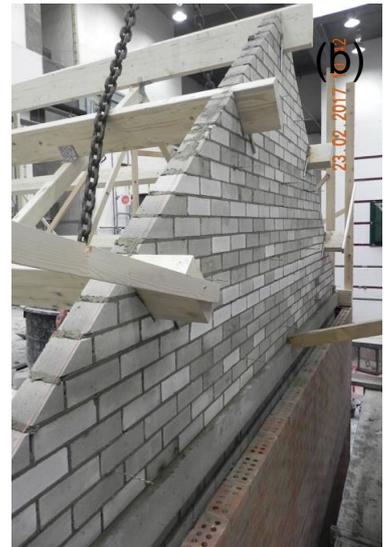
The timber roof is a simple structure consisting of one ridge beam, two timber plates on top of the longitudinal outer leaves of the walls and two girders per side between the ridge beam and the timber plates, at approximately 1.2 m of distance. Tongue and groove planks, with a width equal to 182 mm and a thickness of 18 mm, will be nailed on top by means of two 60x2 mm nails at each intersection (Figure 1.9 (a)). The planks did not cover the entire inclined length of the roof. Figure 1.9 (a) shows also the detail of their lay and connection with the timber beams. The timber beams of the roof are supported by the transverse inner CS leaves (West and East gables), whereas this connection was further reinforced by the presence of L-shaped steel anchors, as shown in Figure 1.9 (b). The roof diaphragm is characterised by four openings (three with dimension 54x45 cm, one 54x72 cm large) allowing, by means of a cable system, to sustain the RC slab in case of need and preventing a global collapse on the shaking table. The opening in the North-East corner is larger, granting access to the first floor (see Figure 1.10).

The in-plane stiffness of the timber diaphragm is essentially provided by the nailed connections between beams and planks, as well as by the effectiveness of the tongue and groove joints. The roof has been completed by the installation of clay tiles.

Figure 1.9 Details of the roof structure: (a) geometry of the timber diaphragm; (b) connection between the timber beams and the West gable.

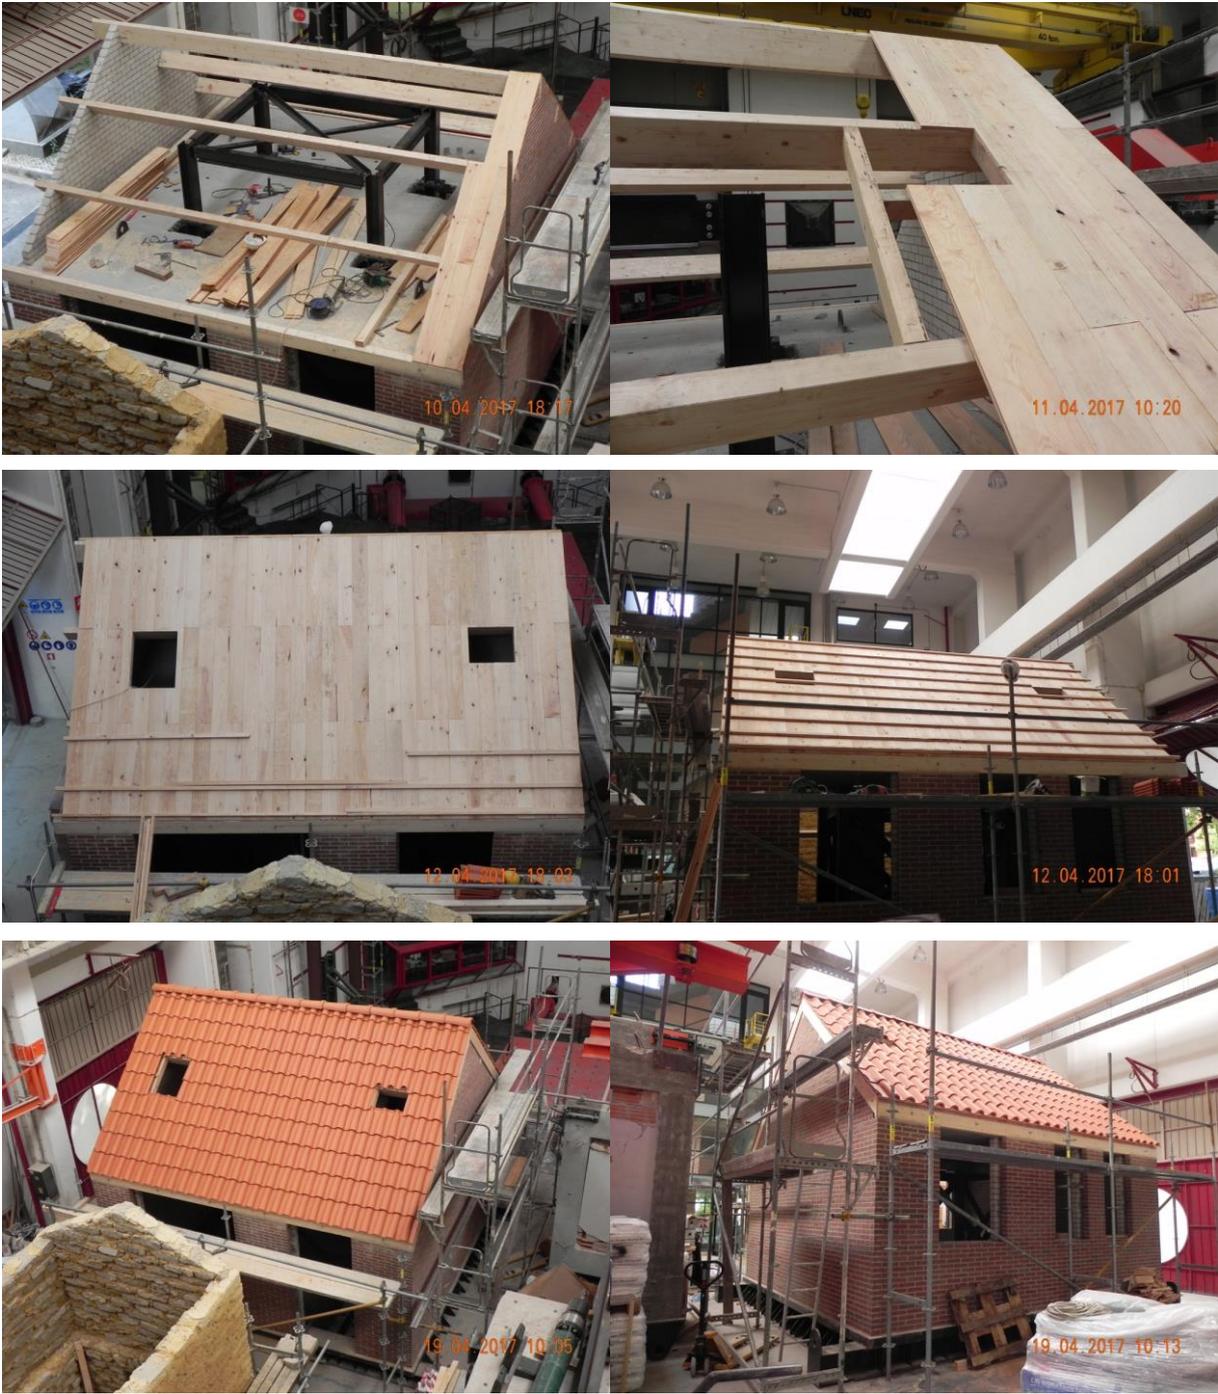
Figure 1.11 Construction of the roof and views of specimen after the laying of the tiles.

Table 1.2 indicates the masses of the different elements characterising the roof structure, while Figure 1.11 shows pictures of the roof construction and views of the specimen with the roof completed with the laying of the tiles.

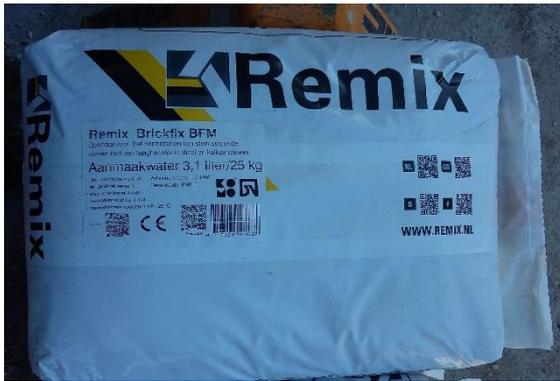
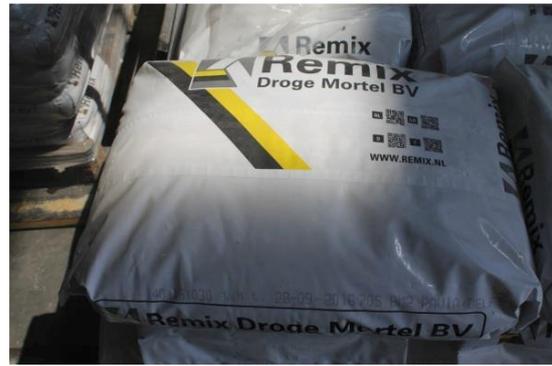
Product used in bedding mortar
for calcium silicate blocks
ref.:150102 t.h.t.

Product used in bedding mortar
for clay bricks
ref.: 1401151030 t.h.t.

Figure 2.1 Types of product used in each bedding mortar.

The bedding mortar used in the masonry with calcium silicate blocks is different from the one used in the masonry with clay bricks. Both mortars are pre-dosed with cement and hydraulic lime, with the references of the products used in the two bedding mortars shown in Figure 2.1.

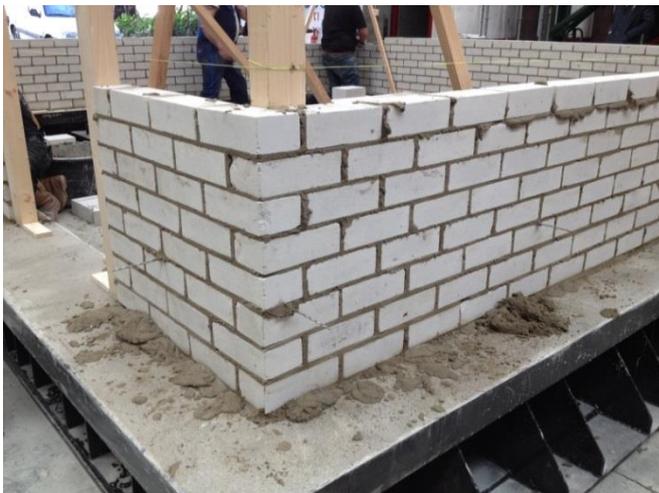
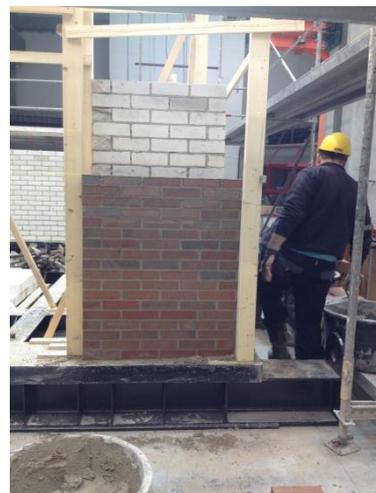
Figure 2.2 Construction of the full scale model at the time of collection of mortar samples.

The mortar samples were collected by LNEC technicians during the construction of the full-scale model and during the construction of the specimens for characterisation tests (*wallettes* and *triplets*). Figure 2.2 illustrates the construction of the full-scale model in one of the phases in which the mortar samples were collected. Figure 2.3 illustrates the construction of masonry characterisation specimens.

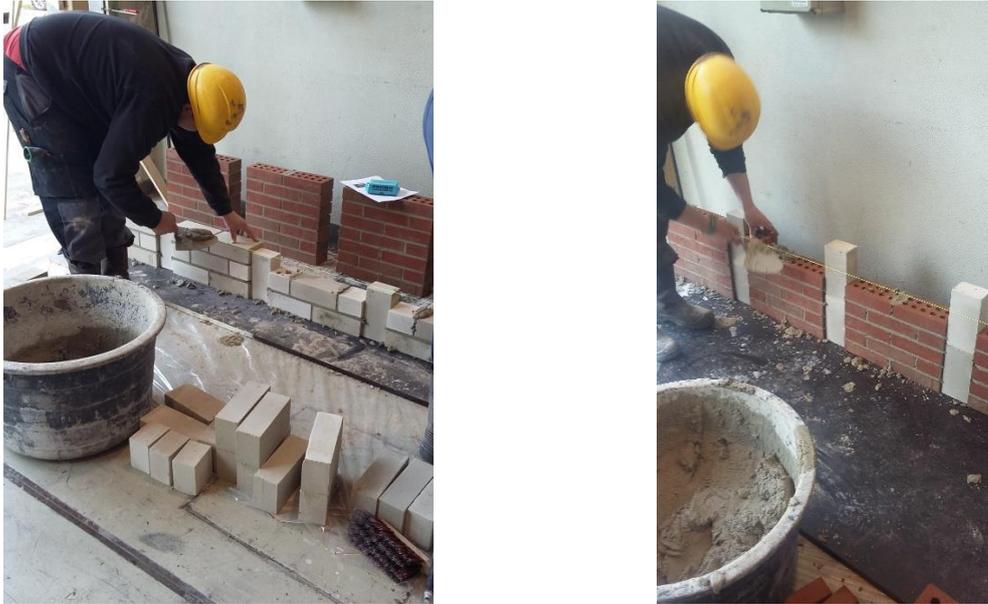
Figure 2.3 Construction of characterisation specimens at the time of mortar sampling.

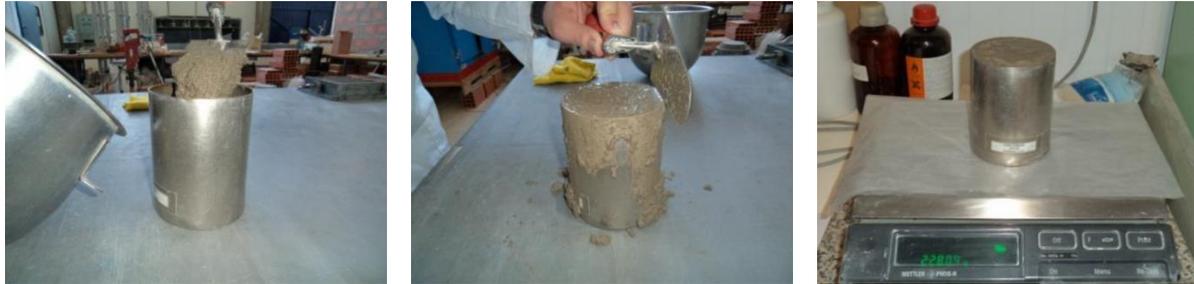
Figure 2.5 Carrying out the determination of bulk density of fresh mortar.

The bulk density was determined by the quotient between the sample mass and its volume, for standard compaction conditions. The adopted methodology for this test is described in the standard EN 1015-6 "Methods of test for mortar for masonry - Part 6: Determination of bulk density of fresh mortar" (1998). The test starts by the pre-determination of the mass of the container (cylindrical cup), thus obtaining m_1 . Then, using a spatula, the cylindrical cup is filled with a first layer up to approximately half of its capacity. The contents are then compacted with 10 strokes carried out from the oscillation of the container on alternate sides. The process continues by filling the container a little over its capacity, and repeating the same compaction process as described above. Finally, the surface is leveled with the aid of a spatula by removing the excess mortar so that the surface becomes flat and coincident with the upper edge of the container. The outer surface of the container is conveniently cleaned to remove any residual mortar and the assembly is weighed (thus obtaining m_2).

Figure 2.5 shows some phases of the test being performed, while the results obtained for the collected mortar are given in Table 2.4.

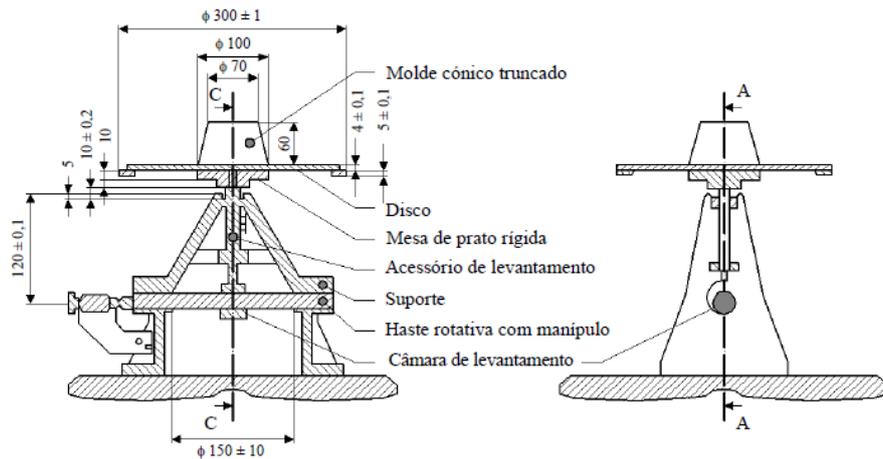
Figure 2.6 (a) presents a schematic representation of the spreading table and in Figure 2.6 (b) some phases of the tests performed are illustrated. The results obtained for all mortar samples collected are given in Table 2.5.

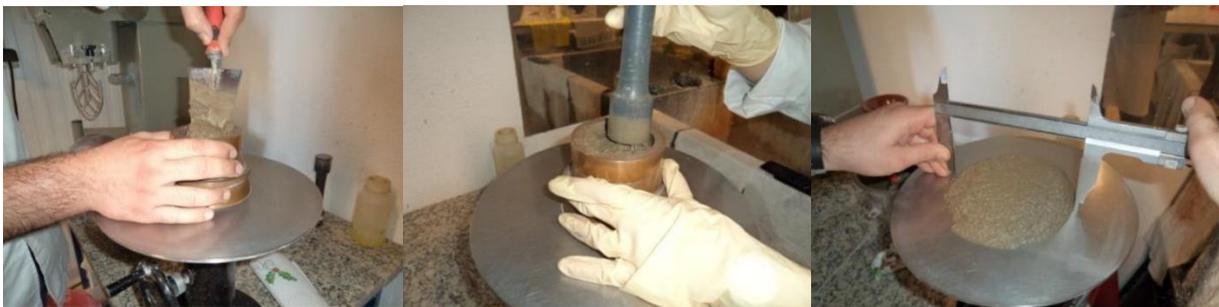
Figure 2.6 Determination of consistence of fresh mortar by scattering: (a) schematic representation of equipment; (b) test run.

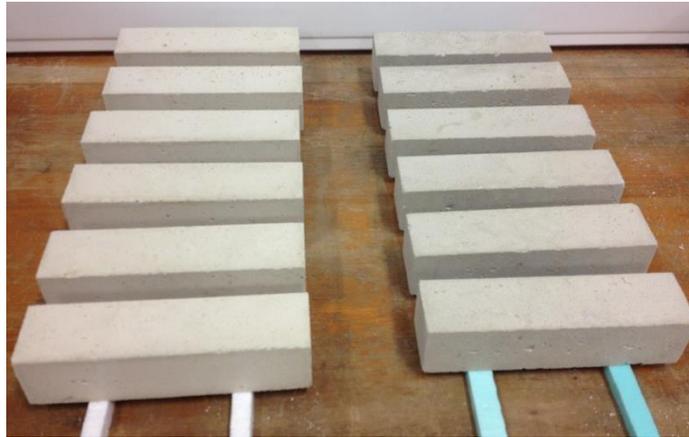
Figure 2.7 Part of mortar specimens.

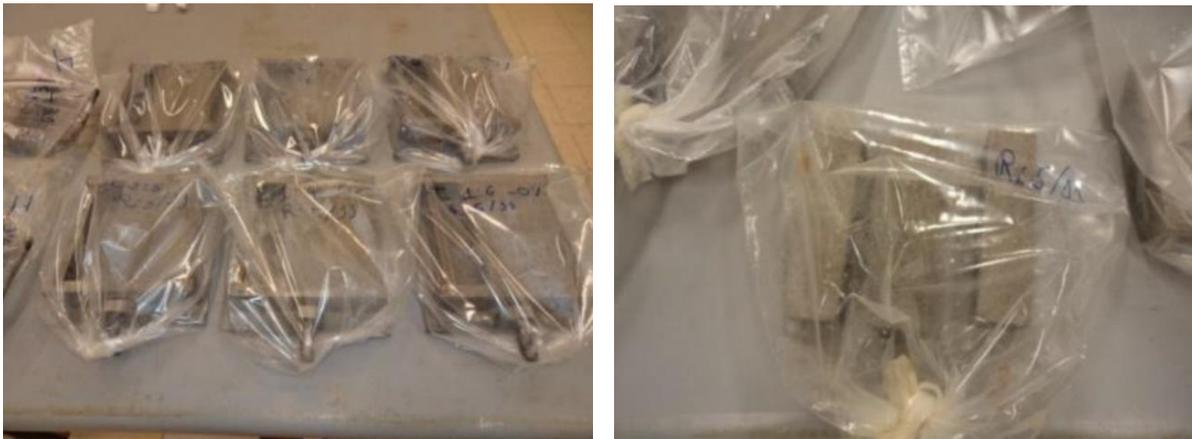
Figure 2.8 Curing conditions of mortar specimens.

"Methods of test for masonry - Part 11: Determination of flexural and compressive strength of hardened mortar" (1999) which correspond to placing the mold in a plastic bag of polyethylene for 2 days, ensuring a relative humidity of $95 \pm 5\%$, in a room wrapped at $20 \pm 2^\circ\text{C}$ and a relative humidity of $65 \pm 5\%$. Subsequently, the specimens were demoulded and kept under the aforementioned curing conditions for 5 days, after which the specimens were removed from the bag and remained in the same room (at $20 \pm 2^\circ\text{C}$ and at a relative humidity of $65 \pm 5\%$) until the date of the test. Figure 2.8 illustrates the reported curing conditions of some of the specimens.

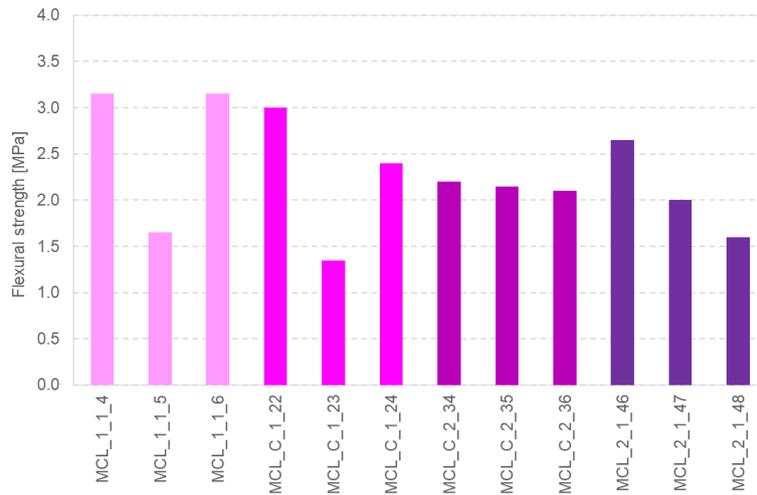
Figure 2.27 Flexural strength test results for bedding mortar specimens used with clay bricks (MCL) after 20 days of age.

In order to obtain a relation between the maturation time and the mechanical properties of the mortars, Figure 2.26 to Figure 2.31 show the test results for the determination of flexural and compressive strengths of bedding mortar specimens for the clay bricks (MCL) after 10 days, 20 days and 28 days of age. Additional results are shown in Annex II. In the plots of Figure 2.29 to Figure 2.31, the compressive strength is represented with bars and the value of the modulus of elasticity for the corresponding specimens is represented by a line.

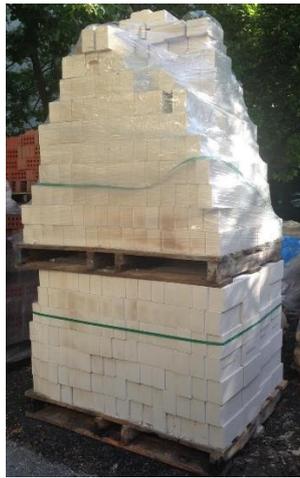
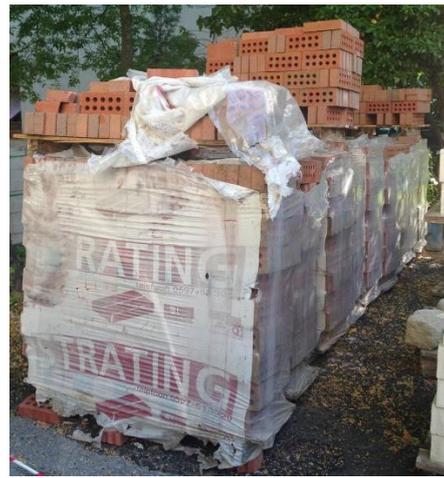
Figure 2.36 Collection of test pieces.

Several specimens of each type of block were collected and selected from the material used for the construction of the full-scale model and the characterisation samples (Figure 2.36 and Figure 2.37). The specimens collected were more than 30 days inside the premises of the laboratory units without specific packaging until the date of the test.

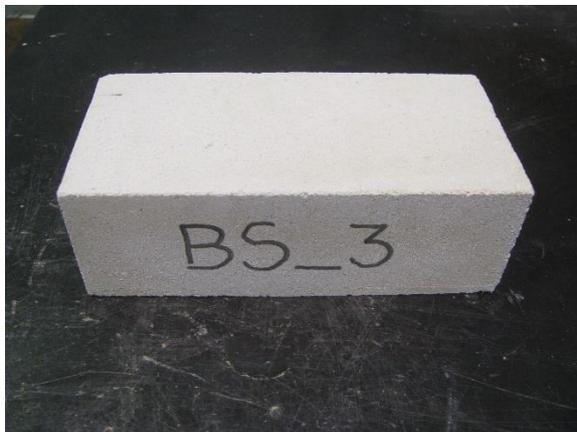
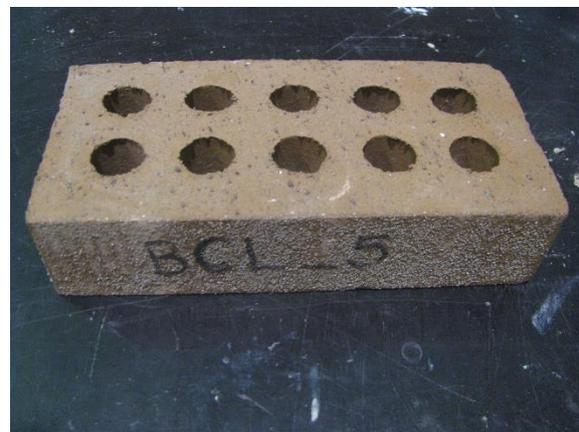
Figure 2.37 Blocks units.

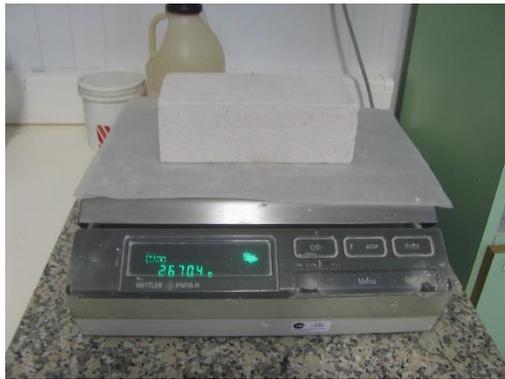
Calcium silicate blocks (BS)

Figure 2.38 Drying the blocks in a ventilated oven.

The test for determination of the moisture content was carried out on six specimens of each type based on the procedures described in EN 772-10 "Methods of test for masonry units Part 10: Determination of moisture content of calcium silicate and autoclaved aerated Concrete units" (1999), in NP EN 1097-5 "Tests of the mechanical and physical properties of the aggregates. Part 5: Determination of the water content by drying in a ventilated oven" (2011), and in the procedure of LNEC FE Pa 47 (2015). This test has as its main objective to determine the moisture content by the thermogravimetric method.

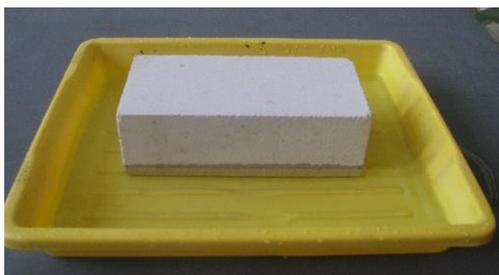
Calcium silicate blocks (BS)

The test for determination of the capillarity coefficient was performed on six specimens of each type of block by the procedures described in EN 772-11 "Methods of test for masonry units Part 11: Determination of water absorption of aggregate concrete, autoclaved aerated concrete" (2011) and in the LNEC PE / Sup-01 test procedure (2006). The results of this work are presented in Table 2.15. To perform this test the specimens were initially dried at 105 ± 5 ° C until 0.1% of constant mass was obtained. After cooling, the faces that were immersed in water (2 measurements per dimension, near the edges) are measured and the area that is in contact with the water is determined. Subsequently the initial mass of the specimen was measured and the blocks inserted in a tray with elements that allow the passage of water under them, with the face to be submerged downwards, immersed in water up to 5 ± 1 mm, as shown in Figure 2.40. After the specified period for the material concerned, which in this case is 60 ± 2 s, the specimen is removed and the surface water is removed with absorbent paper and the specimens are weighed.

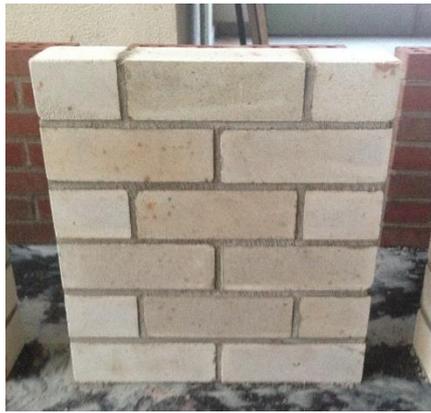
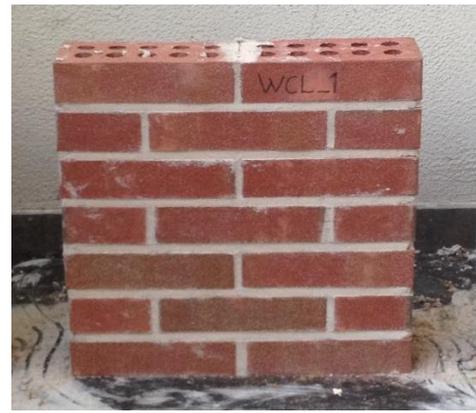
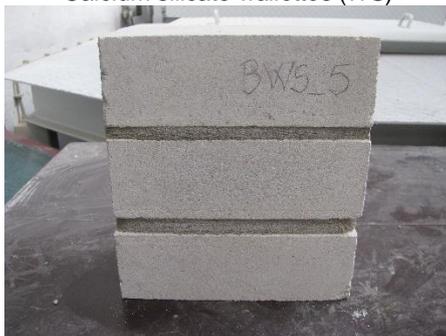
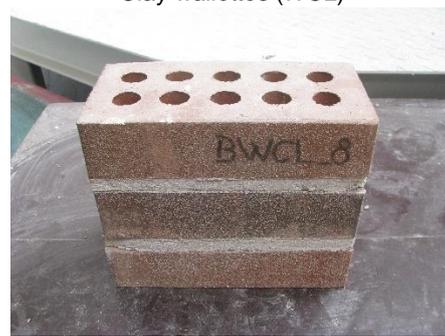
Figure 2.41 Types of masonry specimens (wallettes and triplets) built for testing.

For the two types of existing masonry (masonry consisting of calcium silicate blocks and masonry consisting of clay bricks), fourteen small walls were constructed, which are called *wallettes*, with six layers for calcium silicate blocks *wallets* with dimensions approximately 433 x 102 x 475 mm, and seven layers for clay brick wallets with dimensions of approximately 430 x 100 x 410 mm. This dimensions are according to the provisions of norm NP EN 1052-1 (2002). Thirty-six specimens with three blocks, which were designated as *triplets*, were dimensioned with approximately 236 x 212 x 101 mm for the calcium silicate *triplets* and 170 x 210 x 100 mm for the clay *triplets*. Figure 2.41 shows the two *wallettes* and *triplets* types that were constructed for the tests.

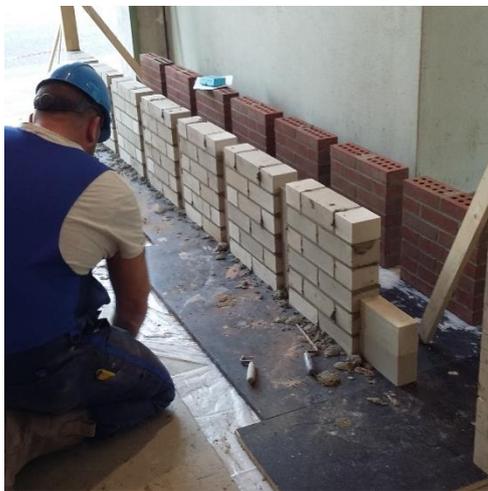
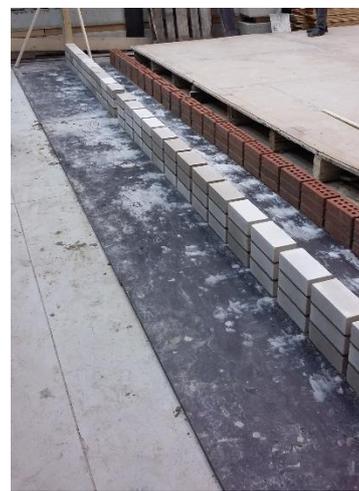
Figure 2.42 Construction of wallettes and triplets.

The construction of the specimens for the characterisation tests (*wallettes* and *triplets*) took place in February 2017 during the construction of the full-scale model and was carried out by construction professionals from the Netherlands, as shown in Figure 2.42.

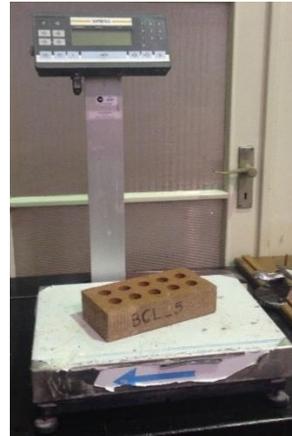
Triplets

Figure 2.43 Example of characterisation (measure and weight) of all specimens.

All of the specimens were measured with a caliper and weighed on a digital weighing-machine, as shown in Figure 2.43.

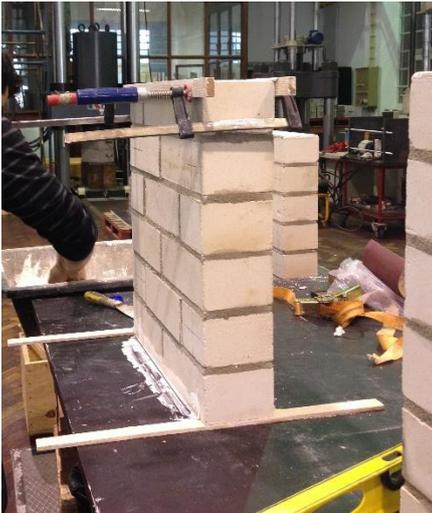
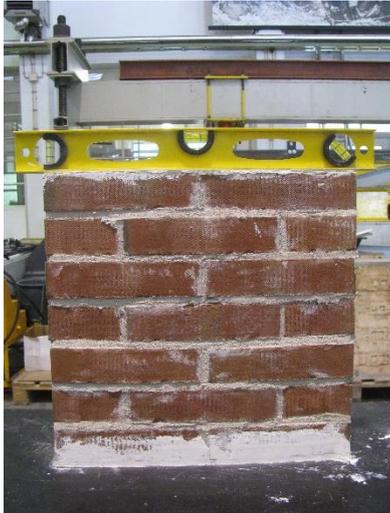
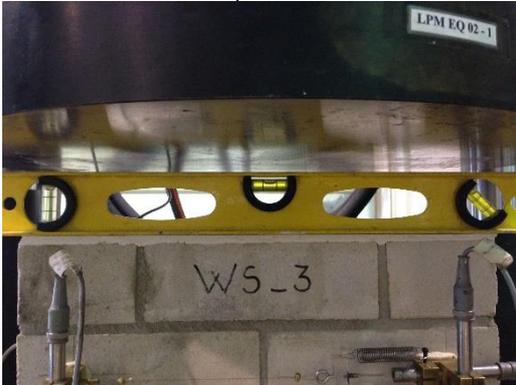
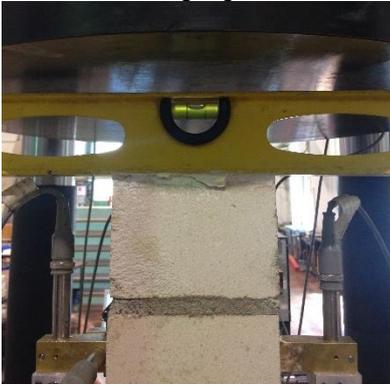
Figure 2.45 Regularisation of the *wallettes* faces.

This test was carried out in the abovementioned *wallettes*. Due to the small irregularities of the lower and upper faces of the specimens (areas that would be in contact with the plates of the press), these faces were regularised with a thin layer of gypsum, as shown in Figure 2.45. After this regularisation a very fine layer of gypsum is placed on both sides already with the specimen on top of the testing machine, which are leveled by the plates of the press, as shown in Figure 2.46.

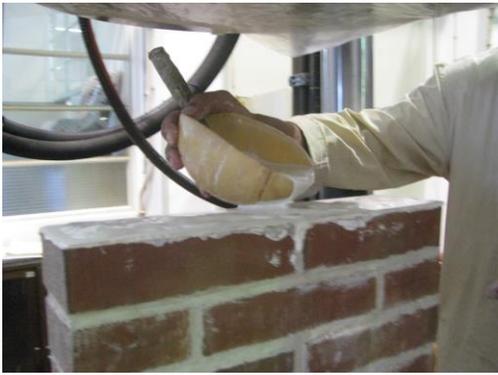
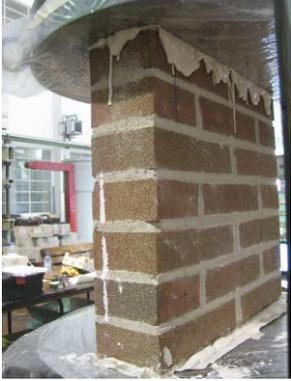
Figure 2.46 Final regularisation of the *wallettes* faces on top of the testing machine.

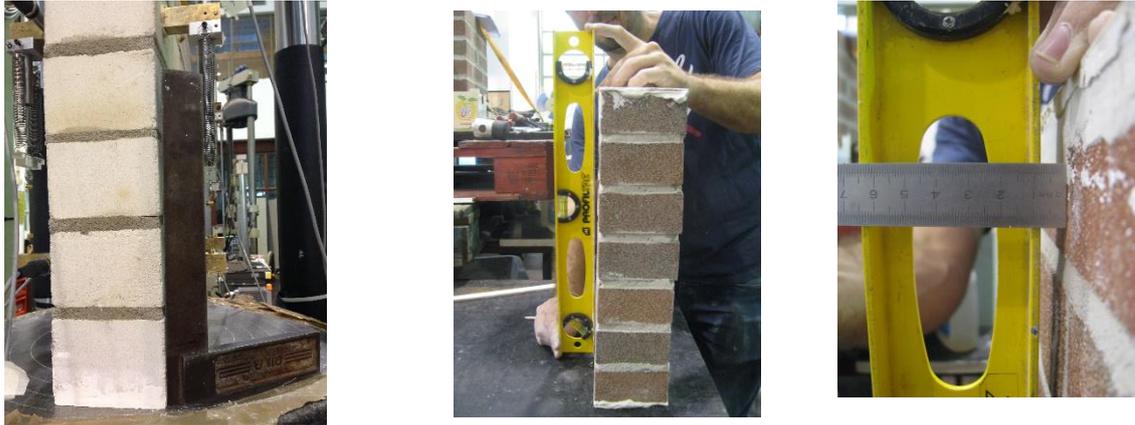
Wallettes were not perfectly tiled at the time of construction, as shown in Figure 2.47

Figure 2.47 Lack of verticality in wallettes.

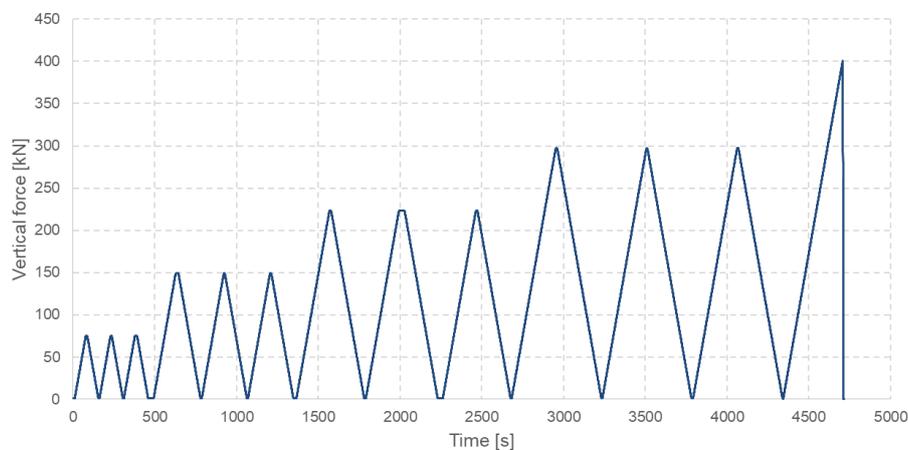
The test procedure for the calcium silicate *wallettes* consists essentially in placing the specimen in the test machine for load application without shock, i.e. in a gradual way and at a controlled speed until the failure of the specimen. Several increasing cycles of loading and unloading were carried out, with increments of 74 kN and starting at 74 kN (at each load level three cycles were performed), as illustrated in the plot of Figure 2.53 which shows the force as a function of time. The test was performed on a machine with a capacity of 1000 kN, with a control in force and with a test speed of 1.1 kN/s. A sampling frequency of 5 Hz was used, each run lasting approximately 75 minutes. The load application was performed vertically to the specimen.

Figure 2.53 Application of force as a function of time applied to calcium silicate wallettes.

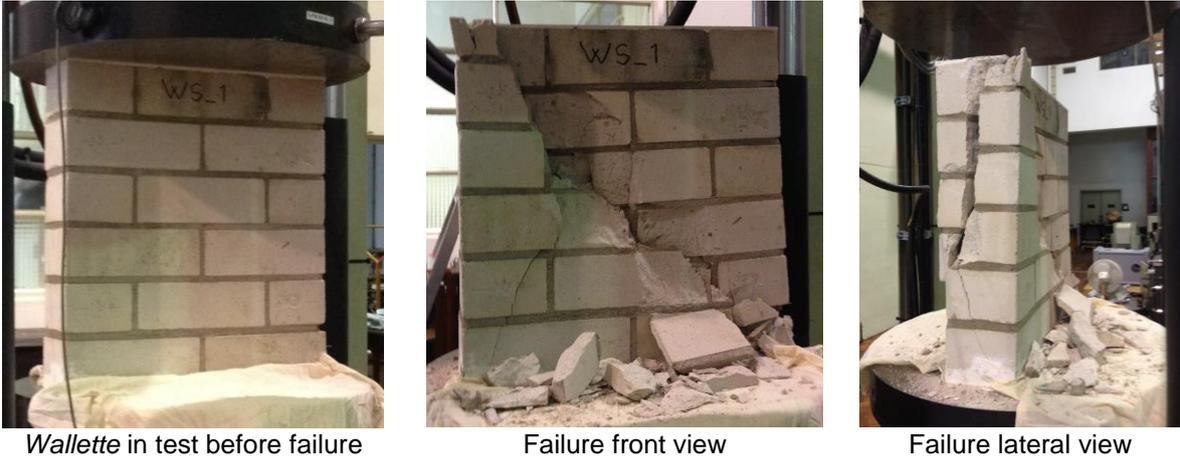
Figure 2.54 Calcium silicate block walette (WS_1) during the test and after failure.

Figure 2.54 and Figure 2.55 present two calcium silicate *wallettes* during the test and after their failure, while in Annex V the figures with the obtained fractures are presented for all specimens.

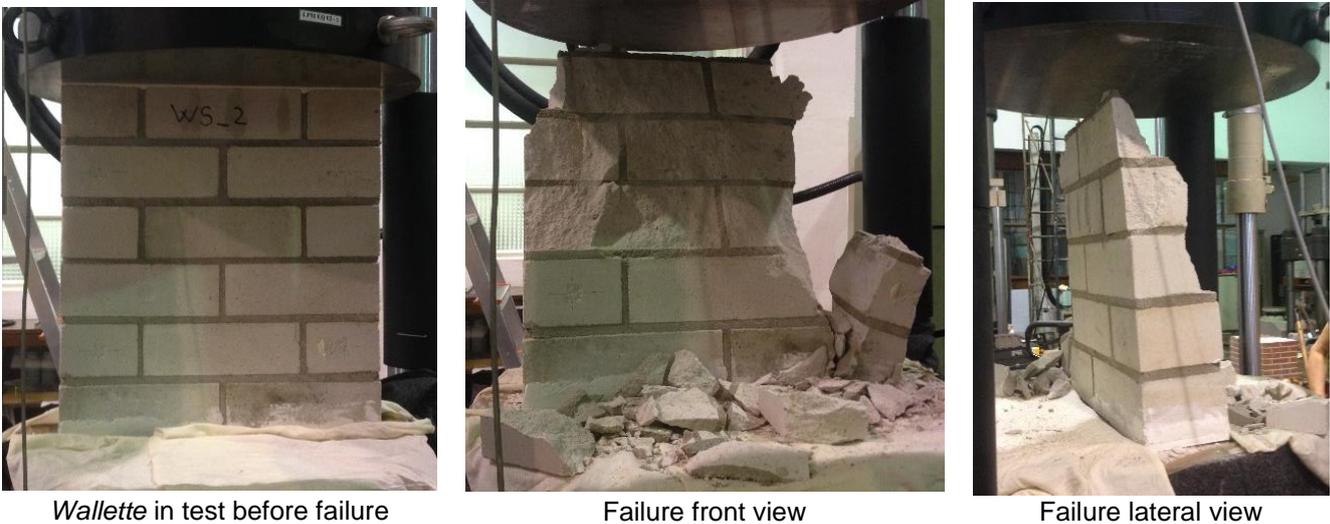
Figure 2.55 Calcium silicate block walette (WS_2) during the test and after failure.

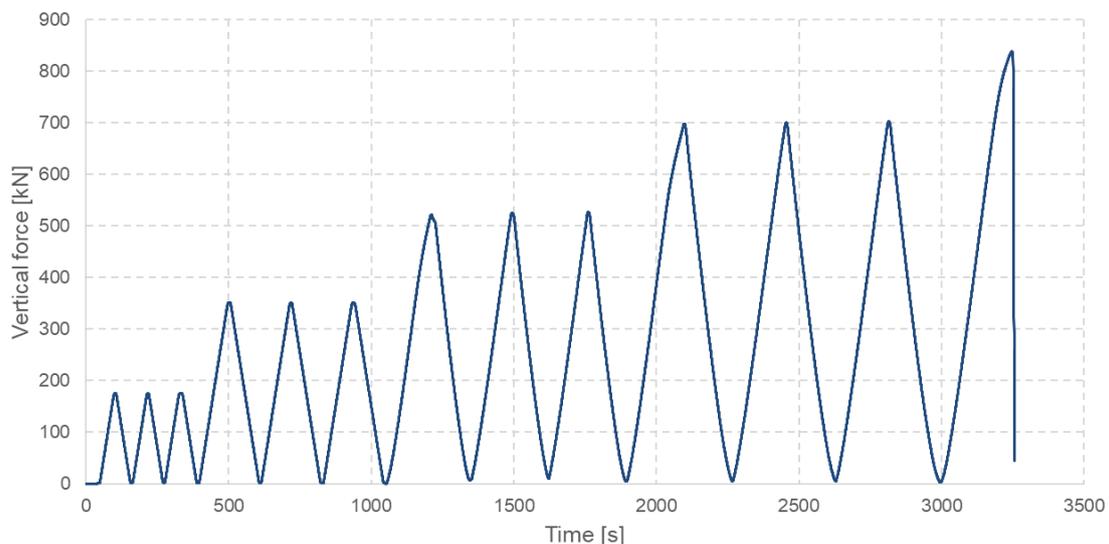
For clay *wallettes* several increasing cycles of loading and unloading were carried out, with increments of 175 kN and starting at 175 kN (at each load level three cycles were performed), as illustrated in the plot of Figure 2.68 which shows the force as a function of time. The test was again performed on a machine with a capacity of 1000 kN, with a control in force in the cycles up to 500 kN of load level and in displacement-control for cycles reaching load levels above 500 kN. The test speed while in force control was of 3.5 kN/s and while in displacement control was of 0.01 mm/s. A sampling frequency of 5 Hz was used, each run lasting approximately 60 minutes. The load application was performed vertically to the specimen.

Figure 2.68 Application of force as a function of time applied to clay wallettes.

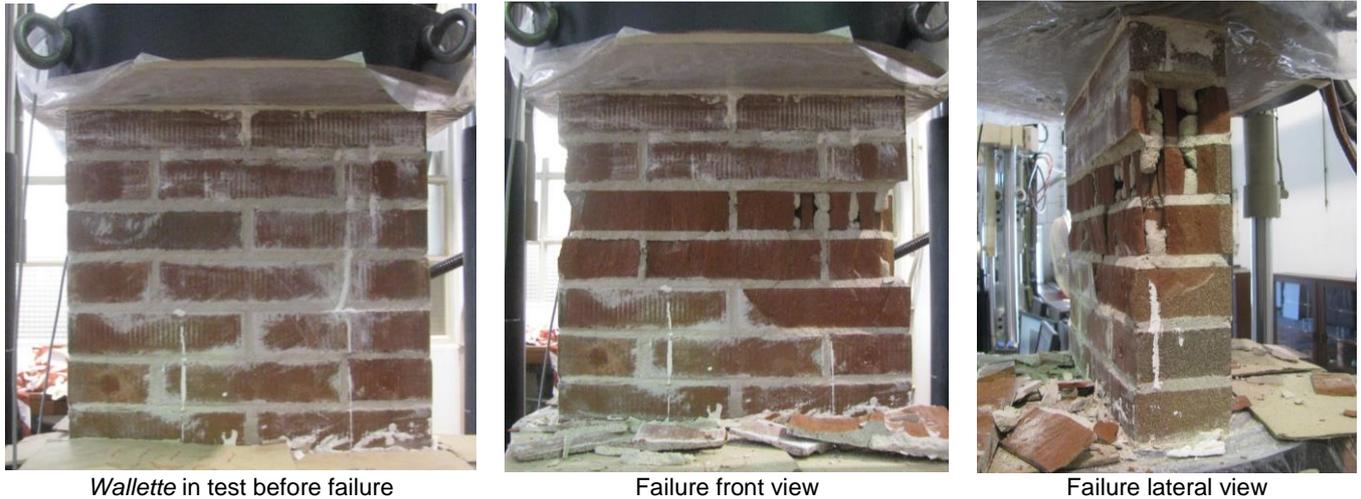
Figure 2.69 Clay brick walette (WCL_6) subjected to test and after failure.

Figure 2.69 presents a clay *wallette* during the test and after its failure. In Annex V the figures with the obtained fractures are presented for all specimens.

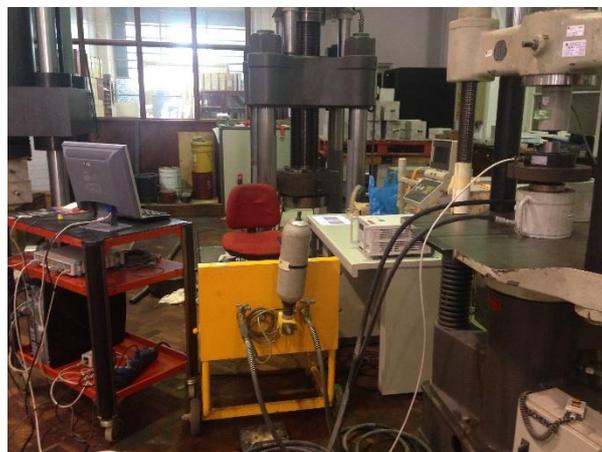
Figure 2.87 Calibration of the complete test chain.

The hydraulic jacks, load cell and acquisition equipment, i.e. the complete test chain, were duly calibrated immediately prior to the start of the tests with the collaboration of the Metrological Quality Unit of the LNEC Scientific Instrumentation Centre, as shown in Figure 2.87. Given the existence of small irregularities on the lateral sides of the triplets (areas to be pre-compressed) a neoprene rubber was placed between the specimen and the plates of the hydraulic jacks that apply the pre-compression.

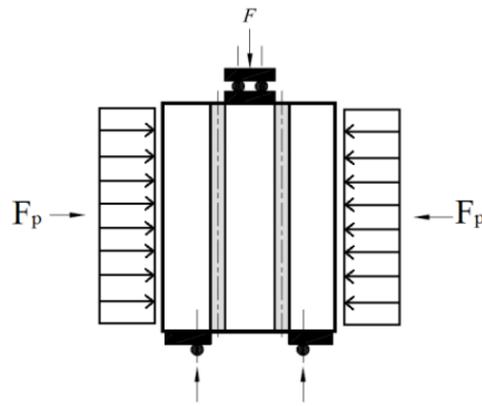
Figure 2.88 Test scheme for the determination of shear strength.

The initial shear strength of the masonry was determined with a shear action defined by three points of application of load parallel to the horizontal joints and with the simultaneous application of a pre-compression force perpendicular to the horizontal joints. The tests were carried out, recording the load and deformation values, identifying the representative values upon failure, and the test was finalised after confirmation of the significant reduction of the shear force and measurement of the deformation for the various pre-compression levels.

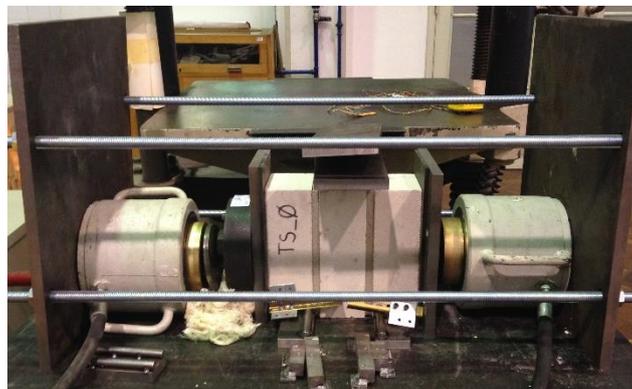
Figure 2.89 Final version of the shear strength test device.

A device was initially created to perform this test, which was modified over several iterations until the definitive version that was actually used. Figure 2.89 shows the final device. The details of these elements can be found in Annex VI.

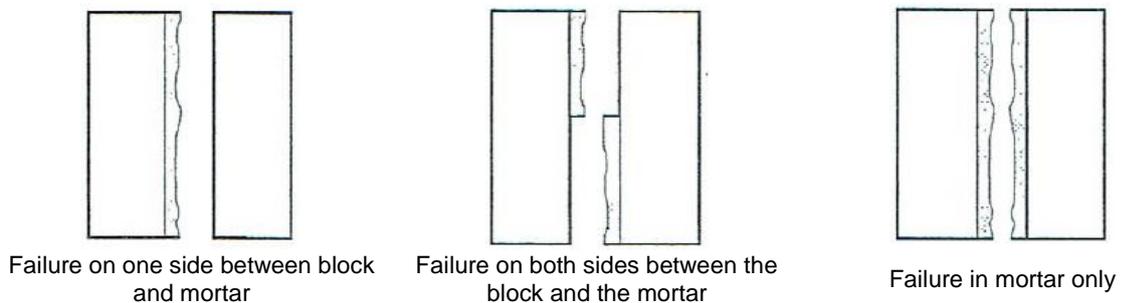
Figure 2.95 Acceptable collapse mechanisms for the shear strength test.

The acceptable collapse mechanisms for the test to be considered valid are shown in Figure 2.95.

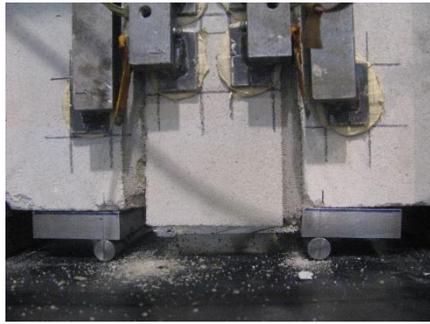
Calcium silicate triplet

Figure 2.96 Completion of the test for the two types of triplets tested.

The test is finished upon the measurement of the friction after fracture formations, while there is contact between the two materials, as shown in Figure 2.96

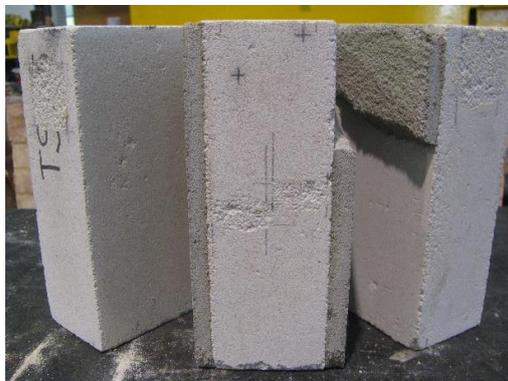
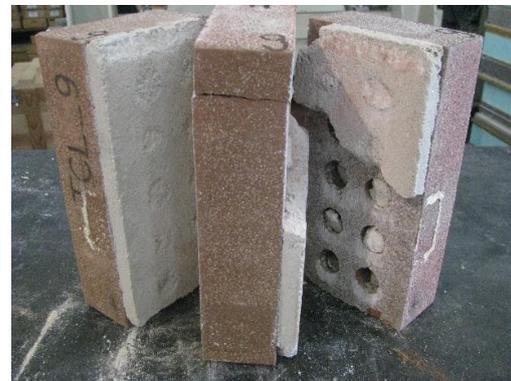
Figure 2.97 Example of one of the failure mechanisms obtained for each triplet in the shear strength test.

The type of failure mechanisms obtained in the various tests are as exemplified in Figure 2.97. Annex V presents further details on the obtained fractures for all the specimens tested.

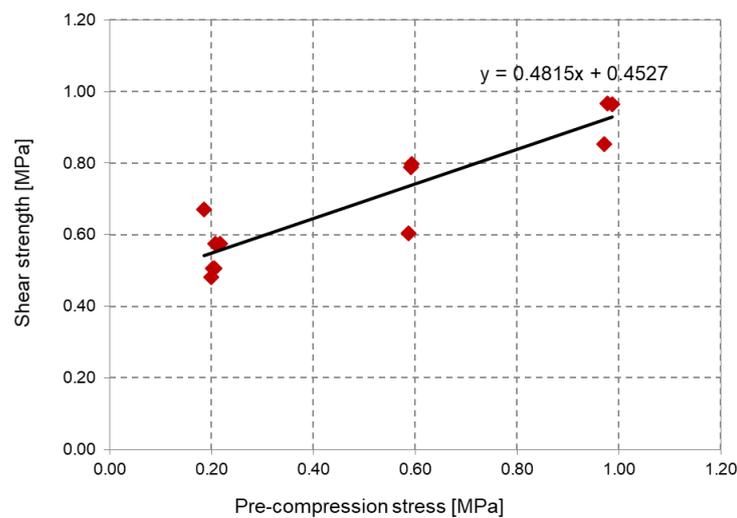
Figure 2.98 Shear strength, cohesion and internal friction angle for the calcium silicate triplets.

The plots in Figure 2.98 and Figure 2.99 relate the individual value of the failure stress to the shear strength and the individual pre-compression stress value of each *triplet* of each type of masonry, according to the point 10 of standard NP EN 1052-3 (IPQ, 2005). The plots for all specimens are given in Annex VII.
