Collapse Shaking Table Test on a URM Cavity Wall Structural (LNEC-BUILD1) Representative of a Dutch Terraced House

**U. Tomassetti, A. A. Correia, F. Graziotti, A. I. Marques, M. Mandirola
and P. X. Candeias**

Eucentre

Date September 2017

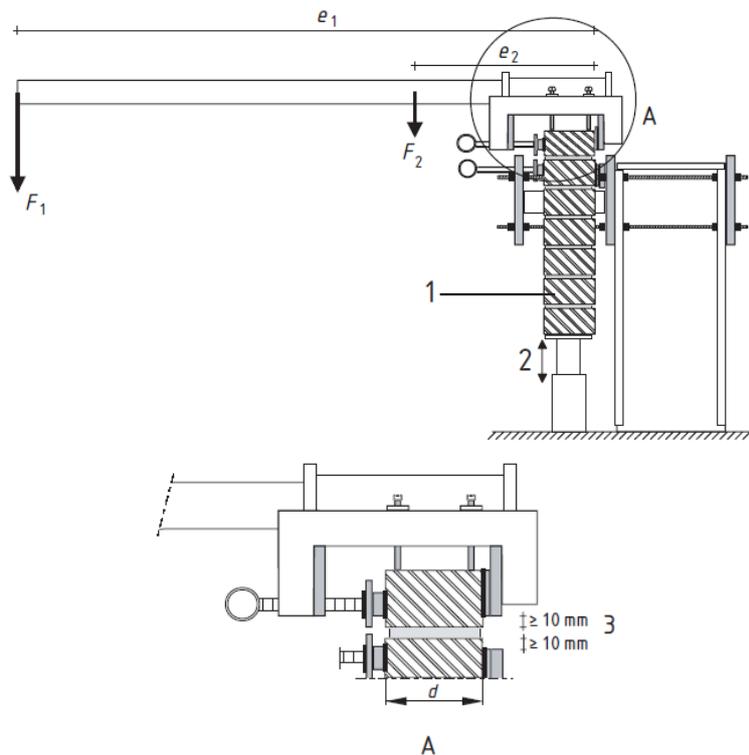
Figure 2.101 Example of a possible device for the test in accordance with EN 1052-5 (CEN, 2005).

The main idea of the test is to keep the specimen rigidly held while a clamp is applied to the top unit, see Figure 2.101. A bending moment is applied to the clamp by a lever until the top unit is torn from the remaining part of the specimen. From the stresses achieved by the specimen, the bond strength of the masonry can be evaluated.

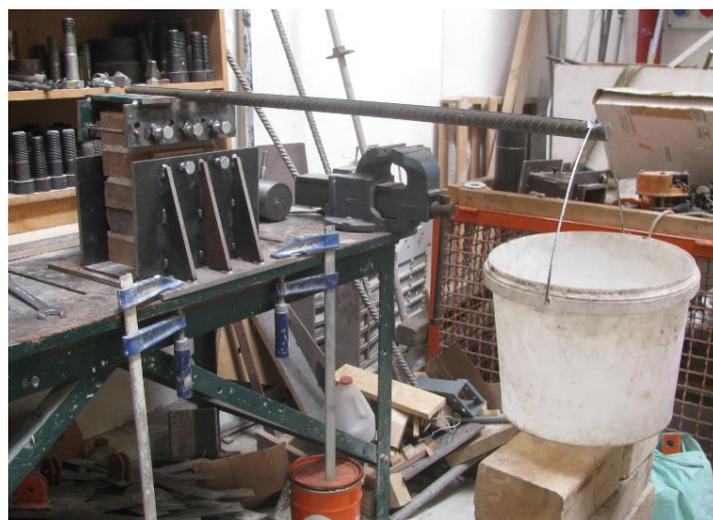
Figure 2.102 Device used for the test.

A device was created to carry out this test. It was modified during the test campaign, since initially a torque wrench with a memory needle for moment recording was planned to be used but in the end a horizontal bar was used instead. Figure 2.102 shows the final device, whose details can be found in Annex VI.

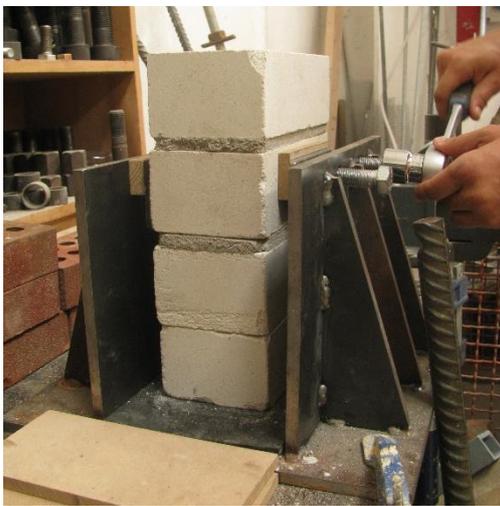
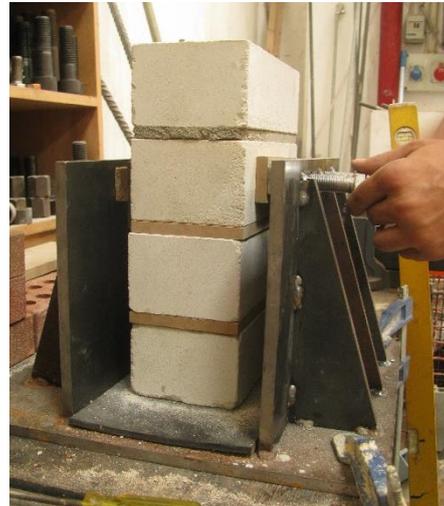
Figure 2.103 Test of the two connections in calcium silicate blocks using the same test device.

1. The lower frame was attached to a rigid plate and a position for the *triplet* was defined, according with the standard. The screws were clamping approximately with equal torque (it was used a ratchet torque wrench). Bricks and small pieces of timber were used with the thickness of the joints to ensure the same fixing height as defined in the standard. This was envisaged for two reasons: i) since the lower structure is common to the two types of *triplets* that have different heights; and ii) so that after the first failure of the connection the specimen could be raised to the required height, allowing the second connection to be tested, as shown in Figure 2.103 and Figure 2.104;

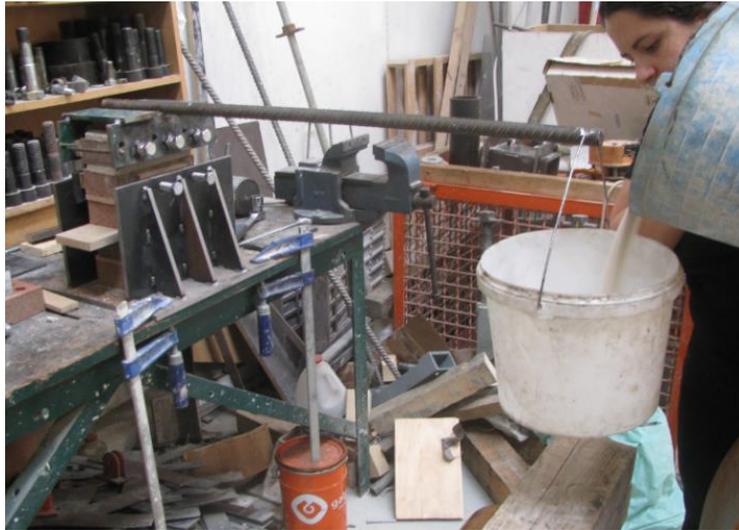
Figure 2.105 Application of vertical force until bond failure.

4. Apply the vertical force on the lever end that should be approximately 1 meter long as per indication of the standard. Sand pouring on a bucket was used for applying the vertical force up to a bond failure, as shown in Figure 2.105;

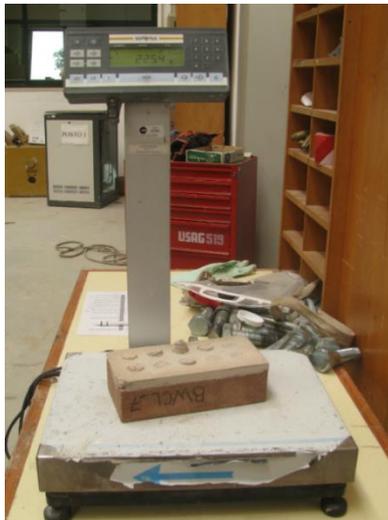
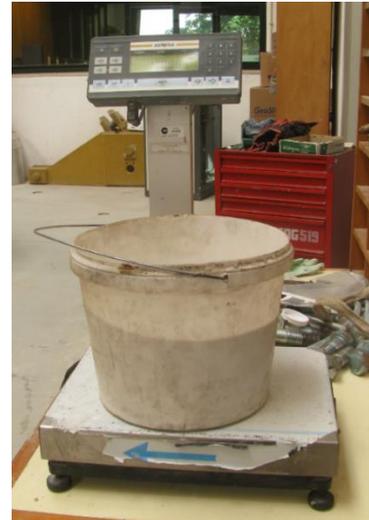
Figure 2.106 Measure of the weight of the top unit, its adherent mortar and sand volume leading to failure.

5. Weighing of the top unit, the adherent mortar and the sand volume (including the container) leading to a bond failure, as shown in Figure 2.106.

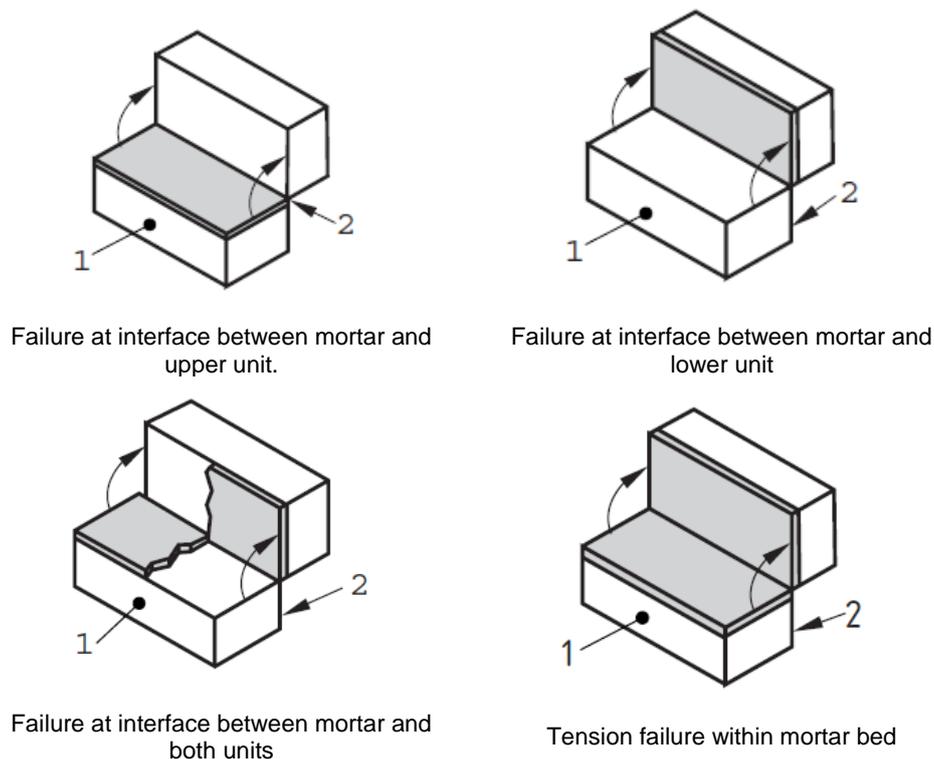
Figure 2.107 Admissible failure mechanisms for the bond wrench test.

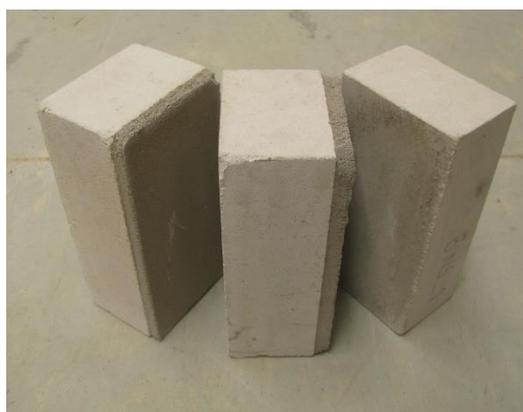
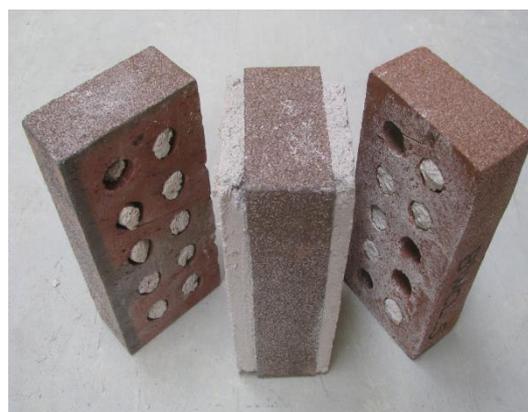
Figure 2.108 Example of failure mechanisms obtained for each triplet type in the bond wrench test.

Calcium silicate triplets

Clay triplets

The modes of failure represented in Figure 2.107 were considered valid to calculate the bond strength, according to EN 1052-5 (2005). The type of bond failure mechanisms obtained in the tests are those exemplified by Figure 2.108. In Annex V, the pictures for all tested specimens are presented.

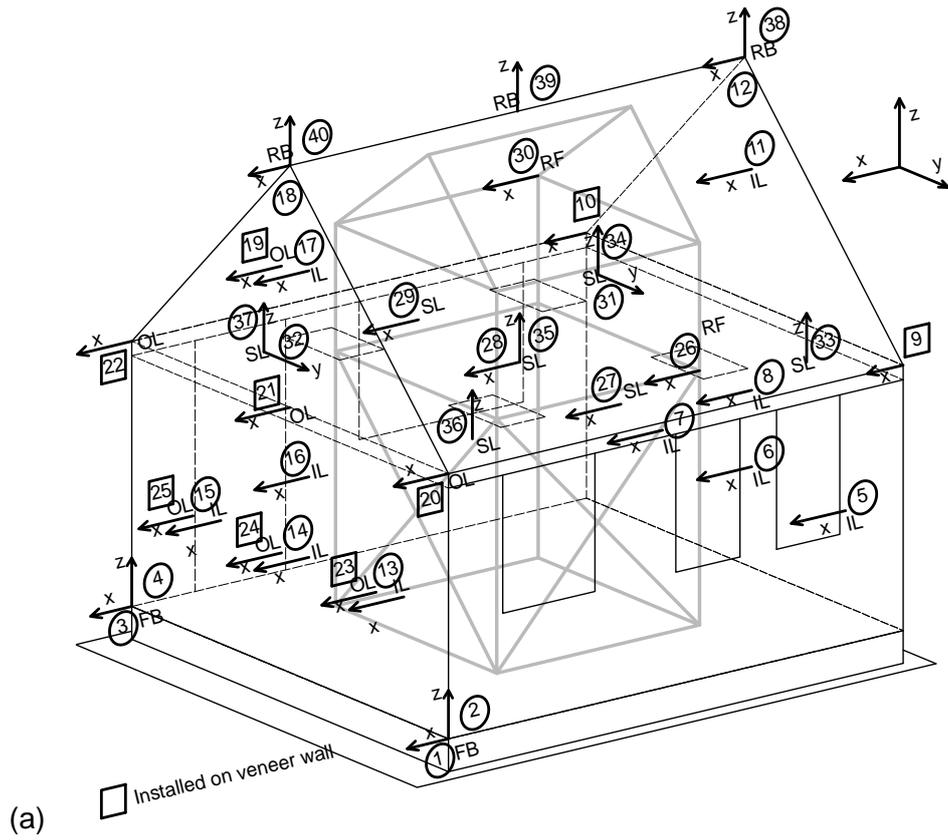
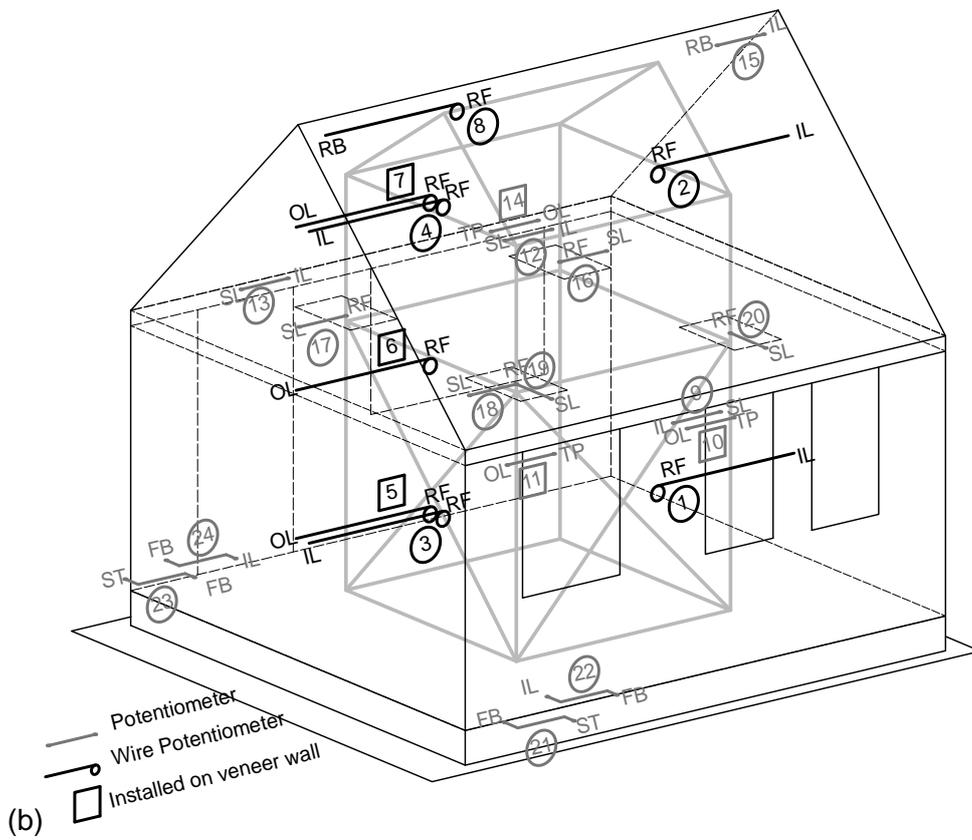
Figure 3.1 Locations of the instrumentation: accelerometers (a) and displacement transducers (b) (letters indicate the component at which the transducers is attached to: SL = slab, RF = reference frame, IL = inner leaf, OL = outer leaf, FB = foundation beam, ST = shaking table, TP = timber plate and RB = roof ridge beam).

Table 3.1 and Table 3.2 list the accelerometers and the displacement transducers, respectively describing their location in the specimen and the column (Col.#) identifying the recorded histories in the .txt files containing the test experimental data. The data is organised in matrix form and named in accordance to Table 4.1. The data acquisition time step is 0.005 s, columns 35 to 74 contain the acceleration time-histories recorded by the accelerometers mounted on the structure. The displacement histories recorded by wire potentiometers are listed in columns 9 to 16, while those recorded by traditional potentiometers are found in columns 17 to 32. Columns 1 to 8 contain the actuators read-out data, in terms of longitudinal (x direction), transverse (y direction) and vertical (z direction) displacements and accelerations. Columns 33 and 35 contain the actuators longitudinal and vertical forces. The last columns (75 to 90) contain quantities that were not directly measured, such as average floor displacements, total base-shear force and the inter-storey drift ratio time-histories. In general, the authors suggest to use these last sets of data (especially for the FEQ-300% when many instruments saturated). Table 3.1 specifies also the lumped mass associated to each instrument in computing the inertial forces. Table 3.3 specifies the content of all the remaining columns of the .txt files.

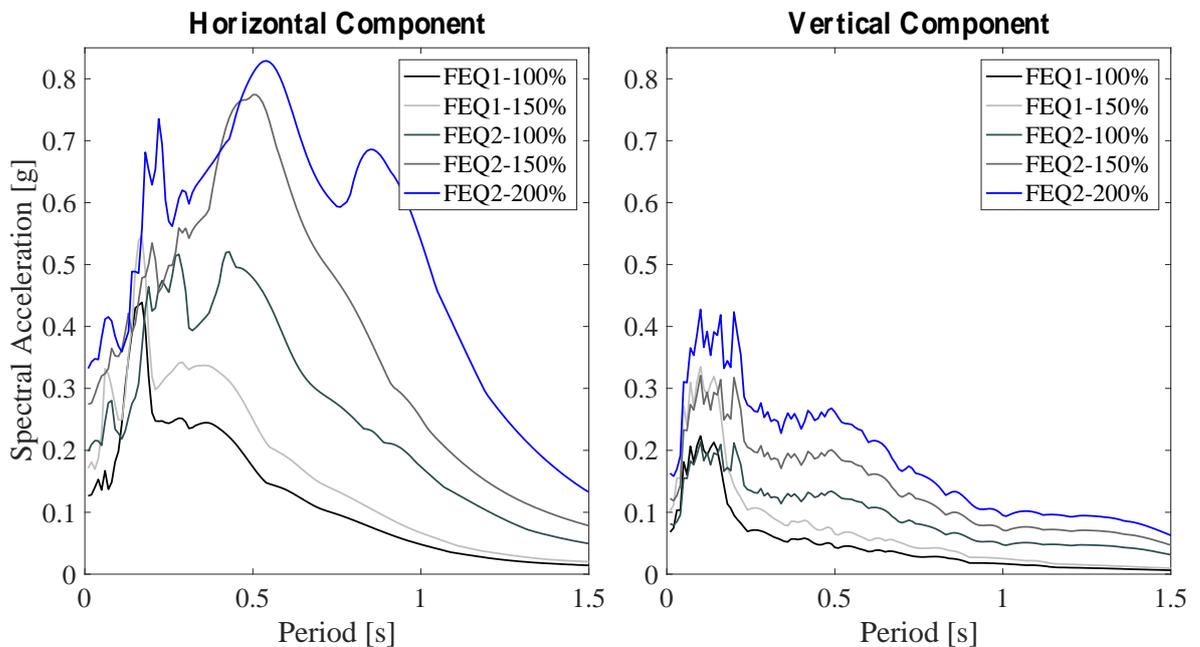
Figure 4.2 Theoretical horizontal and vertical 5% damped acc. response spectra of the experimental inputs.

Figure 4.2 shows the 5% damped acceleration response spectrum of the selected experimental inputs, which reflect the induced seismicity input already filtered by the dynamics of the EUCBUILD-1 specimen and of the shaking table system of EUCENTRE.

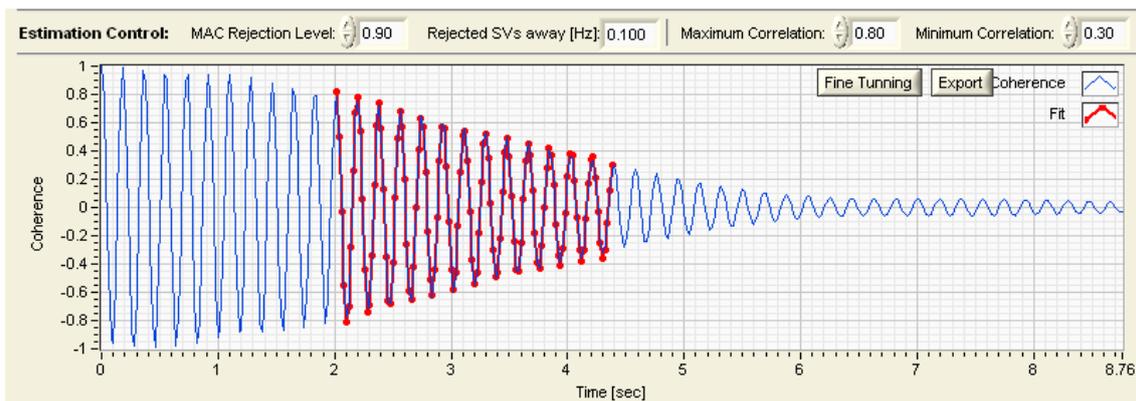
Figure 5.4 Frequency estimate (zero-crossings) and damping (logarithm decrement) of the impulse response estimate.

This method allows more accurate estimates of the vibration frequencies, since it is based on the adjustment to the zero-crossings of the auto-correlation function and not only on a peak value, which can be influenced by several factors such as frequency resolution. The modal damping can be obtained from the logarithmic decrement of the impulse response function, as shown in Figure 5.4.

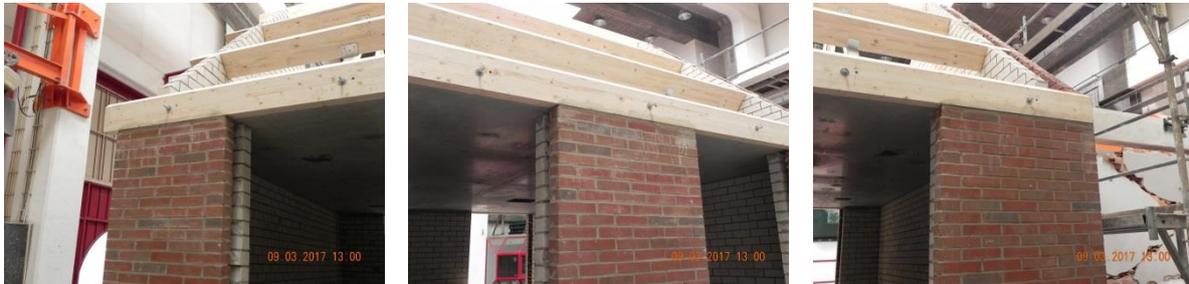
Figure 5.5 Joints filled with mortar.

Two weeks after placing the reinforced concrete slab on the load bearing walls, its temporary support was removed and the bed joint at the top of the walls with openings was filled with fresh mortar, as depicted in Figure 5.5.

As mentioned before, the weight of the slab is intended to be supported by the CS walls without openings only. When the temporary support of the slab was removed, the mortar layers at the connection of the slab to the blind walls had already hardened, but no additional vertical loads were applied to those walls other than their dead weight.

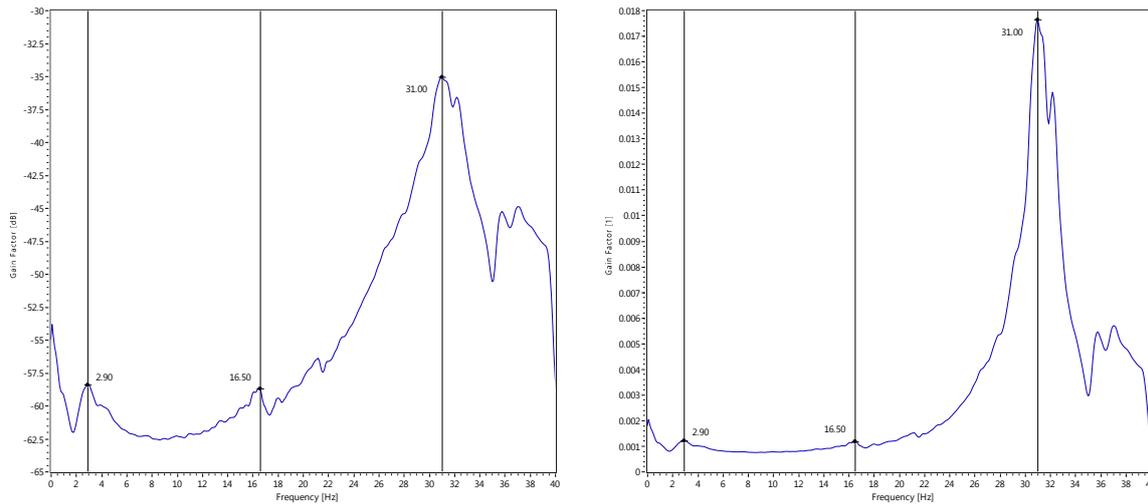
Figure 5.9 Frequency response function of East wall in decibel scale (left) and in linear scale (right), after removing the temporary support.

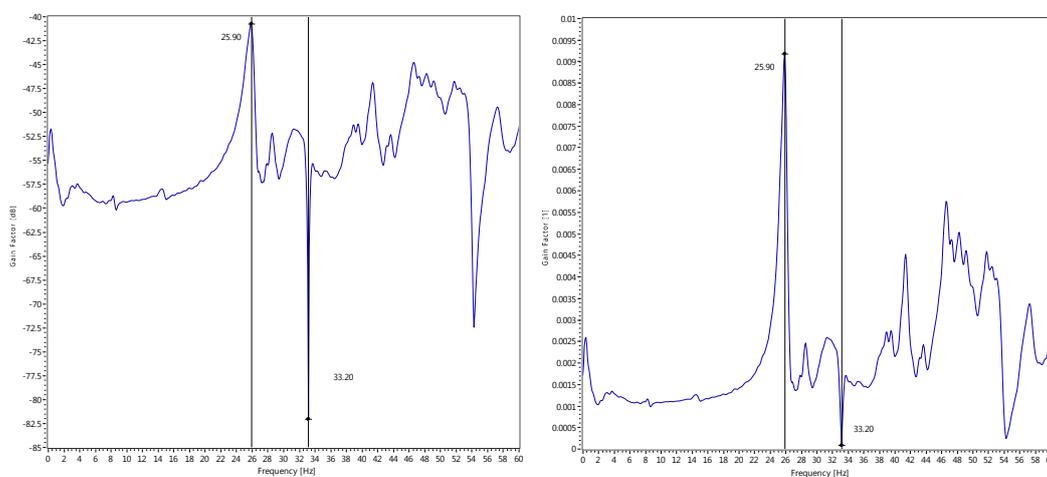
Figure 5.10 Frequency response function of West wall in decibel scale (left) and in linear scale (right), before removing the temporary support.

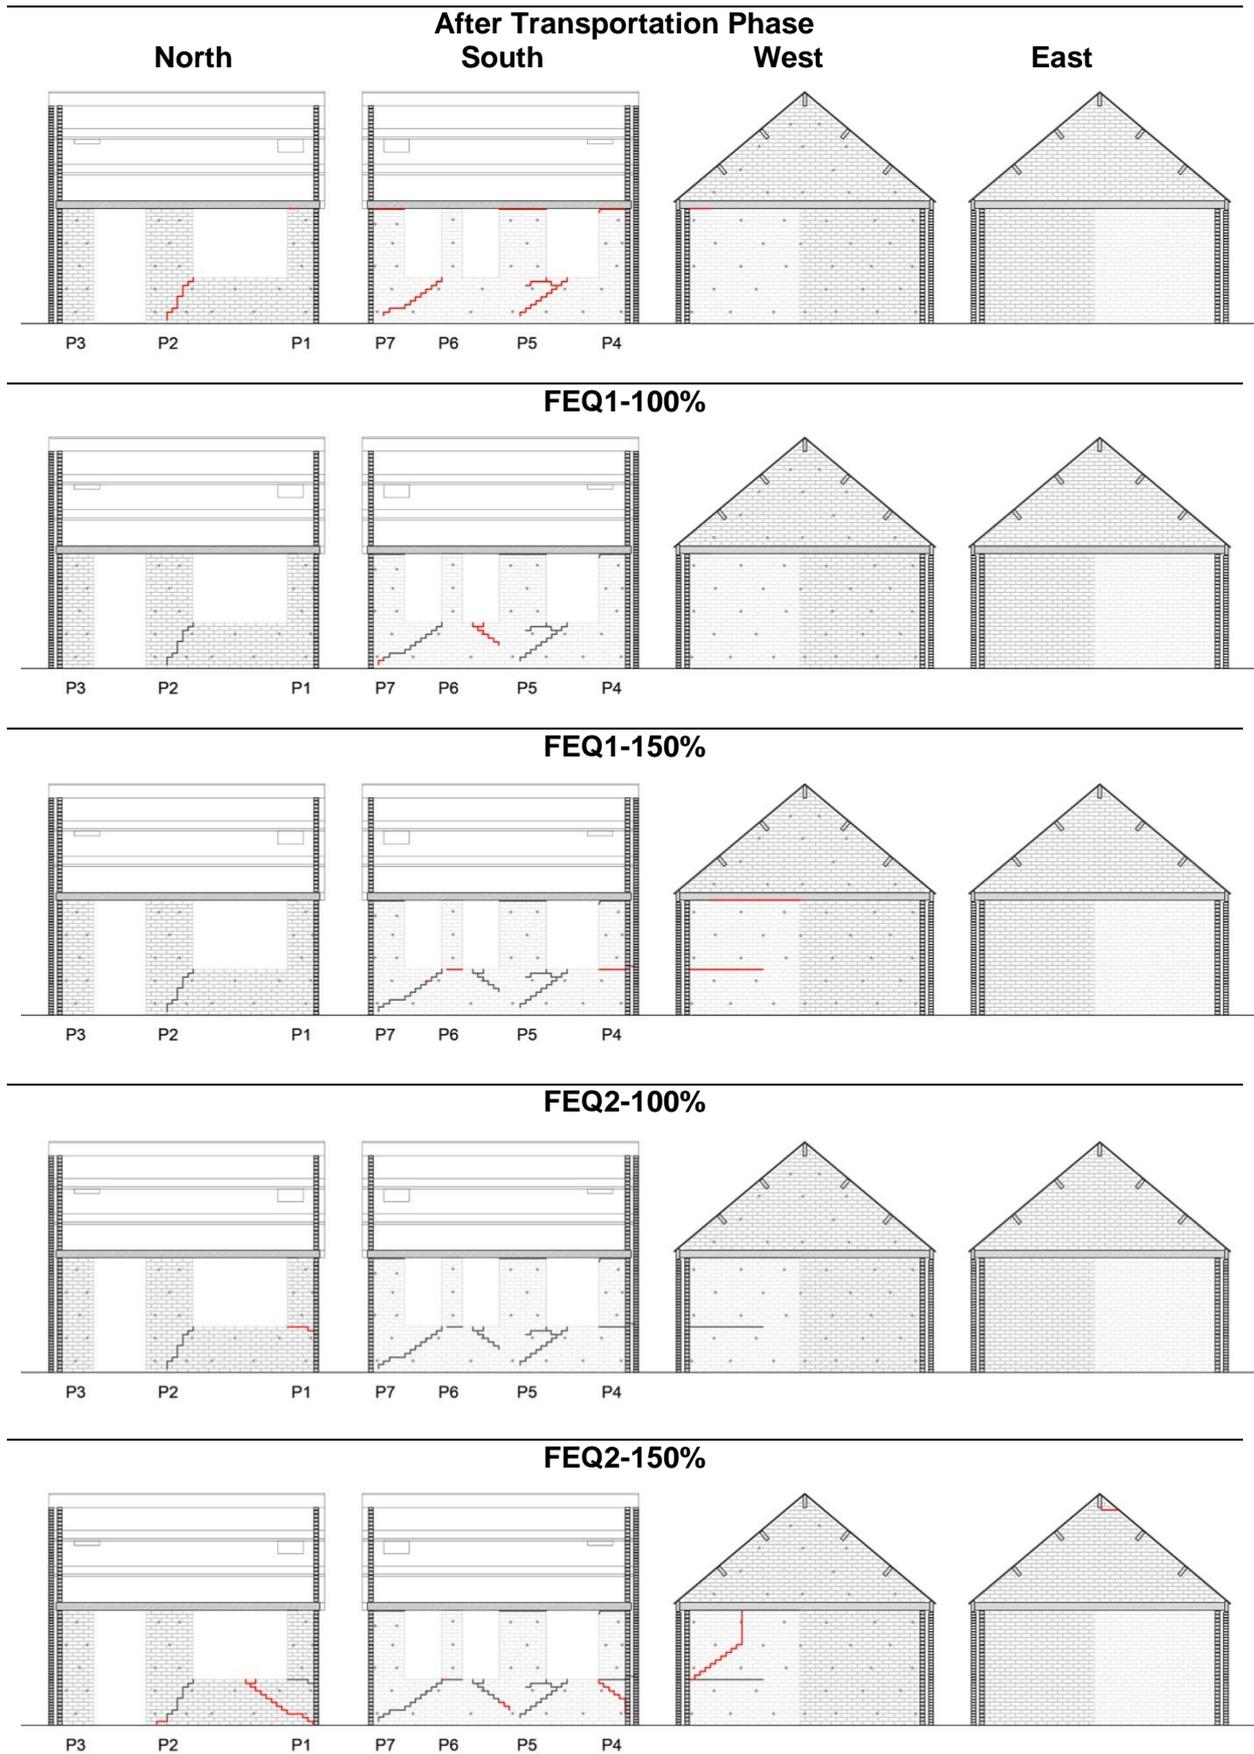
Figure 5.35 Evolution of the crack pattern in the Inner CS walls: up to test FEQ2-150%.

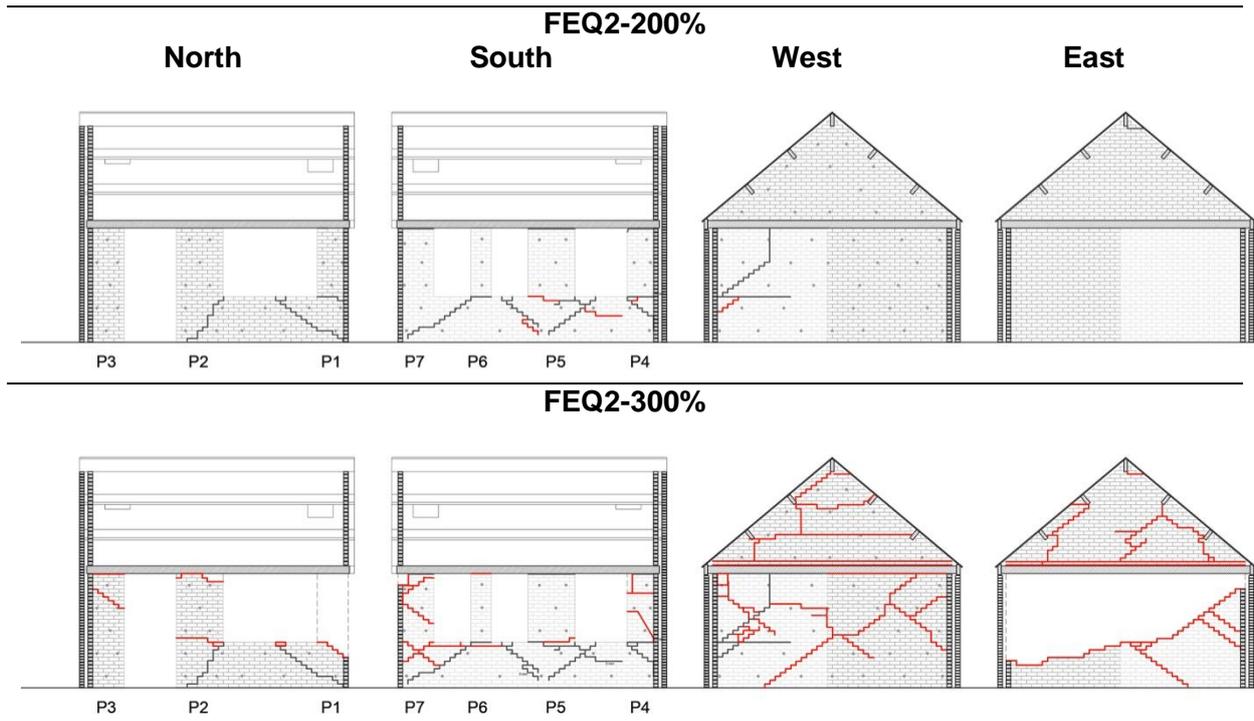
Figure 5.36 Evolution of the crack pattern in the Inner CS walls: from test FEQ2-200% to test FEQ2-300%.

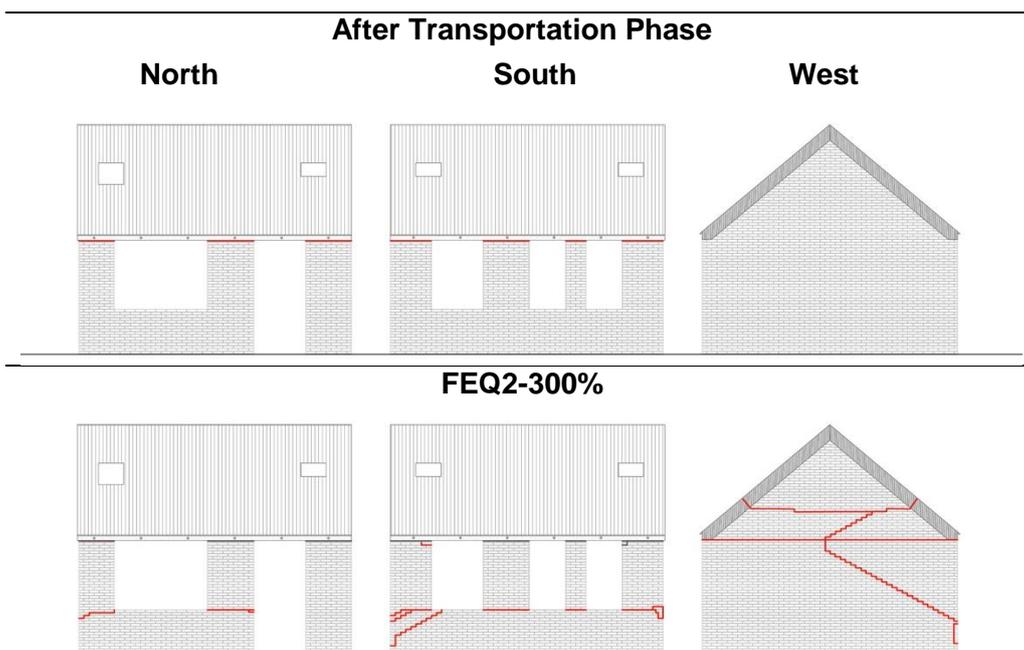
Figure 5.37 Evolution of the crack pattern in the outer clay veneer walls.

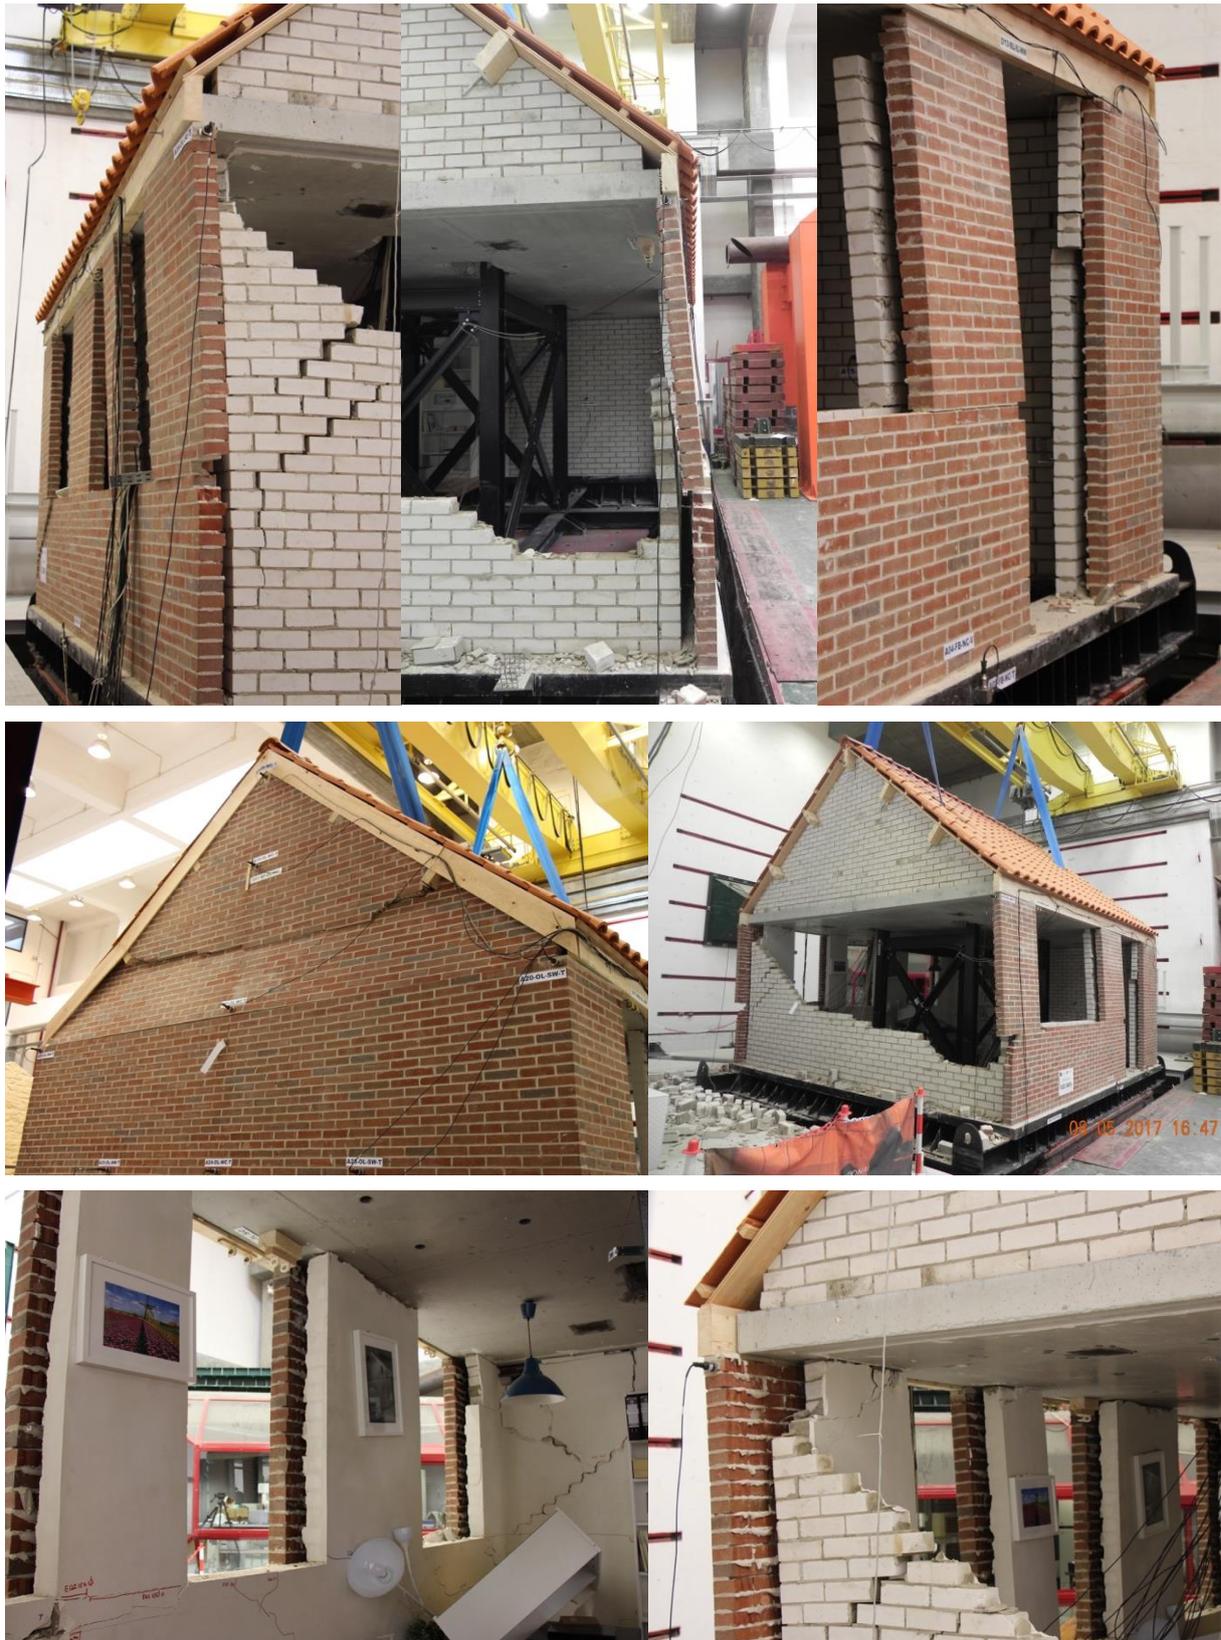
Figure 5.39 Pictures of the specimen at the end of the test FEQ-300%.

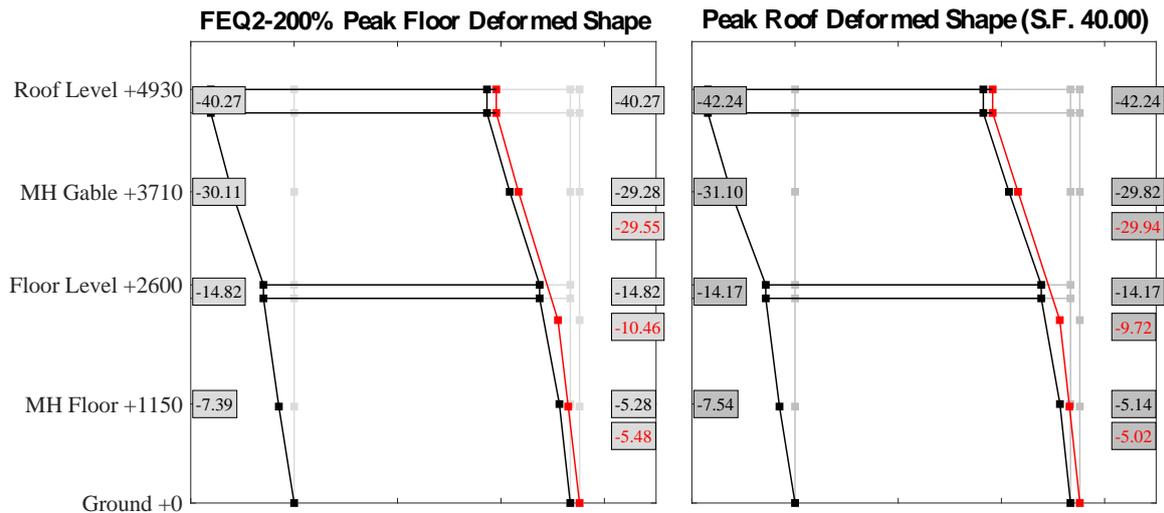
Figure 5.73 FEQ2-200%: Longitudinal cross section deflected shape.

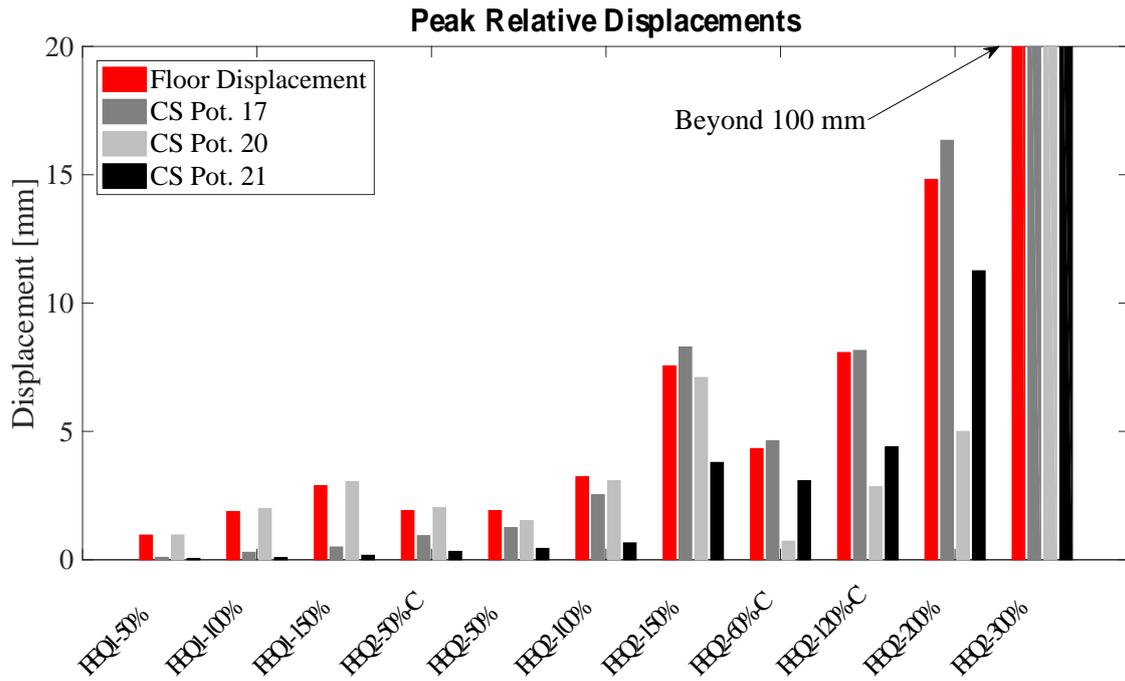
Figure 5.74 Differential displacement recorded between the top of the CS longitudinal piers and the RC slab.

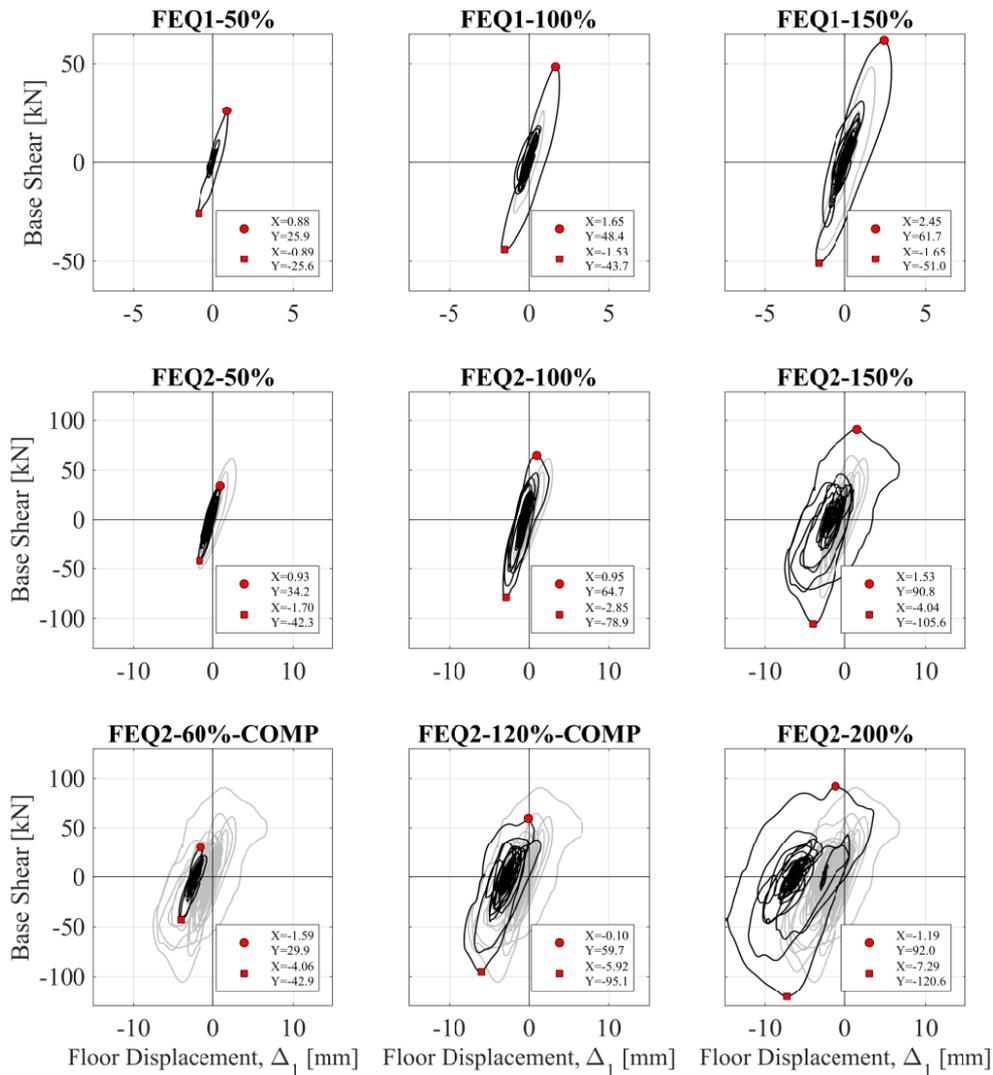
Figure 5.81 Evolution of specimen hysteretic response.

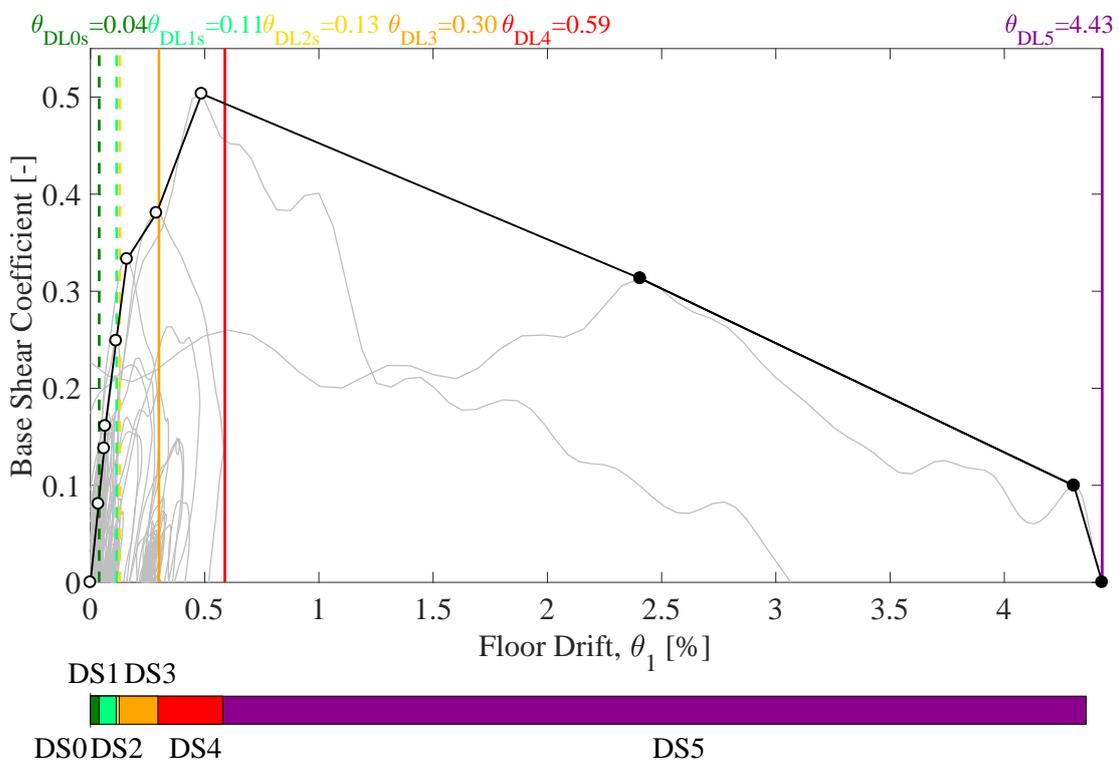
Figure 5.88 Identification of the DLs on the building backbone curve.

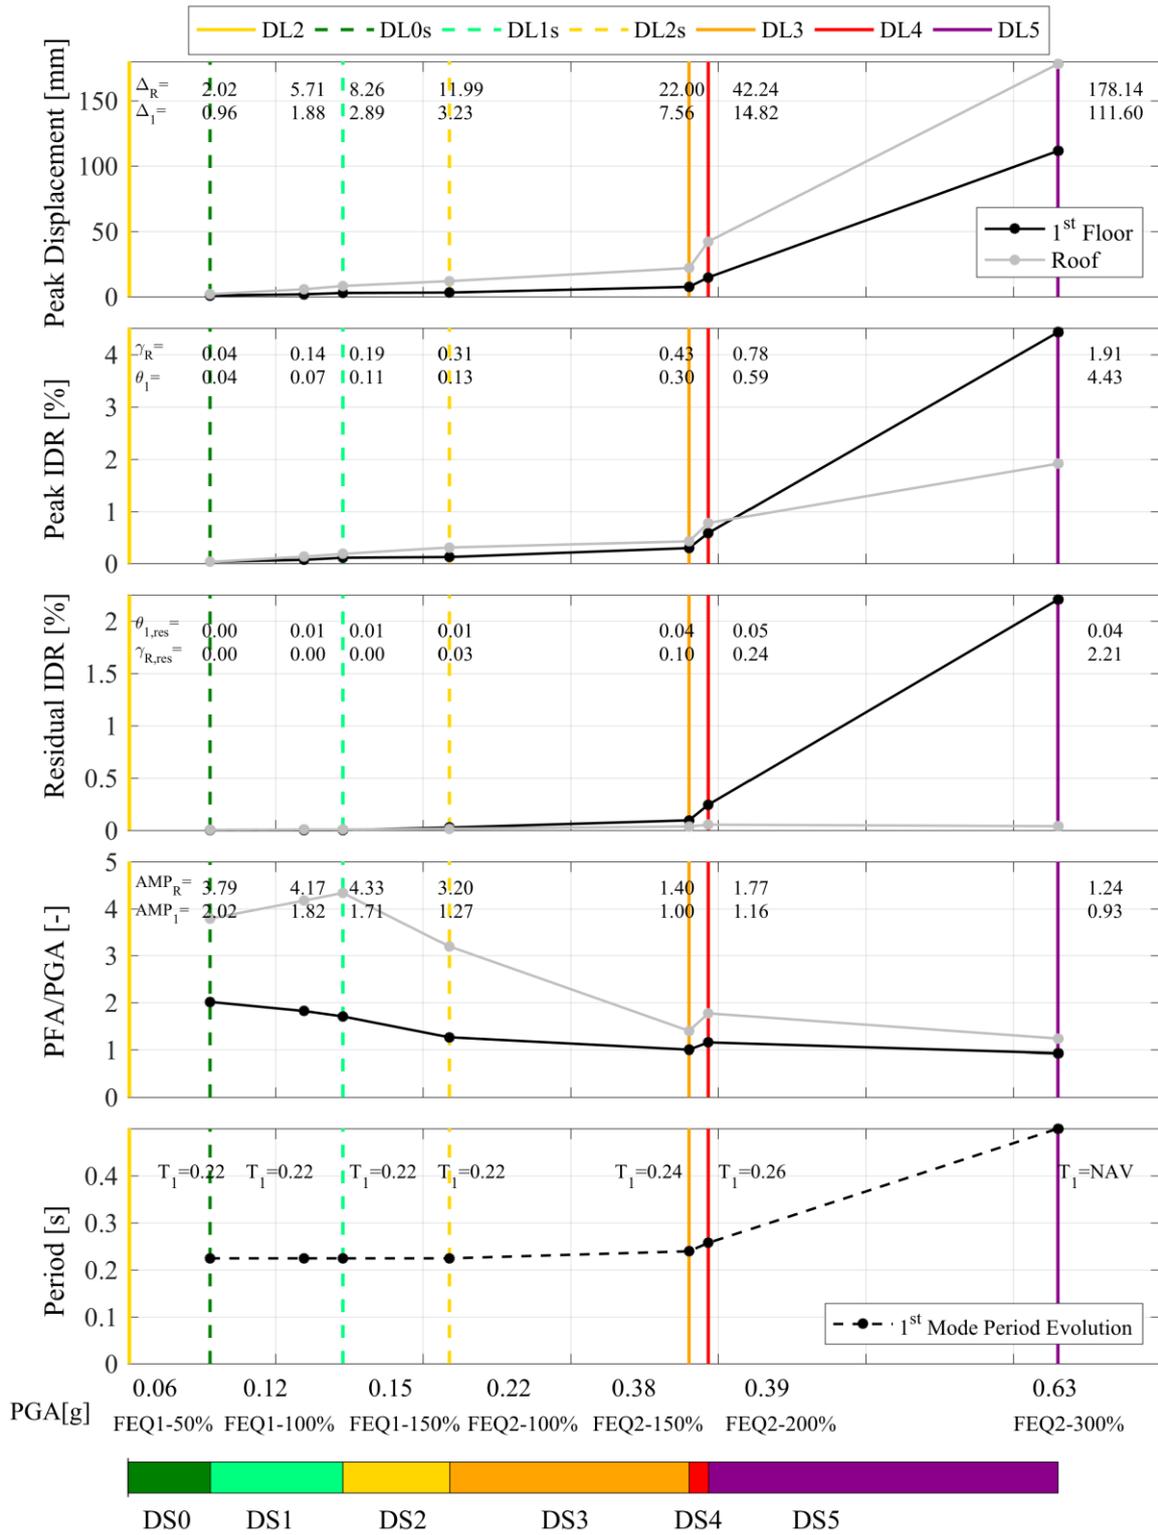
Figure 5.89 Summary of the performance of the building specimen.

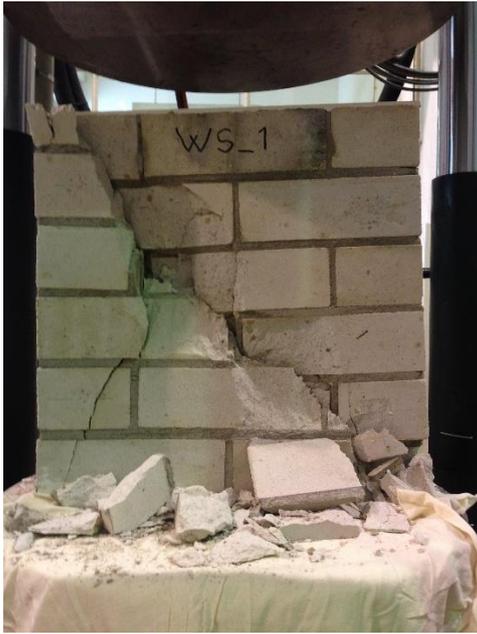
Wallette WS_1 – front side

Failure mechanisms of calcium silicate *wallettes* for compressive strength tests:

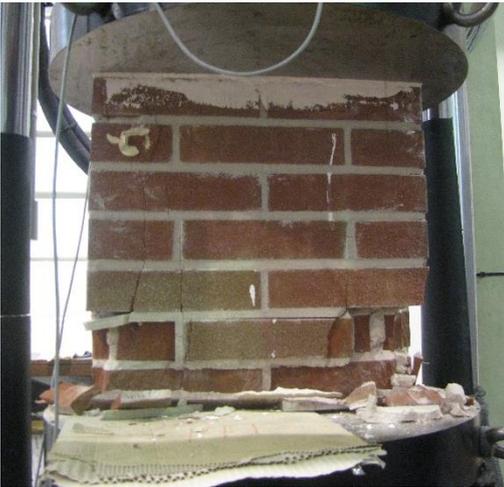
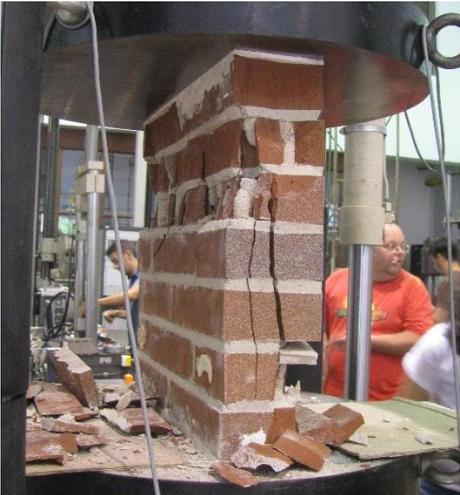
Wallette WCL_1 – front side

Failure mechanisms of clay *walletes* for compressive strength tests:

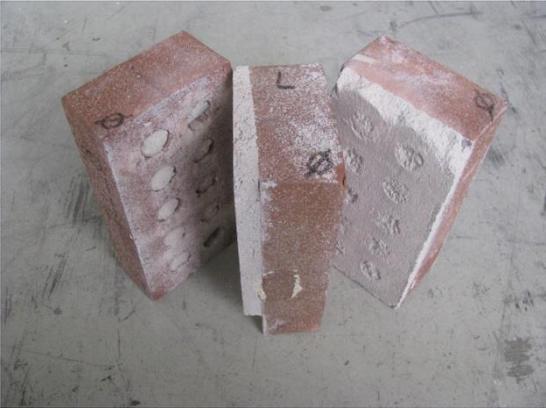
Triplet TCL_0

Failure mechanisms of clay triplets for shear strength tests:

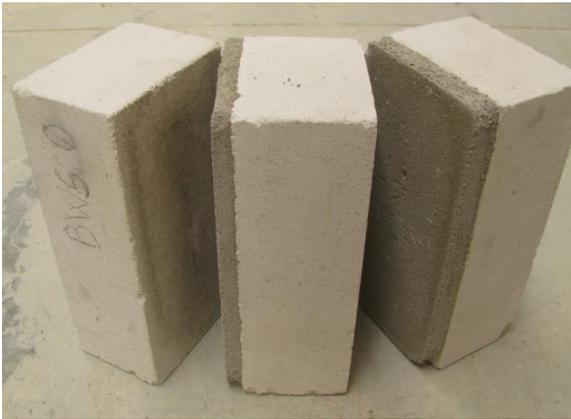
Triplet BWS_0

Failure mechanisms of calcium silicate triplets for bond wrench tests:

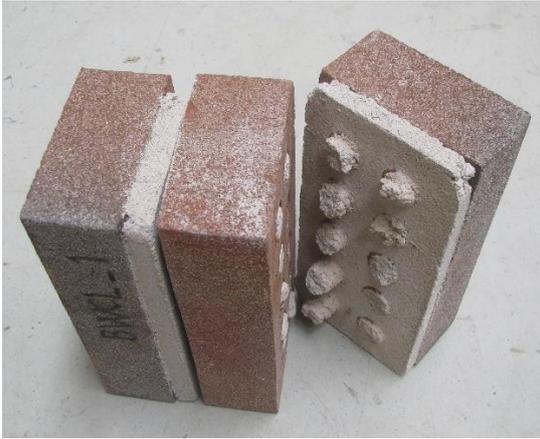
Triplet BWCL_1

Failure mechanisms of clay triplets for bond wrench tests:
