Material Characterisation Version 1.3 Report

EUCENTRE – P&P – TU Delft – TU Eindhoven

Datum January 2016

MATERIAL CHARACTERIZATION

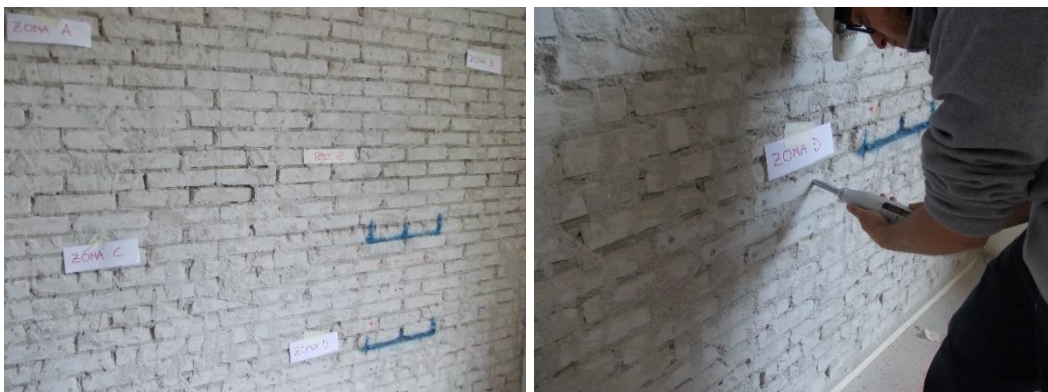
The instrument used to perform the test is the Schmidt Rebound Hammer N type (impact energy = 2.207 Nm) (Figure 1).

Figure 1. Rebound Hammer Test: identification of the 4 zones (left) and performance of the test (right).

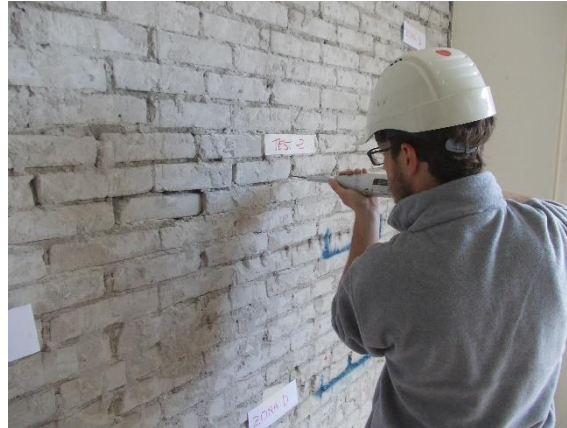
The results of the test can be correlated to the compressive strength of the mortar.

Figure 2. Penetrometric Test on Mortar.

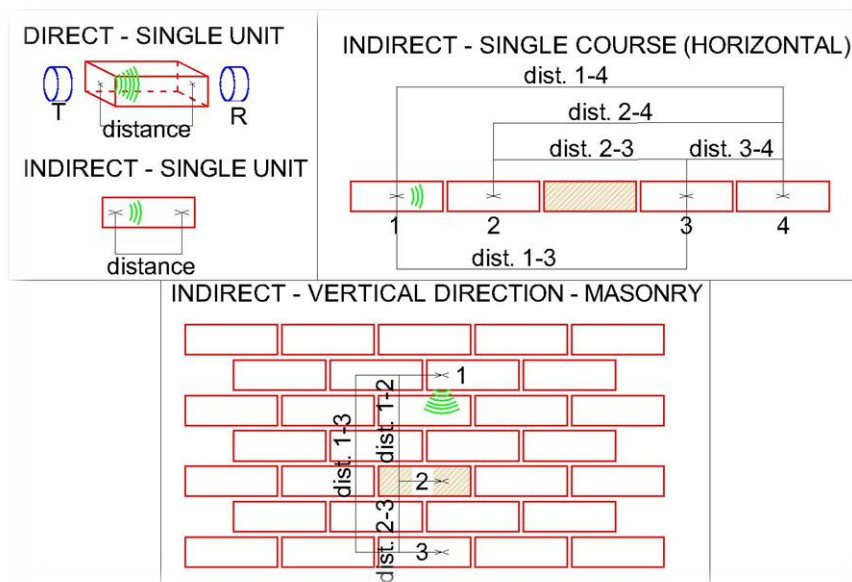
- Direct if the transmitter and the receiver are aligned one opposite to the other, with the sample in between;
- Indirect if the transmitter and receiver are positioned on the same plane (*e.g.* same wall side).

Figure 3. Ultrasonic Test: direct and indirect single unit configuration (top left) indirect horizontal configuration (top right) and indirect vertical configuration (bottom).

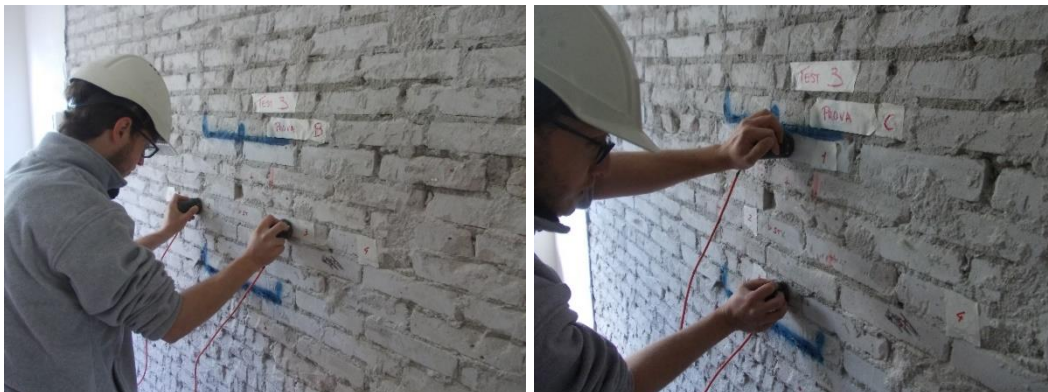
Figure 4. Ultrasonic Test: indirect horizontal configuration (left) and indirect vertical configuration (right).

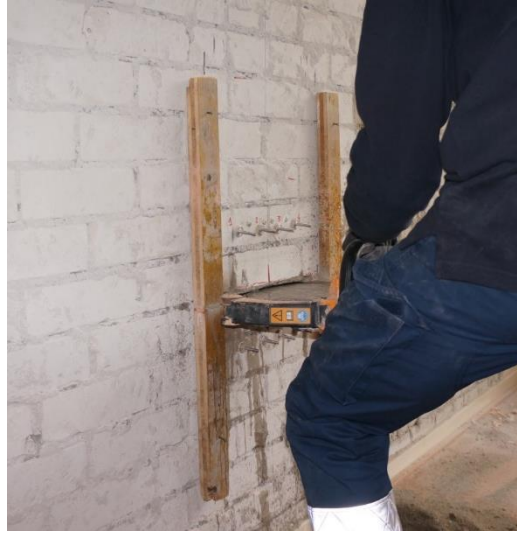
The test is based on the idea of cutting a slot in a masonry bed joint (Figure 5). Four couples of points across the slot are selected before the cutting and their distance is measured (Figure 6). Consequently to the cut of the slot the compressive stress acting on the slot will cause a reduction of thickness of the slot, i.e. reduction of the distance of the couples of points. At this point a flat jack is inserted in the slot and oil is pumped in to increase the pressure, when the original thickness of the slot is restored it means that the pressure in the flat jack equalized the compressive stress in the wall.

Figure 5. Single Flat Jack Test: cutting of the slot in the masonry wall.

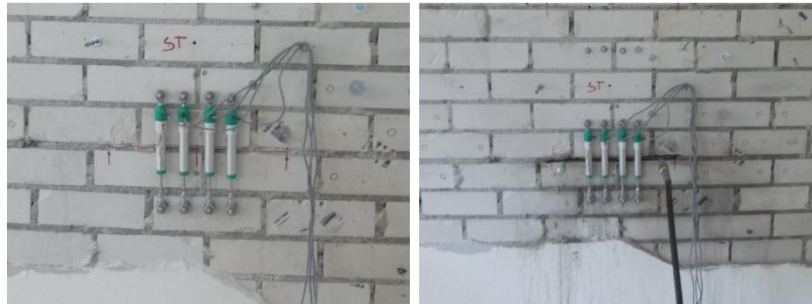
Figure 6. Single Flat Jack Test: measurement of the point distance (left) and performance of the test (right).

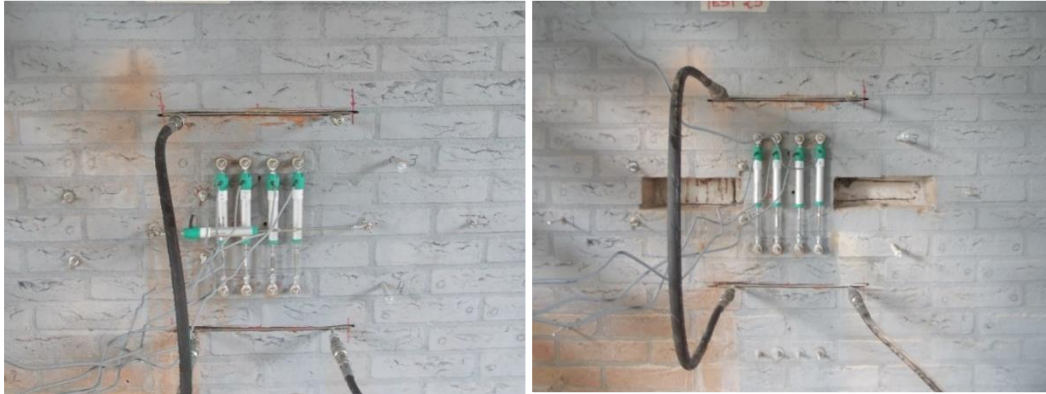
The test is performed in two different configurations: the “standard configuration” (Figure 7 left) and in the “Shove Test configuration” (Figure 7 right). The latter of the two is necessary for the interpretation of the Shove Test

Figure 7. Double Flat Jack Test: “standard configuration” (left) and “Shove Test configuration” (right).

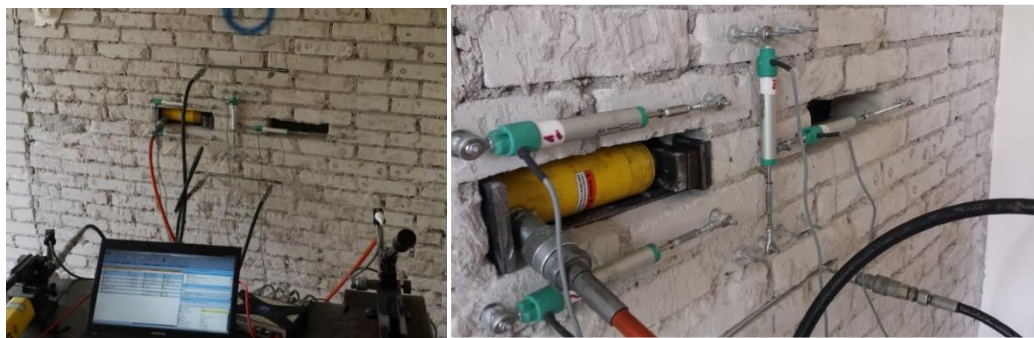
The test is usually performed after the Single and Double Flat Jack test. The flat jacks used for the latter are kept into place, a masonry unit is selected as reference and the two units on the side are removed (Figure 8). At this point a horizontal jack is inserted on one side of the brick and a horizontal LVDT is installed to record horizontal displacements of the reference unit. By controlling the vertical compression stress using the flat jack and the horizontal force it is possible to obtain several couple of points vertical compressive stress/shear stress. Plotting this point in a graph and performing a linear regression it is possible to obtain the value of cohesion and friction coefficient of the masonry material.

Figure 8. Shove Test: setup.

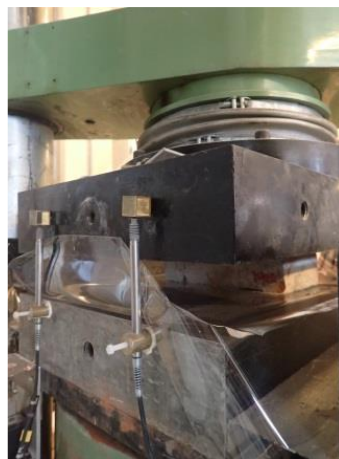
The test is performed to measure the compressive strength, $f_{mu,c}$, the normalised compressive strength, $f_{bu,c}$, and also the elastic modulus, $E_{mu,c}$, of masonry units.

Figure 9. Compression Test on Masonry Unit.

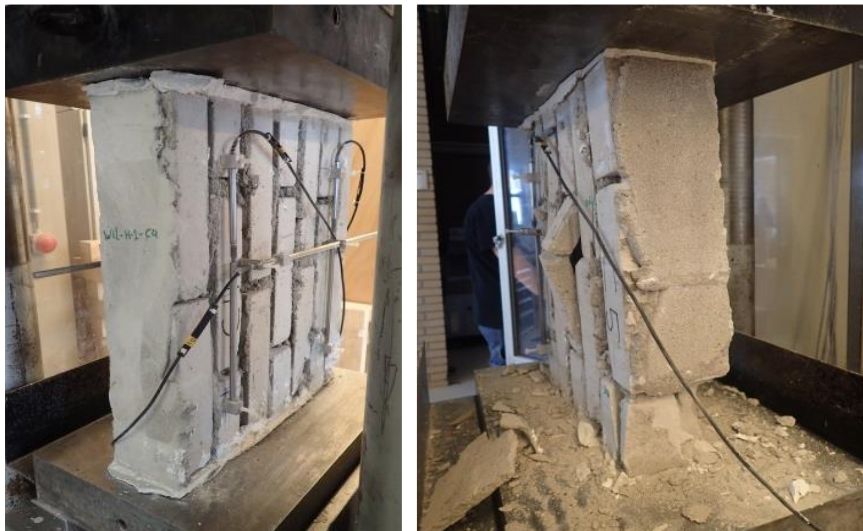
In this test the masonry samples is tested with the mortar bed joints parallel to the direction of application of the force (Figure 11). The test allows the calculation of different mechanical parameters like: the compressive strength of masonry for horizontal configuration $f_{m,h}$, the secant Young's modulus in the horizontal direction evaluated at 30% of the ultimate strength $E_{m1,h}$ and at 70% of the ultimate strength $E_{m2,h}$, the horizontal Young's modulus evaluated in the stage between the 30% and 70% of the ultimate strength $E_{chord,h}$ and finally the fracture energy G_{c-f} .

Figure 11. Horizontal Compression Test on Masonry Samples.

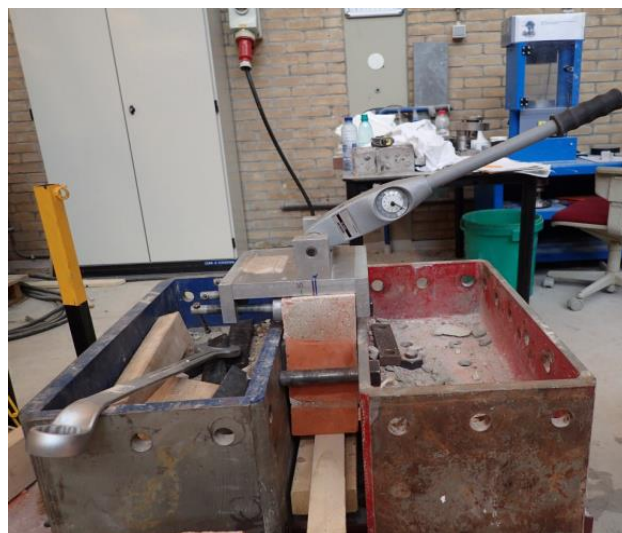
The test is performed to investigate the bond wrench strength of the bed joints, $f_{b,bj}$.

Figure 13. Bond Wrench Test.

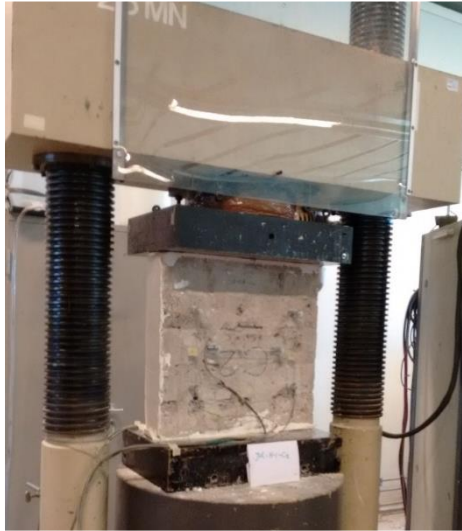
The test is performed to calculate the vertical elastic modulus of the masonry material $E_{m,v}$ as well as the compressive strength $f_{m,v}$. The mechanical parameters obtained from the test can be directly compared to the ones obtained from the Double Flat Jack Test performed in.situ.

Figure 14. Vertical Compression Test on Masonry Samples.

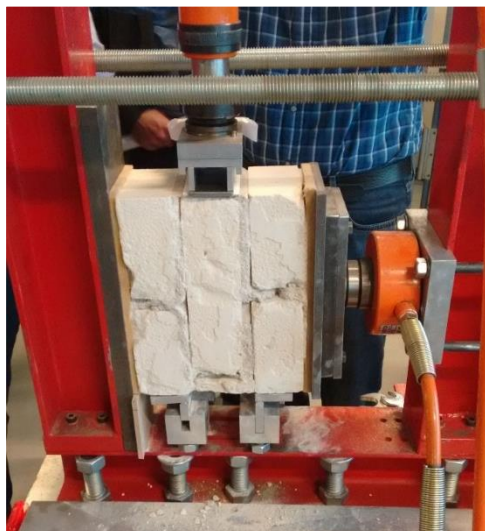
The tests allows the calculation of the bed joint shear strength parameters for the Coulomb criterion, i.e. cohesion τ_0 and friction coefficient μ . The results of this test can be directly compared with the results of the Shove Test performed in-situ.

Figure 15. Shear Triplet Test.

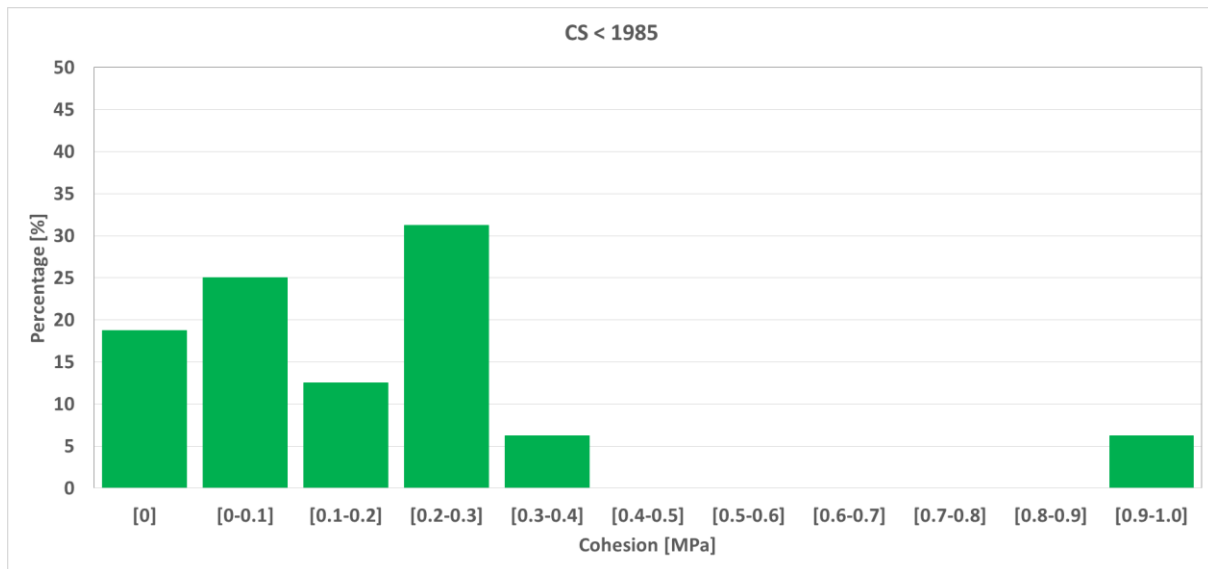
Figure 18. Cohesion distribution for Calcium Silicate < 1985 masonry typology.

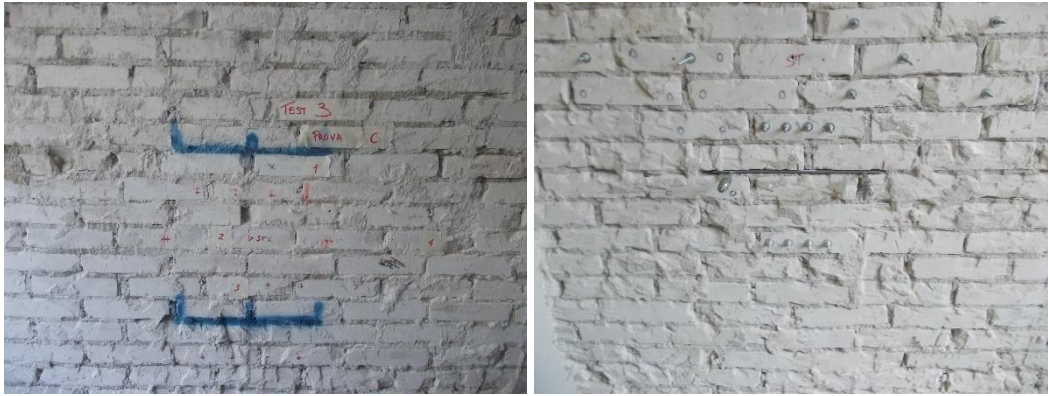
Figure 19. Example of Poor Quality masonry for the Calcium Silicate < 1985 typology.

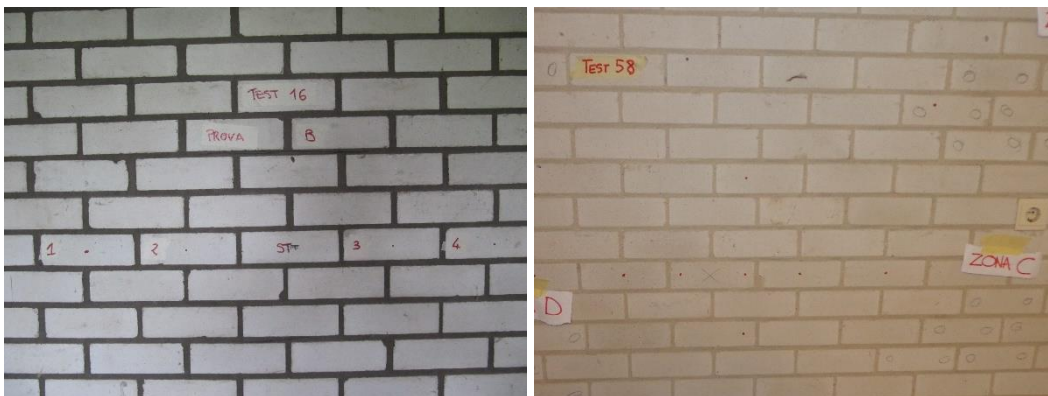
Figure 20. Example of Good Quality masonry for the Calcium Silicate < 1985 typology.

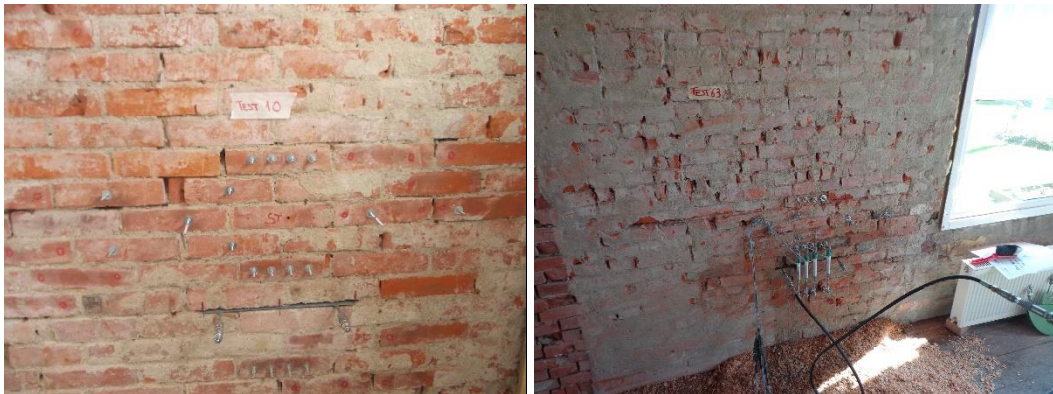
Figure 27. Example of Poor Quality masonry for the Clay < 1945 typology.

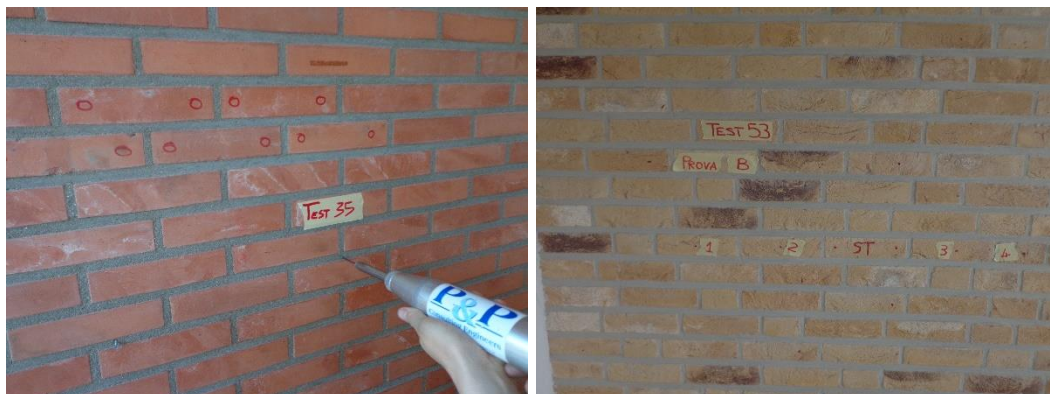
Figure 32. Example of Newer Units masonry for the Clay > 1945 typology.

Despite the limited variability of this masonry typology it is possible to identify some sub typologies that are here presented. It was observed that in several buildings belonging to this group the test location showed “newer” masonry units with a really good layout and perfectly filled joints we refer in particular to: KWE-H-2, ROE-S-3 and HOO-H. The test performed in these three structures have been grouped in a sub typology called “Newer Units” (Table 8, Figure 32). In the remaining structures it is visible that the masonry walls were built in an older period. The latter can be divided according to the layout and the masonry units in three sub typologies. The first sub typology is called “Older Poor Quality” (Figure 33) and it groups the location where a poor quality masonry was found, this group includes test location found in the building: BEA-S-1 and location 42 of the structure ROE-S-2. The second group is the one including all the Test of the structure BEA-S-2 where particular masonry units were found. The latter are characterized by a well-defined shape and a dark colour, from the extraction of masonry sample from the wall it was possible to see that these units are hollow core and not solid. This sub-typology was labelled with the name “Older Dark Good Quality” (Figure 34). The fourth and final sub typology was called “Older Good Quality” (Figure 35) and includes the locations 41, 43 and 44 of the structure ROE-S-2. As expected the subdivision of the main material typology Clay > 1945 in four sub typologies leads to a reduction of the scatter in the results for each single typology.

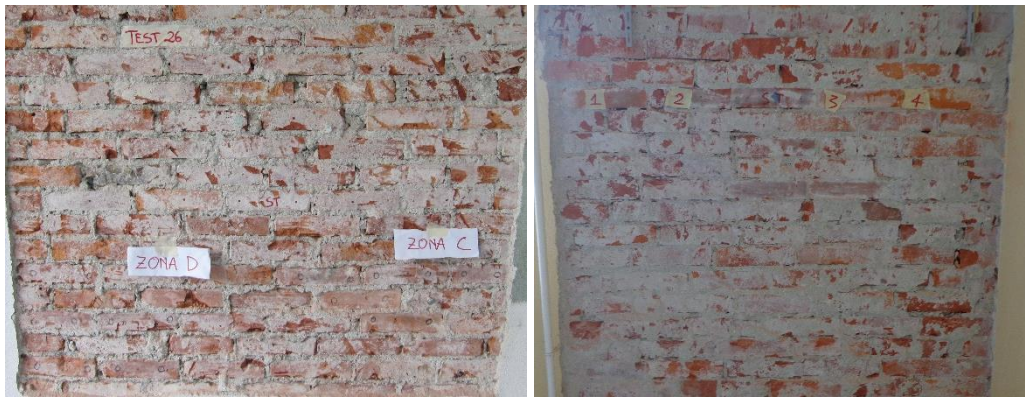
Figure 33. Example of Older Poor Quality masonry for the Clay > 1945 typology.

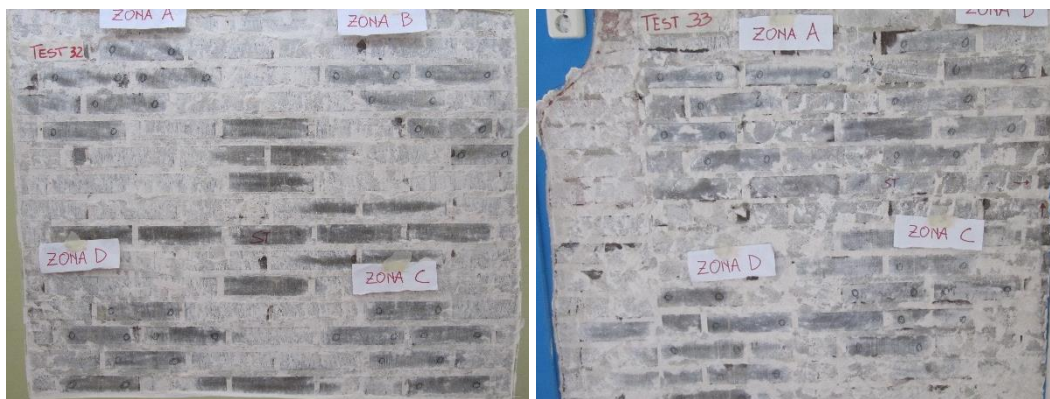
Figure 34. Example of Older Dark Good Quality masonry for the Clay > 1945 typology.

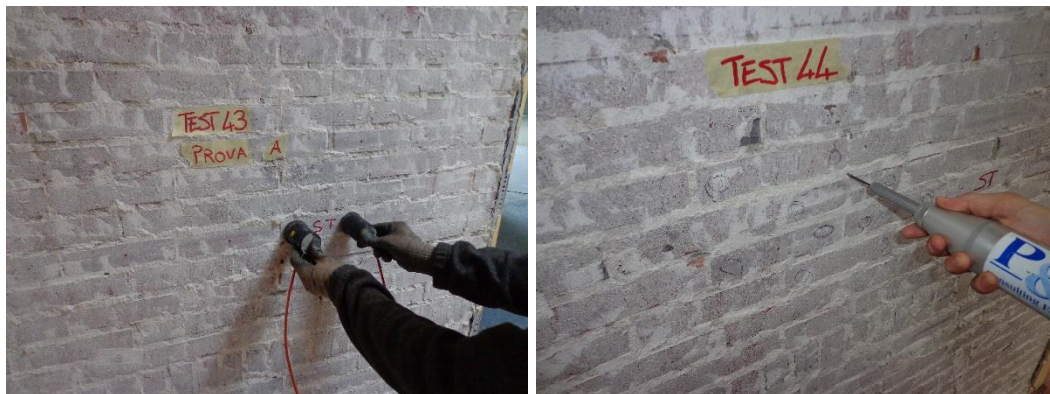
Figure 35. Example of Older Good Quality masonry for the Clay > 1945 typology.

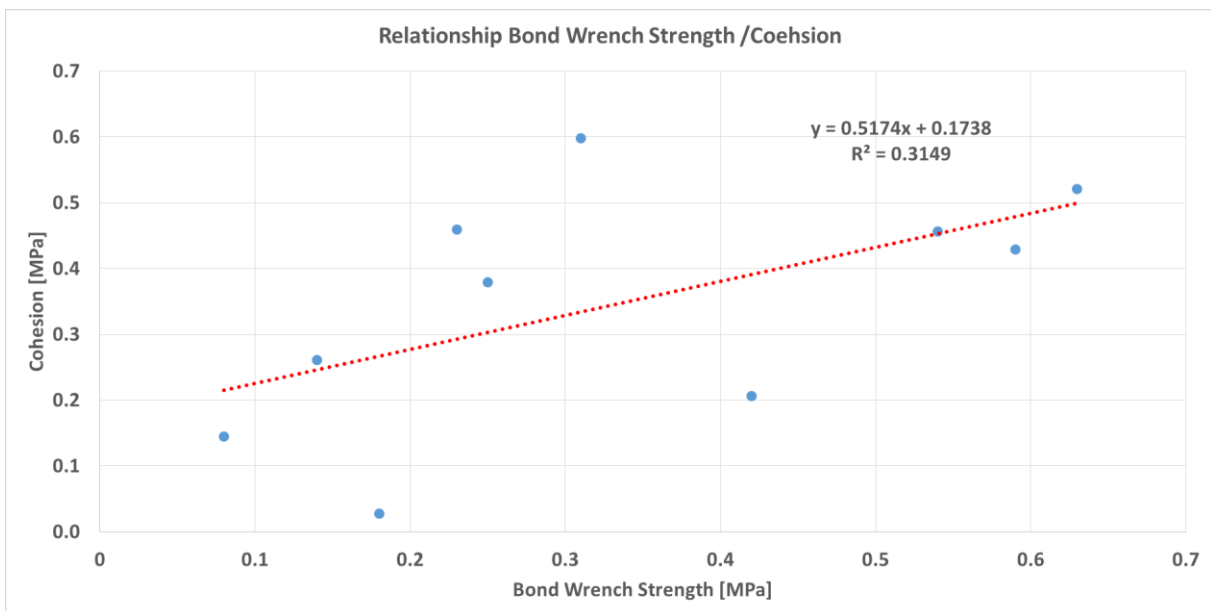
Figure 45. Correlation between the results from the Bond Wrench Test and the Cohesion.
