# **Experimental campaign on cavity walls systems representative of the Groningen building stock**

**Alberto Pavese, Francesco Graziotti and Guido Magenes**

**Eucentre**

Date June 2016

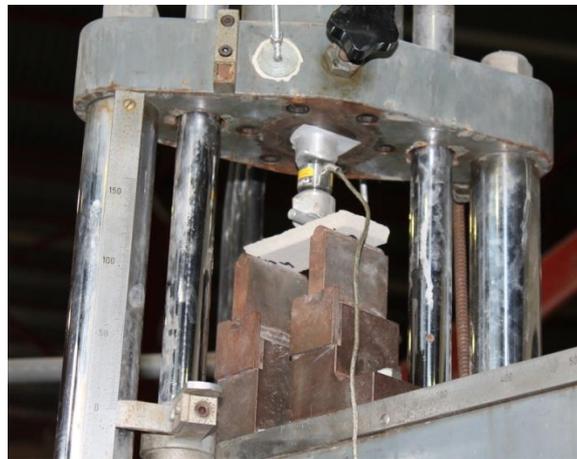
The specimens were loaded in bending and the resulting two broken parts were subsequently loaded in compression, adapting the procedure of the EN 1015-11 to this geometry.

*Figure 7. Bending Test on the mortar specimens taken "in-situ".*

The bending test on the samples gives information on the tensile strength, while the compression test allow to compute the compressive strength of the mortar.

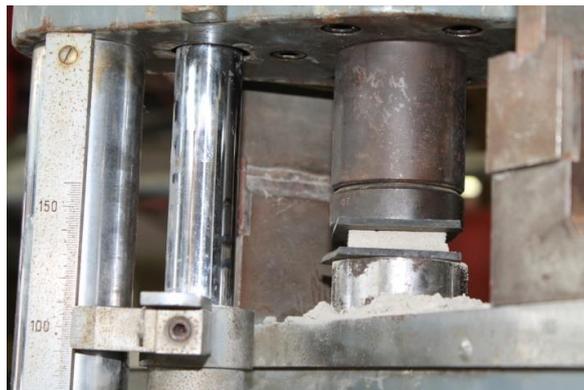
*Figure 8. Compressive Test on half specimen of the mortar taken "in-situ".*

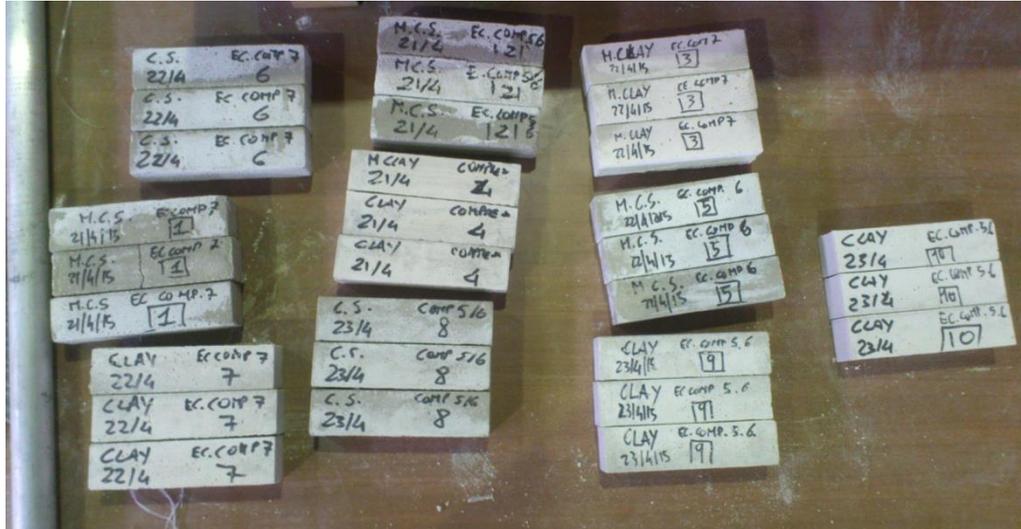
The samples of mortar were casted during the constructions of masonry walls and specimens used for the in-plane and out-of-plane tests as well as others tests on smaller specimens (e.g. wallettes for the compressive test on the masonry).

Figure 10. View of the mortar specimens.

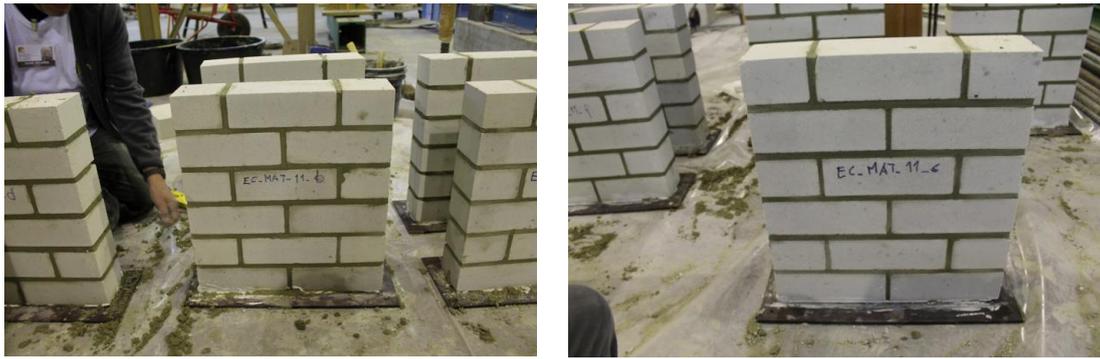
Figure 24. View of the C.S. masonry wallettes

The date of construction of the masonry wallettes (Specimens EC\_MAT\_11\_a/b/c/d/e/g) was 25/3/2015. The compression tests were performed from 22<sup>nd</sup> April 2015 to 4<sup>th</sup> May 2015.

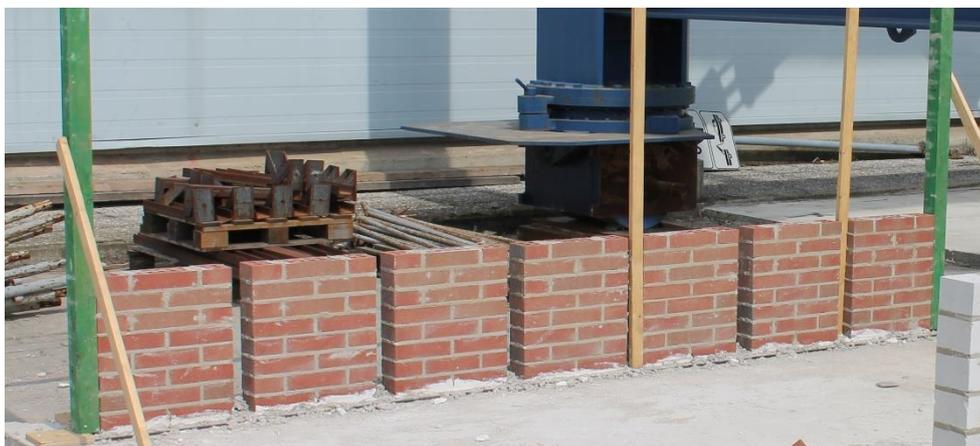
Figure 38. View of the Clay Masonry wallets (EC\_MAT\_21\_a/g).

The date of construction of the masonry wallets (Specimens EC\_MAT\_21\_a/g) was 21/4/2015. The compression tests were performed the 10-29/6/2015.

Figure 38 shows also the instrumentation adopted and the brick texture of clay wallets.

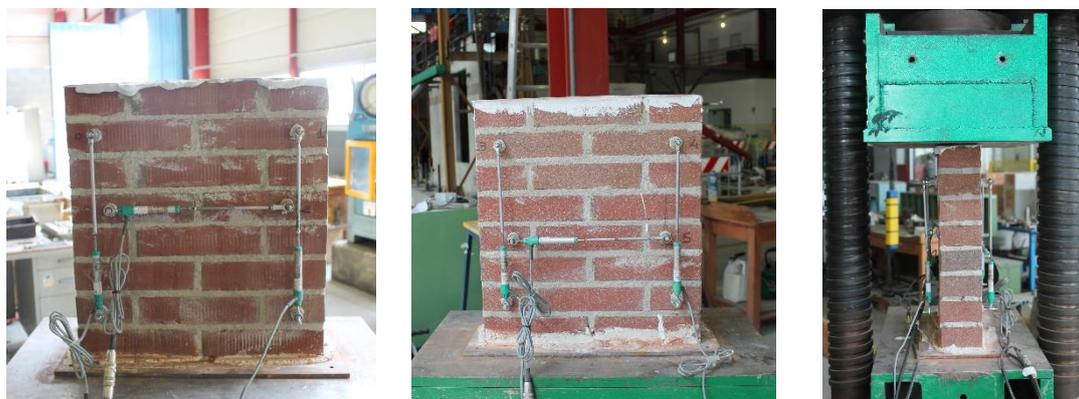
*Figure 41. Setup of the compressive test on clay masonry wallettes*

The test envisaged the failure of the test specimens by means of vertical compression load applied at their top. The loading protocol consisted on series of 3 cycles of loading and unloading at constant force amplitude; the force amplitude was then increased progressively for the further cycles and the force increment is equal to 98 kN. The loading velocity is consistent with UNI EN-1052-1 prescriptions. Figure 42 shows the applied loading history.

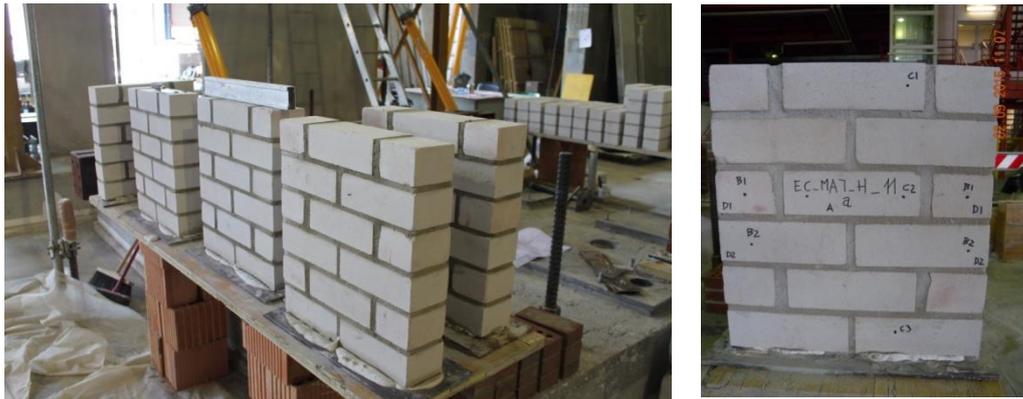
Figure 53. View of the Calcium Silicate Masonry “house” wallets.

The date of construction of the masonry wallets (Specimens EC\_MAT\_H\_11\_a/b/c/d/f/g) was 24/6/2015. The compression tests were performed between the 23- 28/9/2015.

Figure 53 shows the masonry walleets built by the Dutch masons in the DICAr laboratory.

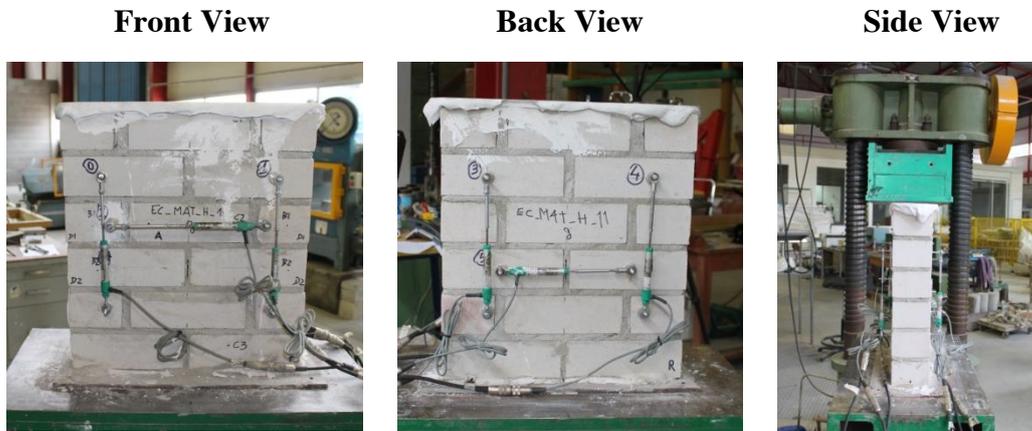
Figure 55. Setup of the compressive test on CS masonry wallettes.

Figure 55 shows the test layout and the positioning of the test specimen on the testing machine.

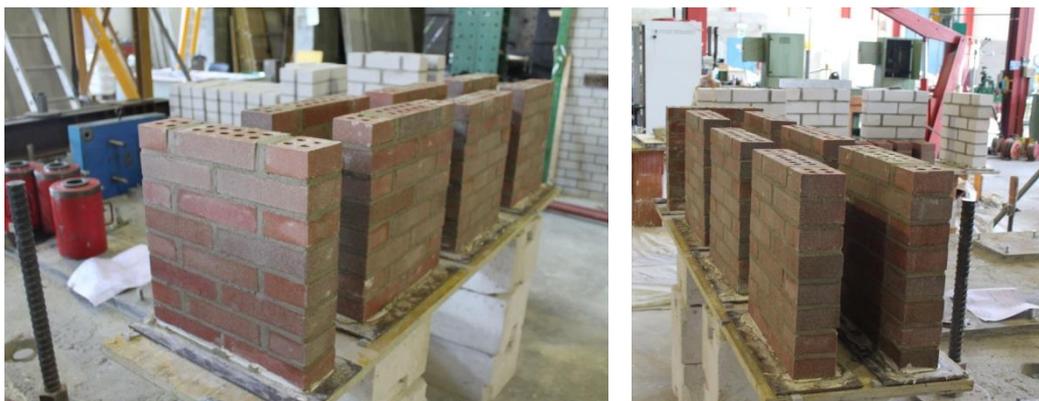
Figure 66. View of the clay masonry wallets, “house”.

The date of construction of the masonry wallets (Specimens EC\_MAT\_H\_21\_b/c/d/e/f/g) was 24/7/2015. The compression tests were performed between the 29/9-1/10/2015.

Figure 66 shows the masonry walleets built by the Dutch masons in the DICAr laboratory.

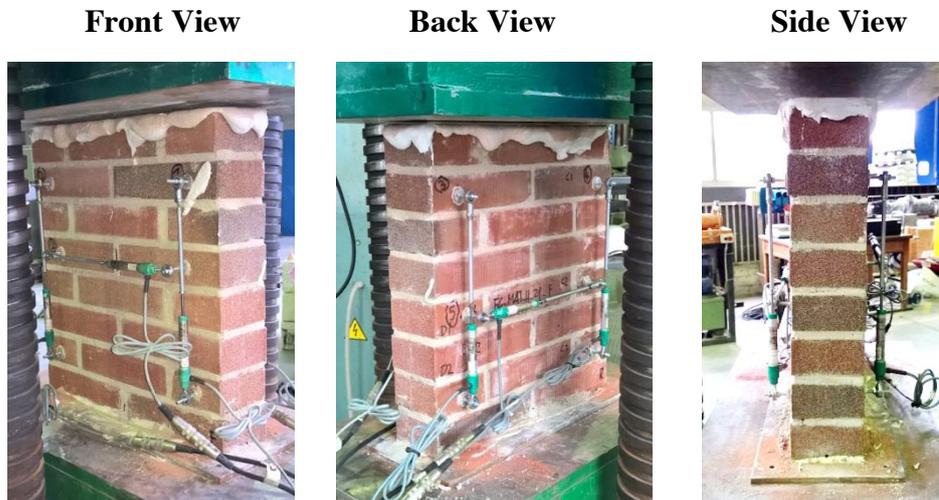
Figure 68. Setup of the compressive test on clay masonry wallettes.

Figure 68 shows the test layout and the positioning of the test specimen on the testing machine.

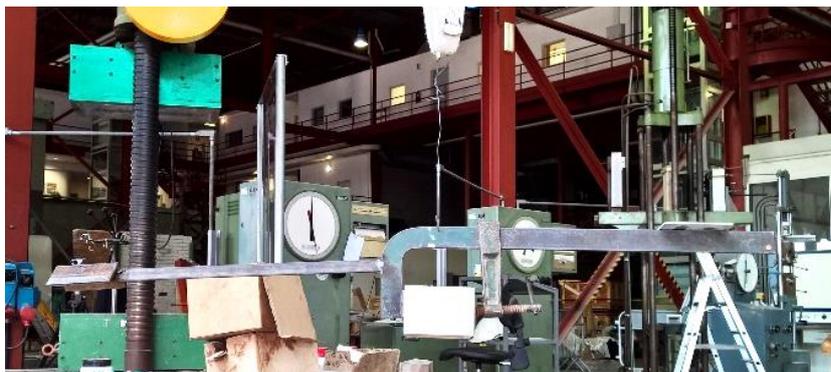
- $h$  height of the specimen
- $e_1$  distance from the applied load to the tension face of the specimen in mm
- $e_2$  distance from the centre of gravity of the lever and upper clamp from the tension face of the specimen in mm. In the present case this distance is equal to half width of the brick because the upper clamp is perfectly balanced, *i.e.* its centre of mass is aligned vertically with the center of mass of the bricks.

Figure 81. Balanced upper clamp for bond wrench test.

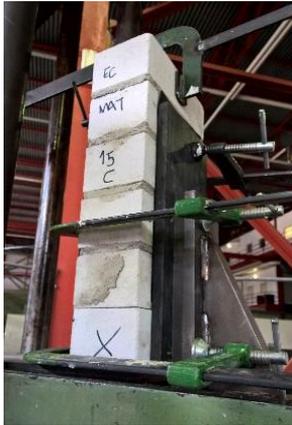
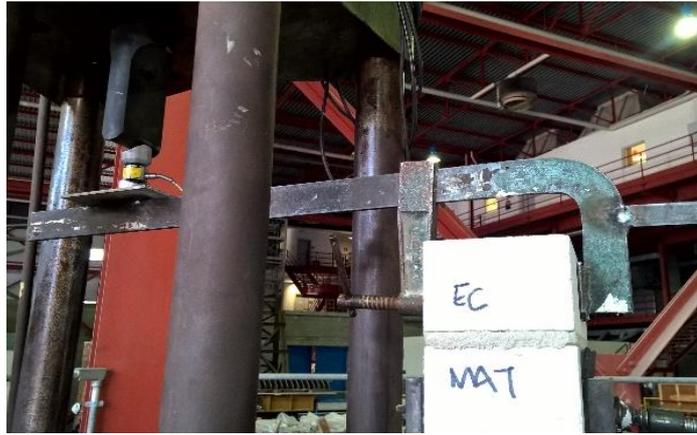
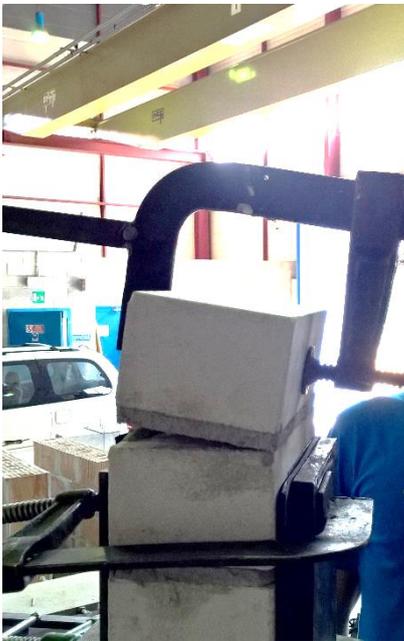
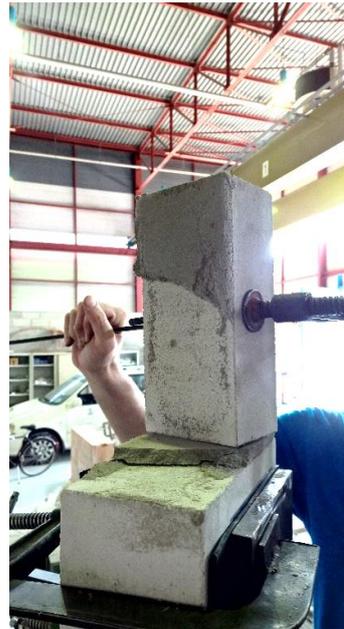
*Figure 83. Test performed on CS specimens.*

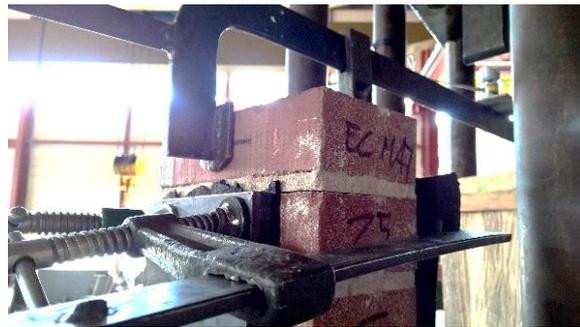
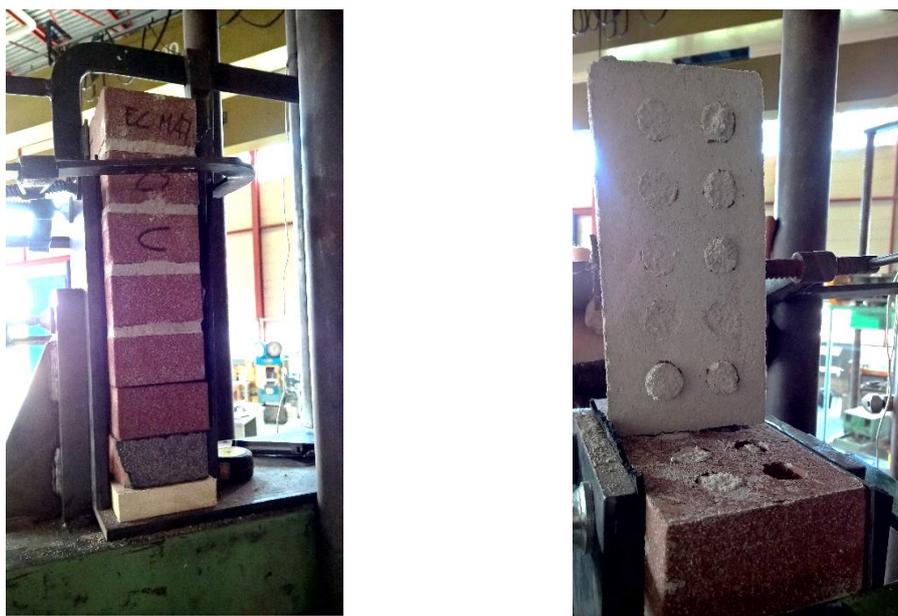
Figure 84. Test performed on clay specimens.

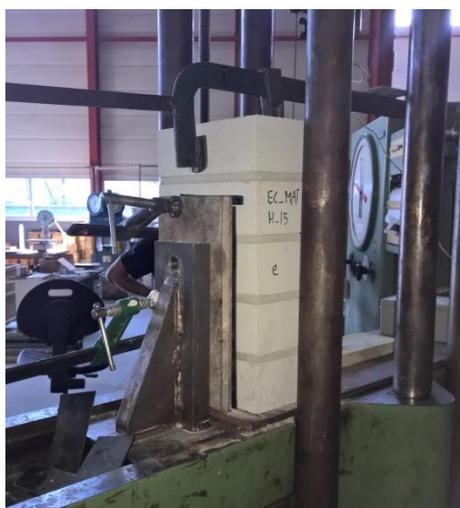
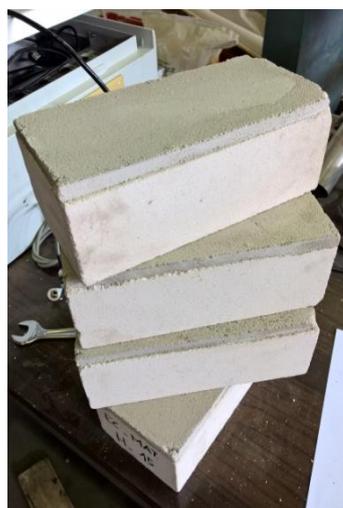
Figure 85. Test performed on CS specimens.

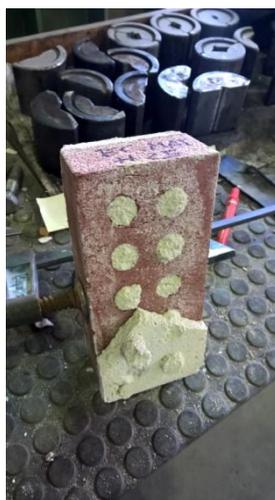
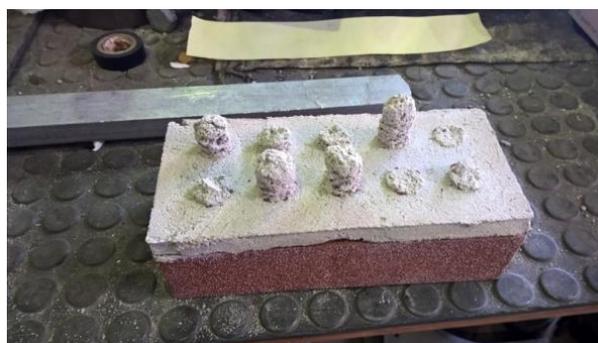
Figure 86. Test performed on clay specimens - failure of the joint.

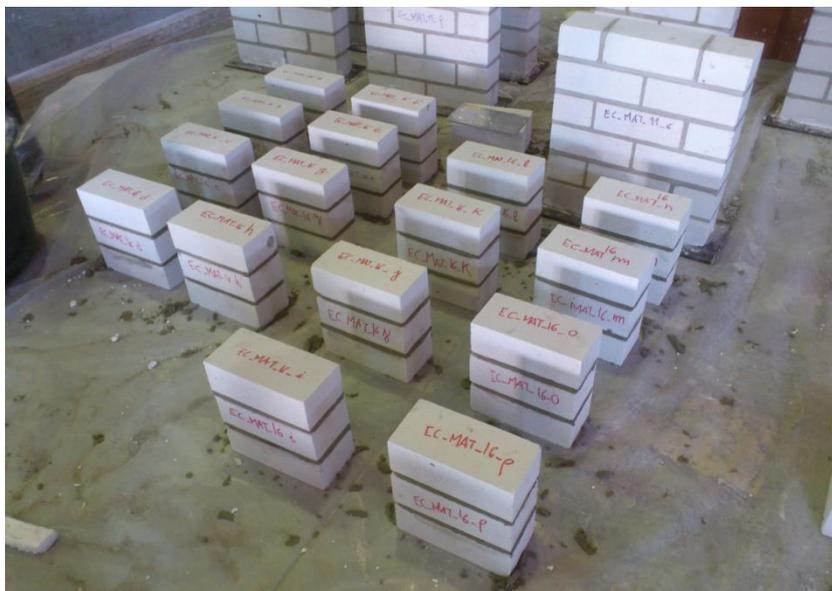
The test specimens were composed by 16 triplets of C.S. masonry (Figure 92) built by Dutch masons in the DICAR laboratory, with the same materials used to cast the walls tested both in-plane and out of plane. Nevertheless, it was possible to test only ten of them.

Figure 92. View of the specimens (EC\_MAT\_16\_a/p) for Triplet Test.

The date of construction of the Triplets (Specimens EC\_MAT\_16\_a/p) was the 27/3/2015. The triplet shear tests were performed between 5-26/6/2015.

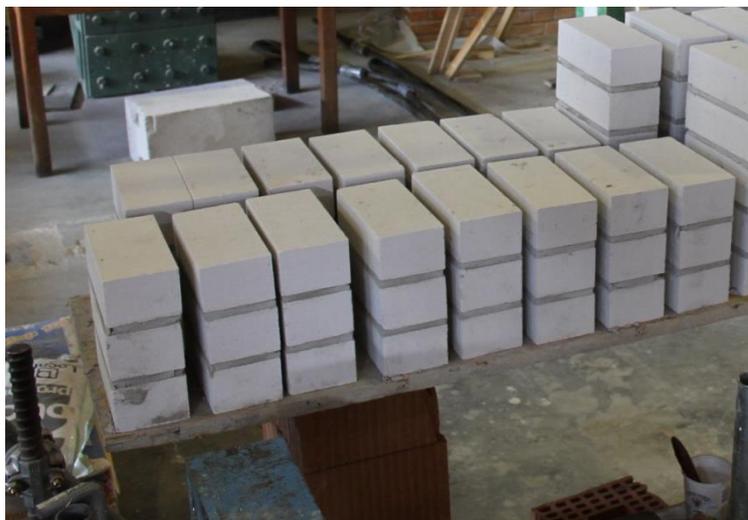
The test specimens were composed by 15 triplets of C.S. masonry (Figure 94) built by Dutch masons in the DICAr laboratory, with the same materials used to build the full-scale test-house. Nevertheless 3 specimens were damaged during the preparation of the test, hence only 12 triplets were tested.

Figure 94. View of the specimens (EC\_MAT\_H\_16\_A/P) for Triplet Test.

The date of construction of the Triplets (Specimens EC\_MAT\_H\_16\_A/P) was the 24/7/2015. The triplet shear tests were performed between the 3rd and the 19th of November 2015.

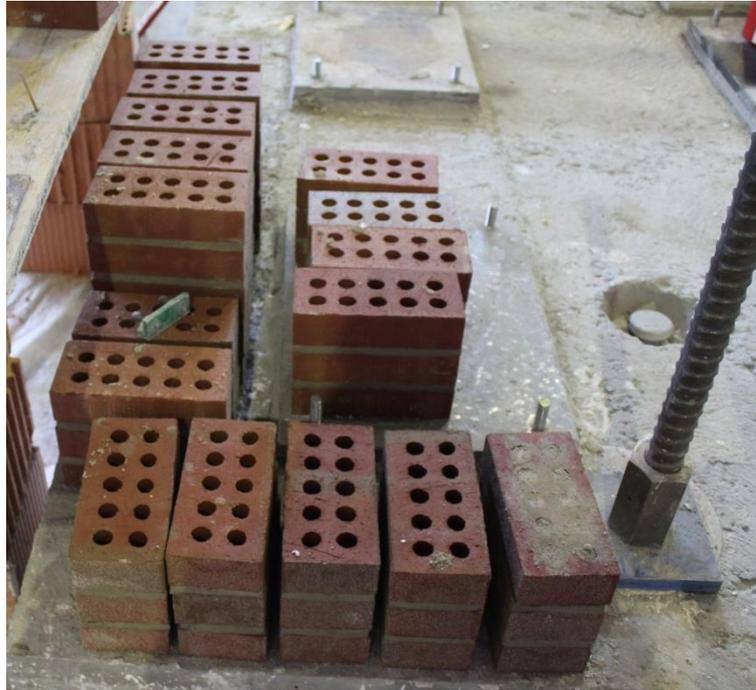
The test specimens were composed by 10 triplets of clay masonry (part of them are shown in the following Figure 97), built by Dutch masons in the DICAr laboratory, with the same materials used to build the full-scale test-house.

Figure 97. View of part of the specimens (EC\_MAT\_H\_26\_A/P) for Triplet Test.

The date of construction of the Triplets (Specimens EC\_MAT\_H\_26\_A/L) was the 24/7/2015. The triplet shear tests were performed between the 9<sup>th</sup> and the 27<sup>th</sup> of October 2015.

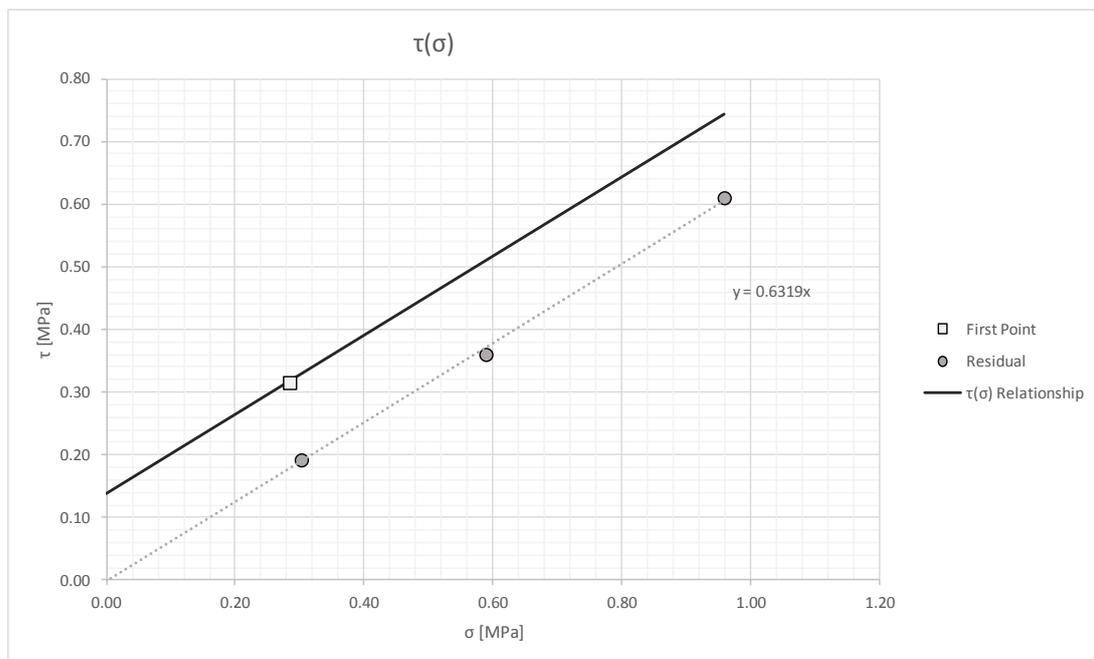
Figure 99. Triplet Test, Clay specimen EC\_MAT\_H\_26-G,  $\sigma$ - $f_v$  plot

- The couple of values  $(\sigma_I, f_{vI})$ : the shear strength  $f_{vI}$  at the first level of compression imposed on the specimen  $\sigma_I$ : both cohesion and friction contribute to shear strenght;
- The couples of values  $(\sigma_i, f_{vi})_{residual}$ : the shear strength  $f_{vi}$  corresponding to the value of compression imposed on the specimen  $\sigma_i$ , after the first shove of the central brick: only the friction contributes to shear strength, because the bedjoints of mortar are already cracked.

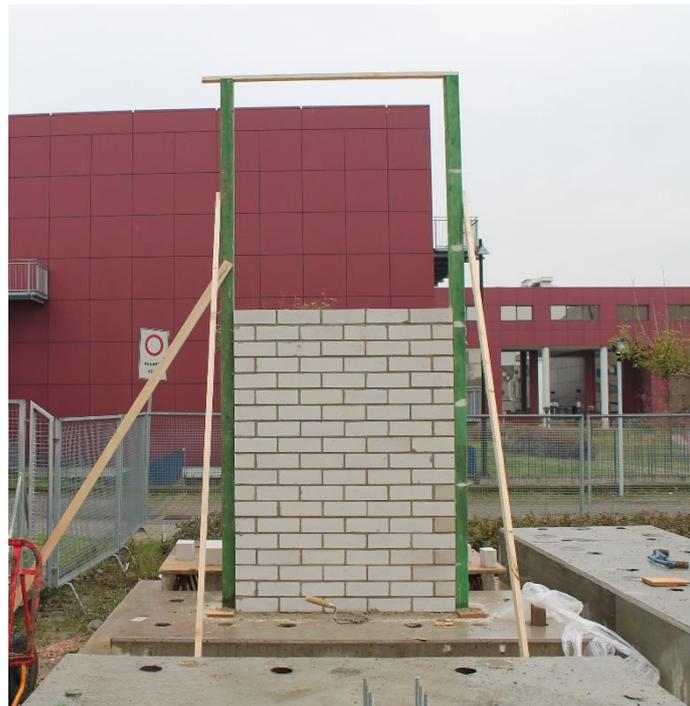
Figure 102. Slender wall during the construction phases.

The following pictures (Figure 102 to Figure 104) show the specimens during the construction phases.

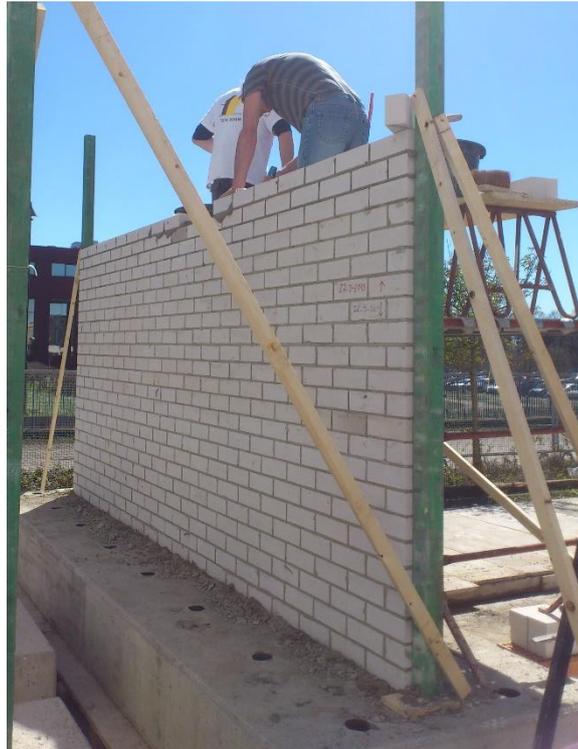
*Figure 103. Squat wall during the construction phases.*

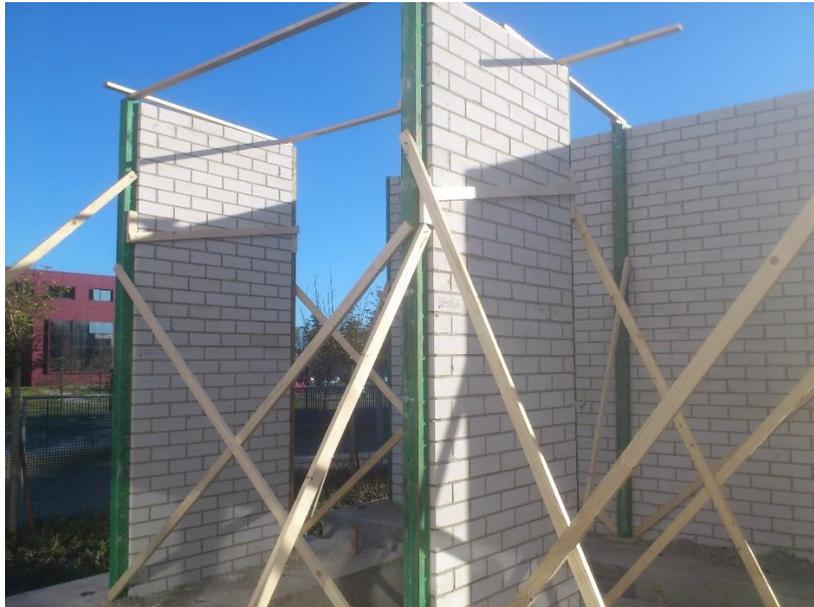
*Figure 104. Specimens for In-Plane tests during the construction phases.*

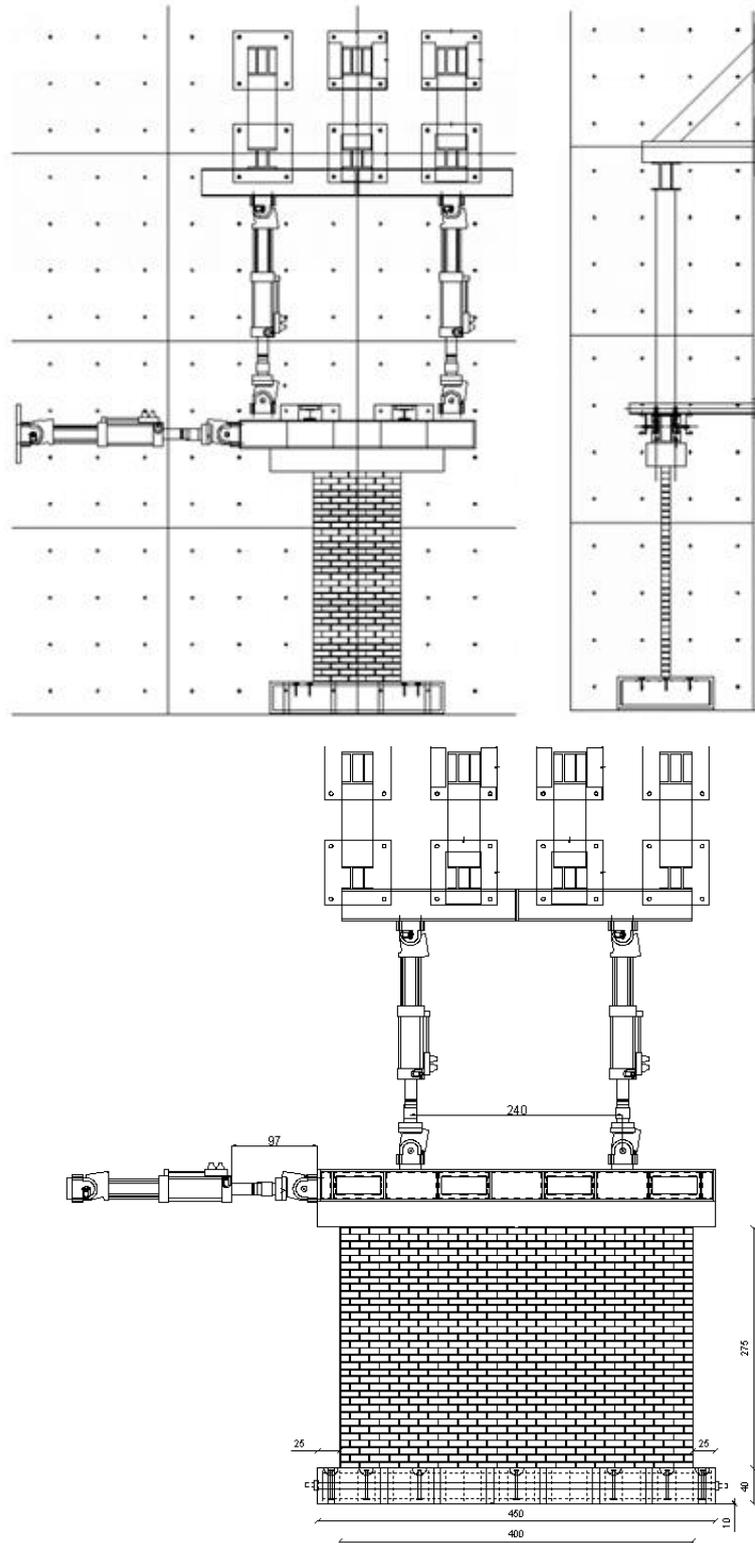
Two vertical servo-hydraulic actuators apply the vertical load on the wall, reacting on a steel frame fixed on a strong wall. The two vertical actuators allow to control the vertical load applied and to provide different boundary conditions (*e.g.* cantilever and double-fixed boundary conditions). The reinforced concrete footing is bolted to a strong floor. The horizontal actuator allows to apply horizontal forces and displacements according to the test protocol. The wall is restrained from out-of-plane deflections by a low-friction sliding restraining system.

Figure 105. Test set-up.

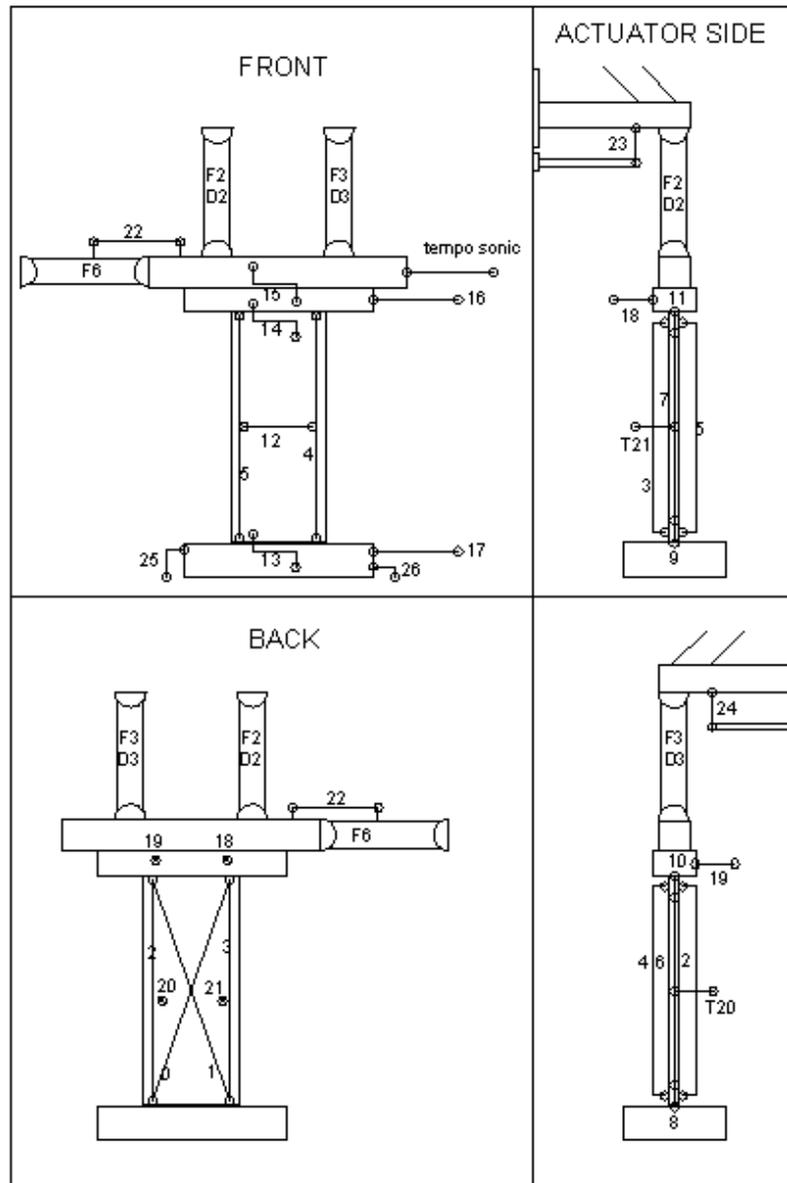
The wall instrumentation for all the specimens is reported in the following figures (from Figure 106 to Figure 108). All the displacement transducers are mounted at middle stroke, fixed to the specimen with flat head nail anchored in the masonry and a plate with threaded rod is glued at the head of the nail. In this case, if the end scale of the transducer is reached, failure of the bonding of the two parts prevents the instrument from getting damaged. The instruments indicated with the letter “T” are spring-loaded potentiometers. The initial distance between the measure bases, with eventual extension of the transducers, has been measured after the installation of the instruments (for details refer to the Appendix A1 shared with the experimental raw data).

Figure 106. EC\_COMP\_2: Location of the instruments.

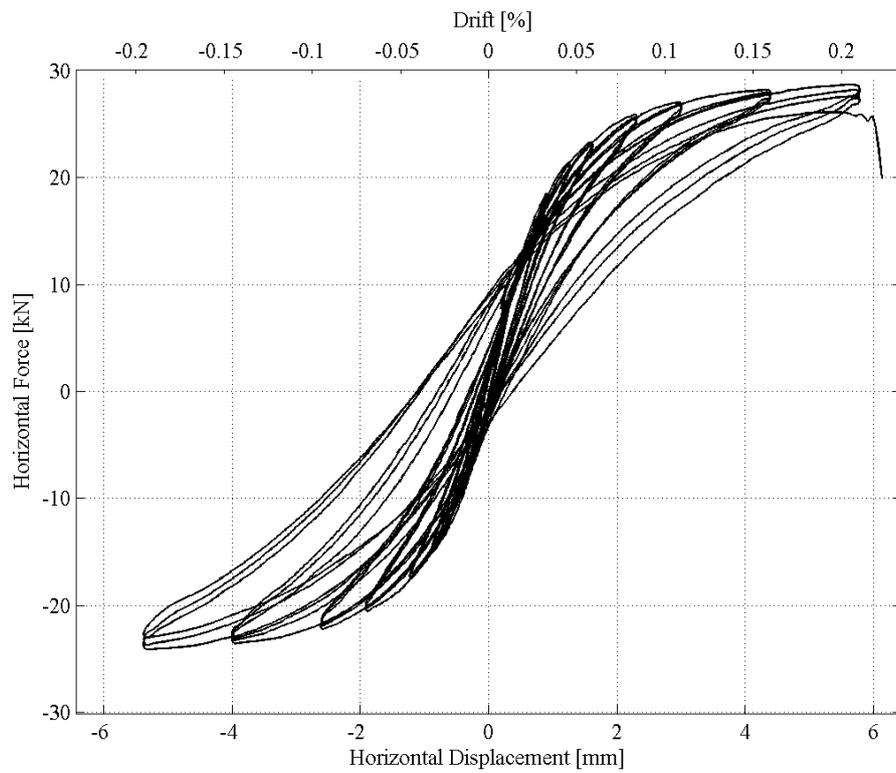
The hysteretic behavior of the specimen during the test is reported in Figure 118.

Figure 118. Hysteretic behaviour of specimen EC\_COMP\_2 during the test.

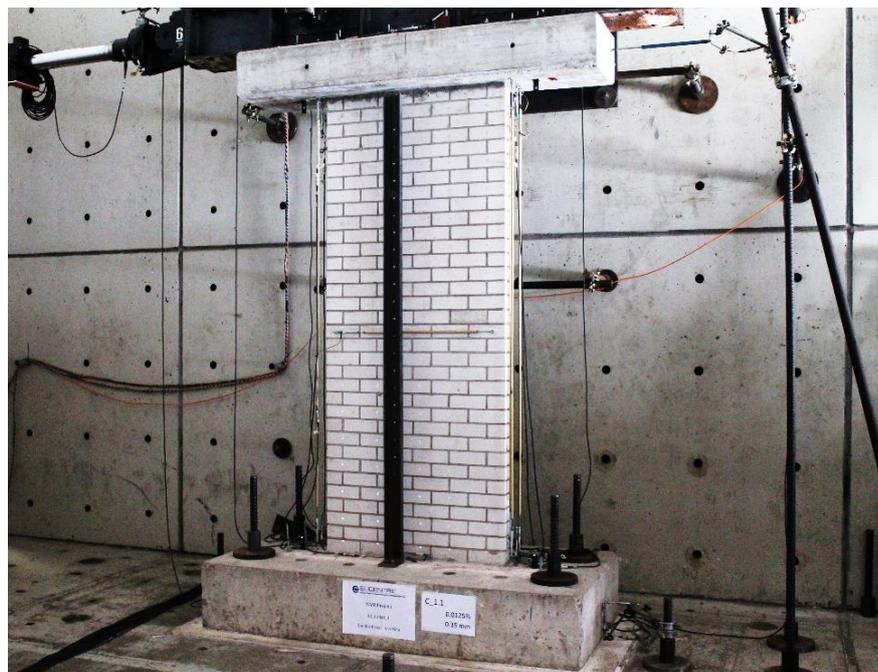
EC\_COMP\_1 is the second of the three quasi-static in-plane tests performed (in double fixed conditions) in the TREE Labs of EUCENTRE. This specimen is 1.1 metres long and 2.75 metres high. The applied overburden stress is 0.52 MPa.

*Figure 122. EC\_COMP\_1: Test set-up.*

A picture of the test set-up is reported in Figure 122.

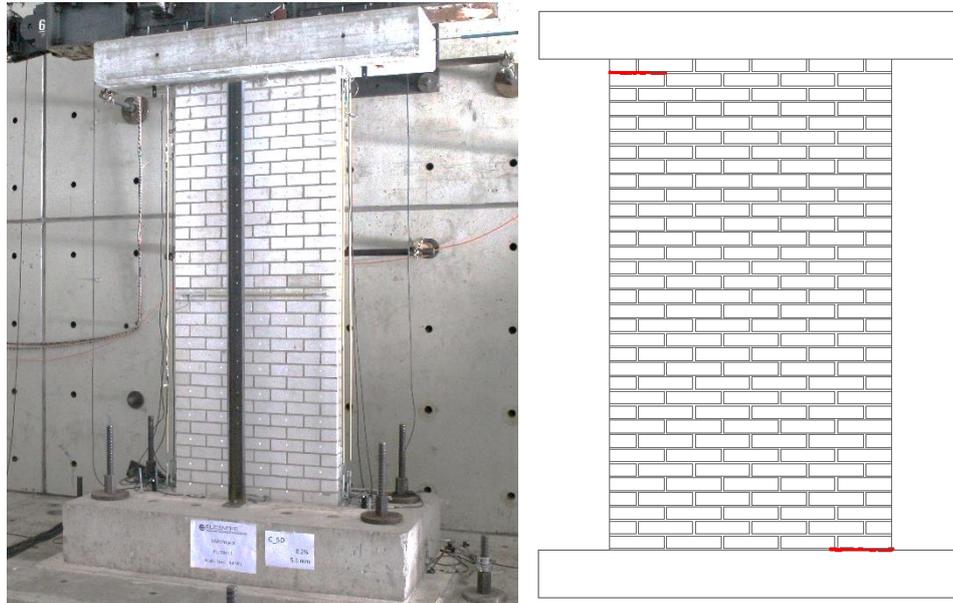
In particular, during CYCLE 5\_D (drift 0.2%) the specimen suffered slight damage and the formation of the first few cracks was observed (two horizontal cracks, one at the base of the wall and one on top of the wall) as shown in Figure 123.

Figure 123. EC\_COMP\_1: crack pattern after CYCLE 5\_D (drift 0.2%).

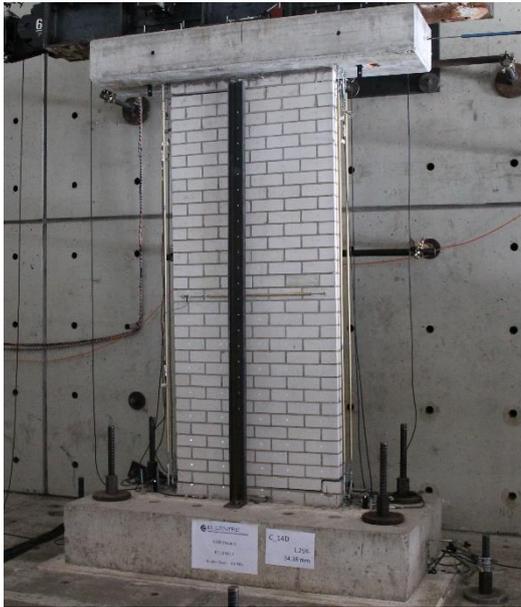
The first cracks in the brick at the base of the wall have been observed during CYCLE 14\_D (drift 1.25%), as reported in Figure 126.

Figure 126. EC\_COMP\_1: crack pattern after CYCLE 14\_D (drift 1.25%).

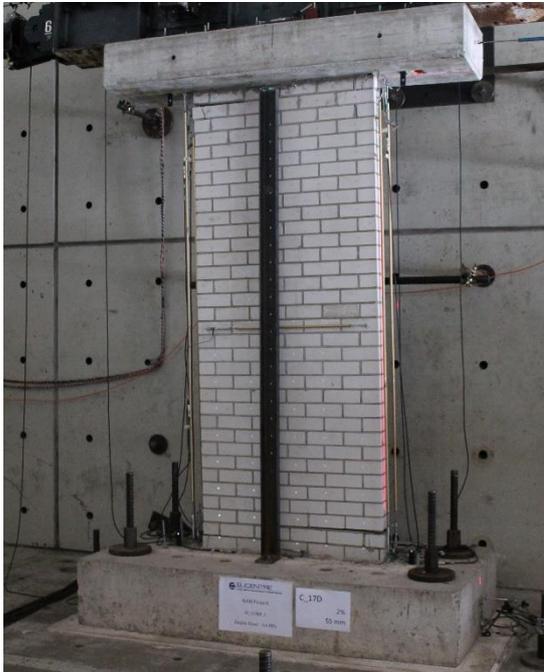
At the end of the test (CYCLE 17\_D, drift 2%) a toe crushing mechanism at the top and bottom of the wall was exhibited, with the expulsion of portions of brick and mortar (Figure 127, in red cracks induced at current cycle, in black the pre-existing cracks and in green the pieces of brick and mortar detached).

Figure 127. EC\_COMP\_1: crack pattern after CYCLE 17\_D (drift 2%).

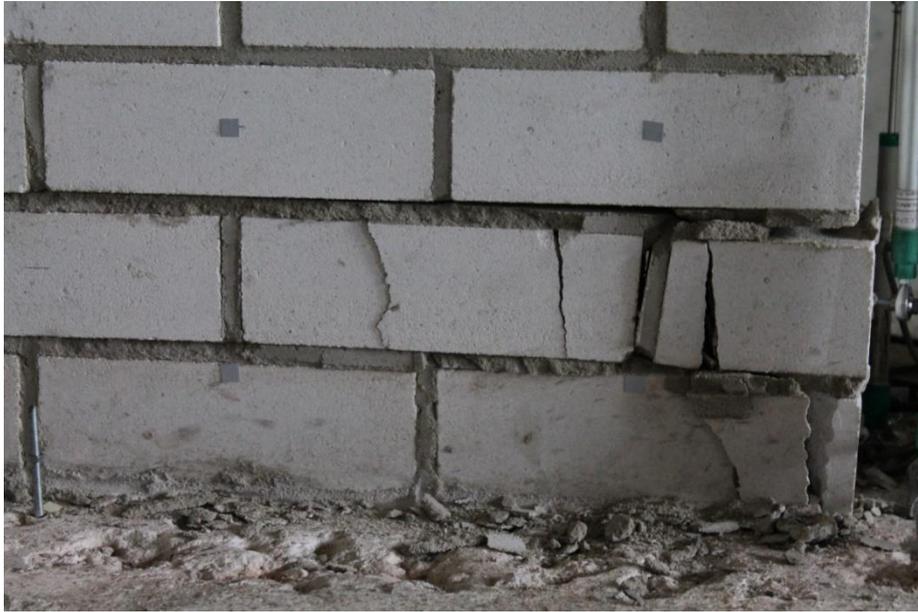
*Figure 128. EC\_COMP\_1. Toe crushing mechanism at the base of the wall, after CYCLE 17\_D (drift 2%).*

Some pictures of the specimen at the end of the test are presented in the following figures (from Figure 128 to Figure 131).

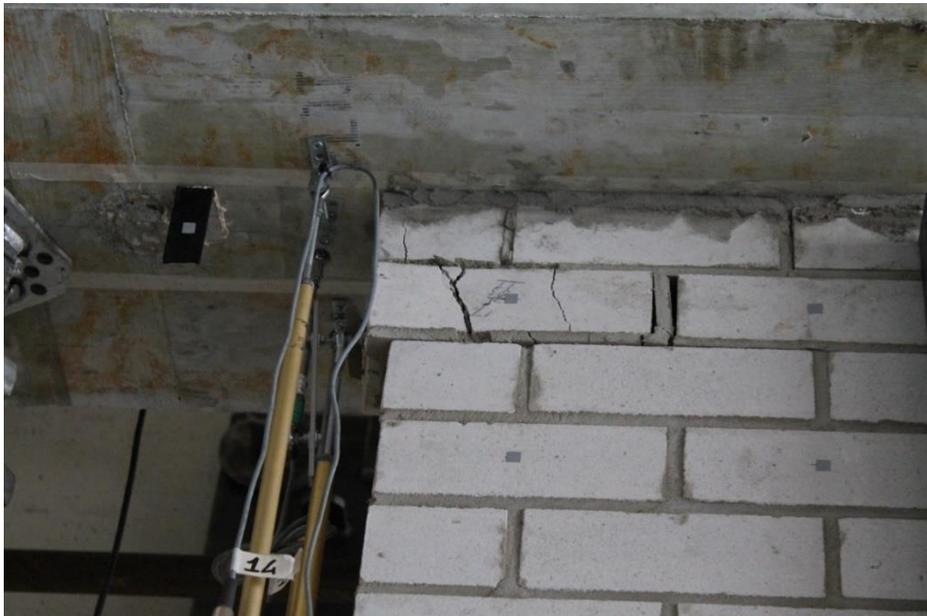
*Figure 129. EC\_COMP\_1. Toe crushing mechanism at the top of the wall (actuator side), after CYCLE 17\_D (drift 2%).*

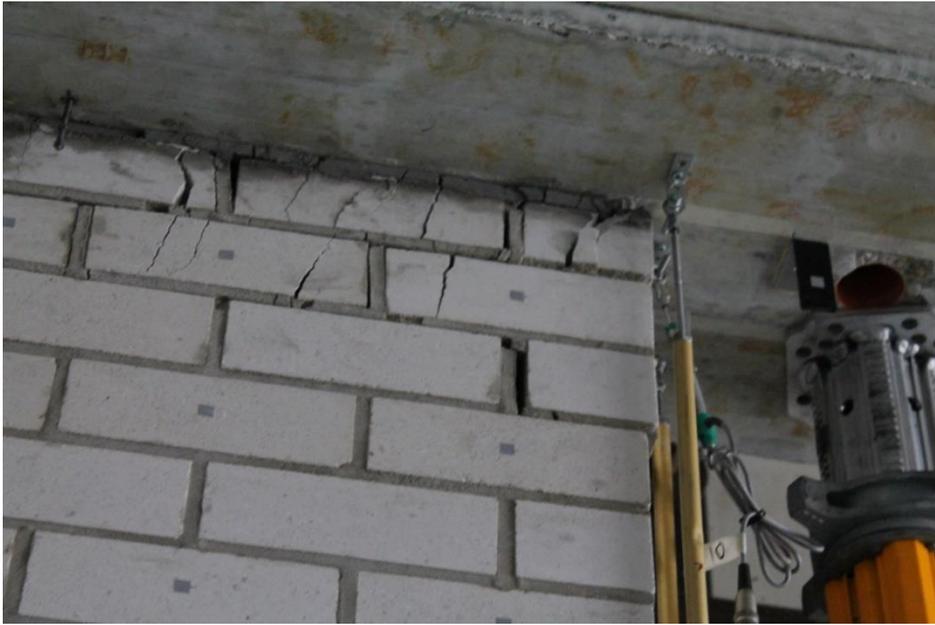
*Figure 130. Toe crushing mechanism at the top of the wall, after CYCLE 17\_D (drift 2%).*

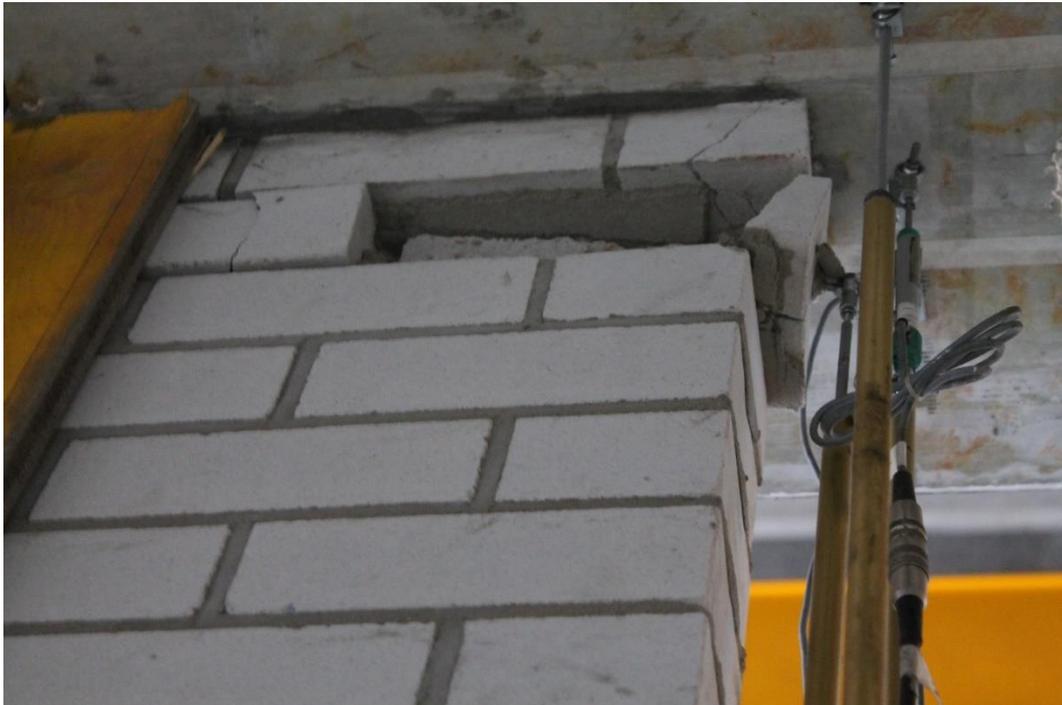
*Figure 131. Expulsion of a portion of masonry due to toe crushing mechanism at the top of the wall, after CYCLE 17\_D (drift 2%).*

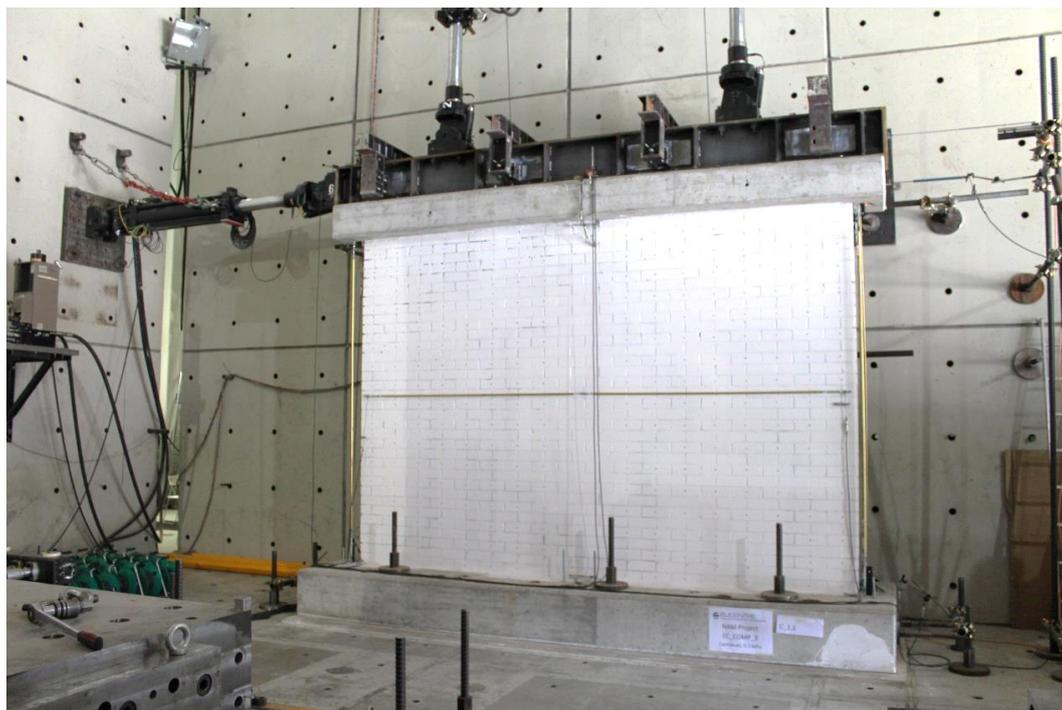
A picture of the test set-up is reported in Figure 139.

*Figure 139. EC\_COMP\_3: Test set-up.*

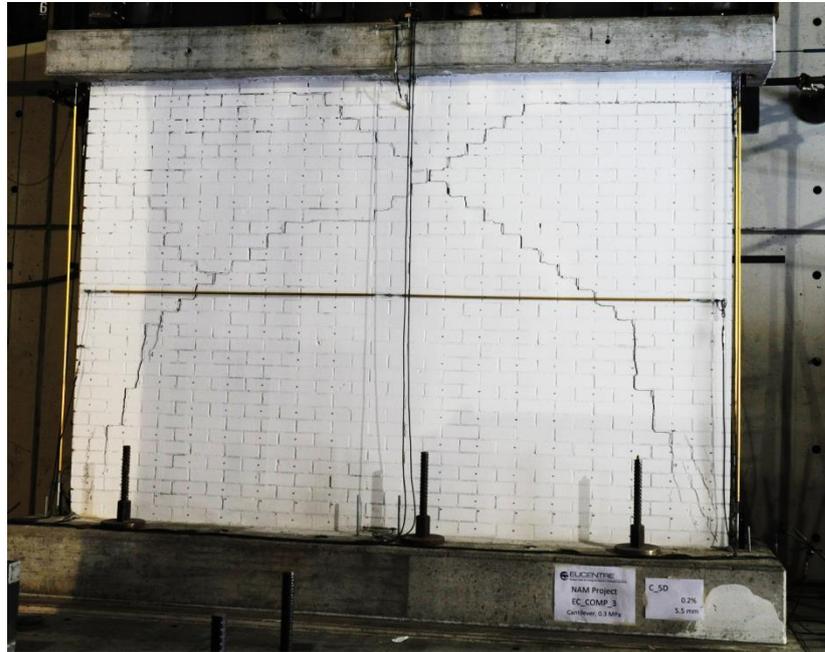
Figure 142. EC\_COMP\_3: crack pattern after CYCLE C\_4D (drift 0.15%).

In particular, after the CYCLE C\_2D (drift 0.075%) the widening of the existing cracks is observed and the first cracks in the brick at the base of the wall appeared (Figure 141). The widening of the exiting cracks is observed also in CYCLE C\_4D (drift 0.15%) in addition to the comparison of new diagonal stepped cracks in the left portion of the wall (Figure 142, in red the cracks induced at current cycle and in black the pre-existing cracks).

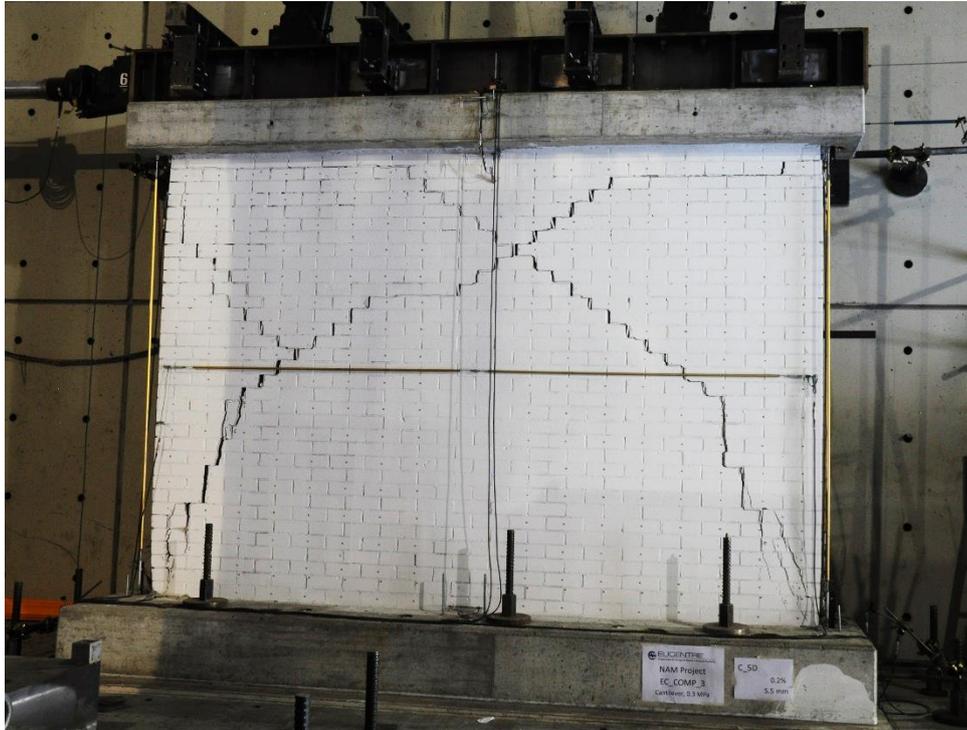
Figure 143. EC\_COMP\_3: crack pattern after CYCLE C\_5D (drift 0.2%).

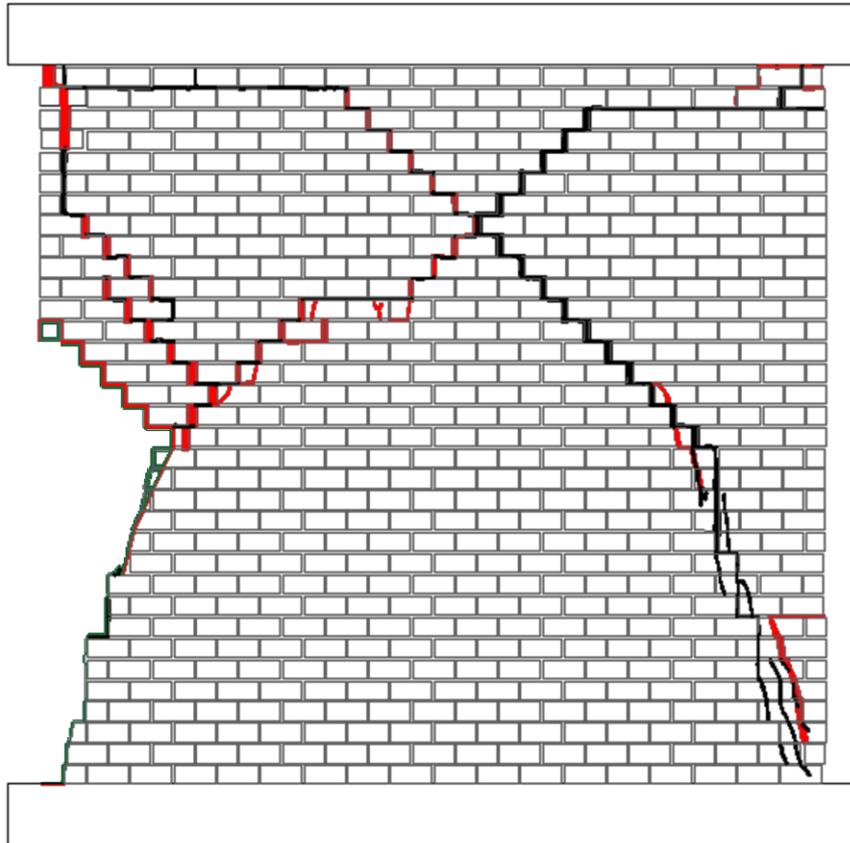
Figure 144. EC\_COMP\_3: crack pattern after CYCLE C\_7D (drift 0.3%).
