# **Experimental campaign on cavity walls systems representative of the Groningen building stock**

**Alberto Pavese, Francesco Graziotti and Guido Magenes**

**Eucentre**

Date June 2016

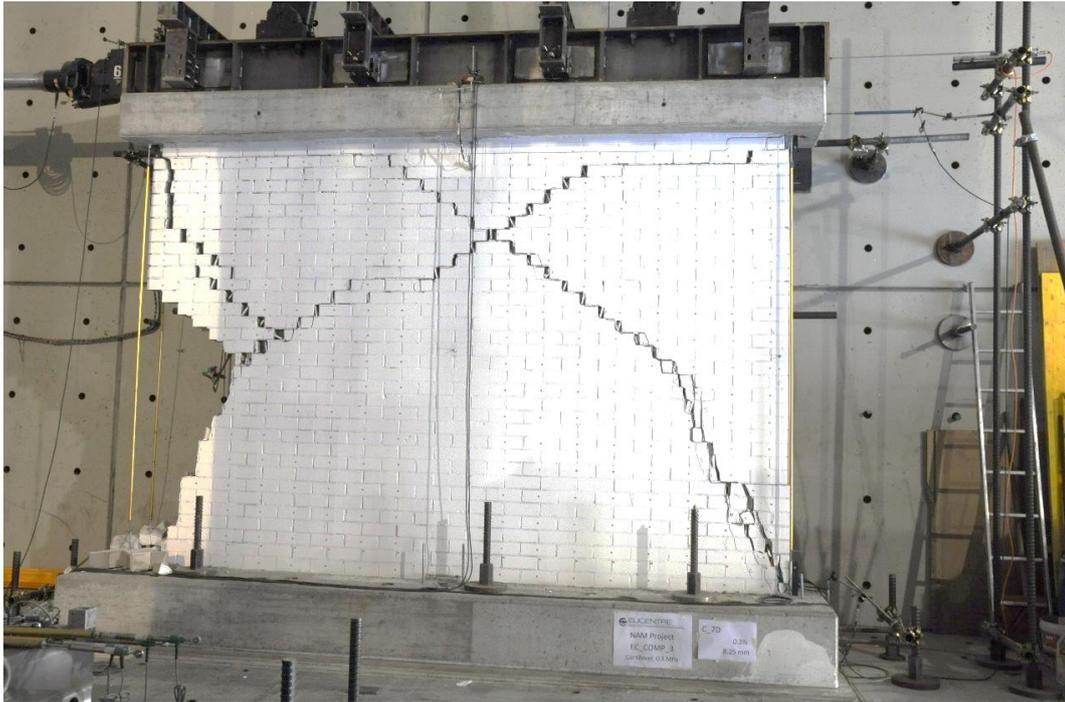
Figure 145. EC\_COMP\_3. Close to collapse condition of the wall, after CYCLE C\_7D (drift 0.3%).

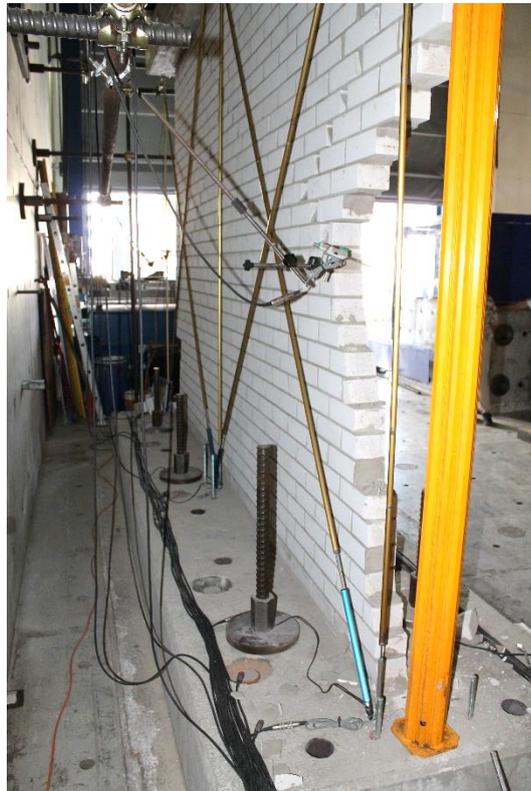
Figure 146 EC\_COMP\_3. Back view of the partial collapse of the wall after CYCLE C\_7D (drift 0.3%).

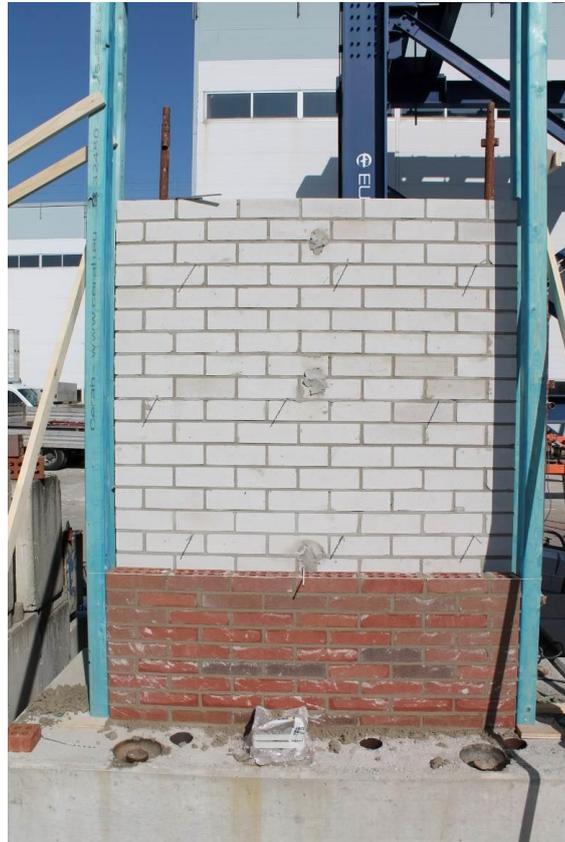
*Figure 165. EC\_COMP\_7 Specimen during construction phases.*

The following pictures (Figure 165 to Figure 169) show the specimens in the construction phases.

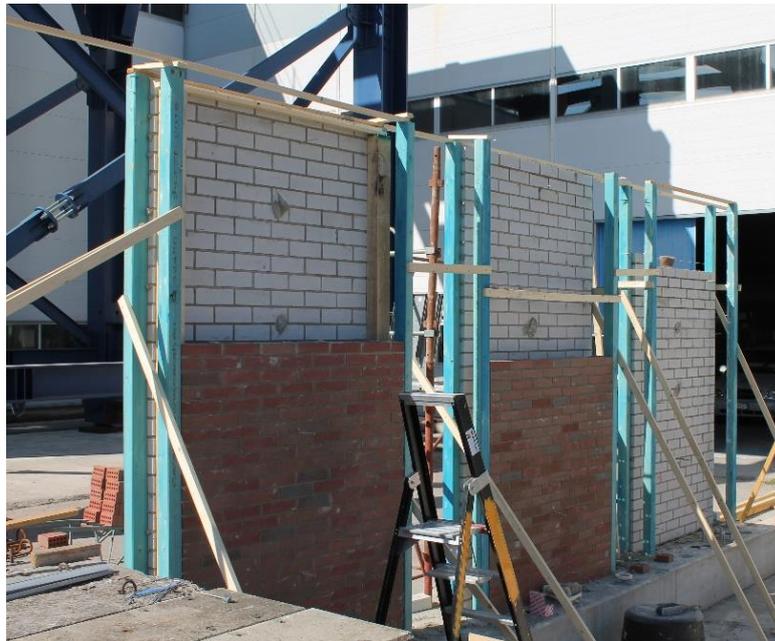
*Figure 166. Cavity Wall Specimens during construction phases.*

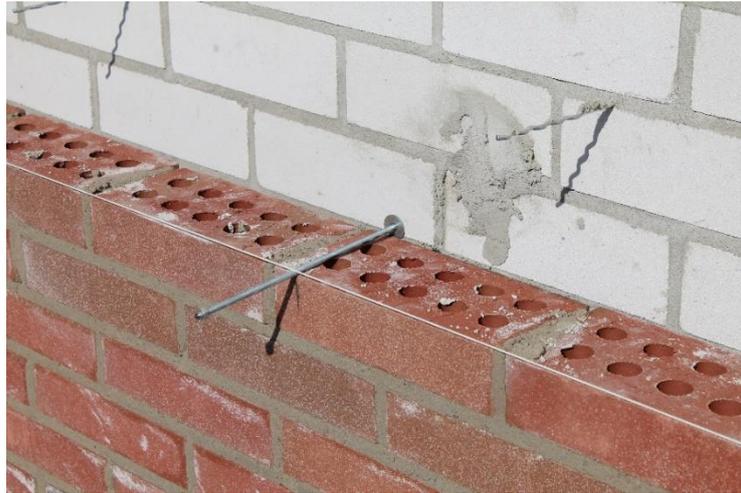
*Figure 167. Detail of tie installed for the specimen transportation.*

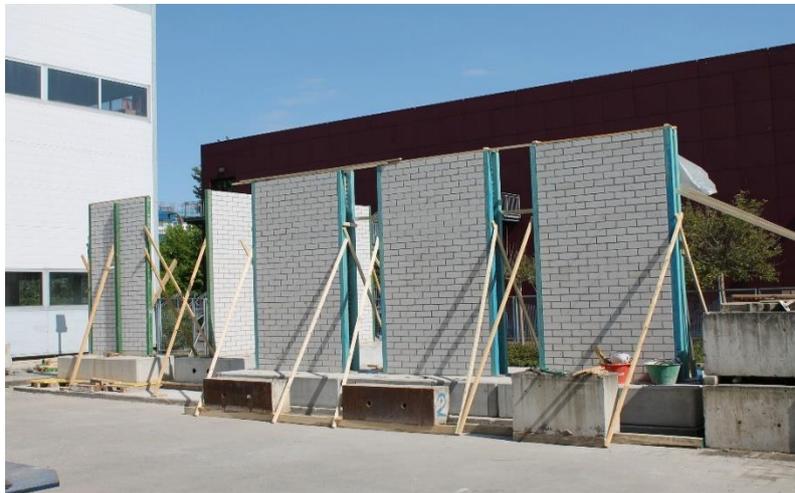
*Figure 168. Cavity Wall Specimens (CS side).*

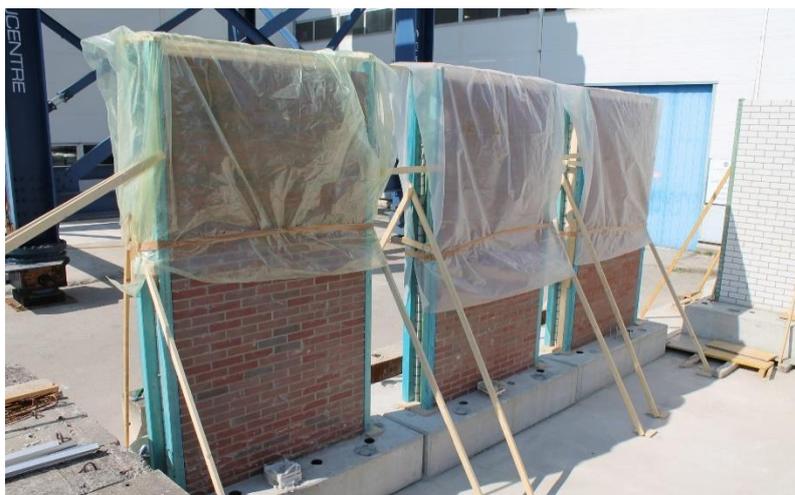
*Figure 169. Cavity Wall Specimens (Clay side).*

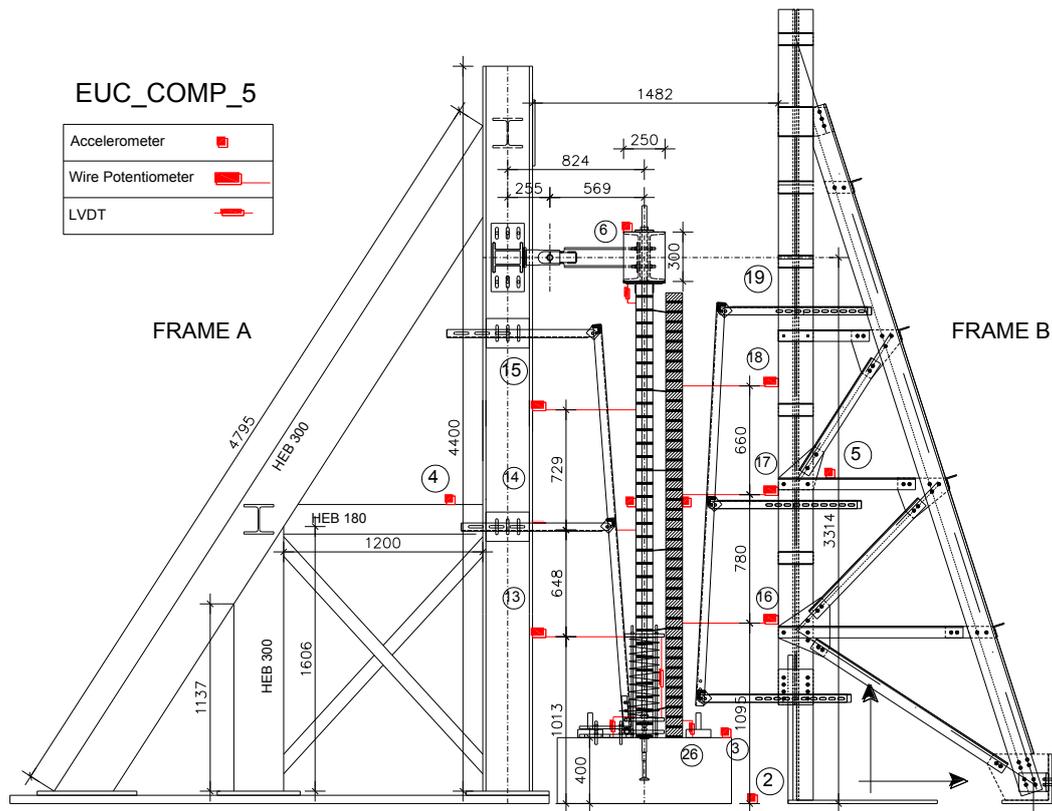
The connection between the frame and the top beam of the tested specimen is made by a couple of arms characterized by a mechanical hinge on the right extremity. The hinge system allows the rotation and the incoming uplift of the wall transferring the floor dynamic input simultaneously at the top of the specimen. The stiffness of the spring system guarantees that the increased force at collapse condition (when the wall height is maximum) is less than 5% of the static initial static pressure. These solutions guarantee a double fixed condition with almost constant overburden pressure.

Figure 171. Test Layout and geometry for the EC\_COMP\_5 Specimen.

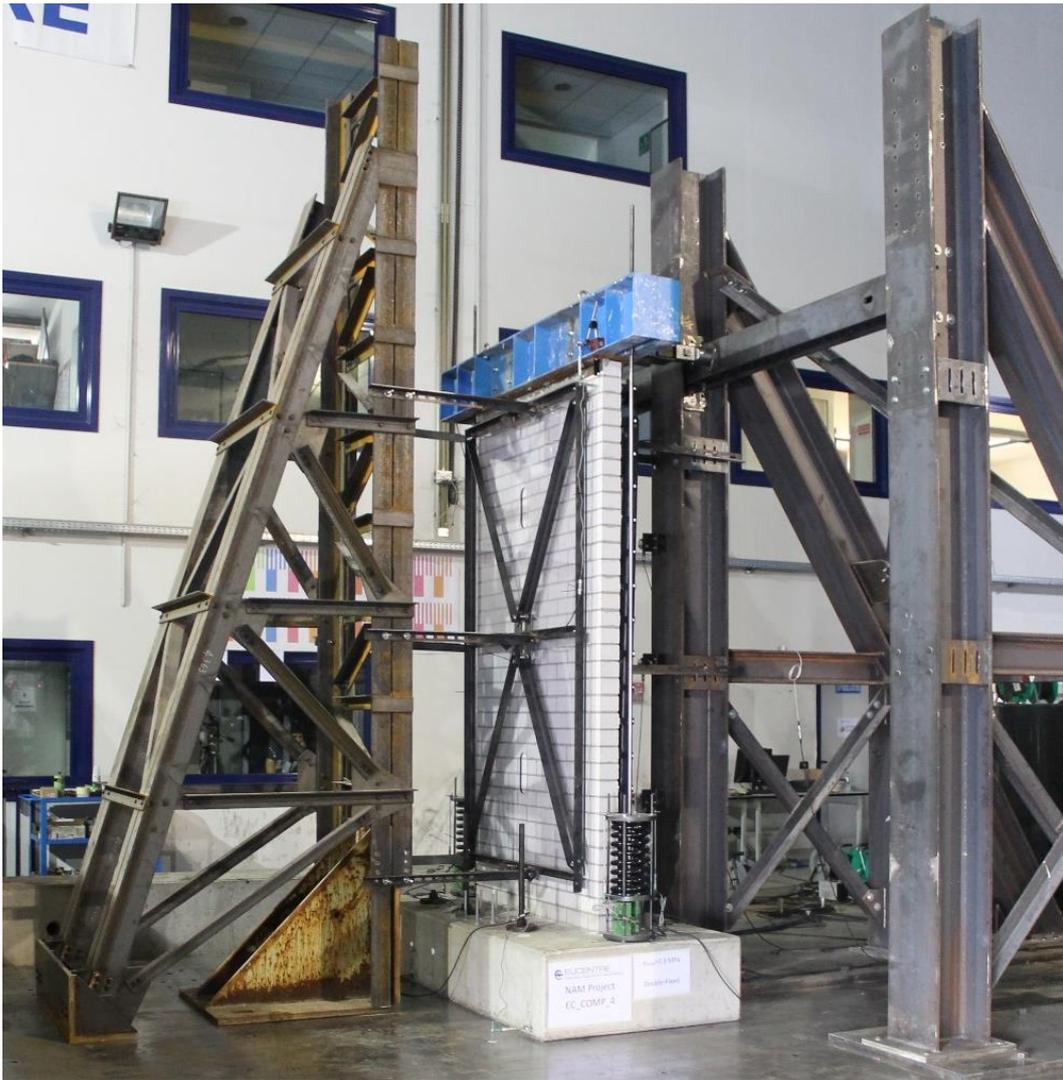
*Figure 173. Testing layout for the EC\_COMP\_4 Specimen.*

Figure 173 shows a picture of the testing layout for the EC\_COMP\_4 specimen.

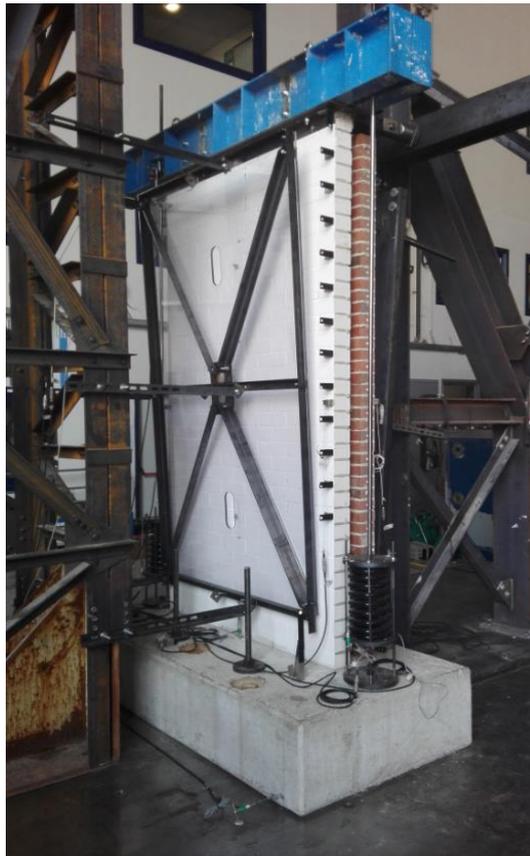
*Figure 175. Experimental layout EC\_COMP\_6 Test.*

Figure 174, Figure 175 and Figure 176 show picture of the testing layout for the EC\_COMP\_5 and EC\_COMP\_6 specimens respectively.

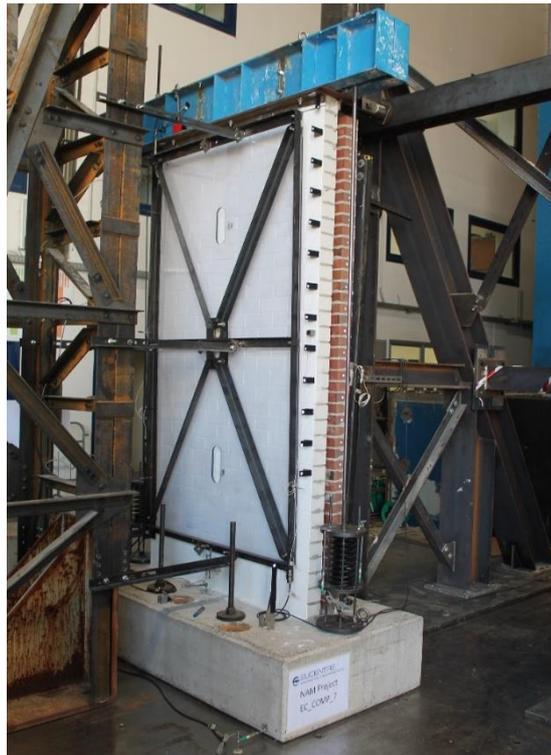
*Figure 176. Experimental layout EC\_COMP\_7 Test.*

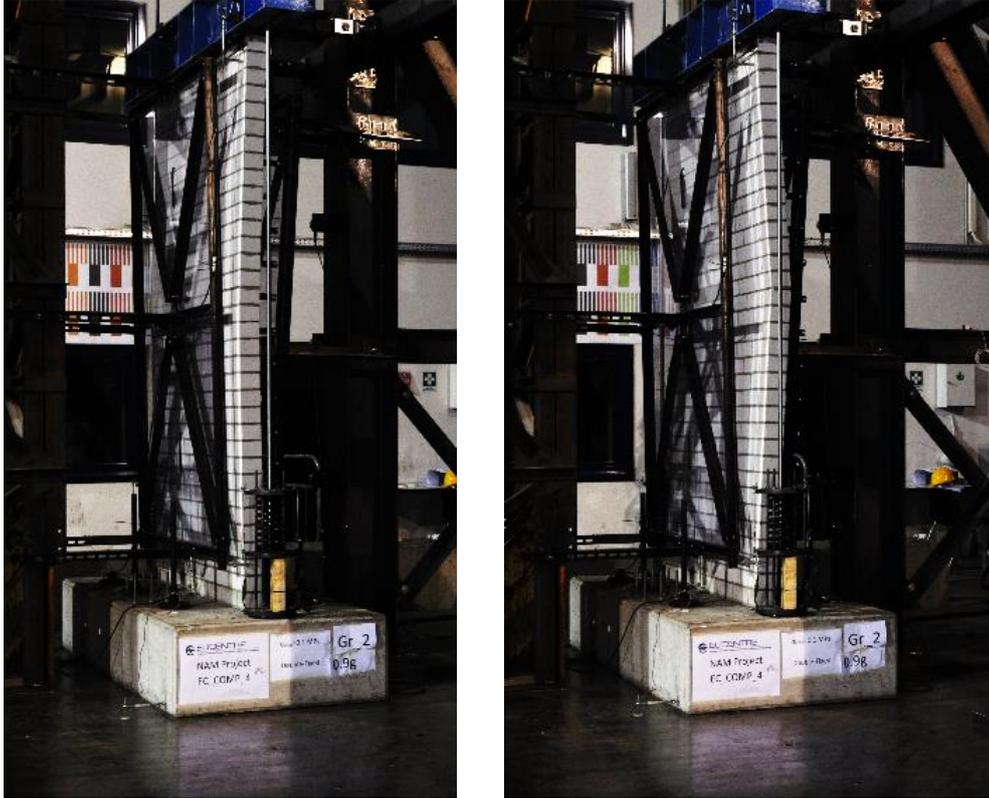
Figure 195 is composed by two video frames showing the deformed shape of the specimen. The bottom crack appeared at the base, the “mid-height” crack between 19<sup>th</sup> and 20<sup>th</sup> layer, the top crack between 33<sup>rd</sup> and 34<sup>th</sup> as expected. Figure 196 shows a view of the mid-height crack after the test.

*Figure 195. Deformed shape of the EC\_COMP\_4 Specimen (left and right)*

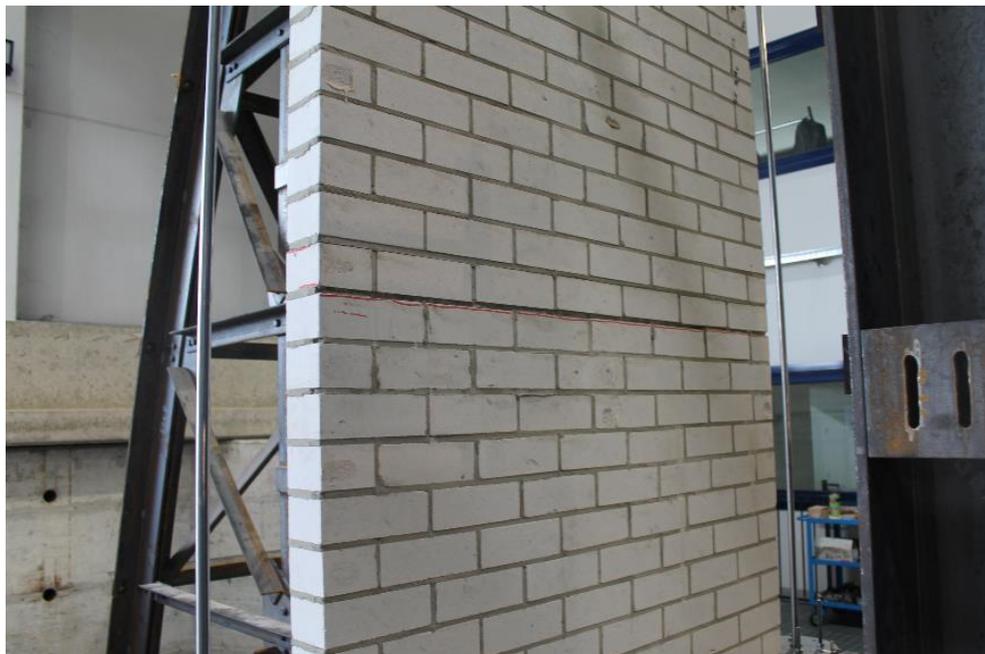
*Figure 196. View of the Mid-height Crack.*

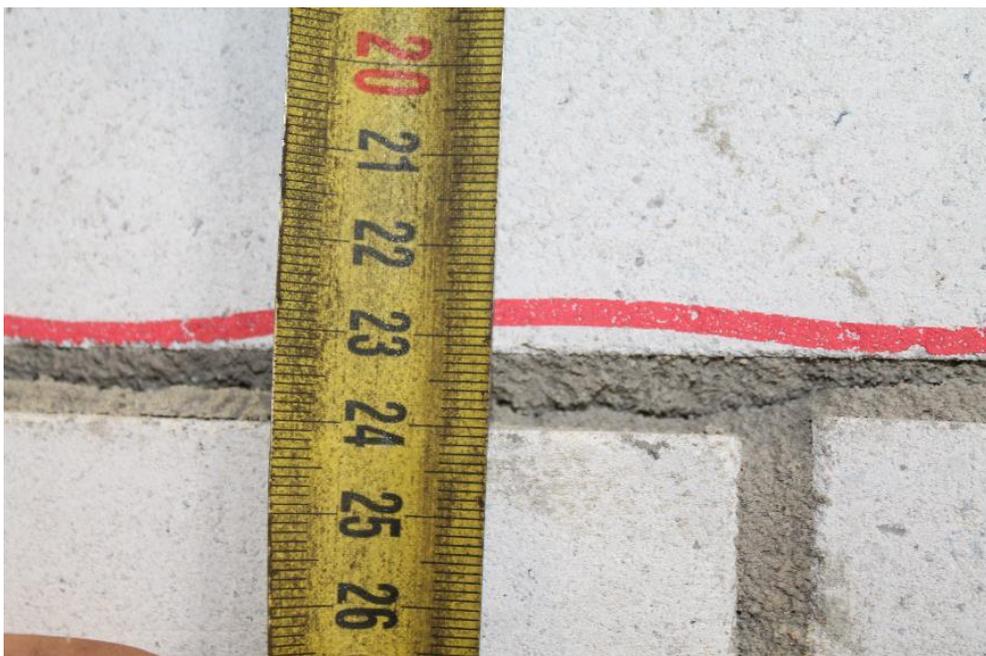
*Figure 198. Decrease in Mortar Bed-joint thickness..*

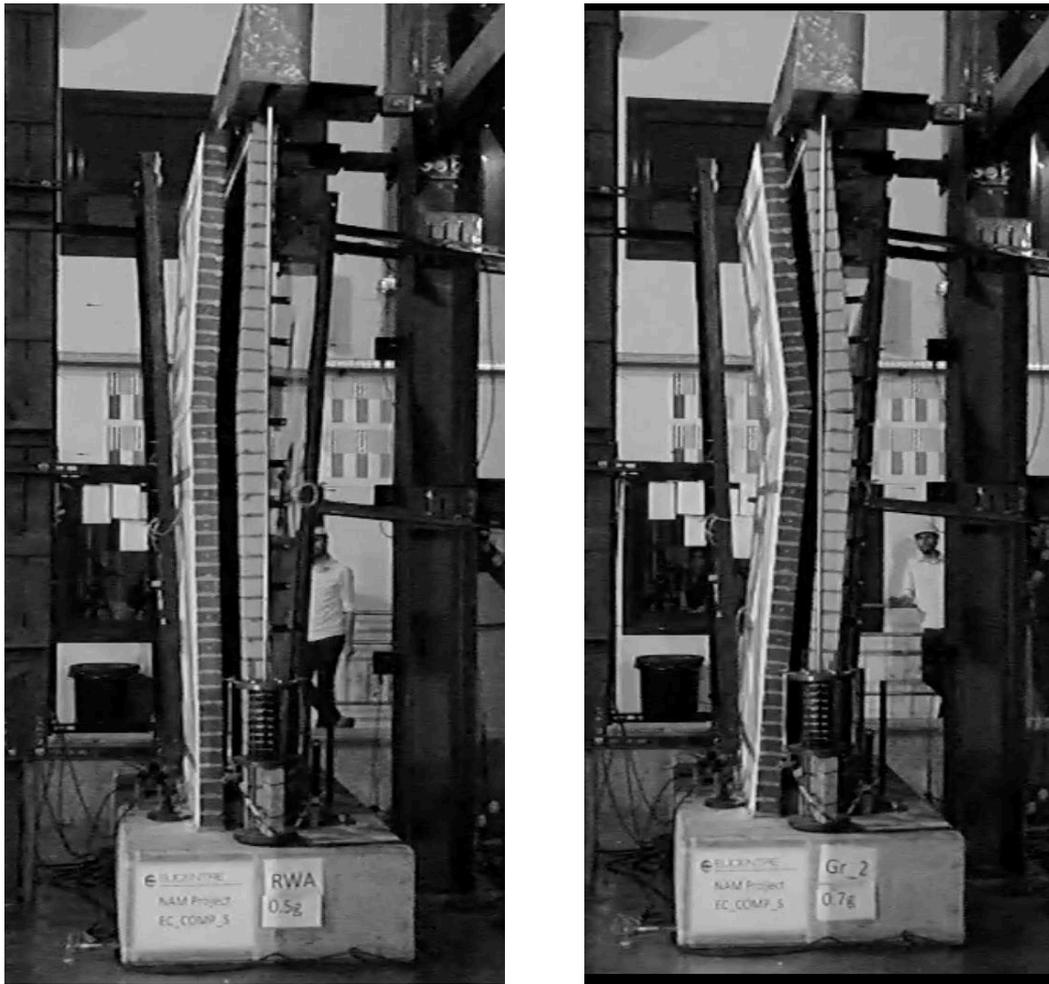
Figure 212 (right) shows the specimen deformed shape during 6.1 test, few instants before the specimen collapse.

*Figure 212. Deformed shape of the EC\_COMP\_5 Specimen (left and right)*

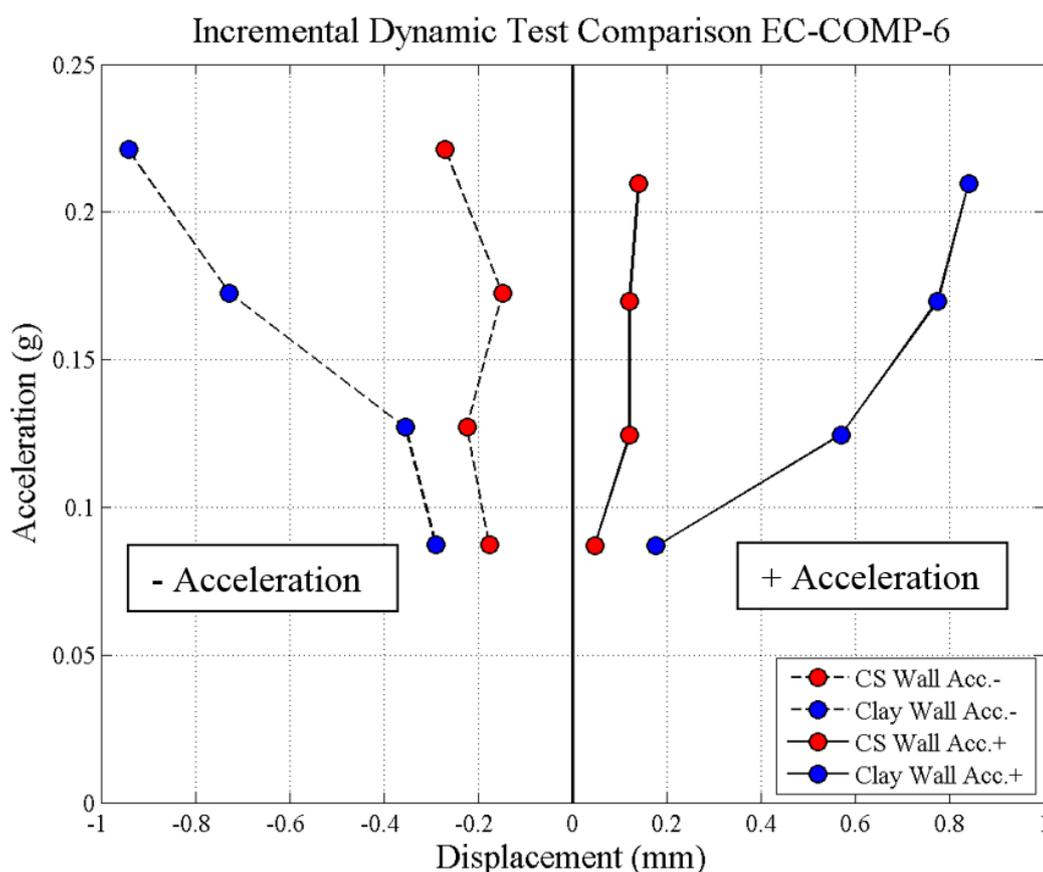
The response peaks recorded in this phase were associated always to a deformed shape where the outer leaf tried to increase the gap between the two walls pulling the ties, independently from the input excitation direction. The inner leaf deformed shape is the classical deformed shape of a beam in double fixed condition, while the outer leaf, much more flexible, tent to deform like a cantilever. Figure 216 shows the horizontal mid-height response peaks of both walls in the testing phase 1. The values shown represent maximum absolute values.

Figure 216. Experimental mid-height response peaks Gr<sub>1</sub> Tests (PGA vs. Max absolute response at mid-height).

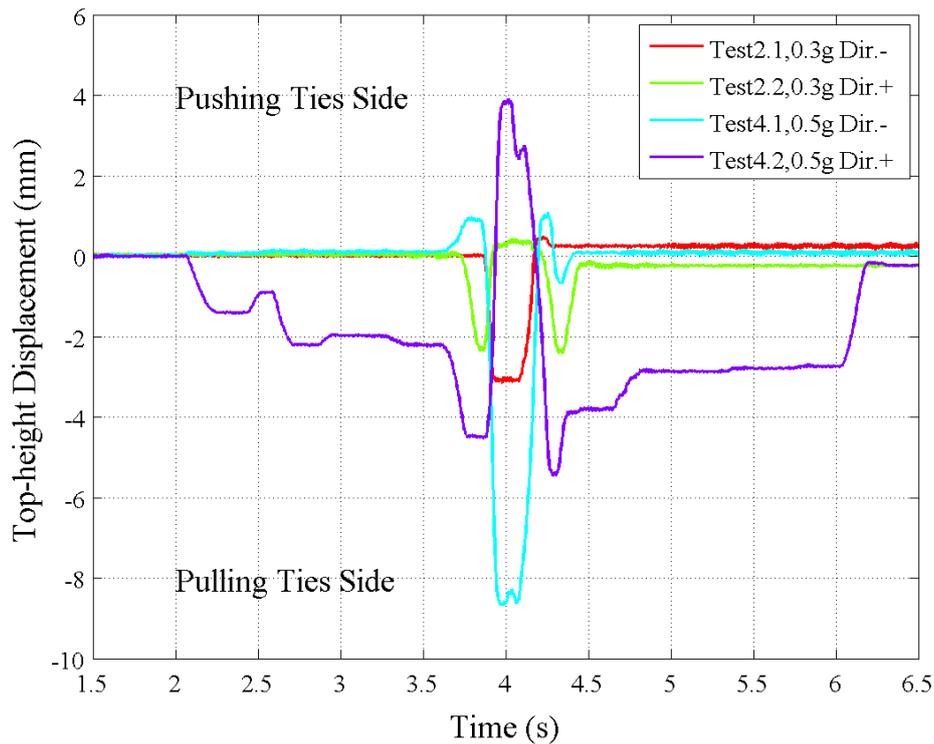
Figure 223 shows the comparison between top clay wall horizontal displacement histories recorded in each RWA test. The negative tests are the ones where the impulse is in the pulling ties direction. In particular, it can be seen as in test 4.2, although the impulse is in the ties compression direction, there is a significant displacement in the pulling ties direction that can be related to degradation of the anchorage on the clay mortar bed-joint due to test repetitions.

Figure 223. Comparison between top clay wall horizontal displacement histories recorded during each RWA test.

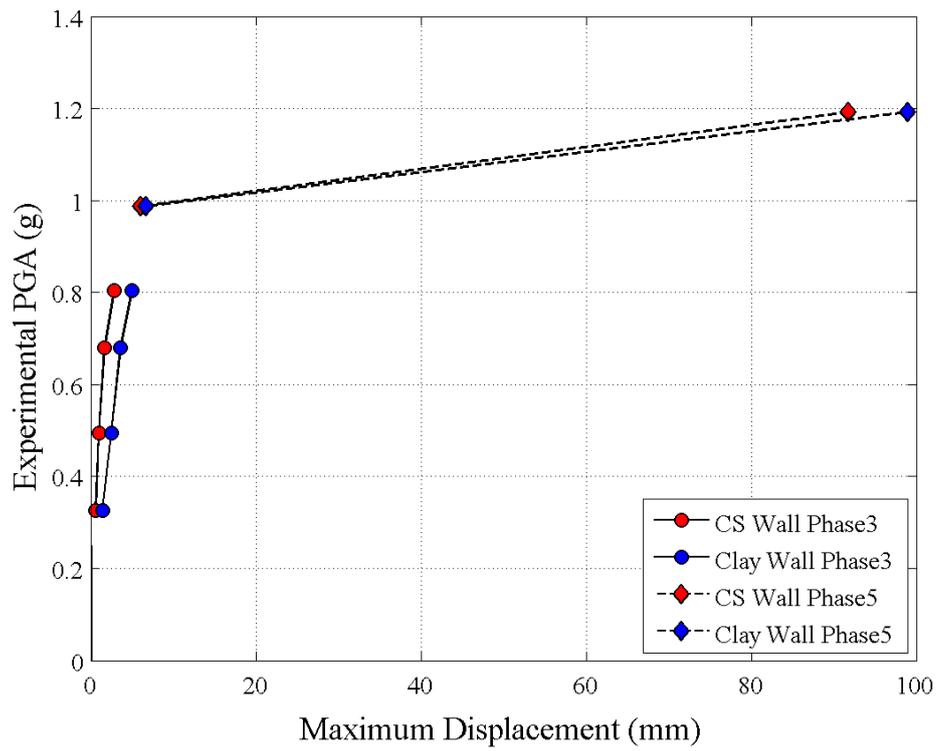
Figure 224. Experimental mid-height response peaks Gr\_2 Tests (PGA vs. Max response at mid-height).

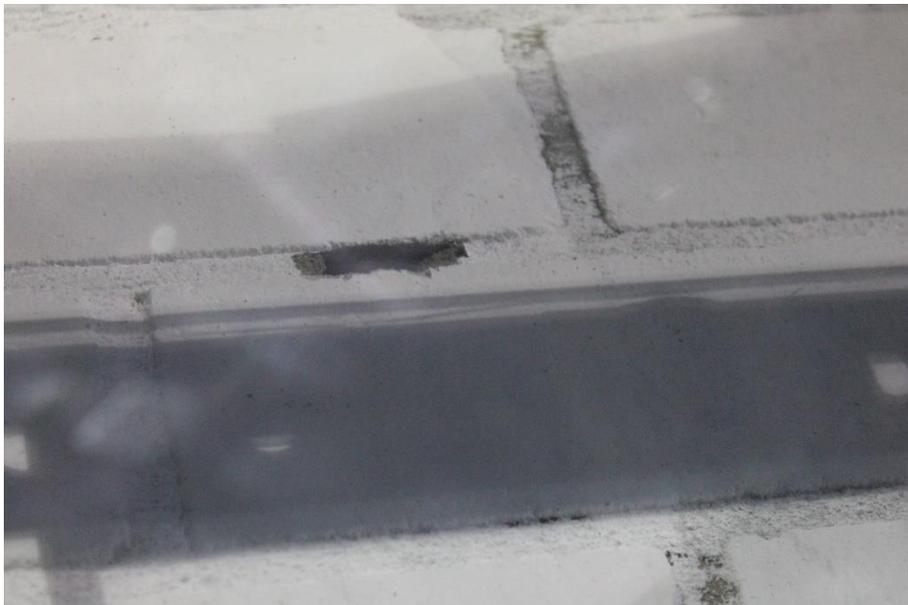
Figure 214Figure 229 shows the damage of the mortar bed joint due to the ties compression force (after 4.1 test).

Figure 229. Damage on the Mortar Bed-joint (after Test 5.1.)

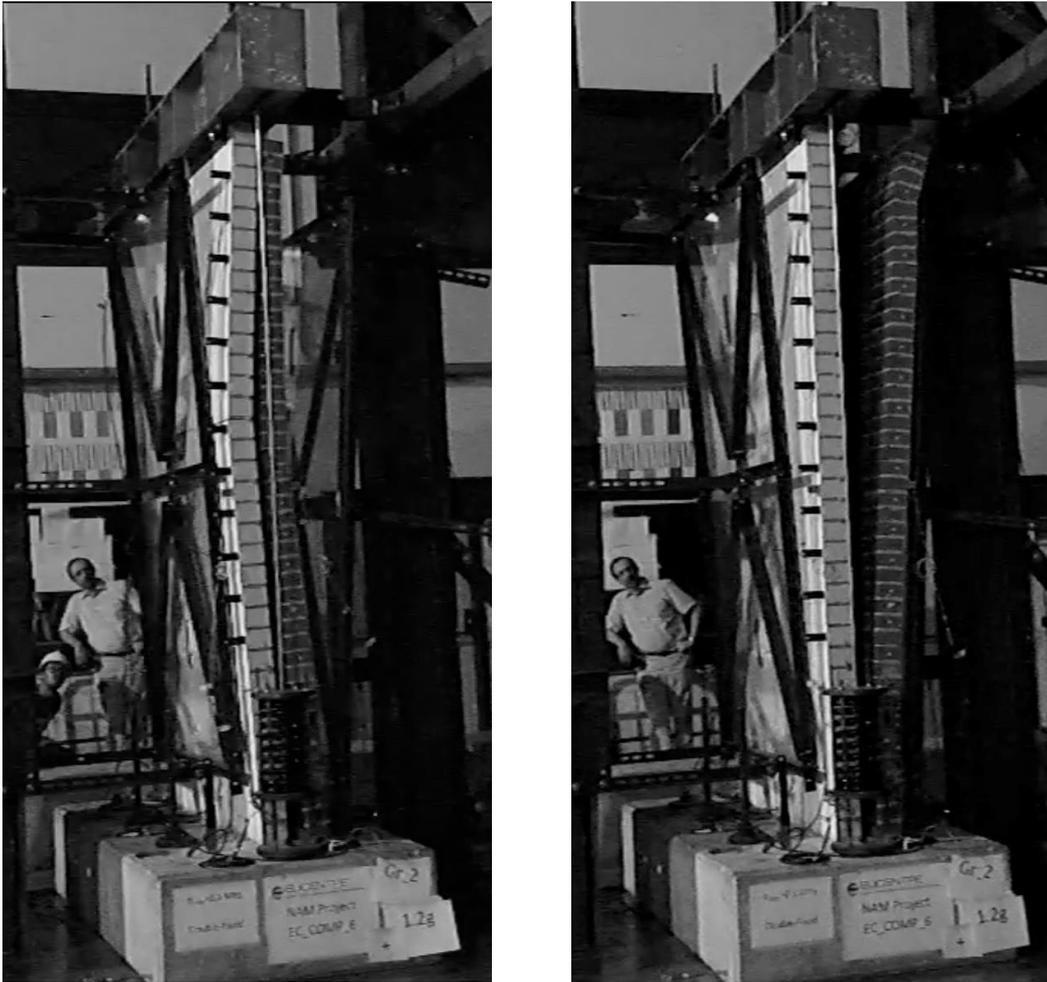
*Figure 230. Deformed shape of the EC\_COMP\_6 Specimen (left and right).*

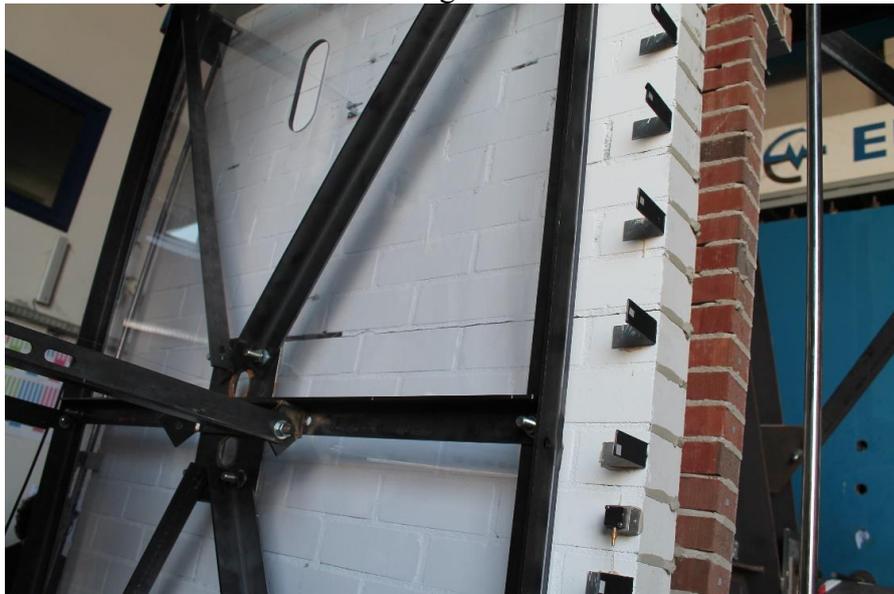
Figure 231 shows the formation of mid-height crack at the end of the test 5.2.

*Figure 231. Formation of mid-height crack (after Test 5.1.).*

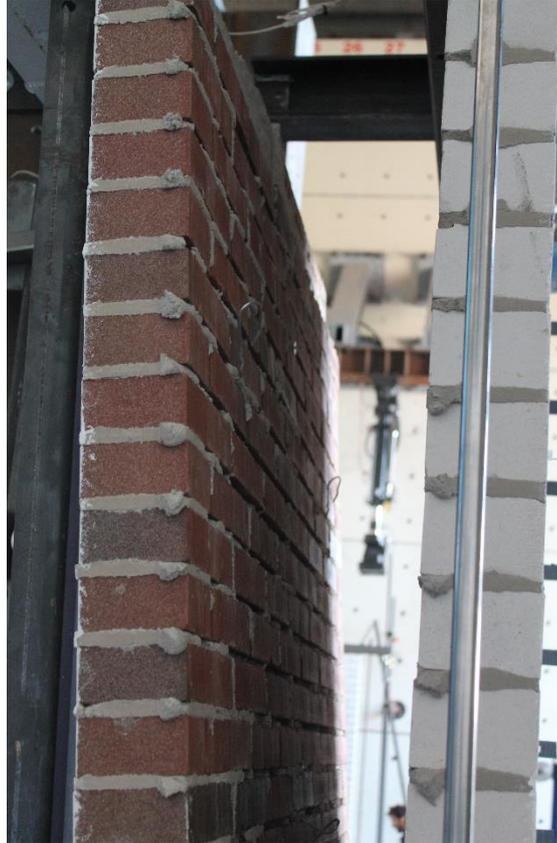
Figure 232 shows the collapse of the outer leaf at the end of the test 5.2. It is worth noticing as the clay collapse is associated to the expulsion of the ties from CS wall bed-joints.

*Figure 232. Separation of the two leaves (during Test 5.1.).*

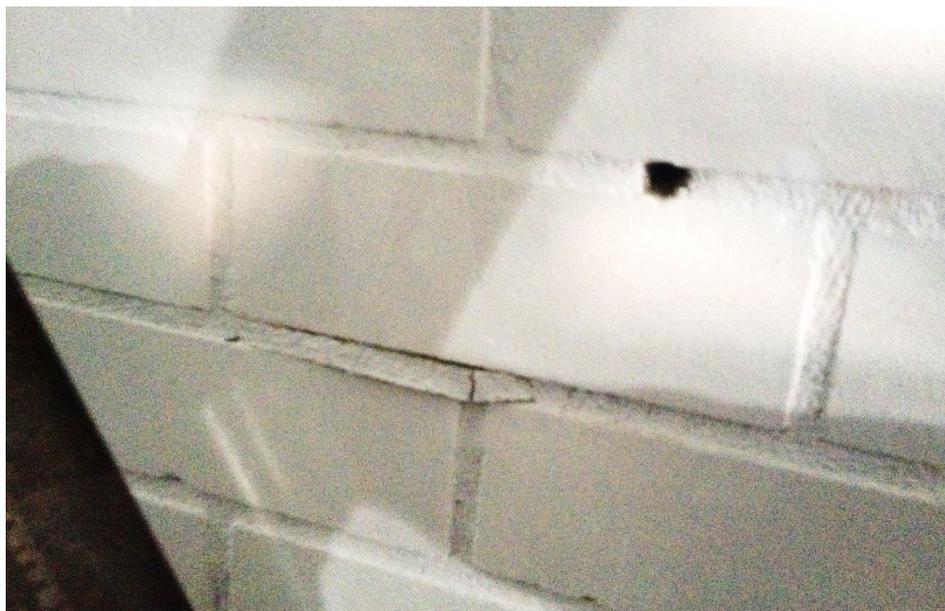
Figure 250 shows the damage of the mortar bed joint due to the ties compression force (after 4.1 test).

*Figure 250. Damage of the mortar bed joint.*

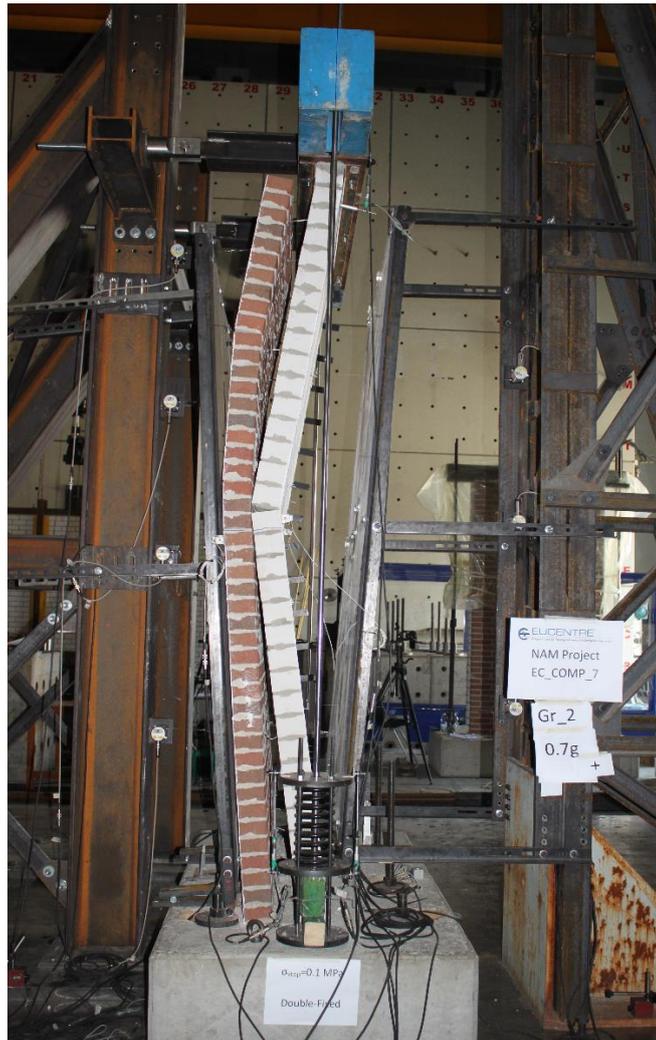
Figure 252 shows the EC\_COMP\_7 specimen collapsed after the 5.4 test.

*Figure 252. Collapse of EC\_COMP\_7 Specimen.*

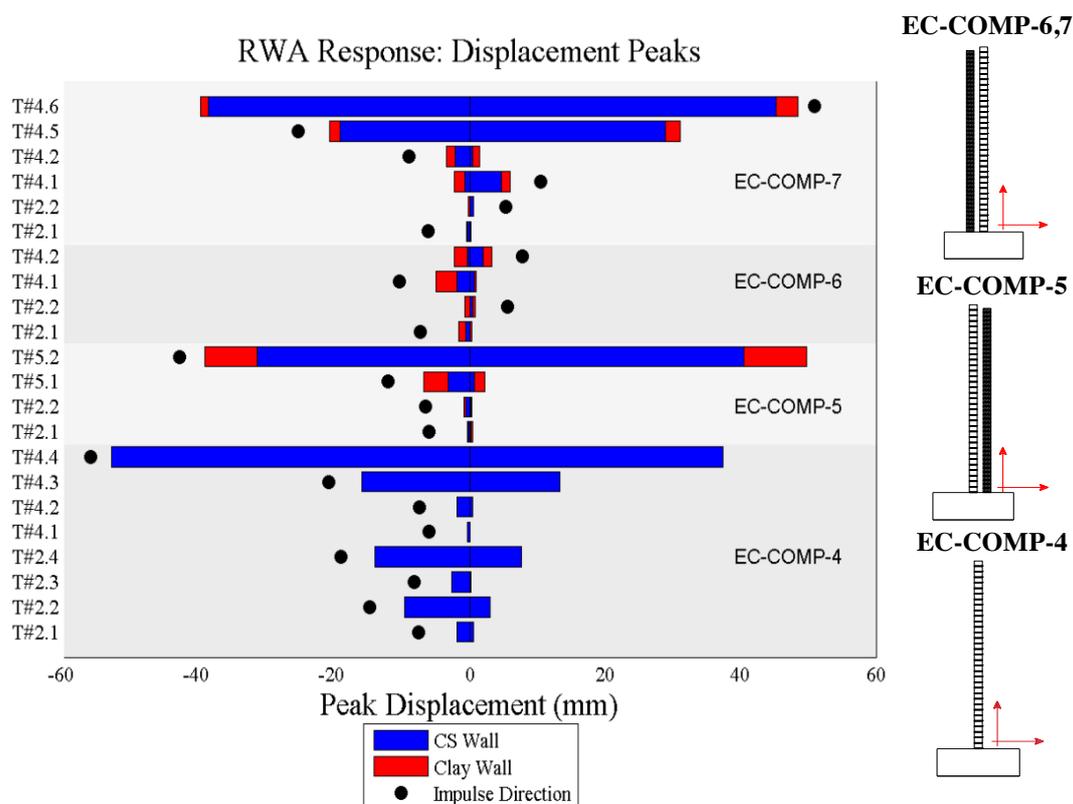
Figure 262. RWA Input: response peaks.

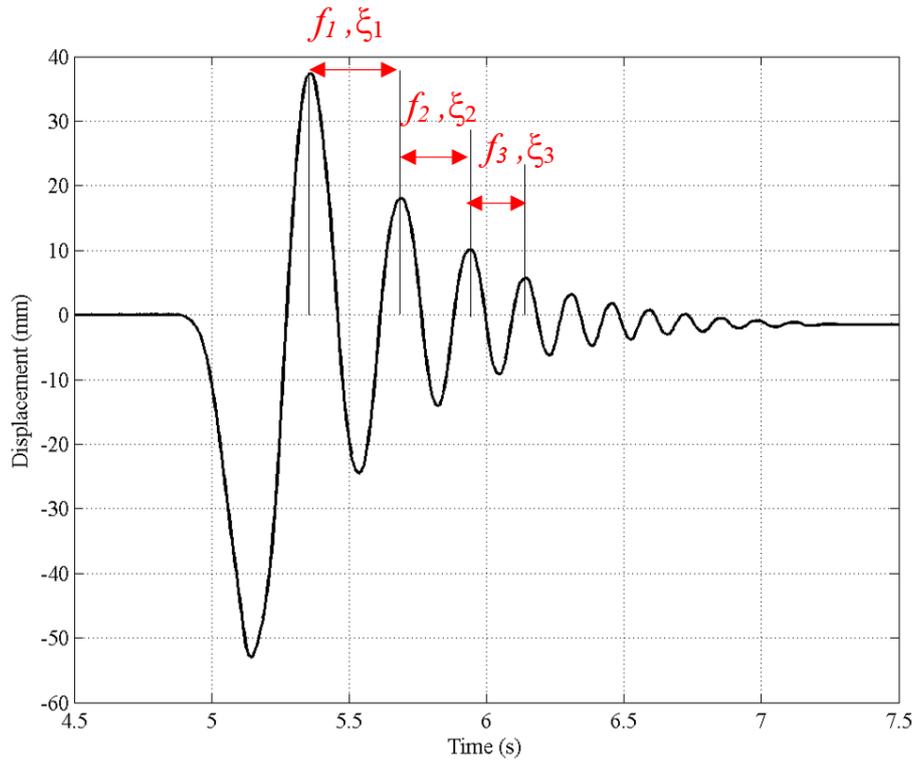
Figure 263. EC\_COMP\_4 Horizontal Mid-height Disp. History during test 4.4.

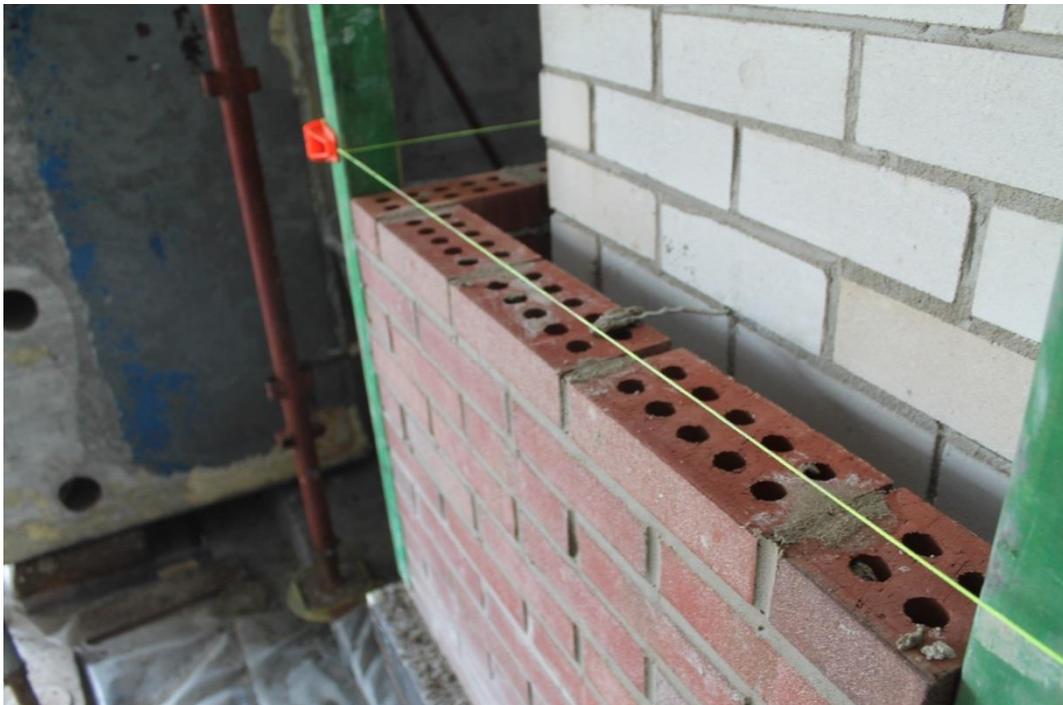
*Figure 268. Cavity wall.*

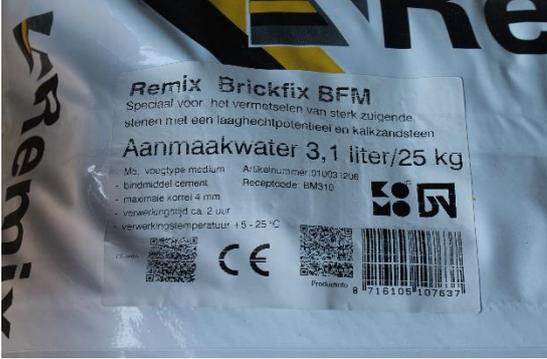
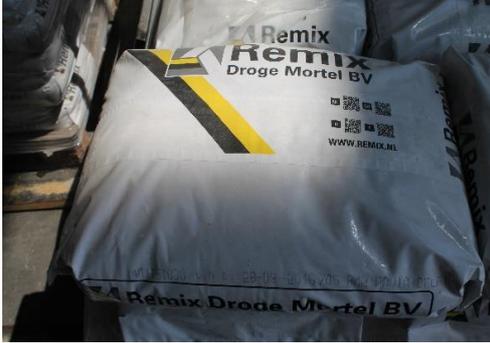
Figure 269. Mortar types.

The mortar used for the calcium silicate bricks is different from the one used for the clay bricks. The thickness of the layers were about 1 cm for both masonries. The Figure 269 shows the identification code of these two materials.

<p>Remix Brickfix BFM Speciaal voor het vermetelen van sterk zulgende stenen met een laaghechtpotentieel en kalkzandsteen Aanmaakwater 3,1 liter/25 kg M3 - voegtype medium - bindmiddel cement - maximale korrel 4 mm - verwerkingstijd ca. 2 uur - verwerkingstemperatuur +5 - 25 °C Ankelnummer: 010921206 Receptcode: BM310 CE Productie: 716105107637</p>

<p>Remix Droge Mortel BV WWW.REMIX.NL</p>
0920150102 t.h.t.: 19-08-2016 705 ITALY	1401151030 t.h.t.: 28-09-2016 705 BM2 PAVIA/DELFT

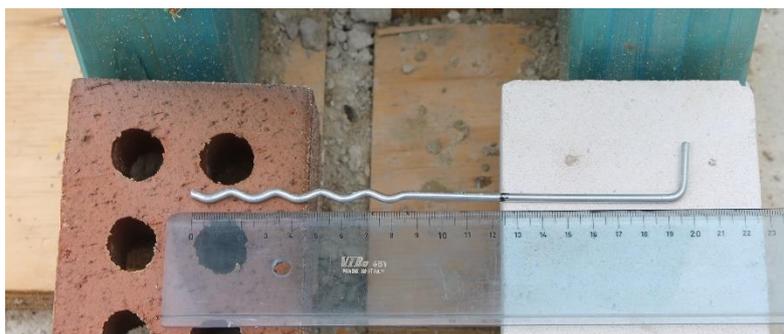
The two walls are connected by steel ties, diameter 3.4 mm, length 200 mm. They are inserted in the mortar joint during the laying of the bricks. The mortar was more generally laid on top of the bricks. The edge with the hook is in the inner leaf (calcium silicate bricks), for a length of about 7 cm. 5 cm on the outer leaf.

*Figure 278. Ties dimensions and geometry.*

The following two photos (Figure 278 and Figure 279) show the size and the method of laying those connections.

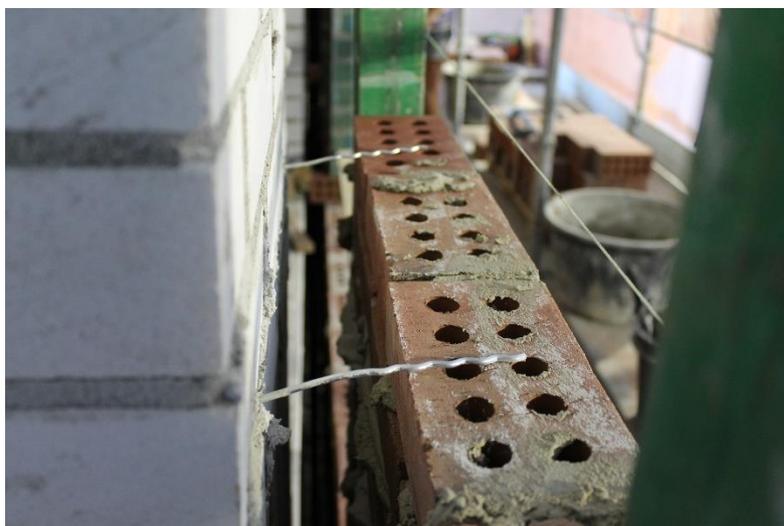
*Figure 279. Laying of the ties.*

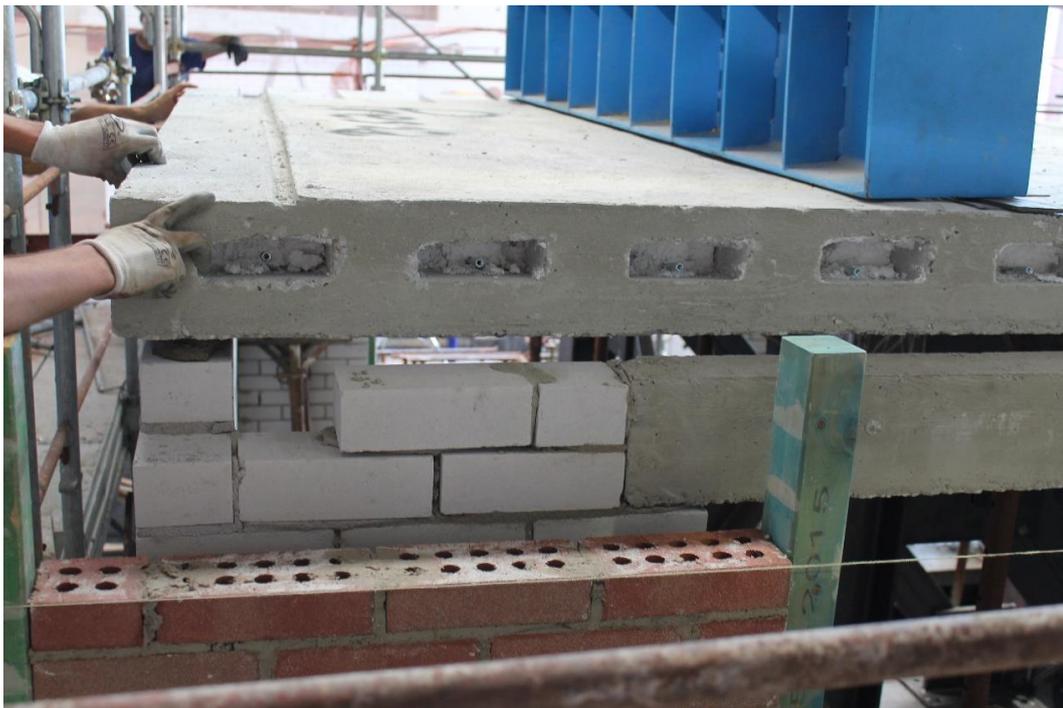
Figure 283. Positioning of the R.C. slab of the first floor - East side

The system is shown in the following Figures (Figure 282, Figure 283 and Figure 284).

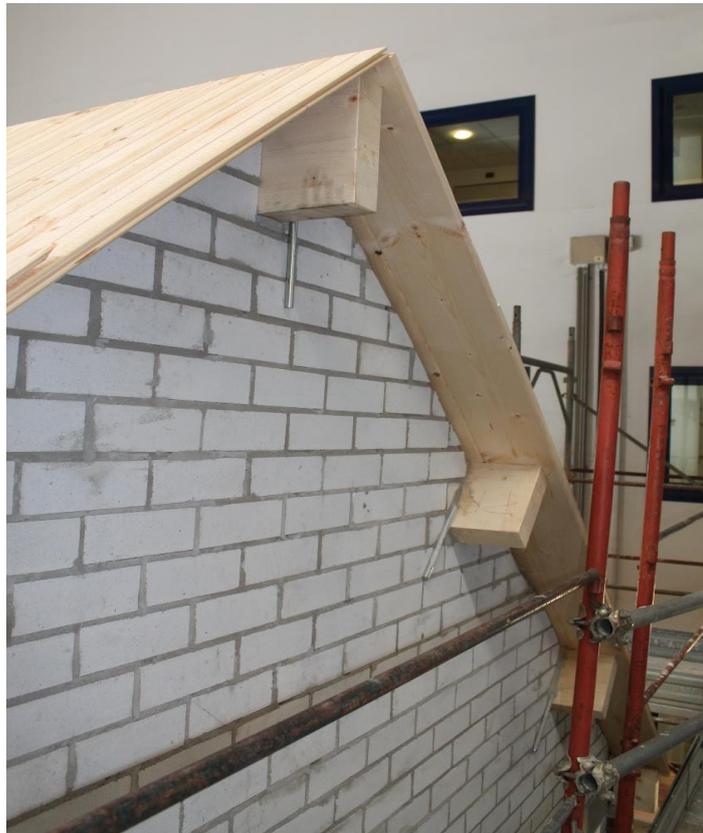
Figure 291. Roof and C.S. gable - South side.

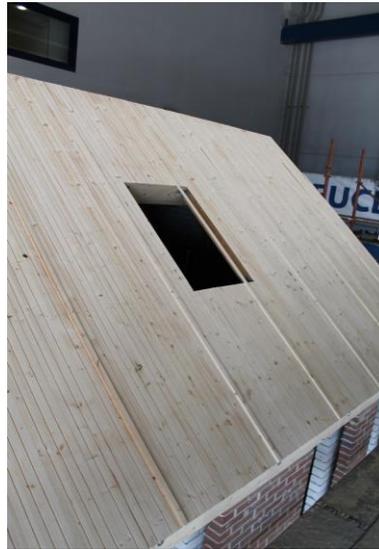
*Figure 294. Roof - West side*

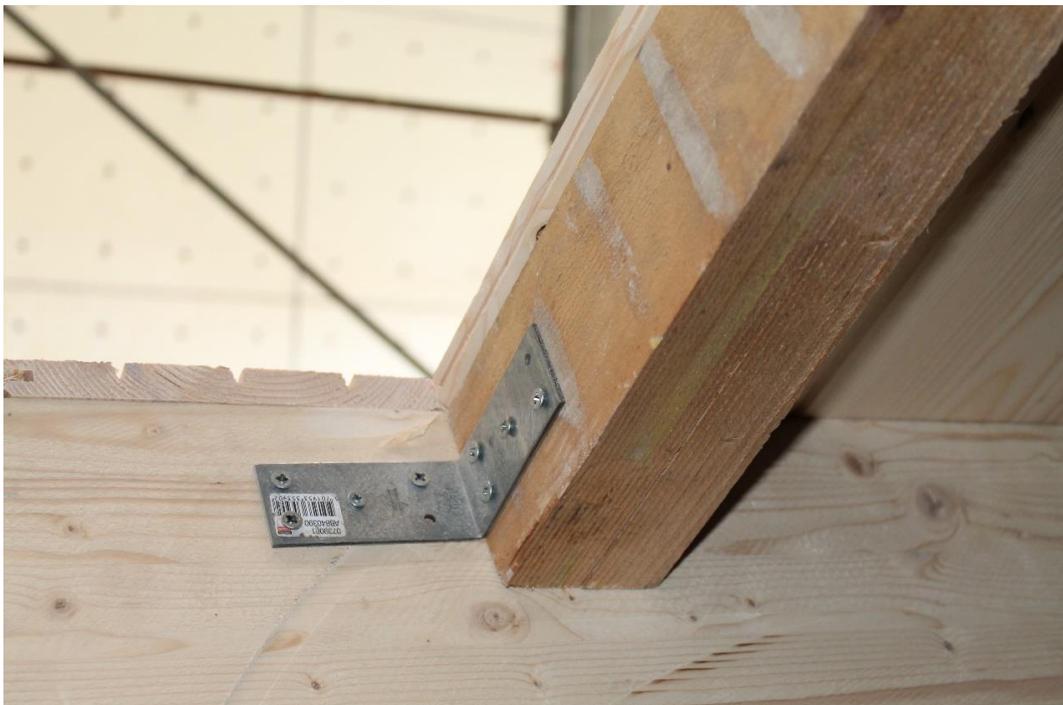
*Figure 295. Detail of the connection between the timber beam of the opening and the girder.*
