# **Experimental campaign on cavity walls systems representative of the Groningen building stock**

**Alberto Pavese, Francesco Graziotti and Guido Magenes**

**Eucentre**

Date June 2016

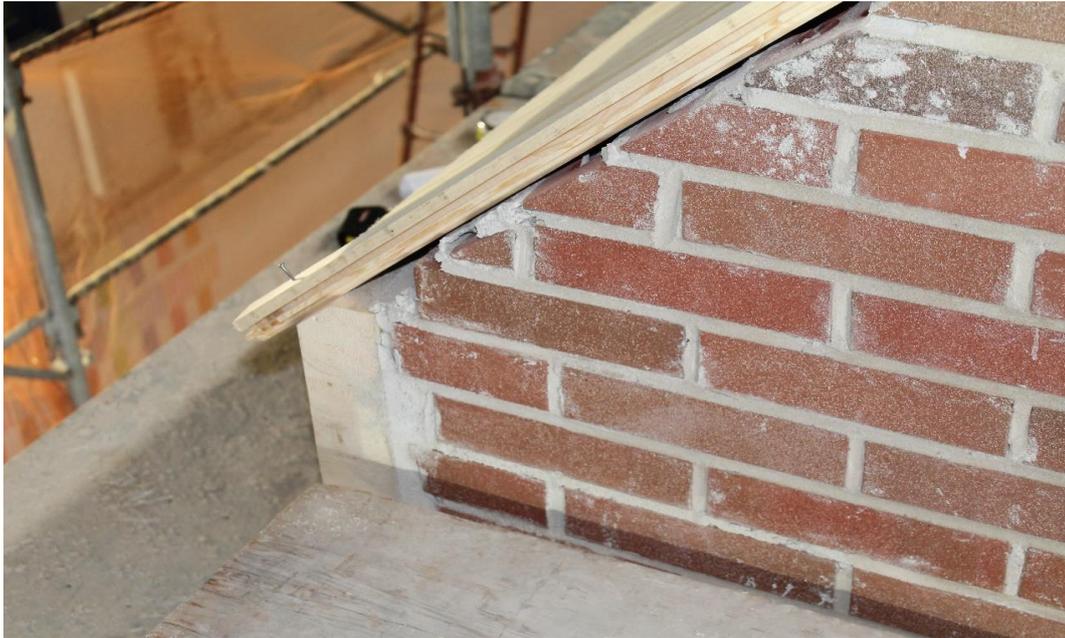
*Figure 296. Detail of the connection between the girder and the clay gable – 1.*

In the following are a series of images that describe the connection between the beam and the gable clay.

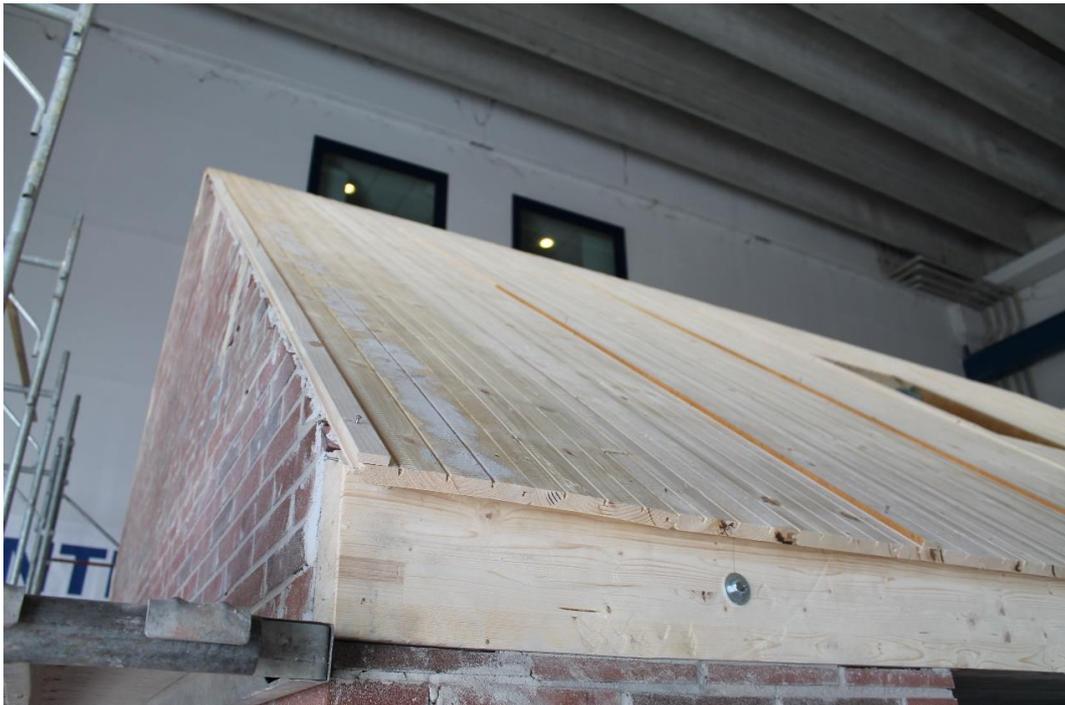
*Figure 297. Detail of the connection between the girder and the clay gable – 2.*

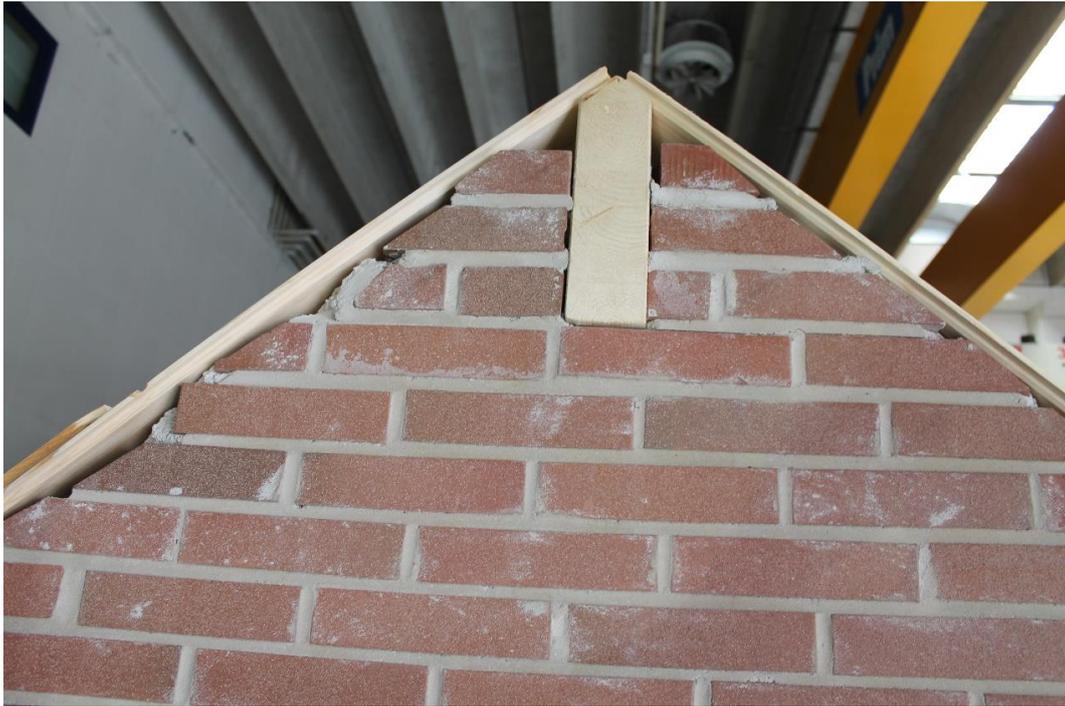
*Figure 298. Detail of the connection between the girder and the clay gable – 3.*

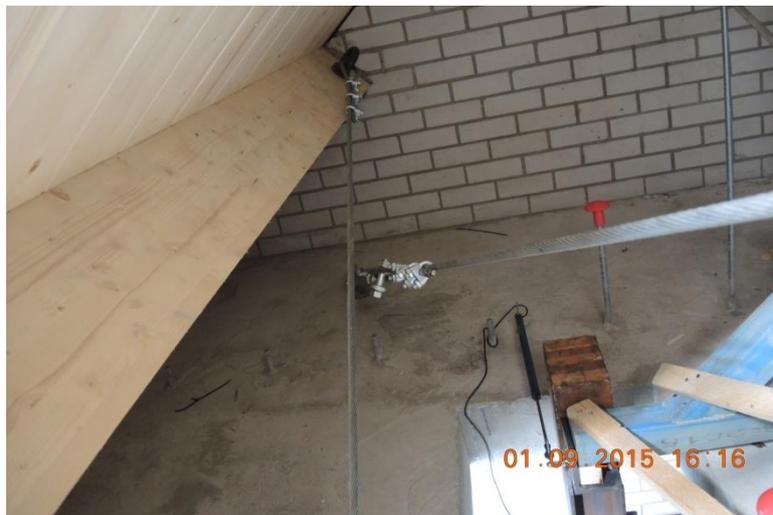
The roof, indeed, has a system of twelve  $\phi 12$  mm rods installed for safety reasons to prevent the local out of plane failure of the specimen gable and the consequently damage of the laboratory. The rods system allows the horizontal out-of-plane displacement of gables till significant displacement level without any force resistance contribution. Applying a tension on the rods it was possible to increase the roof in plane stiffness.

*Figure 299. Detail of two of the rods connecting the second floor to the roof beams.*

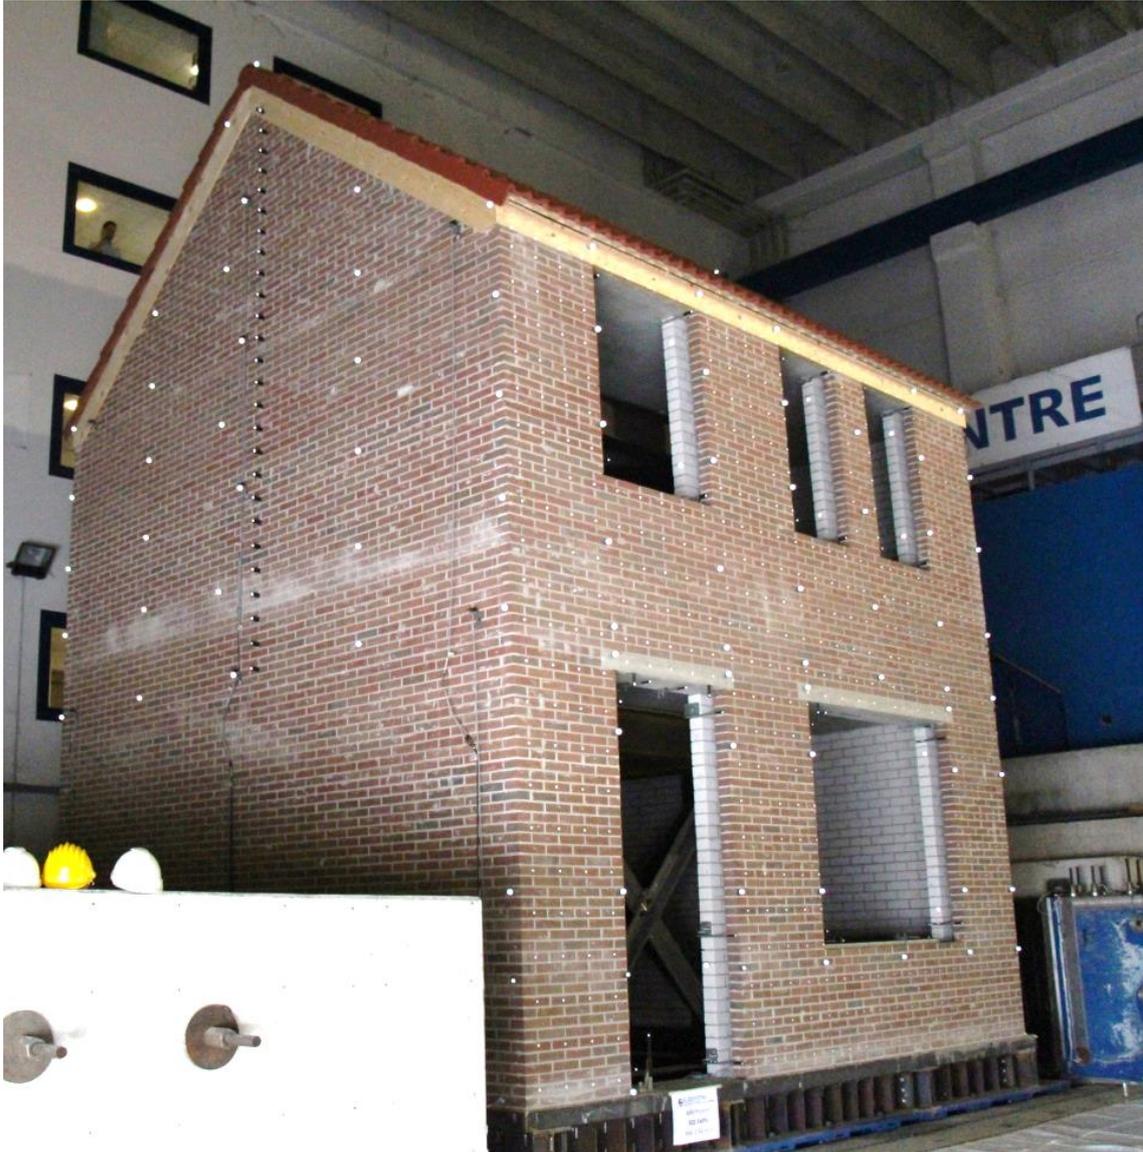
The tiles were added on the roof at the end of the construction. The total mass of the roof (tiles+timber) is 2.8t.

The total mass of the house resulted to be 56 t.

*Figure 300. Picture of the specimen at the end of the construction.*

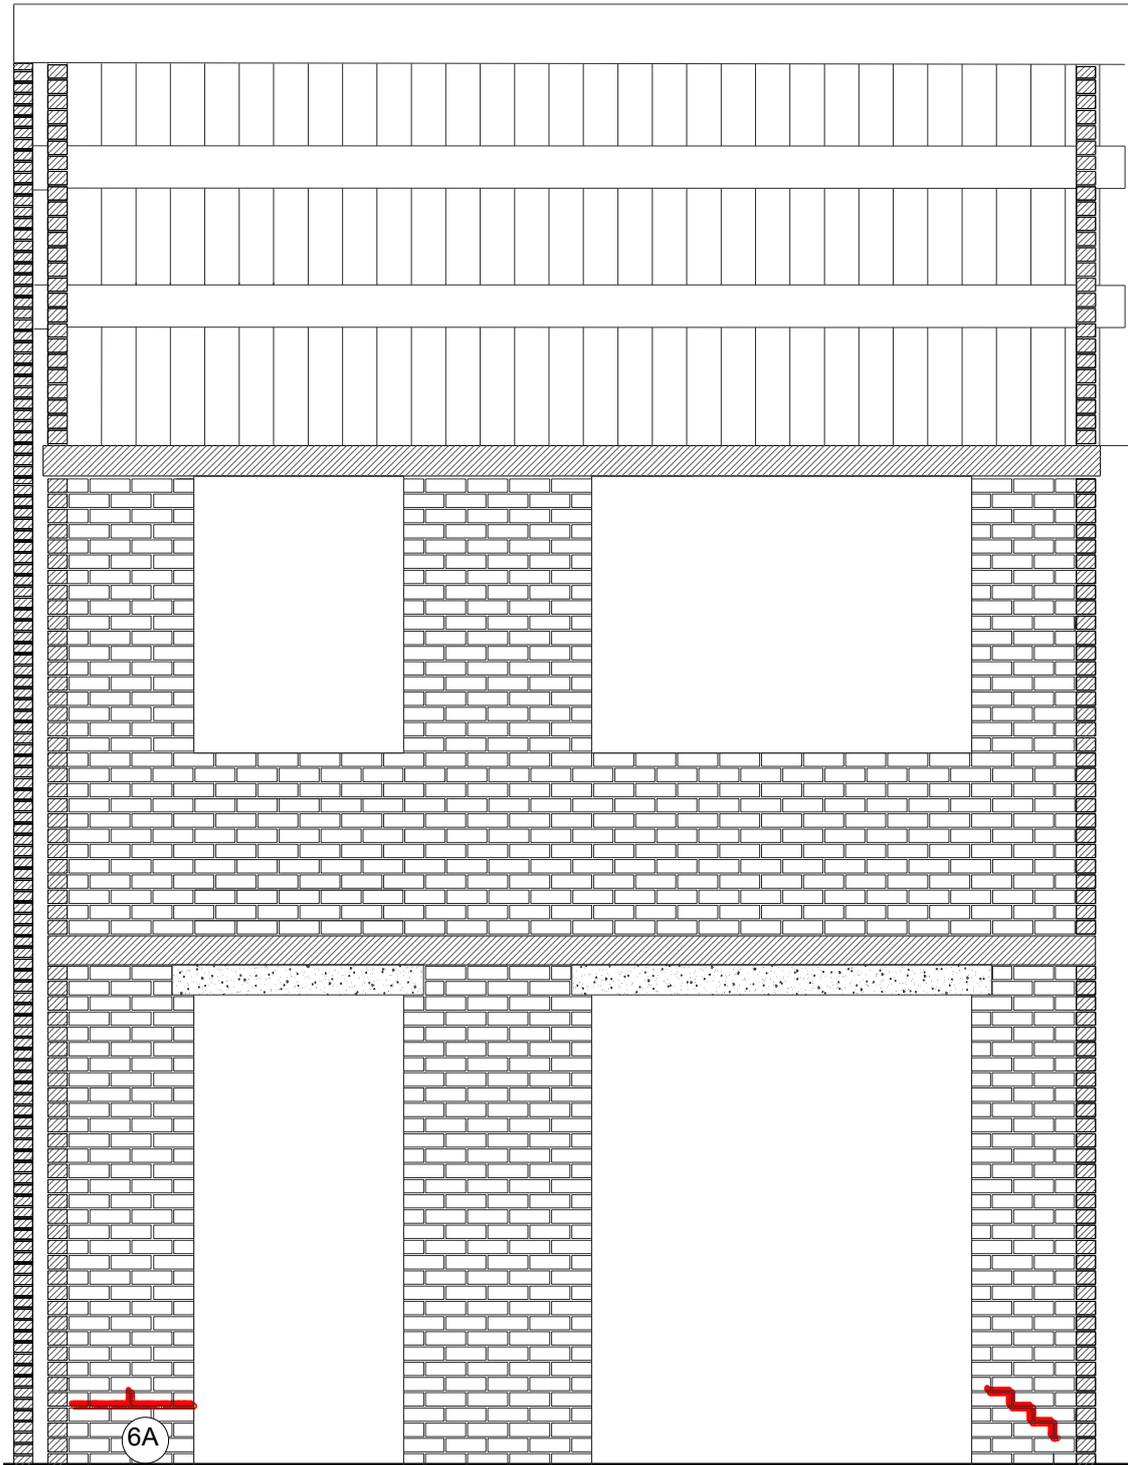
Figure 307. Section of the test-house - inner leaf - east side. Illustration of crack pattern after the test # 16, 100%\_EQ2\_160,  $PGA = 1.6 \text{ m/s}^2$ .

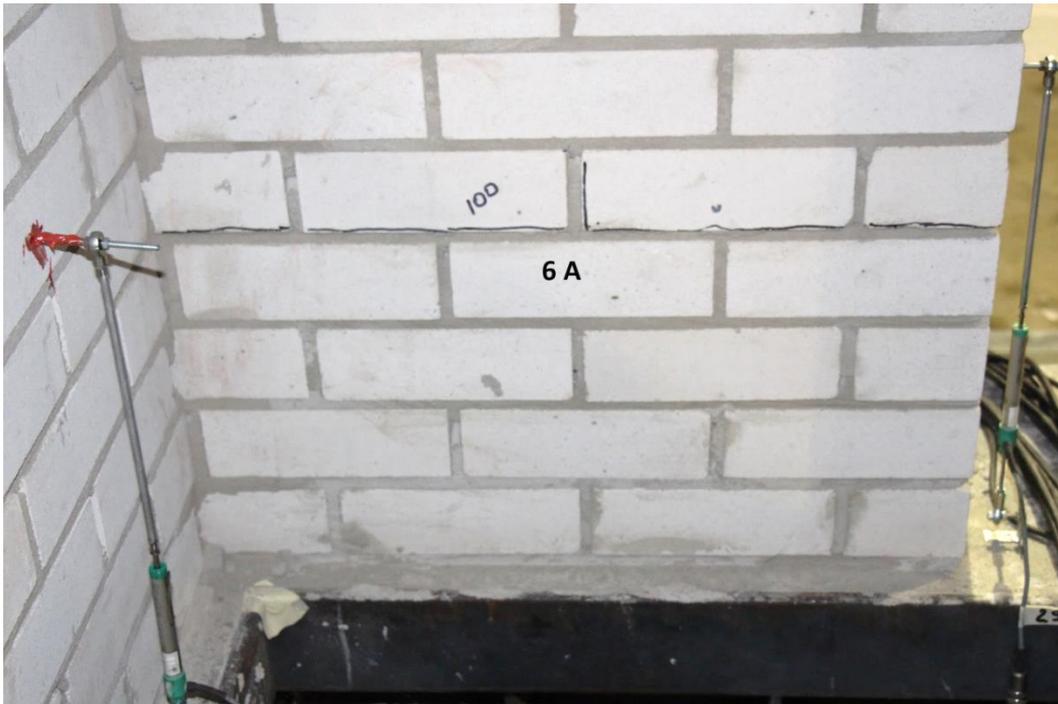
*Figure 308. Crack n 6A after the test # 16, 100%\_EQ2\_160, PGA= 1.6 m/s<sup>2</sup>.*

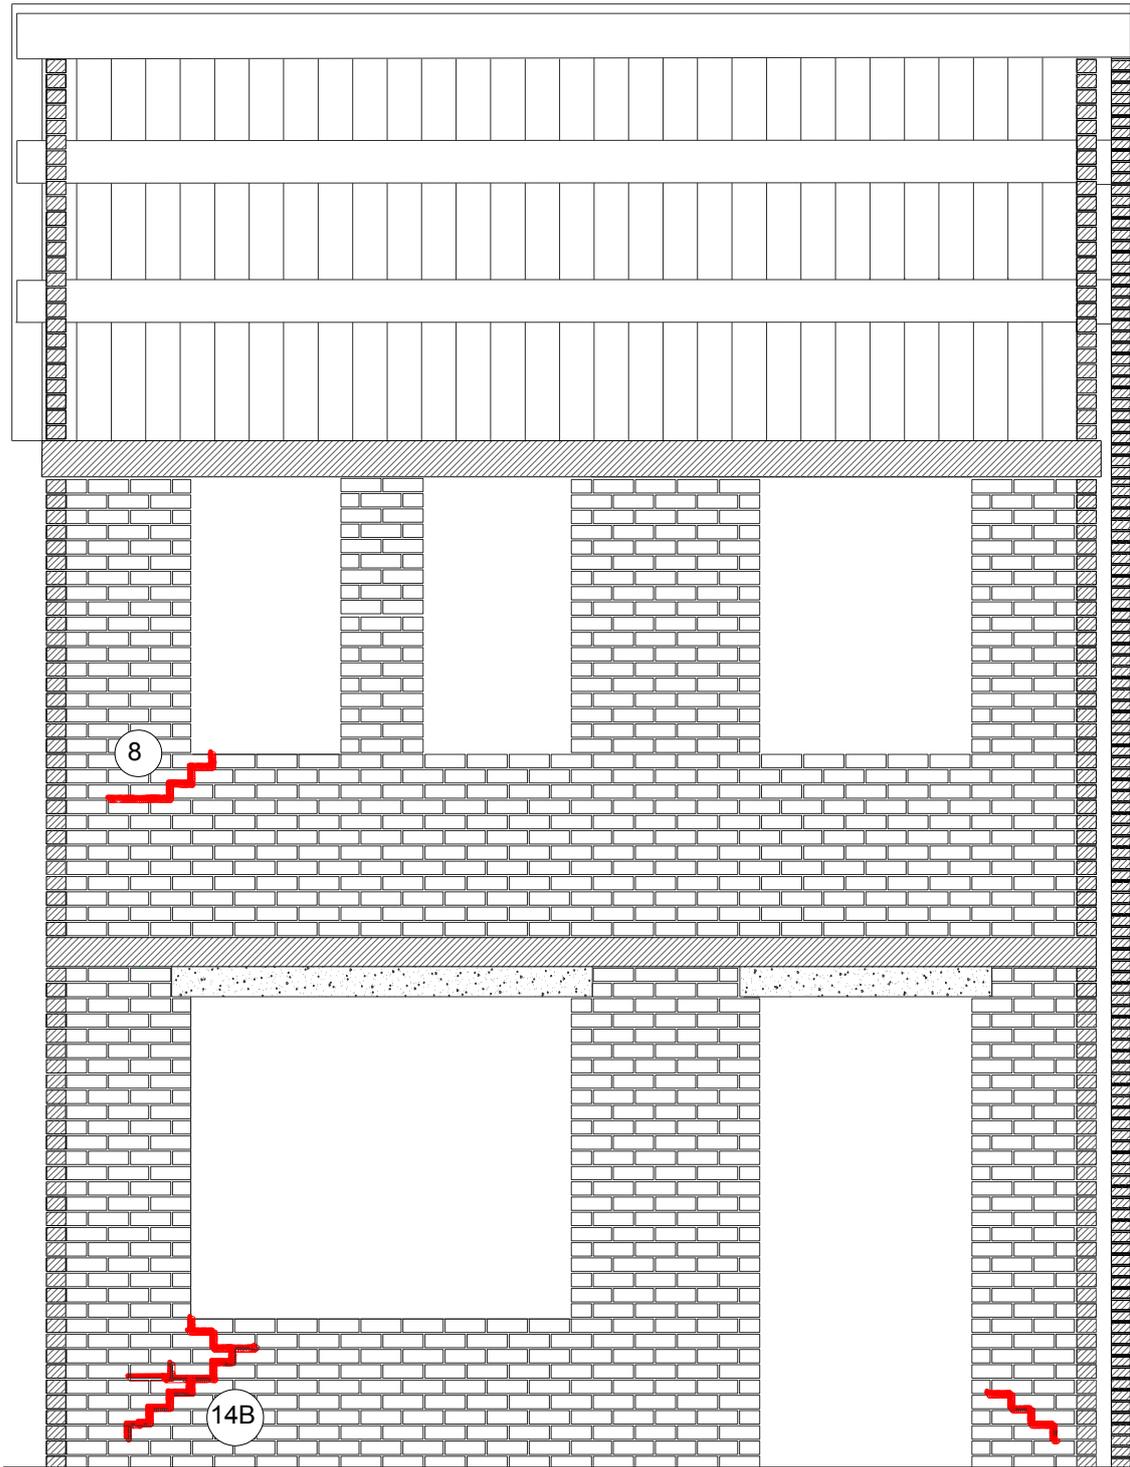
Figure 309. Section of the test - house - inner leaf - west side. Illustration of crack pattern after the test # 16, 100%\_EQ2\_160,  $PGA = 1.6 \text{ m/s}^2$

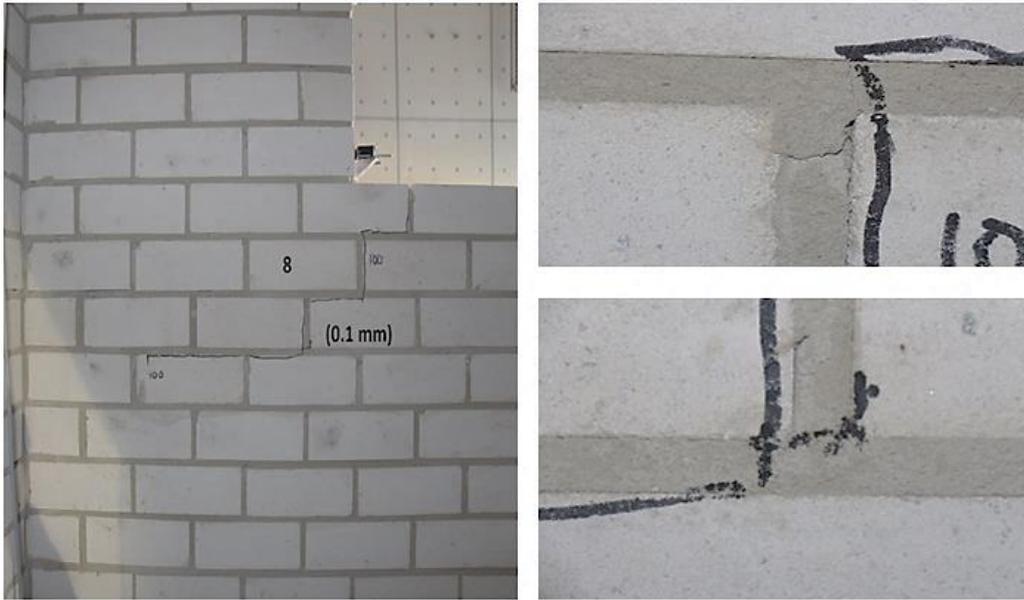
Figure 310. Crack #8 after the test # 16, EQ2\_160%, PGA= 1.6 m/s<sup>2</sup>

During the test performed at 100% of EQ2 ( $1.6 \text{ m/s}^2$ ) the specimen suffered slight damage and the formation of the first few cracks was observed. On the east side of the calcium silicate masonry, two cracks were developed on the first storey, a few centimeters above the base level of the two corner piers. Crack #6A identified on the leftmost pier (see Figure 307 to Figure 311) was developed horizontally, in contrast to the rest cracks that presented a stair-stepped diagonal pattern. On the west side of the building, the inner leaves presented similar to the eastern side damage. Diagonal cracks were developed on the bottom of the first storey corner piers, while another crack was identified at the lower left corner of the leftmost second storey opening (crack # 8, shown in Figure 309 and Figure 310).

Measuring the width of the cracks at the end of each test allowed monitoring the evolution of the damage induced on the body of the masonry subjected to the sequence of increasing intensity ground motions. The following figures summarize the location as well as the extension of the cracks observed at the end of the test at PGA of  $1.6 \text{ m/s}^2$ . The maximum crack width measured was approximately 1 mm, corresponding to crack #14B, while crack #8 was as wide as 0.1 mm (Figure 310).

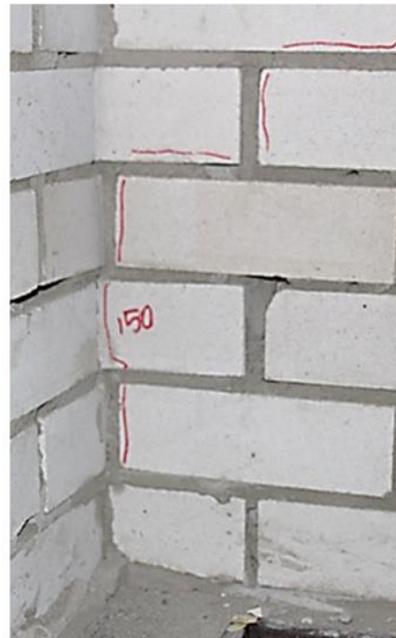
Concerning the damage observed on the west side, widening of the existing crack #14B occurred, from an opening of 1 mm to that of 2 mm (shown Figure 312). The newly developed crack, # 9, originating from the corner of the second storey central opening, was 1 mm wide, while the width of crack No. 8 did not change, remaining stable at 0.1mm.

Figure 312. Cracks #14 and #14B after the test # 19, 125%\_EQ2\_200, PGA=  $2 \text{ m/s}^2$ .

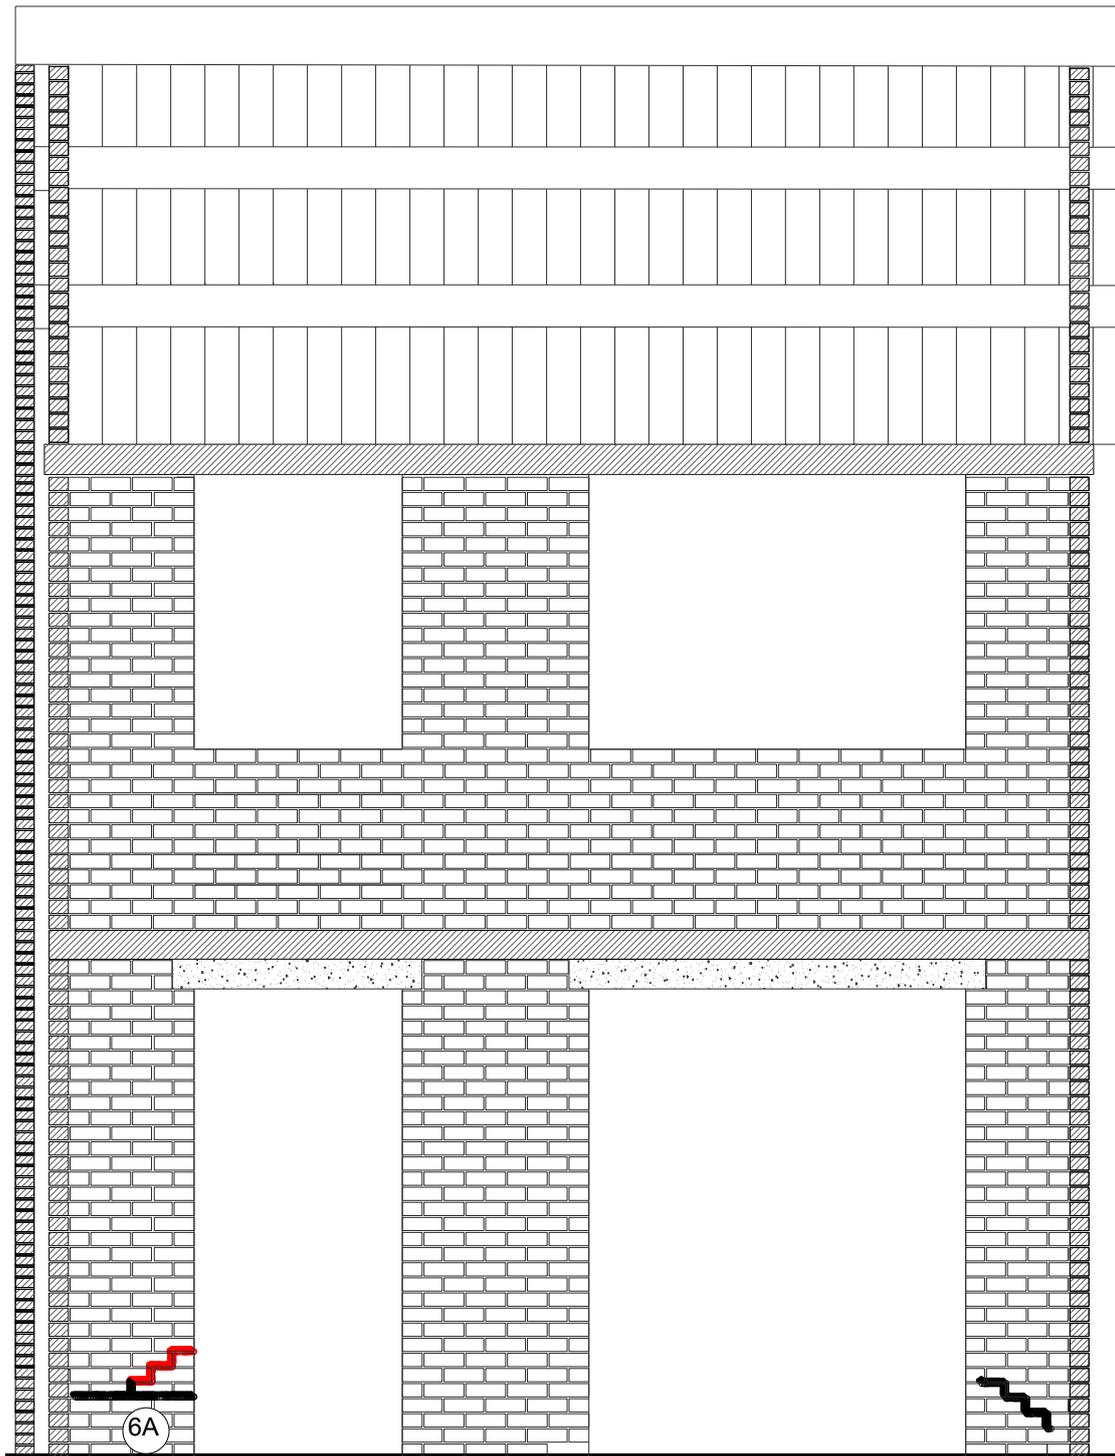
*Figure 313. Section of the test-house - inner leaf - East-side. Illustration of crack pattern after the test # 19, 125%\_EQ2\_200,  $PGA = 2 \text{ m/s}^2$ . In red cracks induced at current test and in black the pre-existing cracks.*

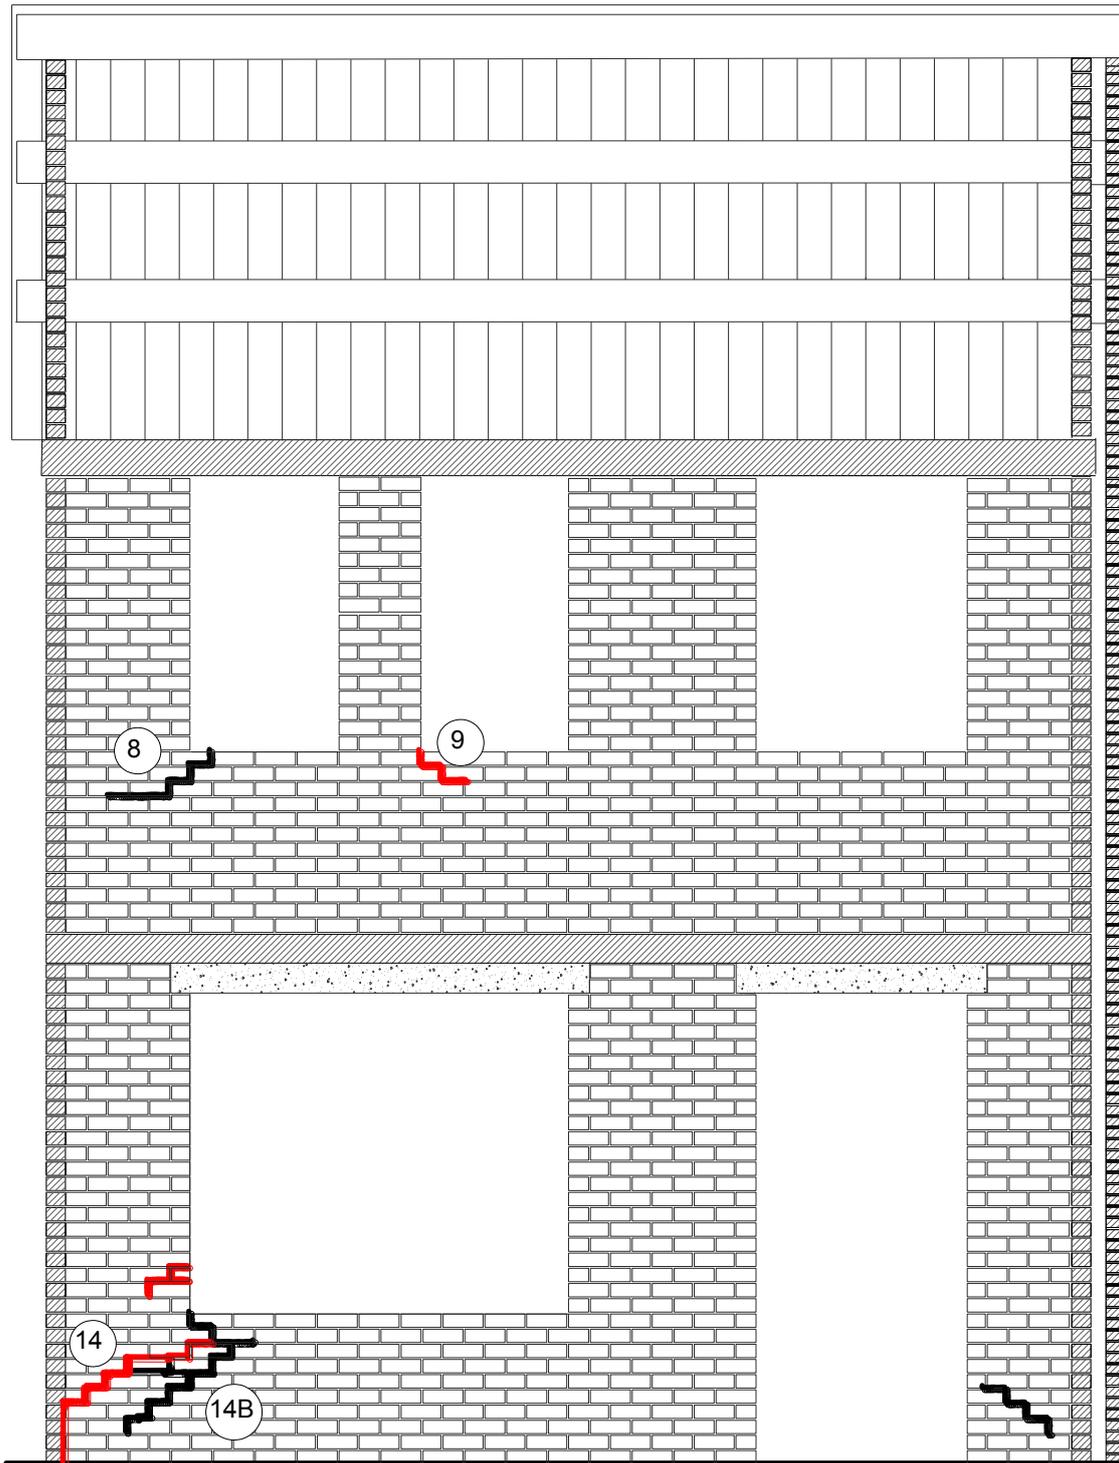
Figure 314. Section of the test-house - inner leaf - west-side. Illustration of crack pattern after the test # 19, 125%\_EQ2\_200,  $PGA = 2 \text{ m/s}^2$ . In red cracks induced at current test and in black the pre-existing cracks.

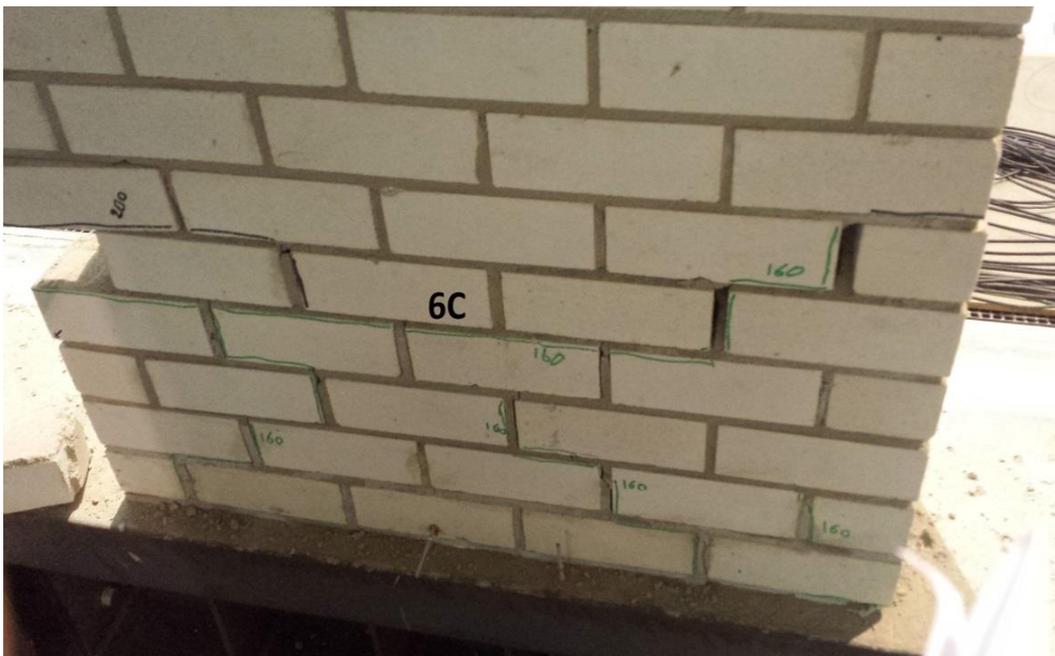
*Figure 315. Crack #6C after the test # 21, 150%\_EQ2\_240, PGA=  $2.4 \text{ m/s}^2$ .*

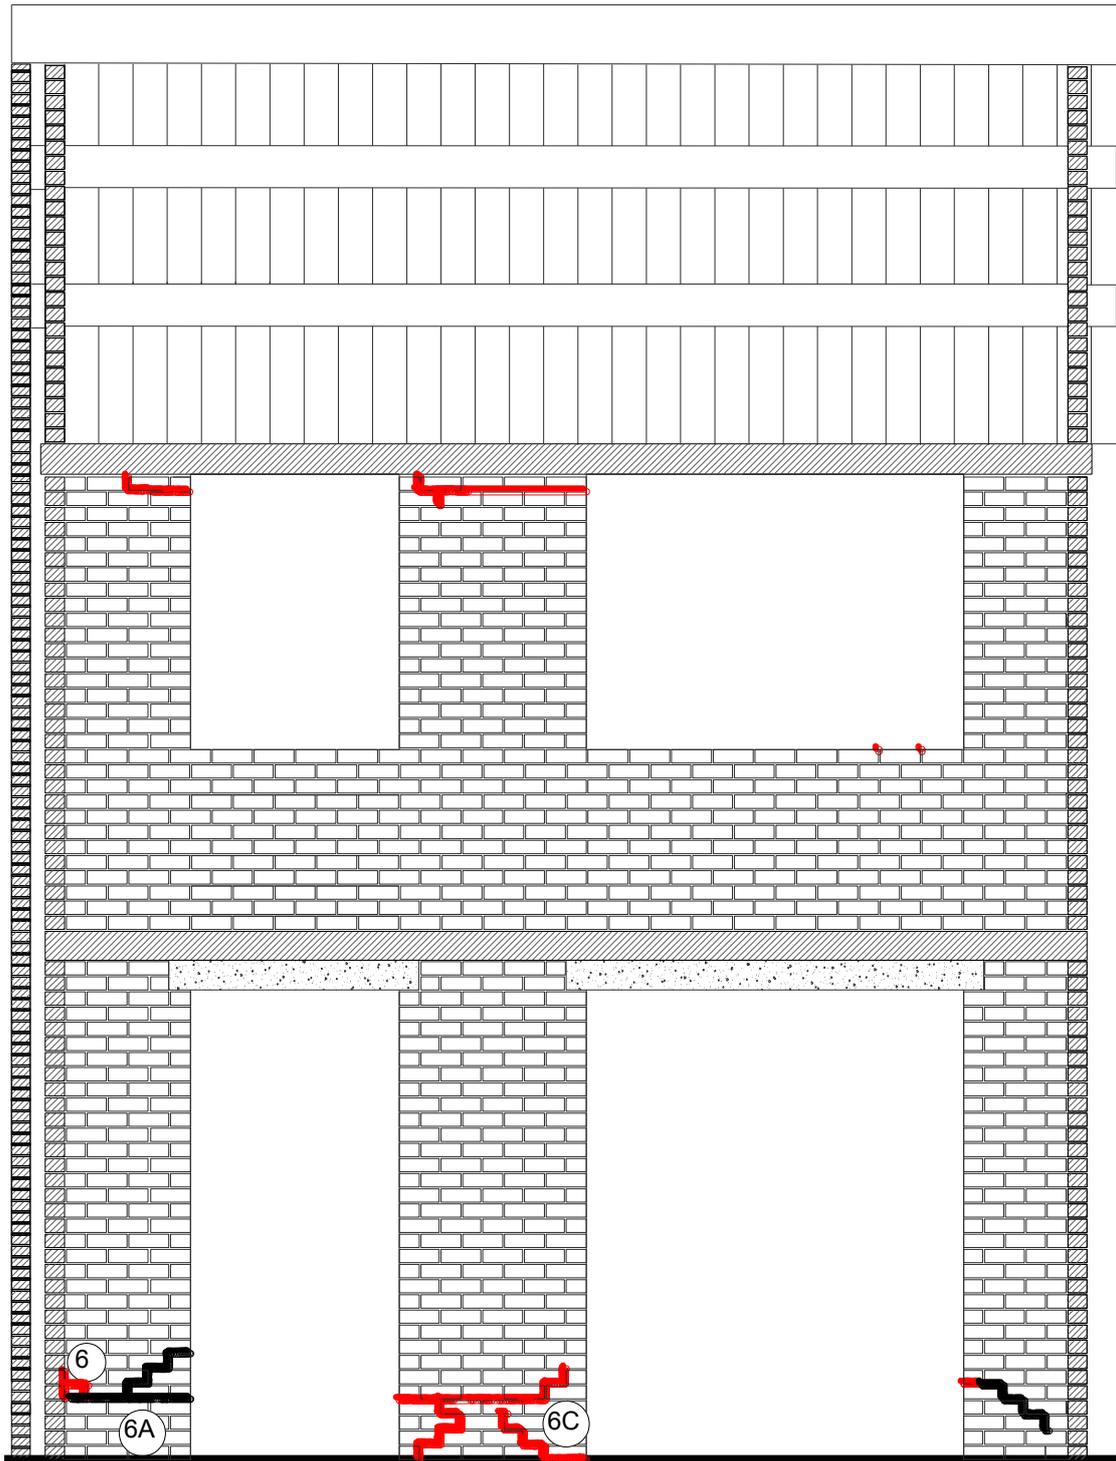
Figure 316. Section of the test-house - inner leaf - east-side. Illustration of crack pattern test after the test #21, 150%\_EQ2\_240,  $PGA= 2.4 \text{ m/s}^2$ . In red cracks induced at current test and in black the pre-existing cracks.

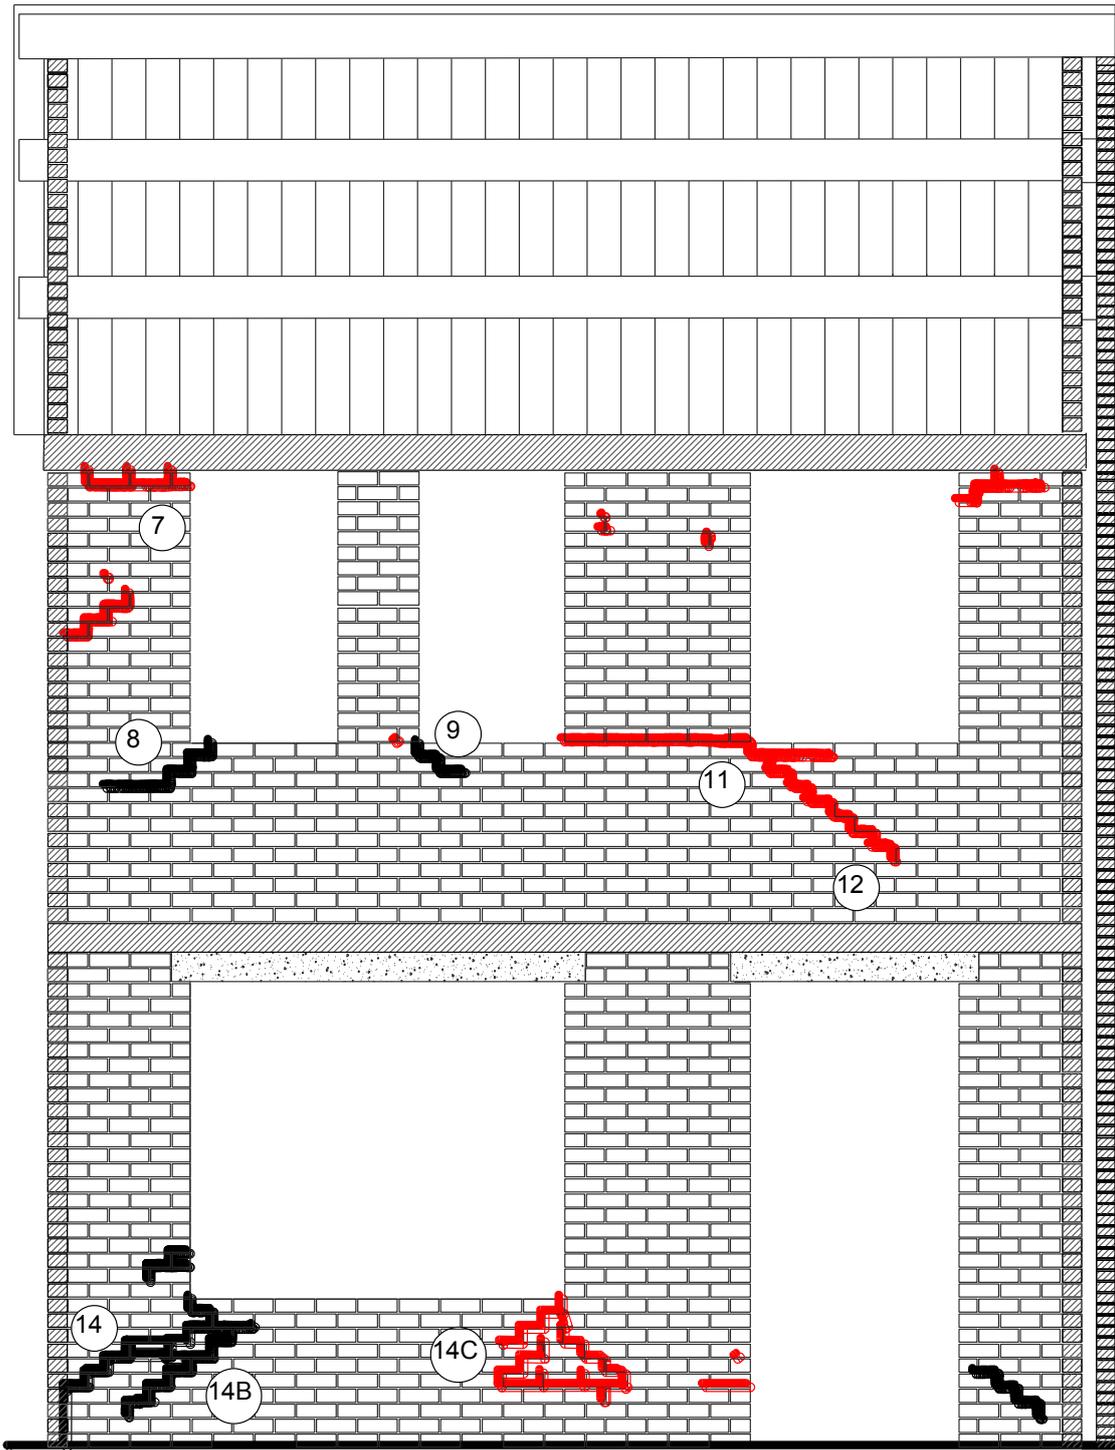
Figure 317. Section of the test-house - inner leaf - west-side. Illustration of crack pattern after the test #21, 150%\_EQ2\_240,  $PGA = 2.4 \text{ m/s}^2$ . In red cracks induced at current test and in black the pre-existing cracks.

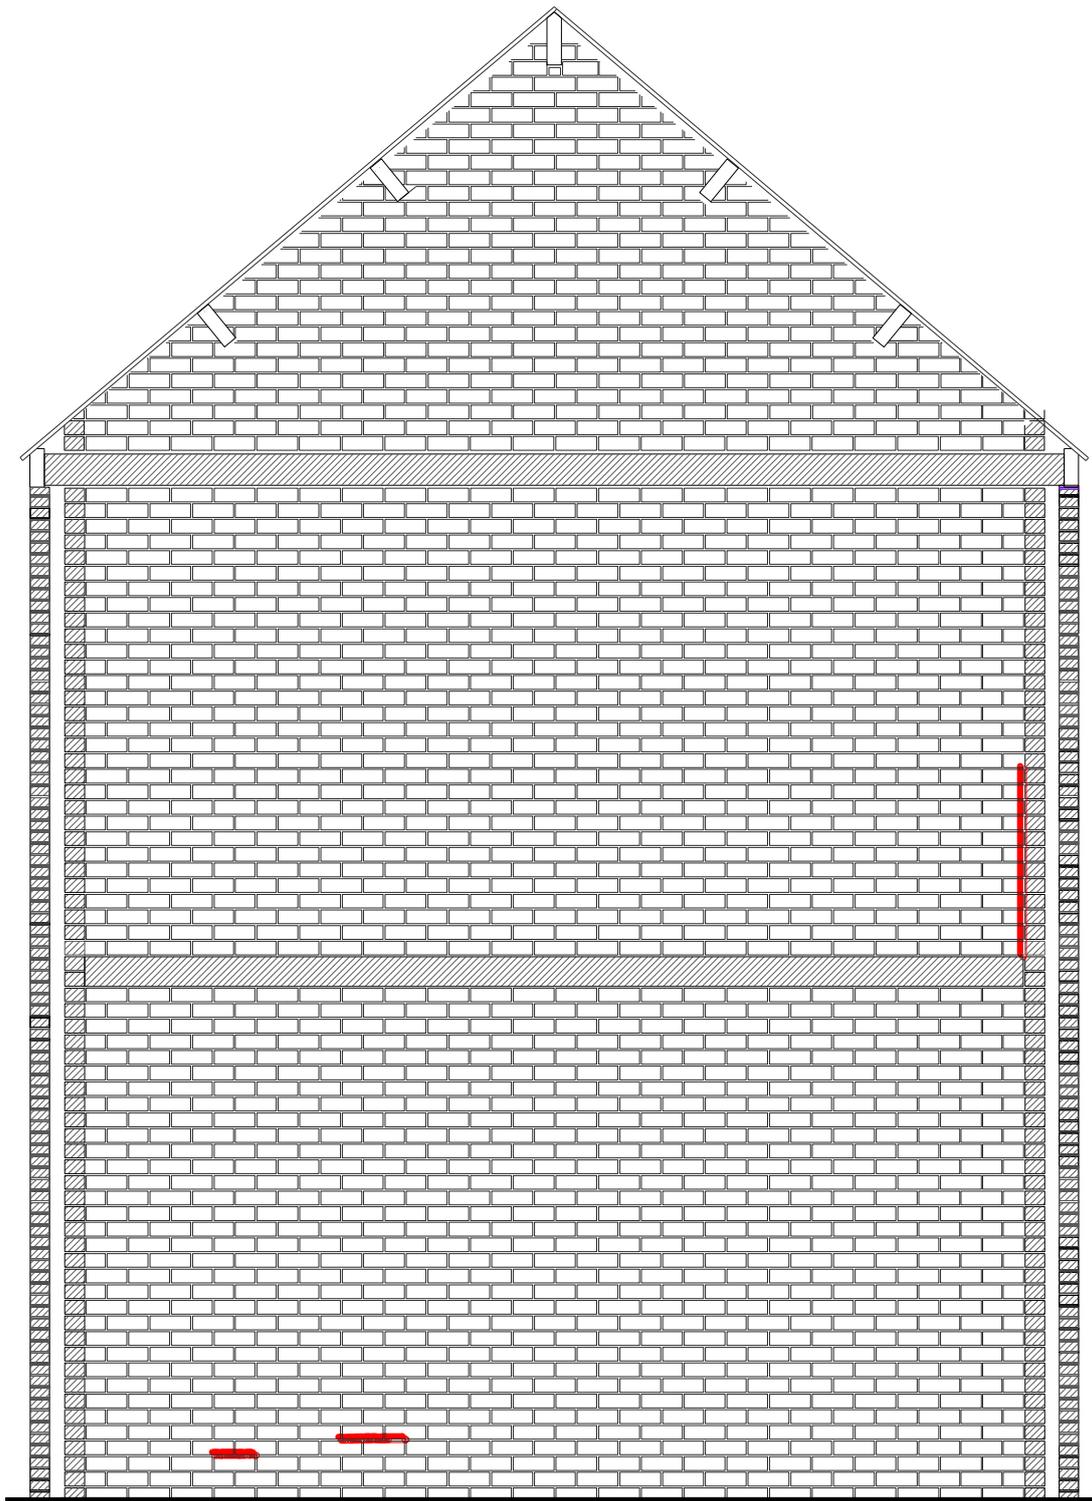
*Figure 318. Section of the test-house - inner leaf - north-side. Illustration of crack pattern after the test #21, 150%\_EQ2\_240, PGA= 2.4 m/s<sup>2</sup>. In red cracks induced at current test and in black the pre-existing cracks.*

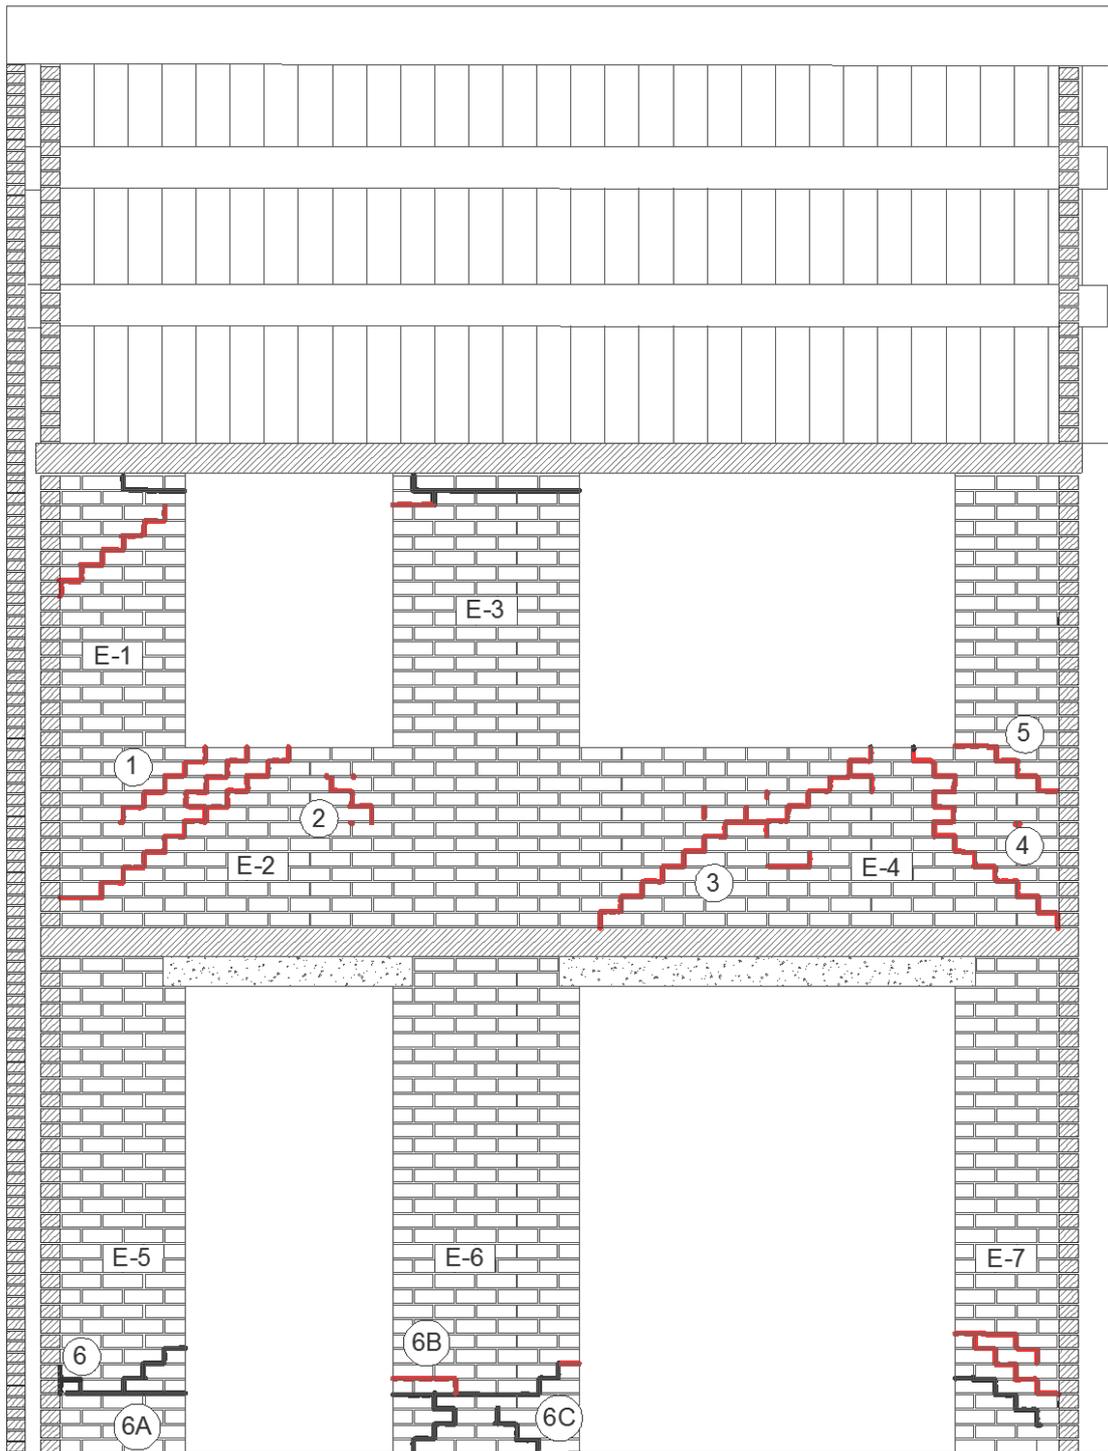
Figure 319. Section of the test-house - inner leaf - east-side. Illustration of crack pattern after the test # 23, 200%\_EQ2\_320,  $PGA = 3.1 \text{ m/s}^2$ . In red cracks induced at current test and in black the pre-existing cracks.

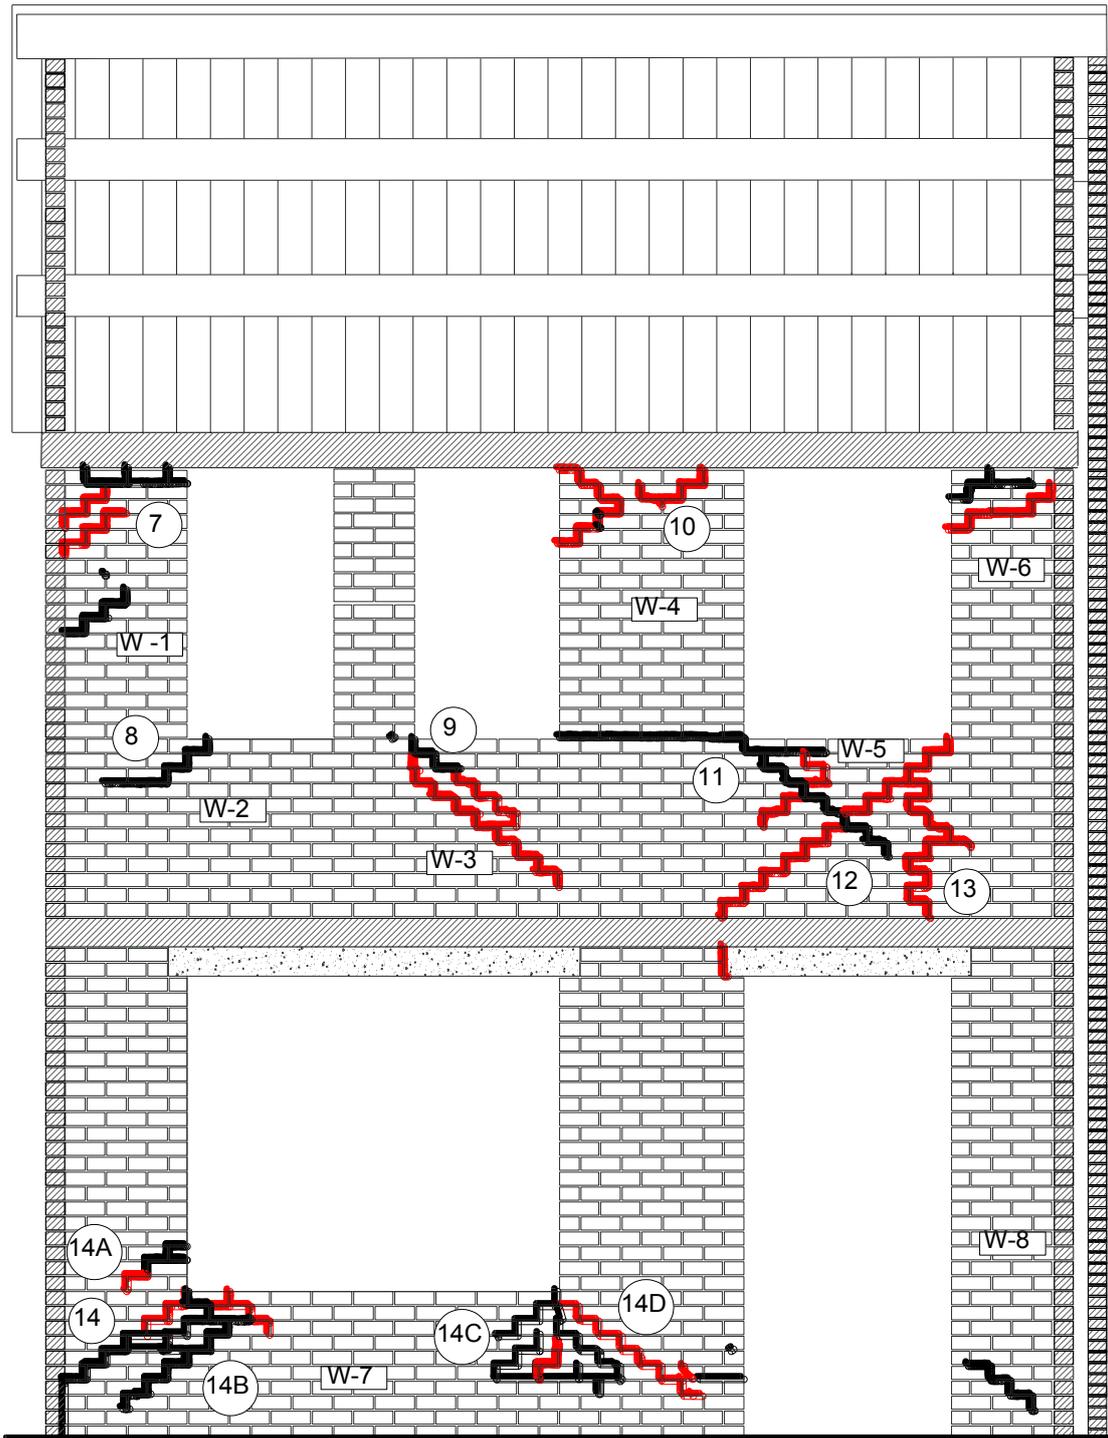
Figure 320. Section of the test-house - inner leaf - west-side. Illustration of crack pattern after the test #23, 200%\_EQ2\_320,  $PGA = 3.1 \text{ m/s}^2$ . In red cracks induced at current test and in black the pre-existing cracks.

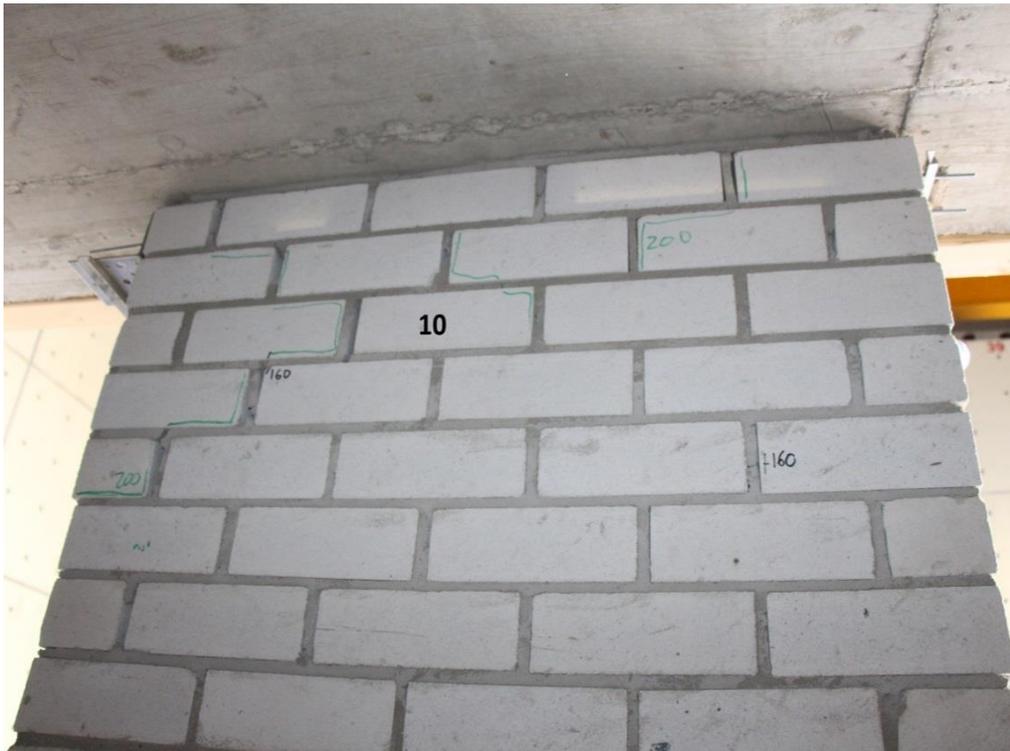
Figure 321. Crack #10 after the test # 23, 200%\_EQ2\_320, PGA= 3.1 m/s<sup>2</sup>
