# **Experimental campaign on cavity walls systems representative of the Groningen building stock**

**Alberto Pavese, Francesco Graziotti and Guido Magenes**

**Eucentre**

Date June 2016

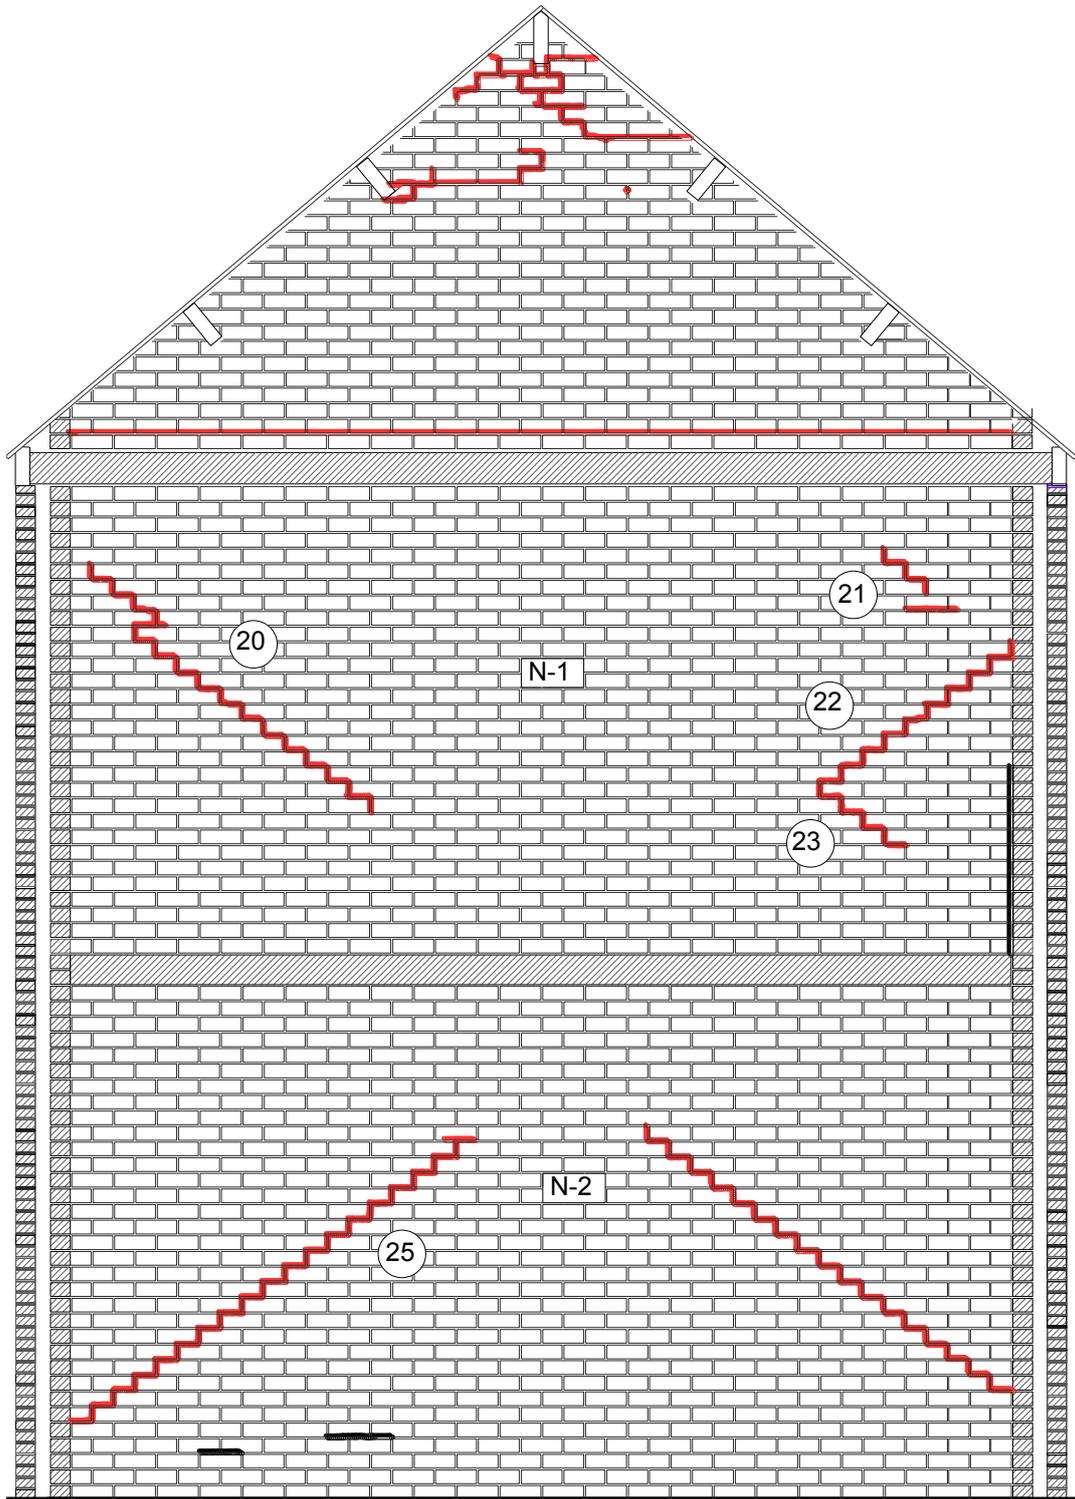
Figure 322. Section of the test-house - inner leaf – north side. illustration of crack pattern after the test # 23, 200%\_EQ2\_320,  $PGA= 3.1 \text{ m/s}^2$ .

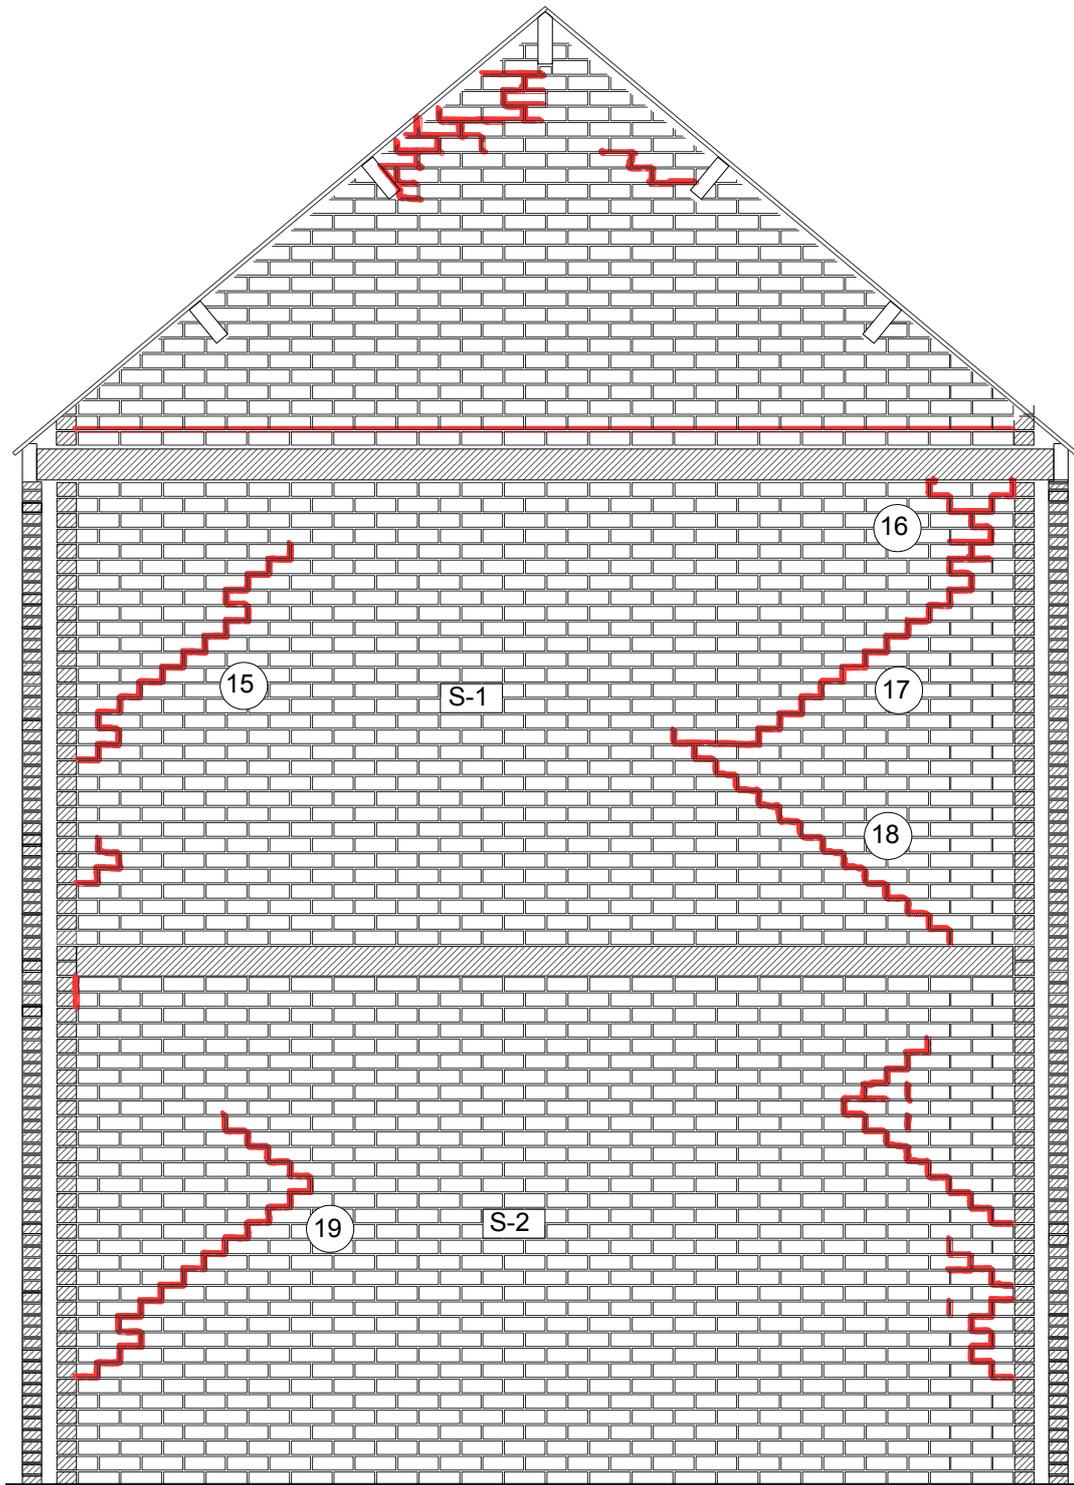
Figure 323. Section of the test-house - inner leaf – south side. illustration of crack pattern after the test # 23, 200%\_EQ2\_320,  $PGA = 3.1 \text{ m/s}^2$ .

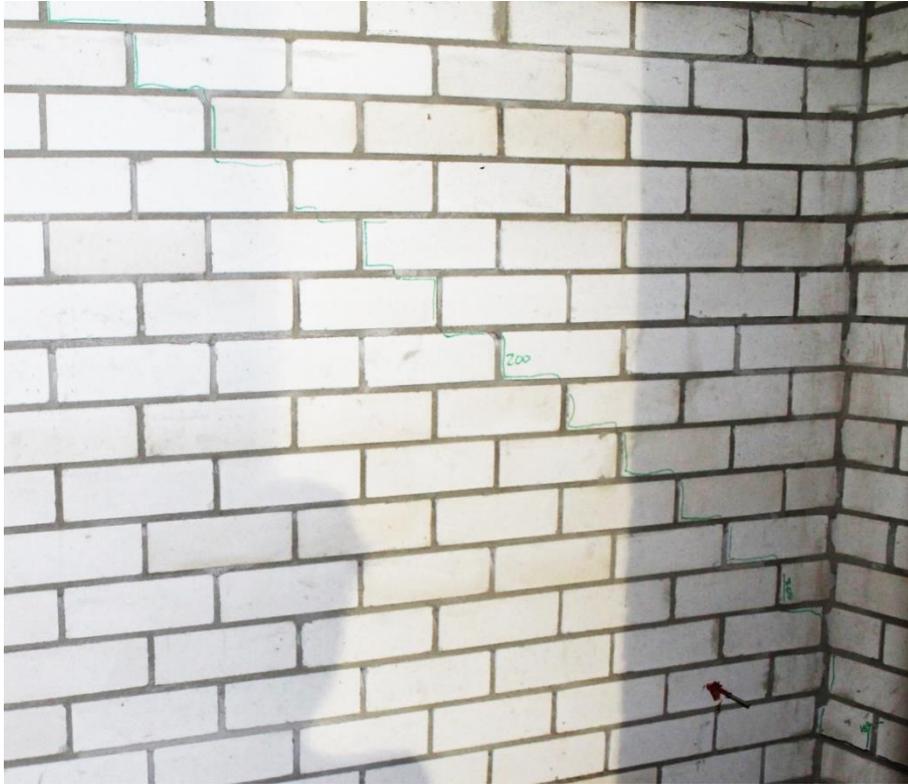
*Figure 324. Crack after the test # 23, 200%\_EQ2\_320,  $PGA= 3.1 \text{ m/s}^2$ .*

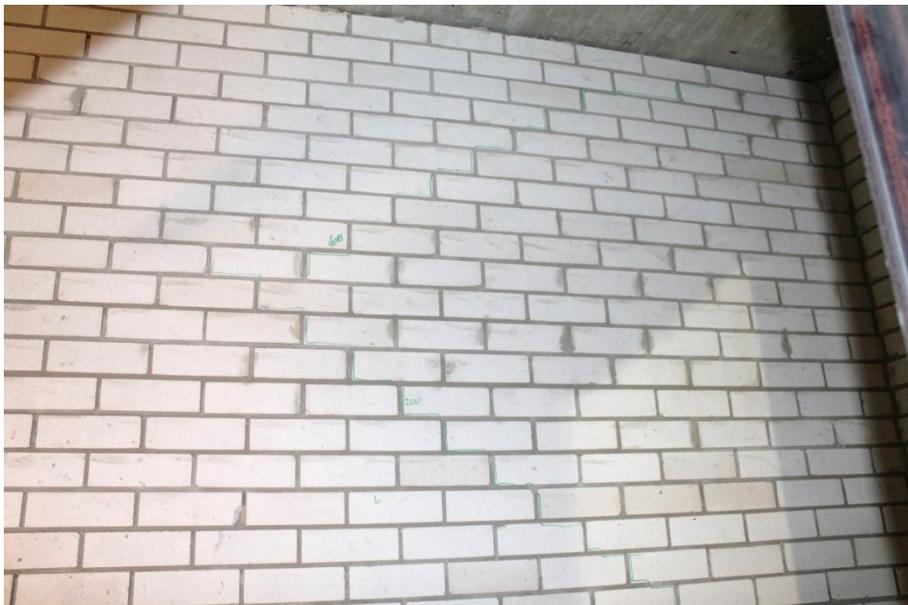
*Figure 325. Crack after the test # 23, 200%\_EQ2\_320,  $PGA= 3.1 \text{ m/s}^2$ .*

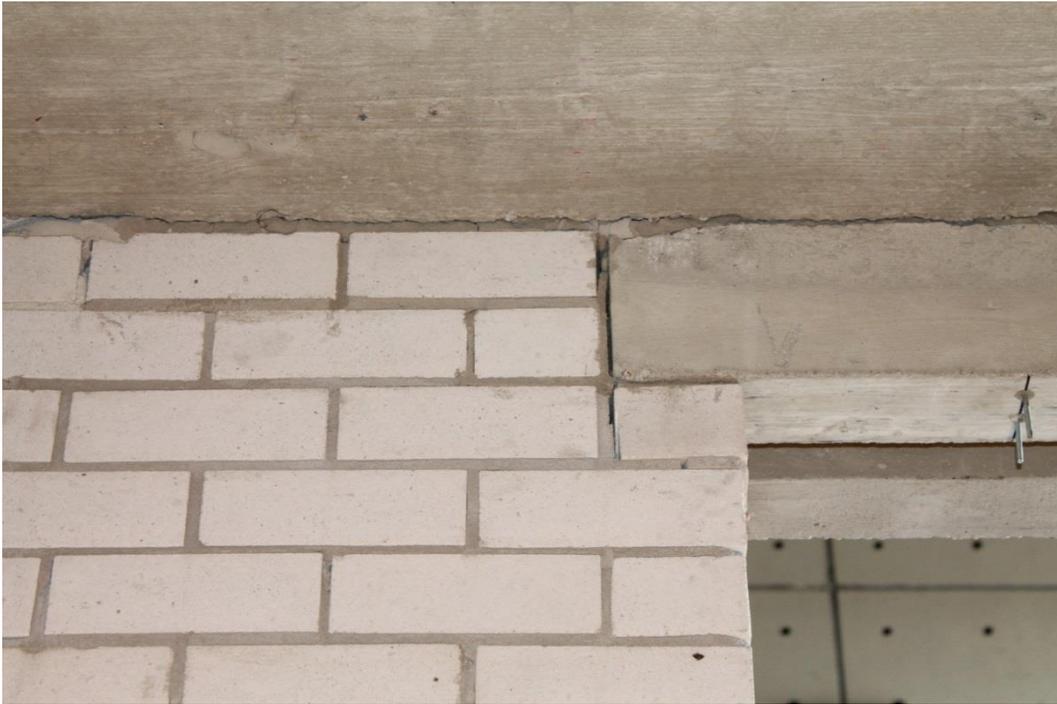
*Figure 326. Sliding of the concrete lintel with respect to the masonry support, after the test # 23, 200%\_EQ2\_320,  $PGA = 3.1 \text{ m/s}^2$ .*

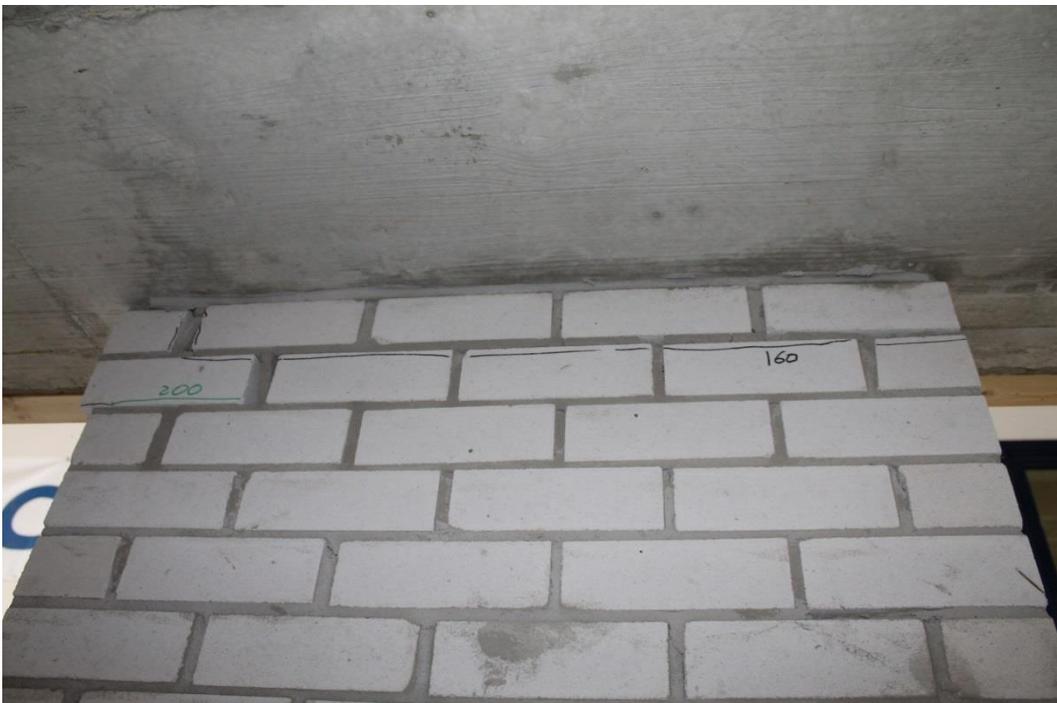
*Figure 327. Horizontal crack due to sliding identified on the top of calcium silicate pier, after the test # 23, 200%\_EQ2\_320,  $PGA = 3.1 \text{ m/s}^2$ .*

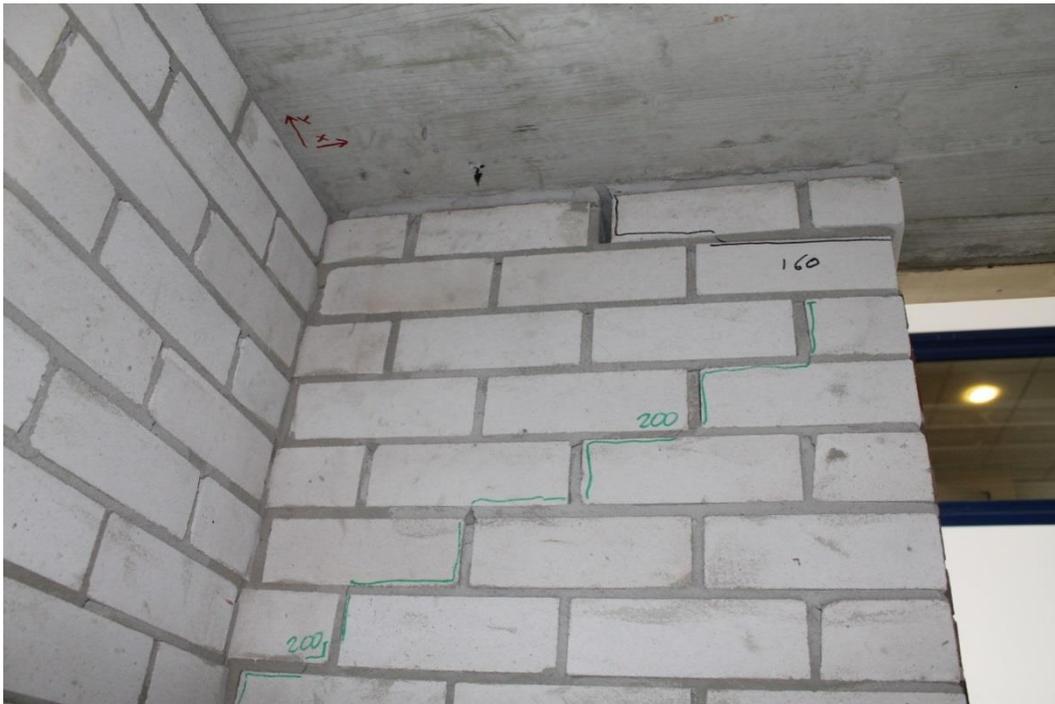
Figure 328 Increase of the sliding observed on the top of the pier and formation of a new stair-stepped crack, after the test # 23, 200%\_EQ2\_320,  $PGA = 3.1 \text{ m/s}^2$ .

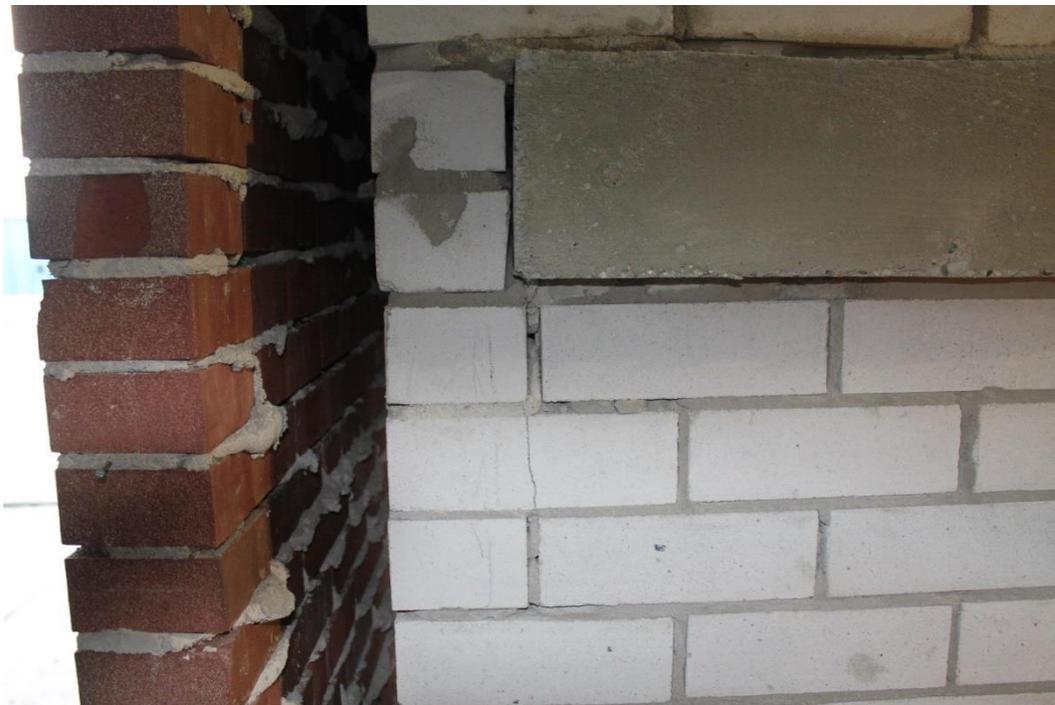
Figure 329. Fracture of brick at the interface between flange and S wall, after the test # 23, 200%\_EQ2\_320,  $PGA = 3.2 \text{ m/s}^2$ .

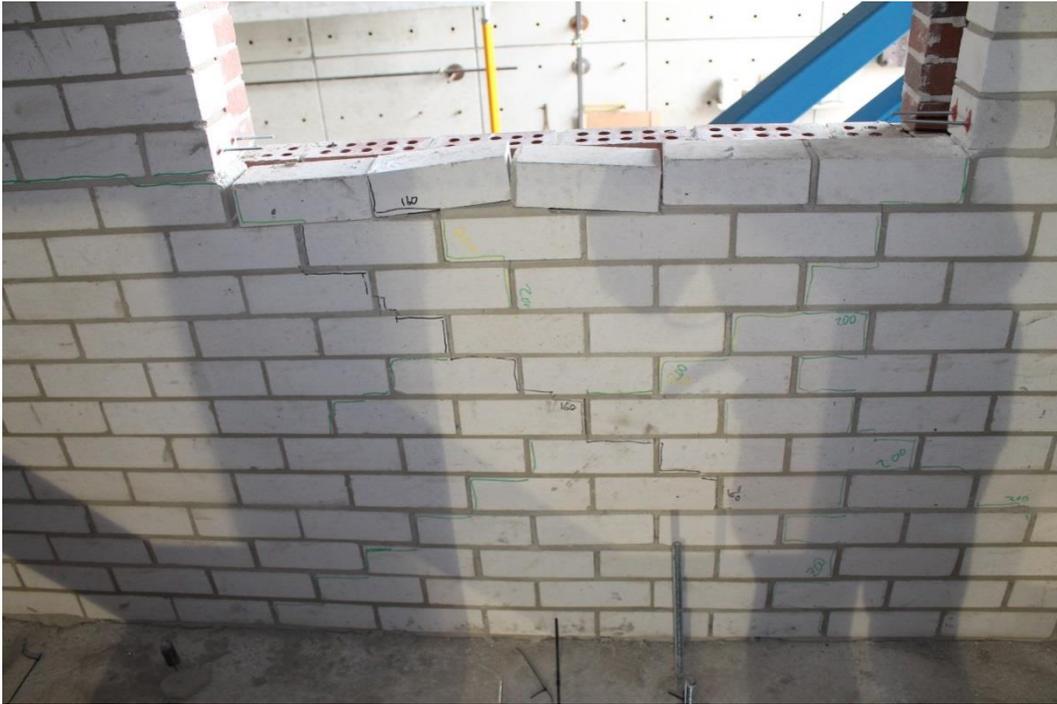
Figure 330. De-cohesion of masonry blocks observed in the calcium silicate masonry, after the test # 23, 200%\_EQ2\_320,  $PGA = 3.1 \text{ m/s}^2$ .

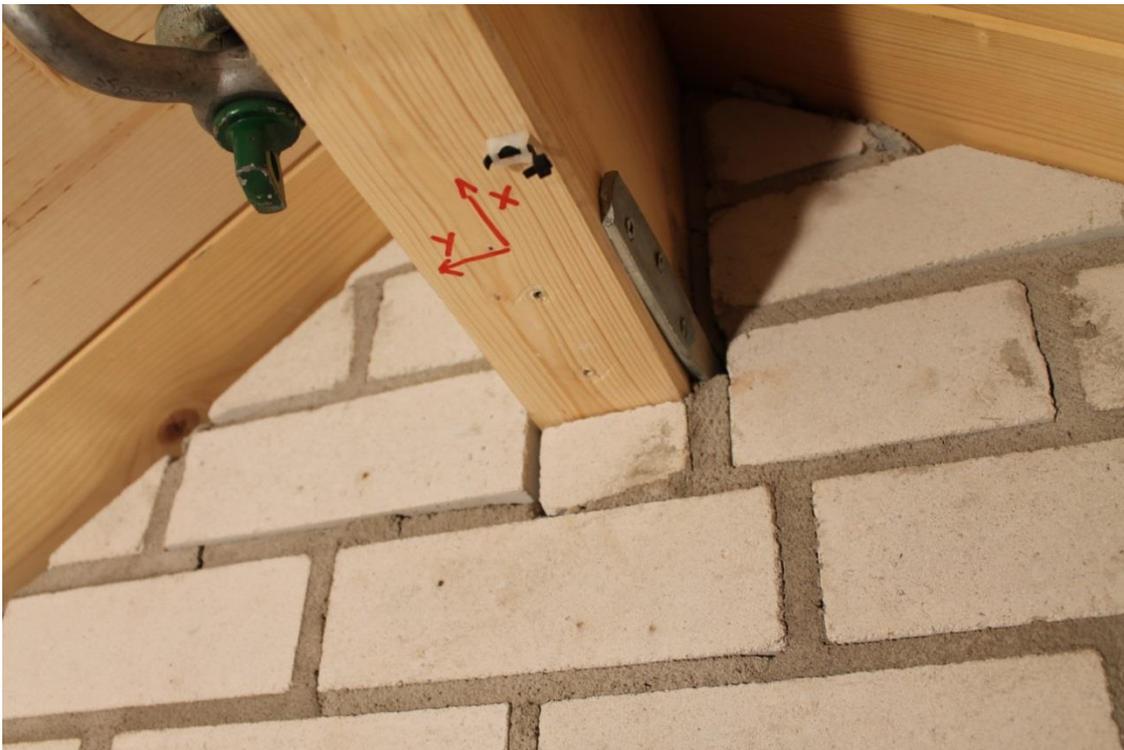
Figure 331. Cracks around the timber beams due to pounding of the beams on the supporting masonry gable walls, after the test # 23, 200%\_EQ2\_320,  $PGA = 3.1 \text{ m/s}^2$ .

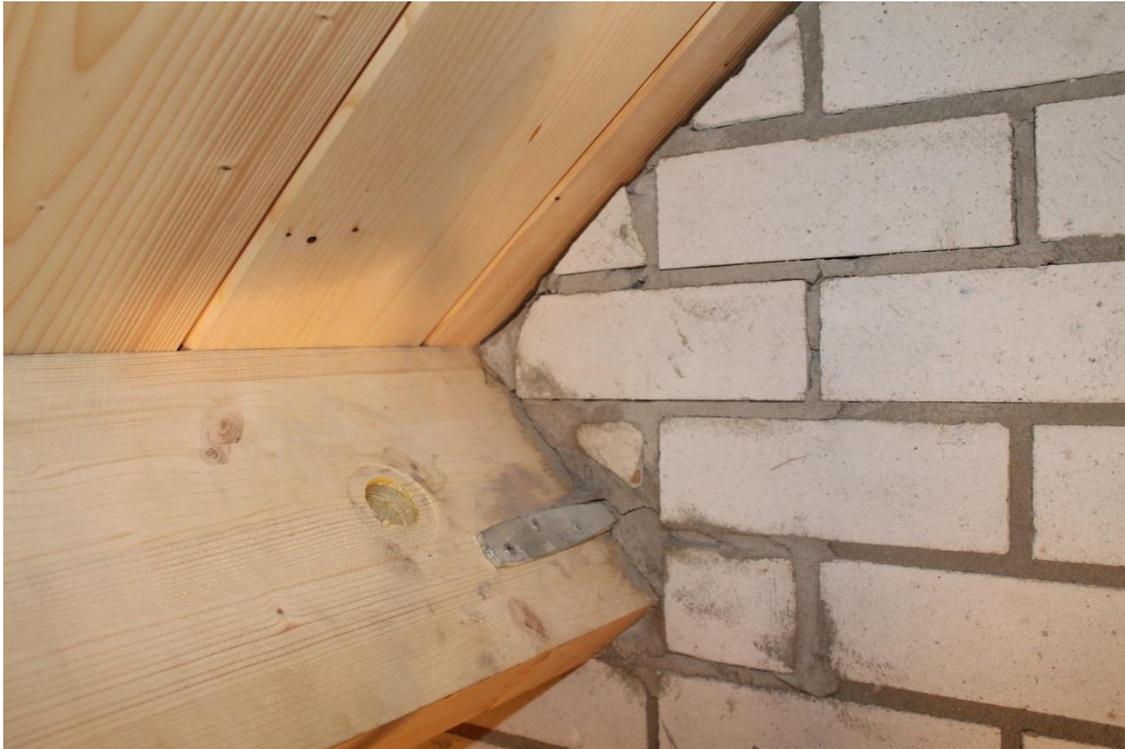
*Figure 332. Cracks around the timber beams due to pounding of the beams on the supporting masonry gable walls, after the test # 23, 200%\_EQ2\_320,  $PGA= 3.1 \text{ m/s}^2$ .*

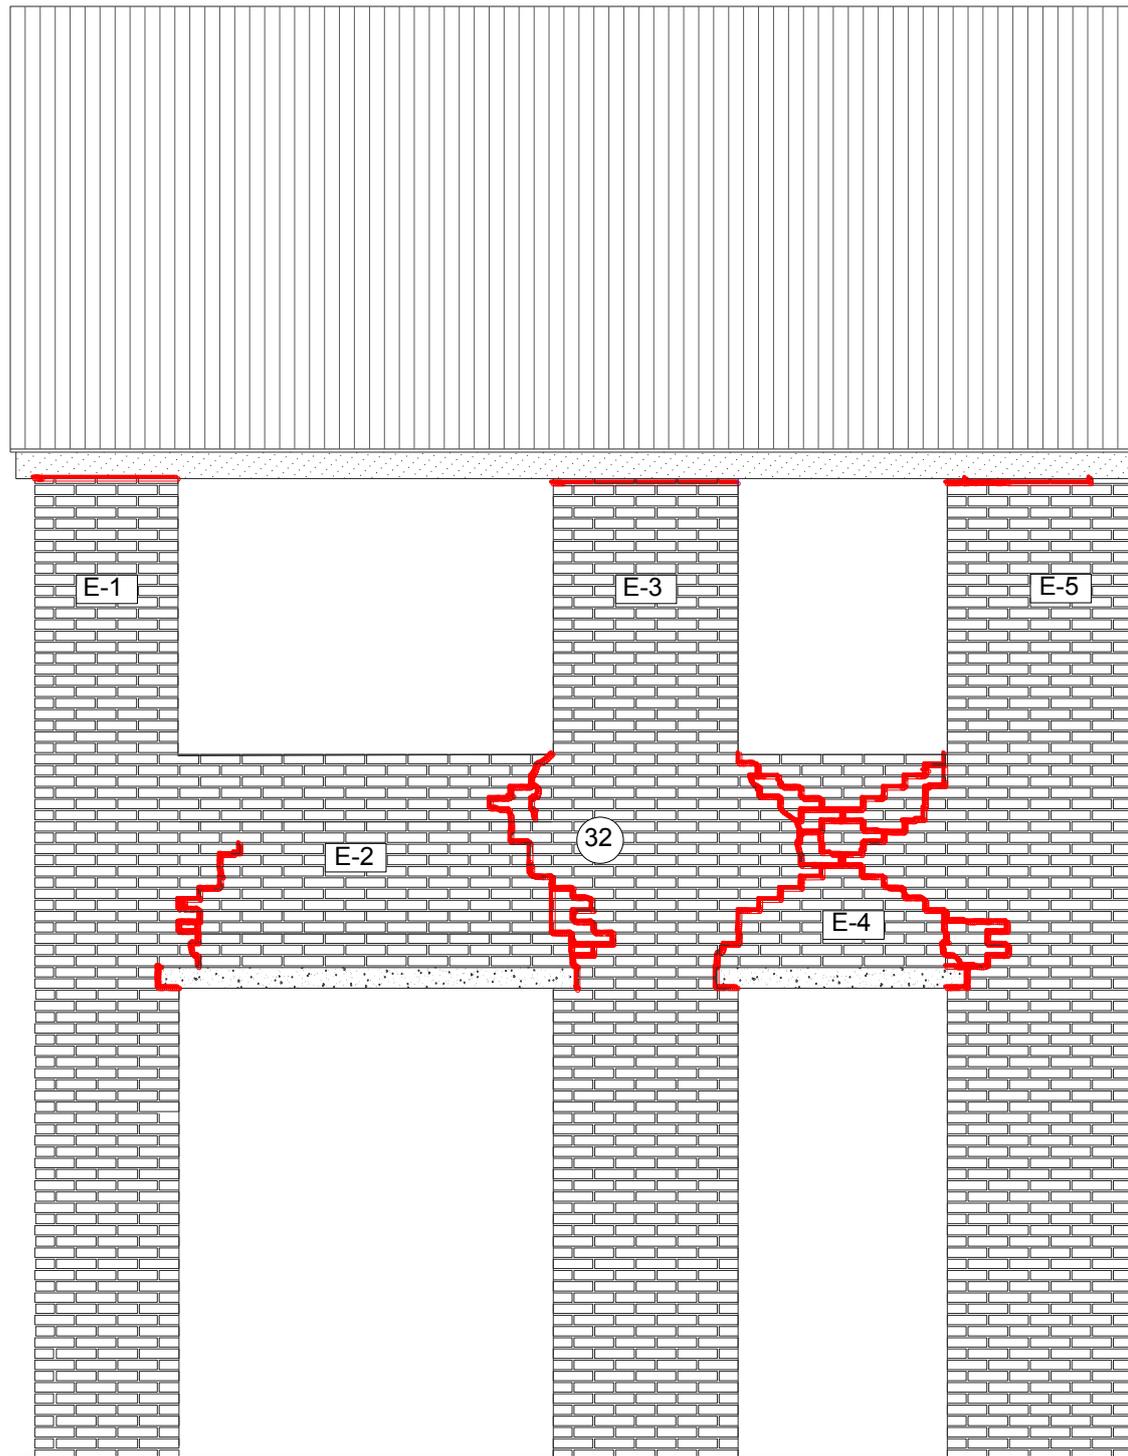
Figure 333. Elevation view of the test-house - outer leaf - east-side. illustration of crack pattern after the test # 23, 200%\_EQ2\_320, PGA= 3.1 m/s<sup>2</sup>.

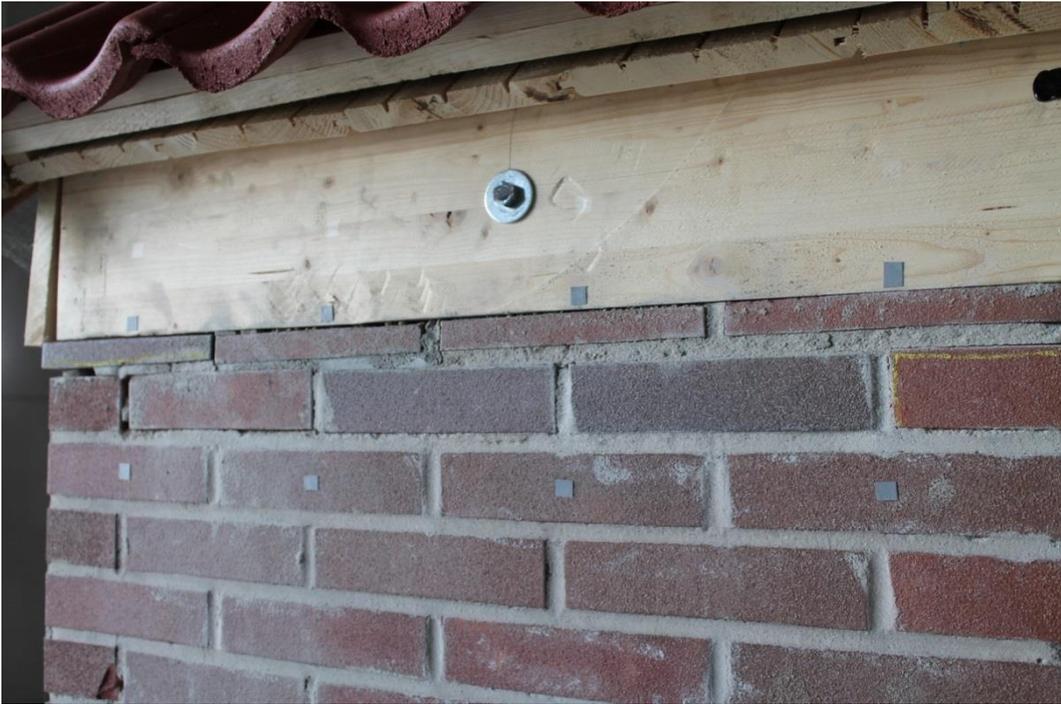
*Figure 334. Crack after the test # 23, 200%\_EQ2\_320, PGA= 3.1 m/s<sup>2</sup>.*

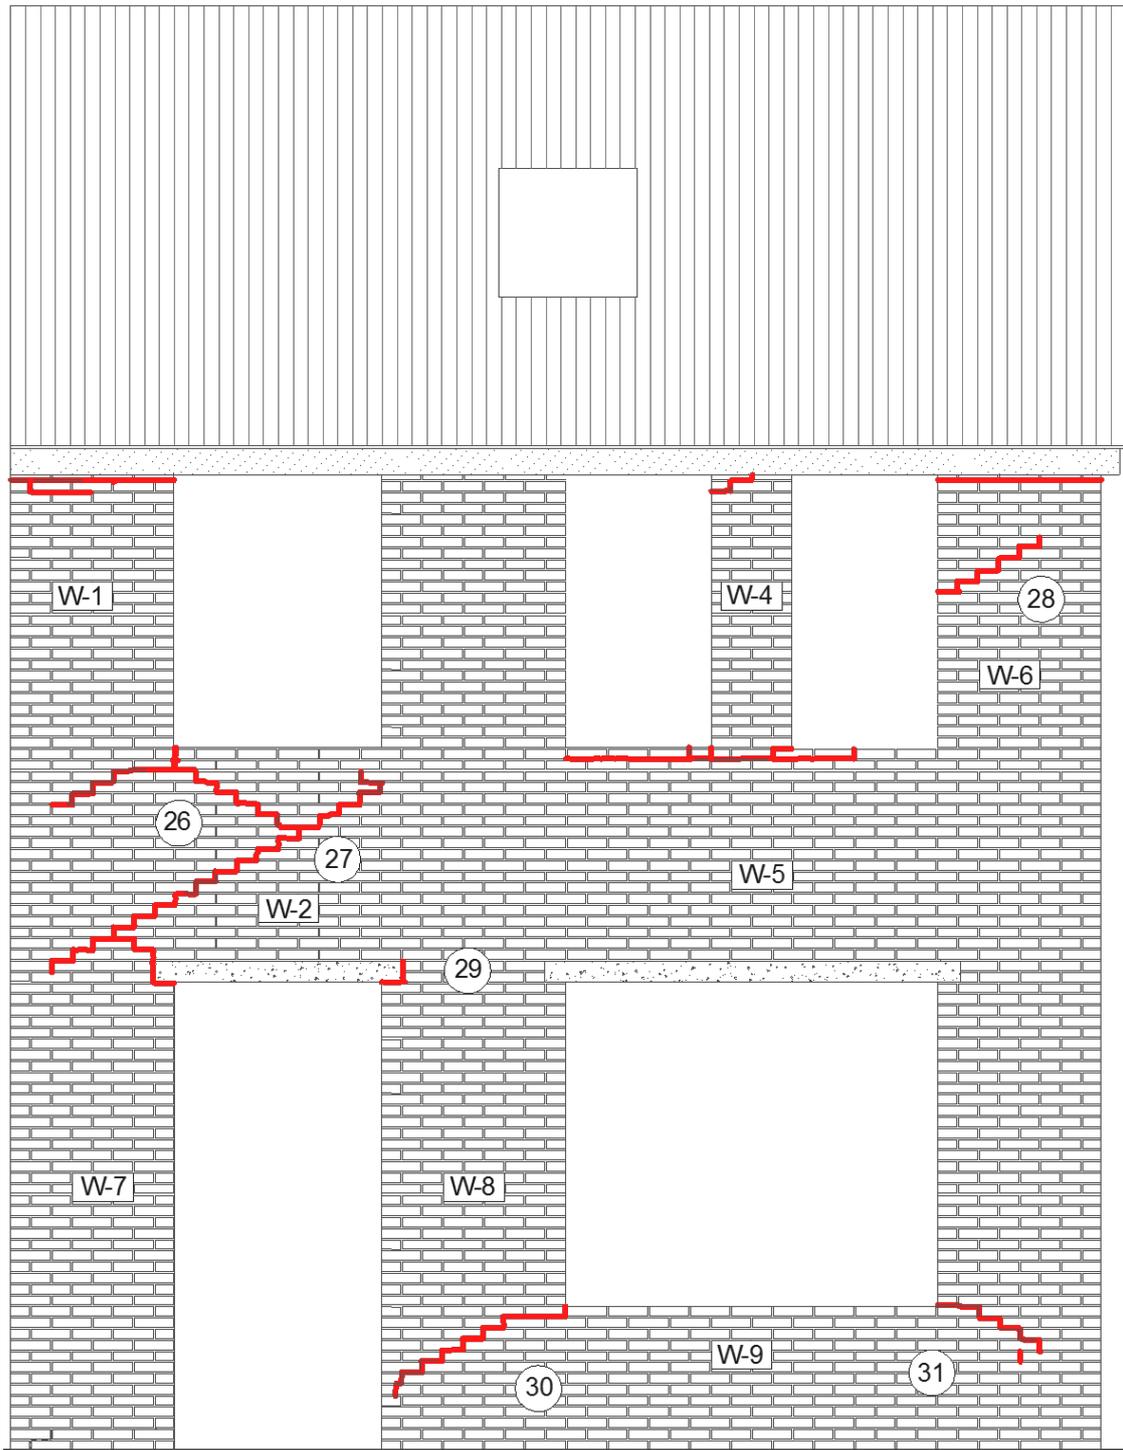
Figure 335. Elevation view of the test-house - outer leaf - west-side illustration of crack pattern after the test # 23, 200%\_EQ2\_320,  $PGA= 3.1 \text{ m/s}^2$ .

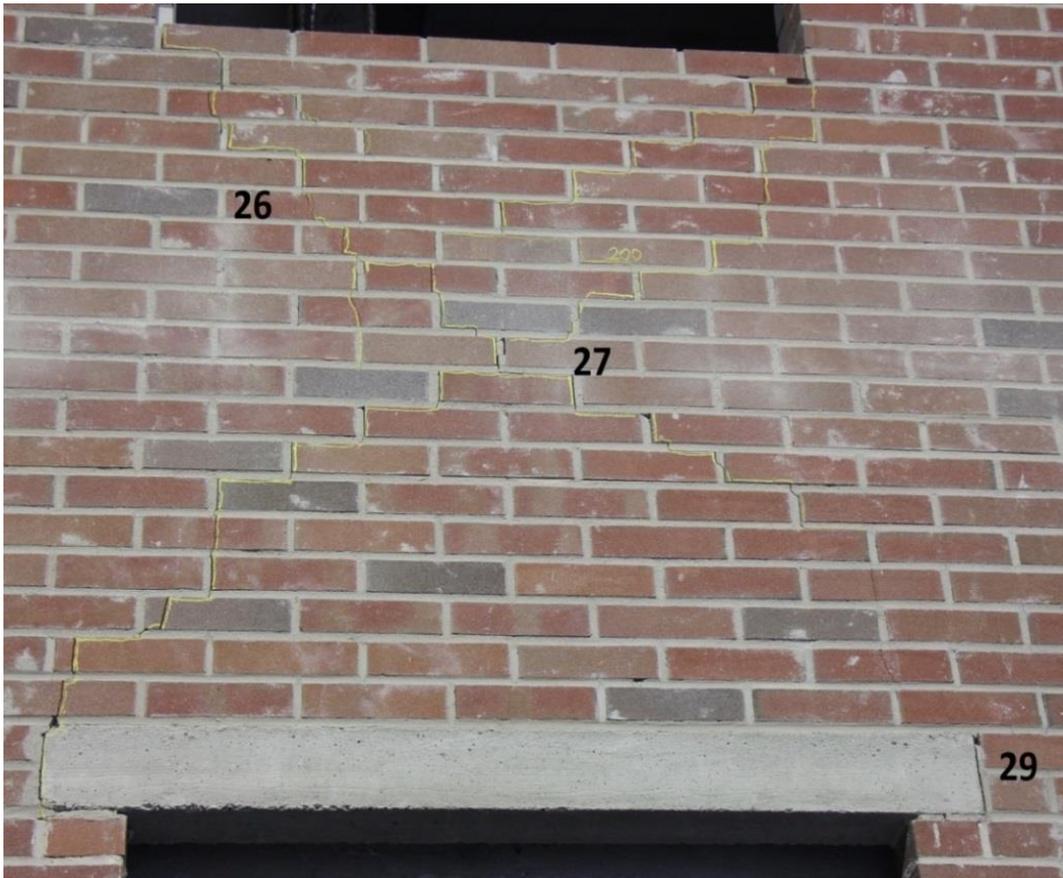
Figure 336. Cracks 26, 27 and 29 after the test #23, 200%\_EQ2\_320, PGA= 3.1 m/s<sup>2</sup>.

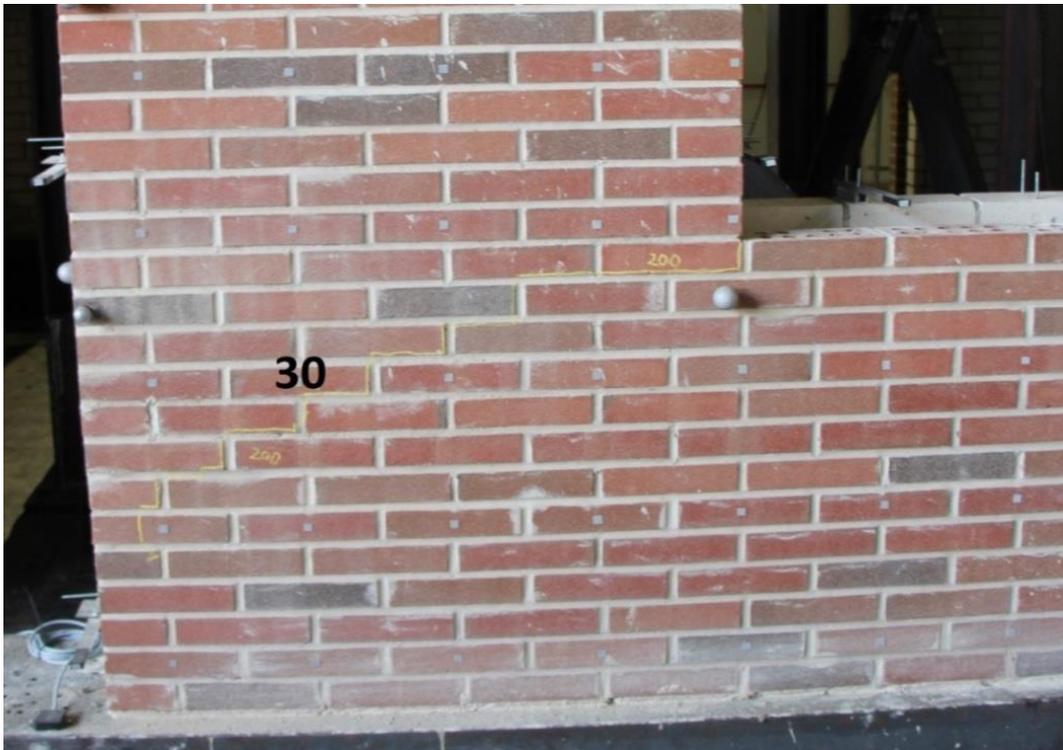
Figure 337. #30 after the test # 23, 200%\_EQ2\_320, PGA= 3.1 m/s<sup>2</sup>.

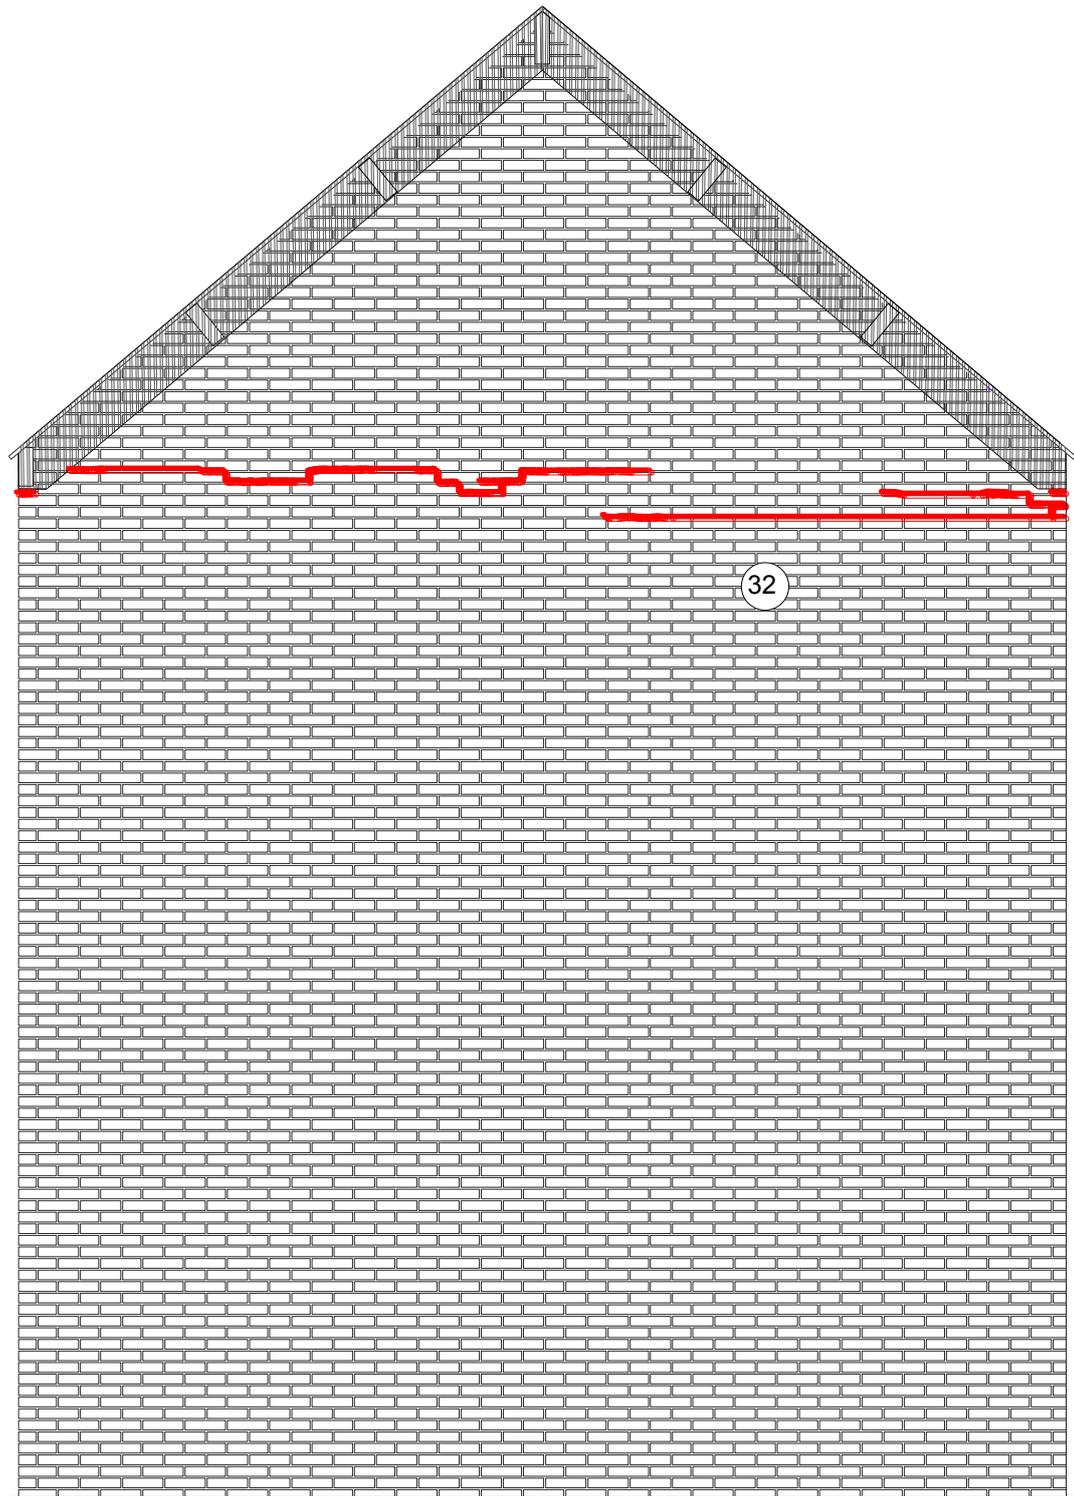
*Figure 338. Elevation view of the test-house - outer leaf - north side. Illustration of crack pattern after the test # 23, 200%\_EQ2\_320, PGA= 3.1 m/s<sup>2</sup>.*

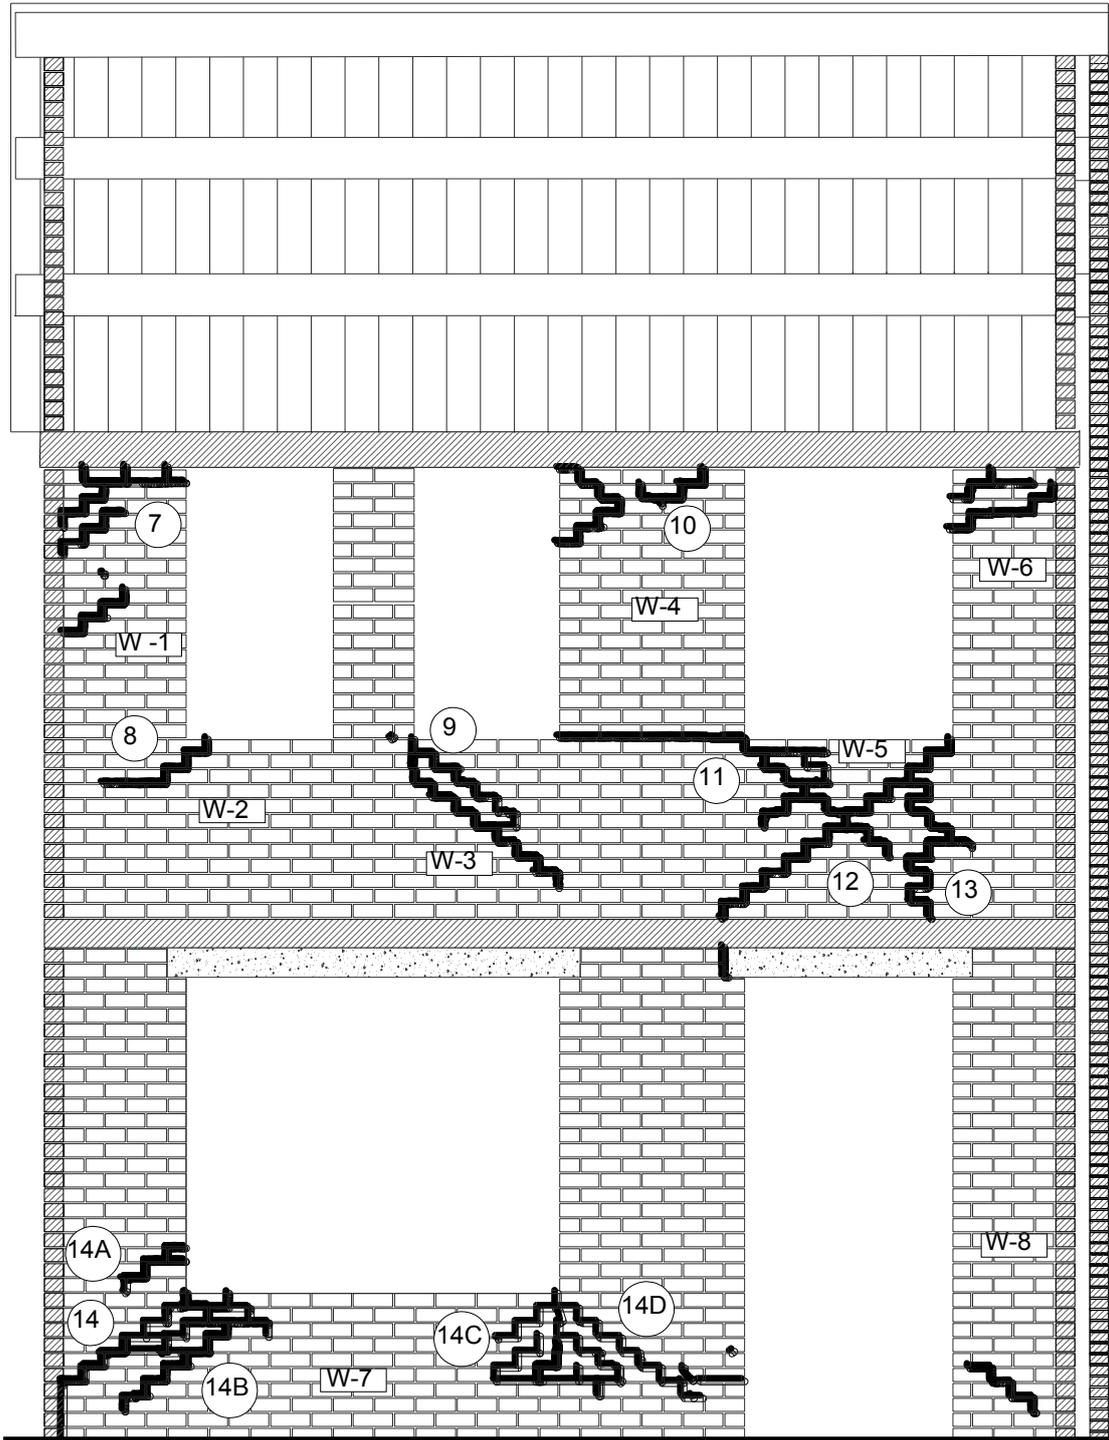
Figure 341. Elevation view of the test-house - inner leaf - east-side. Illustration of crack pattern after the test # 29, 60%\_EQ2\_100,  $PGA= 1,0 \text{ m/s}^2$ .

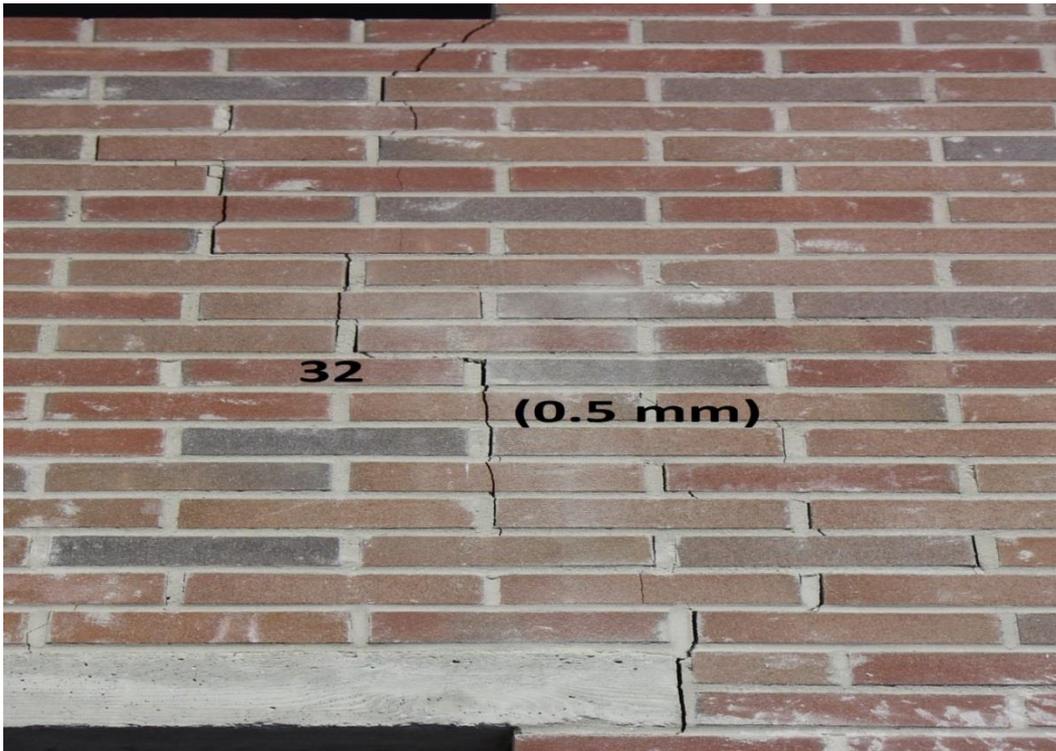
Figure 342. Crack #32 after the test # 29, 60%\_EQ2\_100,  $PGA= 1.0 \text{ m/s}^2$ .

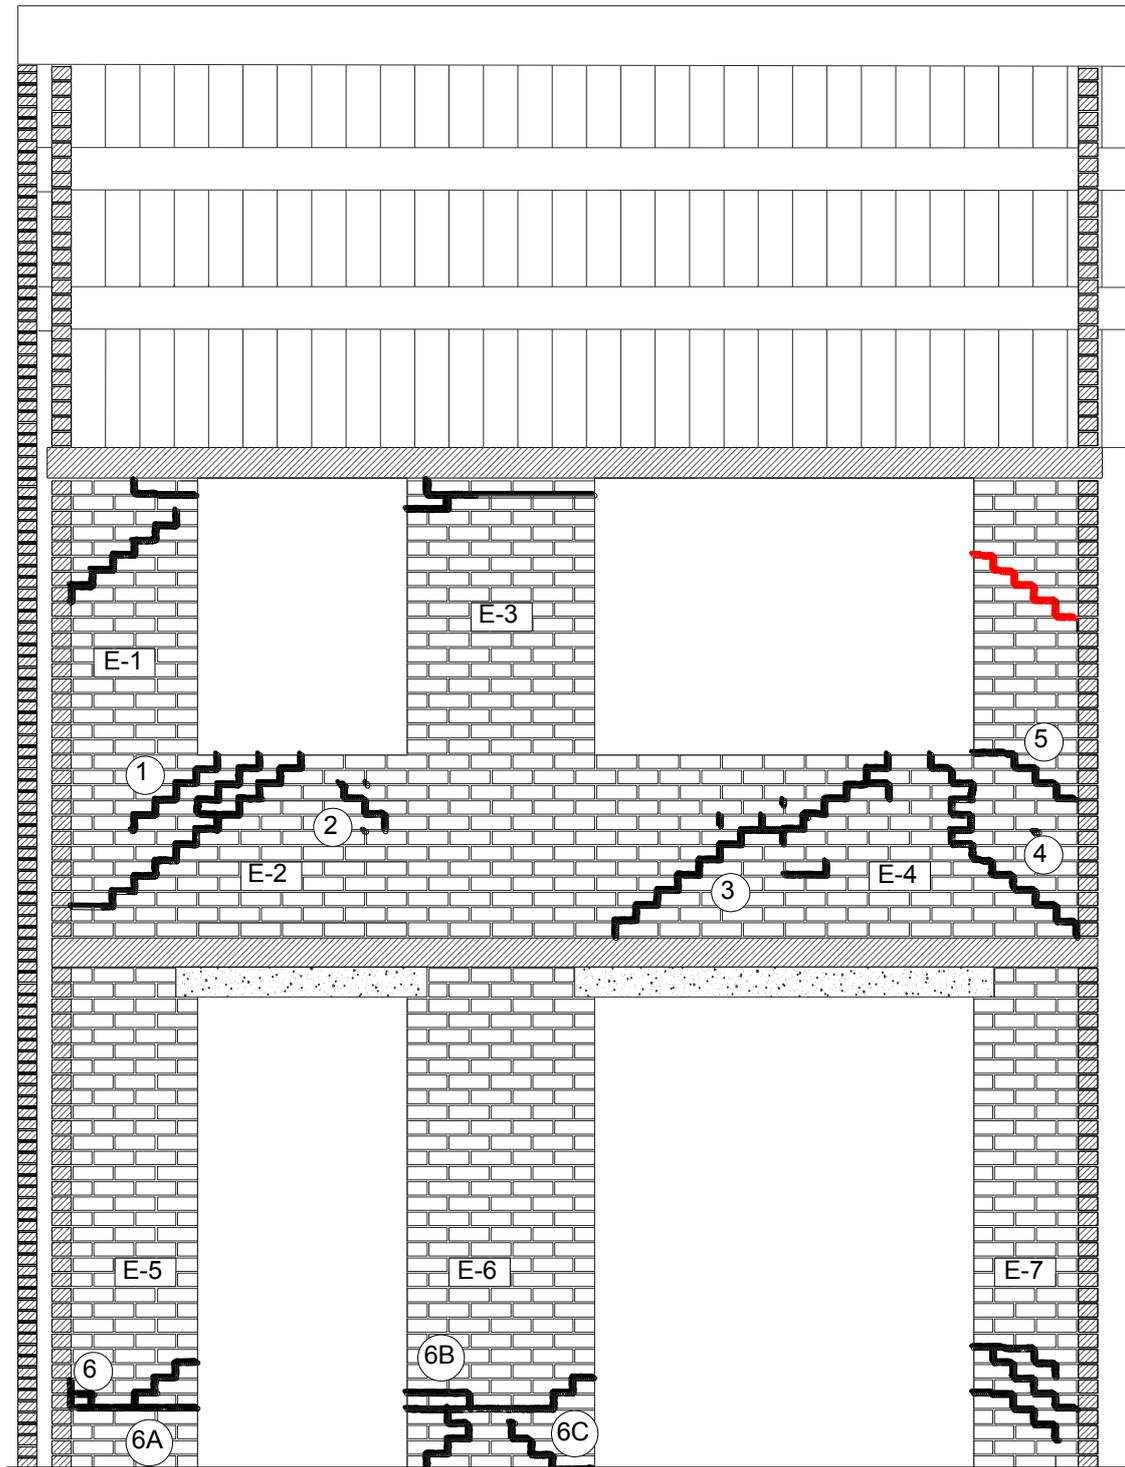
Figure 344. Elevation view of the test-house - inner leaf - west-side. Illustration of crack pattern after the test #29, 60%\_EQ2\_100, PGA= 1.0 m/s<sup>2</sup>. In red cracks induced at current test and in black the pre-existing cracks.
