# **Experimental campaign on cavity walls systems representative of the Groningen building stock**

**Alberto Pavese, Francesco Graziotti and Guido Magenes**

**Eucentre**

Date June 2016

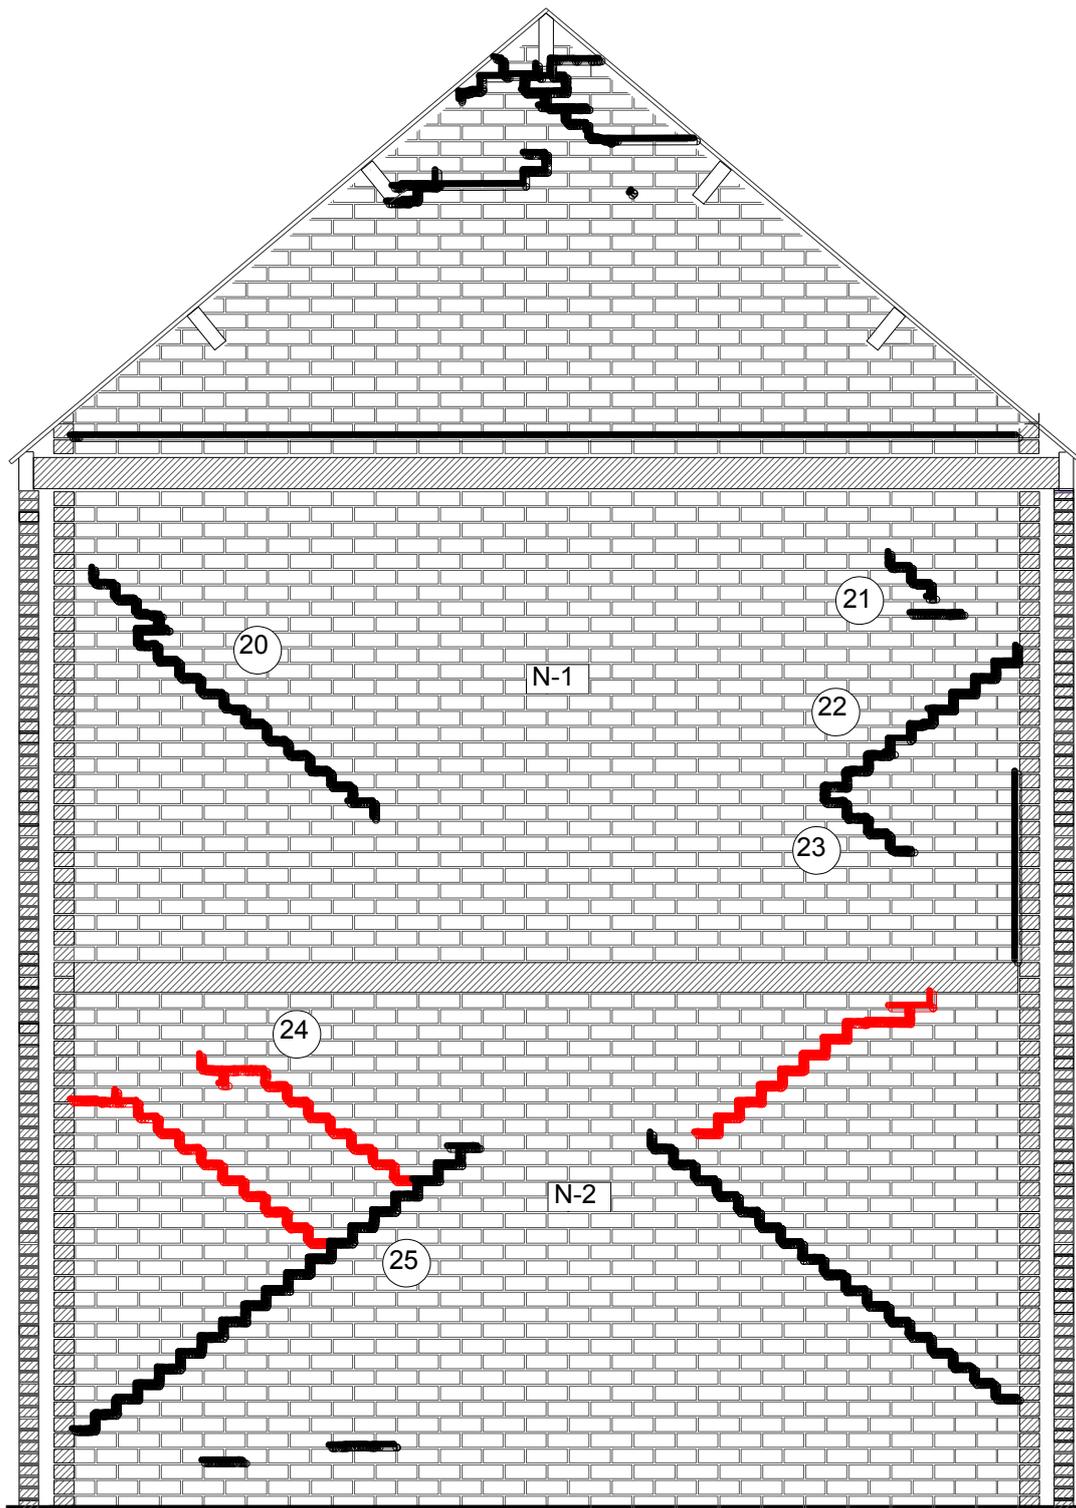
Figure 345. Section of the test-house - inner leaf – north side. Illustration of crack pattern after the test # 29, 60%\_EQ2\_100, PGA= 1.0 m/s<sup>2</sup>. In red cracks induced at current test and in black the pre-existing cracks

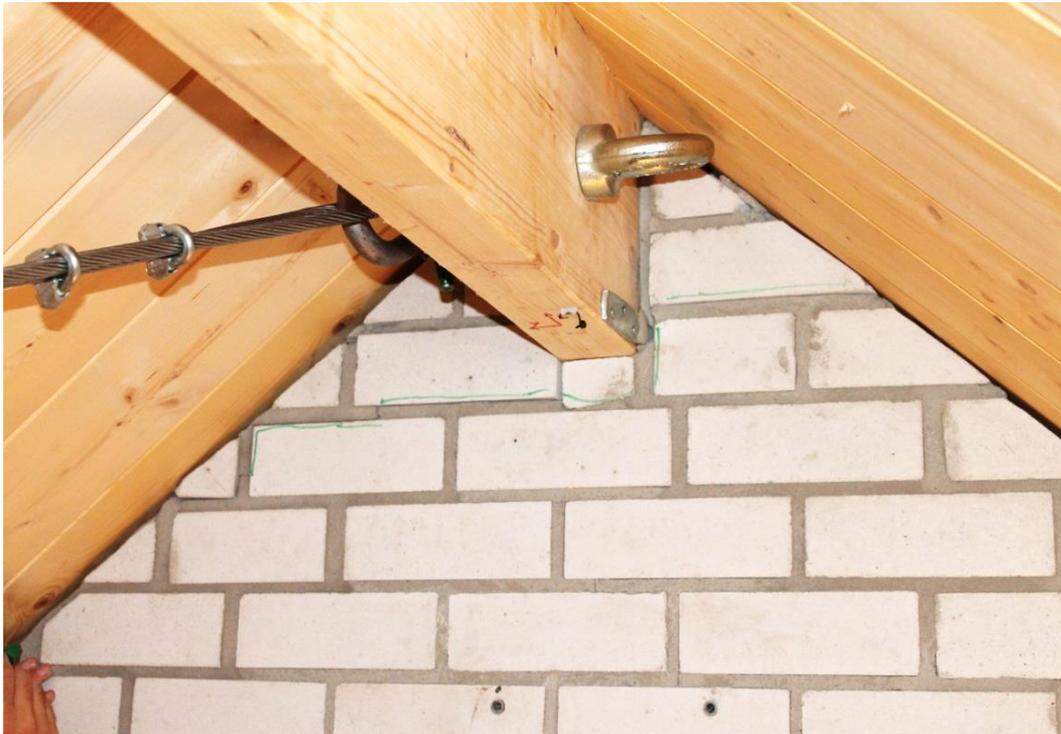
*Figure 346. Cracks observed around the ridge timber beam due to pounding (after the test #29, 60%\_EQ2\_100, PGA= 1.0 m/s<sup>2</sup>).*

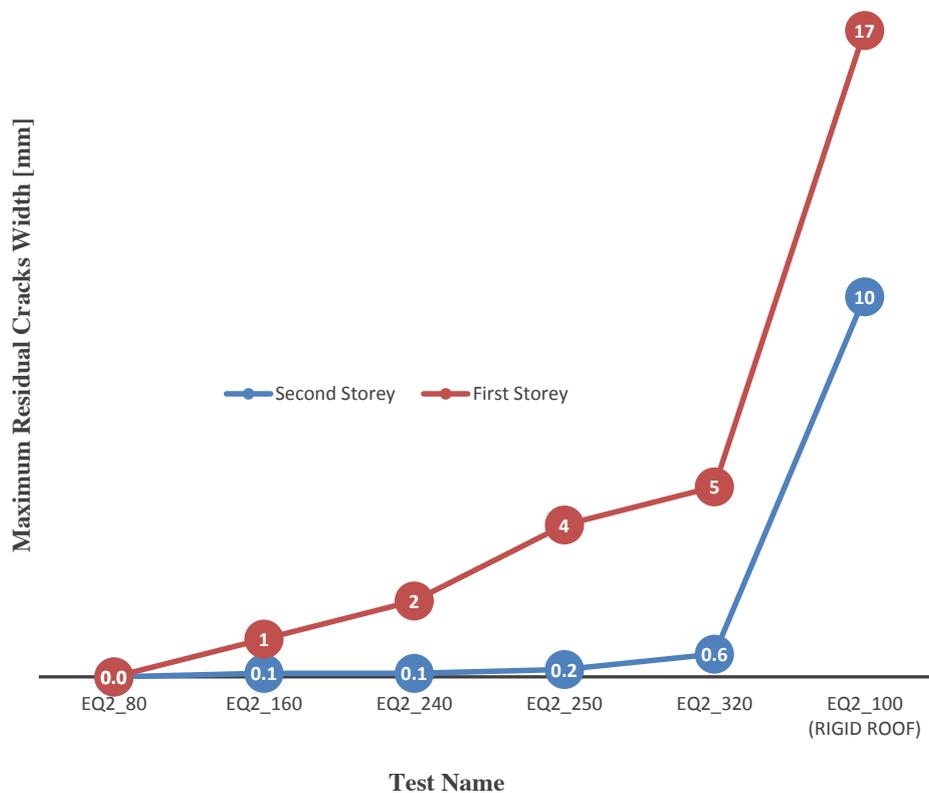
Figure 347. Evolution of maximum width of residual cracks after each test, first and second storey

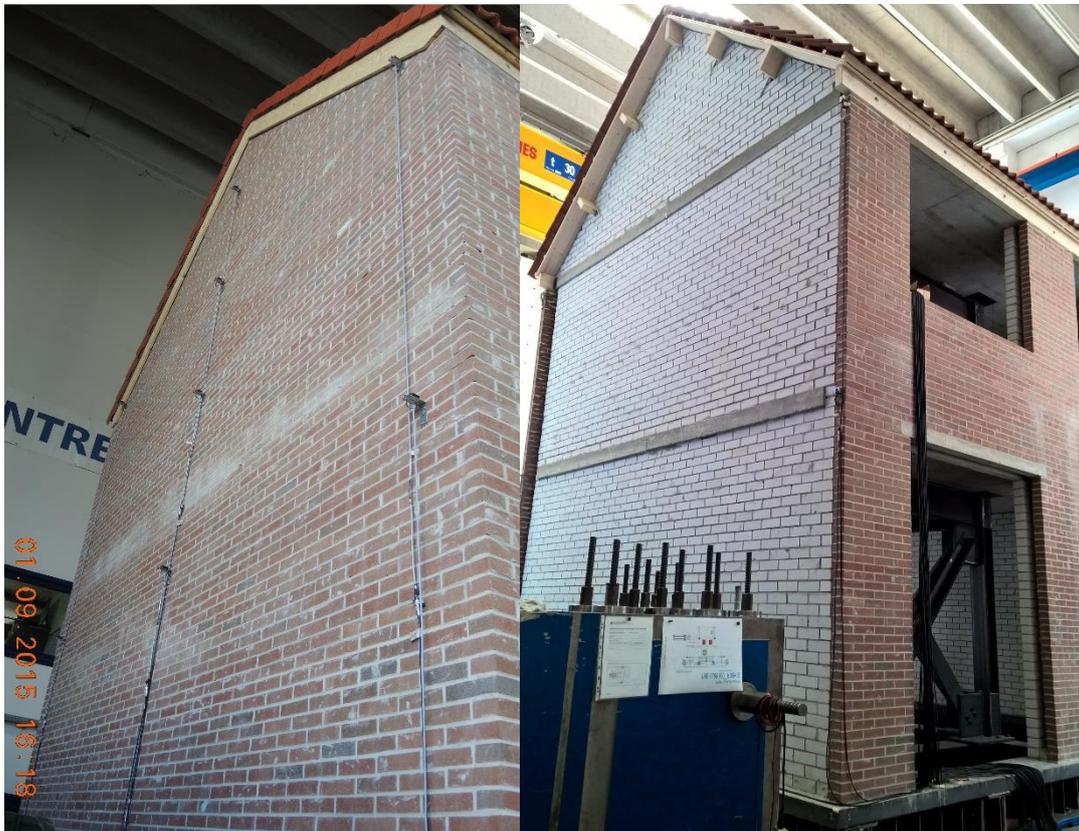
The following pictures show a view of the North façade (left) and the South façade (left);

On the left it is possible to see accelerometers #16, #17, #18 (first floor level), #22 (mid-height first-floor wall), #19, #20, #21 (second floor level) and #23 (1/2 of the gable). On the right picture it is possible to see accelerometers #12, #13 (first floor level on the veneer wall) and #14, #15 (second floor level on the veneer wall).

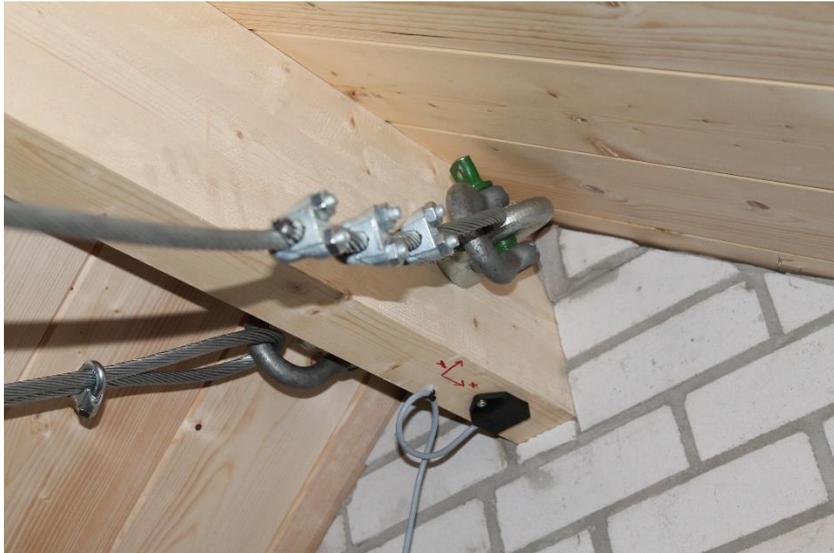
The following picture shows a view of accelerometer #9.

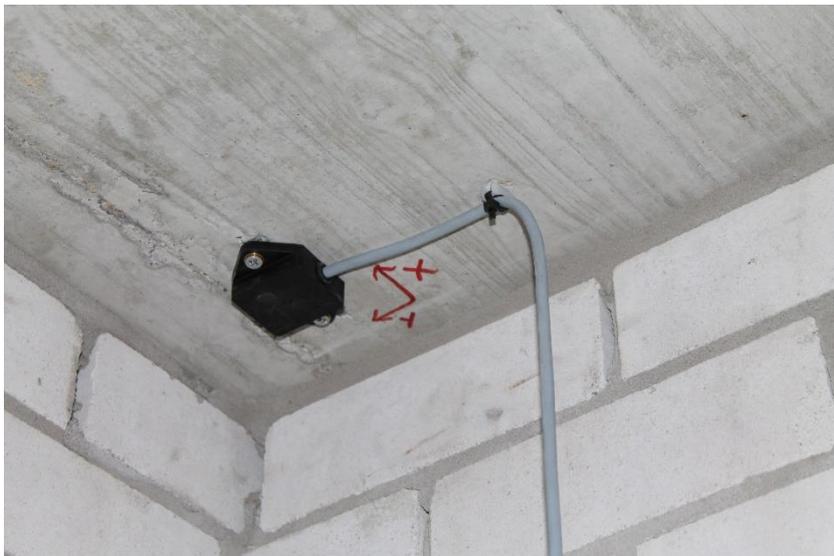
The following picture shows a view of accelerometer #6.

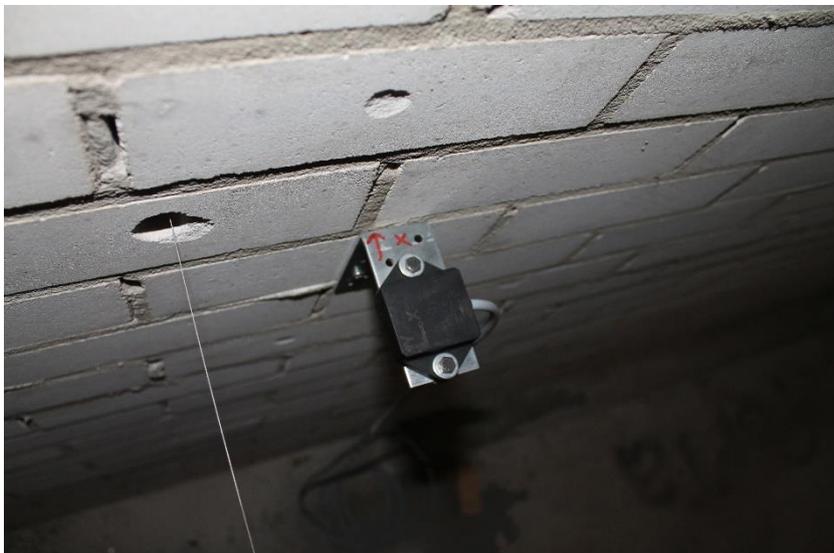
The following picture shows a view of the accelerometer #25 and the wire of the potentiometer #9.

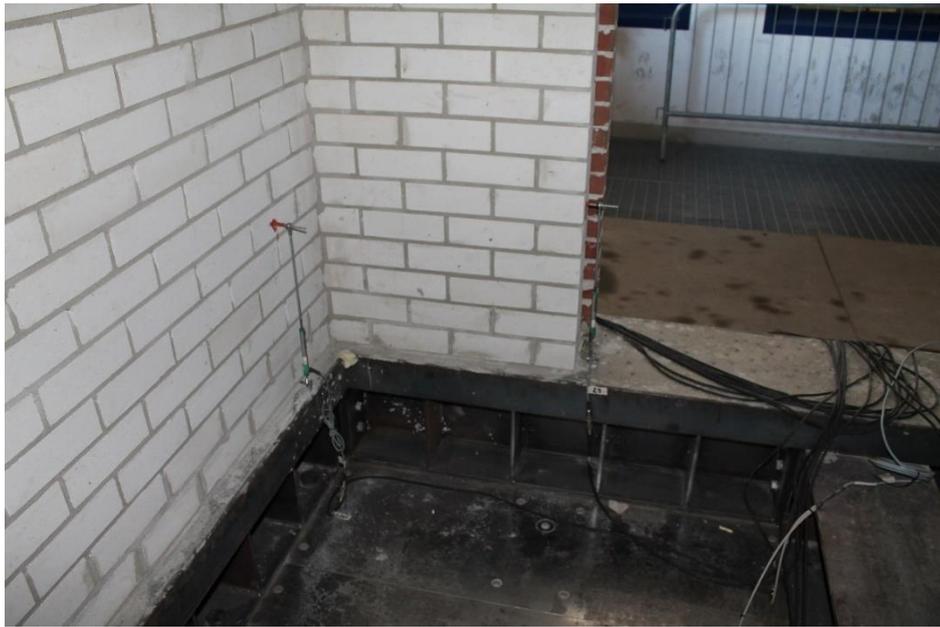
The Following picture shows potentiometers #26 (right) and #27 (left) .

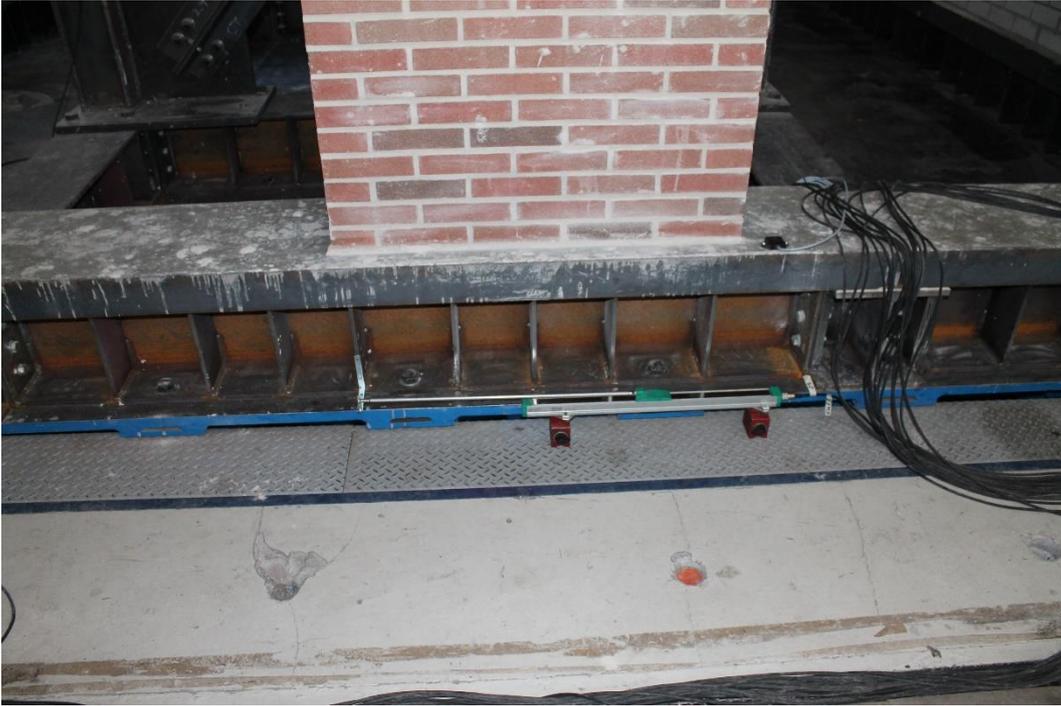
The Following picture shows the potentiometer #25.

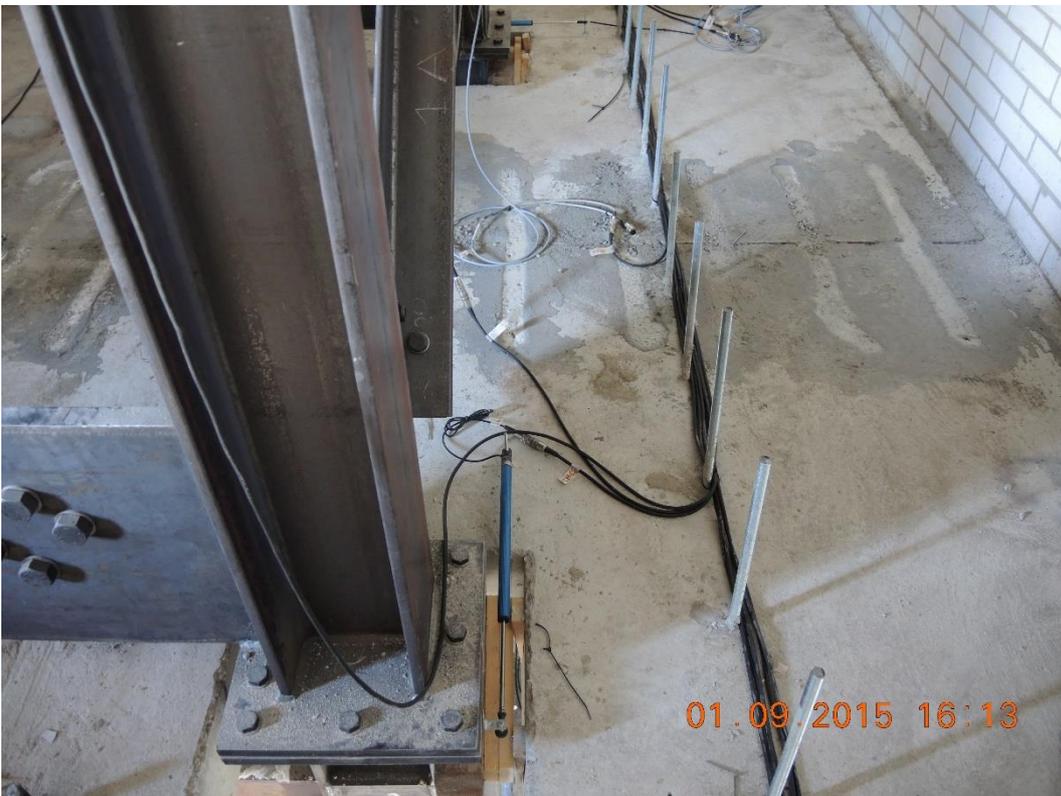
The picture below shows the potentiometers #14 and #11 (in the background).

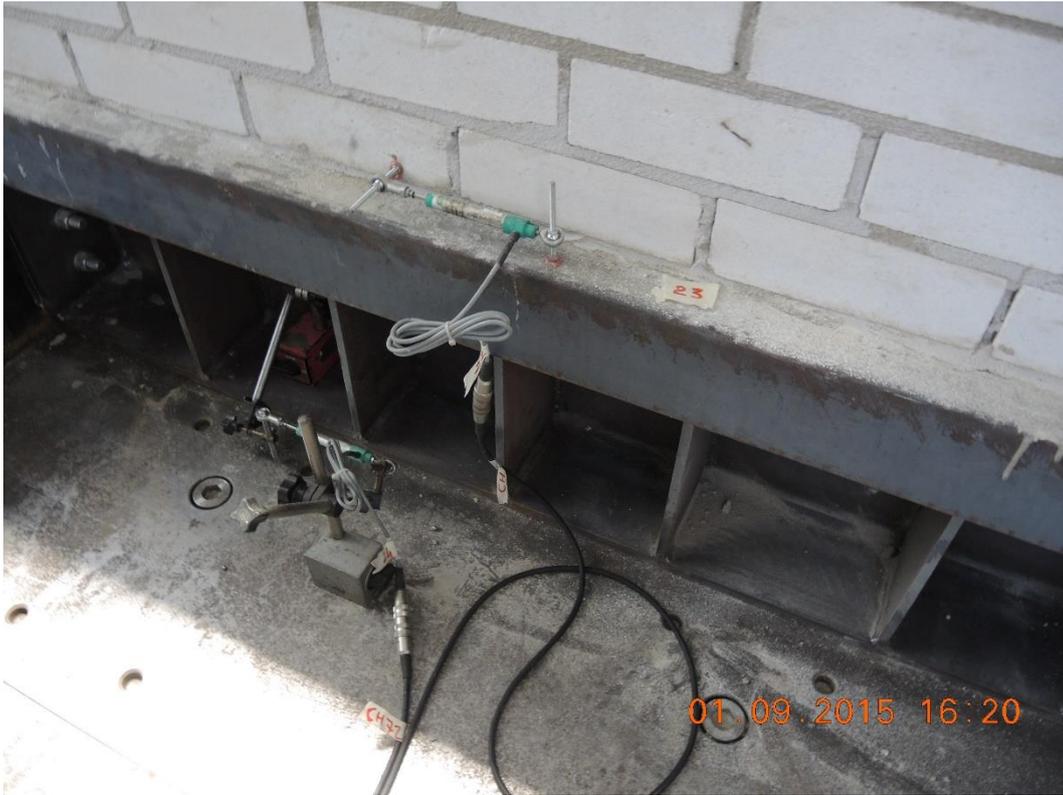
The picture below shows the potentiometers #21 and #23.

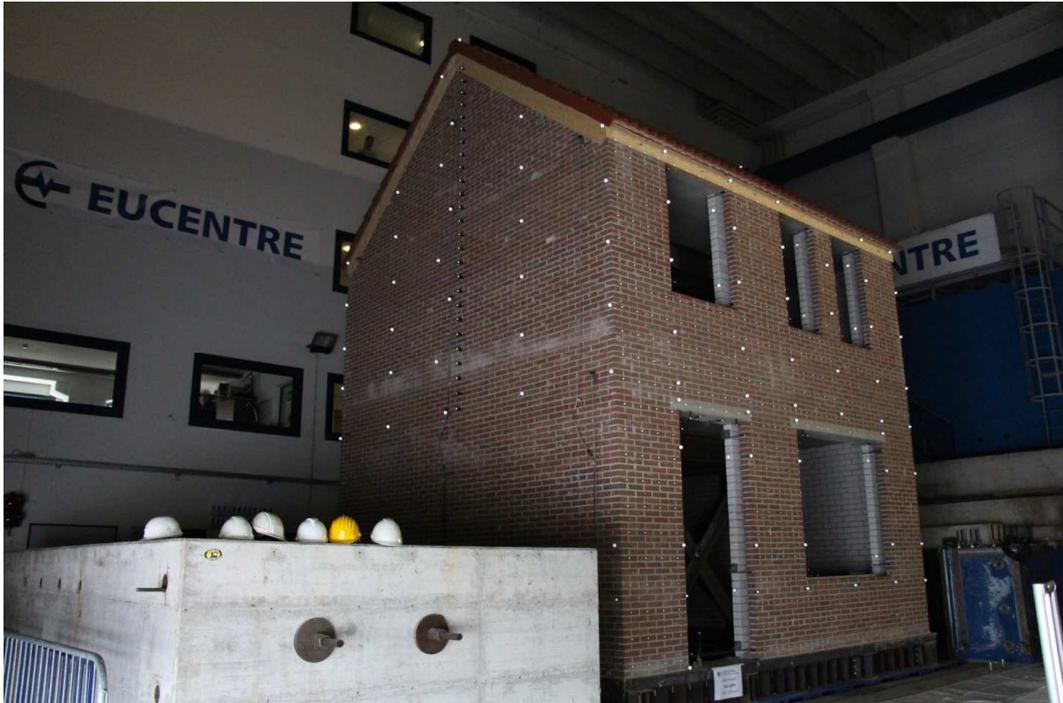
### 3D optical acquisition system

The experimental data recorded by the 3D optical acquisition system are provided for all the dynamic tests, summarised in the following table. All the data are organised in .C3D files named as reported in Table 1.

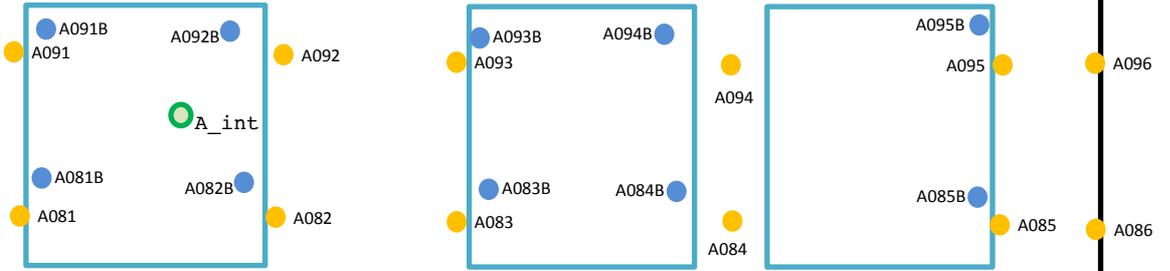
● A101      ● A102      ● A103      A105 ●      ● A106

● A071      ● A072      ● A073      ● A074      A075 ●      ● A076

● A061      ● A062      ● A063      ● A064      A065 ●      ● A066

The label and position of each marker is reported in the following figures. During each test, the trajectories of some markers was not reliable and the data has been removed from the matrix. In particular, the missing marker are reported in Table 2.

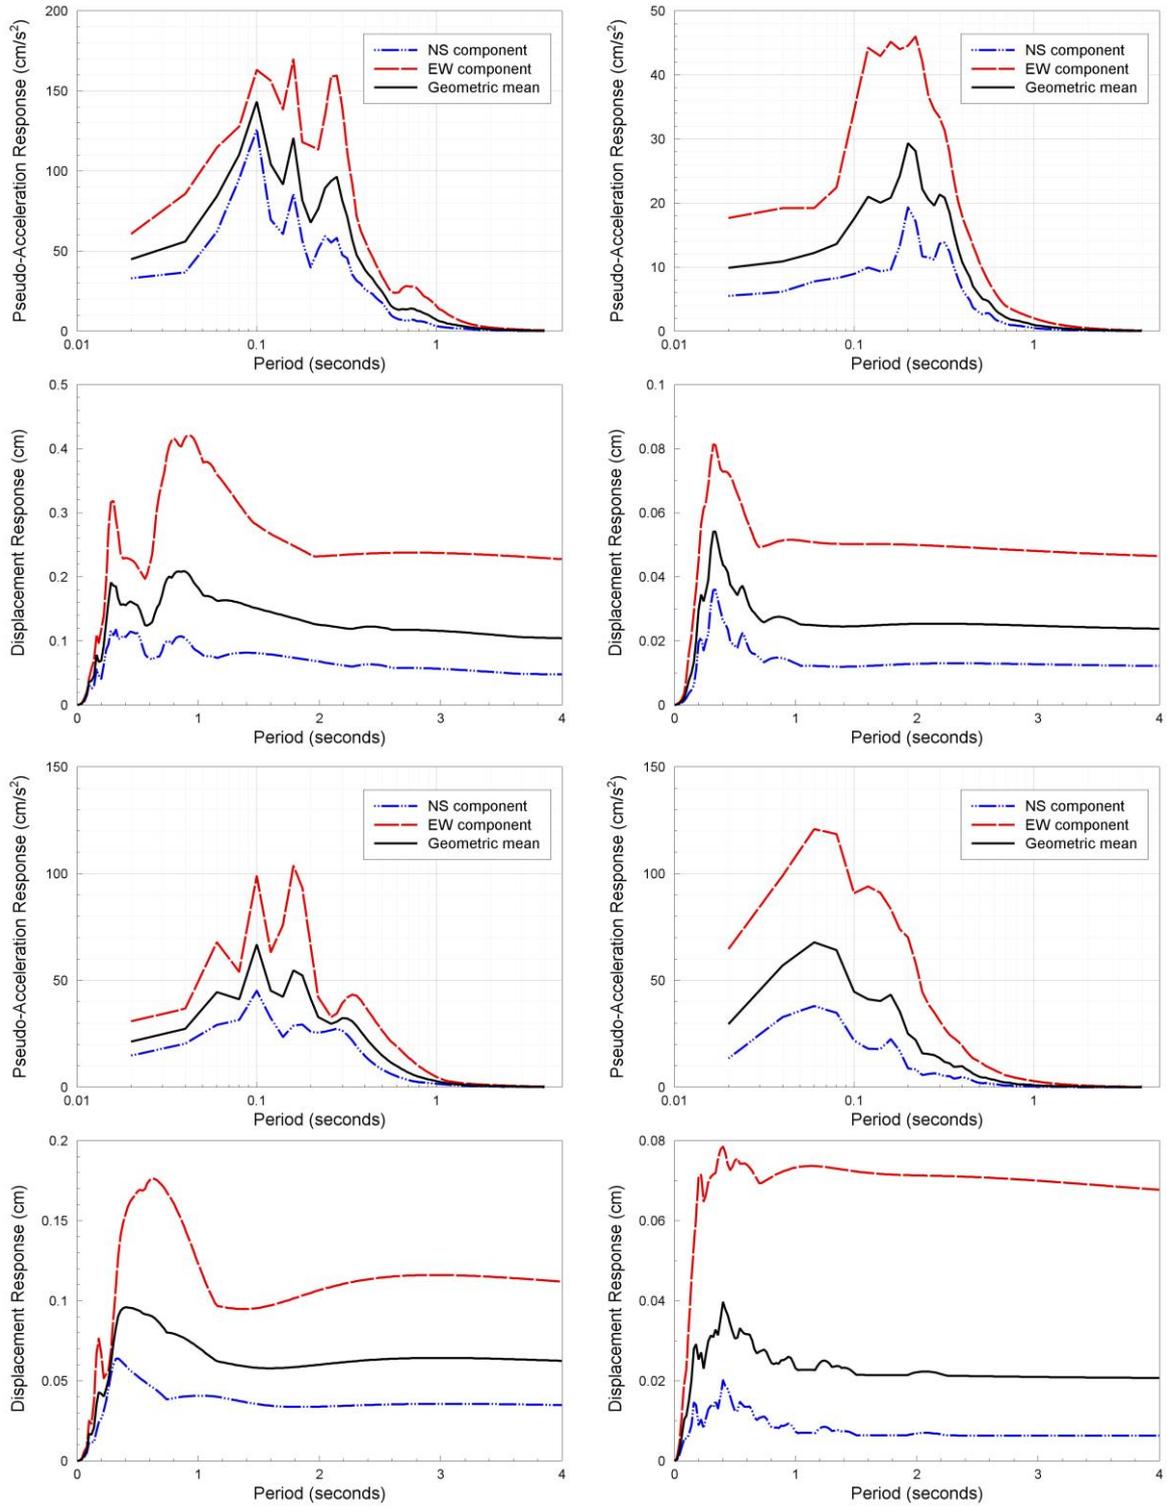
Figure 7. Example response spectra from the Groningen field, illustrating the strong polarization in the horizontal components

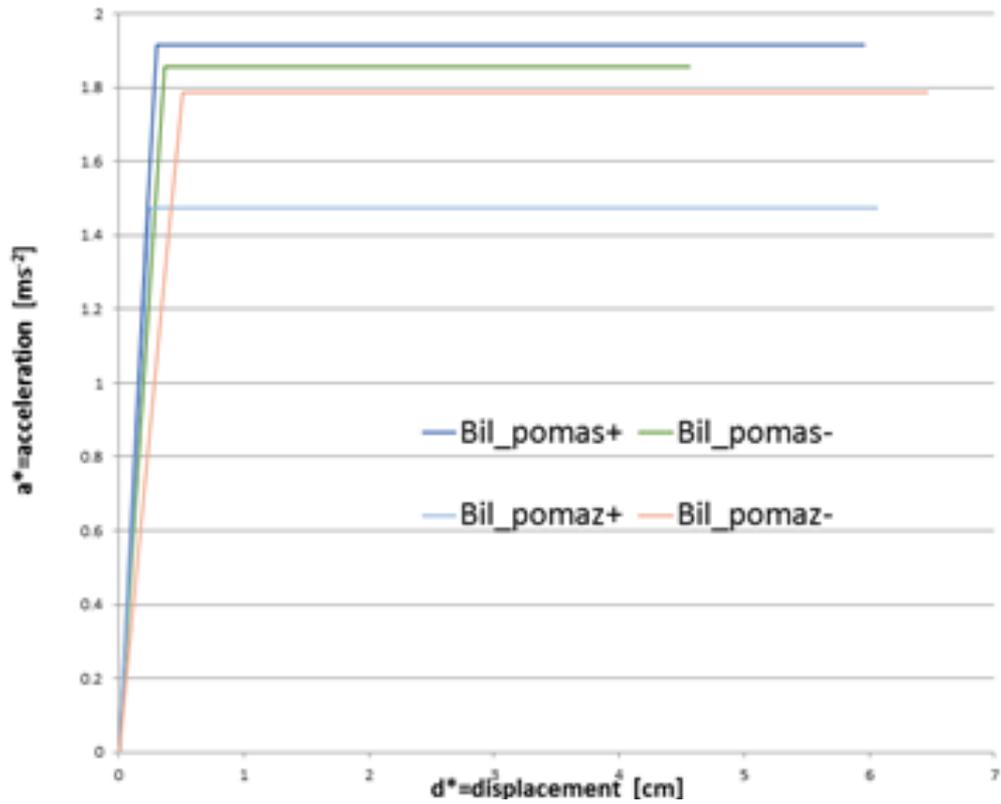
Figure 1. Bilinearised capacity curves for the masonry structure to be tested

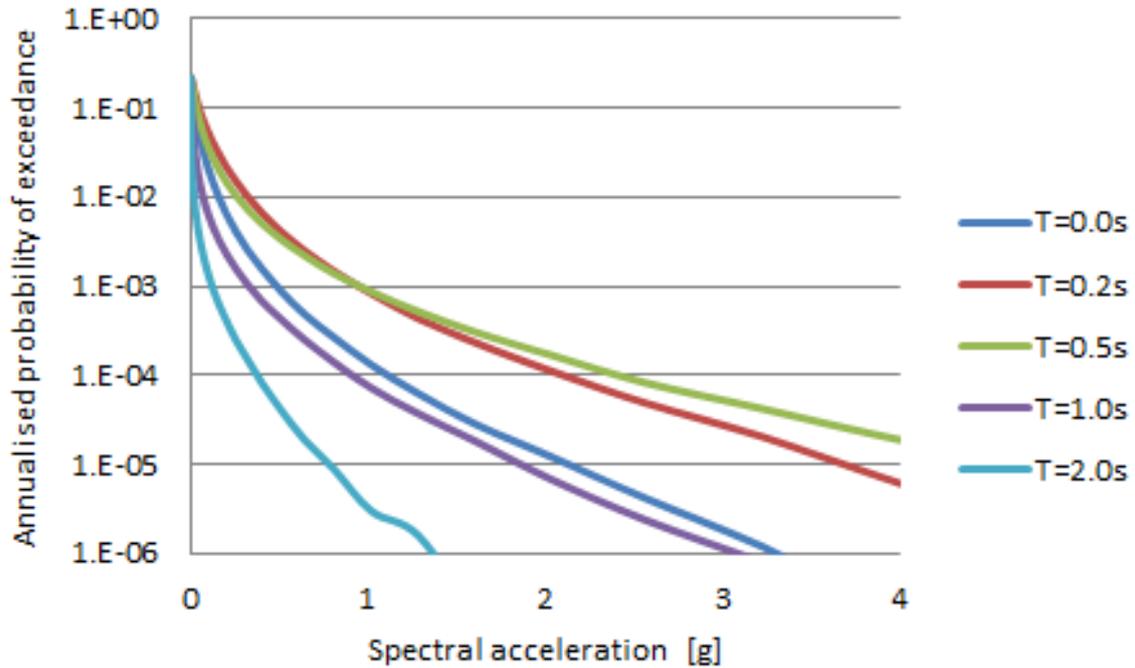
Figure 3. Mean seismic hazards for Loppersum

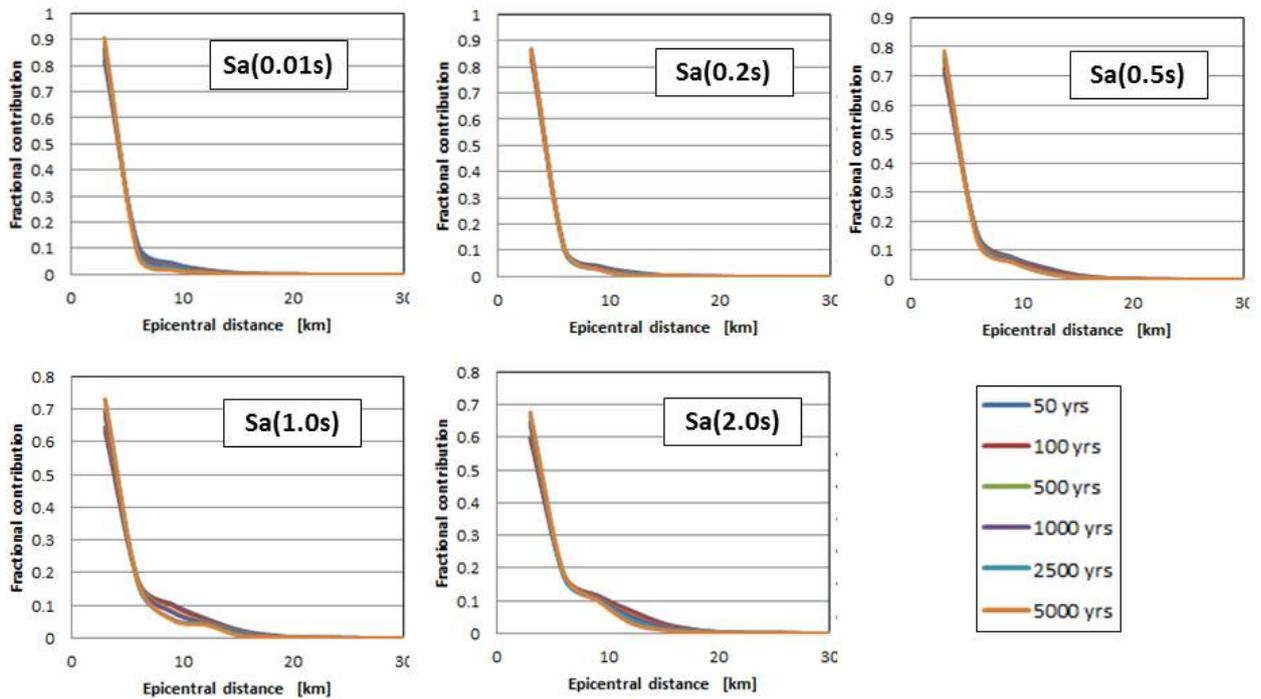
Figure 3. Disaggregation plots for hazard contributions by distance (the truncation at 3 km is unintentional and a result of the software originally being coded for hypocentral distance)

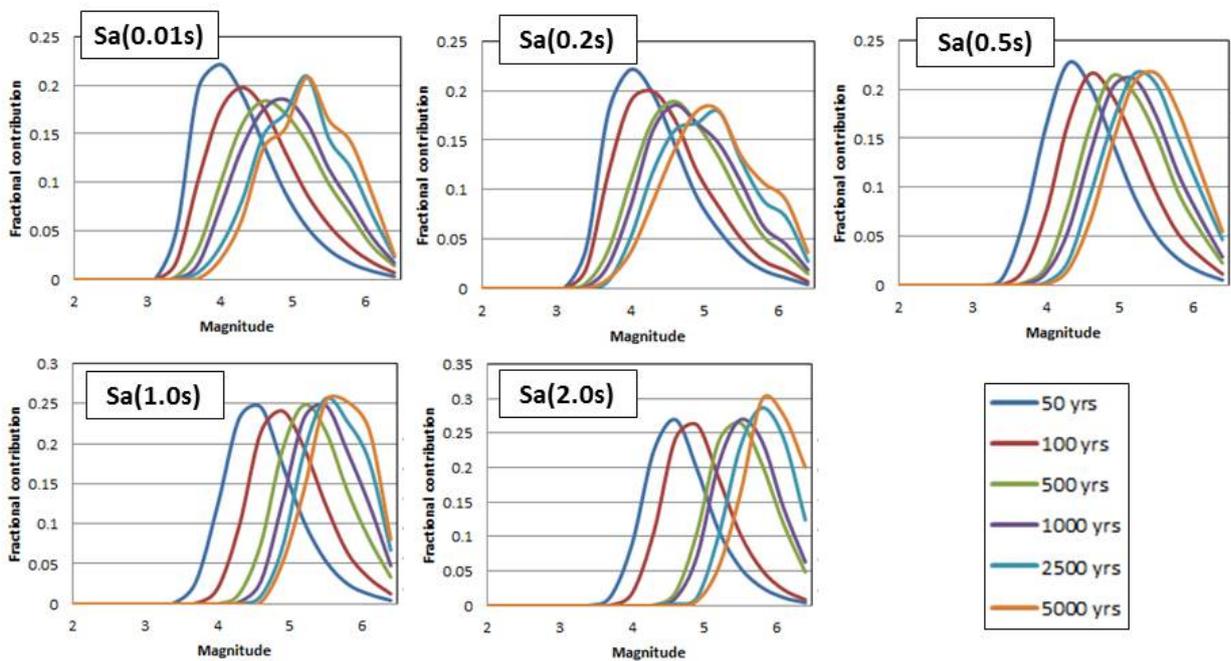
Figure 5. Disaggregation plots for hazard contributions by magnitude

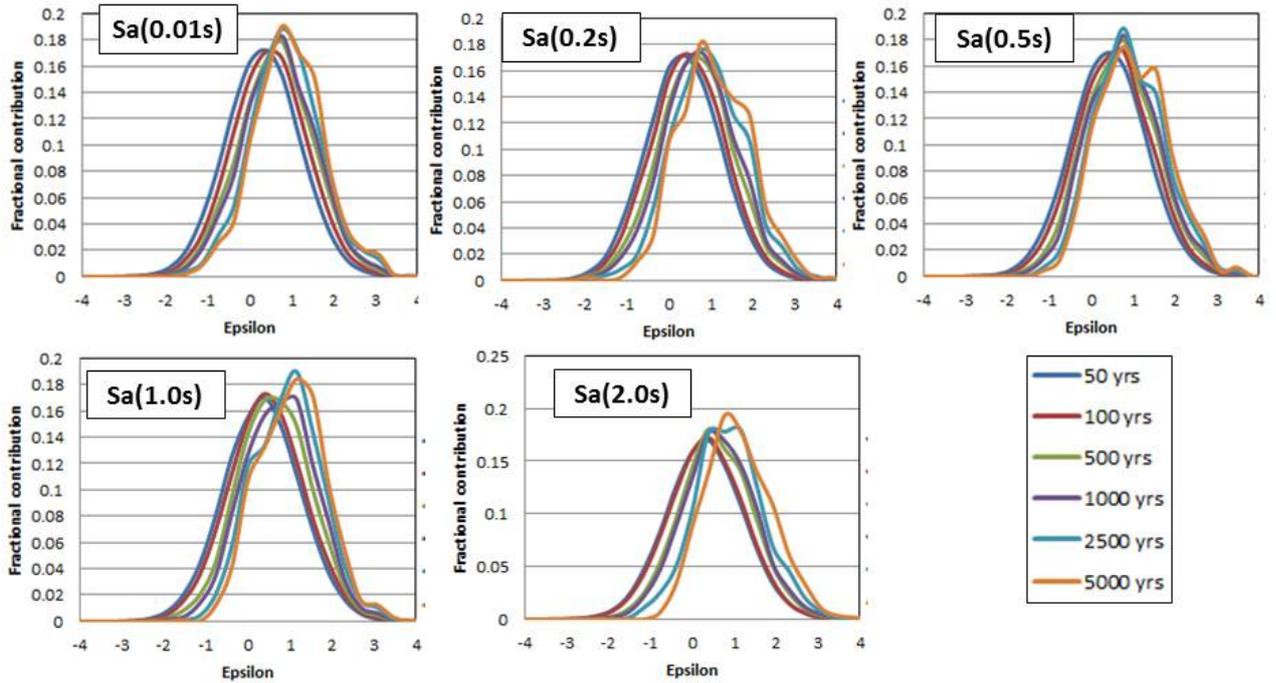
Figure 6. Disaggregation plots for hazard contributions by epsilon

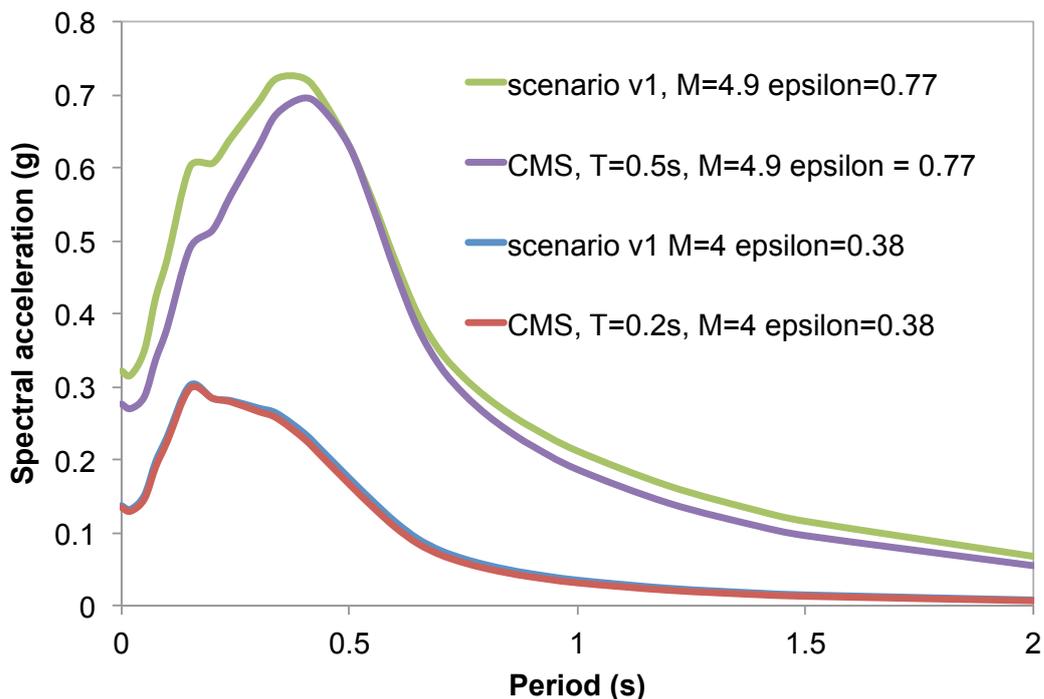
Figure 7. Scenario and conditional mean spectra for the scenarios in Table 3.

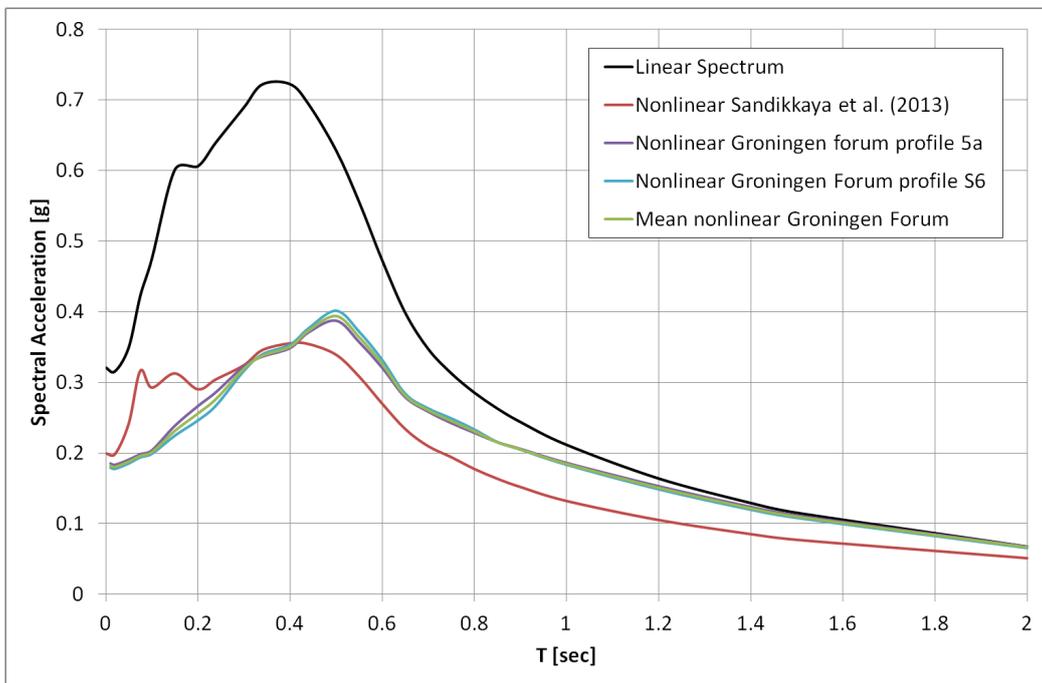
Figure 9. Nonlinear amplified spectra for the scenario 2 based on the Sandikkaya *et al.* (2013) and the non-linear site response amplification functions derived for the ground surface at the Groninger Forum site.

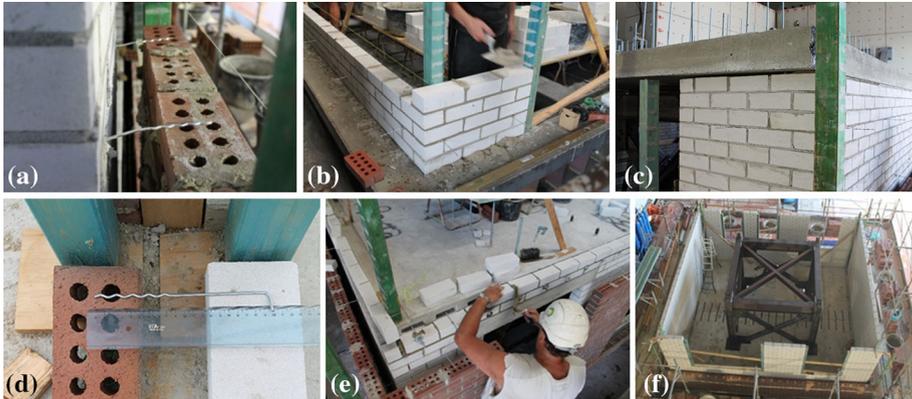
**Fig. 5** Construction details of the specimen: **a** positioning of cavity steel ties; **b** building phase of inner CS leaf; **c** laying of the second floor slab; **d** geometry of steel tie; **e** construction of CS leaves at second floor level; **f** safety steel frame

It is well known among the engineering community that construction details can significantly affect the seismic response of a structure, especially a URM building. Observation of damage caused by major earthquakes, as well as laboratory tests (Tomažević et al. 1991; Magenes et al. 2014) have shown that the role of the connections between horizontal and vertical structural elements is of primary importance for ensuring a good structural performance. The construction details of the specimen were representative of the Dutch common practice of the '60s and '70s. Figure 5 presents pictures captured during the construction phase of the specimen.

which is indicated by red dots in Fig. 4. Details of this connection are also shown in Fig. 5c, d. This solution was meant to represent a common technique associated with a cast-in situ RC slab where the bars were embedded in the masonry before casting the slab. Since the construction in the laboratory environment required the slabs to be precast, the connectors were pre-inserted in the concrete and then anchored to the masonry in a second phase. As recurrent in the building stock, an air gap (hole sleeve in Fig. 6c) was left in order to guarantee differential thermal expansion of the components. There was no direct connection between the outer clay veneer wall and the first-floor slab.

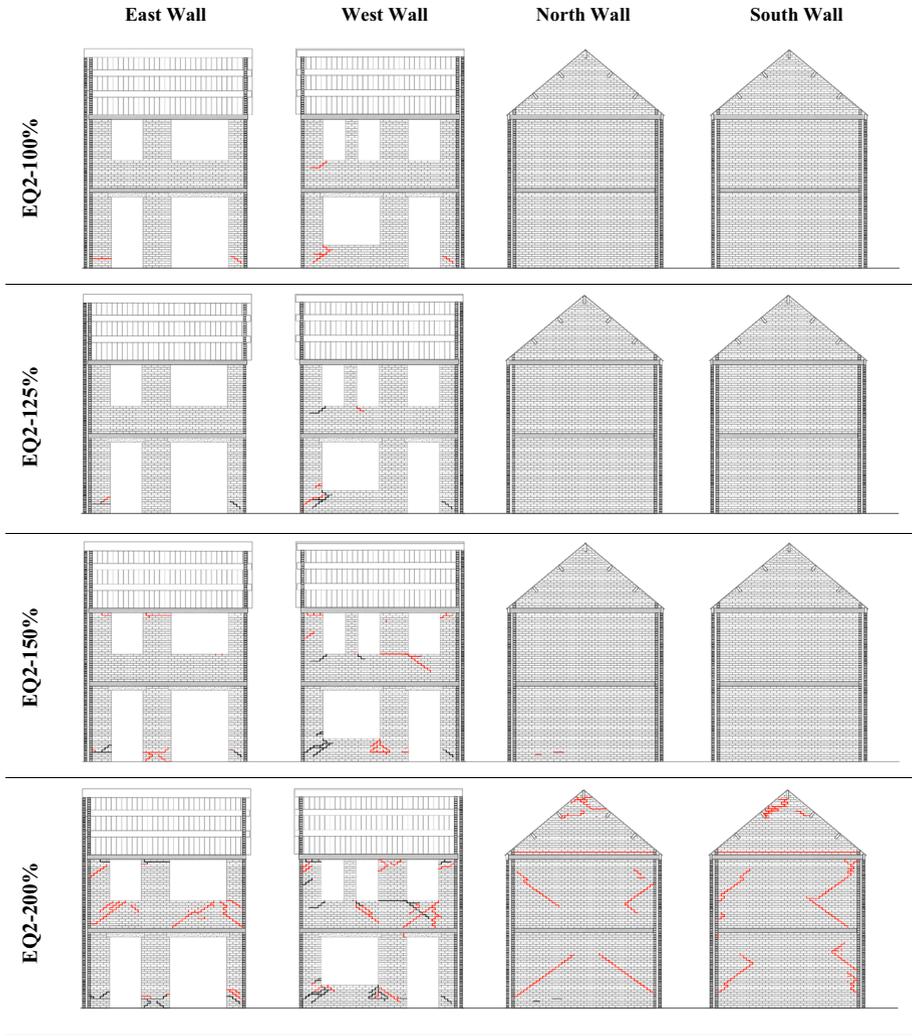
**Fig. 11** Crack pattern evolution of the inner CS walls

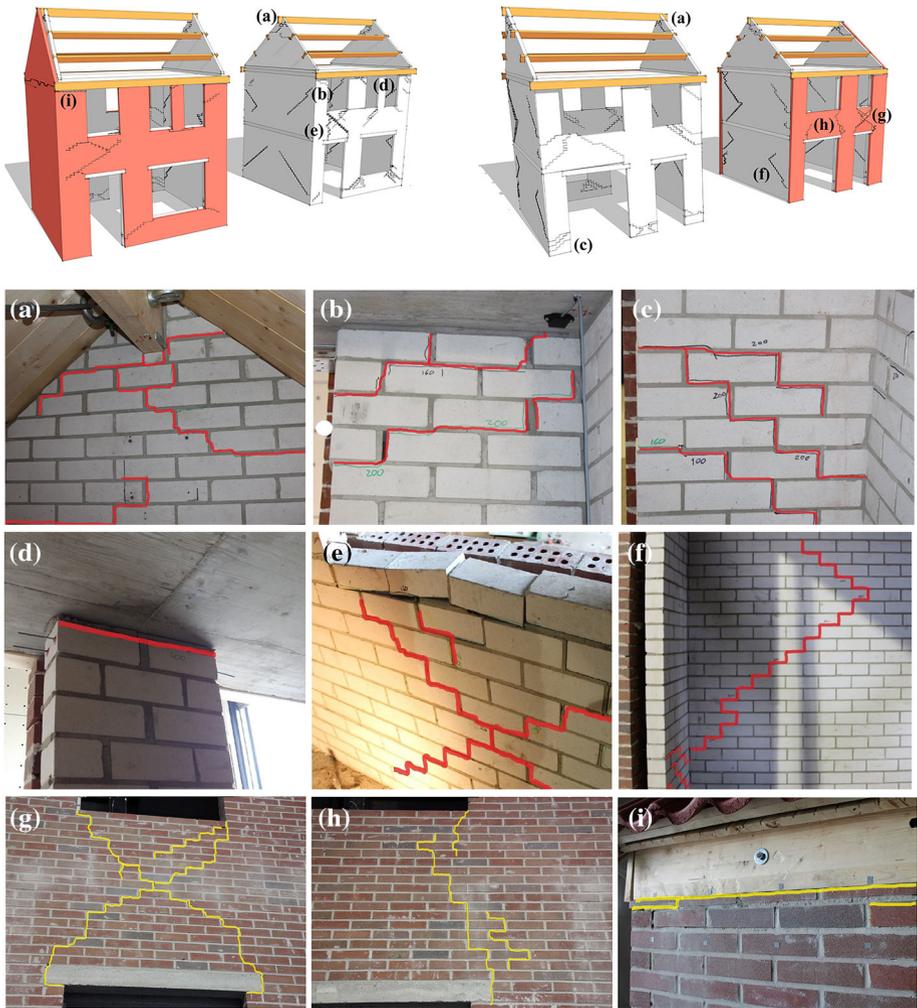
**Fig. 13** 3D view of the observed crack pattern at the instant of attainment of the peak second floor displacement: **a** pounding of the ridge beam on the North CS gable; **b** flexural cracks on the top of the second storey; **c** flexural cracks on the bottom of a first storey pier; **d** sliding at the interface of the second storey pier and the slab; **e** de-cohesion of masonry blocks and diagonal shear cracks through the joints; **f** stair-stepped cracks in the transverse walls; **g** shear failure of the veneer’s short spandrel with the formation of X-shaped crack pattern, **h** flexural cracks in the veneer’s long spandrel; **i** sliding at the interface of the veneer and the timber wall plate

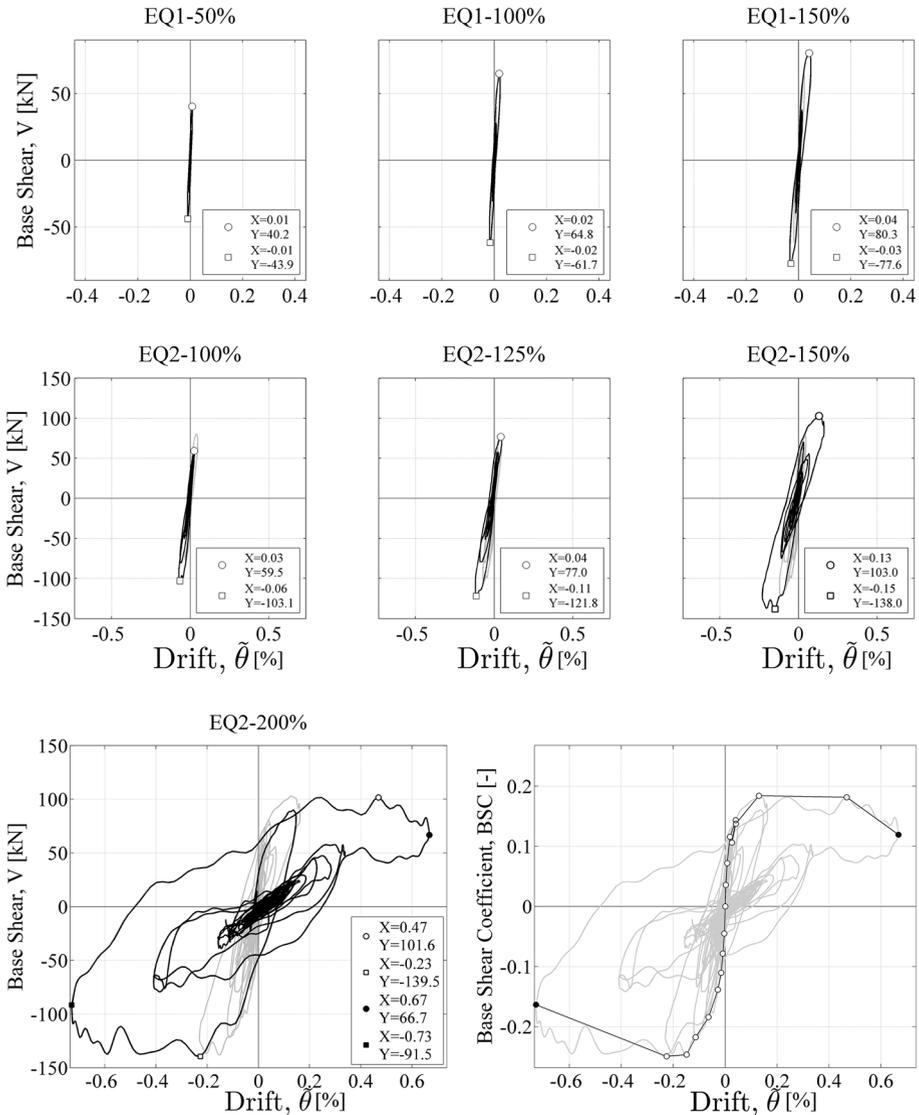
**Fig. 16** Evolution of the global hysteretic response in terms of base shear versus global drift ratio (*left*); Backbone curve in terms of base shear coefficient (*right*)

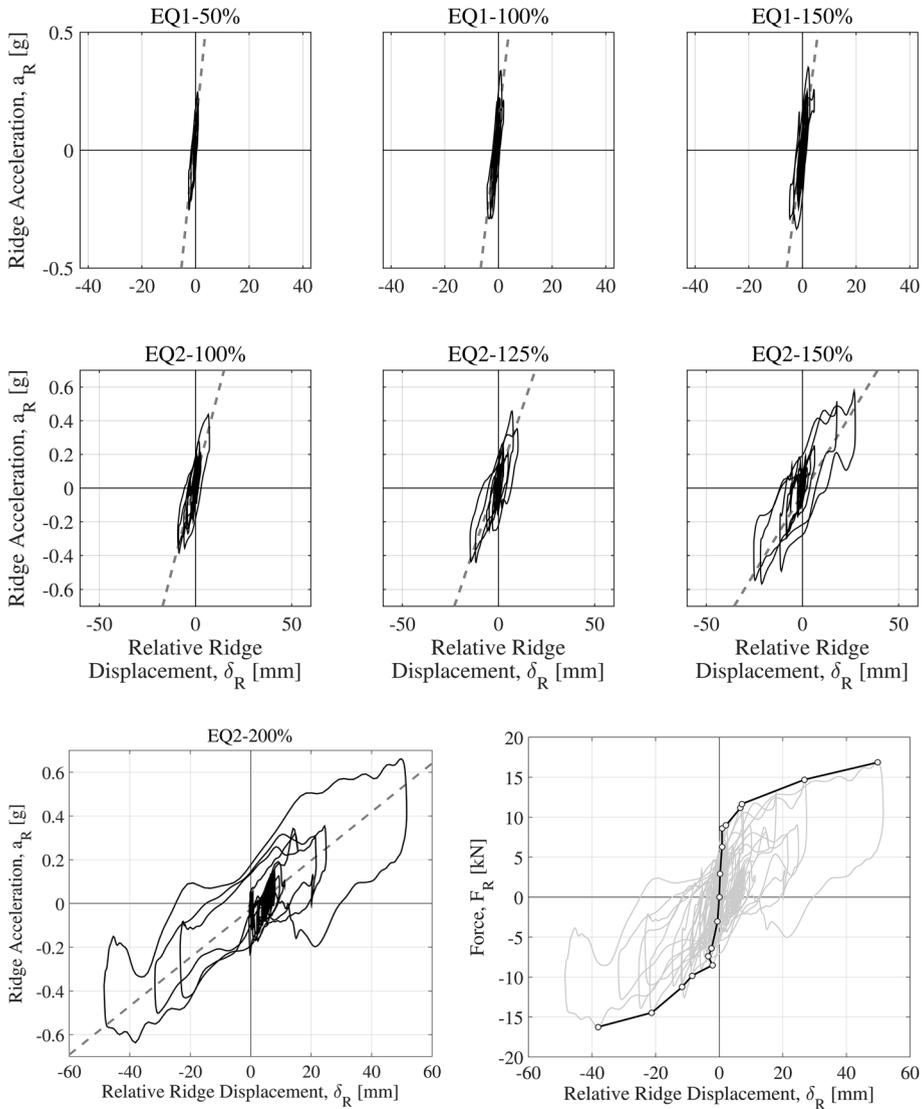
**Fig. 17** Evolution of the roof hysteretic response in terms of acceleration versus relative displacement at the ridge beam level (*left*); Backbone curve (*right*)
