# **Experimental campaign on cavity walls systems representative of the Groningen building stock**

**Alberto Pavese, Francesco Graziotti and Guido Magenes**

**Eucentre**

Date June 2016

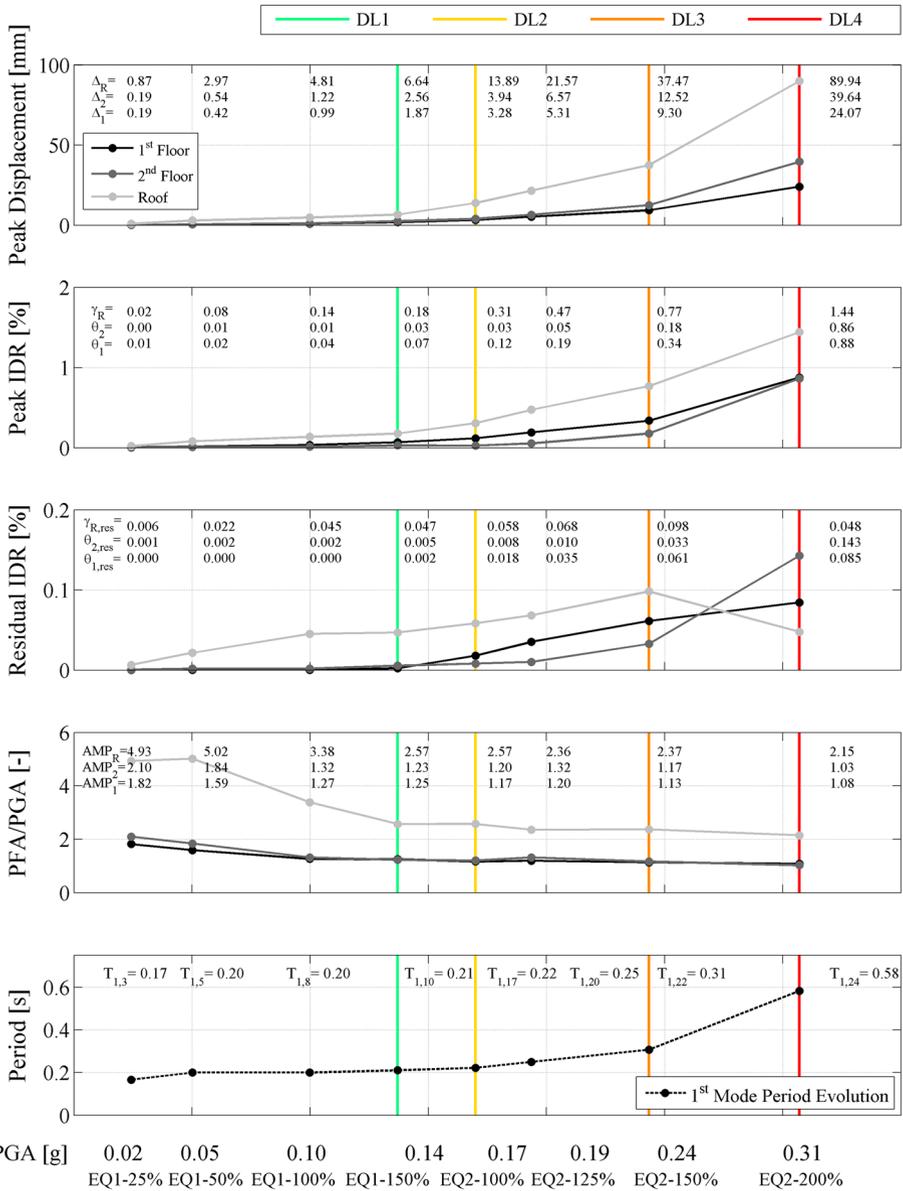
Fig. 20 Summary of the performance of the building specimen

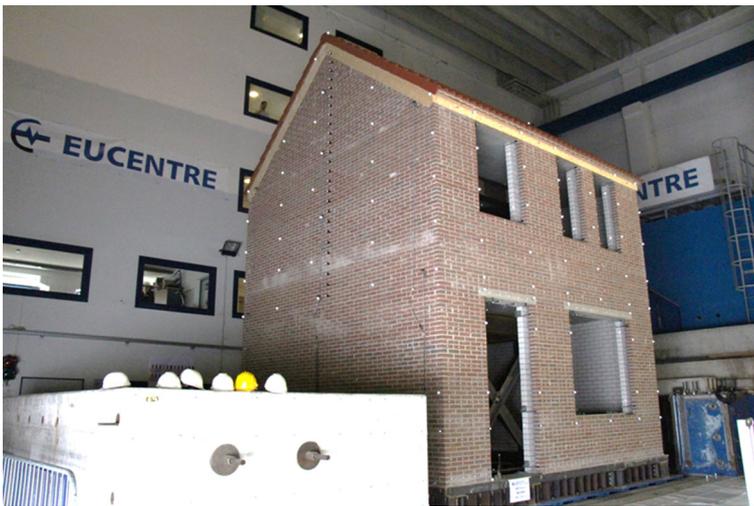
**Fig. 21** 3D optical acquisition system (markers illustrated with *white dots*)

The data obtained by the 3D optical acquisition system (Fig. 21) can be found in the same database. The synchronized data are provided for the shaking-table tests listed in Table 6, organized in *C3D* files.

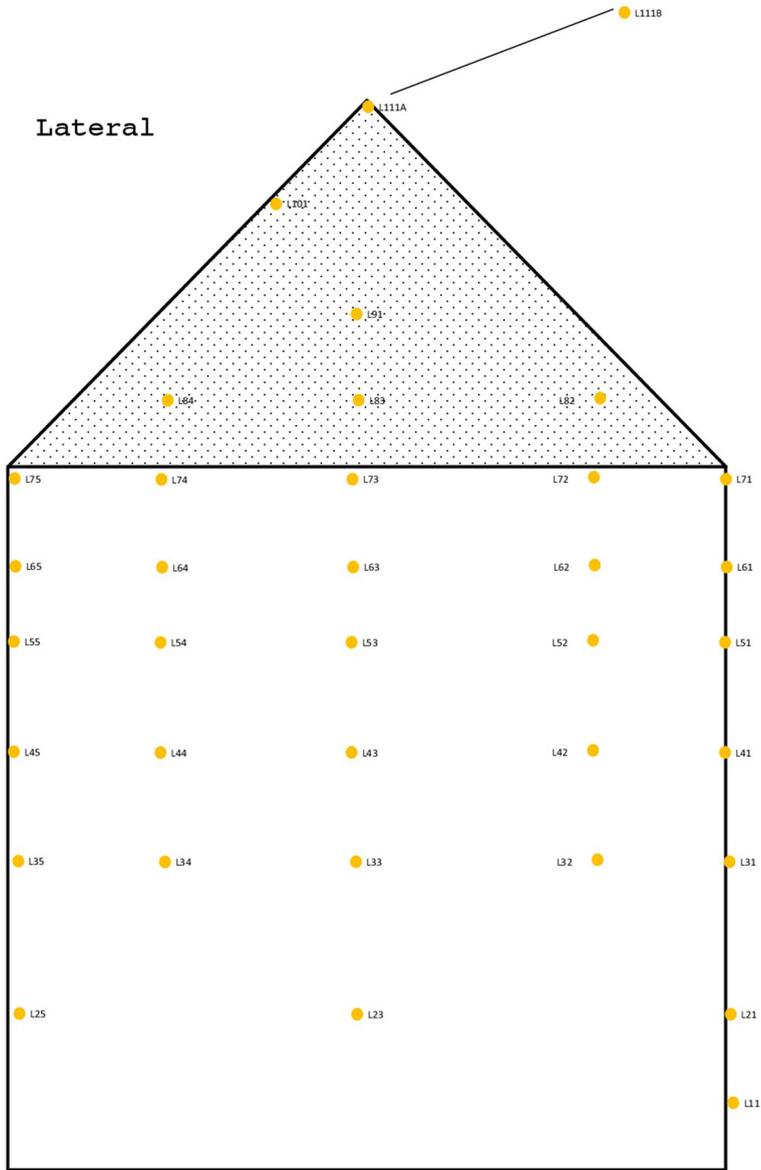
**Fig. 22** 3D optical acquisition system: markers mounted on the North façade of the building specimen
