Client: Nederlandse Aardolie Maatschappij

### Arup Project Title: Groningen Earthquake Structural Upgrading

Risk Assessment of Falling Hazards in Earthquakes in the Groningen region: Appendices 1-4

Issue Rev.0.03 | 29 March 2016

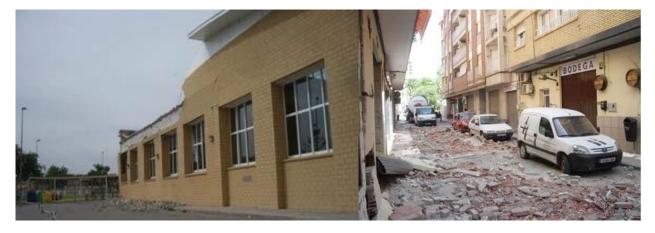
#### Figure A2.1 Parapet Collapse and Debris in Streets

- Collapsed parapets, which in several cases inundated narrow streets with debris (Figure A2.1)
- Out of plane failure of non-load-bearing masonry walls (Figure A2.2) and
- Shear failure and out of plane collapse of masonry infill panels (Figure A2.3)

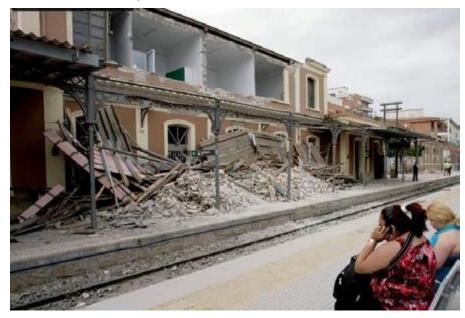
Figure A2.2 Out of Plane Masonry Wall Failure (Lorca Station)

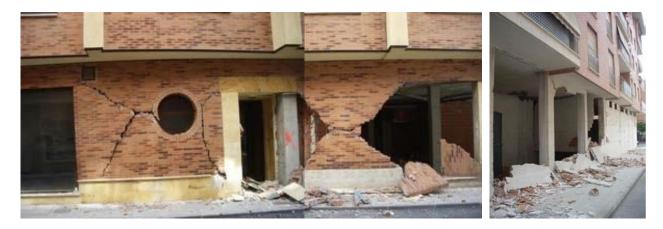
Figure A2.3 Shear Failure and Out of Plane Collapse of Infill Panels

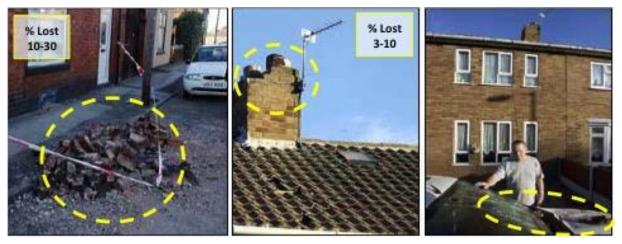
Figure A2.9 Dudley 2002, Images of the earthquake damage<sup>22</sup>:

In the West Midlands<sup>18</sup> the moderate level of shaking caused damage to three chimneys, all belonging to older (pre-WW1) houses. There was a total of 1,086,700 households in the West Midlands at the time<sup>19</sup>, of which 21.4% were assumed to be pre-WW1<sup>20</sup>. The epicentre was under Brick Kiln Lane, a road with 42 residences, none of these were damaged<sup>21</sup>.

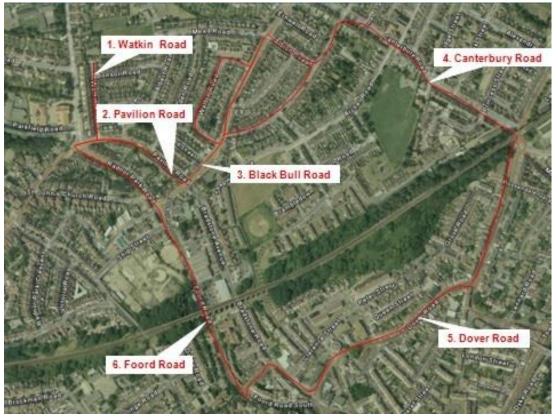
Figure A2.11 Survey Area, Folkestone 2007

A survey was carried out on the afternoon of the day of the earthquake by staff of Arup and others, who provided copies of their photographs of damage from the surveyed area of 707 houses<sup>24</sup> (see figure A2.11).

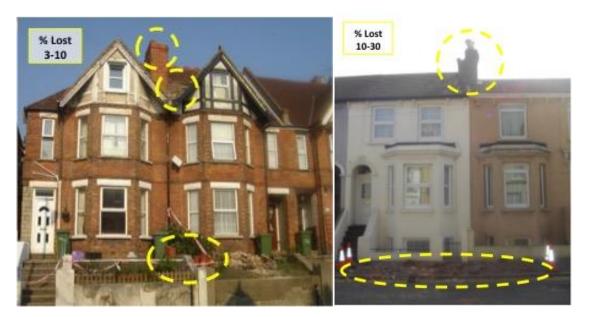
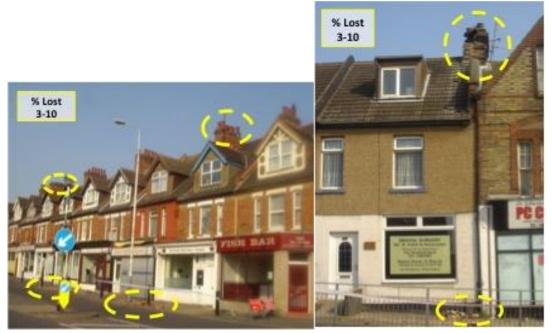
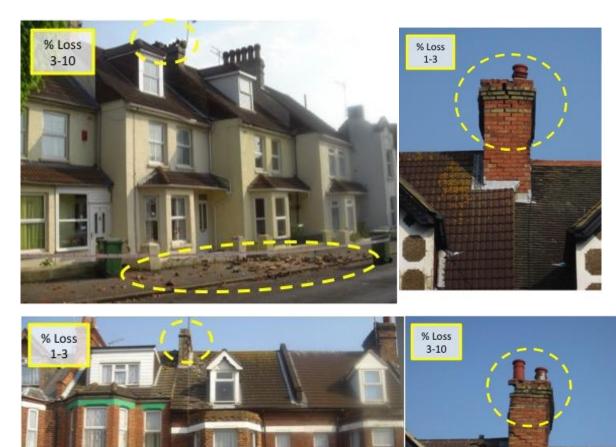
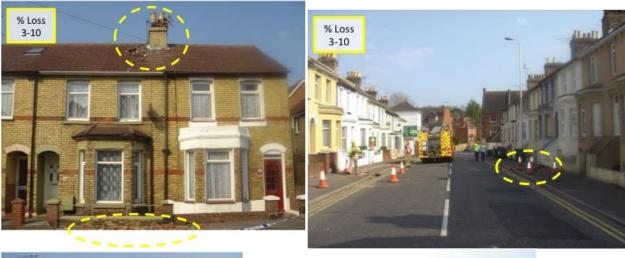
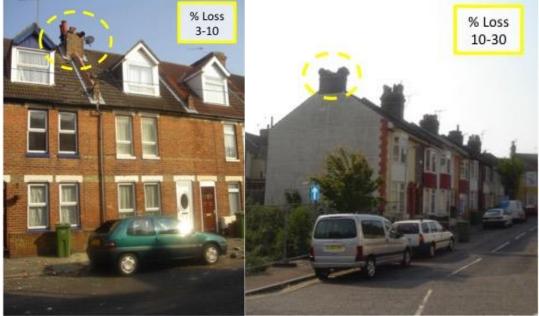
Figure A2.12 Images of the earthquake damage showing assessment of % volume lost

12 chimneys were significantly damaged, corresponding to 1.7% of the buildings. The proportion of masonry volume lost from those chimneys ranged from 1% to 20%, with the average volume loss about 9% (see Figure A2.12). In all but one cases, virtually all of the debris detached from the chimney fell to the ground on account of the steep design of the roofs. The one exception was when debris was trapped in a valley between two front roof gables.

The general style of chimney in the area had several chimney pots per stack. In every chimney damaged at least one chimney pot fell to the ground. All chimneys, apart from one, were located in the middle of the roof; a number of roof tiles were thus damaged by falling chimney debris and added to the debris on the ground. The photographs used to generate the summary table below are provided as Figure A2.12.

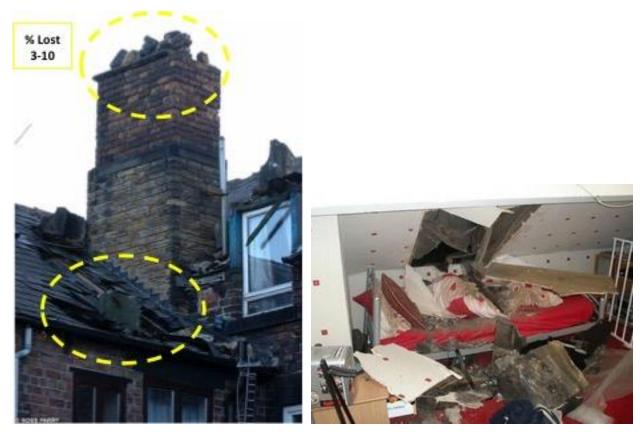
Figure A2.13 (b) Damaged chimney in South Yorkshire and the damage caused by debris inside

The chimney in South Yorkshire fell through the roof and caused the only reported injury – a broken pelvis sustained by a man as the chimney fell onto his bed in an attic room. The chimney was located in the middle of the roof, in the middle of a row of terraced houses. The chimneys in Gainsborough were only slightly damaged with an average of 5% volume lost<sup>28</sup>.

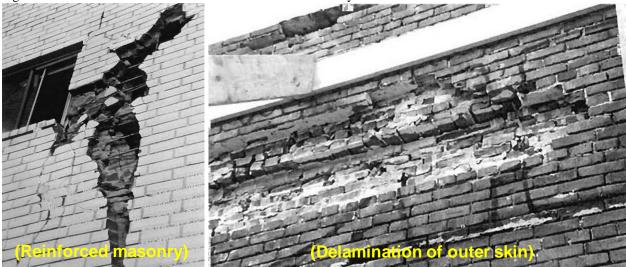
#### Figure A2.18 Delamination from URM and Reinforced Masonry Walls

Examples of damage to walls, showing how "strengthening" using stays and tie-bars with plates or anchors failed to be effective, are provided in Figure A2.16 (parapets), A2.17 (URM walls) and A2.18 (delamination from URM and reinforced masonry walls). All photos are reproduced from the EEFIT report<sup>33</sup>.

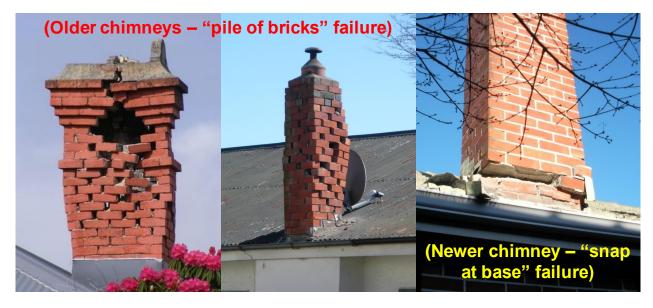
Much useful information on chimney performance was provided in the book "All Fall Down" devoted to the loss of Christchurch chimneys in the earthquakes<sup>29</sup>. Figure A2.31(all photos reproduced from the book with the author's permission) illustrates well the different failure mechanisms that applied to newer/better condition and to older/poorer condition chimneys.

Figure A2.31: Failure Mechanisms for Chimneys
