# **Experimental campaign on Reinforced Concrete buildings typical of the Groningen region**

**Cyclic testing of a full-scale two-storey Reinforced  
Concrete precast wall-slab-wall structure  
representative of the Groningen building stock  
(EUC-BUILD4).**

**Eucentre**

Date June 2017

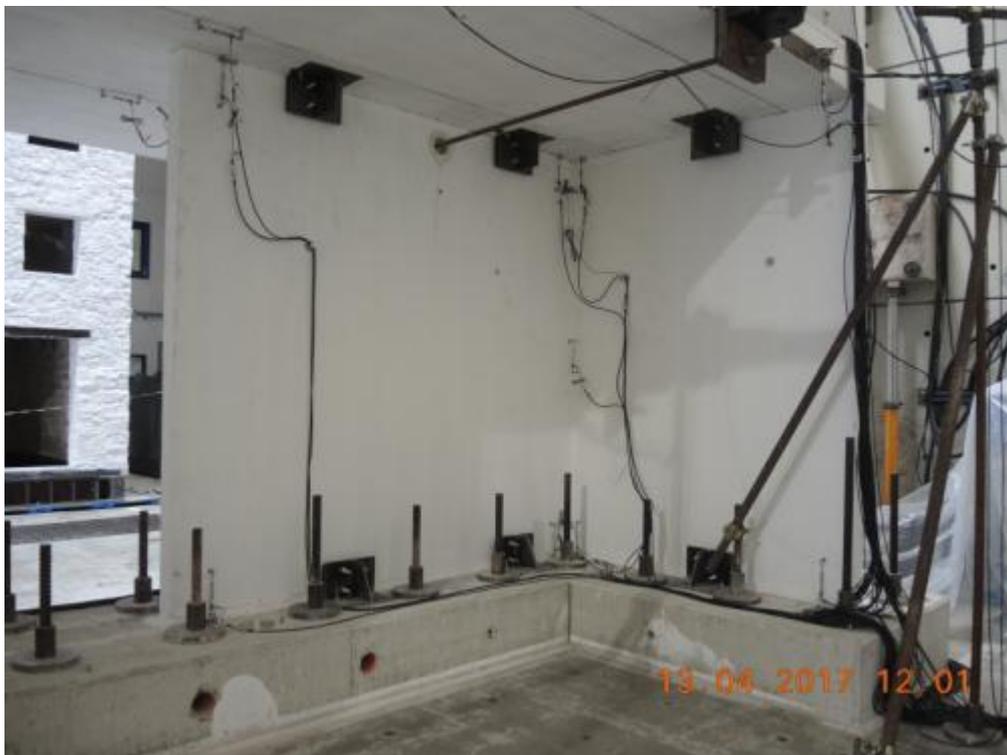
The first sign of damage that affected EUC-BUILD4 full-scale specimen was detected at the end of Test run #3, which consisted of two displacement-controlled cycles for a top displacement of up to 2.8 mm (see Table 19). At the end of testing for the first two preliminary force-controlled cycles, the mock-up building did not experience any type of “eye-catching” damage. On the other hand, minor cracks formed at the base of the ground-floor stability wall as well as in correspondence to the connections between the latter structural element and the lateral walls. Figure 170 to Figure 175 collect the most noticeable observations. More in detail, the development of minor cracks in correspondence to the North corner of the stability wall is reported in Figure 170, Figure 171 and Figure 172, noting also that such cracks formed on both East and West sides of the wall. Figure 173 and Figure 174 then present the crack pattern in the joint between the stability wall and the orthogonal walls. Also in this case, the crack propagated on both sides of the stability wall, along its top half. Another minor crack opened up in one of the two South-sided transversal wall, as shown in Figure 175.

**Figure 170. Development of cracks in the ground-floor stability wall.**

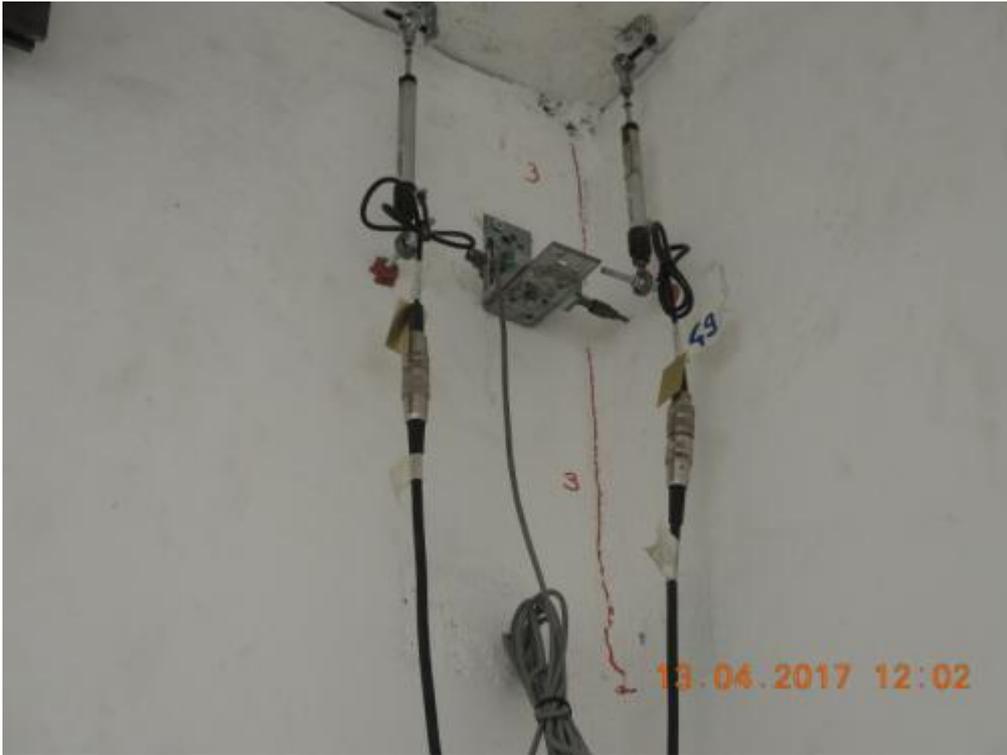
Figure 173. Crack opening in correspondence to the connection between stability and lateral walls – Top.

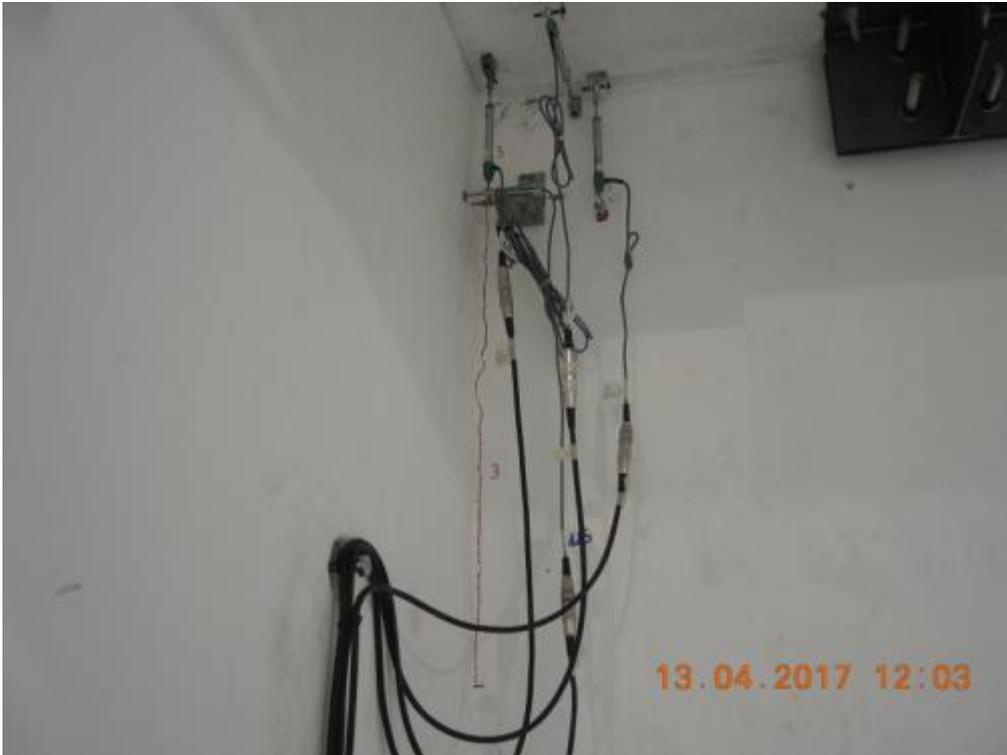
Figure 174. Crack opening in the connection between stability and lateral walls – Opposite side.

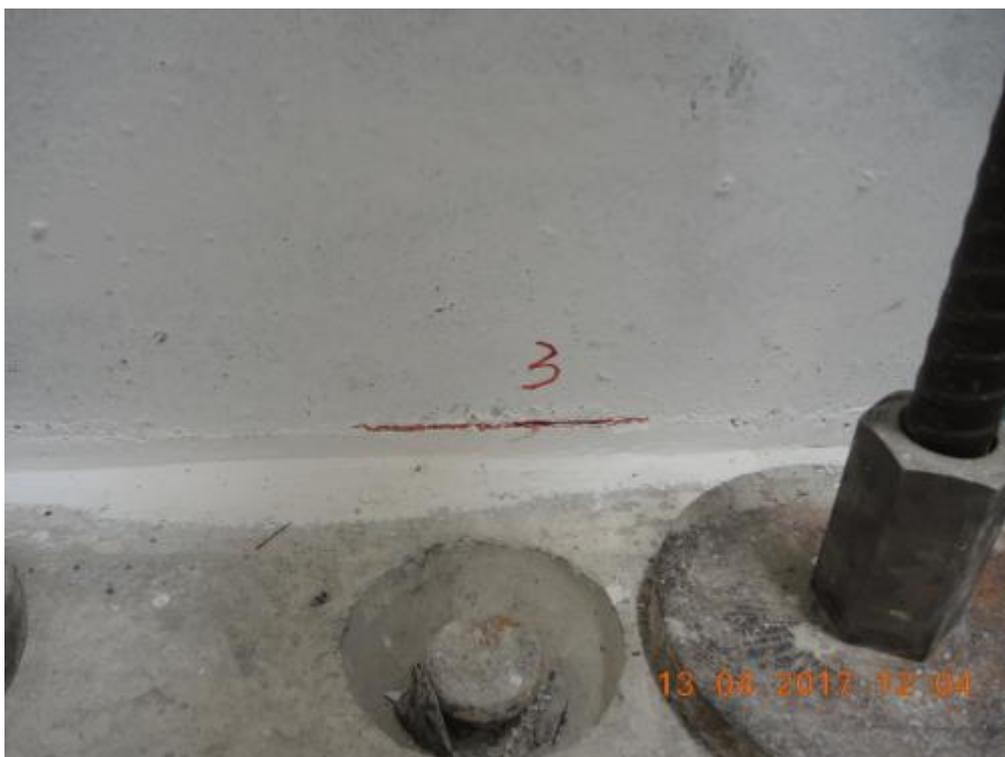
**Figure 175. Development of a crack at the base of one of the transversal walls at the South side.**

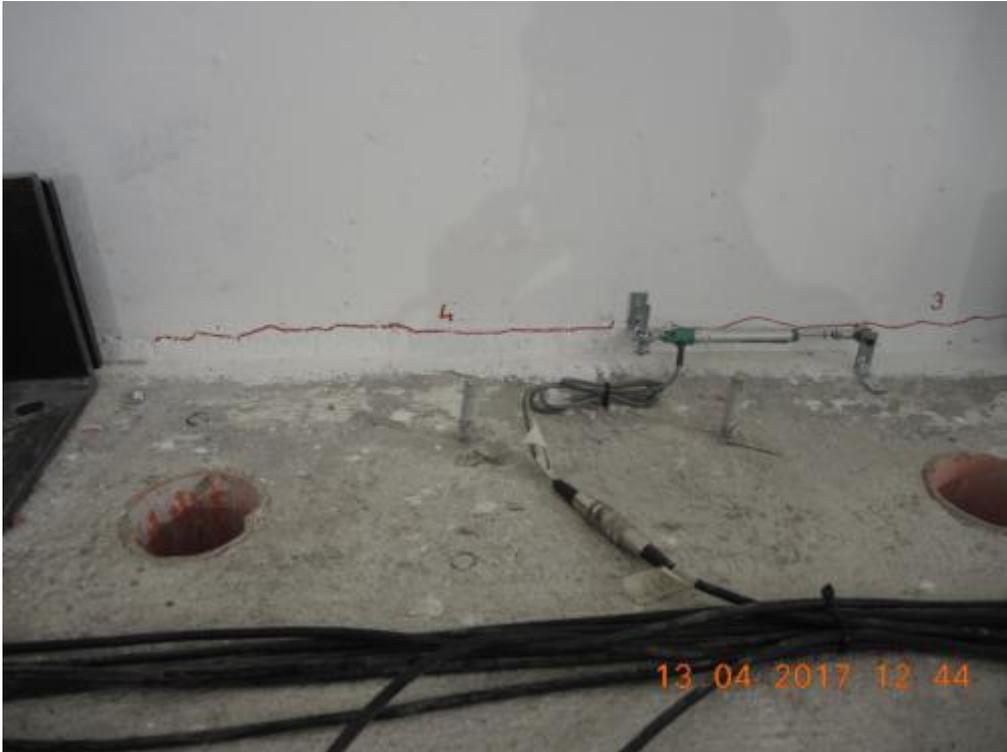
EUC-BUILD4 suffered further damage during Test run #4, as presented in Figure 176 to Figure 179. In detail, minor flexural/tensile cracks caused by the application of the previous series of cycles were observed to evolve and propagate along the depth of the ground-floor stability wall (Figure 176 and Figure 177) and the same consideration can be drawn from Figure 178, in which the development of the vertical crack opened up in the three-way connection between the stability and transversal walls can be appreciated. Both the East and West side views confirm the propagation of this vertical crack down the storey height. It can also be noted that a new crack opened up at the base of one of the two ground-floor transversal walls, as shown by the West side view reported in Figure 179. However, the latter crack did not develop at both sides of these 120 mm-thick walls, nor along their entire width.

Figure 176. Propagation of horizontal cracks along the depth of the ground-floor stability wall – Wall base.

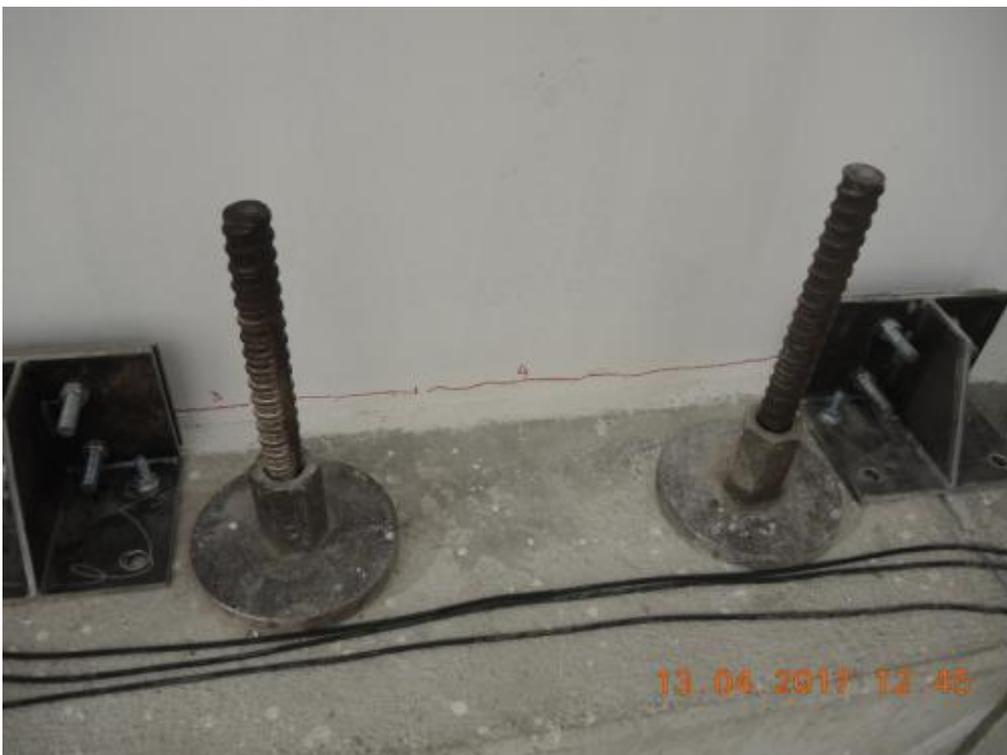
Figure 177. Propagation of horizontal cracks along the depth of the ground-floor stability wall – Opposite side.

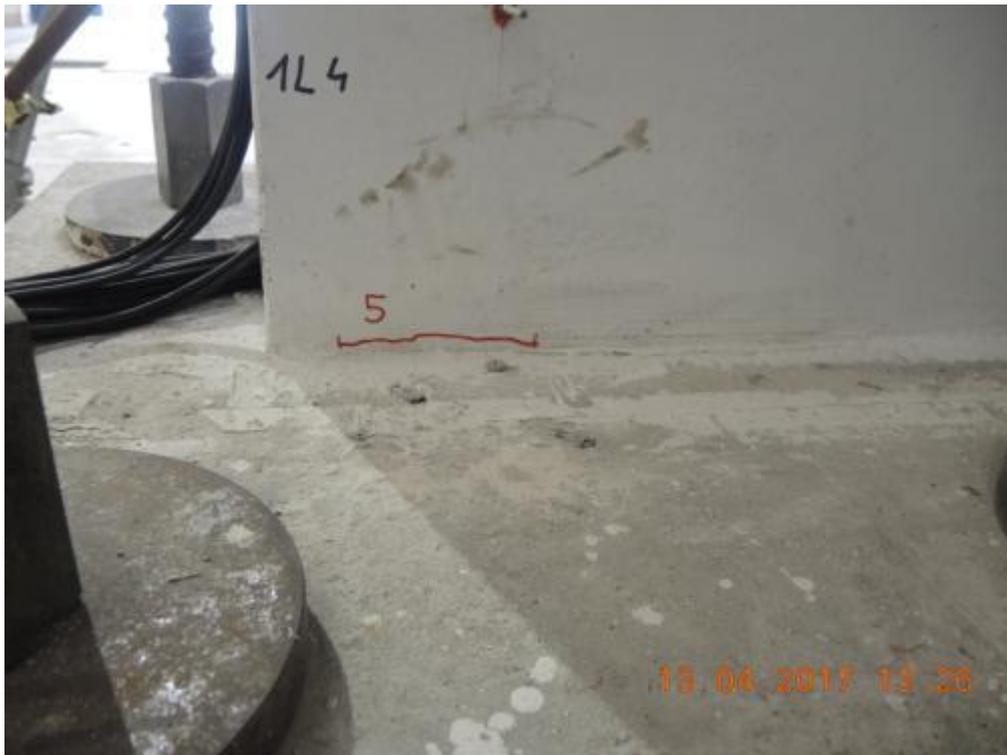
As depicted in Figure 180 to Figure 182, first signs of new damage were found in the North ground-floor transversal walls of EUC-BUILD4 specimen. Indeed, a new crack formed in correspondence to the two-way panel-to-panel connection and propagated along the height of these walls (see Figure 180). In addition to that, some other cracks developed at the wall base, as pointed out in Figure 181 and in Figure 182, which present the South and East faces of the first-storey transversal wall, respectively. Once again, the width of these cracks was relatively moderate; noteworthy is that they did not form on both the two sides of the wall, which means that North and West faces of these wall panels remained intact. Finally, it can be noticed that cracks developed along the wall height in the joints of the two adjacent lateral walls simply because they are disconnected with each other, niches/joints apart. As presented in Figure 184, a similar occurrence was observed in the South lateral walls.

Figure 181. Crack pattern at the base of lateral wall W1L4 – North side, internal edge.

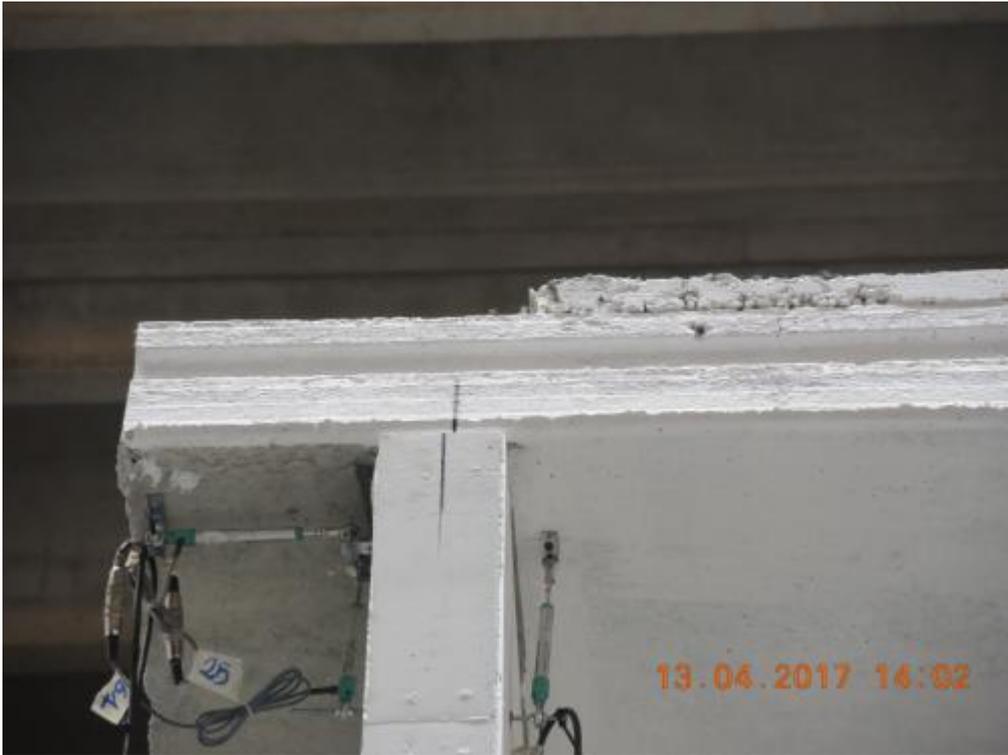
**Figure 186. Detail of the second-storey floor slab after Test run #6 – accumulation of displacement residuals.**

Figure 186 confirm that sliding of slabs on the walls underneath was pronounced as far as this stage of the testing sequence is regarded. According to that, the accumulation of residual displacements was non-negligible. Flexural cracks developed at the base of the South transversal walls mostly in correspondence to the internal/North face, as presented in Figure 187 and Figure 192. The crack/damage pattern of the North lateral walls evolved as well. In particular, Figure 193 and Figure 194 show the propagation of horizontal flexural cracks at the base of the North face of those lateral walls because of their out-of-plane rocking. This resisting mechanism was nearly symmetric during cyclic reversals and hence cracks were also found to propagate at the base of the South face of these walls (Figure 195). The propagation of a previously formed vertical crack in the grout of a panel-to-panel joint was then observed in the North transversal walls (see Figure 196). Such a damage mode is reported therein along with the loss of verticality of these transversal walls at the end of this stage of cyclic testing. Observations regarding the transversal walls of the structure are then completed by Figure 197, which reports the horizontal crack at the base of the second-storey lateral walls opposite to the stability wall (i.e. North side ones).

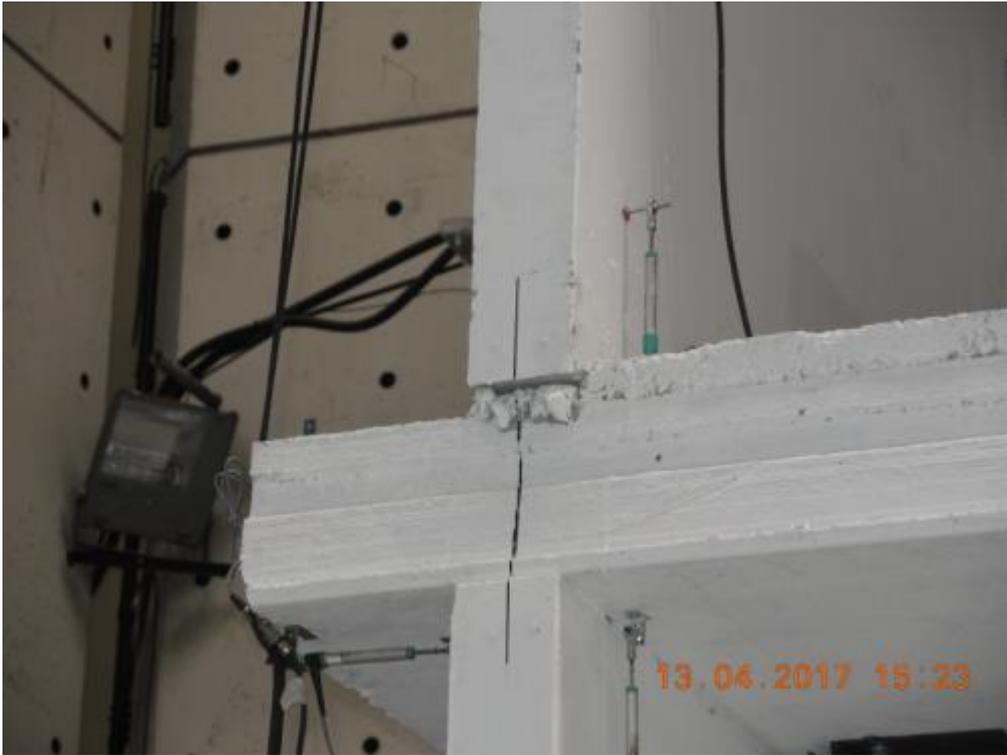
Figure 198 and Figure 199 present the detail of a slab-wall joint of the first and second storey, thus confirming that residual displacements were mostly accumulated at the second floor of the mock-up building. Sliding of slabs on the fabric felts was significant and this, in addition to the accumulation of displacements during the previous steps, caused a few potentiometers to go out-of-range.

**Figure 198. Detail of the first-storey floor slab after Test run #7 – top displacement = 16.8 mm.**

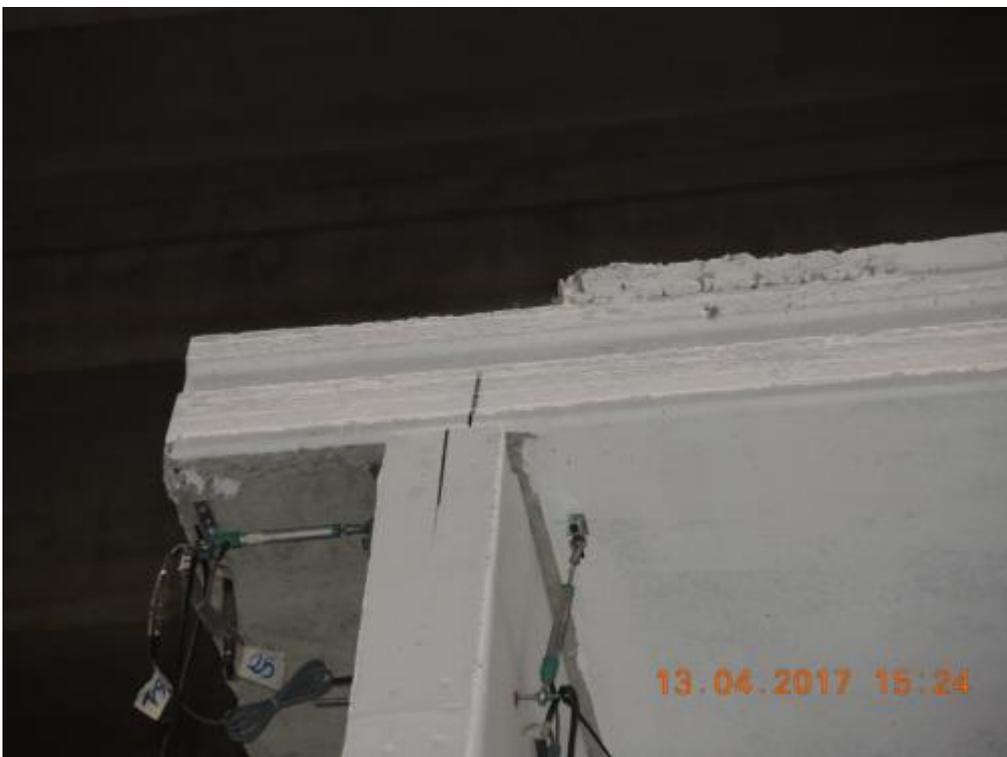
**Figure 199. Accumulation of displacement residuals due to sliding – Detail of the second-storey floor slab.**

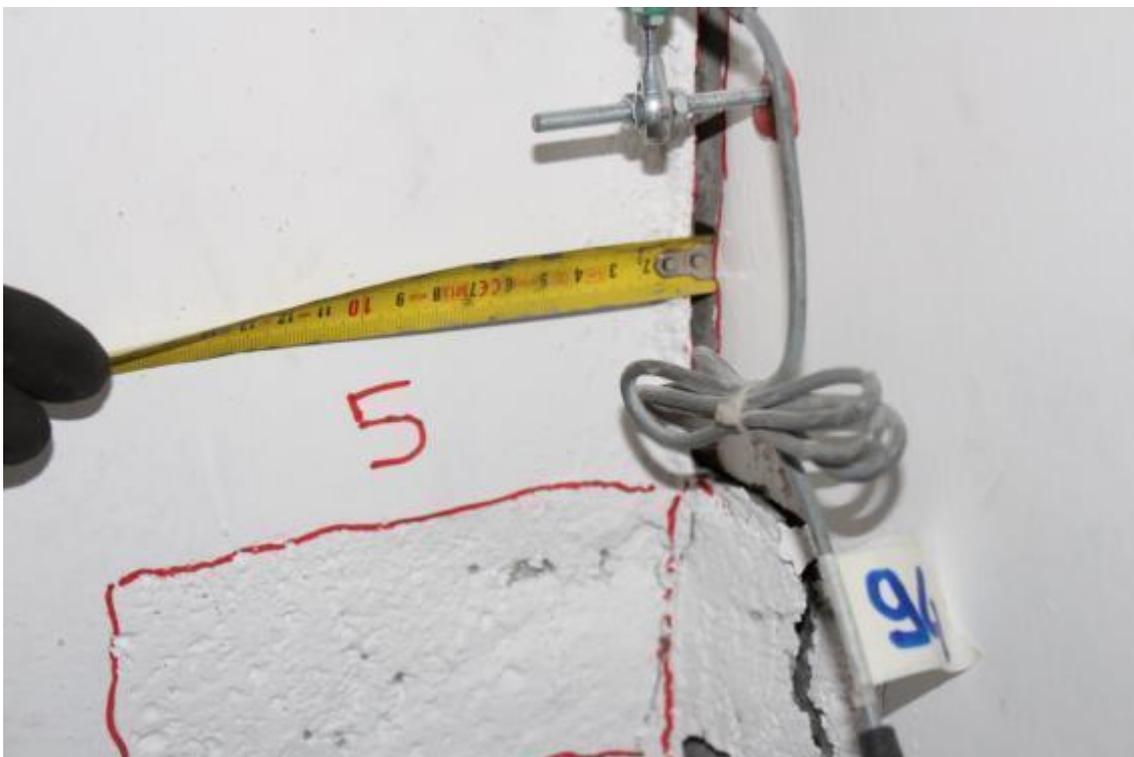
**Figure 205. Detail of gap opening between the stability and lateral walls – Mid-height, West side.**

In Figure 201 and Figure 202, details regarding the complete detachment between the lateral walls and the stability wall are provided. As shown in Figure 203, the latter wall-element was also the one that underwent more damage at the base. At the end of Test run #7, the horizontal crack due to rocking was running through the entire wall depth. Other global and enlarged views of the gap opening between the stability and lateral walls are presented in Figure 204, Figure 205 and Figure 206. Damage was very severe, as all four anchorages of the wall-panel were observed to collapse. It

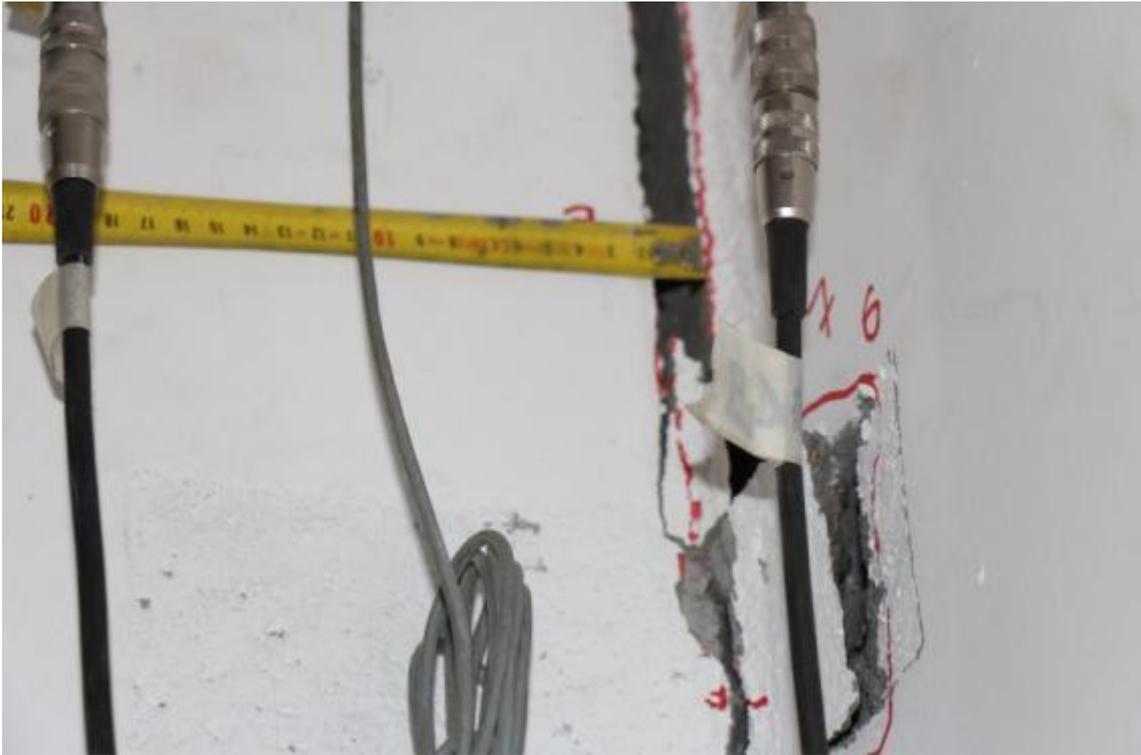
**Figure 206. Detail of gap opening between the stability and lateral walls – Top, West side.**

is noteworthy that the maximum gap opened in the top connection and was approximately 25-30 mm wide. Figure 211 and Figure 212 are finally presented to confirm the type and nature of failure mechanism undergone by these joints. As previously explained and now shown in such photos, connections were found to fail in the hook reinforcement embedded in the niches of the transversal wall. No dislodgement was observed after the removal of the grout around these anchors, and the mechanism was reaffirmed to be a flexural one that was induced by the hook embedded in the stability wall.

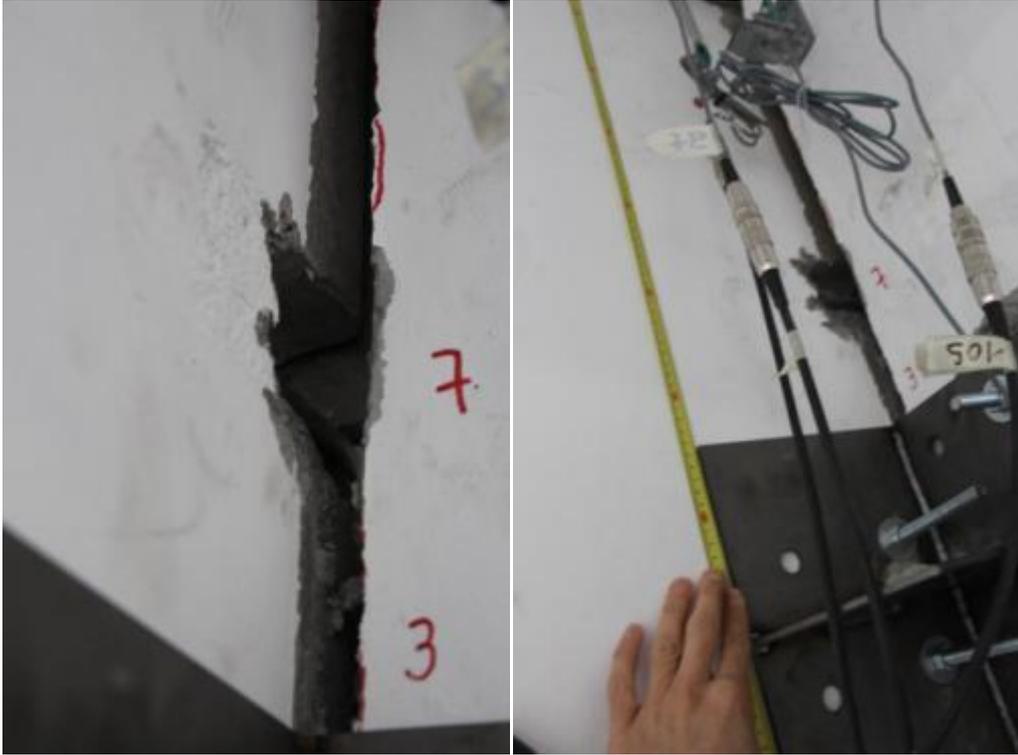
- damage was too extensive and a permanent gap of approximately 25 mm remained between the stability and transverse walls at the top of the ground floor, as can be seen in some of the photos collected below (i.e. Figure 215 to Figure 217). By contrast, at the bottom of the wall the gap could be closed.
- again as can be seen in the photos that are presented below (Figure 215 - Figure 219), not all bolts that tie the steel angles to the precast walls could be screwed-in. Normally one would have liked to use four bolts per plate, but instead only two could often be employed because of the presence of existing rebars internal to the walls (if a proper retrofitting design would have been carried out, this would have obviously been avoided).

Figure 216. EUC-BUILD4 “retrofitted” specimen – Detail of the gap between stability and lateral walls.

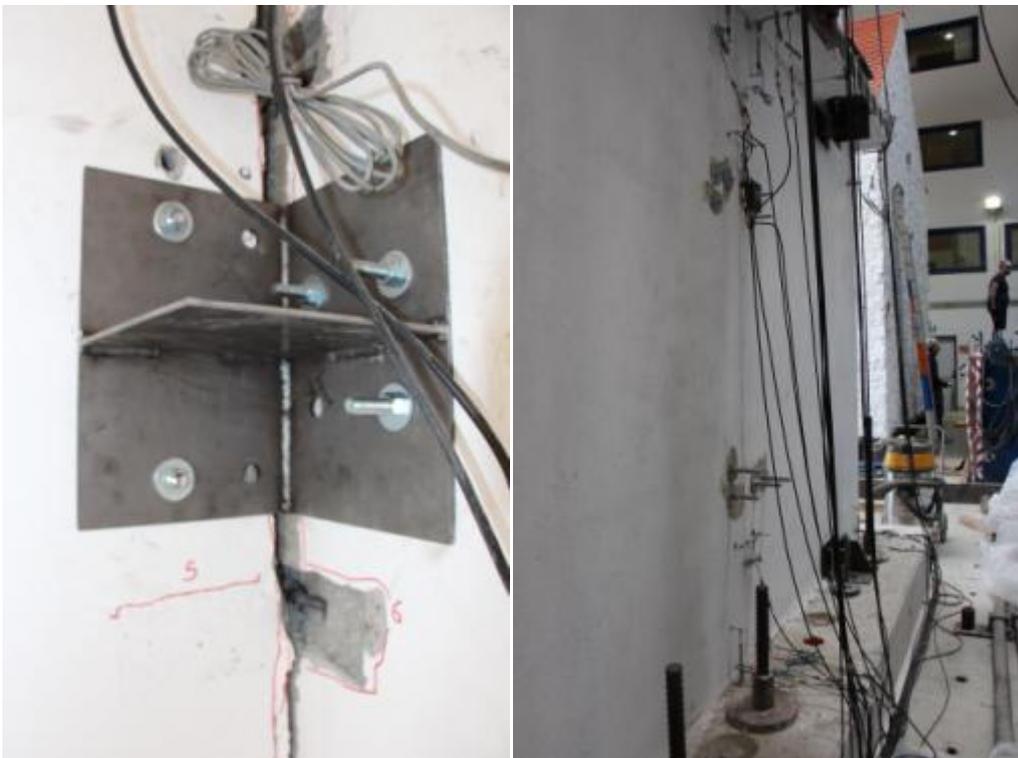
Figure 217. EUC-BUILD4 “retrofitted” specimen – Number of bolts per angle and opposite wall face.

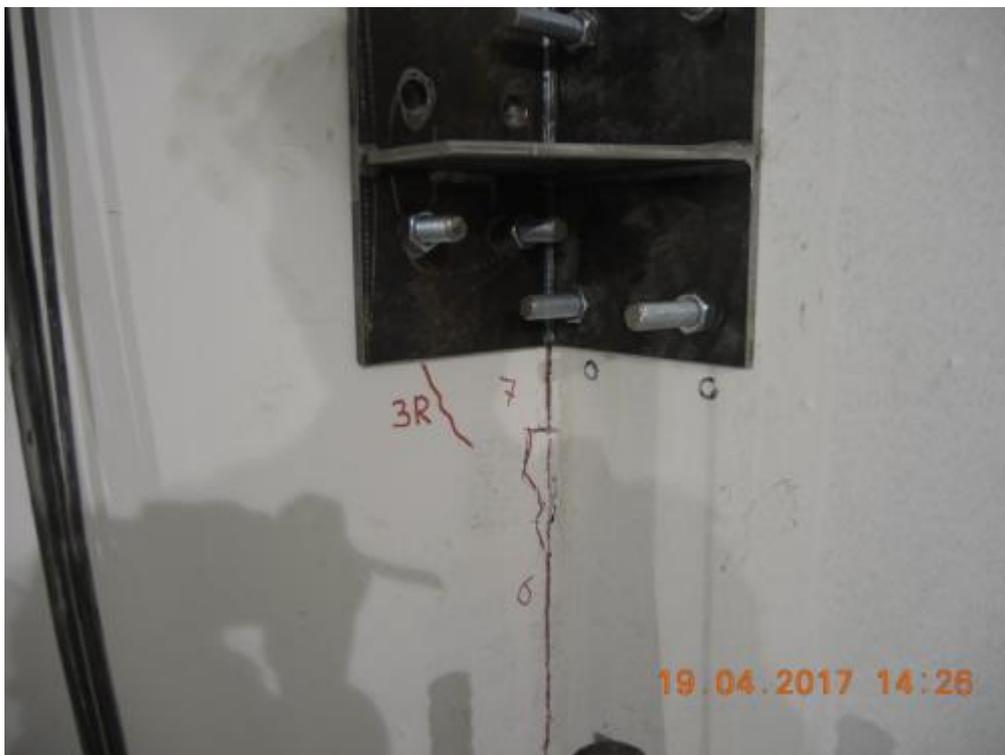
A detailed photographic sequence showing the primary observations collected after the first displacement-controlled step of the testing sequence (Test run #3R) is reported from Figure 261 to Figure 264. Needless to say that cyclic tests for a top displacement of 2.8 mm caused only very limited damage to the retrofitted specimen. A few minor cracks were observed to develop in the transversal walls close to the bolted steel angle clips. In more details, Figure 261 and Figure 262 present a view of the cracks above and below the bottom steel flanged angle connecting the ground-floor stability and lateral walls. The North face is shown therein, whereas the crack pattern of the external/South face can be observed in Figure 263 and Figure 264.

Figure 261. Development of new cracks in the transversal walls (internal face) – Below the steel angle.

The latter very minor cracks developed close to the washers and bolts that were used to tie the steel angles to the walls. Even though they are very short and narrow in width, these cracks might still be indicative of the fact that, as normally foreseen by proper retrofitting design (prevented in this case by the presence of existing rebars internal to the walls), four bolts per plate (instead of only two per each) would be a preferred solution.

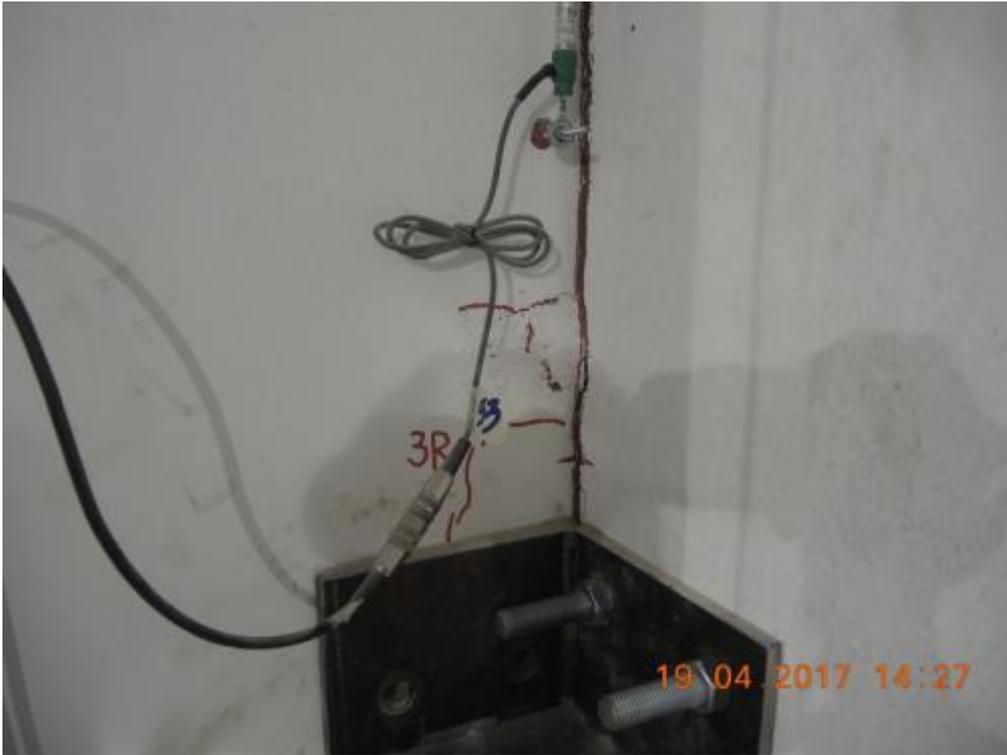
Figure 262. Development of new cracks in the transversal walls (internal face) – Above the steel angle.

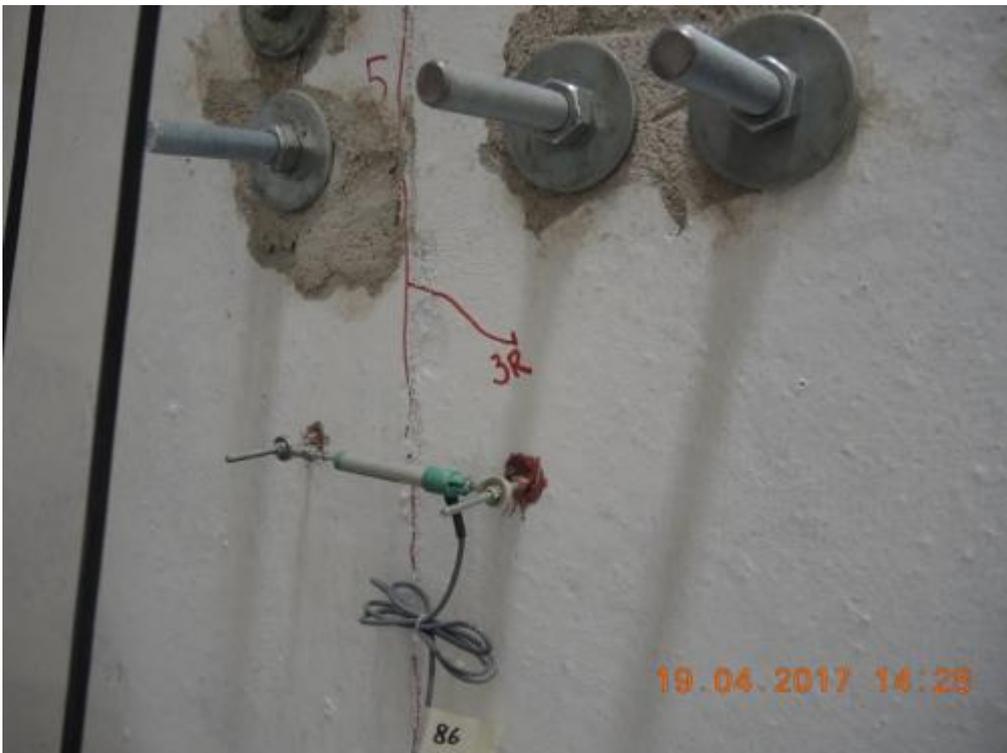
Figure 263. Crack pattern of the transversal walls (external/South face) – Below the high-strength rods.

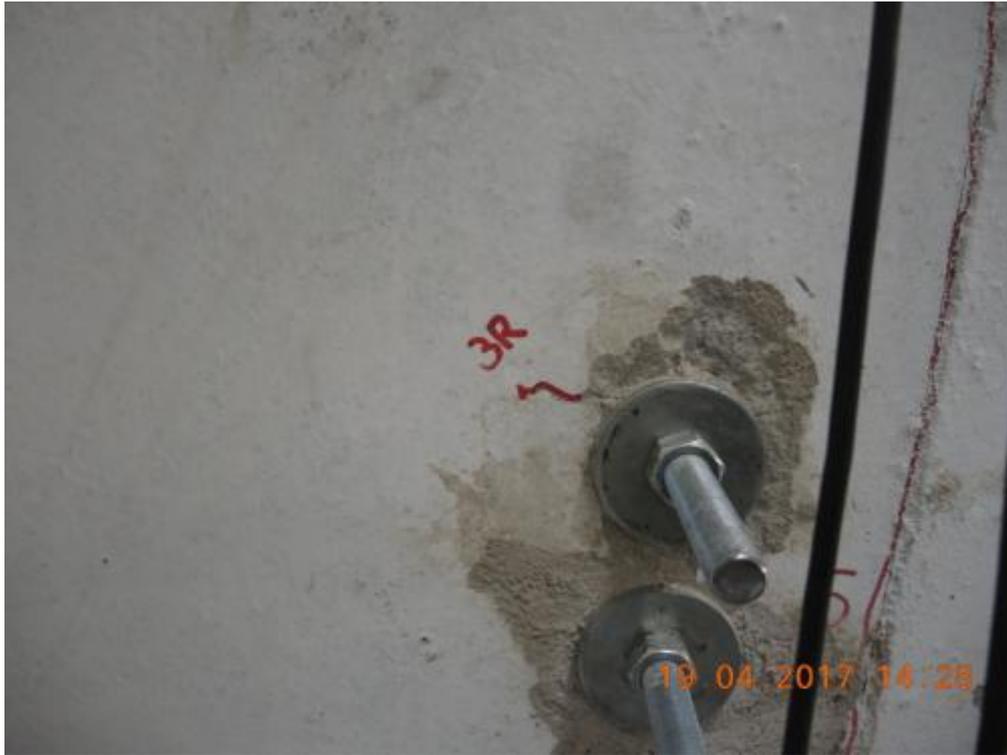
**Figure 264. Crack pattern of the transversal walls (external/South face) – Opposite wall panel.**

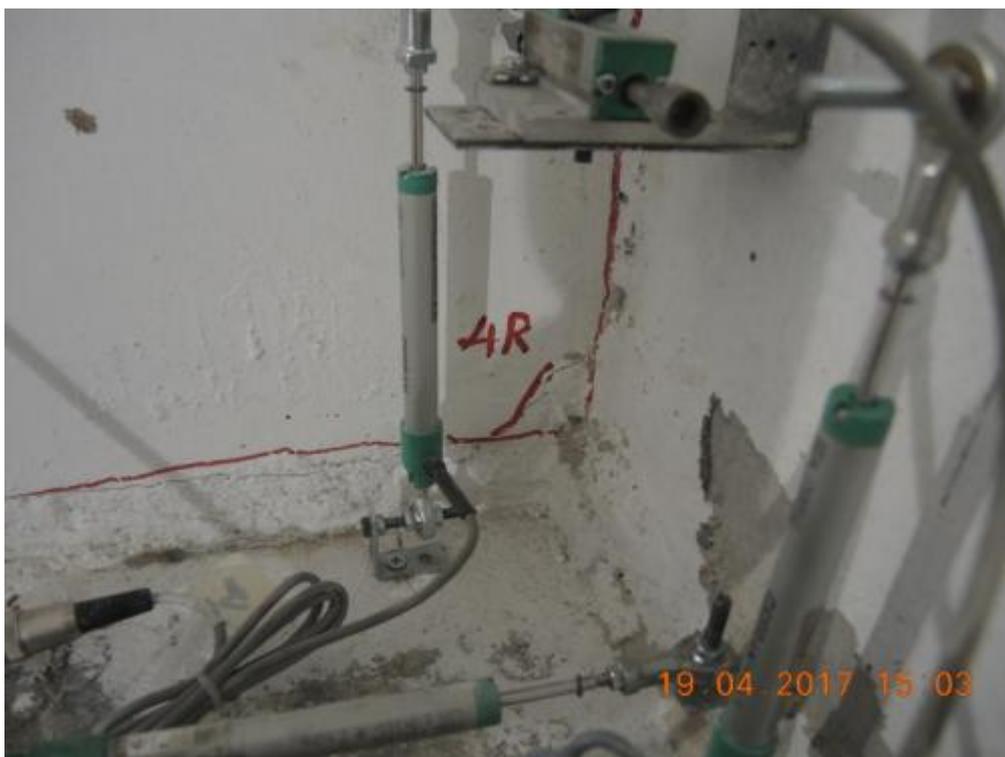
At this step of testing, only a new crack opened up at the base of the South ground-floor lateral wall and those already present in the specimen did not develop any further. Figure 265 shows this minor crack, which took place in the West corner of the South-East-sided transversal wall. Needless to say that it had moderate length and width.

Figure 265. Formation of new minor cracks at the base of the transversal walls – South side.

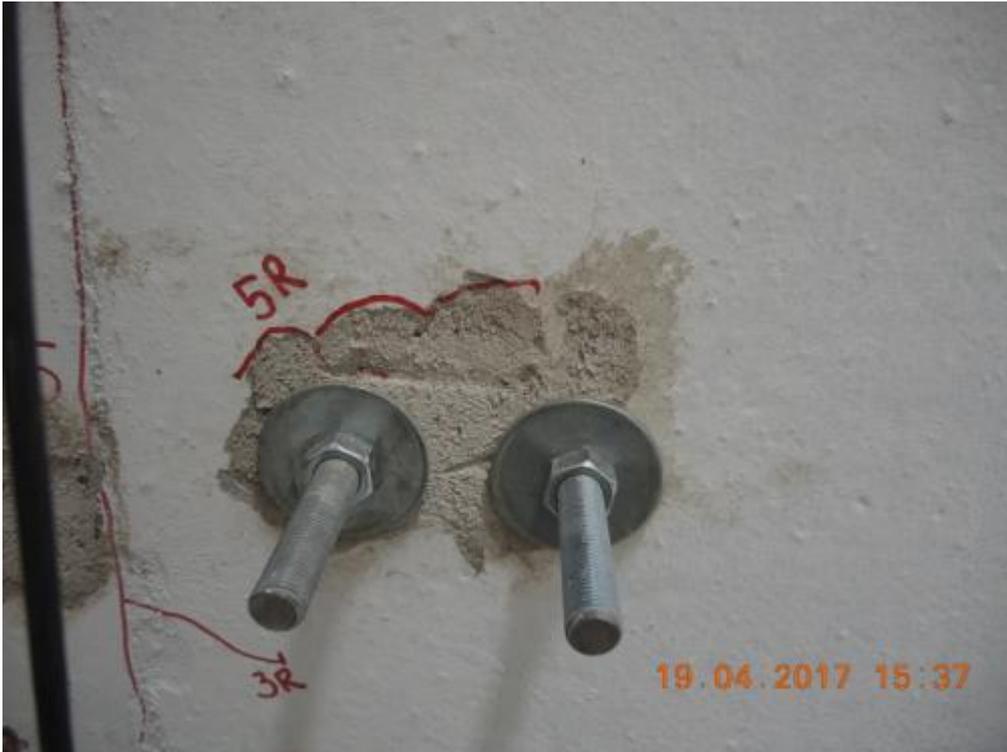
In particular, Figure 266 depicts a crack running around the grout injected in correspondence to the bottom steel angle used to tie the ground-floor stability wall to the South-East transversal one. Even though this crack is slightly more pronounced than those developed during Test run #3R, its width is, in any case, very moderate. However, cracks like that shown in Figure 266 propagate as a result of the “not-fully-effective” retrofitting intervention implemented in this case. If this is the likeliest reason for cracking close to the steel clipping angles, they can be obviously and easily avoided in the case that a proper retrofitting strategy/scheme would have been designed as a structural upgrading measure for an intact/undamaged structure. It can be concluded that the grout was still resistant enough to permit the imposed forces to be carried past it.

Figure 266. Development of crack pattern in correspondence to the implemented retrofitting intervention.

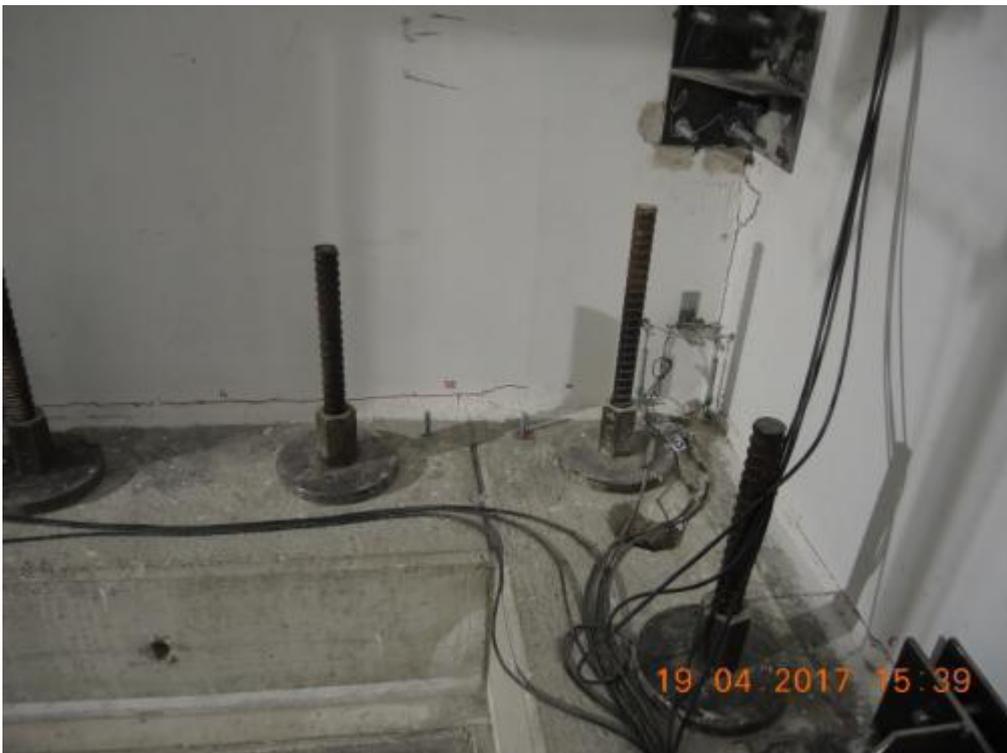
Finally, Figure 267 shows the crack pattern at the base of the ground-floor stability wall. Horizontal cracks due to the in-plane rocking of this precast wall-element propagated along its entire depth. It is worthwhile to mention that cracks developed only on the West face of the stability wall.

Figure 267. Propagation of crack pattern at the base of the ground-floor stability wall – West side.

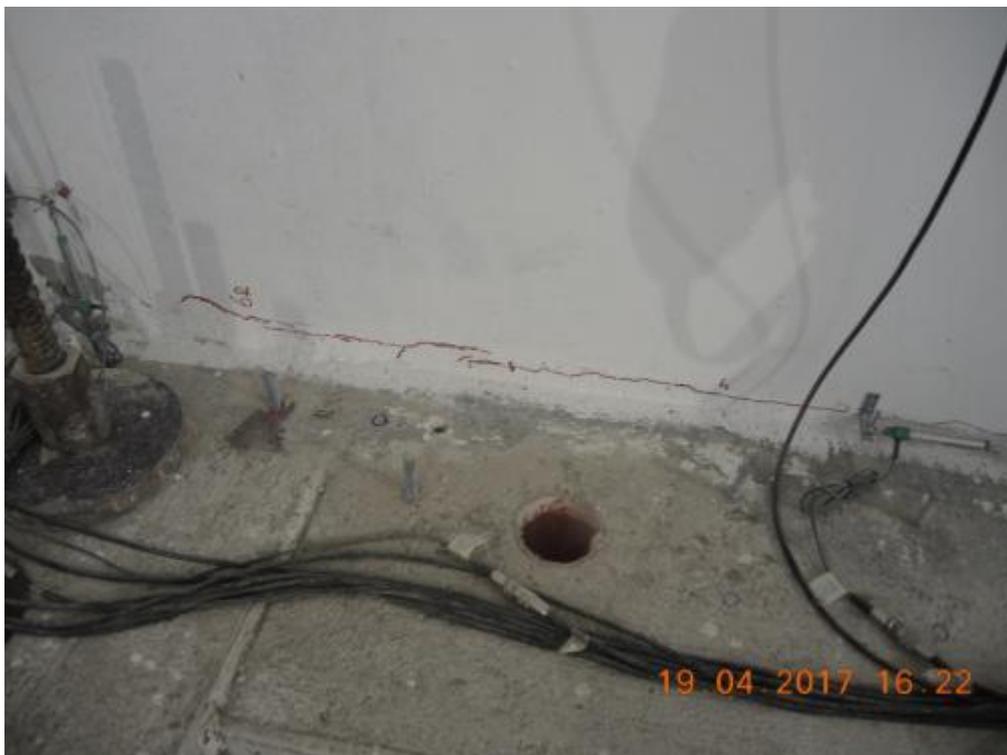
Figure 268 and Figure 272 present clear views of the evolution of crack pattern in the East and West face of the stability, thus confirming that the horizontal cracks at the base of this structural element propagated even further toward the South lateral wall panels. In accordance with the observations in Figure 268 and Figure 272, the base of the wall is almost completely cracked at this stage of testing, given that damage took place on both sides of the wall along its entire depth. Furthermore, it can be noticed that a new crack opened up in the North/internal face of one of the transversal wall panels, as pointed out by Figure 269. A careful survey of the South/external face of this wall also confirms that cracks previously-formed close to the steel angles evolved even further, as evidenced in Figure 270 and Figure 271. Also noteworthy is that the application of top displacements equal to 11.2 mm caused cracking of the injection grout in correspondence to both the top and bottom steel angles.

**Figure 268. Propagation of crack pattern at the base of the ground-floor stability wall – East side.**

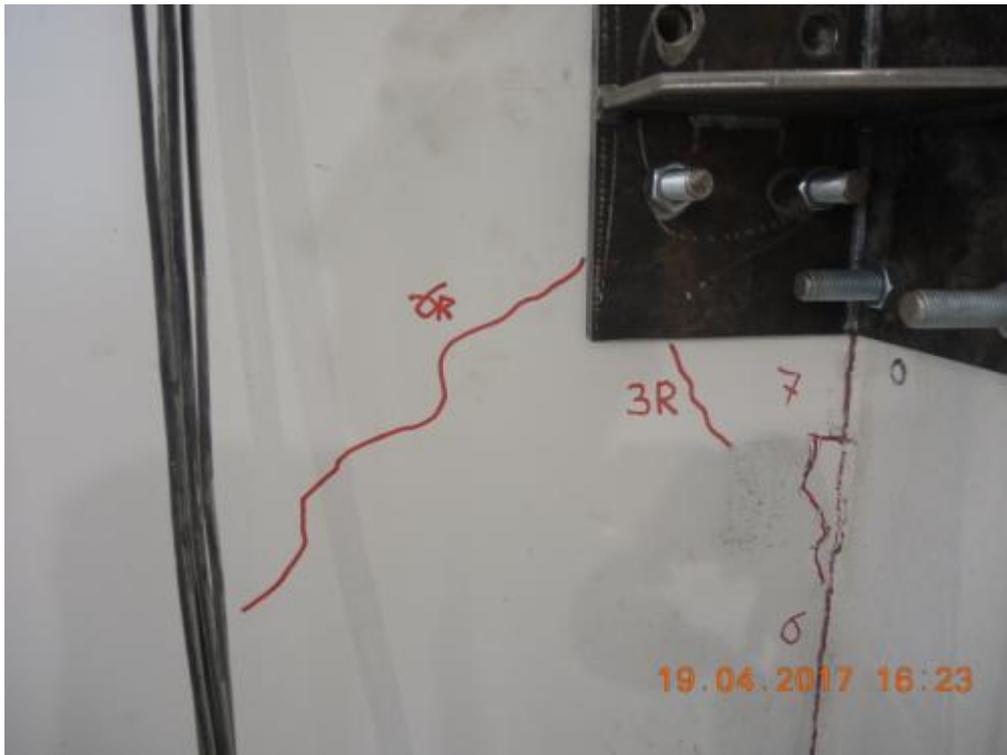
Figure 269. New crack in one of the transversal walls (internal face) – Below the steel angle.

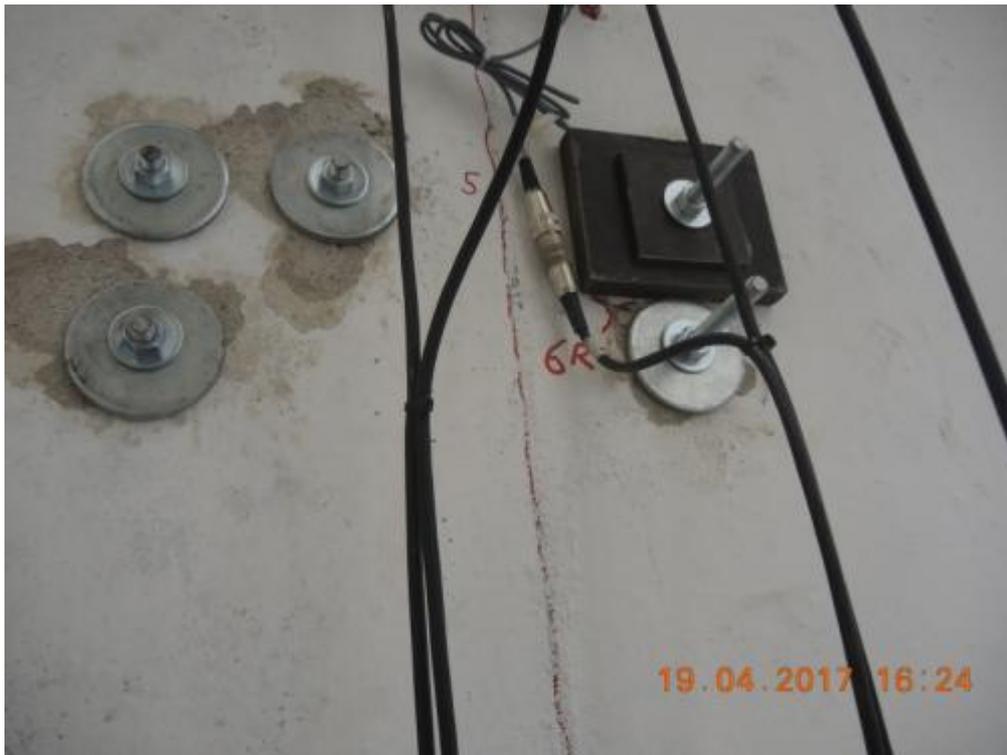
Figure 271. Evolution of crack pattern in correspondence to the implemented retrofitting intervention – Top.
