# **Experimental campaign on Reinforced Concrete buildings typical of the Groningen region**

**Cyclic testing of a full-scale two-storey Reinforced  
Concrete precast wall-slab-wall structure  
representative of the Groningen building stock  
(EUC-BUILD4).**

**Eucentre**

Date June 2017

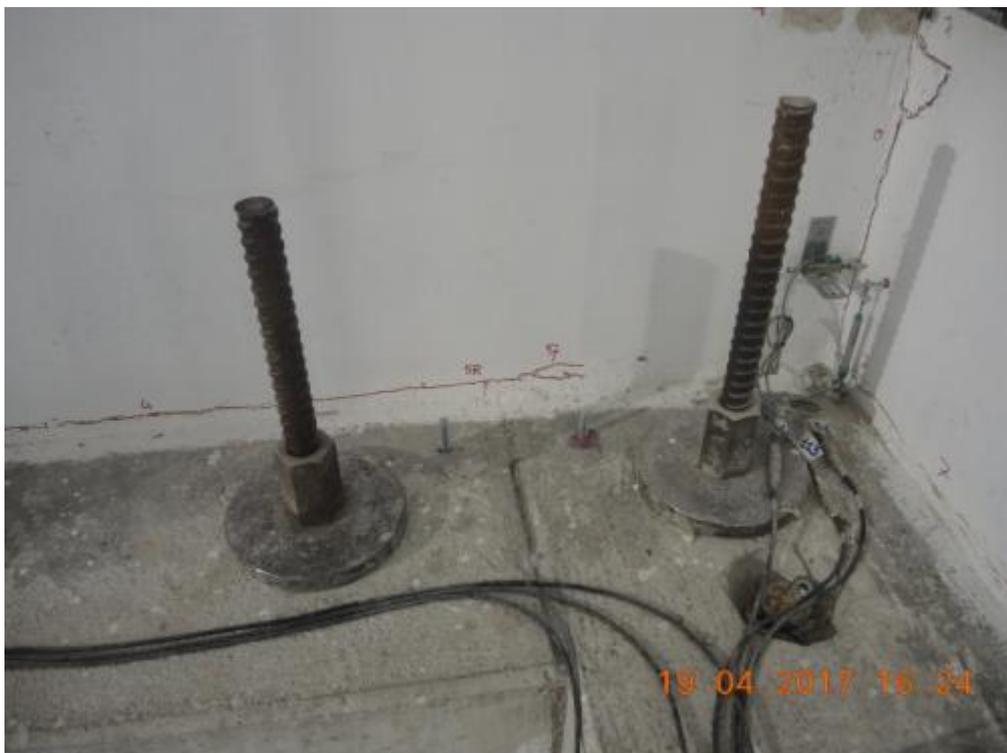
Figure 268 and Figure 272 present clear views of the evolution of crack pattern in the East and West face of the stability, thus confirming that the horizontal cracks at the base of this structural element propagated even further toward the South lateral wall panels. In accordance with the observations in Figure 268 and Figure 272, the base of the wall is almost completely cracked at this stage of testing, given that damage took place on both sides of the wall along its entire depth. Furthermore, it can be noticed that a new crack opened up in the North/internal face of one of the transversal wall panels, as pointed out by Figure 269. A careful survey of the South/external face of this wall also confirms that cracks previously-formed close to the steel angles evolved even further, as evidenced in Figure 270 and Figure 271. Also noteworthy is that the application of top displacements equal to 11.2 mm caused cracking of the injection grout in correspondence to both the top and bottom steel angles.

Figure 272. Crack pattern at the base of the ground-floor stability wall – West side.

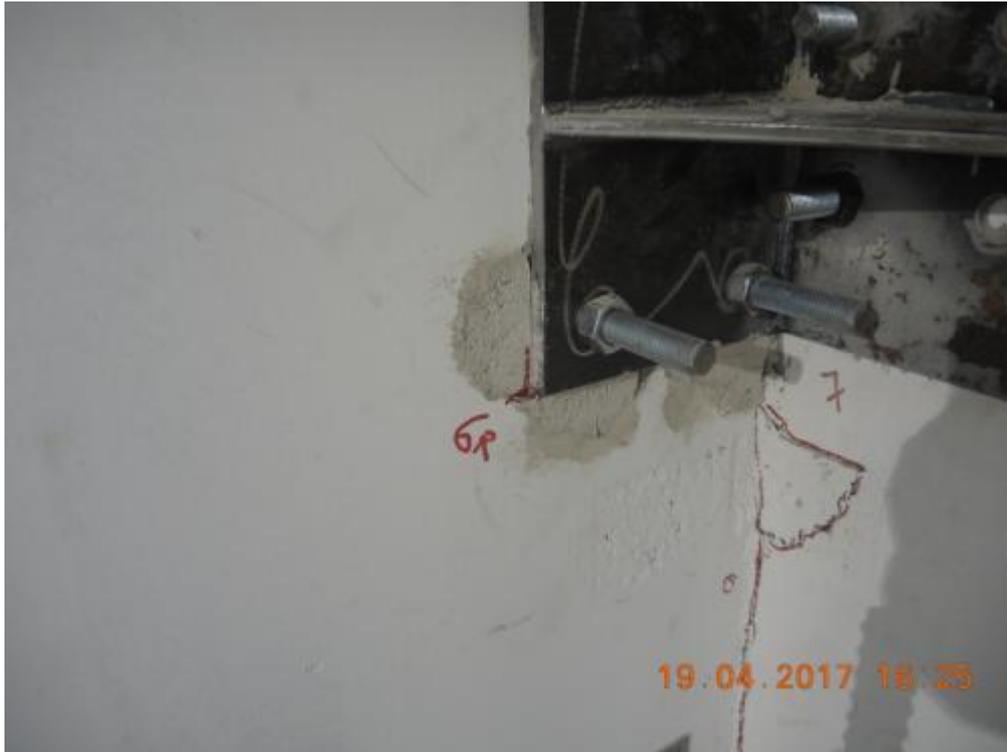
**Figure 273. Crack pattern in correspondence to the bottom steel angle – Opposite/West side.**

Finally, Figure 273 shows an incipient crack in correspondence to the bottom steel angle installed on the West face of the first-storey stability wall. Though this latter crack and abovementioned ones near the top and bottom clipping angles are still moderate in width, it becomes clear that the “retrofitted” specimen has experienced the first evident signs of damage in the walls (except for those previously detected at the base of the ground-floor stability wall).

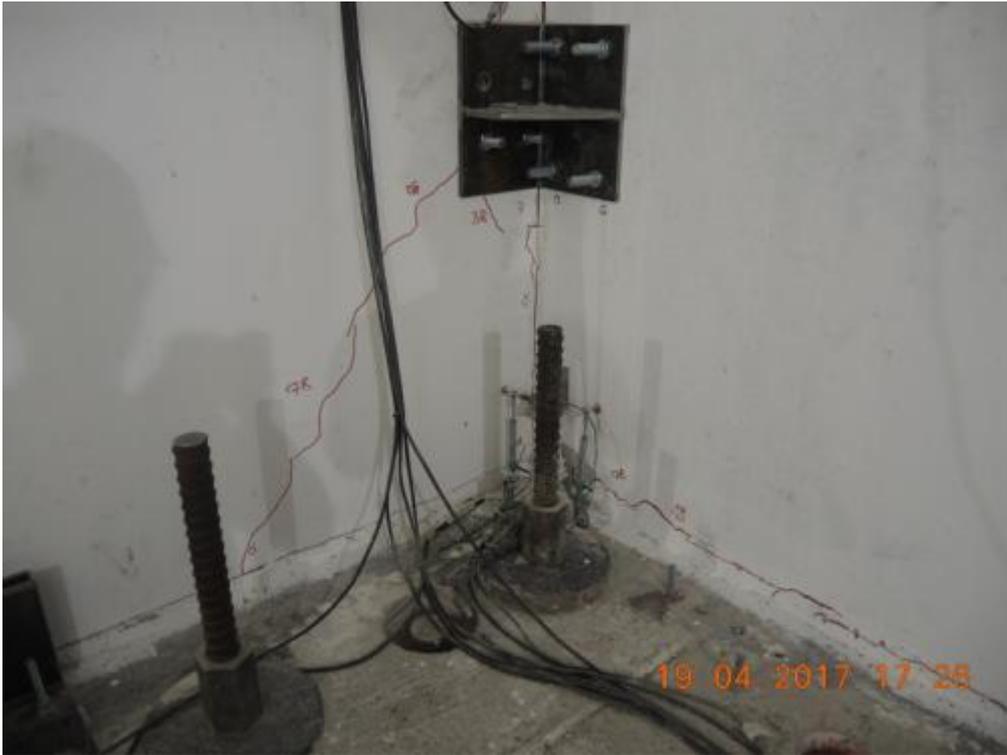
As presented in Figure 274 and Figure 282, the South transversal walls of the first storey underwent further damage in correspondence to the steel angles. In particular, inclined cracks running from the bottom bolted clip angle to the base of the wall were found to develop in the North/internal face and also the opposite face revealed the propagation of a new crack near the installed clip angle. Finally, Figure 283 to Figure 285 present details of the damage pattern along the base of the other panel that compose the South transversal wall.

Figure 274. Propagation of inclined cracks running from the bottom steel angle to the lateral wall base.

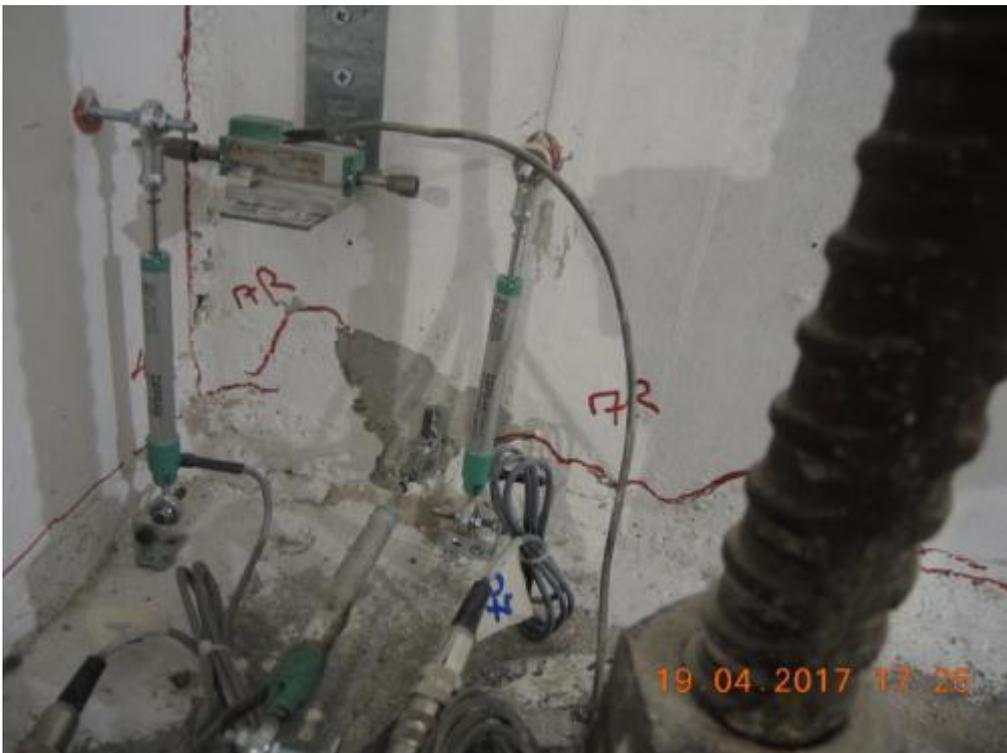
Figure 275. Damage/crack pattern at the base of the ground-floor stability wall – South side.

Nonetheless, it is noteworthy that, as expected, the ground-floor stability wall was clearly the most damaged element of the structure, at this stage of testing, as reported in Figure 275 to Figure 277

and also in Figure 280 and Figure 281; detailed views of the damage/crack pattern at the base of this element are collected there. Concrete spalling was pronounced, especially close to the corners of the panel wall, which were found to be completely cracked. Obviously, horizontal cracks were observed along the base on both sides of the first-storey stability wall. Figure 278 and Figure 279 also show a further secondary damage mechanism, which is minor concrete chipping at the top of the first-storey stability and transversal walls.

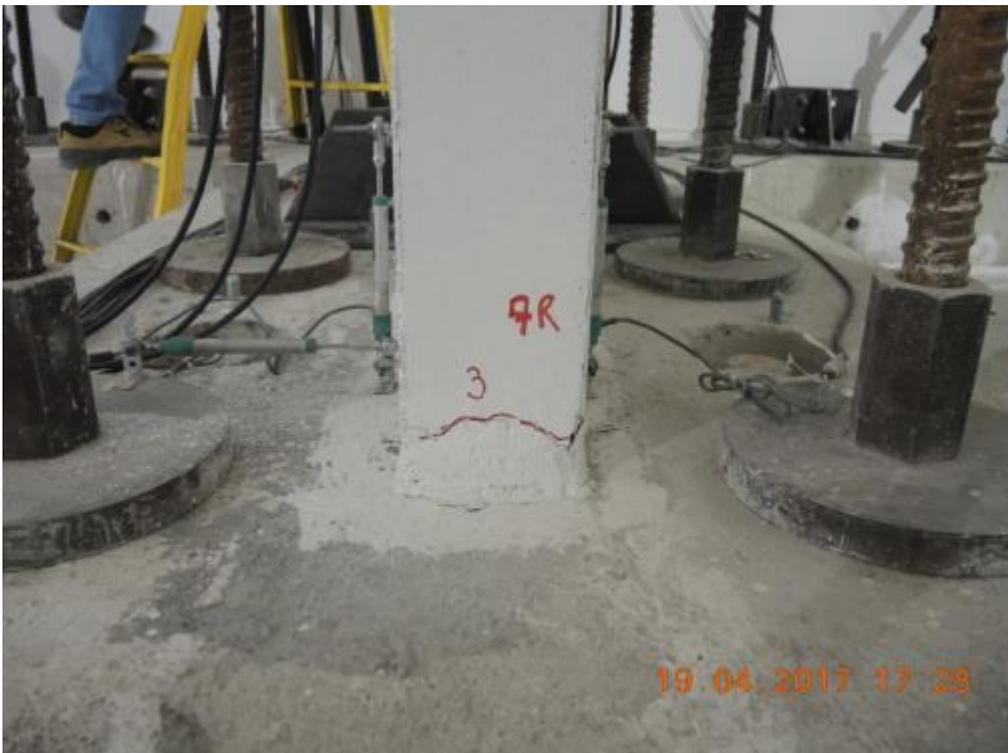
Figure 277. Damage/crack pattern at the base of the ground-floor stability wall – North side, North face.

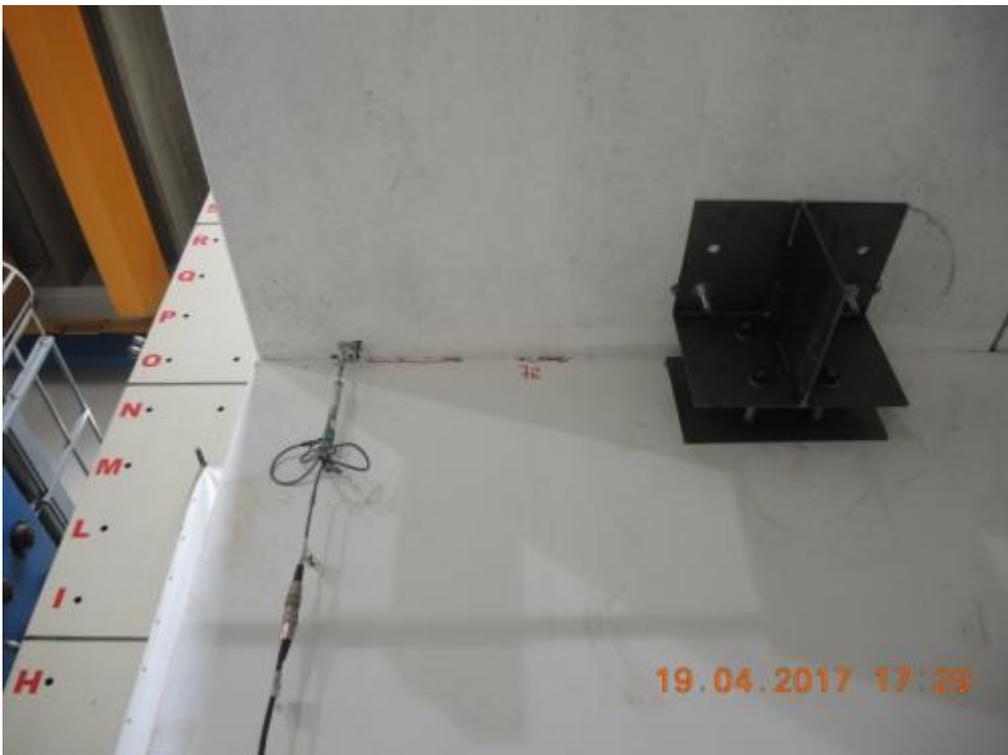
Figure 279. Minor friction-induced concrete chipping at the top of the first-storey transversal wall.

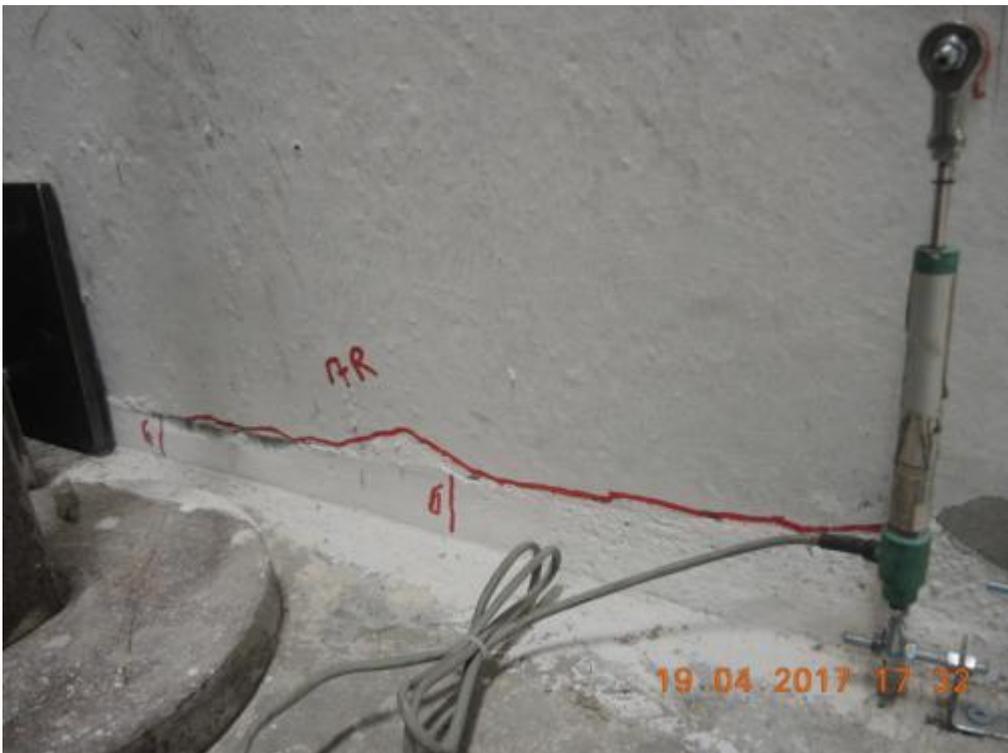
Figure 283. Crack pattern at the base of one of the transversal wall – South side, first floor.

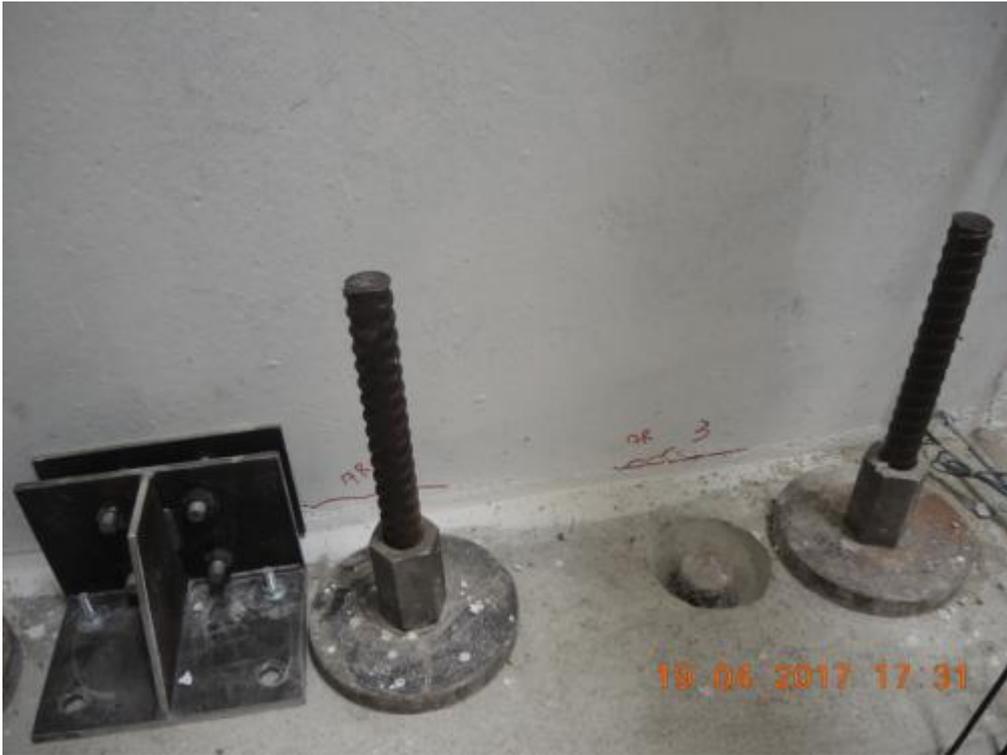
Figure 284. Crack pattern at the base of the other transversal wall – South side, first floor.

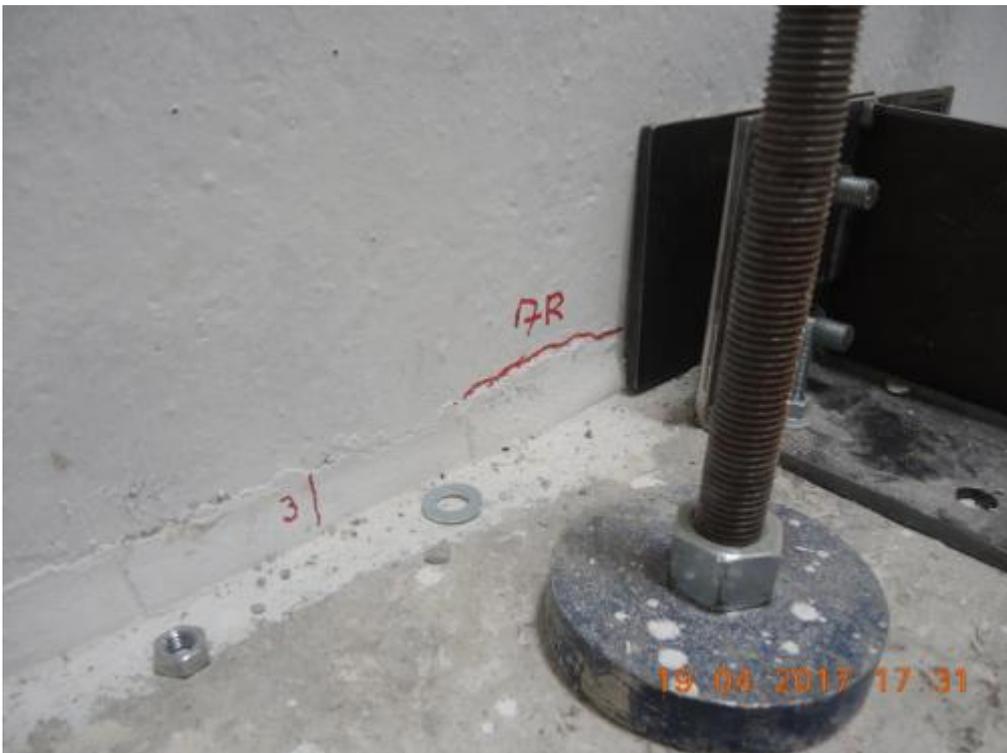
Figure 285. Detail of a minor crack close to one of the sliding restrainers – South side, lateral wall.

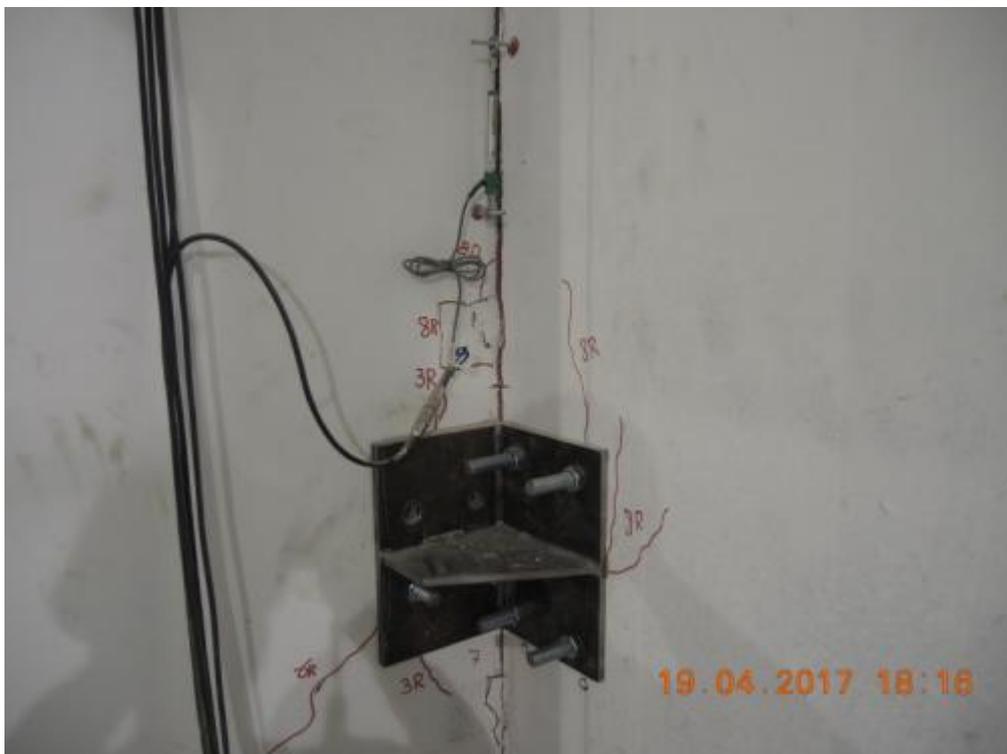
**Figure 286. Crack pattern of transversal and stability walls – Bottom steel angle, East side.**

Figure 286 and Figure 287 point out that further cracks formed in the East face of the stability wall close to the bottom steel angle, thus confirming these elements to be part of the resisting mechanism

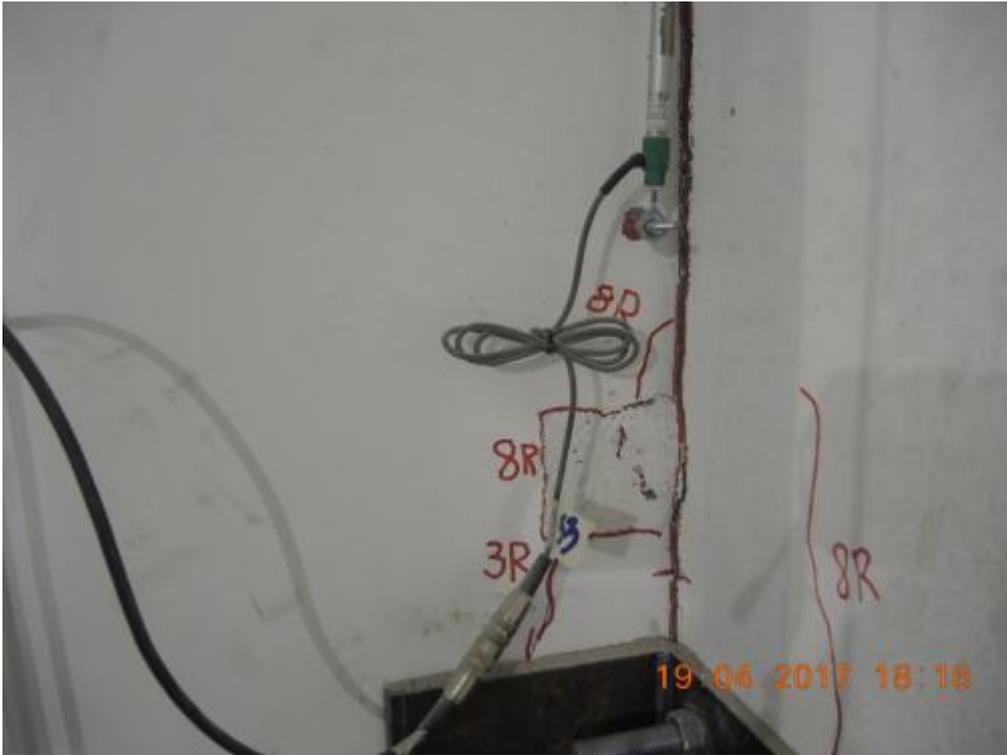
Figure 287. Detail of cracks in the transversal and stability walls – Bottom steel angle, East side.

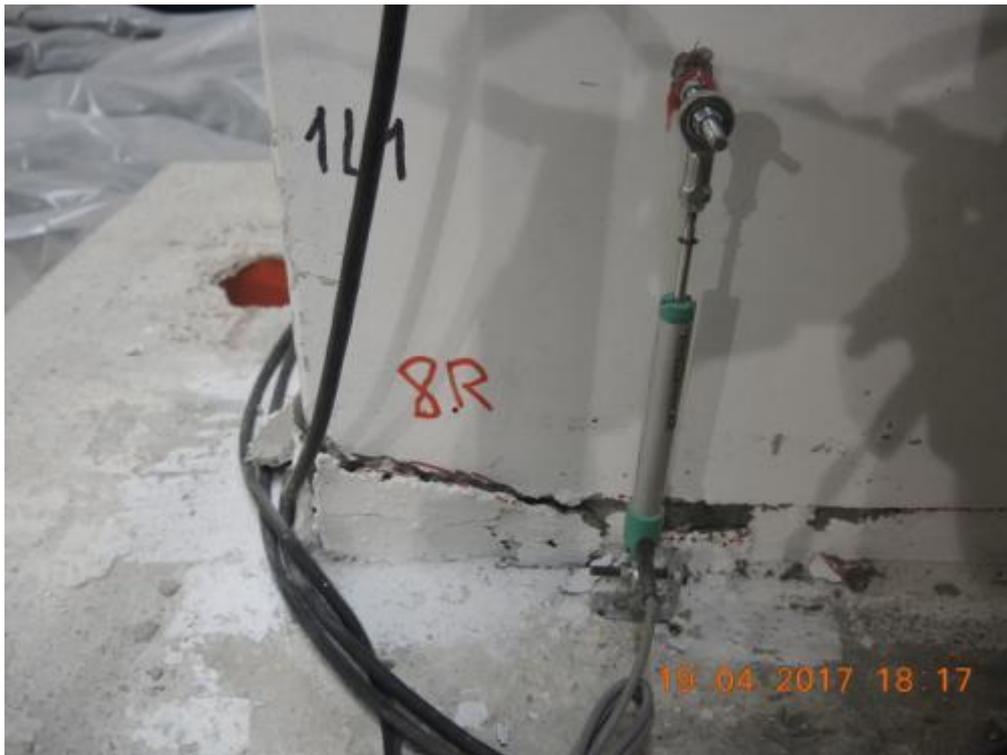
Figure 289. Detail of concrete crushing at the base of lateral wall W1L1 – East side.

of the structure, despite the fact that their design was not optimised. The crack pattern at the base of the transversal walls was found to propagate, as presented in Figure 289 to Figure 291. In particular, Figure 289 and Figure 290 show some details of concrete crushing at the base of lateral wall W1L1, which was particularly significant at the corner of the panel. As one may notice by looking at Figure 291, the corresponding/opposite panel underwent extensive damage too. Indeed, damage was found at the base, especially in correspondence to the opposite corner of the panel.

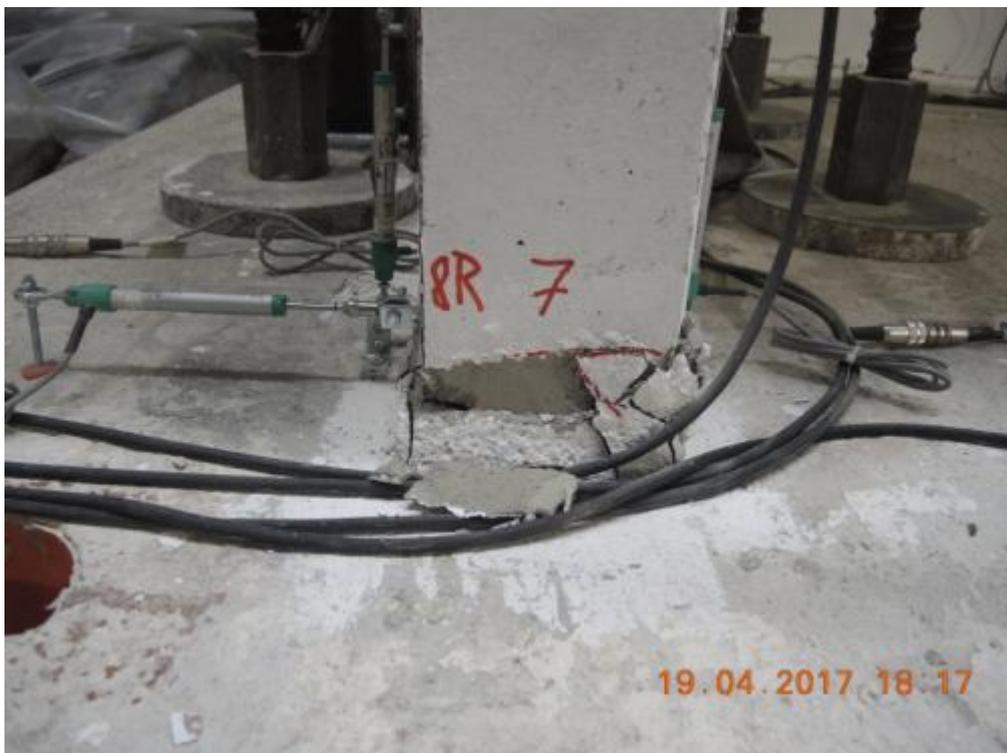
Figure 290. Concrete crushing at the base of lateral wall W1L1 – East side, lateral face.

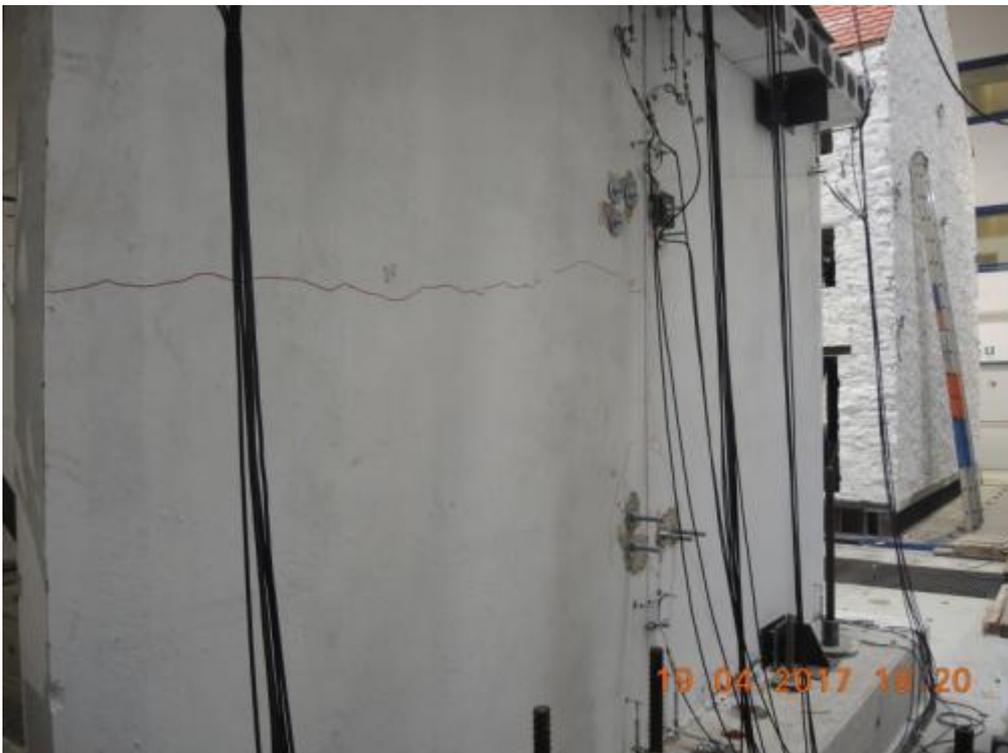
**Figure 294. Full-depth/full-width/mid-height horizontal crack in lateral wall W1L2 – West side, South face.**

Once the full-depth/full-width/mid-height horizontal crack observed in the South-West ground-floor lateral wall has been examined (Figure 292 to Figure 295), attention can be paid to the other cracks that opened up close to the bottom steel angle installed onto the South-East one. Some details of the inclined cracks developed in the South face of the transversal wall W1L1 are reported in Figure 296 to Figure 299. In this latter photo, concrete crushing at the base of this panel was presented as well. It is worth mentioning that, as far as that wall-element is concerned, new cracks were also observed to take place at the top of it, more precisely on the South face of this panel (i.e. wall W1L1). Figure 300 presents a bottom view of those cracks, which are nonetheless minor.

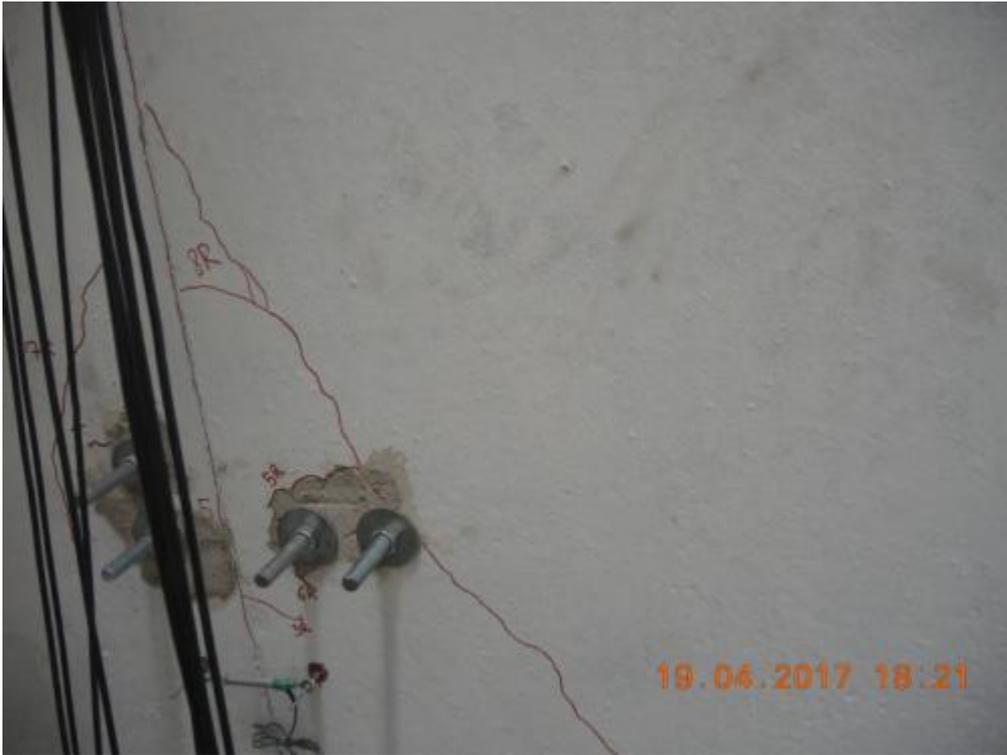
Figure 297. Detail of inclined crack in the transversal wall W1L1 – West side, South face, mid-height.

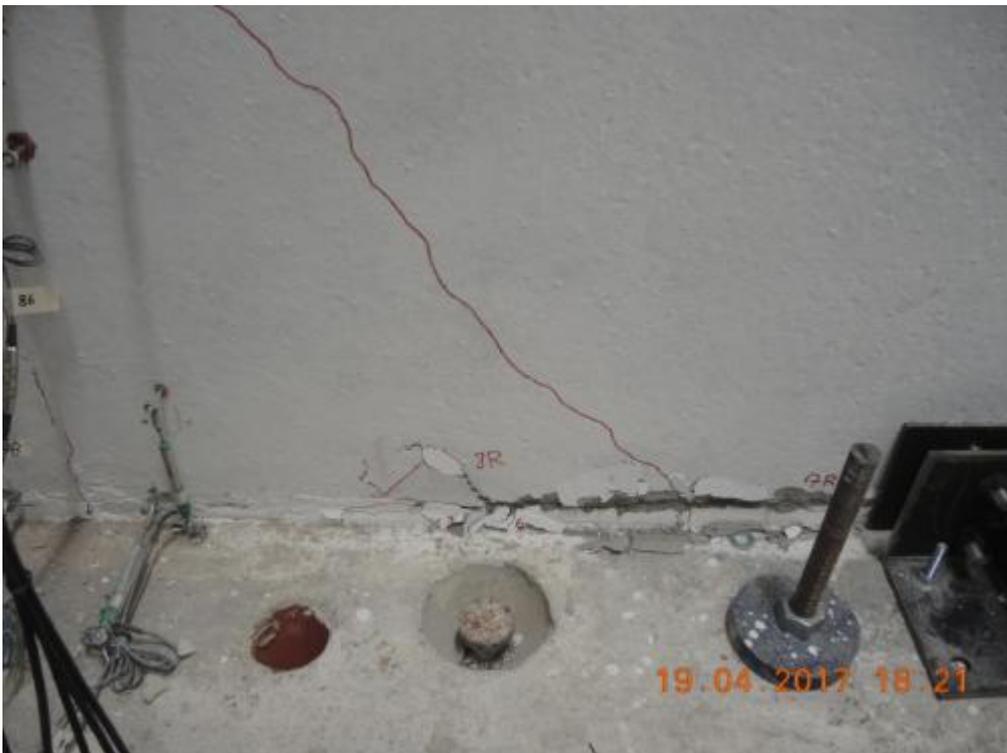
Figure 298. Detail of inclined crack in the transversal wall W1L1 – West side, South face, base.

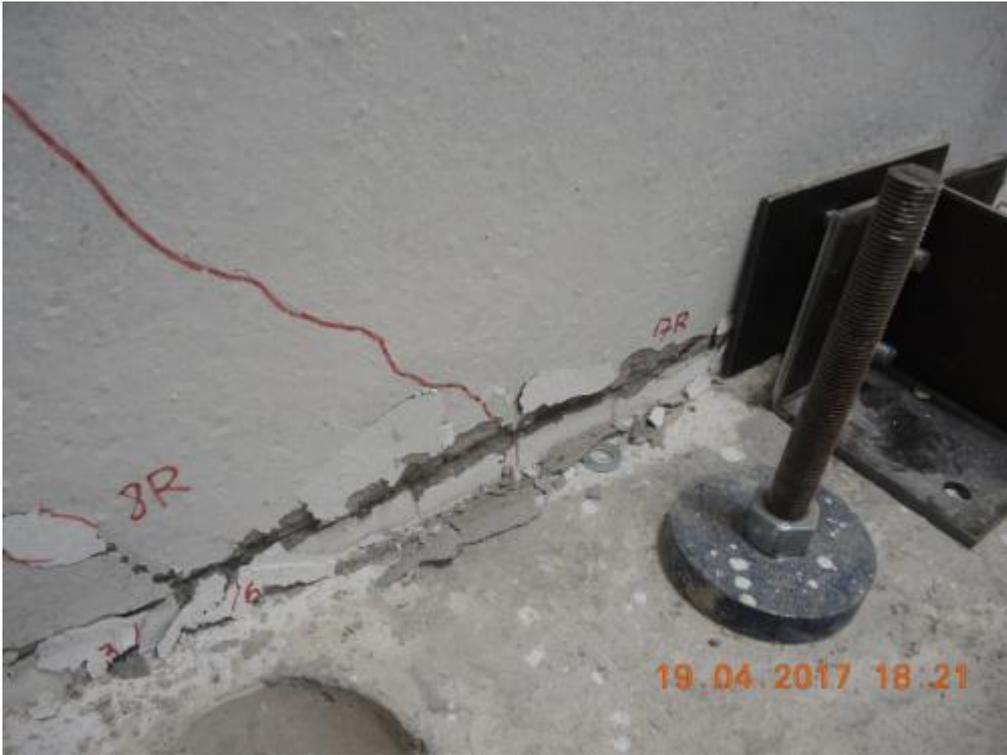
Figure 299. Detail of concrete crushing at the base of transversal wall W1L1 – West side, South face.

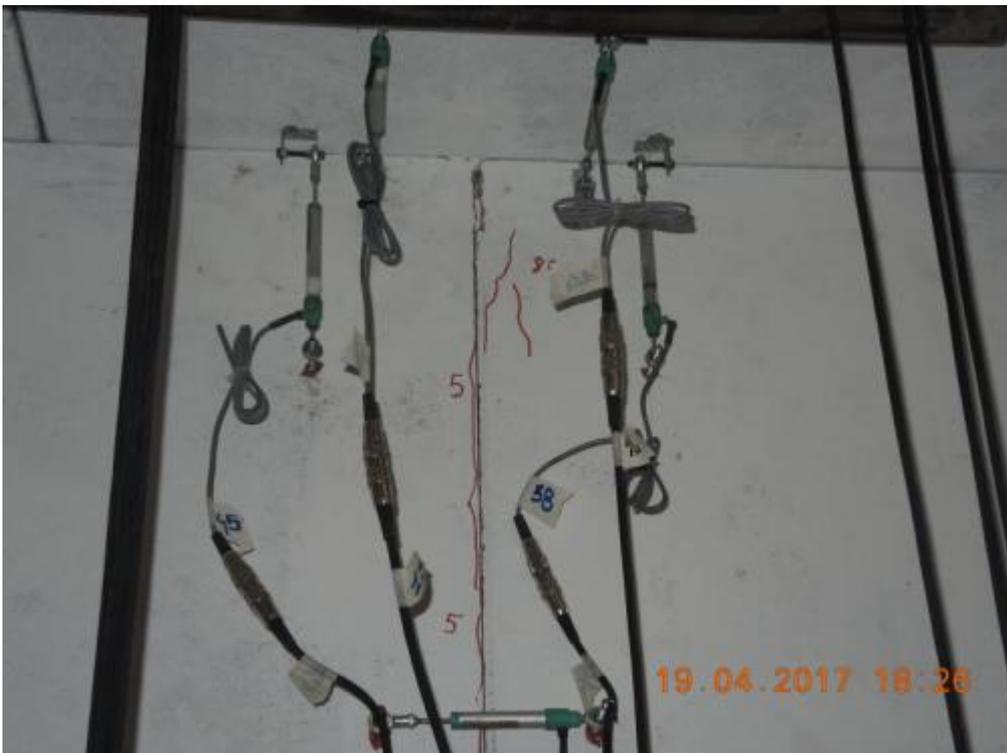
Figure 300. Formation and propagation of new cracks at the top of lateral wall W1L1 – West side, South face.

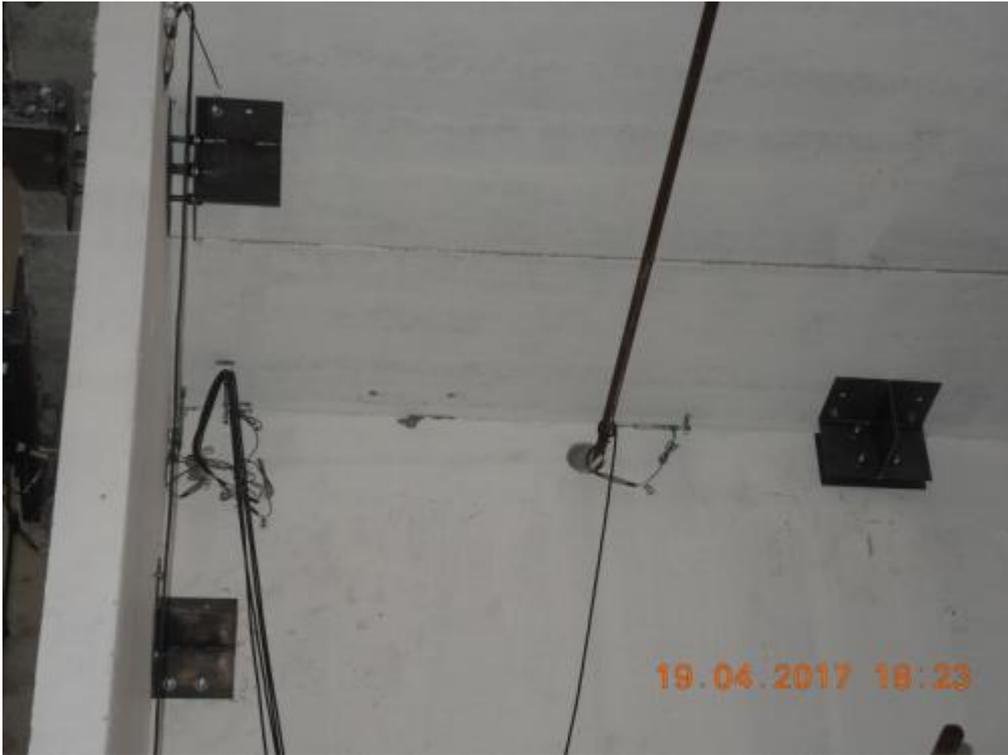
**Figure 301. Detail of post-tensioned bar at the top of the second-storey stability wall – East side.**

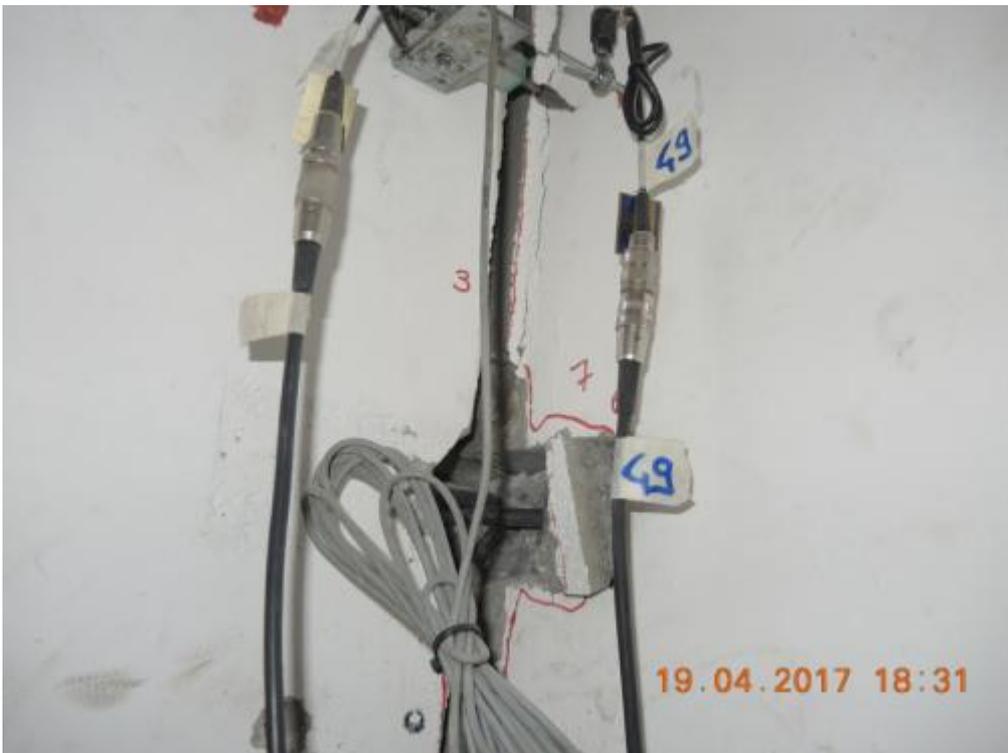
**Figure 302. Detail of a three-way connection after test – West side, first storey.**

Details of the lateral wall W1L1 after the removal of crushed concrete are collected in Figure 308 to Figure 311, whereas enlarged views of three-way connections between the stability and transversal walls were provided in Figure 312. As shown therein and also in Figure 302 to Figure 304, this type of joint exhibited a flexural failure mechanism of the steel anchors embedded in the niches between the two lateral wall panels because of the tensile force exerted by the connectors of the stability wall and hence it is confirmed that no dislodgement was found to take place.

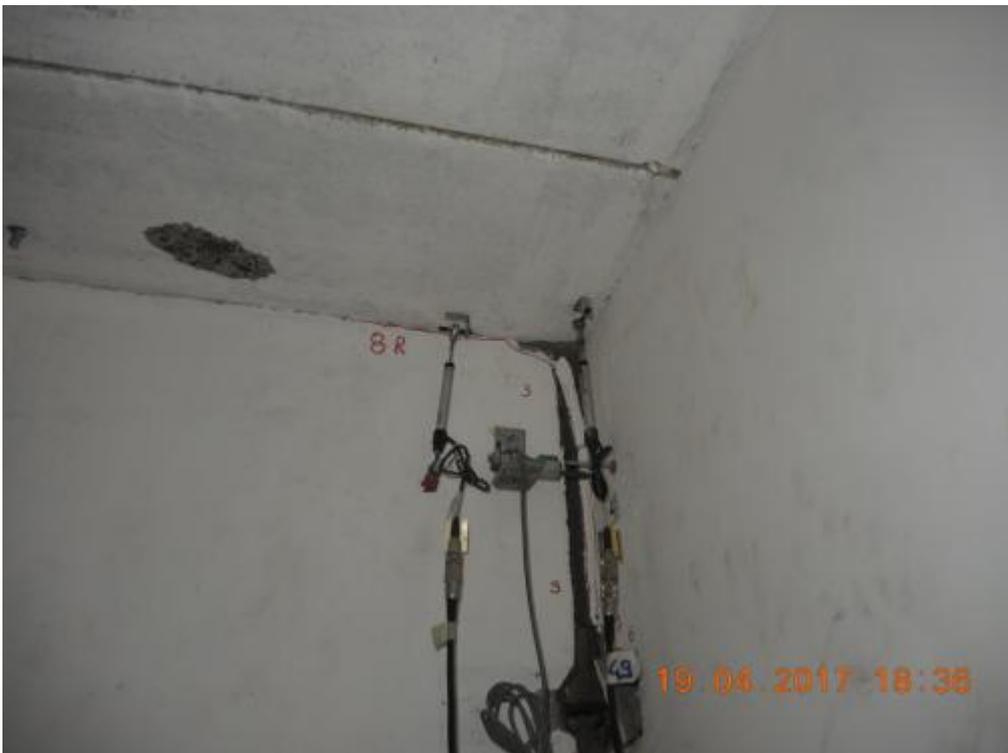
Figure 306. Concrete chipping at the top of the ground-floor stability wall – West side, edge.

Furthermore, Figure 305 to Figure 307 point out another mechanism that was observed at the top of the first-storey stability and transversal walls, which indeed presented chipping of concrete in some zones close to the contact area between them and the bottom of the precast slab panels. As one may see in Figure 315, such a damage mechanism took place in the second-storey walls as well. Despite this type of damage is relatively moderate, it may be indicative of shear force transfer between the horizontal and vertical precast concrete elements of the specimen in its retrofitted scheme.

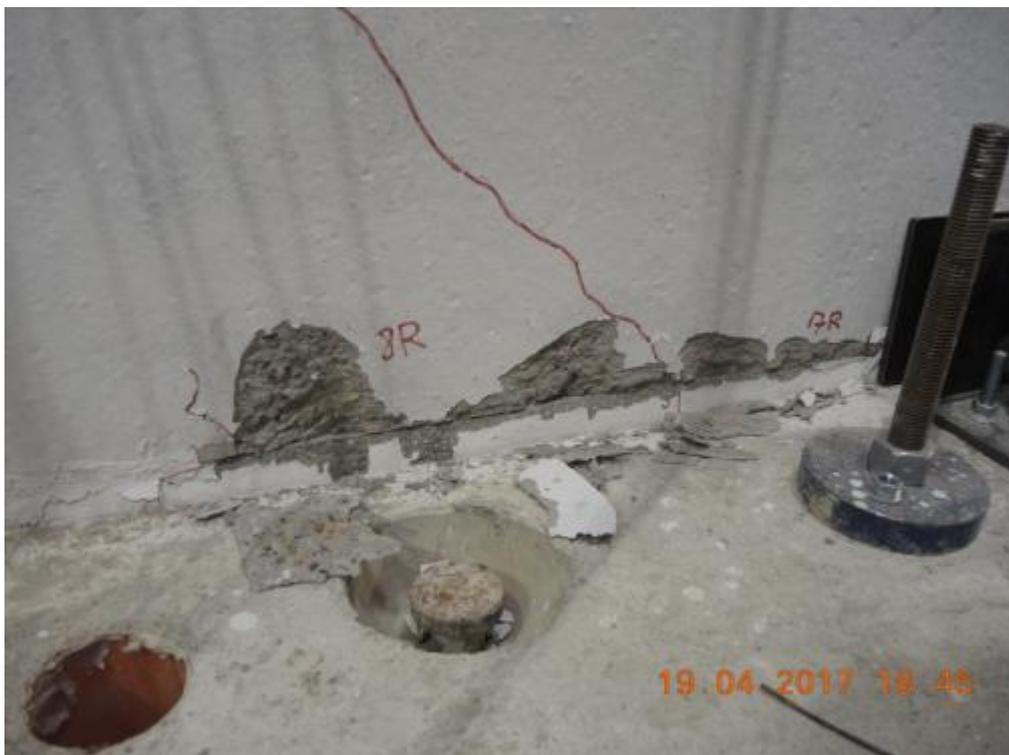
Figure 308. Detail of the base of lateral wall W1L1 after removal of crushed concrete – West side, South face.

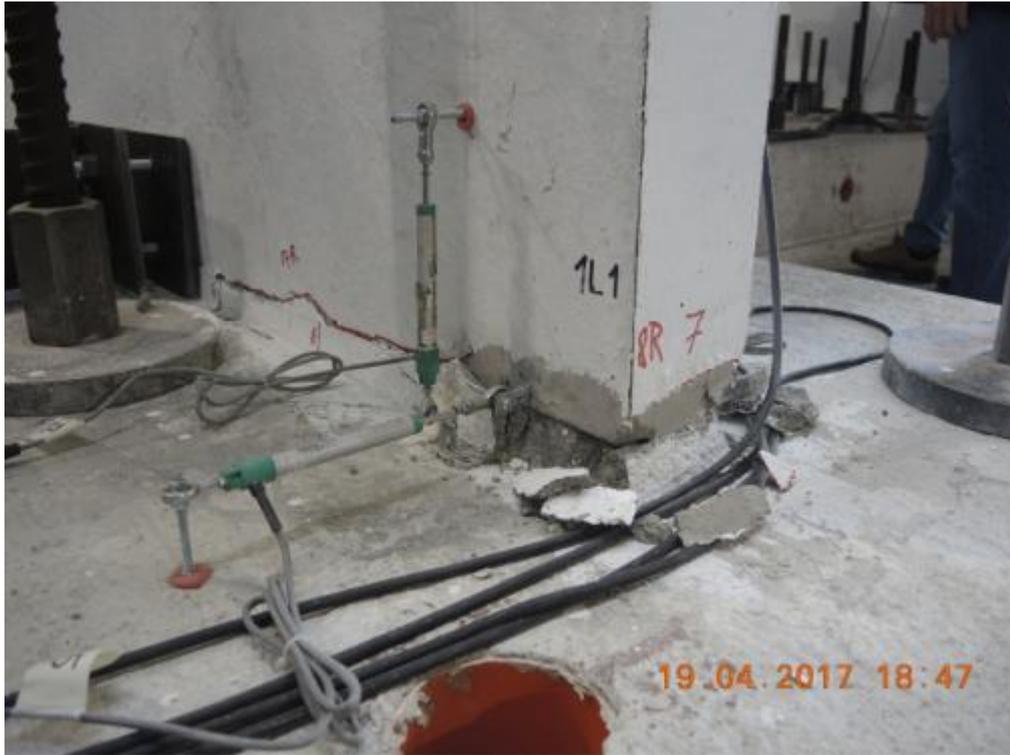
Figure 309. Lateral wall W1L1 after removal of crushed concrete – West side, South face, edge.

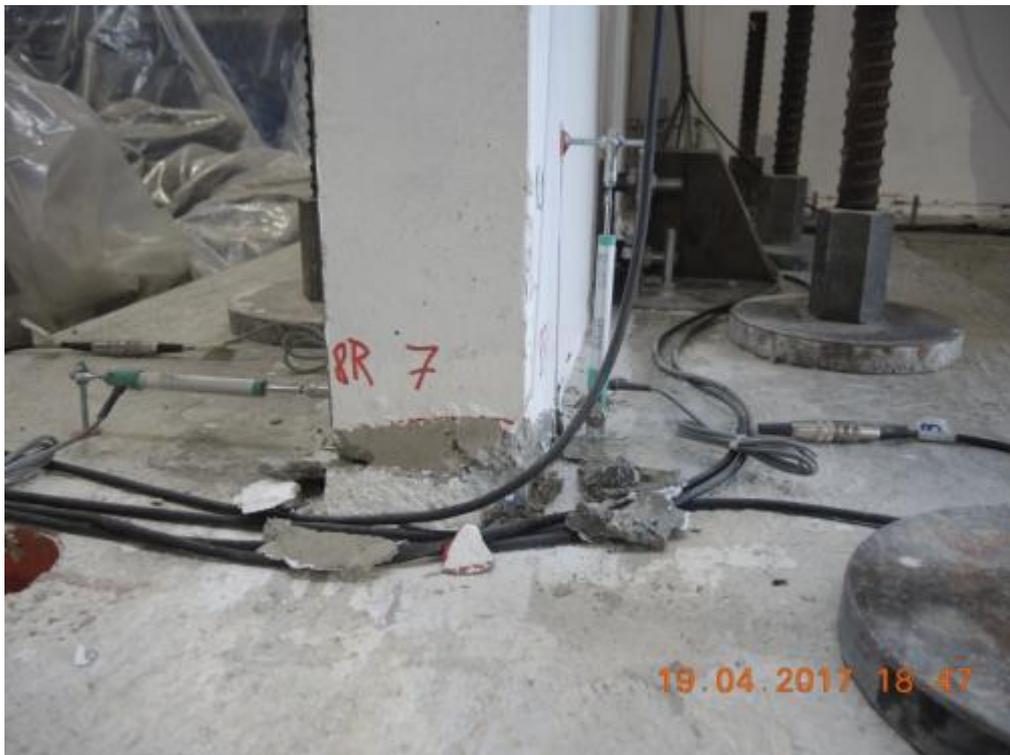
Figure 310. Transversal wall W1L1 after removal of crushed concrete – West side, lateral face, edge.

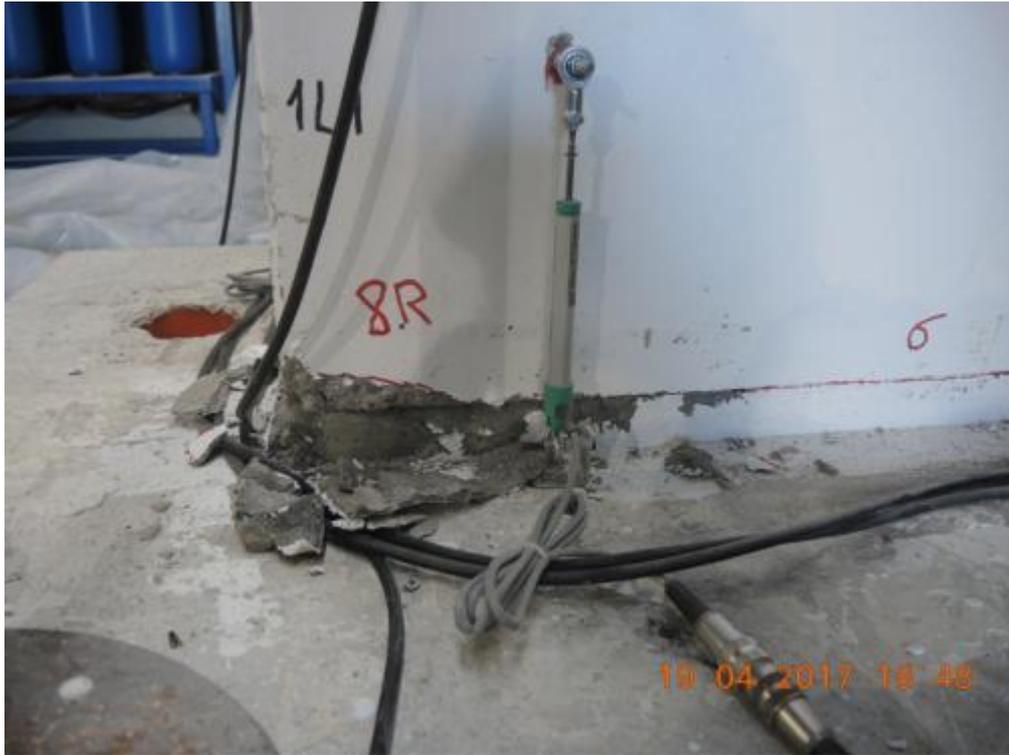
Figure 311. Transversal wall W1L1 after removal of crushed concrete – West side, North face, edge.

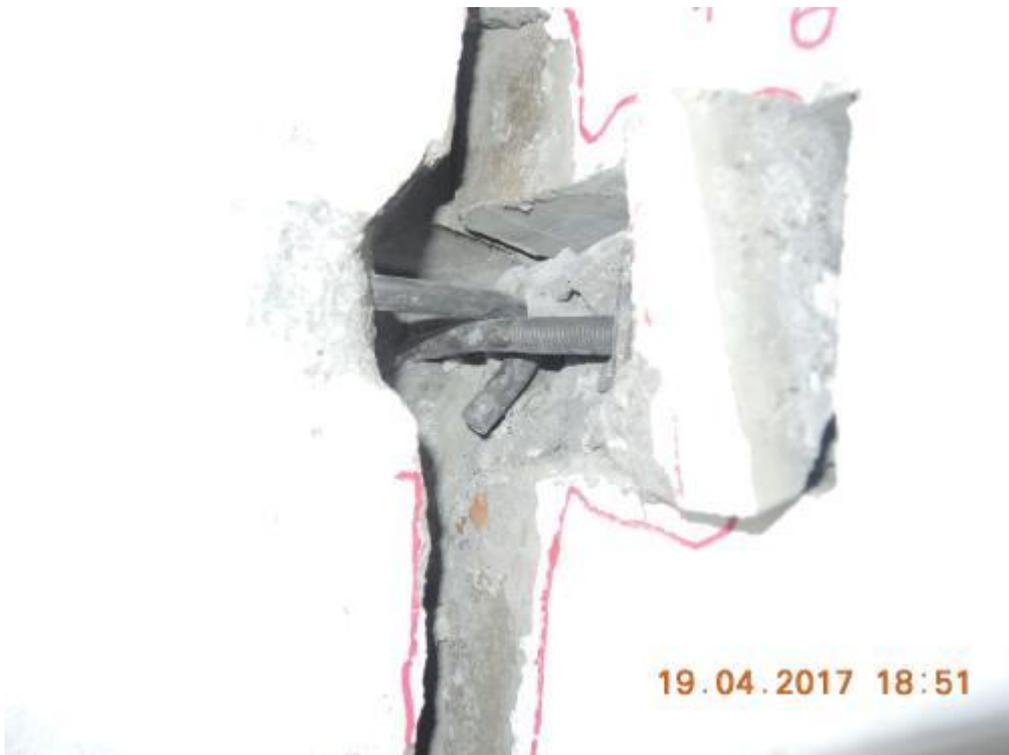
Figure 312. Detail of a three-way joint after removal of crushed grout – West side, North face.

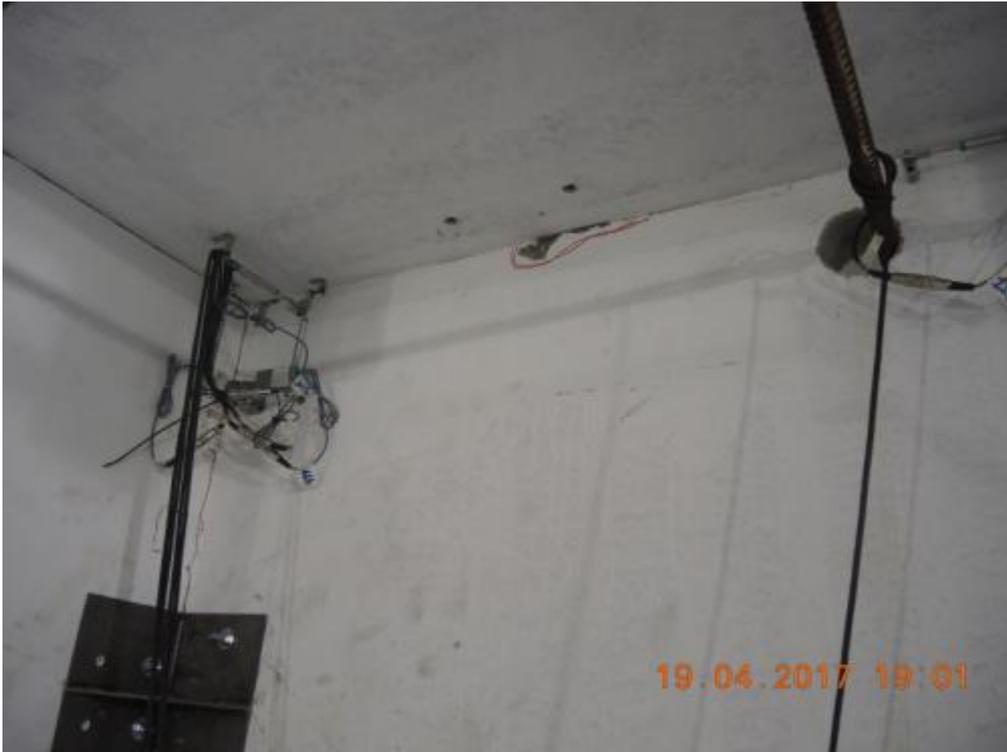
**Figure 315. Chipping of concrete at the top of the second-storey stability wall – East side.**
