# **Experimental campaign on Reinforced Concrete buildings typical of the Groningen region**

**Cyclic testing of a full-scale two-storey Reinforced  
Concrete precast wall-slab-wall structure  
representative of the Groningen building stock  
(EUC-BUILD4).**

**Eucentre**

Date June 2017

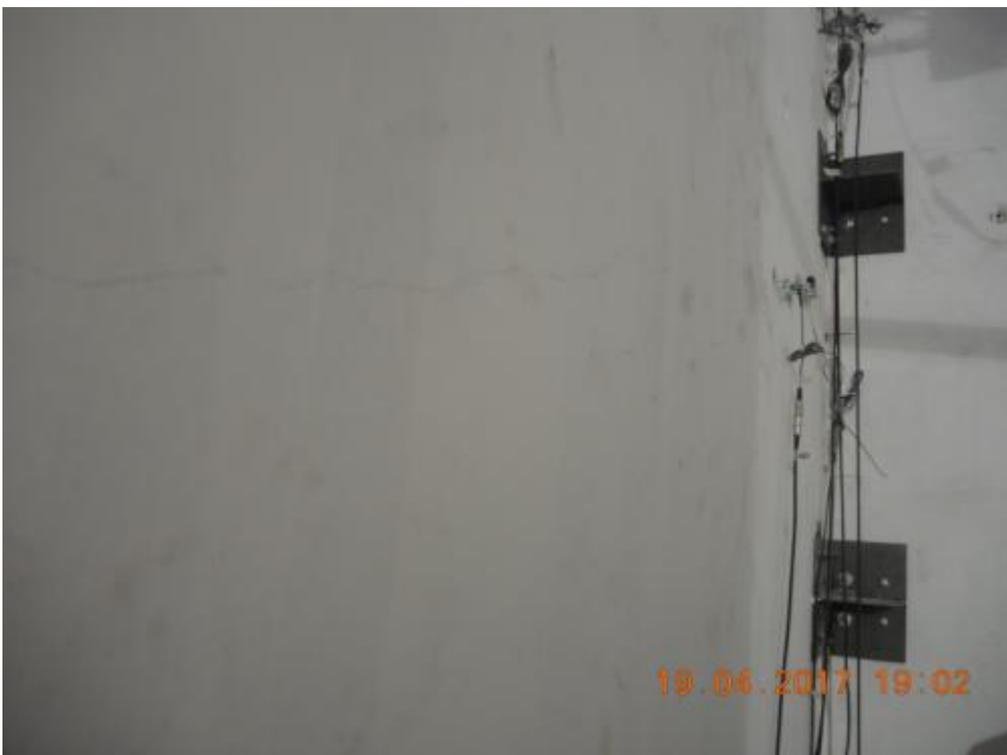
**Figure 316. Detail of pre-existing full-depth/full-width/mid-height crack in the second-storey stability wall.**

To conclude the analysis and discussion of the observed crack patterns, it is noteworthy that the pre-existing full-depth/full-width/mid-height crack in the second-storey stability wall was monitored by visual inspections at the end of each stage of testing and also by means of two instruments having a different accuracy (see Figure 316), to check any type of evolution in width and size that in any case did not occur during testing of EUC-BUILD4 specimen in both the as-built and the retrofitted configuration. Figure 316 shows a global view of the latter crack at the end of the two testing sequences.

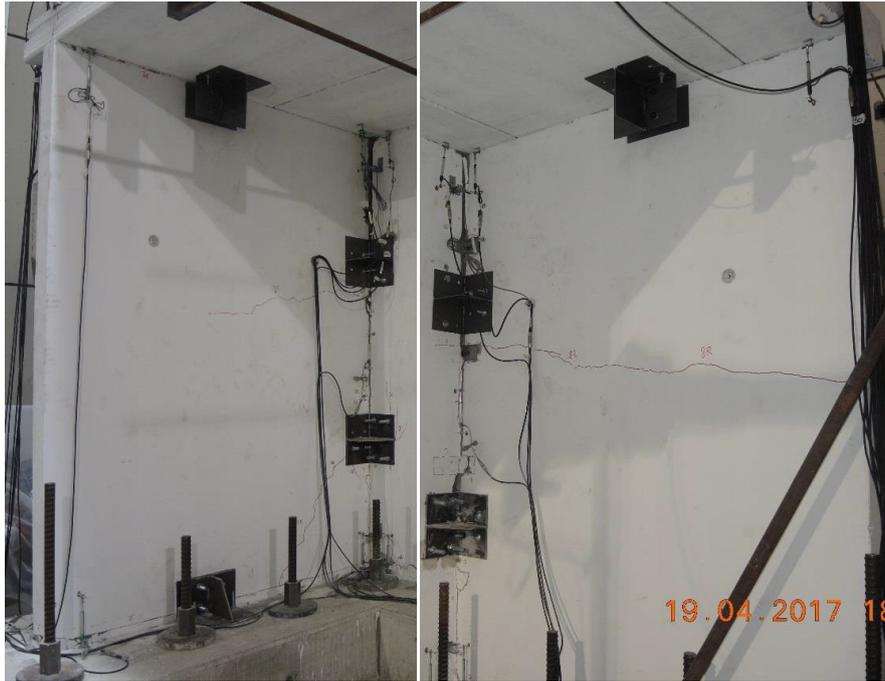
North face of W1L1

Whilst Figure 244 presents the deformed shapes of the retrofitted specimen at positive and negative displacement peaks during Test run #8R, a picture of both the North and South faces of the South lateral walls at the ground floor (W1L1 and W1L2) are collected in Figure 328.

The precise time-step corresponding to the formation of these cracks (Figure 328) is obviously very hard to determine, also because safety precautions impose that visual inspection of the structure can be carried out only at the end of each test run. In any case, it is believed that the cracks on the North face of the walls formed when the specimen was displaced towards the reaction wall, which means positive direction. By contrast, the cracks on the South faces should have formed most likely during a negative displacement.

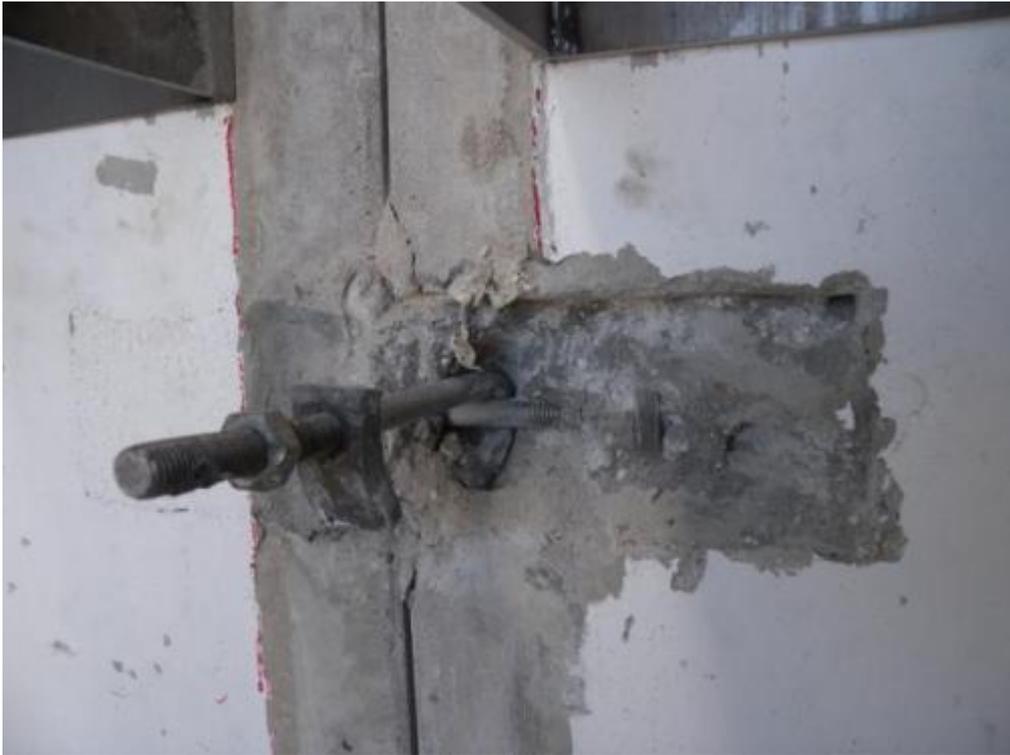
**Figure 337. Detail of a three-way joint between second-storey walls – Anchors and mortar.**

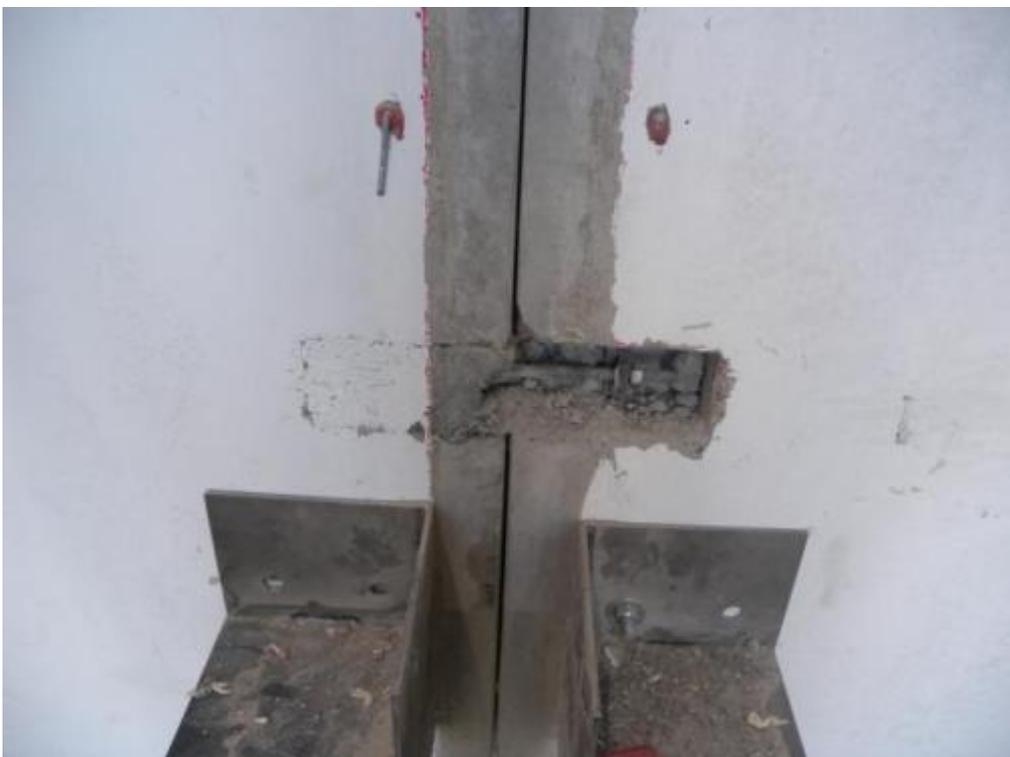
**Figure 338. Detail of anchors and grout in a three-way connection after dismantling of the stability wall.**

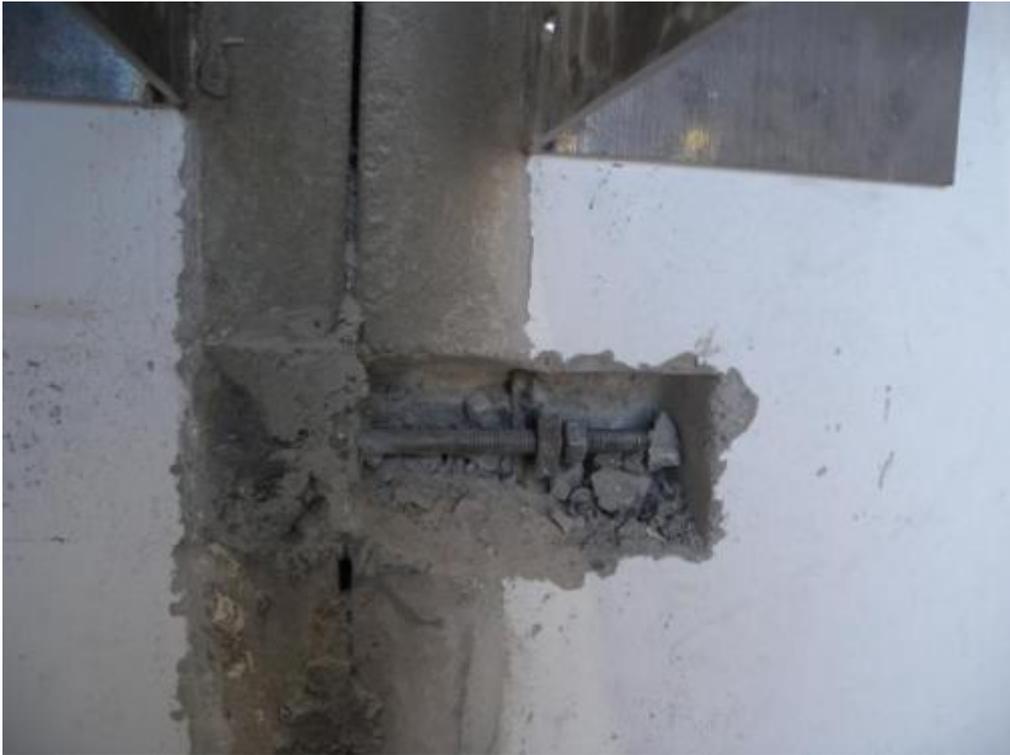
**Figure 339. Enlarged view of a three-way connection after dismantling of the stability wall – Second storey.**

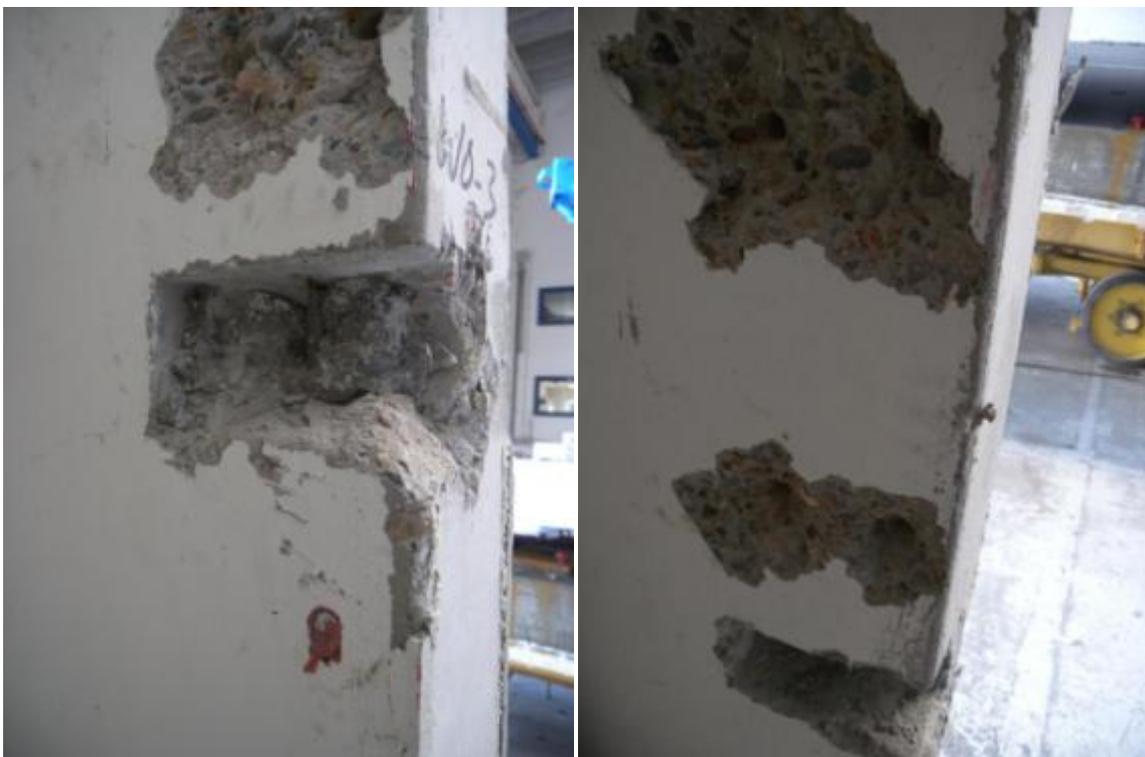
**Figure 340. Detail of grout and wall panels after dismantling of steel angles – Second-storey walls.**

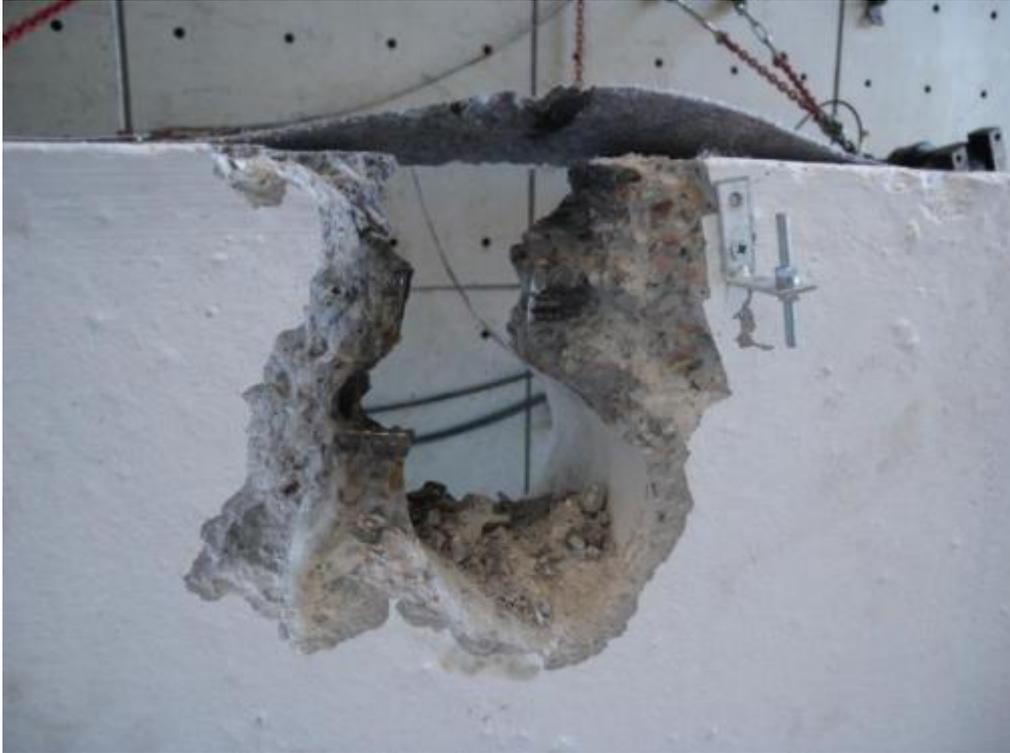
**Figure 344. Detail of cut rebars in the ground-floor stability.**

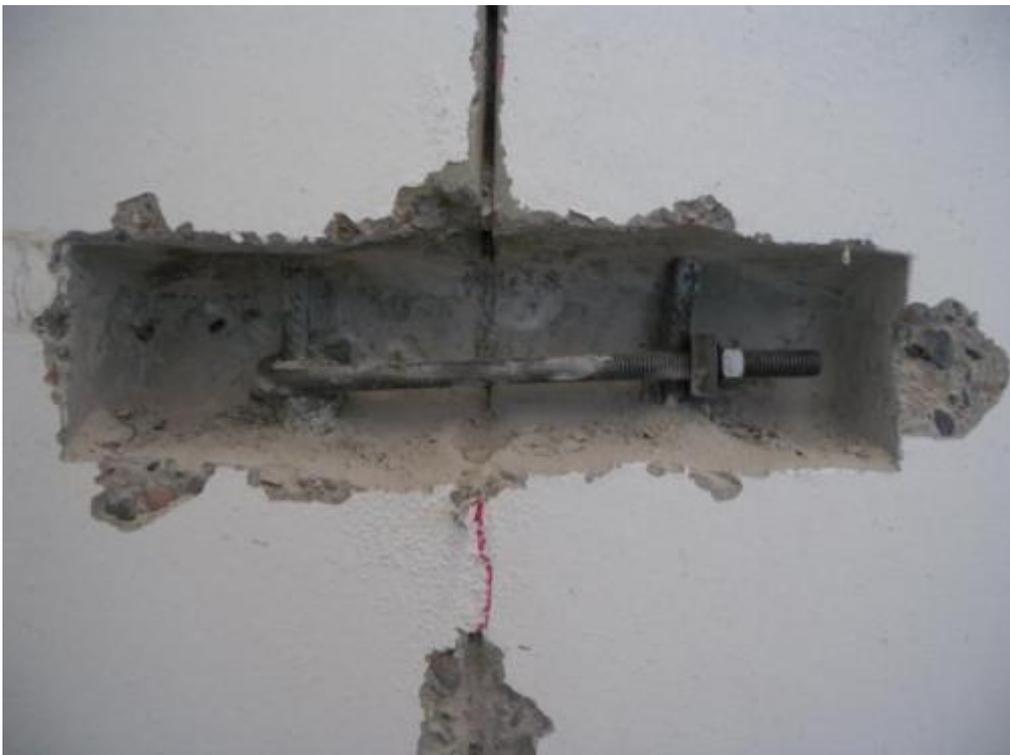
**Figure 345. Detail of hook reinforcement after removal of grout around it – Lateral walls, first storey.**

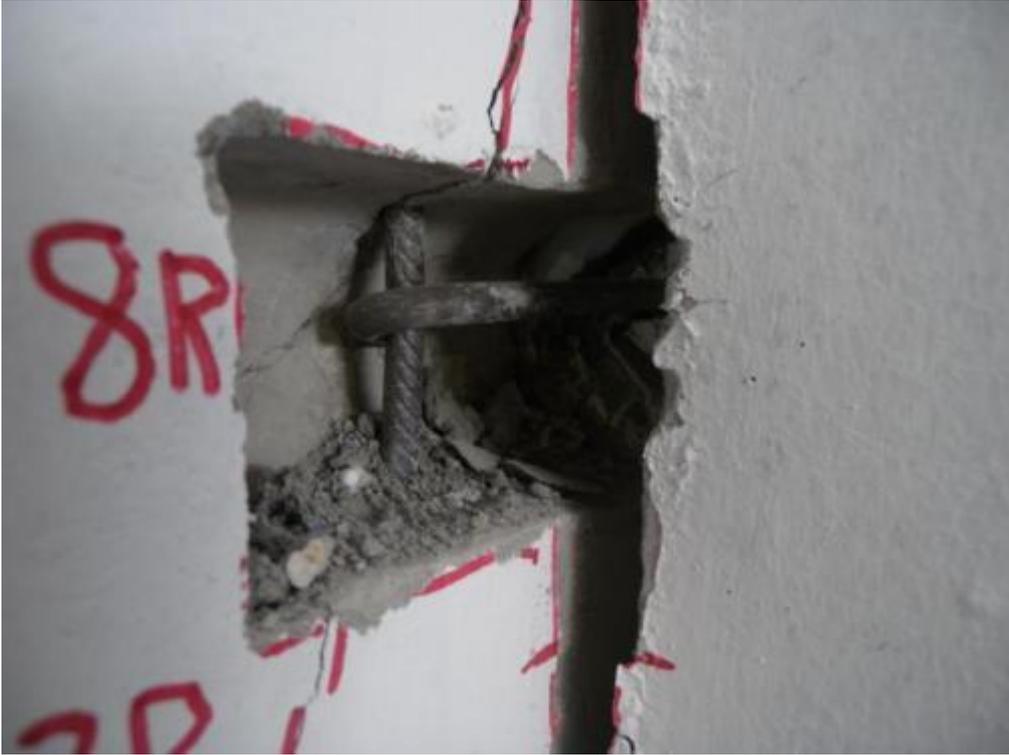
**Figure 352. Enlarged view of bent hook reinforcement before dismantling of wall panels – First storey.**

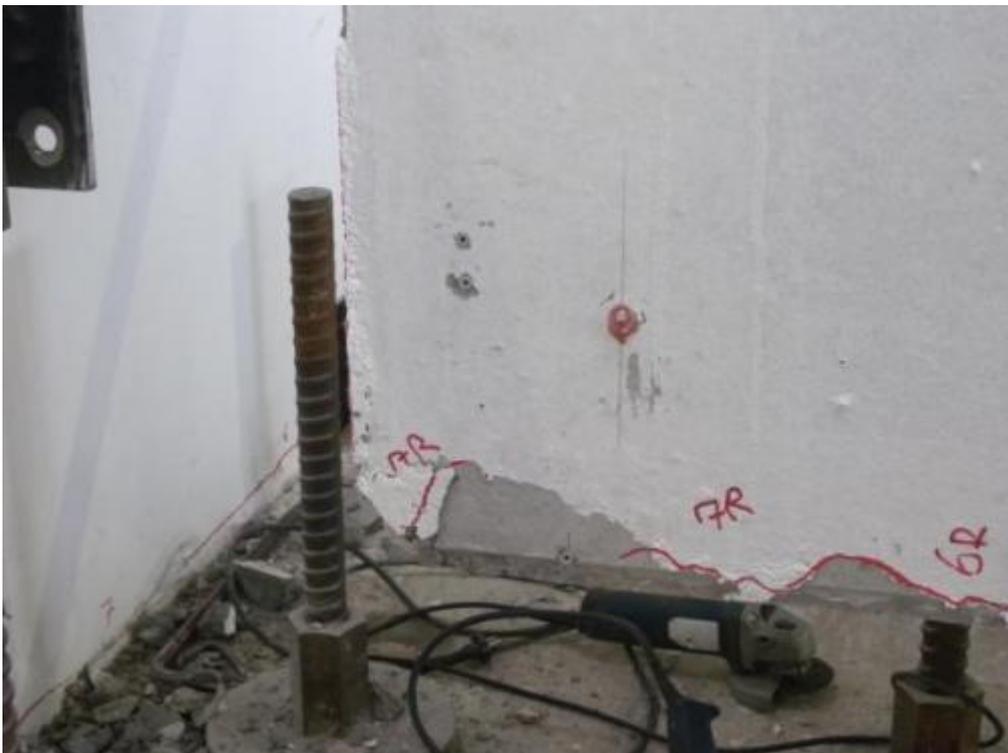
**Figure 355. Ground-floor stability wall panel – Detail of damage at the base, South edge/corner.**

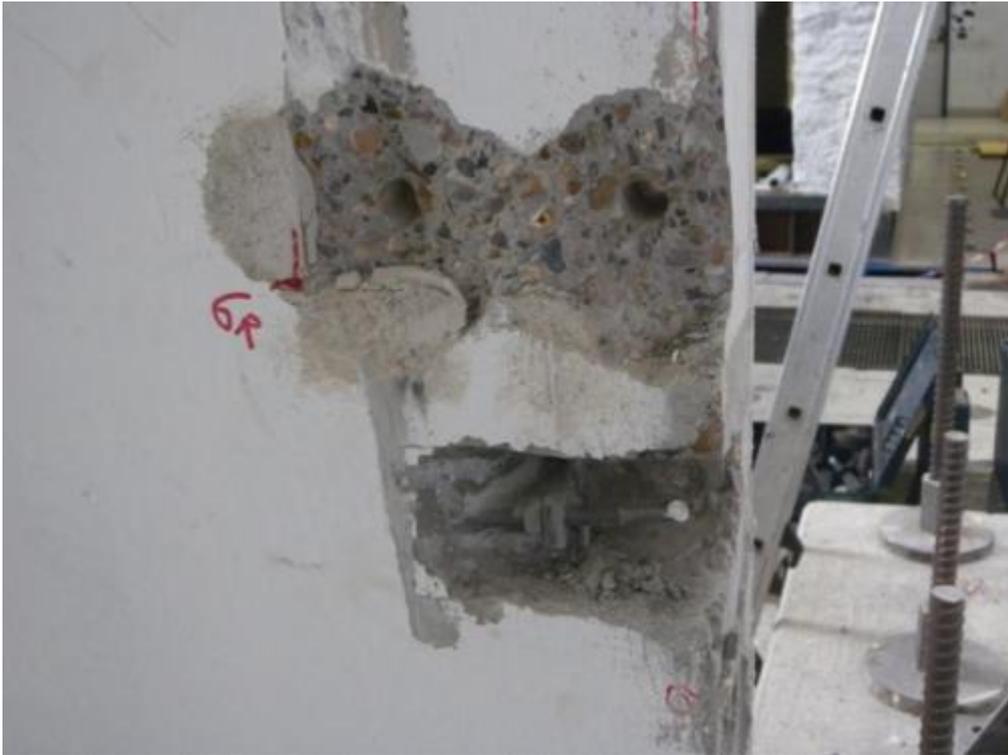
**Figure 358. Ground-floor stability wall panel – Detail of cut hooked anchors and chipping of panel concrete.**

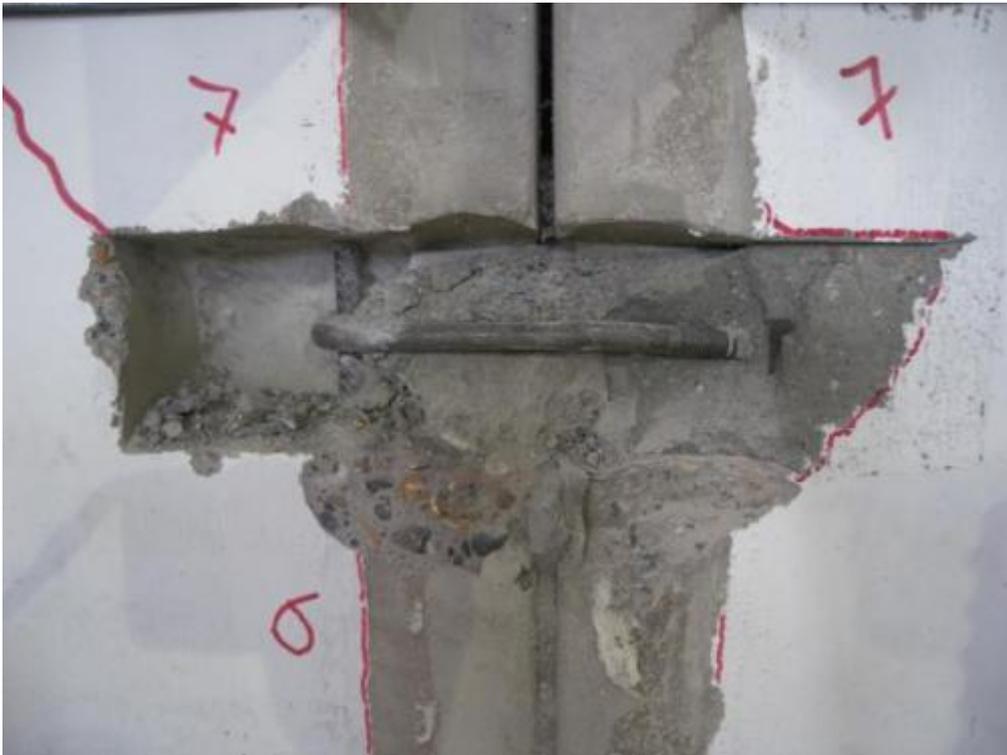
As a result of this, it was possible to adamantly inspect the damaged anchors embedded in the South transversal walls of the first storey. A few photos of them are collected in Figure 360 to Figure 363,

**Figure 360. Detail of flexural failure mechanism of a hooked connector – Below the bottom down clip.**

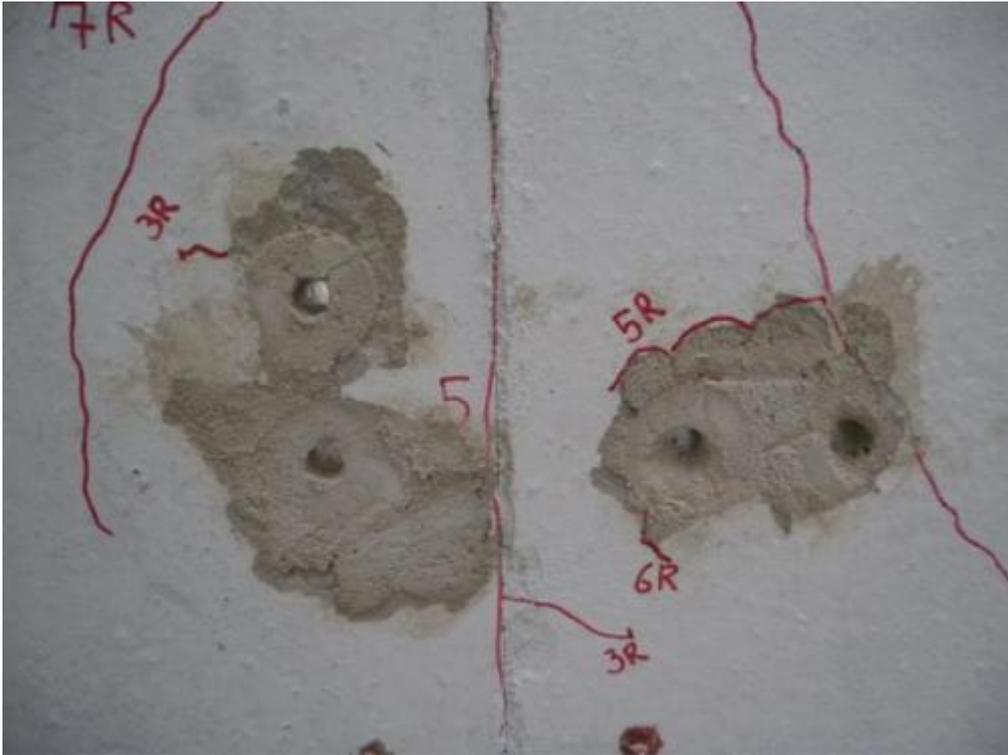
and corroborate previous considerations regarding their failure mechanism. As also shown in Figure 370, permanent bending of them was caused by the orthogonal connectors embedded in the stability wall. The South transversal walls were finally dismantled as presented in Figure 364 to Figure 366, which also highlight the damage pattern at mid-height and close to the steel angles. Other examples of crack patterns produced by those clips are collected in Figure 368 and Figure 369. Noteworthy is that panel reinforcement did not exhibit any sign of damage (see for instance Figure 367).

Figure 365. Removal of screwed clip angles and damage/crack pattern in the transversal wall panels.

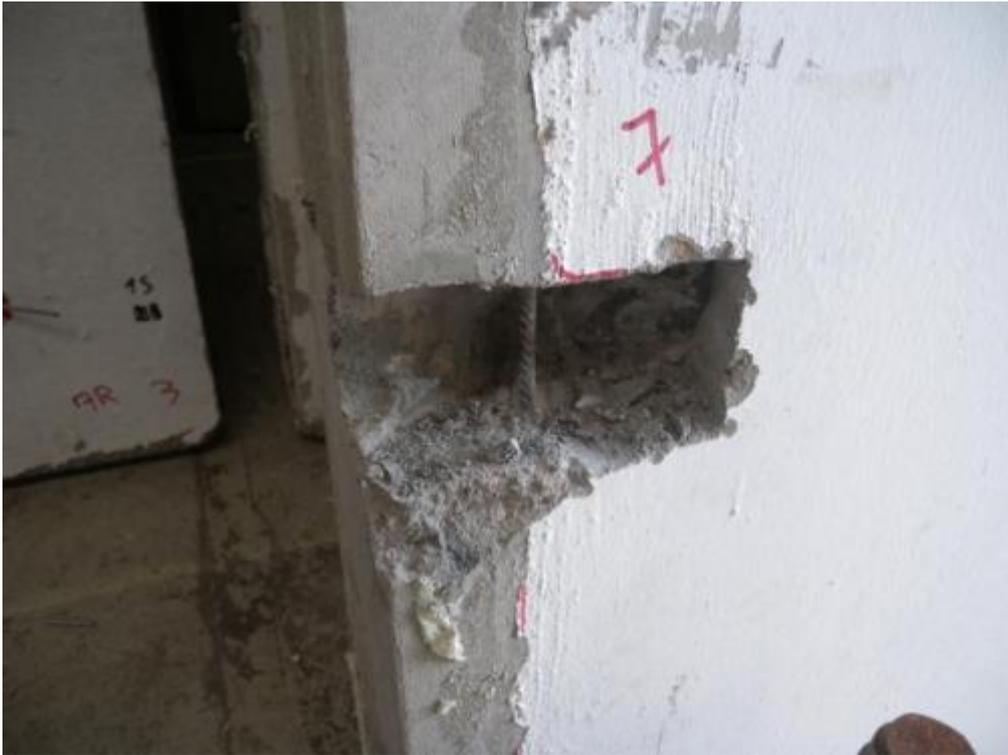
Figure 367. Detail of panel reinforcement passing through the niche of a panel-to-panel connection.

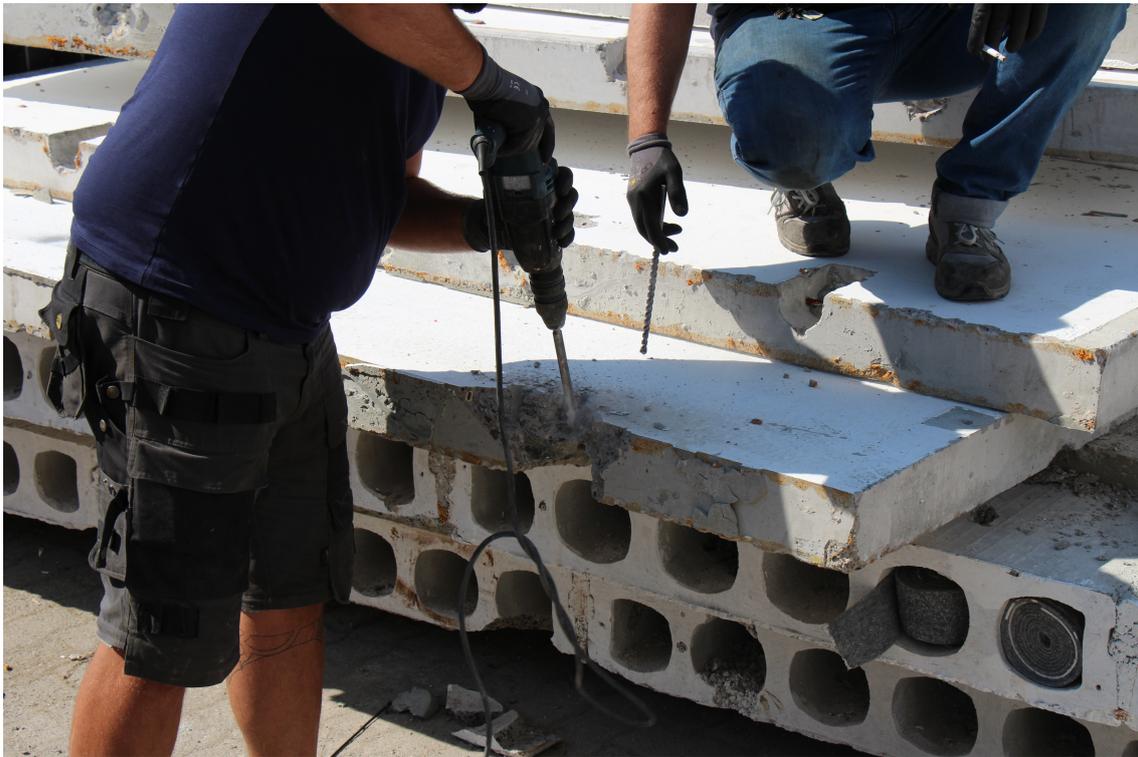
Once the operations of dismantling had been completed, the precast wall-panels were surveyed with a view to inspect construction details. A photographic sequence of this process is reported hereafter (i.e. Figure 371 to Figure 375). As shown in Figure 371, portions of concrete were demolished so as to examine the arrangement of reinforcing rebars close to the niches. Figure 372 presents a detail of 50 mm spacers that were used for the positioning of the steel net before concrete grouting, whereas Figure 373 shows the steel net itself and the position of the 10 mm diameter bar for the arrangement of the steel connectors. The steel mesh consisted of 5 mm diameter rebars, and the spacing between the horizontal and vertical bars was 25 and 18 cm, respectively, as can be gathered from Figure 374 and Figure 375. It is also worth noting that the steel net was not placed in the middle of the panel, as indicated by the fact that the embedment depth of the steel connectors was 40 mm.

**Figure 371. Removal of concrete close to a panel niche.**

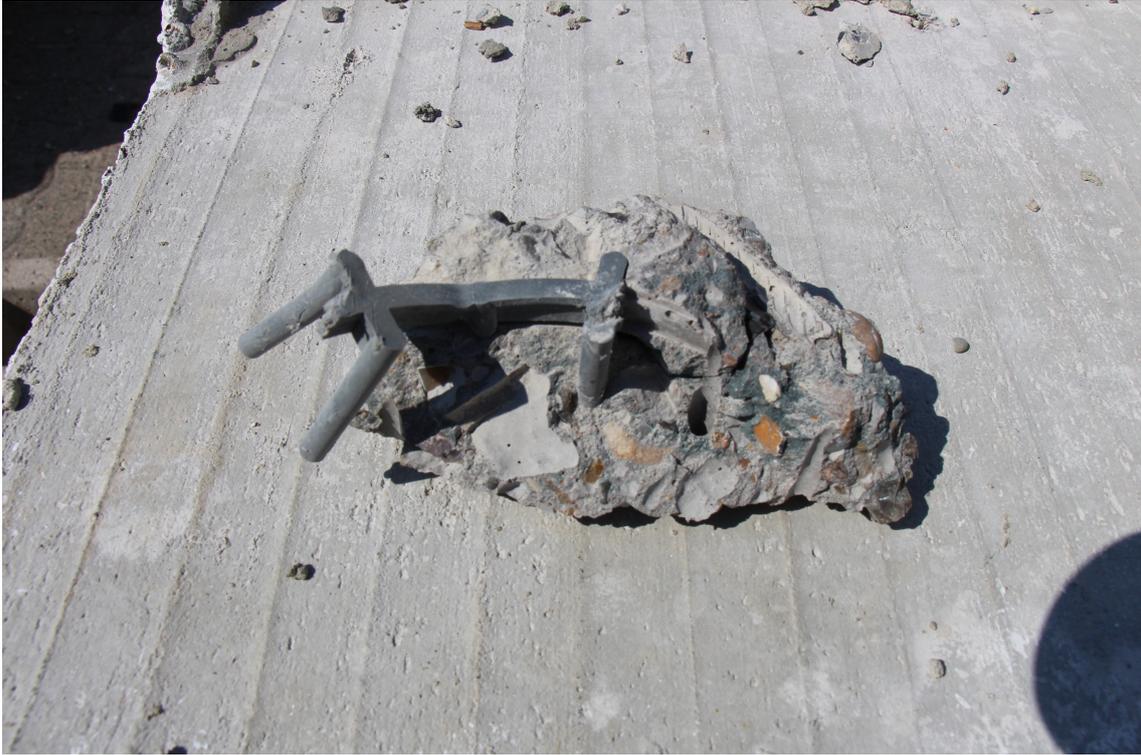
**Figure 372. Detail of a 50mm spacer for the arrangement of the steel net.**

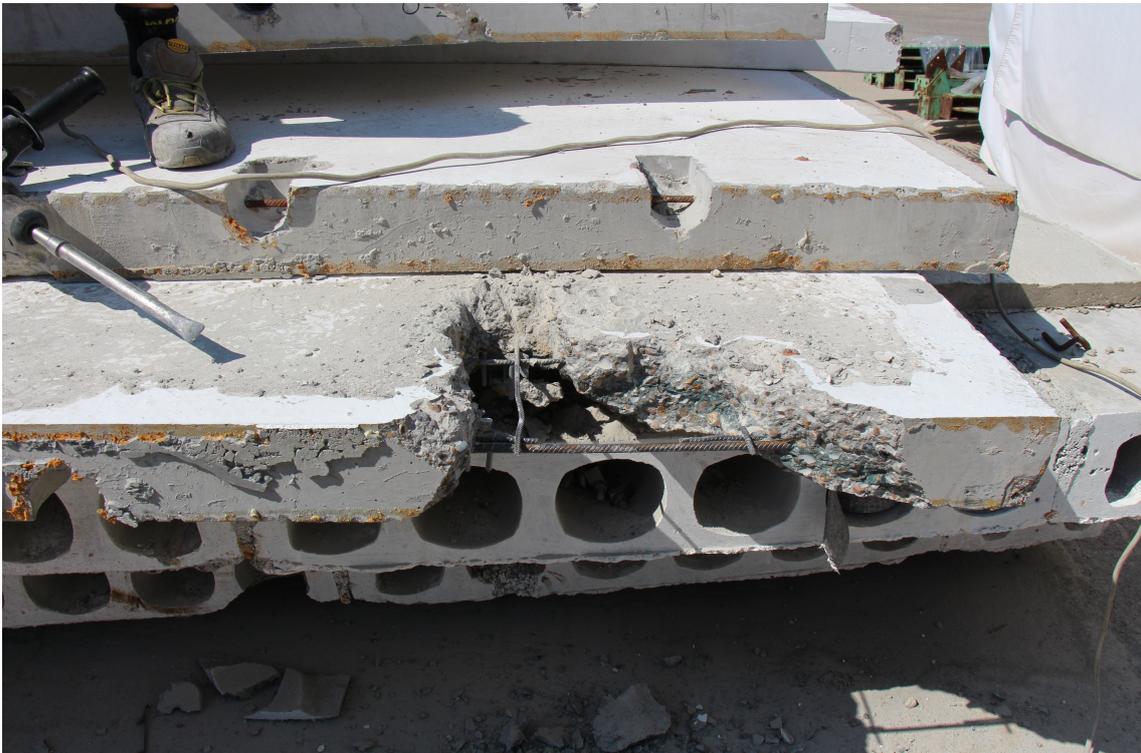
**Figure 373. Detail of steel net and adjacent 10 mm diameter bar for the steel connectors.**

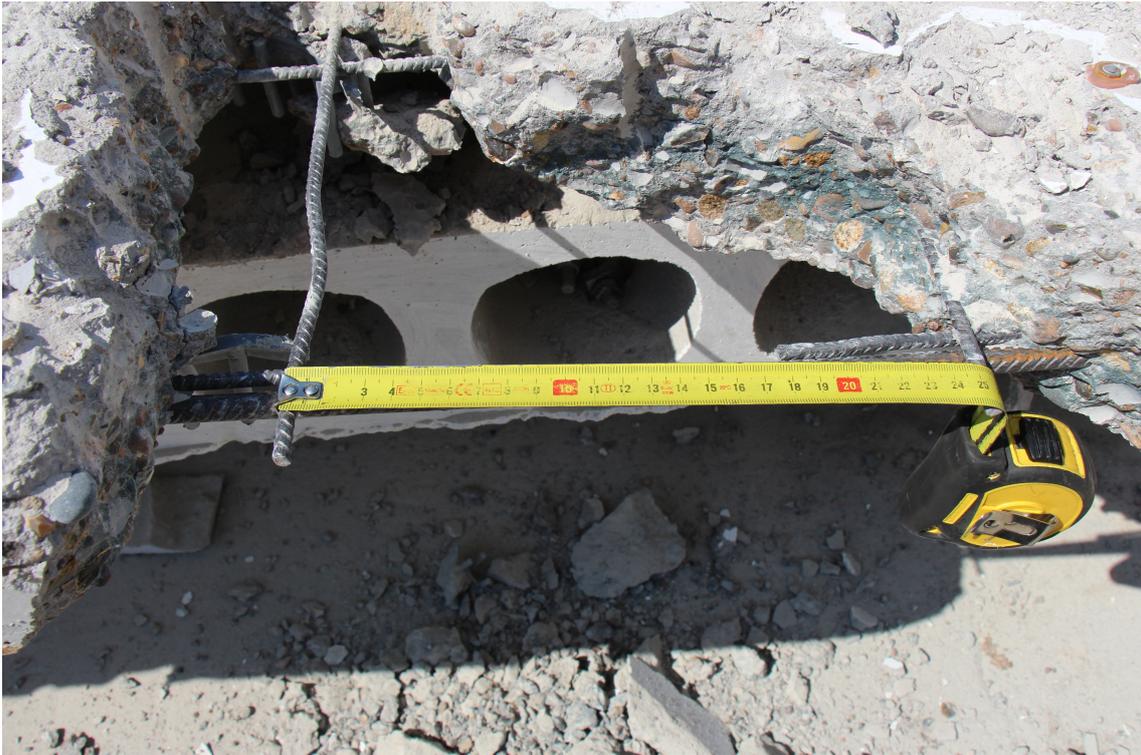
**Figure 374. Spacing between horizontal bars of the steel net.**

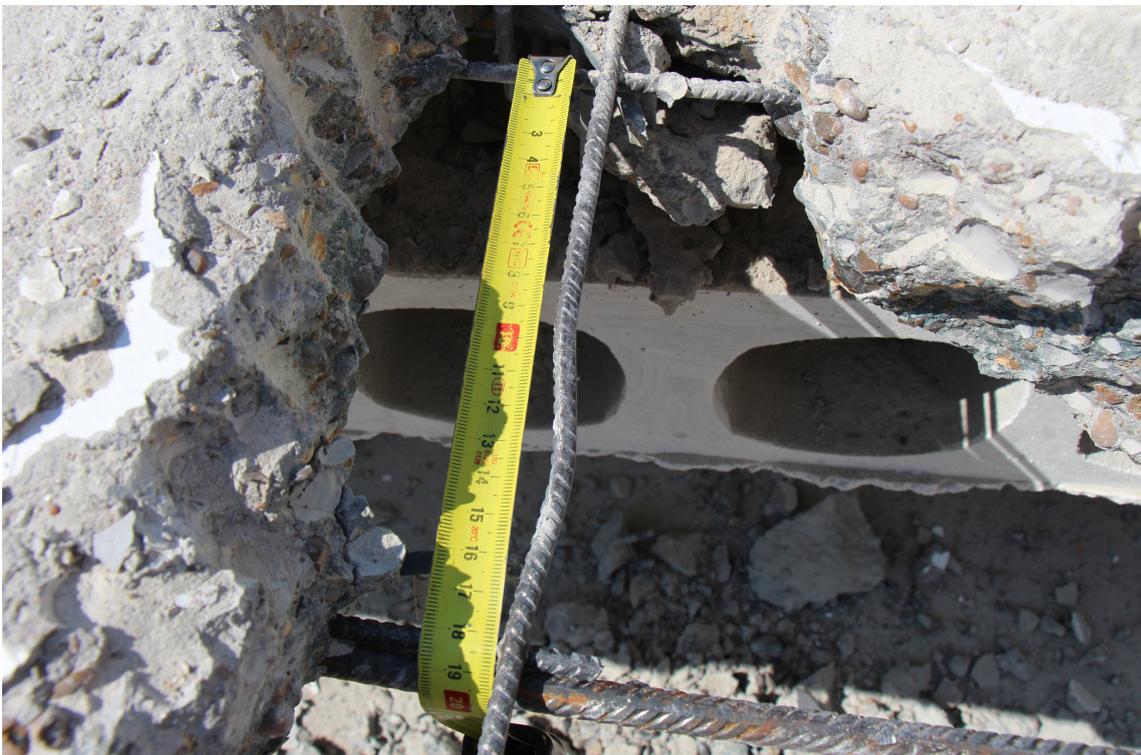
**Figure 375. Spacing between vertical bars of the steel net.**
