Full-Scale Shaking Table Test on a Dutch URM Cavity Wall Terraced House end-unit - – EUC-BUILD-6

M. Miglietta, L. Mazzella, L. Grottoli, G. Guerrini, F. Graziotti

EUCENTRE Italy, University of Pavia and IUSS Pavia

Date October 2018

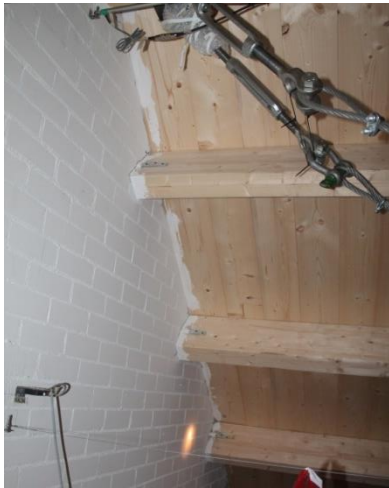
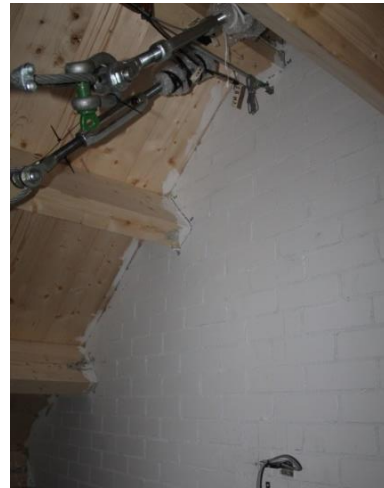
Figure 140 EQ-NPR 33% - Overall view of the cracks on the South gable wall: a) West side; b) East side.

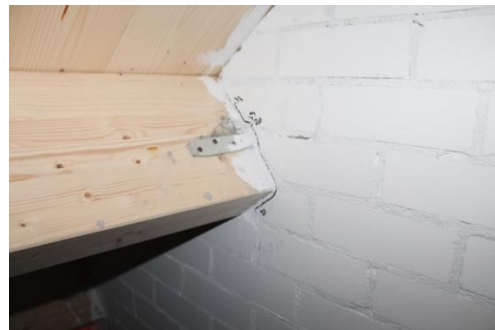
Figure 141 EQ-NPR 33% - Zoom-in on the cracks of the South gable wall: a) West side; b) East side.

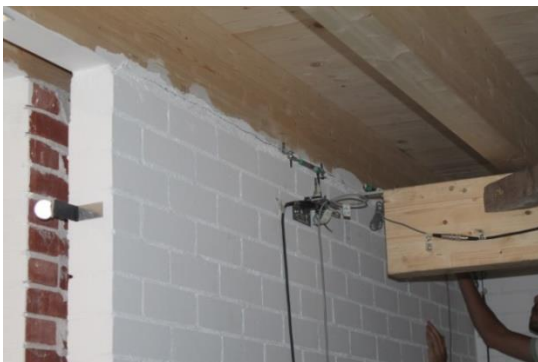
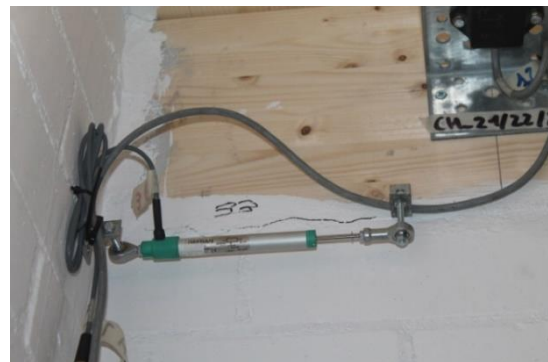
At this stage, the building still did not experience any significant damage. No cracks were detected on the clay outer leaves (Figure 138 and Figure 139), while only minor extension of cracks (with residual width smaller than 0.1 mm) were observed at the interfaces between the calcium silicate inner leaf and the timber joist and planks (Figure 137, Figure 140 and Figure 141). Remarkably, small cracks were detected on the East and West façades between the roof spreader beams and the masonry walls (Figure 136 and Figure 142).

Figure 142 EQ-NPR 33% - West facade sliding cracks: a) overall view of the North side; b) zoom-in on the South side.

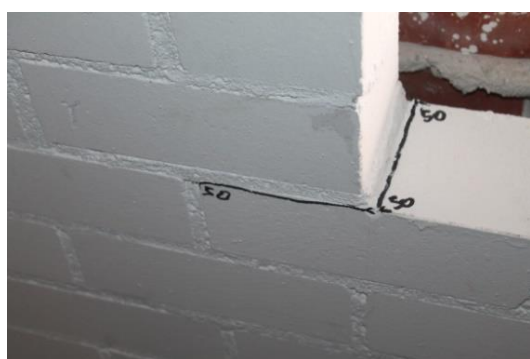
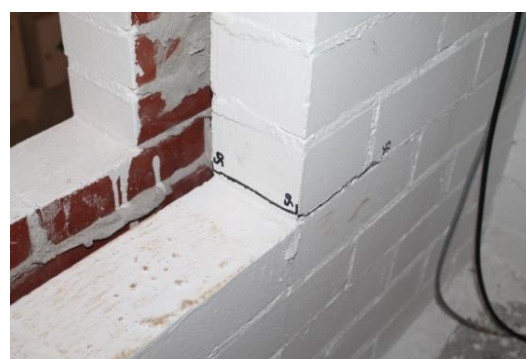
Several cracks (with residual widths smaller than 1 mm) formed throughout the width of walls at the base and top of the piers of the West and East façades, on both inner and outer leaves, especially at the first floor (Figure 143 and Figure 147, Figure 145 and Figure 148). Such evidences denoted the onset of uplift at the base of piers, meaning the activation of flexural mechanisms.

Figure 147 EQ-NPR 50% pier base cracks on the inner leaf: a) C8; b) C9.

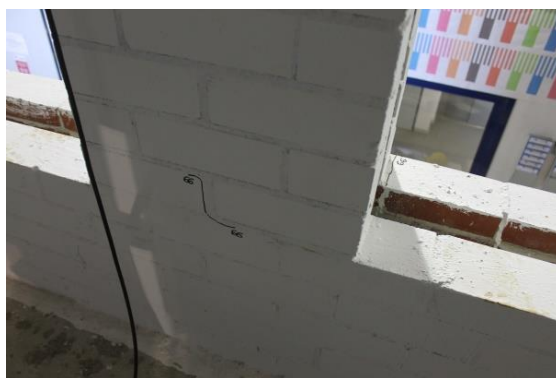
At the ground floor of the East side, the crack at the base of the calcium silicate squat pier extended, showing clearer evidence of rocking (Figure 150). At the second floor all piers were cracked at their top and bottom: the central piers rocked on their bases (C10, Figure 150 and Figure 156) while the spreader beams slid above them; the edge piers behaved as flanges of the transverse walls (C8, C9, Figure 150), with spreader beam sliding as well.

Figure 156 EQ-NPR 66% cracks: C10 overview.

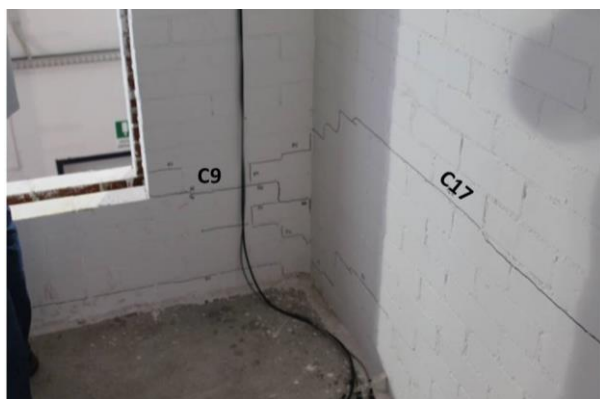
Figure 162 EQ-NPR 85% cracks: a) C9 and C17 overview ; b) C9 and C17 Zoom in.

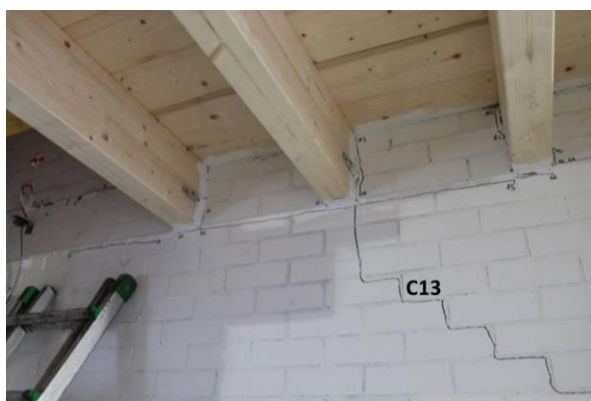
Figure 163 EQ-NPR 85% cracks: a) C12 and C15; b) C13.

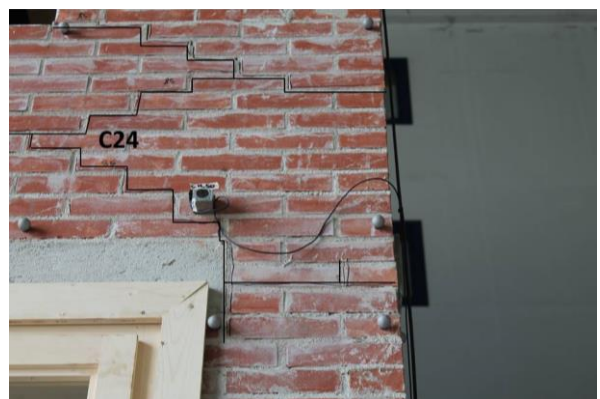
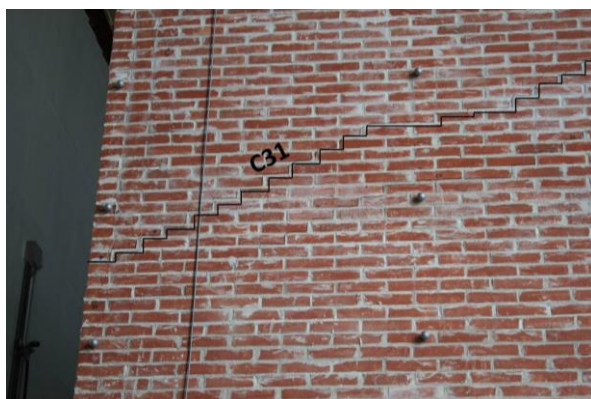
Residual cracks widths after the test were negligible except for crack C24 (Figure 160 and Figure 164), which accumulated around 1 mm.

Figure 164 EQ-NPR 85% cracks: a) C24; b) C31.

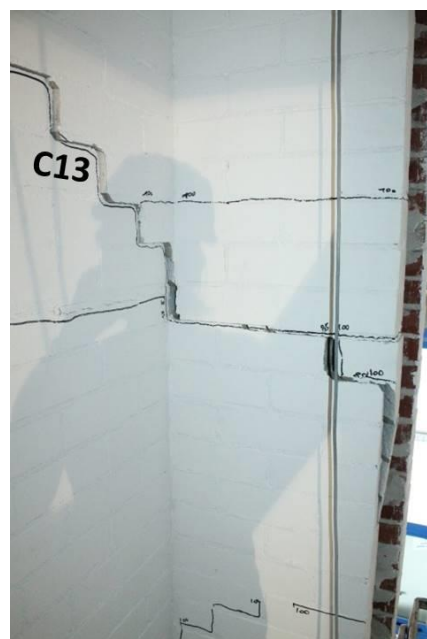
After this test, residual cracks widths became significant: C29 (Figure 168 and Figure 174) C4 (Figure 166 and Figure 171) reached around 1.2 cm; C8 (Figure 166 and Figure 170), C13 (Figure 167 and Figure 170) and C31 (Figure 169, Figure 173 and Figure 174), accumulated 2 cm, 1.5 cm and 1.5 cm respectively, in their out-of-plane directions.

Figure 170 EQ-NPR 100% cracks: a) C8, C11, C13 and C14 overview; b) C13 zoom in.

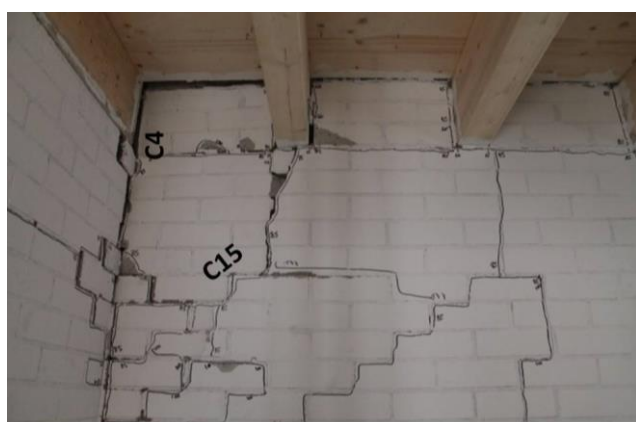
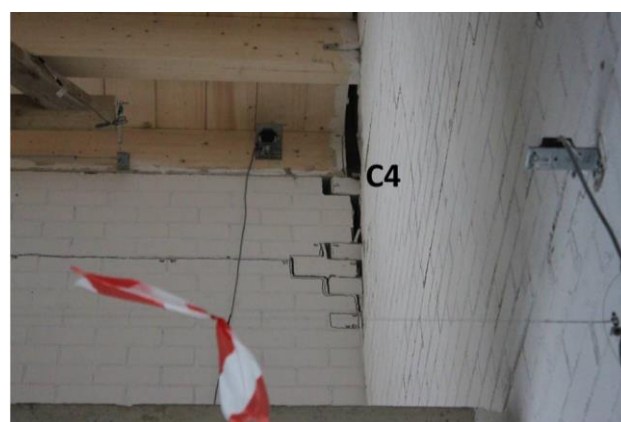
Considering the calcium silicate walls, on the West façade (Figure 175), crack C4 showed 3 cm of residual width (Figure 179); crack C13, on the North façade (Figure 176), led to loss of bricks on the East façade (Figure 181 and Figure 182); crack C14 on the North side (Figure 176) accumulated 3.5 cm (Figure 176, Figure 181 and Figure 183). Considering the clay walls (Figure 177 and Figure 178), the most significant damage was observed on the North façade: cracks C31 and C33 ended with about 3 cm of residual width (Figure 186, Figure 187). Moreover, other cracks (such as C22, Figure 177 and Figure 184; C24 and C25, Figure 177 and Figure 185) showed residual displacements around 1 cm (see Table 25).

Figure 179 EQ-NPR IS 133% cracks: a) C4 and C15 overview; b) C4 zoom in.

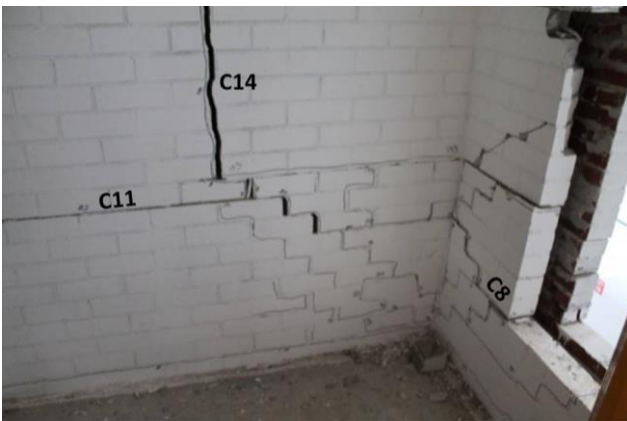
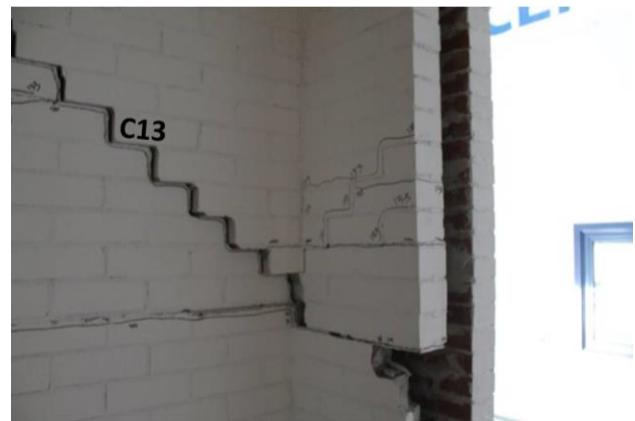
Figure 181 EQ-NPR IS 133% cracks: a) C8, C11 and C14; b) C13.

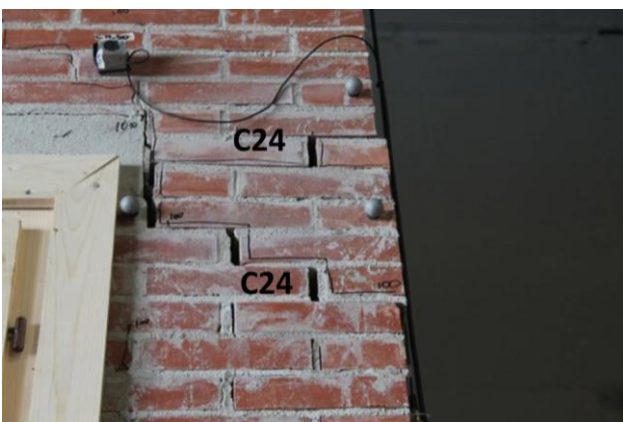
Figure 184 EQ-NPR IS 133% cracks: a) C22 overview; b) C22 zoom in.

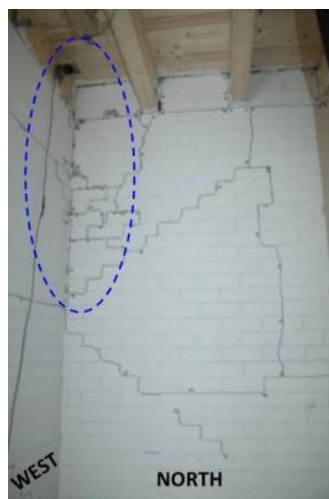
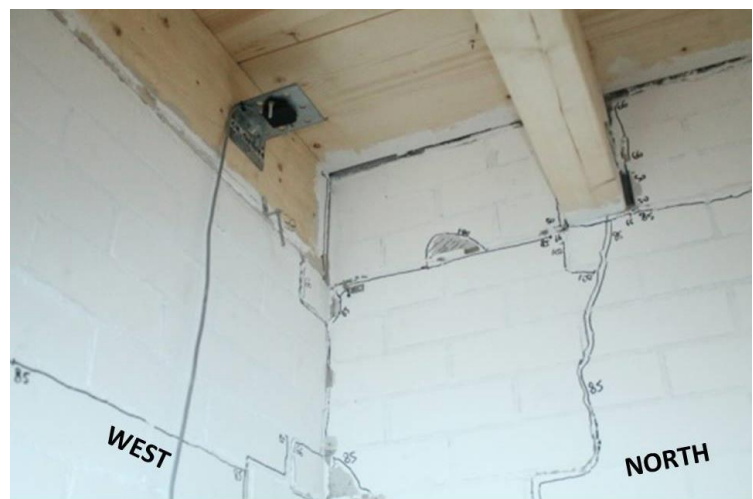
Figure 188 Crack C4 evolution: a) location; b) in-plane residual widths.

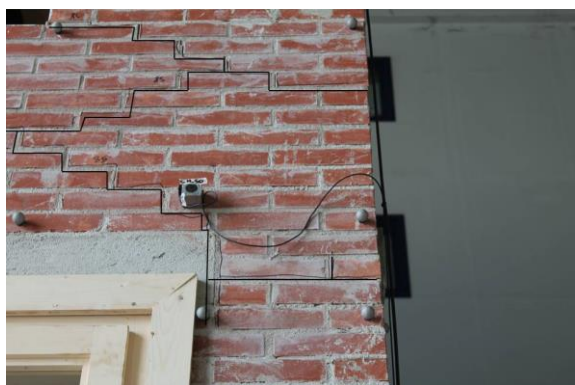
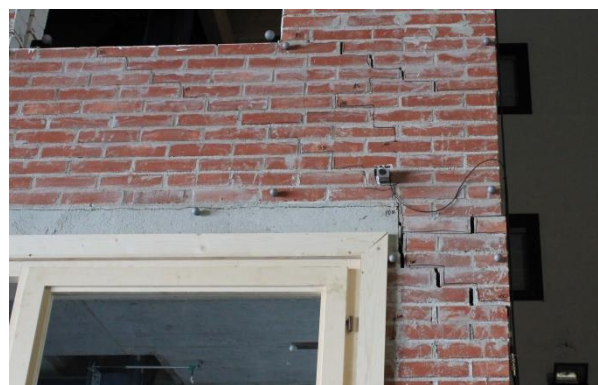
Figure 195 Cracks C24 evolution: a) location; b) in-plane residual widths.
