Experimental campaign on Reinforced Concrete buildings typical of the Groningen region

Dynamic testing of a full-scale two-storey Reinforced Concrete precast wall-slab-wall structure representative of the Groningen building stock (EUC-BUILD5).

Eucentre

Date October 2017

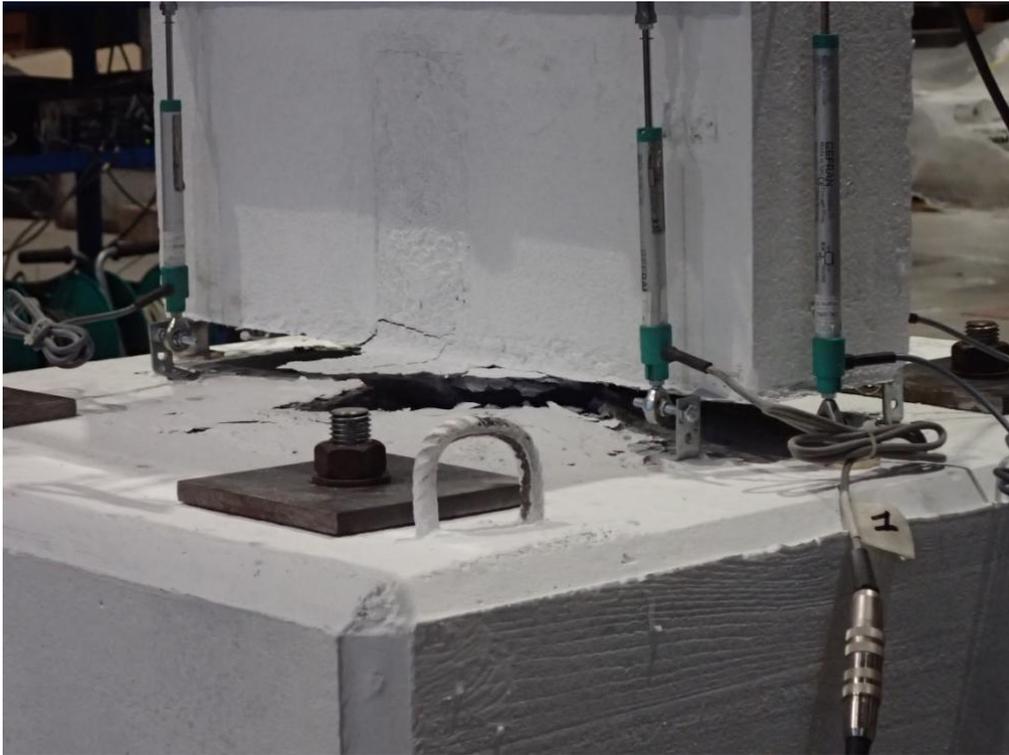
Figure 74 presents the axial force-axial displacement response curve obtained by the monotonic testing of specimen #1, whereas Figure 75 illustrates the type and level of damage for an imposed vertical displacement of 24 mm. It results evident that, after initial cracking, the two portions of the specimen were completely detached, apart from the mechanical connection or continuity ensured by the permanently bent steel connector lodged in the niche of the base portion of the specimen. A photograph showing the flexural failure mode of the upwardly-bent steel connector at the end of the test can be seen in Figure 76. It is worth specifying that this latter photo was taken after the removal of grout, when the steel connector had been already cut.

The specimen resisted a vertical force of about 13 kN for a displacement of 2 mm, after which value a drop in strength can be observed, since the force resisted at 5 mm was approximately equal to 10 kN. Due to a sort of catenary action mobilised by the steel connector, the resistance increased as the displacement was increased, and the specimen reached its maximum load-carrying capacity, which was slightly higher than 14 kN (for an imposed vertical displacement of about 23 mm). Once this displacement level was exceeded, softening started being observed because of the extensive damage (i.e. permanent flexural deformation) of the steel connector in the base connector socket.

Figure 75. Damage and detachment of the two portions of the specimen.

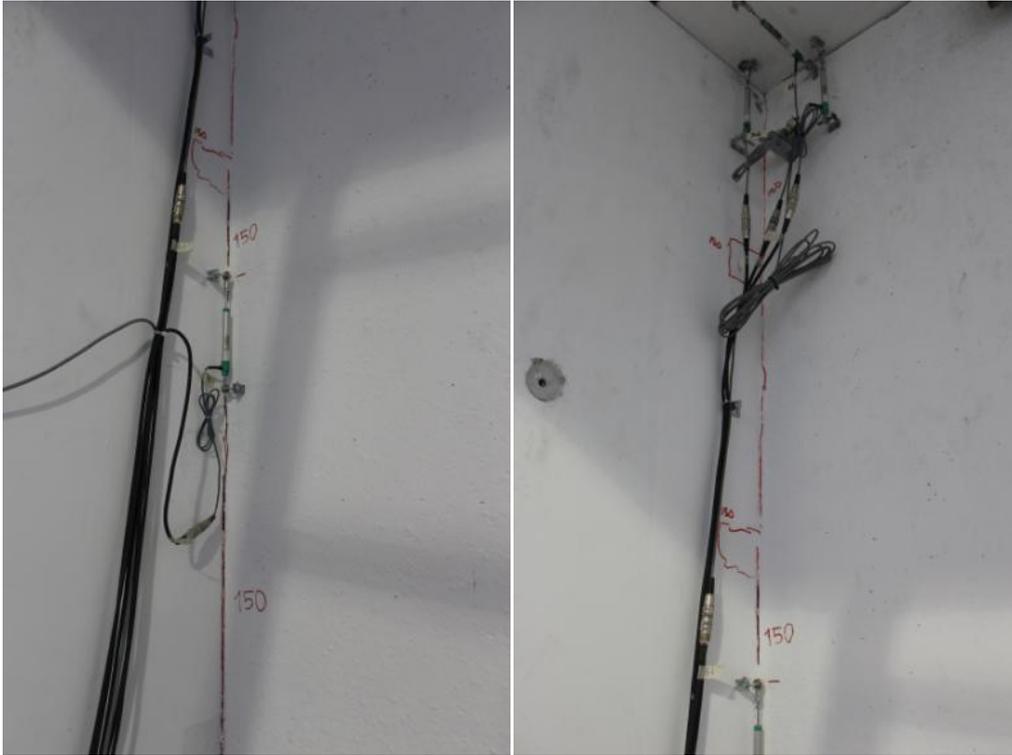
Figure 282. Crack pattern of three-way joints – East and West faces of the ground-floor stability wall.

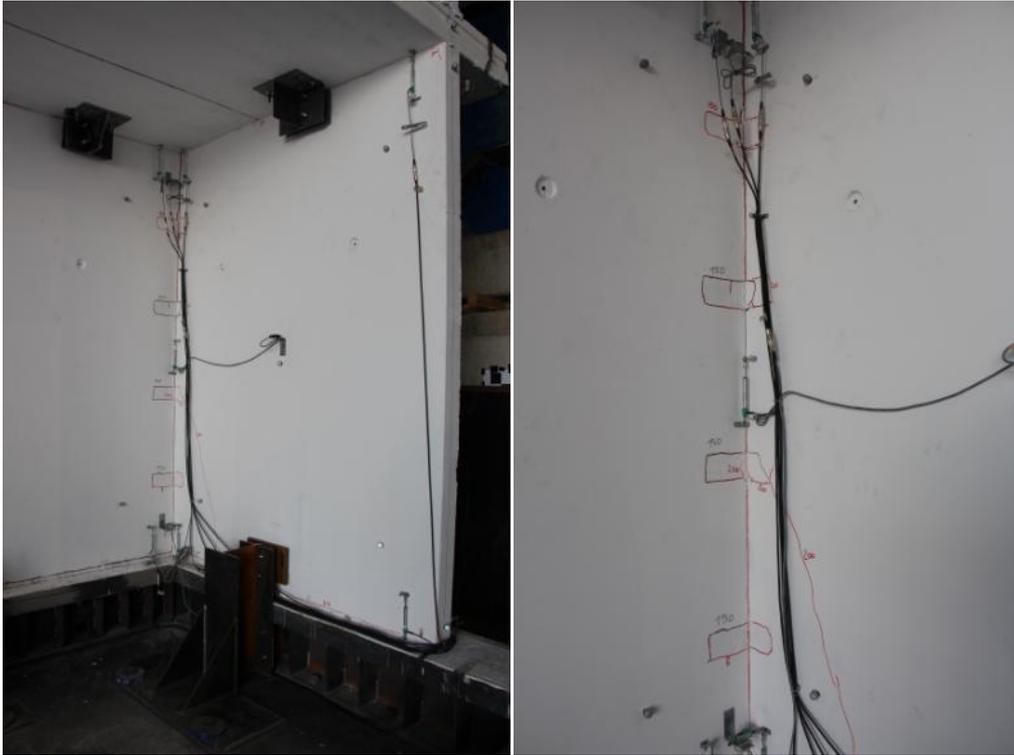
Figure 294. Crack pattern of the ground-floor stability wall – Enlarged view and detail of three-way joints.

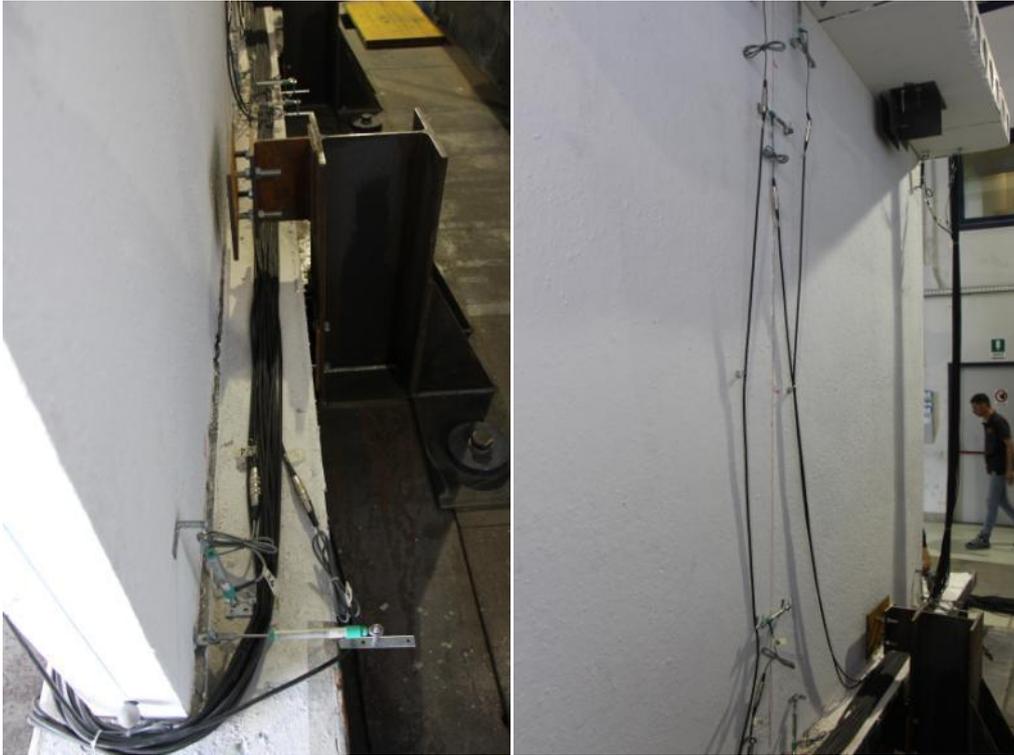
Figure 298. Full-depth/full-width horizontal crack at the base of the first-storey lateral wall 1L2.

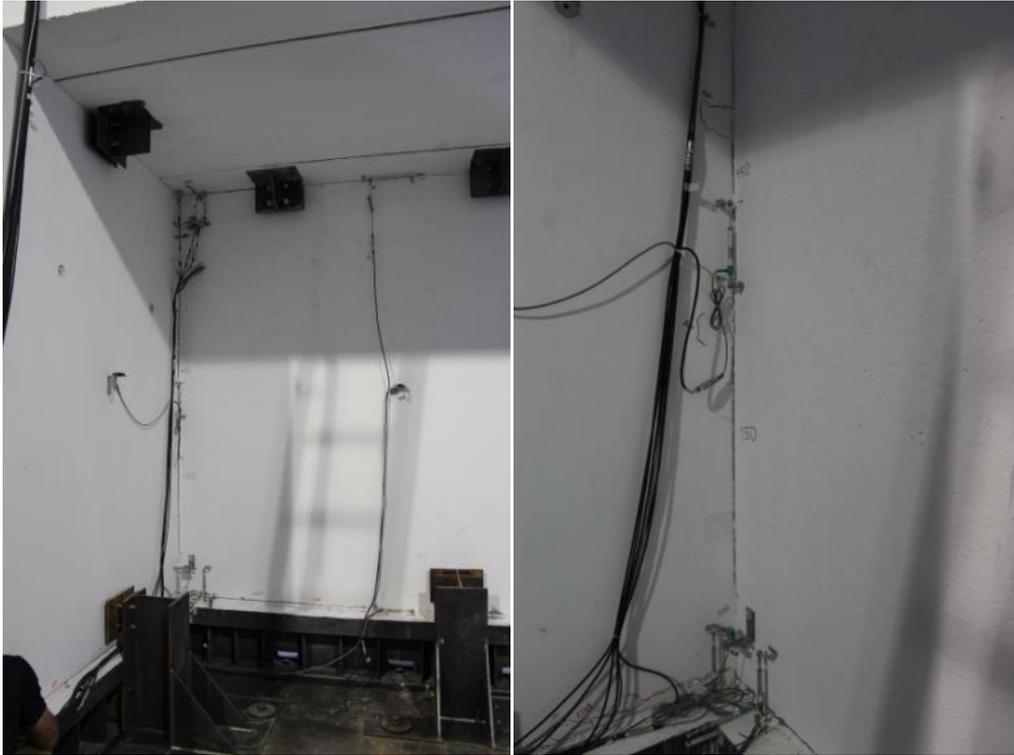
Figure 302. Extensive damage of the top three-way joint – East face of the first-storey stability wall.

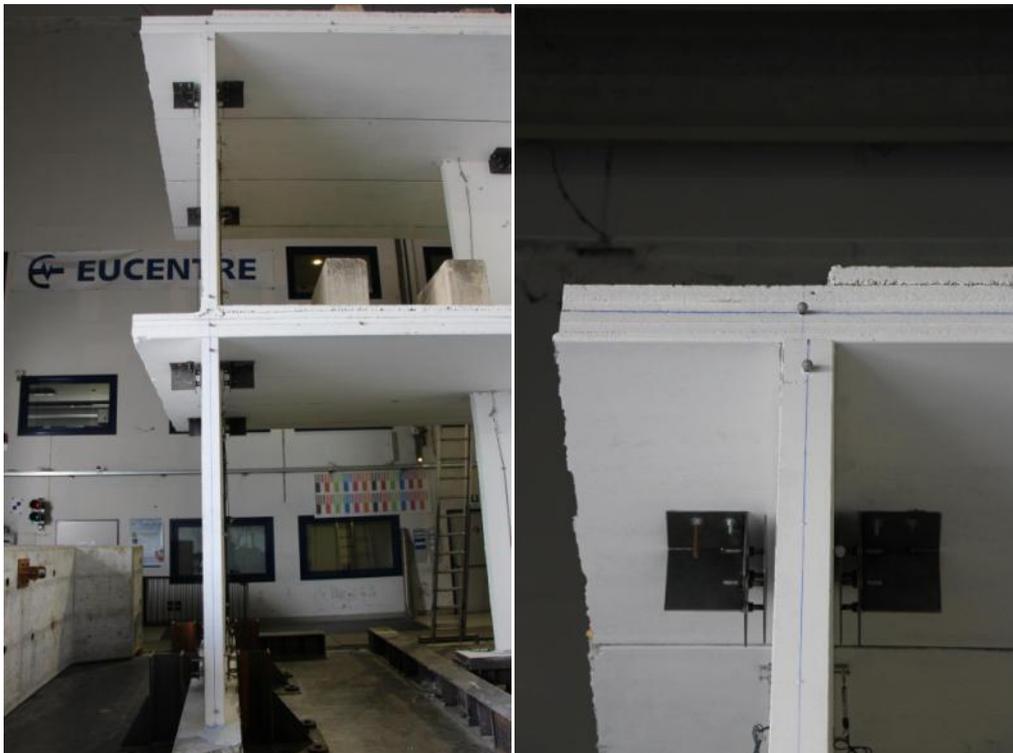
Figure 307. Sliding and accumulation of displacement residuals – Second-storey floor slab, North side.

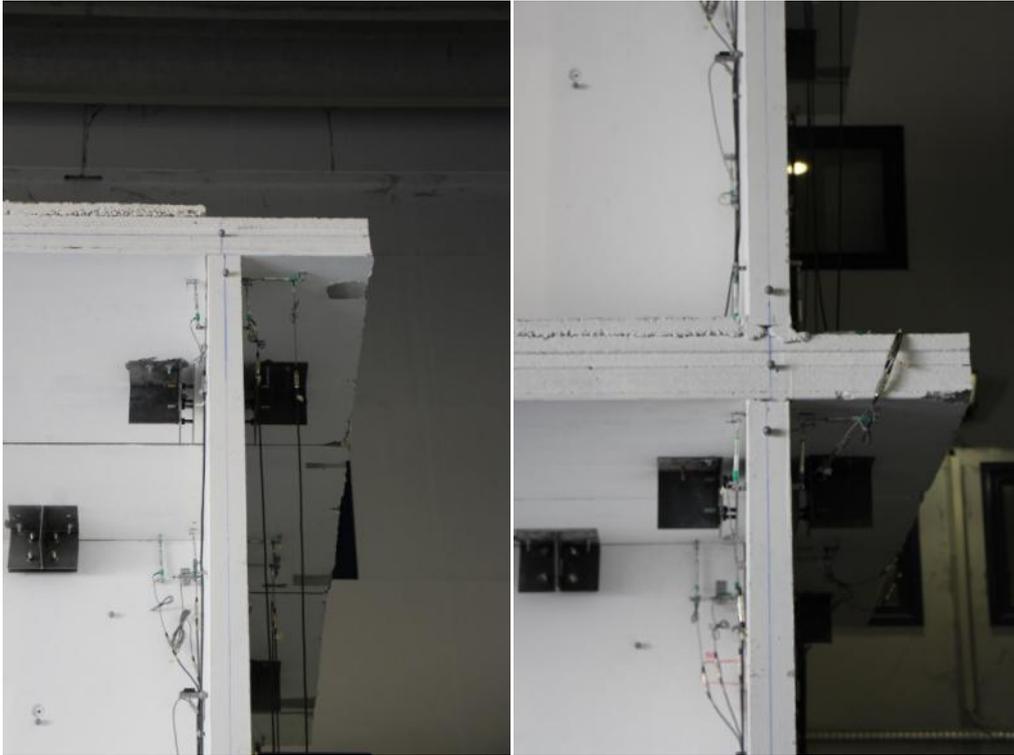
Figure 308. Sliding and accumulation of displacement residuals – Second-storey floor slab, South side.

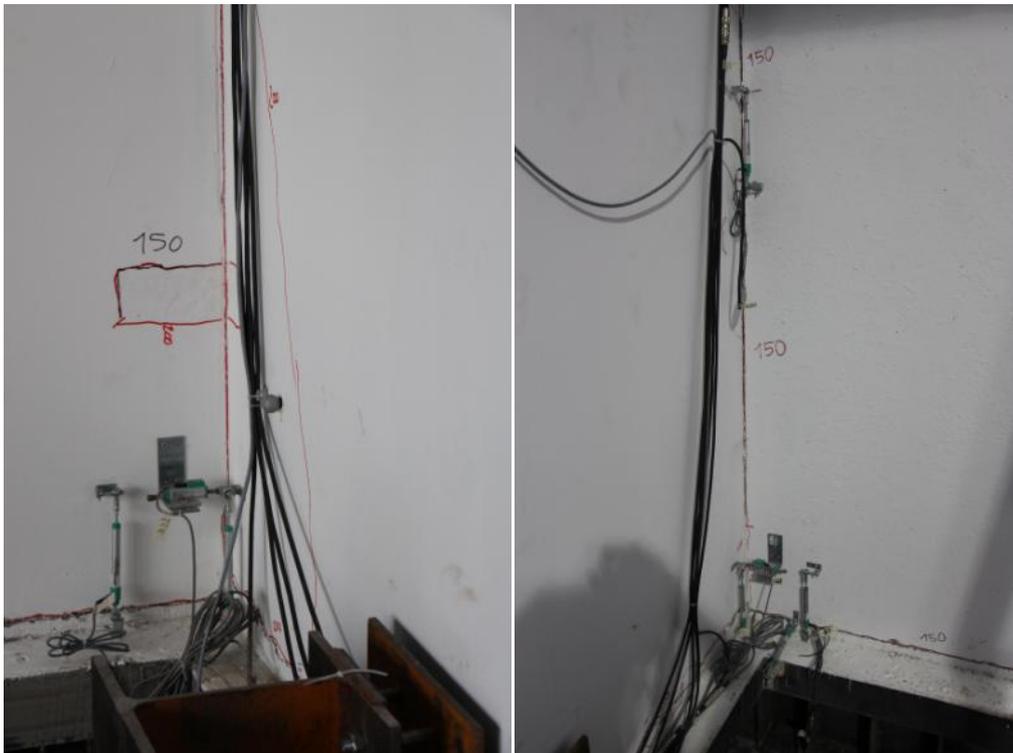
Finally, Figure 315 and Figure 316 provide enlarged and very detailed views of the damage pattern of the top and bottom three-way joints at the end of Test run #08. More in detail, Figure 316 shows the gap opening between the stability and transverse ground-floor walls and may thus provide a very clear picture of the state of EUC-BUILD5 specimen at the end of Test run #08.

Figure 315. Damage pattern of top and bottom three-way joints at the end of Test run #8.

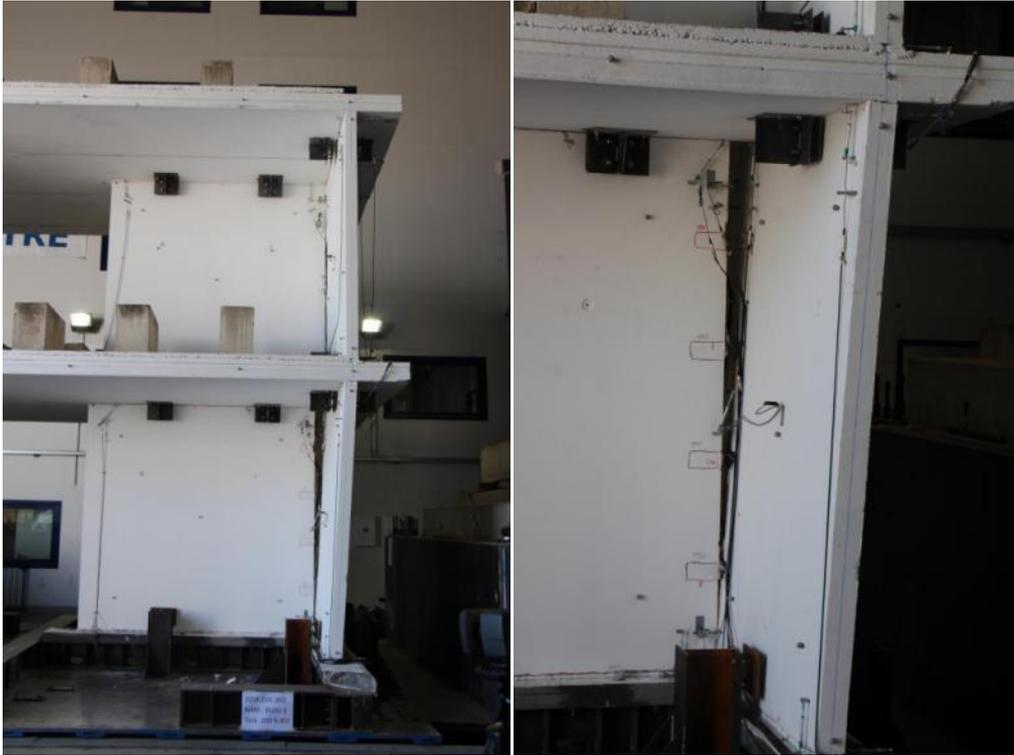
Firstly, Figure 317 shows the deformed shape of the specimen at the end of dynamic testing and gives account of the exaggerated levels of deformation that were reached during the last test run. In Figure 318, an enlarged view of the accumulated permanent displacements is also provided so as to portrait even more clearly how close to collapse the building appeared at the end of the second input motion at 200% intensity.

Figure 318. Loss of verticality and accumulation of residuals due to failure of bent three-way panel joints.

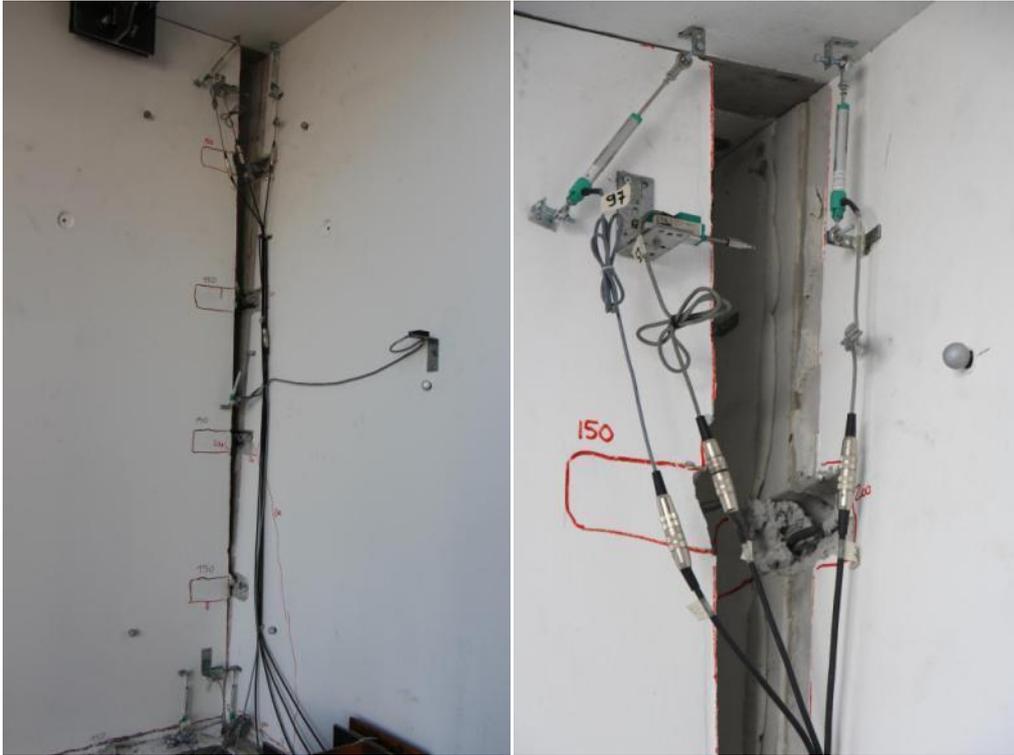
Figure 324. Failure mechanism of three-way panel connections – Detail of permanently-bent steel connectors.

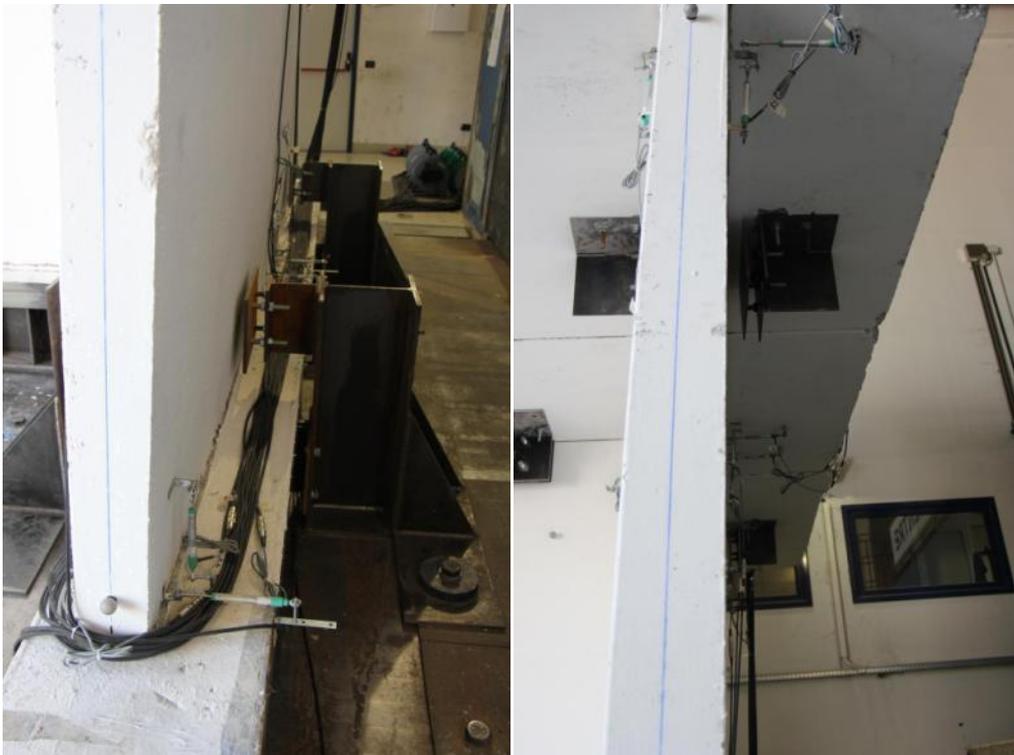
Figure 325. Damage at the base of lateral walls and rocking with loss of verticality – Detail of wall 1L2.

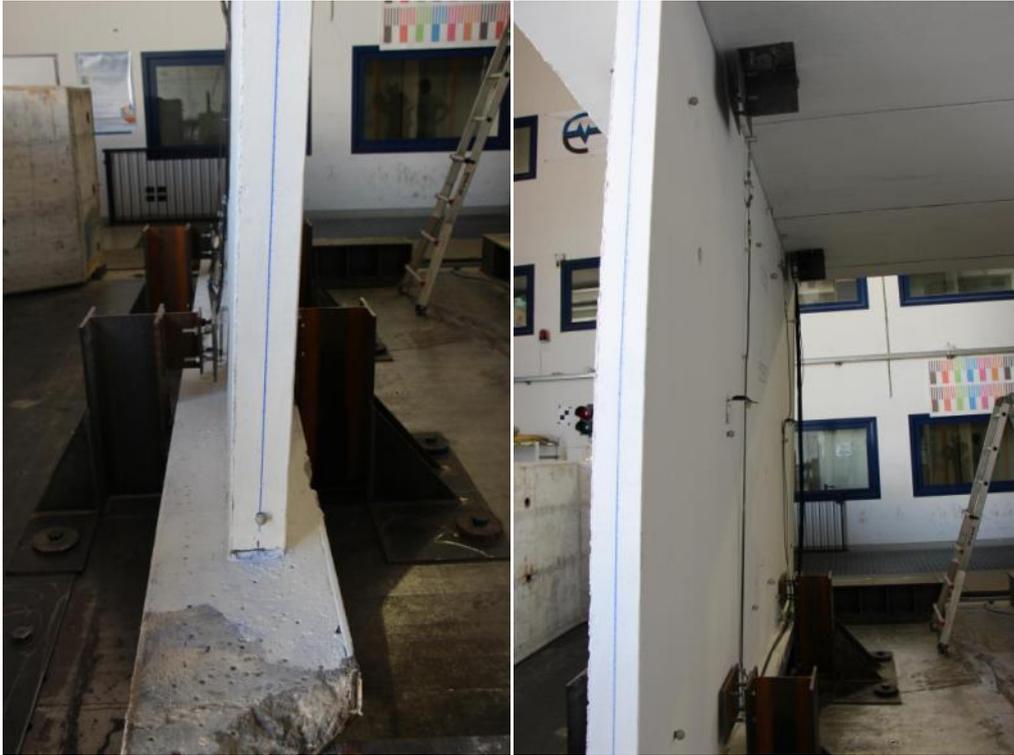
Figure 326. Damage at the base of lateral walls and rocking with loss of verticality – Detail of wall 1L4.

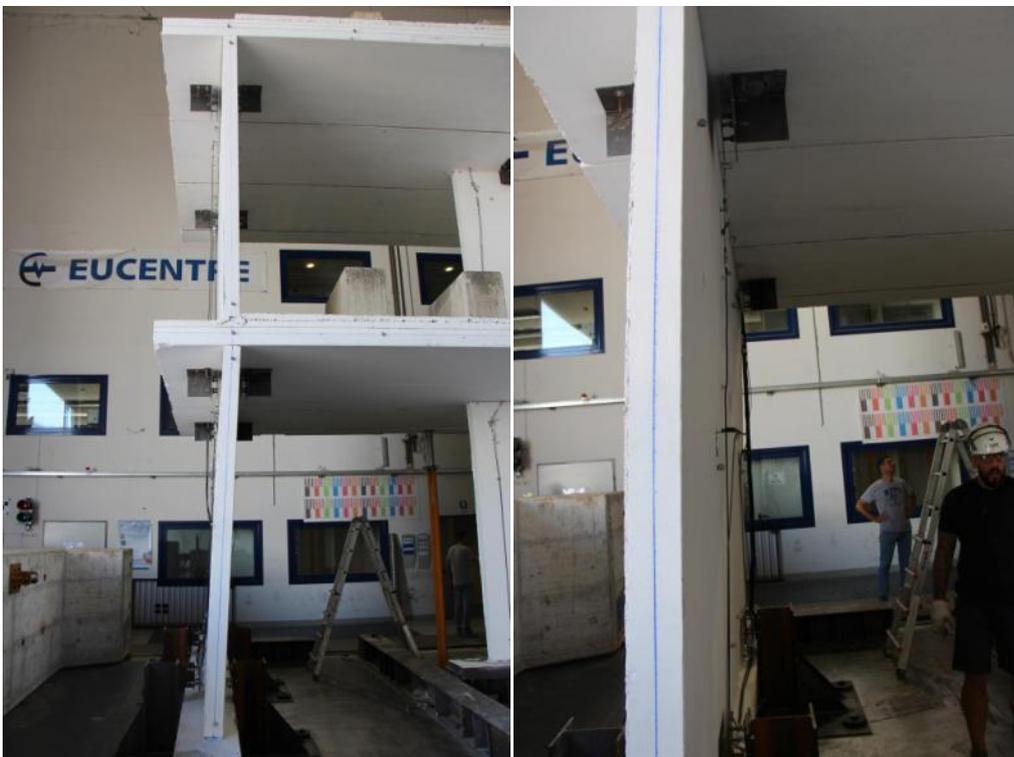
Figure 327. Overall and detailed views of the North-sided transversal walls at the end of testing.

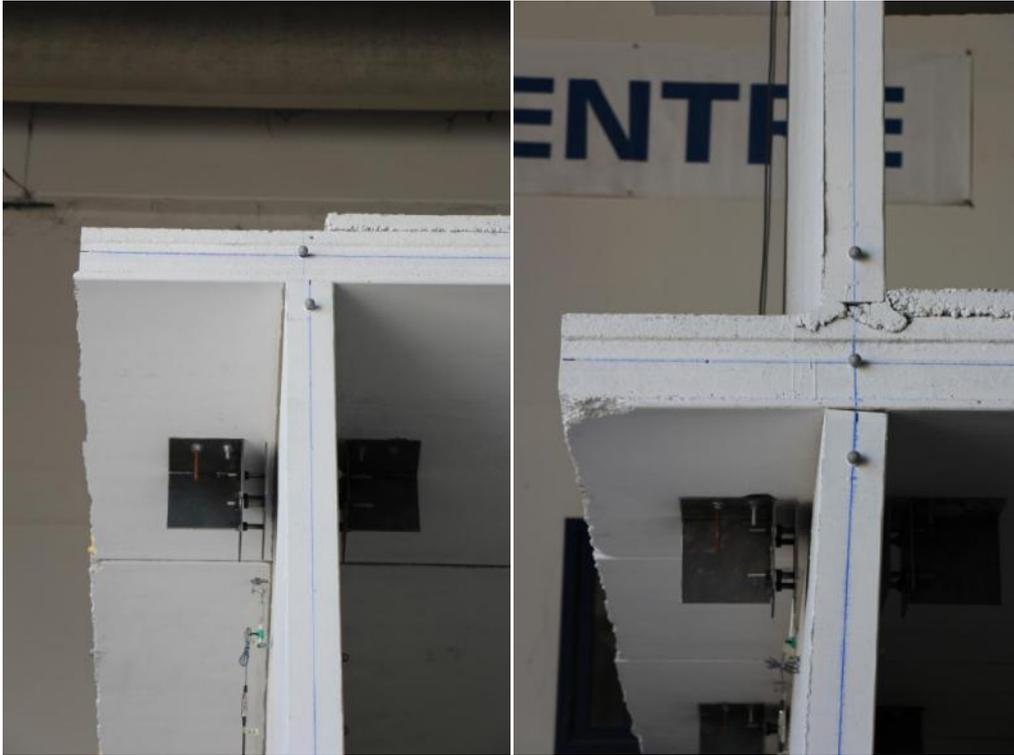
Figure 328. Detailed views of the first-storey and second-storey slabs and North-sided lateral walls.

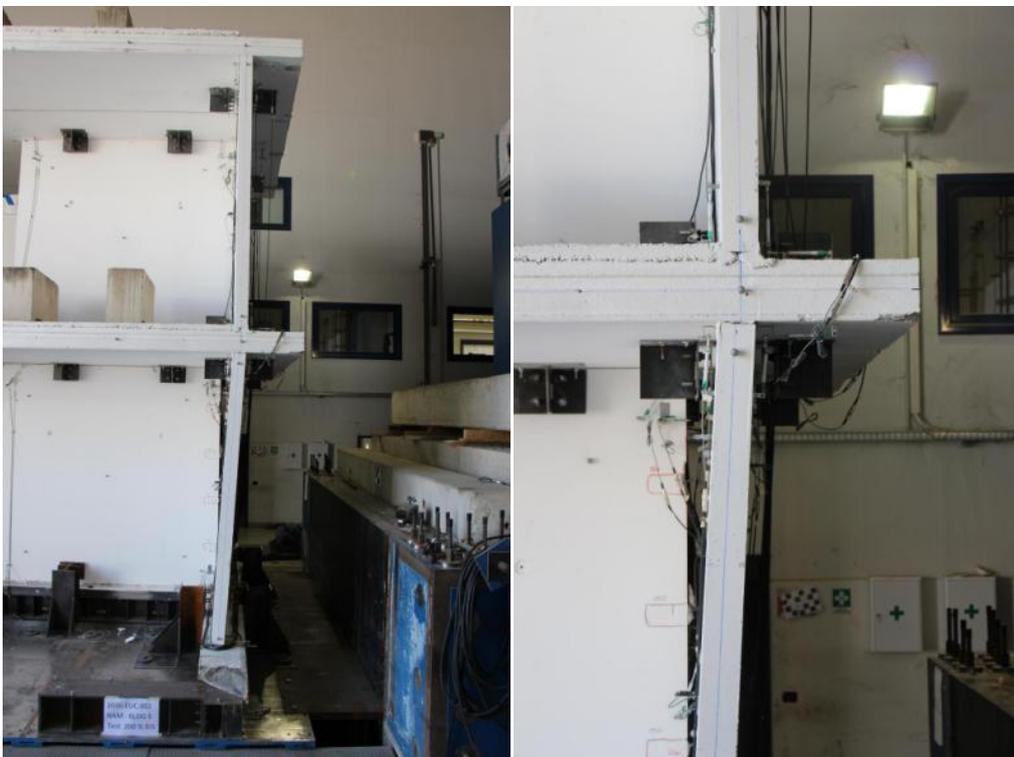
Figure 329. Overall and detailed views of the South-sided transversal walls at the end of testing.

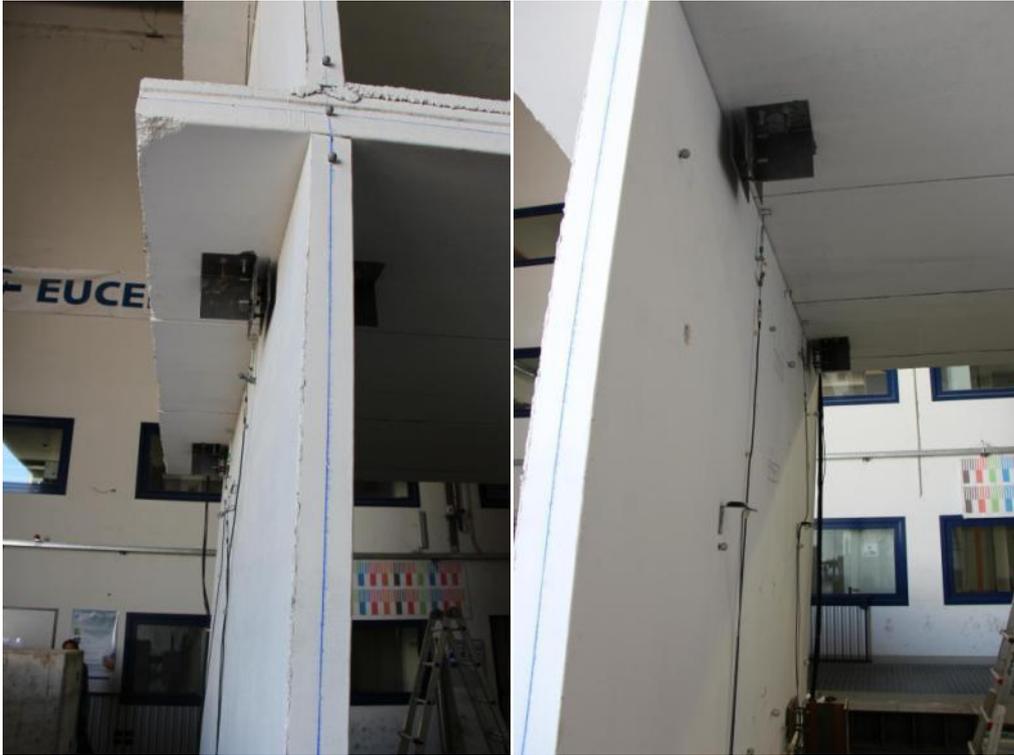
Figure 330. North-sided ground-floor lateral walls at the end of testing – North and South wall faces.

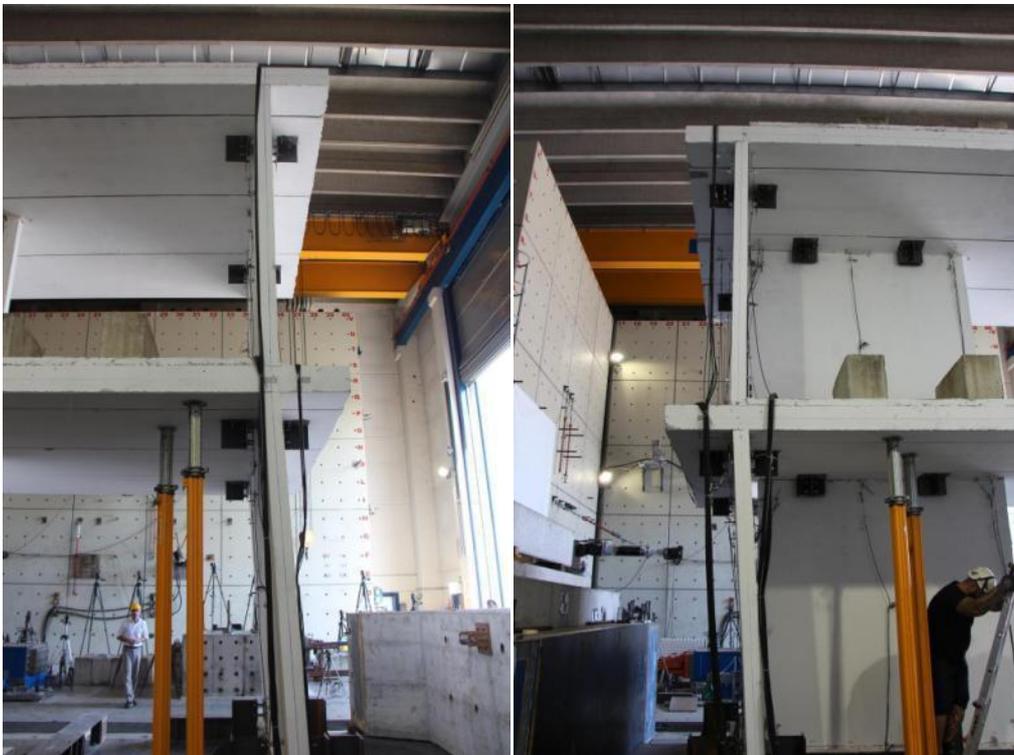
Figure 331. Propping-up at the end of the last test run – North and South sides.

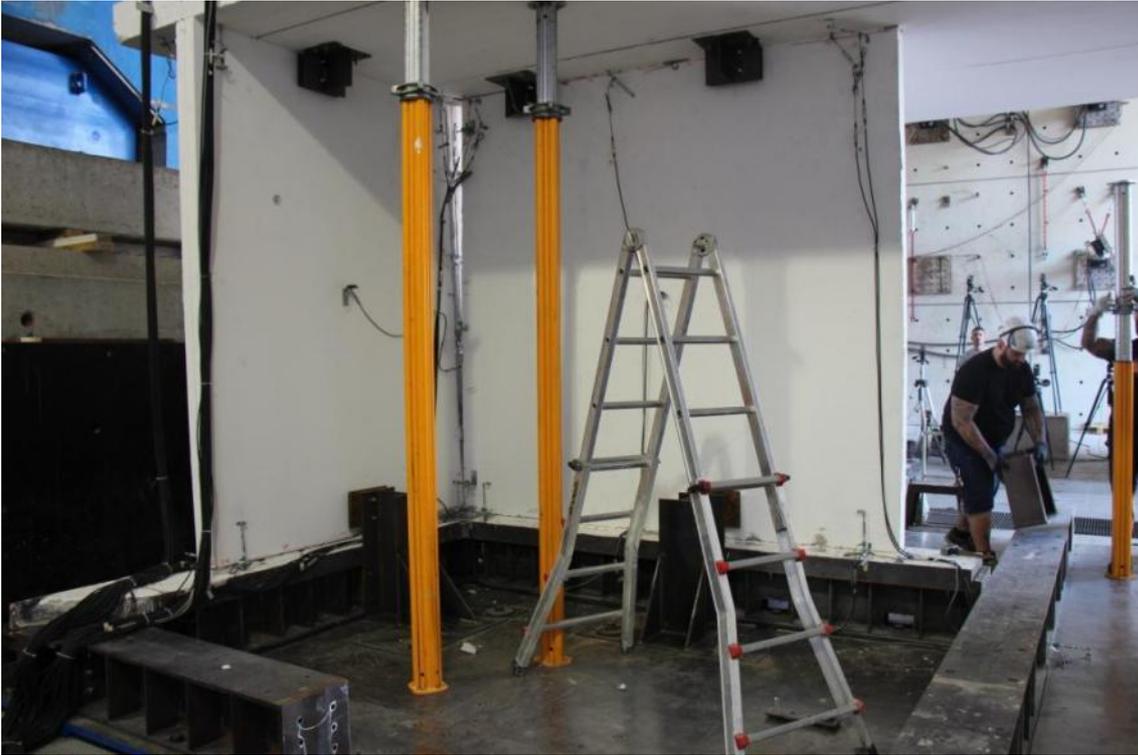
Figure 334. Installation of props in face of the very precarious stability of the structure after the test.

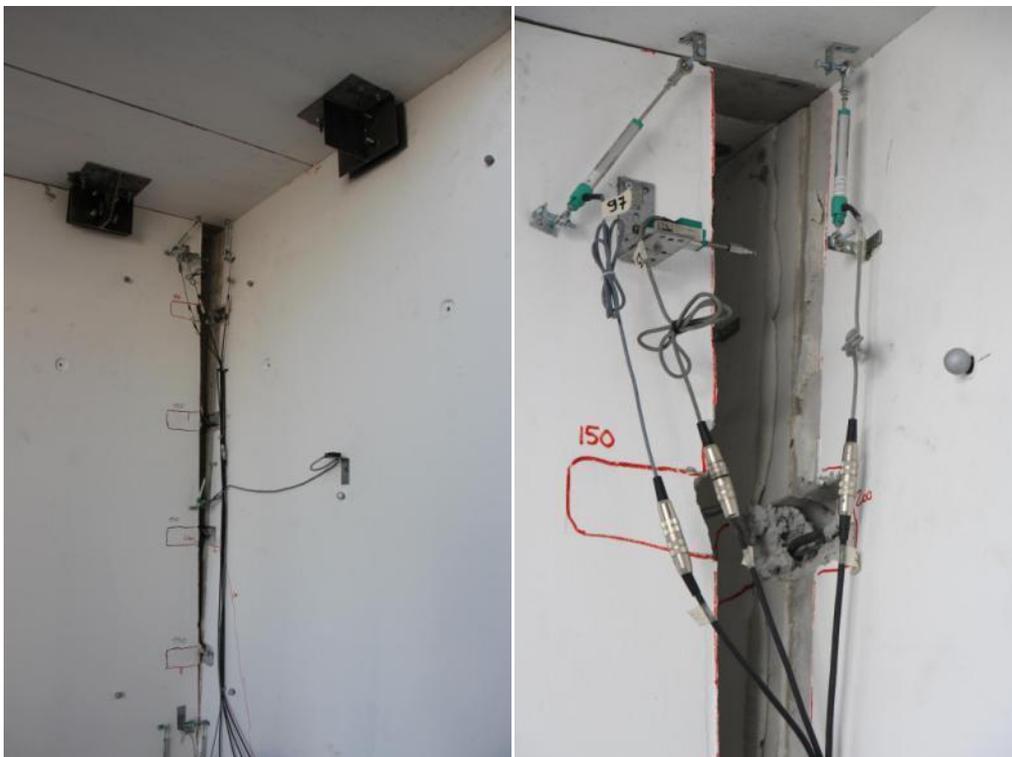
As can be observed e.g. in Figure 337 to Figure 339, the three-way panel joints failed abruptly because of a severe and sudden permanent bending of the steel connectors embedded in the niches of both stability and transversal walls. The gap that had already developed during Test run #08 was shown to widen conspicuously, which implies that the lateral walls lost uprightness rapidly and that displacement residuals accumulated accordingly.

It is finally recalled that Figure 337 to Figure 339 shed light into the behaviour of permanently-bent steel connectors and completely-crushed connectors sockets. Although detailed views of all the four three-way panel connections are herein presented, interested readers may and should also consider the set of photos taken during the dismantling of EUC-BUILD5 specimen (see Chapter 7).

Figure 337. Permanently-bent steel connectors in the top three-way panel joint.

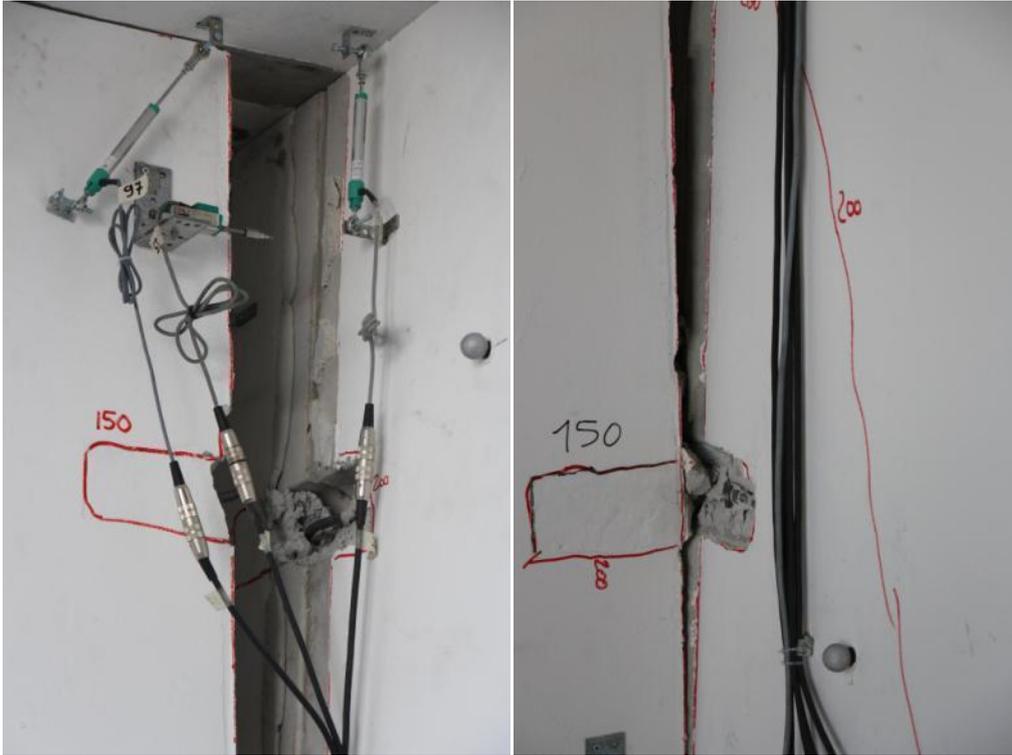
Figure 338. Damage/failure of the top and bottom three-way connections at the end of the last test run.
